CORROSION EVALUATION OF NOVEL COATINGS FOR STEEL COMPONENTS OF  
HIGHWAY BRIDGES

FINAL REPORT  
Project BDV29 977-02  
(800002608)

March 2015

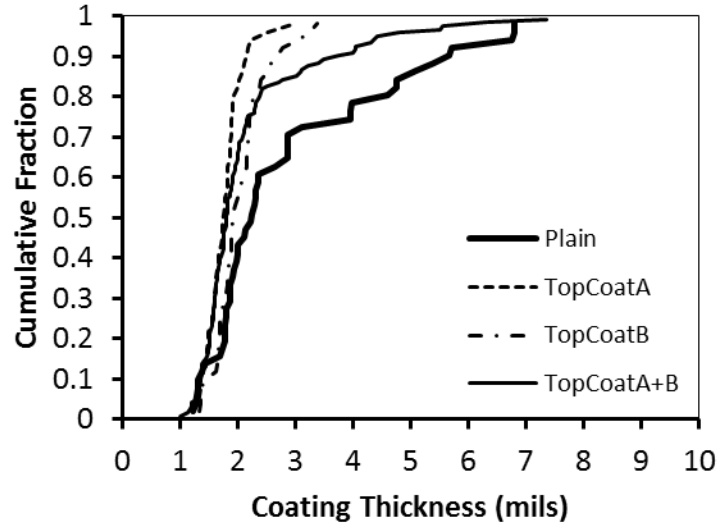
**Figure: 2.6. TDG Sample Coating Thickness.**

The cumulative fraction of coating thickness is shown in Figure 2.6. Coating thickness data were from measurements on both sides of the coupon samples. The coating thickness reported is the total coating thickness including the topcoat application. The thickness of TDG samples observed by optical microscopy was on the order of the median value measured with the magnetic coating thickness gauge. The thickness of the topcoat (on samples with both topcoats, Topcoat A+B) was on the order of 100  $\mu\text{m}$  (~4 mils). Most of the coating thicknesses ranged from about 1.5 mils to about 2.5 mils. About 40% of the plain TDG coupon samples were greater than 2.5 mils (maximum

value was about 7 mils), indicating that the manufacturer's coating process was not properly controlled.

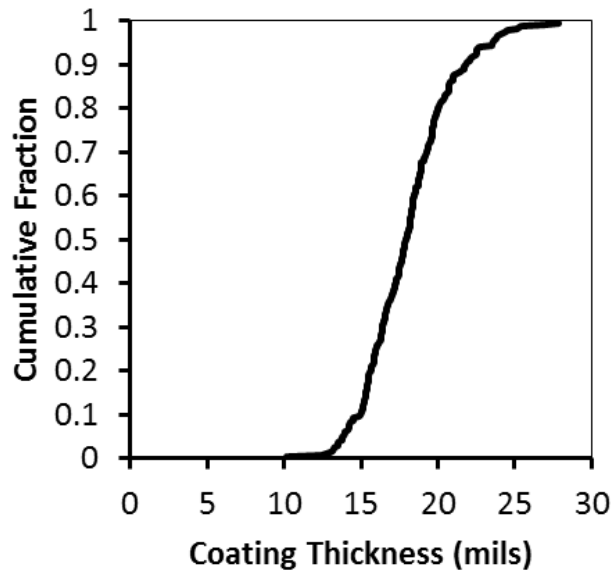
Figure: 2.9 Three-Coat Paint Sample Coating Thickness.

The 3-coat paint system used by the manufacturer consisted of coupons with a solvent based inorganic zinc coat, followed by a Cycloaliphatic Amine Epoxy coat and an Aliphatic Acrylic-Polyester Polyurethane. Typical cross-section appearance is shown in Figure 2.8. The cumulative fraction of coating thickness is shown in Figure 2.9. Coating thickness data was obtained from both sides of the coupon samples. The coating thickness reported is the total coating thickness, comprised of the inorganic zinc (IOZ) layer, epoxy layer, and topcoat.

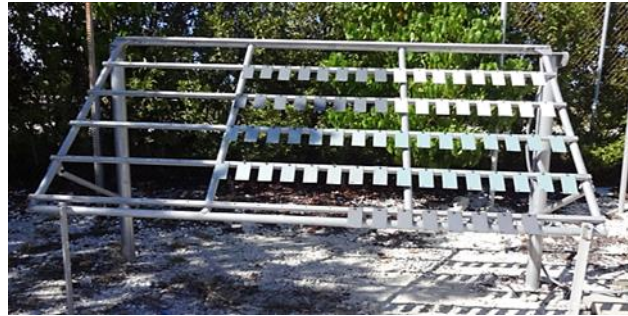
**Figure: 2.15 Outdoor Exposure of Coupons at Beach Test Site.**

The Beach Test Site at Tea Table Key in Islamorada, FL is maintained by FDOT and is situated immediately adjacent to the ocean with a strong presence of warm humid salt air. The test setup is shown in Figure 2.15. The ground cover is typically limestone rock. Video monitoring and weather data is available with the support of existing FDOT weather stations at the site and reports are available online:

Initial outdoor exposure was started on November 1, 2013. Forty-eight coated samples, 16 each of CBPC, three-coat paint, and metallizing were installed; 8 in the as-received condition and 8 with a scratch defect. Twenty-four TDG samples were installed; 16 samples with Topcoat A+B (8 in the as-received condition and 8 with a scratch defect), and 8 plain samples with no topcoat and with a scratch defect.

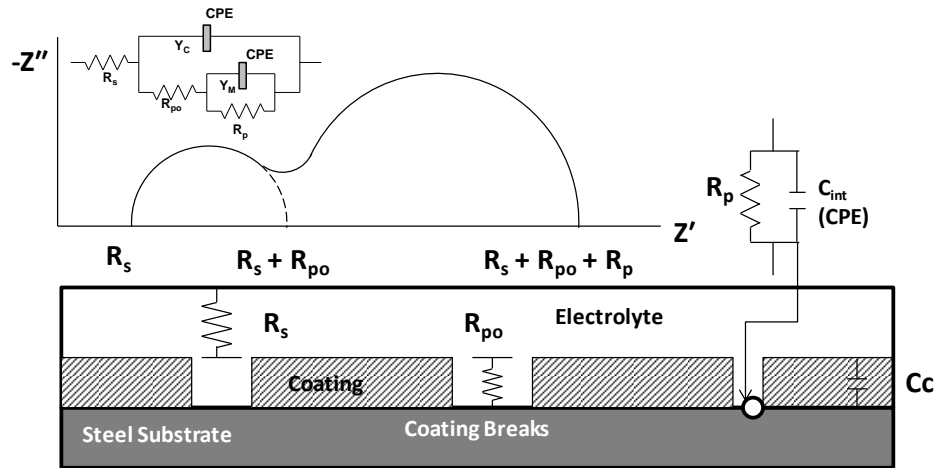
**Figure 2.19 Idealized Impedance Diagram of Coated Metal System with Coating Breaks and Equivalent Circuit Analog.**

EIS testing was done at the OCP condition with 10mV AC perturbation voltage [Murray, 1997; El-Mahdy et al., 2000; Mahdavian et al., 2006] with frequencies between 1 mHz and 100 kHz. The impedance behavior was considered to be characteristic of a coated metal with coating breaks, as shown in the Figure 2.19, and with total impedance expressed as shown in Equation 3.

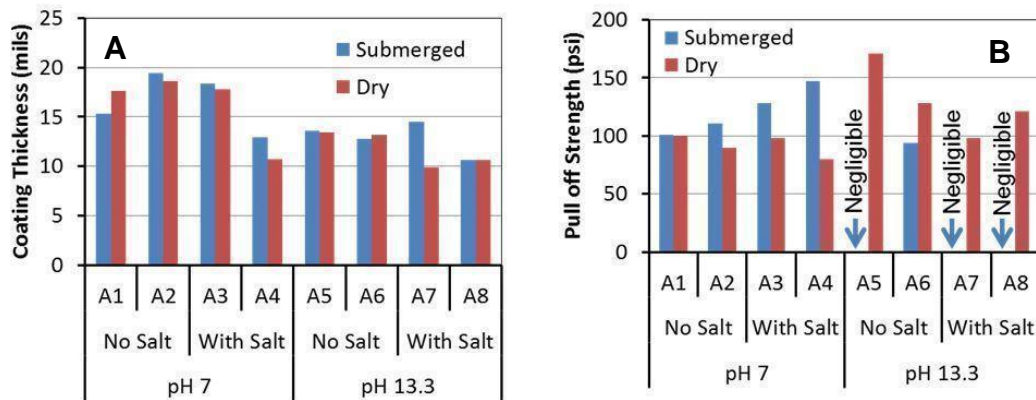
**Figure: 3.1 CBPC Coating Thickness and Pull-off Strength.**

A) Coating thickness. B) Coating pull-off strength.

As described earlier, the as-received pull-off strengths of the CBPC-coated samples were less than 200 psi, with all tests resulting in partial separation of the ceramic material from the steel substrate. Testing of samples after immersion in neutral pH resulted in similar strengths (Figure 3.1). Optical microscopy of sample cross-sections indicated some coating degradation in regions where the coatings were submerged (Figure 3.2). Significant coating degradation was observed for samples immersed in chloride and chloride-free SPS (Figure 3.3).

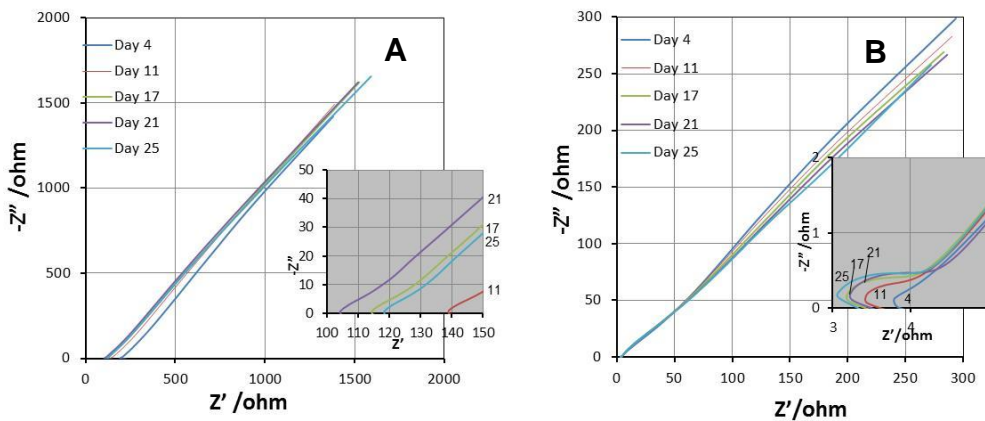
**Figure: 3.5 Nyquist Plot of CBPC Samples in Neutral pH.**

A) Without chloride. B) With chloride.

Results of electrochemical impedance spectroscopy are shown in Figure 3.5. The results did not reveal significant differentiation in the solution or coating characteristics even though significant coating degradation occurred. It was likely that the impedance behavior was dominated by the steel-solution interface at the scratch defects. The measurements were sensitive to identify salt presence in the solution. Both the solution resistance and pore resistance resolved from impedance spectroscopy for samples immersed in solution with no salt additions were greater than those in chloride solutions (Figure 3.6). The coating pore resistance increased for the scribed coated samples placed in the neutral pH chloride solution, which indicated accumulation of corrosion product in the vicinity of the scratch defect.

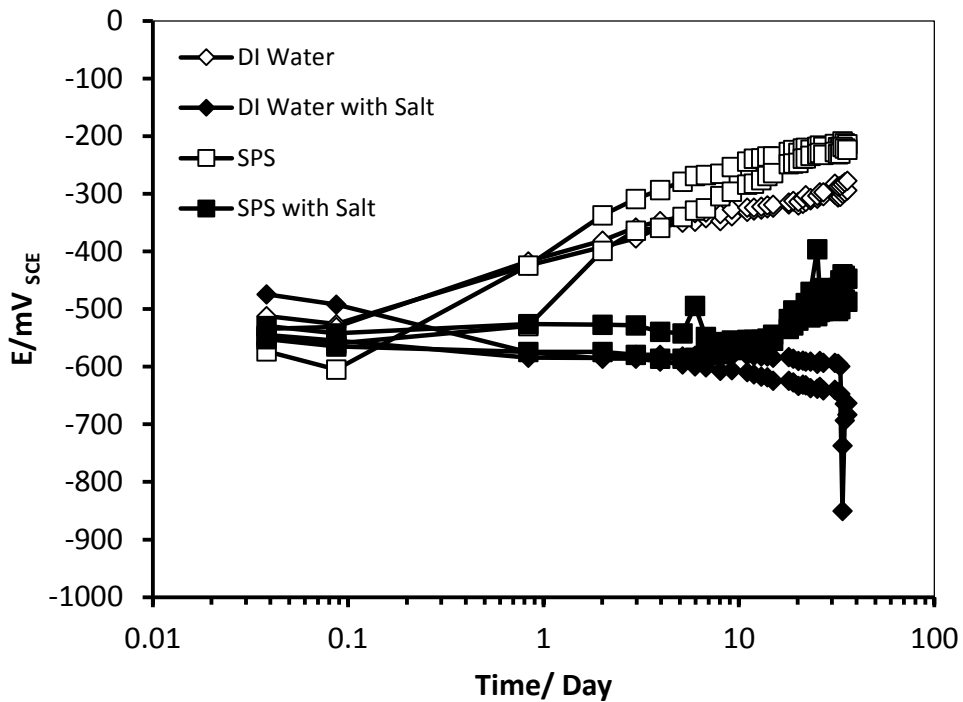
**Figure: 3.7 Open Circuit Potential of CBPC Coated Steel.**

As seen in Figures 3.7-3.8 and in comparison with Figure 3.4, the electrochemical behavior of the coated systems with and without defects exposing steel was identical in all tested solutions (including neutral and pH13 solution, with and without chloride ion). This was not necessarily expected, as the coating without defects exposing steel was thought to maintain characteristics of a barrier coating. Upon moisture penetration through the coating pores, the metal substrate developed electrical potentials generally indicative of passive corrosion conditions in the salt-free solutions and active corrosion in the chloride solutions. The corrosion currents determined by linear polarization resistance measurements furthermore supported the level of corrosion activity of the steel beneath the ceramic coating.

formed during drying). In the earlier testing of samples with introduced scratch defects, corrosion occurred at the exposed steel. As such, it was expected that the coating in the as-received condition would mitigate corrosion formation, but as shown in Figures 3.7 and 3.8, high corrosion activity was measured for the duplicate samples in the neutral pH chloride solution. However, upon examination after exposure in solution (Figure 3.10), significant corrosion developed under the region of the coating that was immersed in solution. The rust accumulation there was not attributed to pre-existing surface rust because the degree of corrosion was much less in the regions of the samples not immersed in solution. This finding indicates that localized undercoating corrosion occurred.

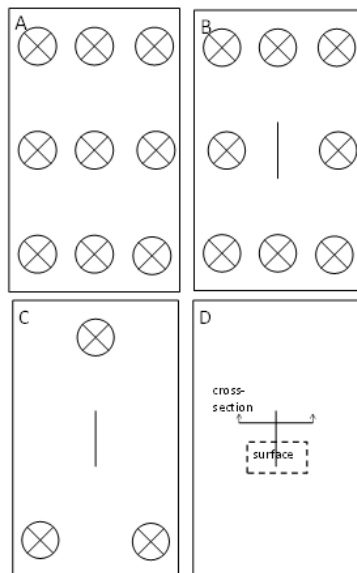
**Figure: 4.3 Sample Testing Surface Locations.**

- A) Approximate coating thickness locations for as-rec'd coupon.
- B) Approximate coating thickness locations for scribed coupon.
- C) Approximate coating pull-off locations.
- D) Approximate locations for metallographic sampling.

Chapter 4.2 discusses photographic comparisons of the coatings before and after exposure to outdoor or salt-fog environments. Chapters 4.3 and 4.4 compares coating thicknesses and coating pull-off strengths after outdoor and salt-fog exposures. Typical measurement locations are shown schematically in Figure 4.3.

The coating thicknesses and pull-off strength were meant to evaluate changes due to exposure conditions and not necessarily the effect of the scribe defect. Local coating degradation due to the presence of the scribe was to be evaluated by optical and microscopy. Typical sampling locations are shown in Figure 4.3.

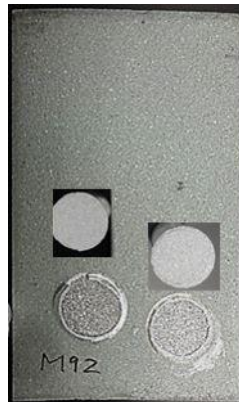
**Figure: 4.33 Metallized Coating Pull-Off in As-Received Condition.**

Photographs of the coated steel coupons after adhesion pull-off strength testing are shown in Figures 4.33 and 4.34. In the as-received condition, Figure 4.33), the metallized coating could be fully extracted from the metal surface. The underlying metal typically had clean surface conditions with no surface rust. As shown in Figure 4.35, the adhesive strength of the as-received metallized coating was typically less than 1,000 psi.

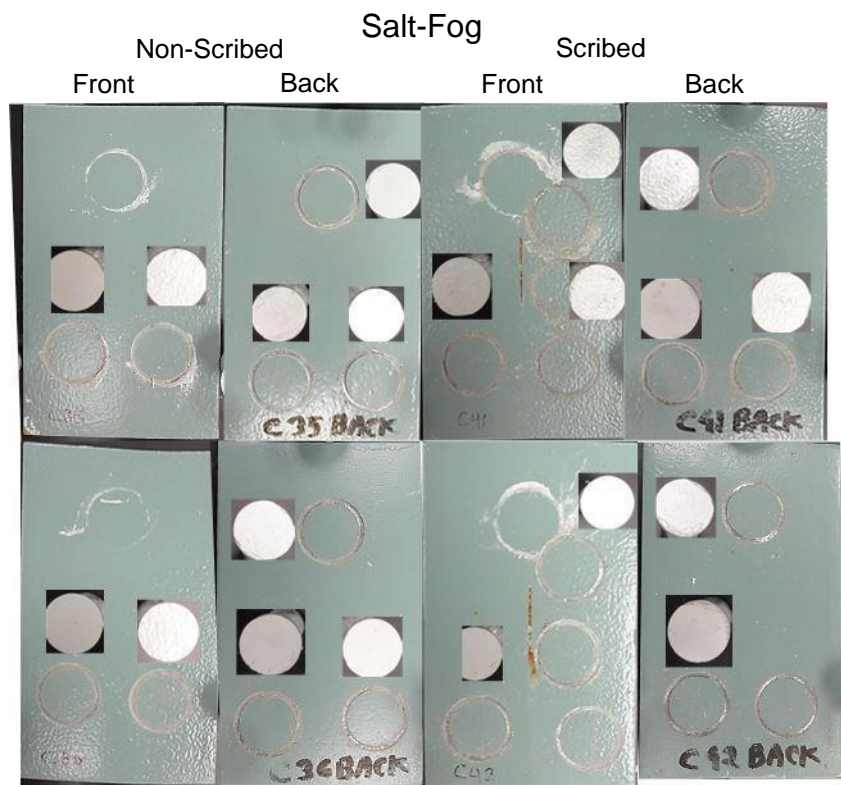
Figure: 4.37 Three-Coat Coating Pull-Off after Outdoor/Salt-Fog Exposure.

The surface appearance of coupons exposed to outdoor and salt-fog conditions after pull-off strength testing is shown in Figure 4.37. Pull-off adhesion testing was done for the top surface of the coupon as well as the surface on the backside of the test samples.

Photographs of the coated steel coupons after adhesion pull-off strength testing is shown in Figures 4.36 and 4.37. In the as-received condition, Figure 4.36, the pull-off testing resulted in failure of the epoxy used to mount the pull-off dolly to the coupon surface. Testing in as-received condition was inconclusive and is pending additional testing.

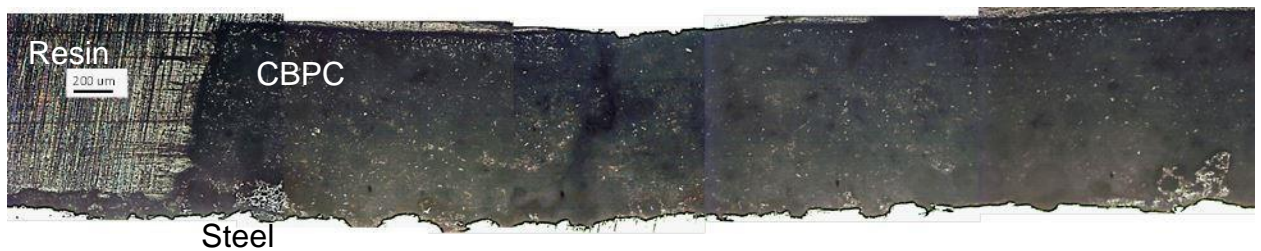
**Figure: 4.40 CBPC Coating Micrograph after 4-Month Outdoor Beach Exposure.**

Generally speaking from testing observations in outdoor and salt-fog exposure, the CBPC coating in the condition provided for testing showed some susceptibility to degradation of the ceramic barrier coating. As seen in Figures 4.40-4.42, defects in the ceramic coating were observed. These defects and general material porosity may lead to enhanced moisture presence within the coating and at the metal interface. The integrity of the ceramic coating was shown to be compromised and lost cohesive strength when exposed in high moisture conditions. In outdoor exposure, although little coating degradation was outwardly observed, pull-off testing showed either coating strength loss (which can be indicative of coating deterioration) or undercoating corrosion development as seen in Figure 4.42. In aggressive salt-fog exposure, coating material degradation, subsequent surface roughening, moisture penetration, and undercoating steel corrosion were apparent. Scribing resulted in no differentiation (beneficial or aggravating) in coating durability due to the presence of exposed steel in atmospheric exposure testing.

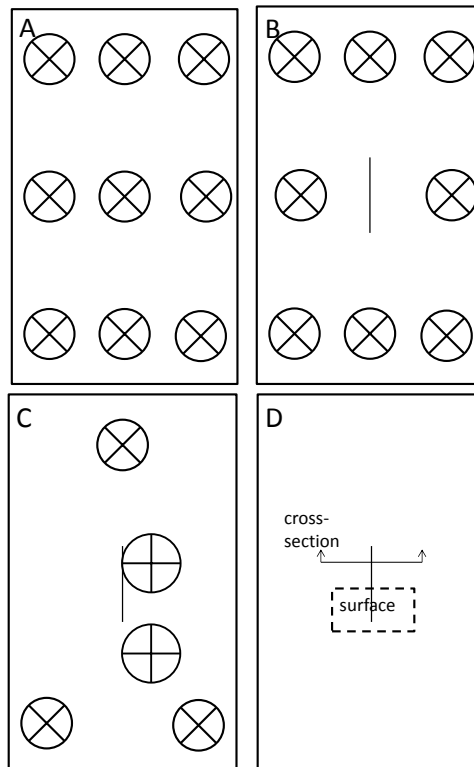
**Figure: 5.3 Sample Testing Surface Locations.** A) Approximate coating thickness locations for as-rec'd coupon. B). Approximate coating thickness locations for scribed coupon. C) Approximate coating pull-off locations. D) Approximate locations for metallographic sampling.

The coating thicknesses and pull-off strengths were meant to evaluate changes due to exposure conditions and not necessarily the effect of the scribe defect. However, two additional pull-off adhesion tests adjacent to the scribe defect were made for the samples tested after 8 months outdoor exposure and 5800 hour salt-fog exposure. Typical sampling locations are shown in Figure 5.3.

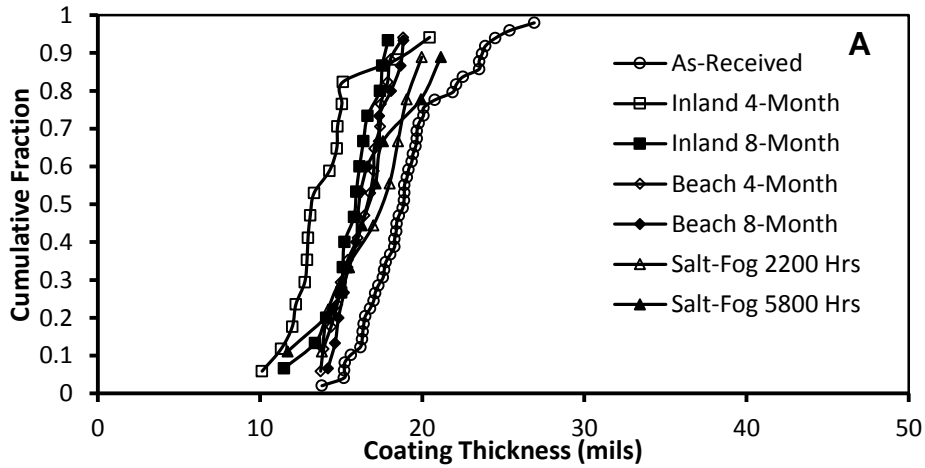
Figure: 5.21 Three-Coat Coating Thickness Decrease (cont.).

A) Actual coating thickness.

B) Change of coating thickness. C) Percent change of coating thickness.

The average coating thickness before and after exposure to outdoor or salt-fog weathering is shown in Figure 5.21a. Direct comparisons of the average coating thicknesses of samples before and after exposure are shown in Figures 5.21b and 5.21c. Figure 5.21b shows the calculated differences in average coating thicknesses and Figure 5.21c shows the percentage differences in the average coating thicknesses relative to the average as-received thicknesses. There is a caveat in the interpretation of the data because the reported thicknesses were the calculated averages of multiple spot measurements throughout the coupon surfaces and there were local thickness variations. Positive values in Figures 5.21b and 5.21c indicate decreases in coating thicknesses after exposure.

Generally, it was observed that coating thicknesses decreased after environmental exposures. It was apparent that the salt-fog environment was particularly harsh (Figure 5.21c). For samples exposed at the inland outdoor exposure site, coating thickness decrease was significant during the initial 4 months, but there was indication of some form of coating thickness increase during the subsequent four months. In the other

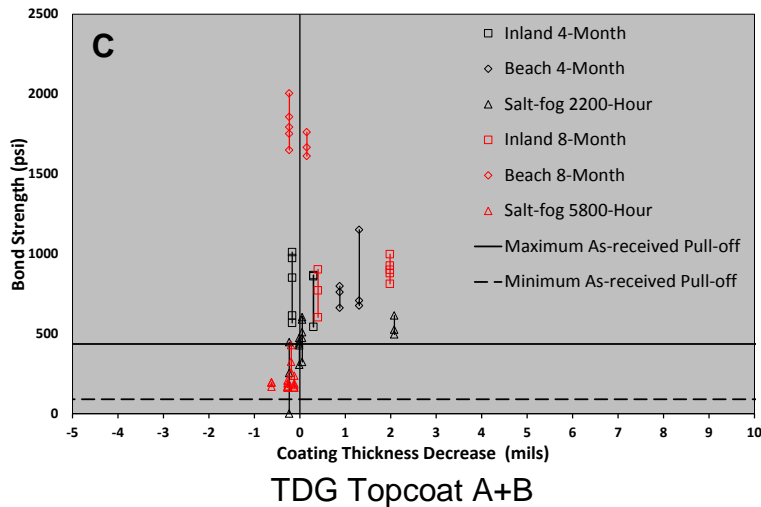
**Figure: 6.8 TDG and Metallized Steel Coating Degradation (cont.).**  
 A) Metallizing. B) Plain TDG.

**Continuation of Figure: 6.8 TDG and Metallized Steel Coating Degradation**  
**C) TDG with topcoat A+B.**

Metallized steel was tested in the research for benchmark comparison with TDG. Generally, coating degradation and corrosion behavior were similar except for the severe surface iron oxidation that was observed on Plain TDG in salt-fog exposure and at some local defect sites on topcoated TDG. Figure 6.8 shows graphs correlating the coating degradation parameters of pull-off strength  $\sigma_{po}$  and coating thickness loss  $t_d$  for metallized steel and TDG. It can be seen that general coating degradation trends for metallized steel and Plain TDG were similar. For both materials, zinc consumption resulting in net thickness loss can occur during early exposure in ambient outdoor exposures. Also in aggressive environments, surface oxides can form and (for testing purposes) can reduce pull-off strengths. As shown in Figure 6.9, similar behavior of metallized steel and TDG with Topcoat A and Topcoat B was observed in electrochemical testing. Potentials remained negative indicating zinc activity. High

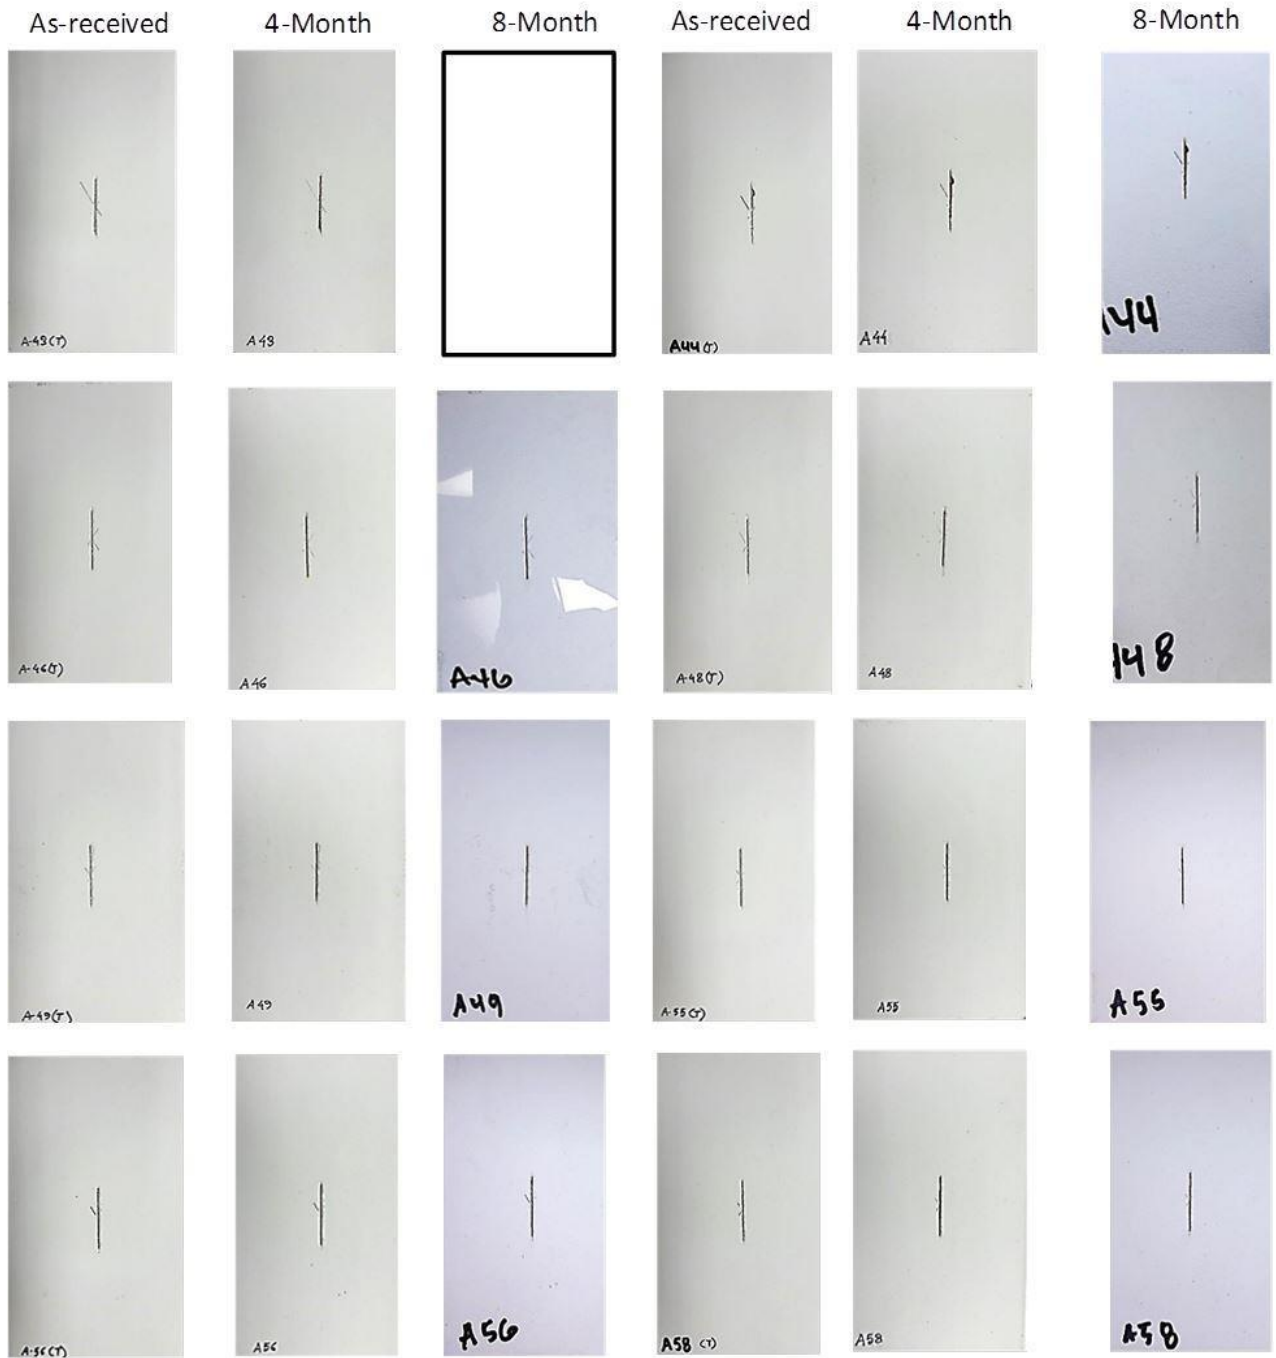
Figure: B.2 CPBC (Scribed) Samples Installed at Inland Test Site

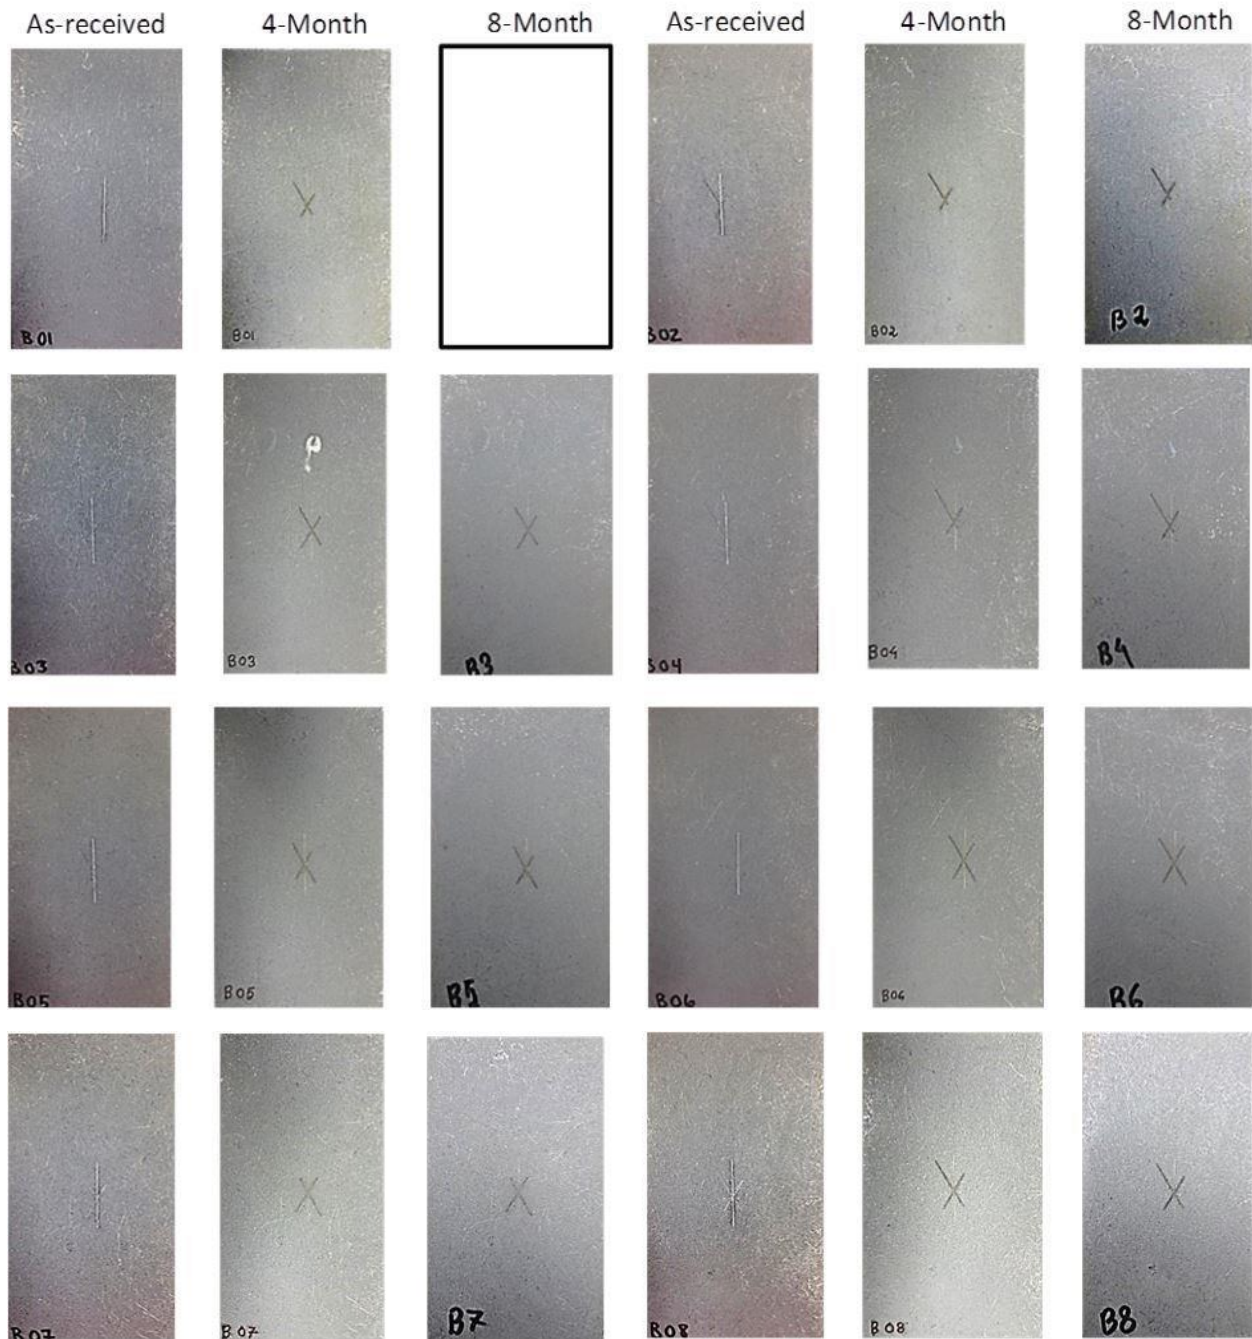
Figure: B.8 TDG (Topcoat A, Scribed) Samples Installed at Inland Test Site

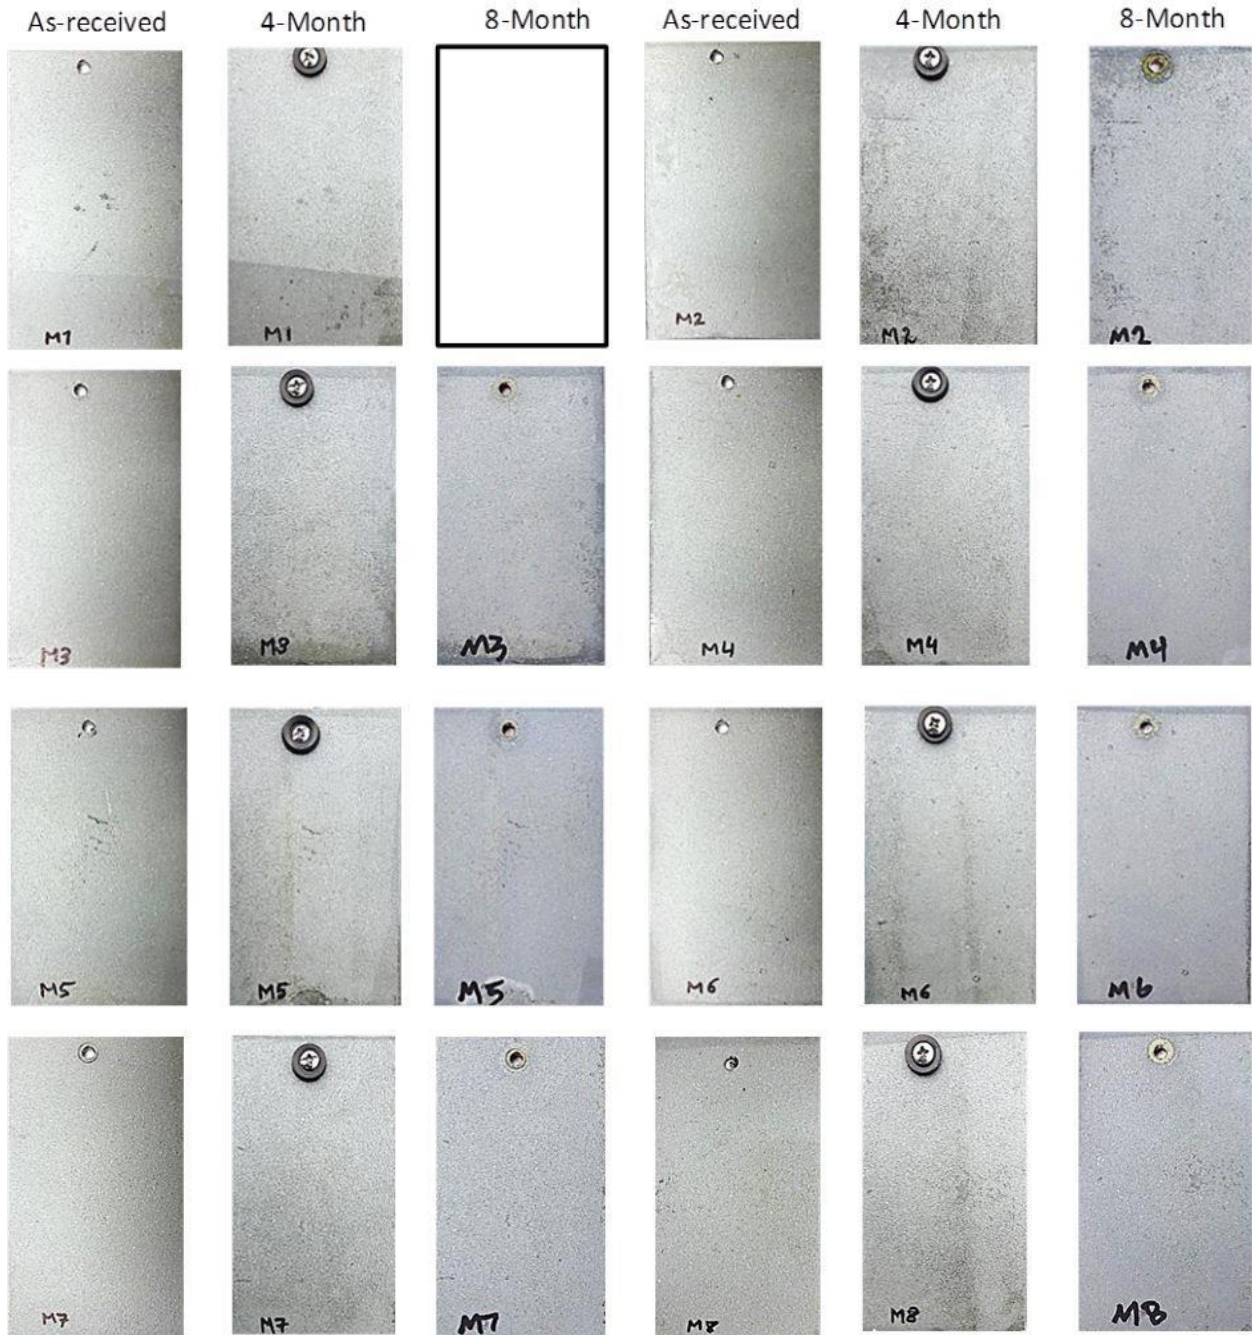
**Figure: B.20 Metalizing (Non-scribed) Samples Installed at Beach Test Site**

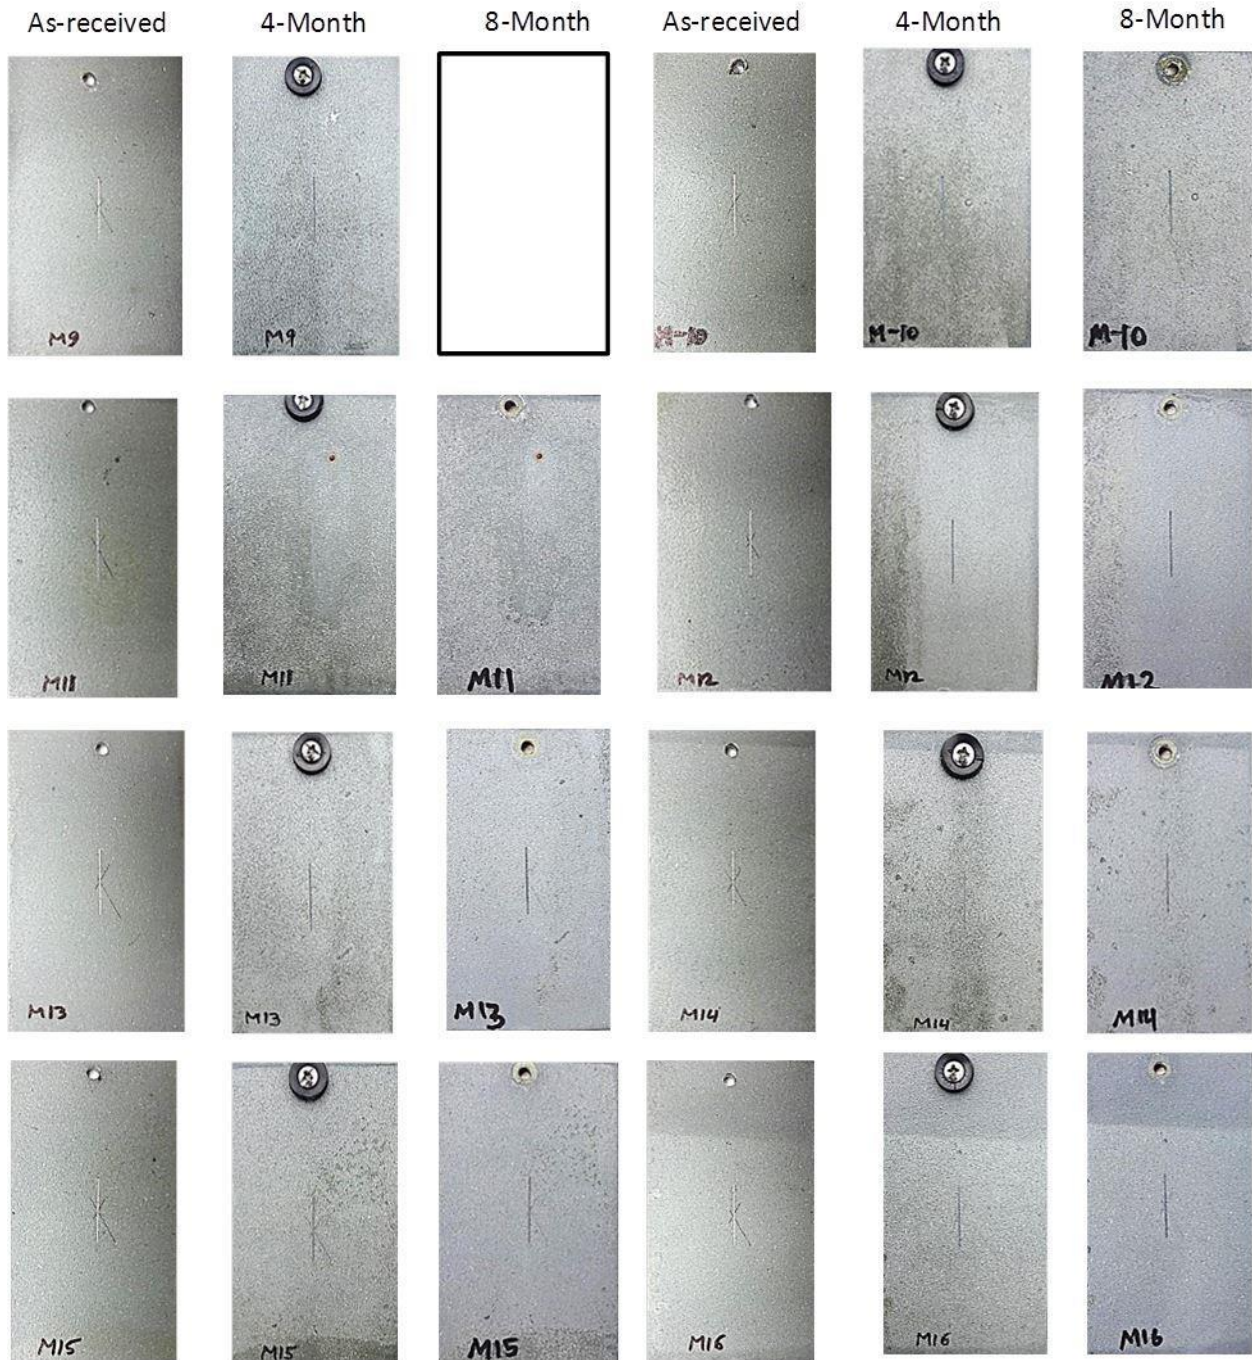
**Figure: B.21 Metalizing (Scribed) Samples Installed at Beach Test Site**

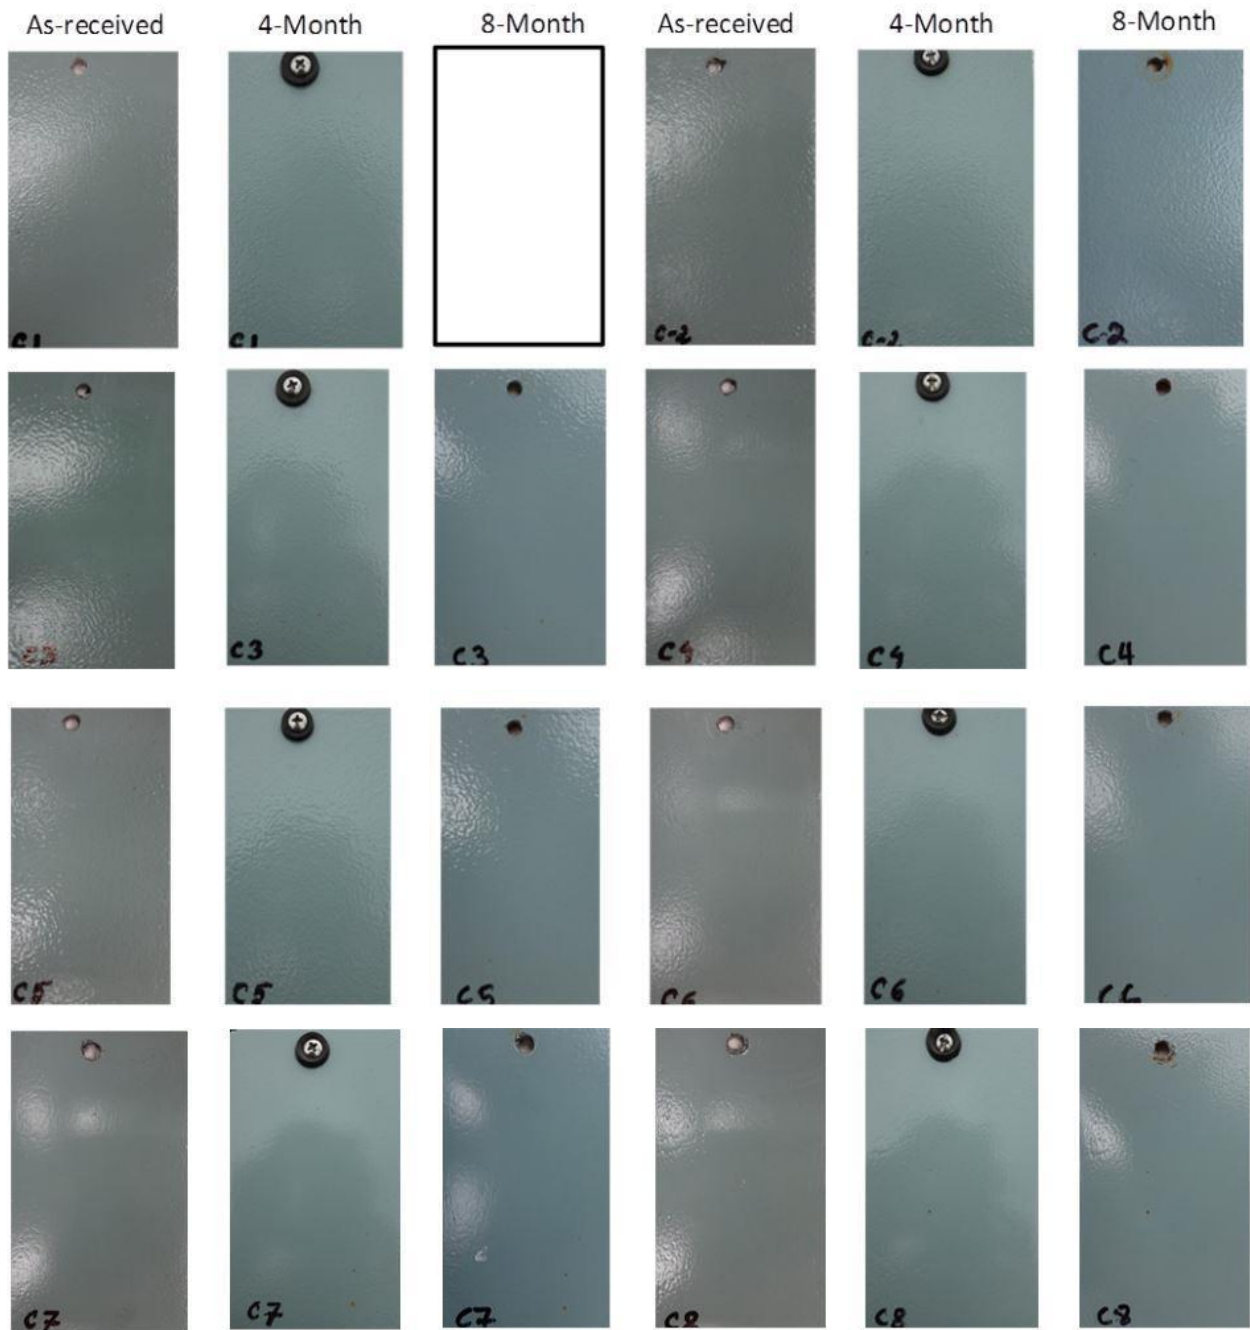
Figure: B.26 Three-Coat (Non-scribed) Samples Installed at Beach Test Site

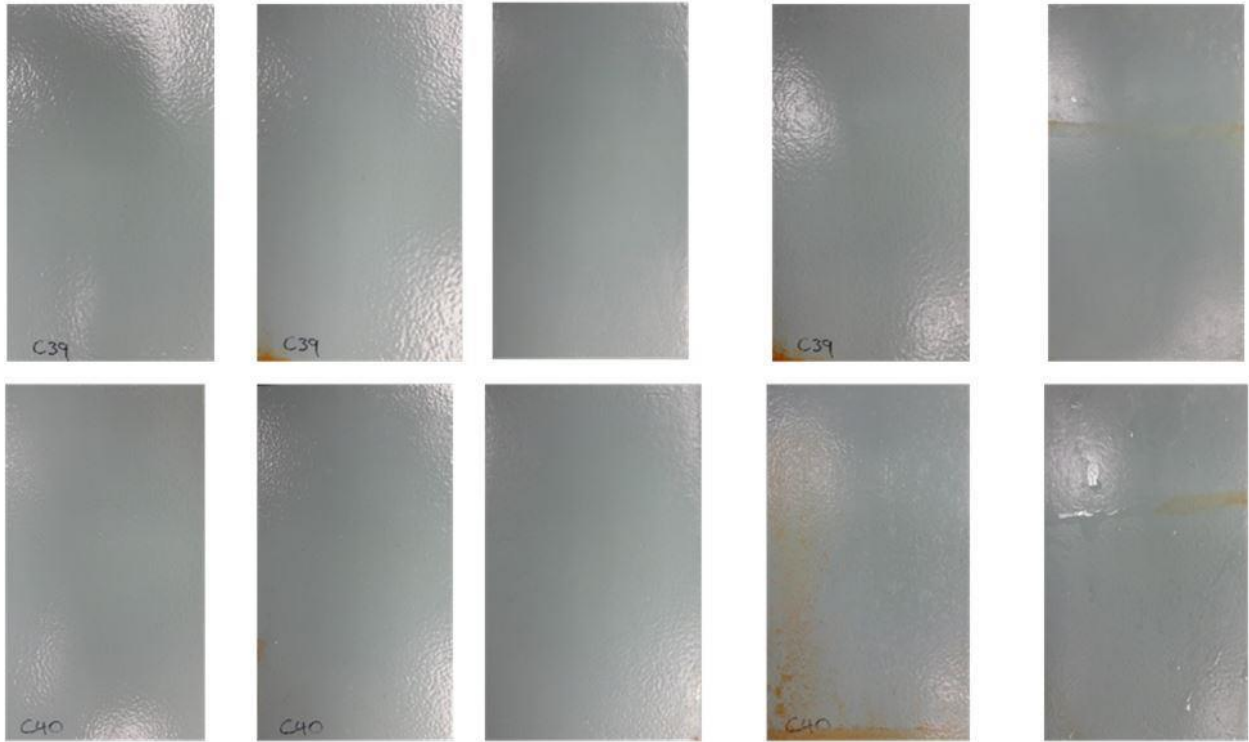
**Figure: B.28 Three-Coat (Non-scribed) Samples Installed in Salt-Fog Chamber (cont.)**

**Continuation of Figure: B.28 Three-Coat (Non-scribed) Samples Installed in Salt-Fog Chamber**
