Wearing Surface Testing and Screening: Yukon River Bridge

FINAL REPORT

Date: September 2015

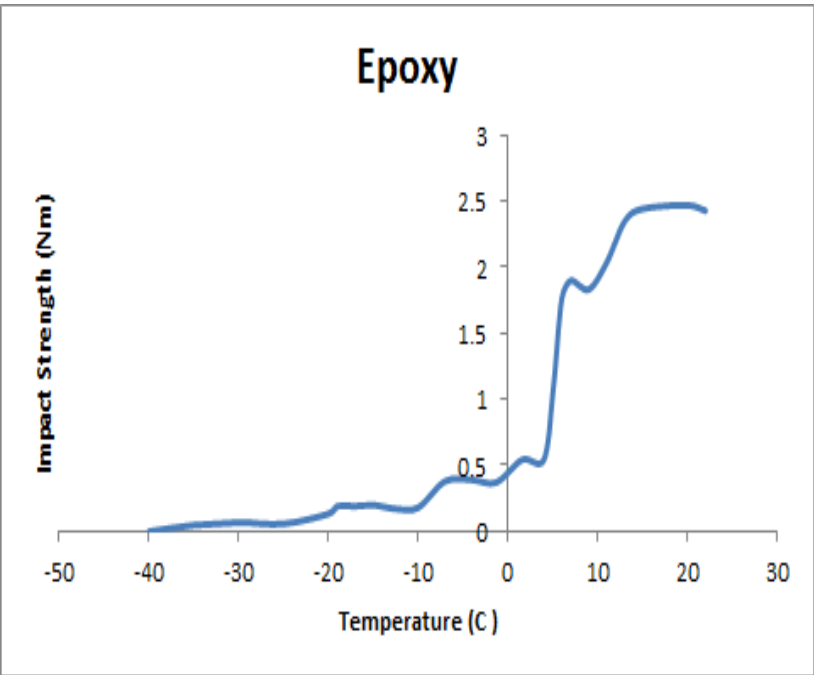
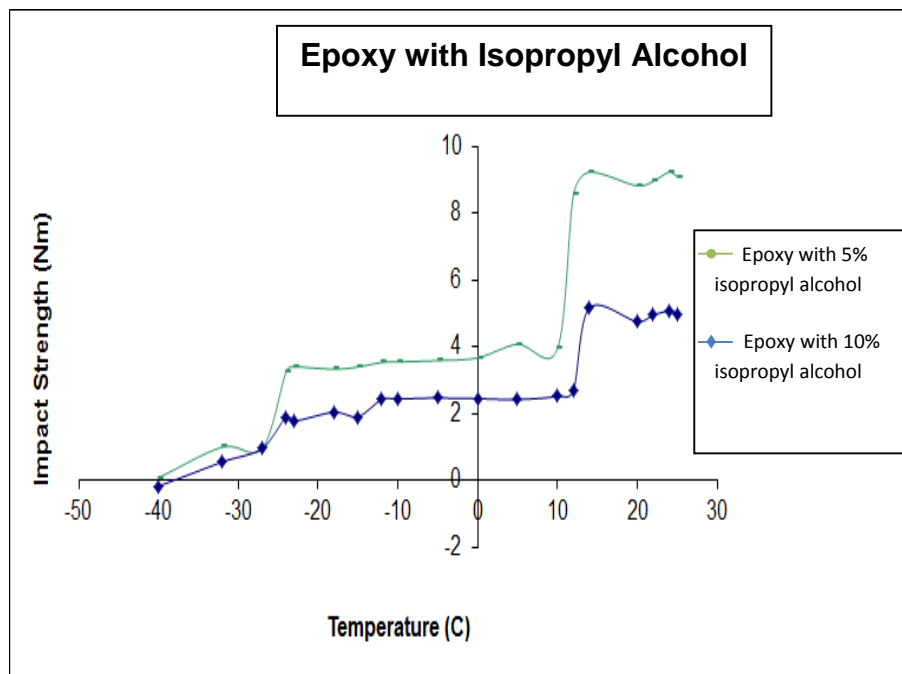
Figure 3: Epoxy samples – temperature rise vs. impact strength.

Figure 4: Epoxy with kerosene samples – temperature rise vs. impact strength.

Figure 5: Epoxy with isopropyl alcohol samples – temperature rise vs. impact strength.

Figure 6: Epoxy with isopropyl alcohol and sand samples – temperature rise vs. impact strength.

Figures 3, 4, 5, and 6 show the Charpy impact tests calculated and graphed by impact strength vs. temperature. The tests were conducted by reducing the temperature of the Charpy samples to -40°C . By attaching a thermistor to the test samples, we conducted the impact tests to view where the brittle-to-ductile transition temperature occurred. The brittle transition temperature is clearly shown in

Figures 3–6 as a large jump that occurs around -27°C , -20°C , or 10°C . The test of 5% isopropyl alcohol has the lowest temperature occurrence as well as the highest impact strength.

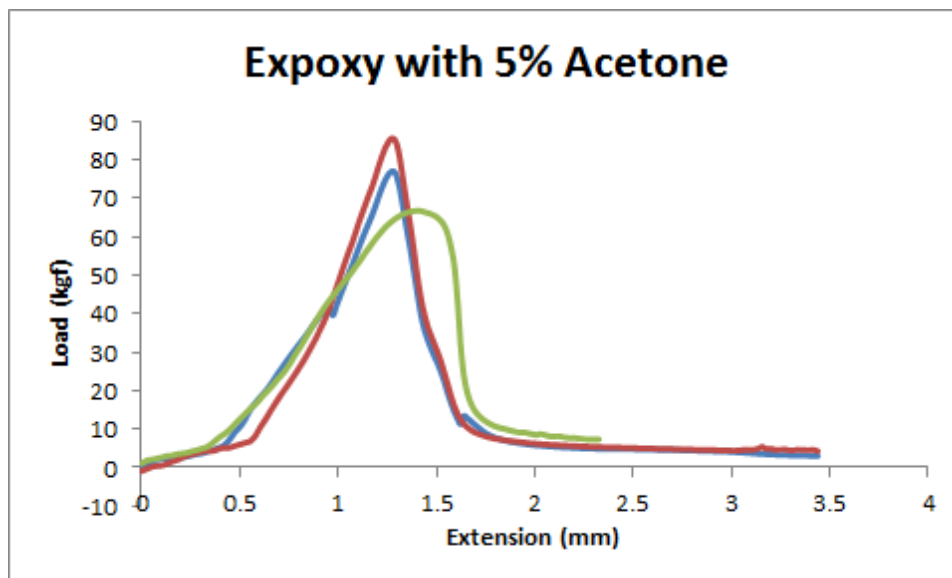
Figure 7: Epoxy samples – extension vs. load.

Figure 8: Epoxy with isopropyl alcohol samples – extension vs. load.

Figure 9: Epoxy with acetone samples – extension vs. load.

Shown in this section are the Instron tensile tests. We performed a bond test, in which different solutions of epoxy were applied to two halves of an ASTM dog bone metal sample, and tested how much force was required to break the material. In Figure 7, regular epoxy is shown, and in Figures 8 and 9, two solvents are shown. The 60% reduction in strength is clearly indicated.

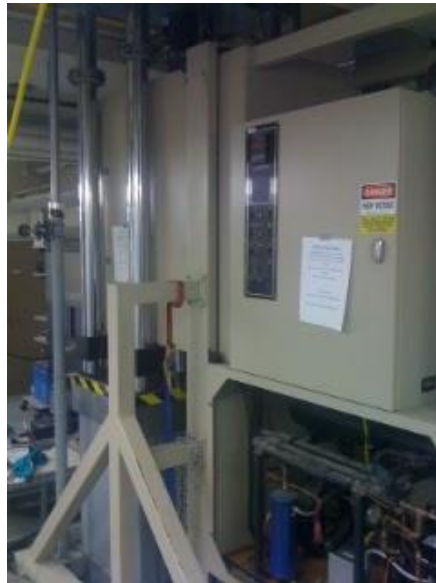
- Environmental Chamber
 - Temperature-controlled chamber.
 - Ability to run bond strength tensile tests across a temperature variation of -50°F to 100°F .
 - After cooling samples to -50°F , Charpy impact tests conducted.
 - Four-point bending test was performed to ensure that product maintained a high bond strength.

Figure 16: Environmental chamber used to freeze the samples.

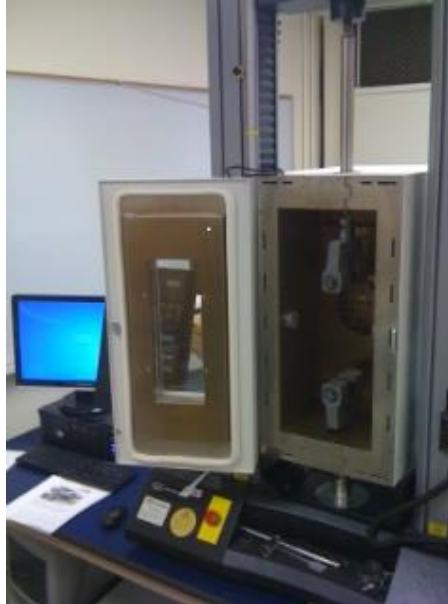
- Tensile Test
 - Allows the ability to measure bond strength with a variety of different materials.

Figure 17: Instron tensile test apparatus.

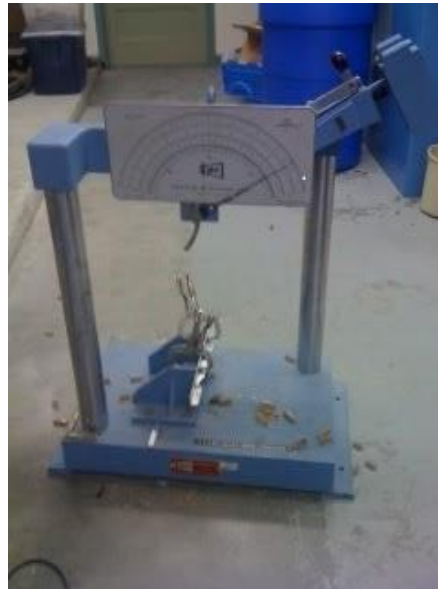
- Charpy Impact Test
 - Measures impact properties of epoxy and its performance in extreme cold.
 - Compared formulated test epoxy with normal strength epoxy.

Figure 18: Charpy.

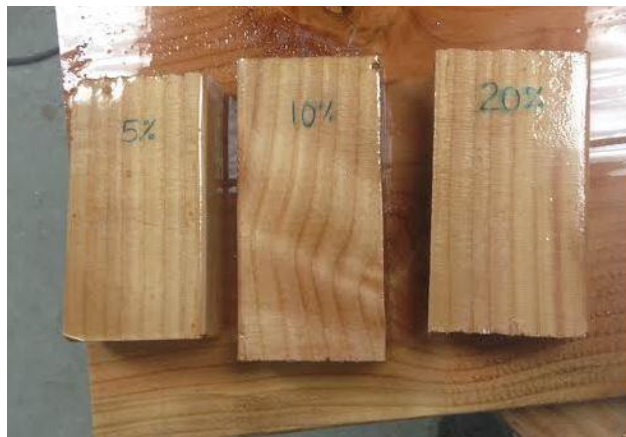
Figure 19: Test samples 3–5%, 10%, 20% isopropyl alcohol.

3.7.1 Determining percent isopropyl alcohol (Figure 19)

In order to test the resistance to moisture migration vs. percent alcohol in an epoxy mix, three different test boards were made. To determine what percent of isopropyl alcohol gave the best results, different percentages of it were added to the Type III dot epoxy. These sample board tests were conducted using the following procedure:

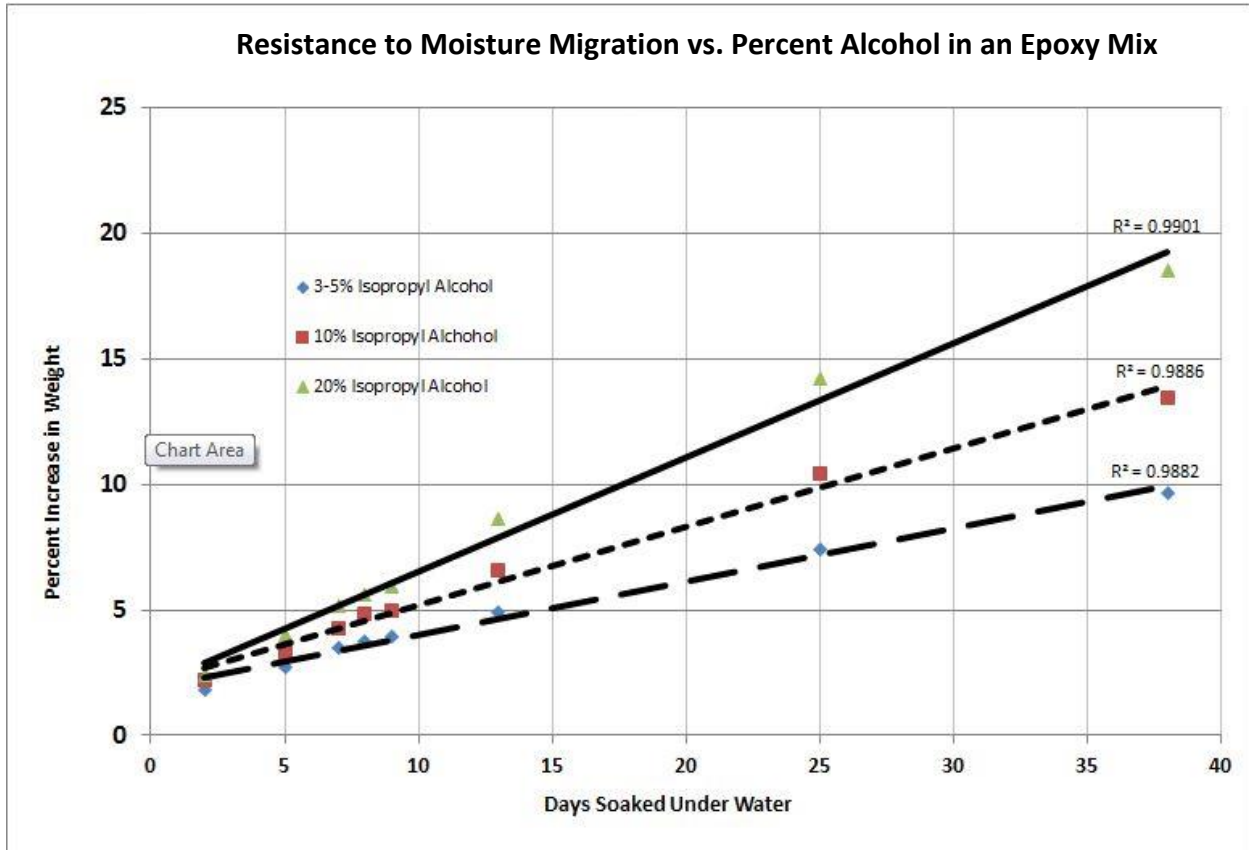
Figure 20: Resistance to moisture migration.

Graph Conclusion for Figure 20: These results gave clear data indicating that 3–5% isopropyl alcohol performed best while still giving the epoxy mobility and workability for application to the planks.

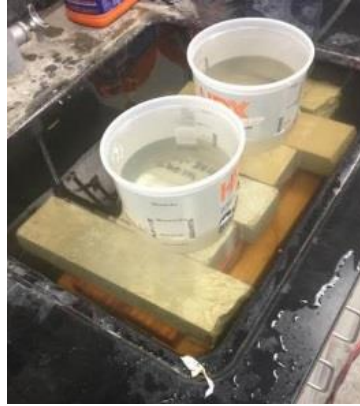
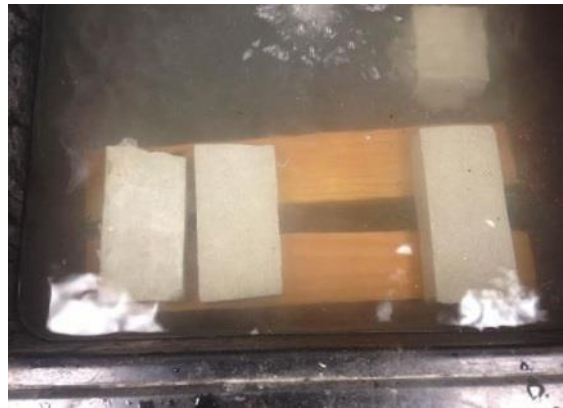
Figure 21: Test samples: no sealing, 1 sealing, 2 sealings, and 3 sealings submerged in water.

10. Boards were then placed under water in a large container.
11. On days 1, 2, 3, 7, 14, 20, 26, and 117 of being submerged in water, the weights were retaken to determine the amount of water each board absorbed. (This was done using a digital scale. Each board was weighed 3 times to ensure accurate results, and the average was then taken for each board).

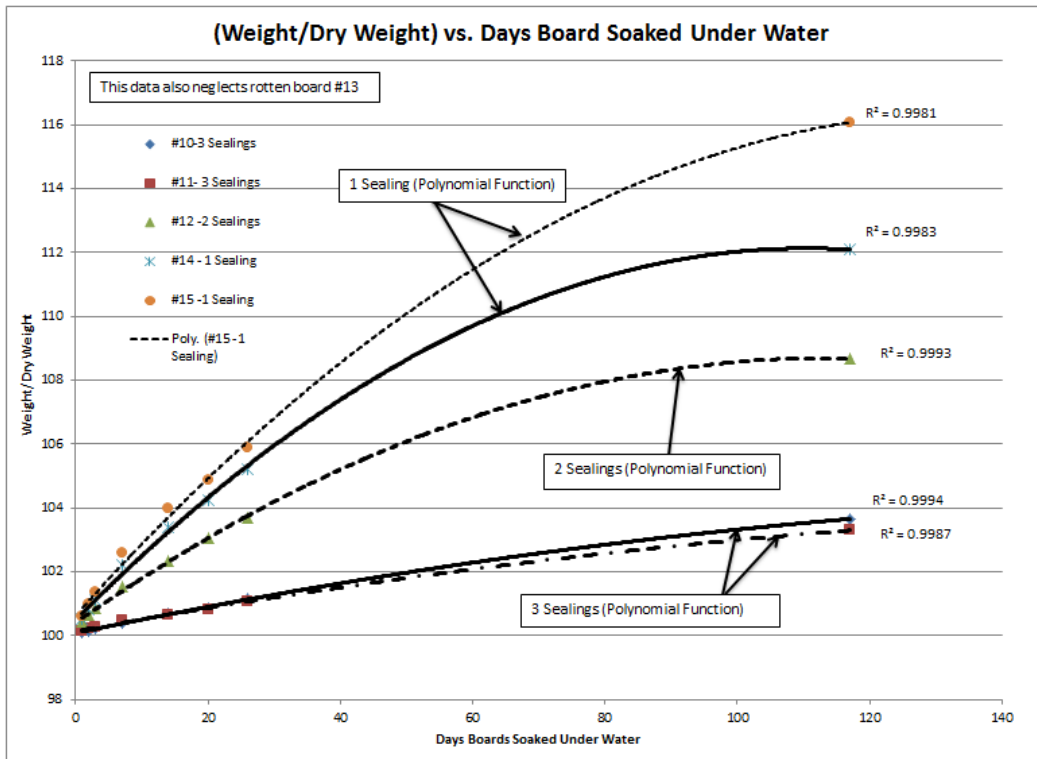
Figure 22: (Weight/dry weight) vs. days boards soaked.

Figure 23: (Weight/dry weight) vs. days boards soaked.

Graph conclusion for Figures 22 and 23: Figure 22 displays all the test sections: 2 with no sealing, 2 with 1 sealing, 2 with 2 sealings, and 2 with 3 sealings. Figure 23 displays all the tests, neglecting the no-sealing samples and the rotten 2-sealings sample. This gave clear data on what was happening as the number of seal coatings was increased.

The results shown in Figures 22 and 23 demonstrate that as the number of seal coatings on the boards is increased, samples weighed less; thus, the samples absorbed less water with an increase in the number of coatings.

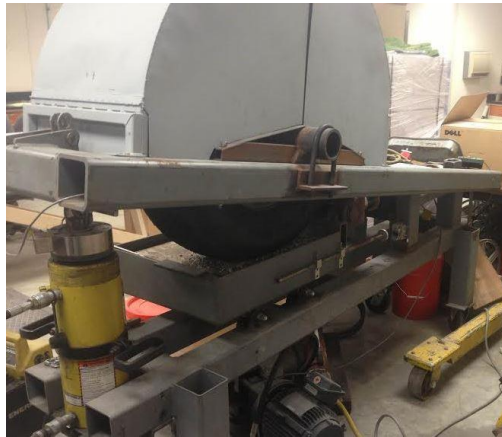
Figure 26: Traction and wear test equipment.

After collecting test sample data on the isopropyl alcohol percentage and the test mixture, a traction wear test was conducted on the samples. This test was conducted by using the machine shown in Figure 26. The tire was loaded onto the sample panel in the tray with a force of 4,500 N, which was determined as an average value for the weight of trucks that pass over the Yukon River Bridge. With the tire locked at its axle, the hydraulic ram moves the tray back and forth, resulting in traction between the tire and the sample panel. This test demonstrates long-term wear to determine how the epoxy mixture

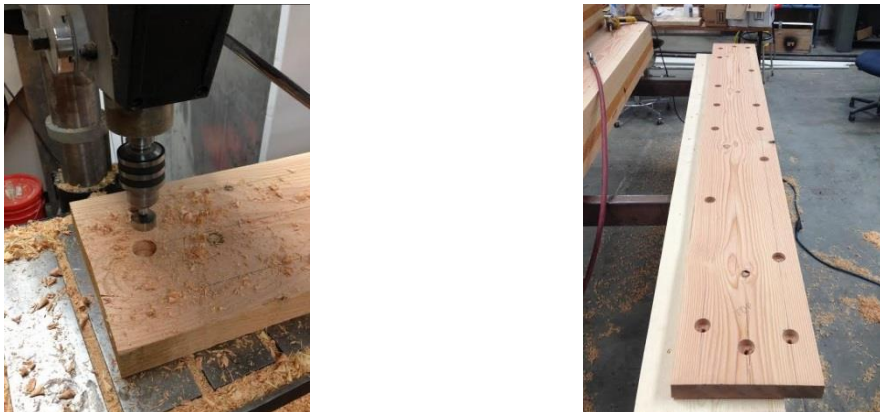
Figure 29: Drilling countersunk holes. Figure 30: Completed board though application process.

4. Countersink 1½ in. diameter hole at 1 in. depth. Be sure to use a jig or a drill press to obtain a hole that is perpendicular to the plane of the board (Figure 29).
5. Using a 3/8 in. drill bit, drill in the center of the countersunk holes (Figure 30) to bore a hole all the way through the board (this hole prevents cracking when bolts are inserted).

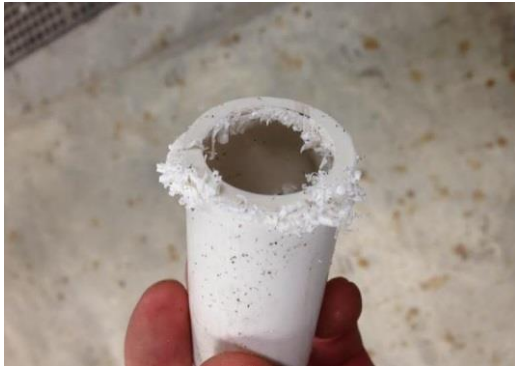
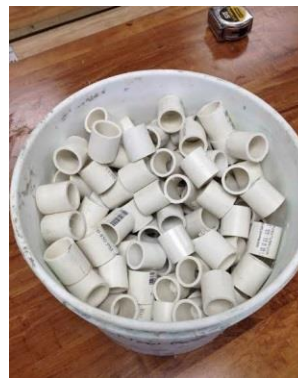
Figure 31: Bur on PVC pipe

Figure 32: De-burred PVC pipe

6. Inspect the holes looking for any slivers; remove with pliers or sandpaper.
7. Sand the surface of the boards.
8. Tack the boards with tacking cloth, to get rid of the impurities and loose wood dust.
9. Cut 1½ in. PVC pipe to 1-5/8 in. lengths. This length is determined by the depth of the countersunk holes plus the thickness of the aggregate coating to meet the desired overall thickness of the planks.
10. De-bur the PVC cut pipe (Figures 31 and 32).

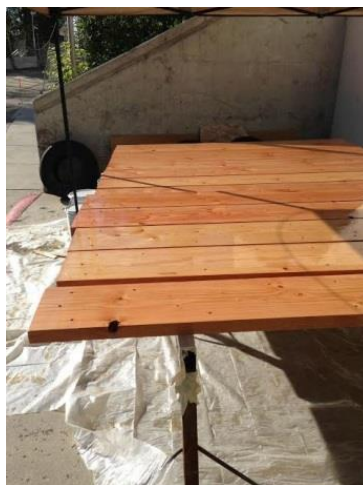
Figure 33: Planks drying after sealing

11. Set out even amounts of epoxy and hardener.
12. Set out a 3–5% by volume amount of isopropyl alcohol.
13. Mix the epoxy and hardener with a low-speed drill; be careful not to mix too fast to avoid unnecessary air formation. Mix for 1 min.
14. Add the isopropyl alcohol, and continue to mix for 2 min.
15. When mixture is well mixed, apply to the boards on 5 of the sides (not the bottom) with a 3/16 in. notched squeegee or a paintbrush. When mixture has been well applied, allow to dry for at least 5–6 hr (Figure 33). Be sure that the coating on the boards is not tacky.

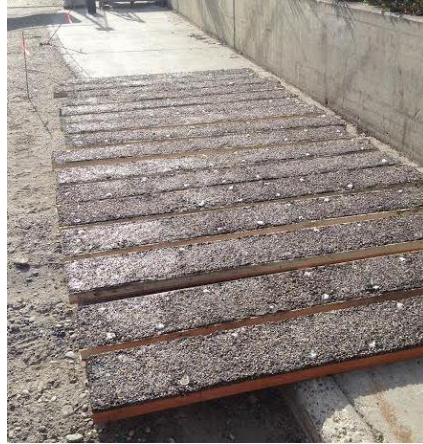
Figure 35: Planks drying.

14. Once the mixture is in place, liberally apply the local aggregate by broadcasting it across the top of the boards. The top of the boards should look like they are covered with evenly dispersed dry aggregate.
15. Allow the mixture to dry on a level surface for at least 6 hr (Figure 35).

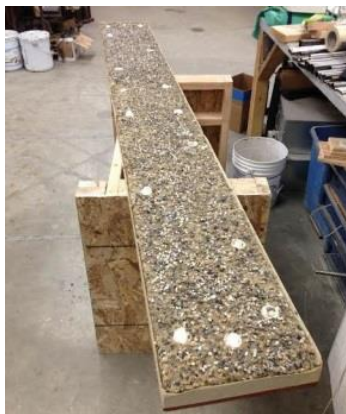
16. When the mixture has completely dried, remove the tape from the edges of the planks as well as the cotton balls inside the PVC pipe (Figure 36).

Figure 36: Removing tape and cotton balls.

Figure 35: Planks drying.....	29
Figure 36: Removing tape and cotton balls.....	29
Figure 37: Chip in plank.....	29
Figure 38: Chip patched.....	29
Figure 39: Additional chip patched.....	31
