## Technical Report 16-12

### *Bridge-in-a-Backpack™*

### *Task 6: Guidelines for Long Term Inspection and Maintenance*

**University of Maine's Advanced Structures and Composites Center**  
**Report Number: 15-34-1023F**

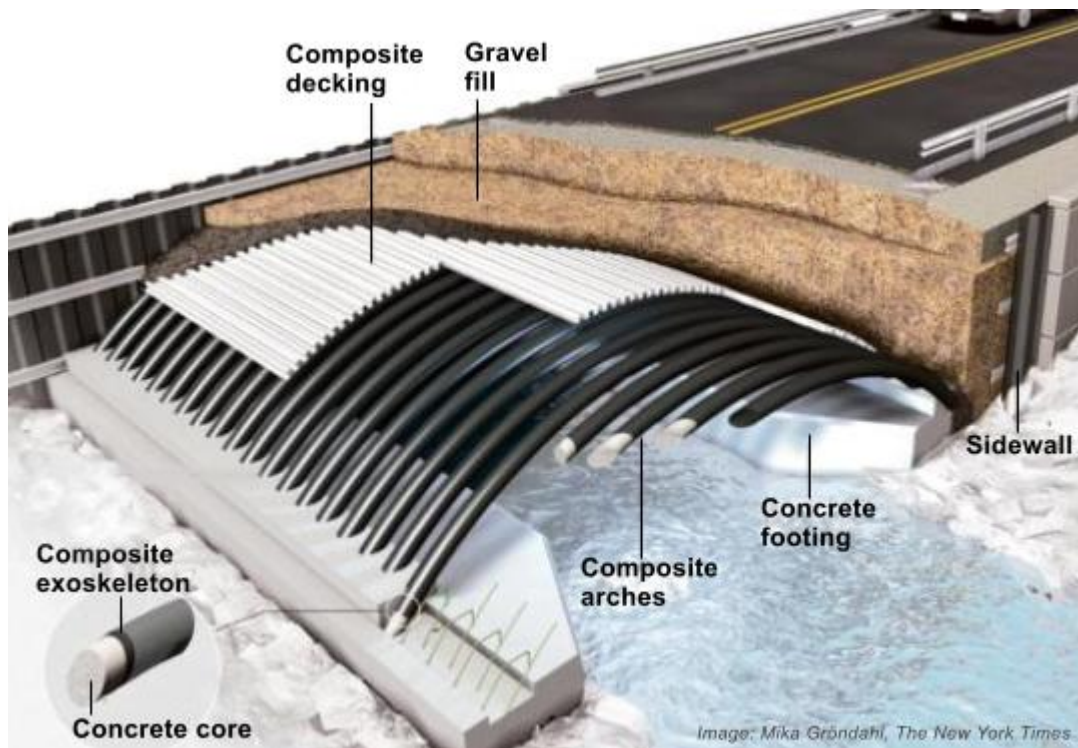
Figure 1: Typical Bridge in a Backpack System

The University of Maine in collaboration with Advanced Infrastructure Technologies (AIT) and the Army Corp of Engineers has developed the Bridge-in-a-Backpack™ system. As Dagher et al [1] and Colgrove [2] describe, this Bridge-in-a-Backpack™ (BiaB) system consists of a buried arch bridge system including structurally integrated stay-in-place concrete-filled fiber-reinforced-polymer (FRP) tubes (CFFTs) as main structural members, an FRP or concrete deck, foundations, and headwalls holding back soil. Parts of a typical BiaB system are shown in Figure 1. The FRP composite tube, typically constructed of braided carbon-glass material within a vinylester resin (VE-based GFRP), provides a stay-in-place form for the concrete and tensile reinforcement as a structurally integrated part of the arch composite section. As such, the durability and structural performance of the FRP composite tube and its bond with the concrete throughout the design life are critical to the overall system durability. The FRP tube is exposed to both the environment on the exterior, and the concrete on the interior, and these dual exposure durability requirements must be taken into account during design, and carefully monitored through inspection during service life to detect damage or degradation that could impact strength or serviceability.

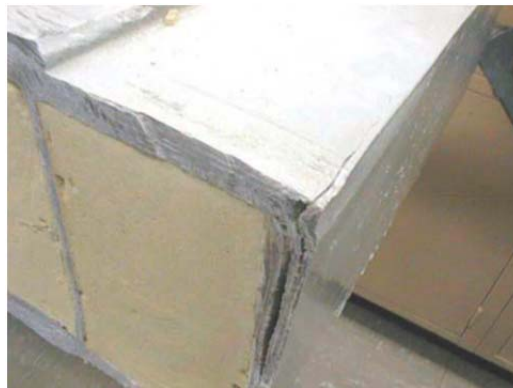
**Figure 2: Voids resulting in surface cracks (Ryan et al [3])**

Ryan et al [3] describes voids and delaminations are regions where the FRP shell or layers of the FRP shell have separated from each other. Voids could be present from construction when air pockets form between the concrete and FRP shell. Delaminations could be caused by impact, excessive flexure or poor quality control during manufacturing. Figure 2 shows a void and resulting surface crack of a foam filled FRP structure. Figure 3 shows a delamination due to a puncture.

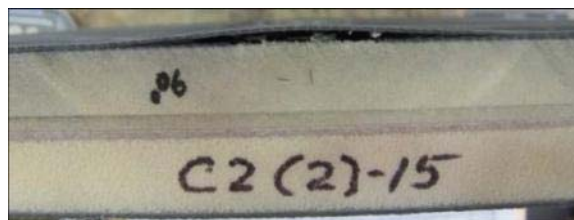
**Figure 3: Delamination due to puncture (Kittridge et al [11])**

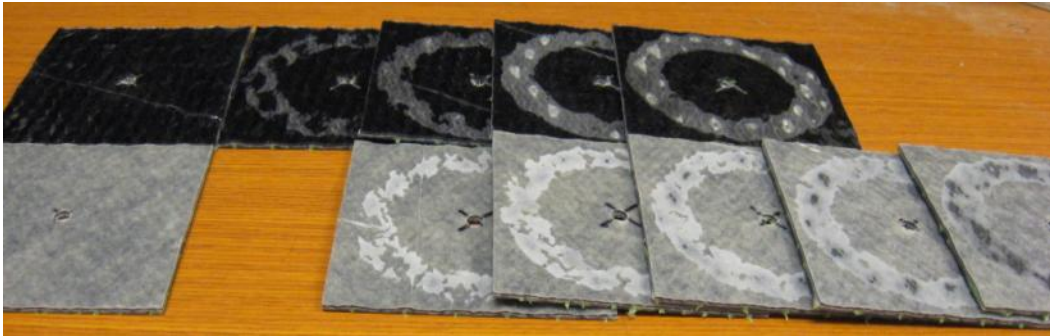
Discoloration may be indicative of structural problems. Whitening due to abrasion or excessive strain such as that seen in Figure 4 is detectable with visual inspection and can be minor or severe depending on the level of damage to the fibers.

**Figure 4: Discoloration due to abrasion, study samples**

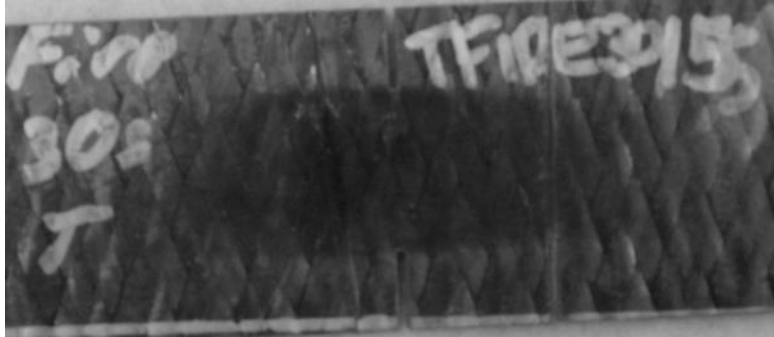
**Figure 8: Fibers exposed due to fire damage**

Fiber exposure often occurs along with other types of damage, such as punctures, abrasion, fire, or scratches and gouges. This is a serious condition due to the significant exposure to fibers and should be remedied. Along with the fiber exposure shown in Figure 2, Figure 4, Figure 5, Figure 9, and Figure 10, fiber exposure due to fire is shown in Figure 8.

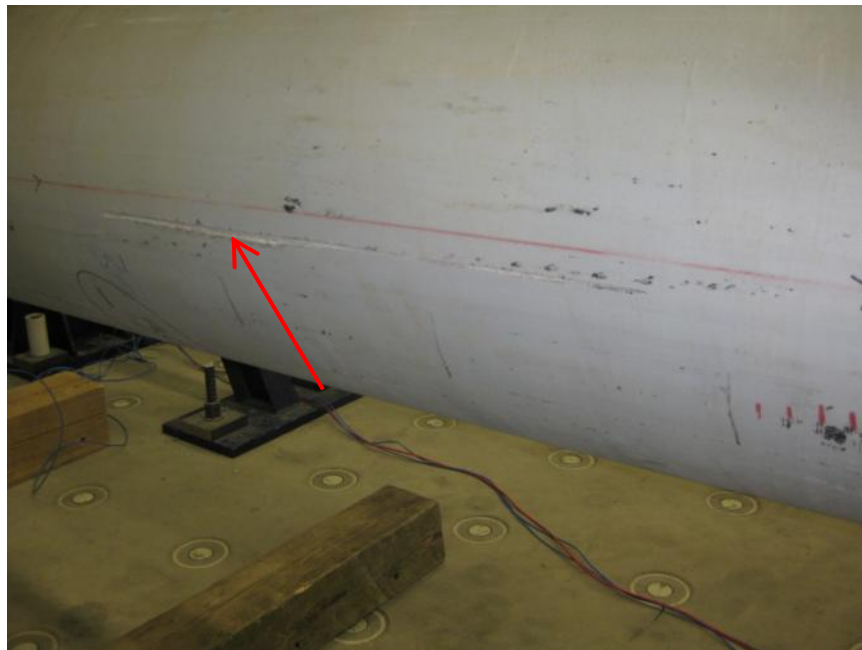
**Figure 9: Scratch in FRP pile**

Scratches are generally seen in the surface of the FRP laminate and can be minor to severe. Severe scratches could develop into cracks where fibers are damaged or cut and cause structural concerns. Scratches could be caused by improper handling during erection or by vandalism once construction is completed. They will usually be detectable by visual inspection and may also be evident with delamination.

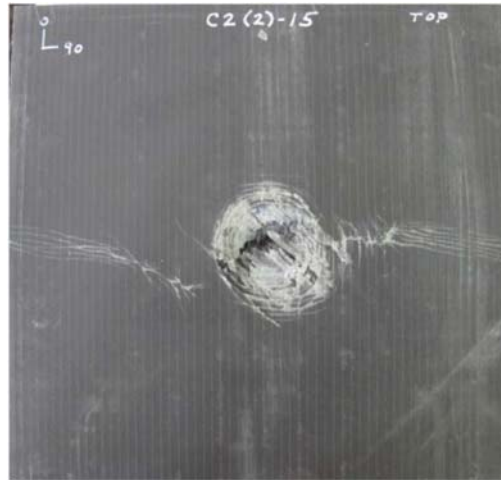
**Figure 10: Cracks form around a puncture (Kittridge et al [11])**

Cracks can form along with other types of damage, and can lead to fiber exposure. Major cracks should be repaired due to the possibility of decrease of structural capacity or exposure of fibers to damaging conditions. Cracks are shown around a puncture damage area in Figure 10.

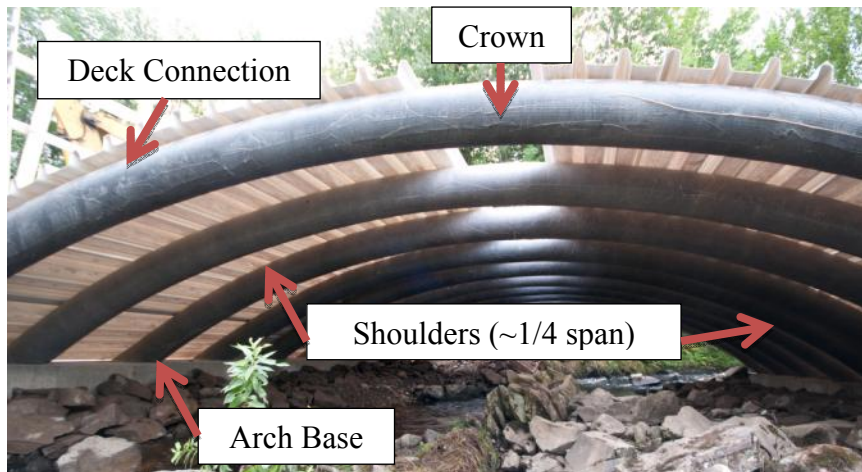
Figure 11: Typical key inspection locations, McGee Bridge under construction

Key locations for inspection of the tubular composite arches include the crown, shoulders (approximate quarter span), and bases of arch where they are embedded in the foundation. Dagher et al [1] has described these are the locations of peak moments and stresses. Additionally, any splices and connections to FRP headwalls and decking are areas to inspect. These areas are shown in Figure 11 and Figure 12.

1. Crown – area of peak moment. Look for distress, particularly discoloration due to excessive strain or excessive deflections
2. Shoulders – area of peak moment. Look for distress, particularly discoloration due to excessive strain or excessive deflections
3. Arch bases – area of peak axial load. Look for distress, particularly discoloration due to excessive strain or splitting of cross section or foundation
4. Splices (as applicable) – look for signs of increased separation of splice components, delaminations, cracks or other deficiencies.
5. Headwall and Deck connections (as applicable) – look for signs of increased separation of connection components, delaminations, cracks, punching or other deficiencies.

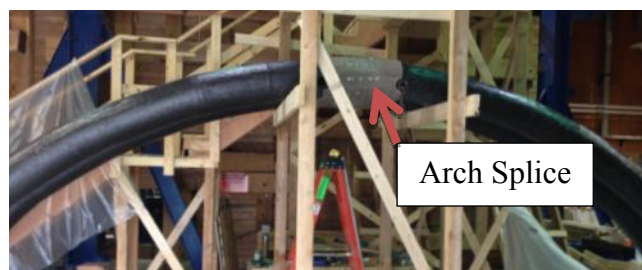
Figure 12: Key inspection location, spliced arch in laboratory

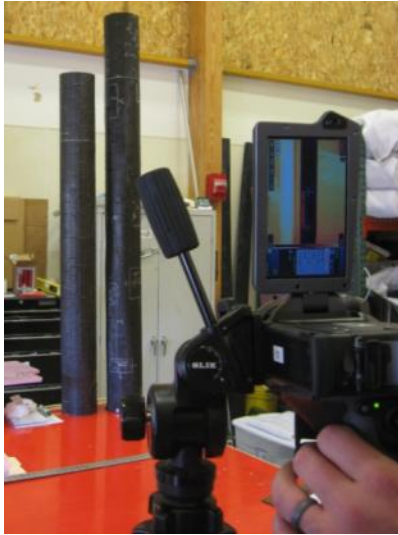
**Figure 13: Infrared camera in use**

As described by Kittridge et al [11], a FLIR SC620 infrared (IR) camera for conducting thermography inspections was used by the Composite Center. This portable camera along with the accompanying ExaminIR analysis software is a high performance IR system used for science and research applications. It has 640×480 resolution, a temperature range of -40°C to 500°C (-40°F to 932°F), accuracy of ±2°C (±3.6°F), 0.65 mrad spatial resolution, and a thermal sensitivity of ≤55 mK. Data (including full field radiometric temperature measurements) are captured either as still images or streaming video. Changes in heat transfer rate (and therefore surface temperature) due to internal flaws create an image that highlights various defects. A photograph of the SC620 is provided in Figure 13.

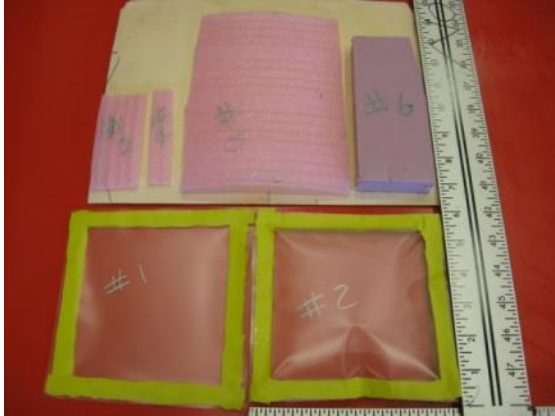
**Figure 14: Materials used to create artificial voids**

The specimens were 6.5 inch diameter hybrid glass/carbon fiber FRP tubes, nominally 6 feet long, with multiple artificial voids directly on the inside of the FRP shell. All tubes were mapped for actual locations, only two are marked on the exterior for locations of actual voids. To produce the voids several materials were used that included  $\frac{3}{4}$  inch Foamular 250 foam board insulation,  $\frac{1}{4}$  foam sill seal, and air pockets formed by sandwiching plastic film with tacky tape. Two different thicknesses of the plastic film air pocket were created. Various size foam blocks were used as well for simulating air voids between concrete and CFRP tube. These materials can be seen in Figure 14 prior to installation. The installed materials can be seen in one tube in Figure 15.

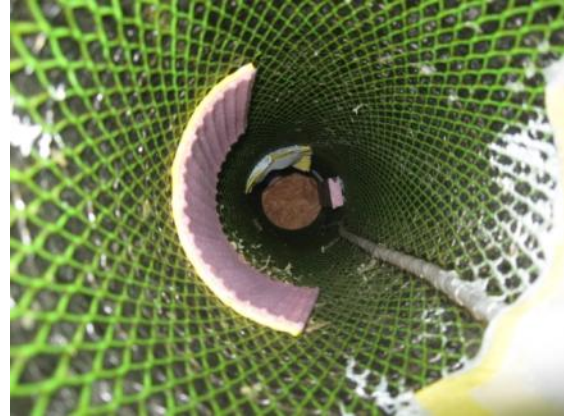
**Figure 15: Inside of tube with artificial voids**

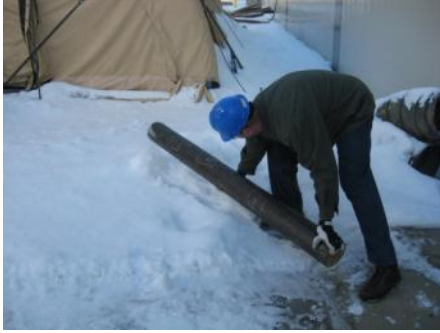
Figure 16: Filling tube with snow

Tubes were filled with snow by packing the snow lightly and tapping the bottom of the tube lightly on the ground by picking it up approximately 6 inches and dropping the plugged end on the ground. This was repeated until the tube was filled to desired level as seen in Figure 16 and Figure 17.

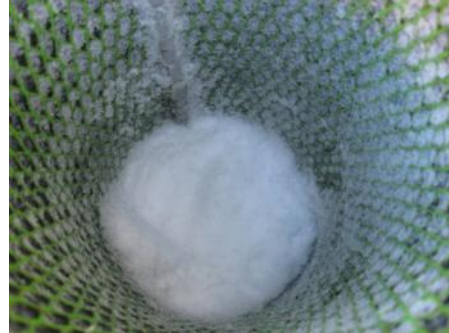
Figure 17: Snow filled tube

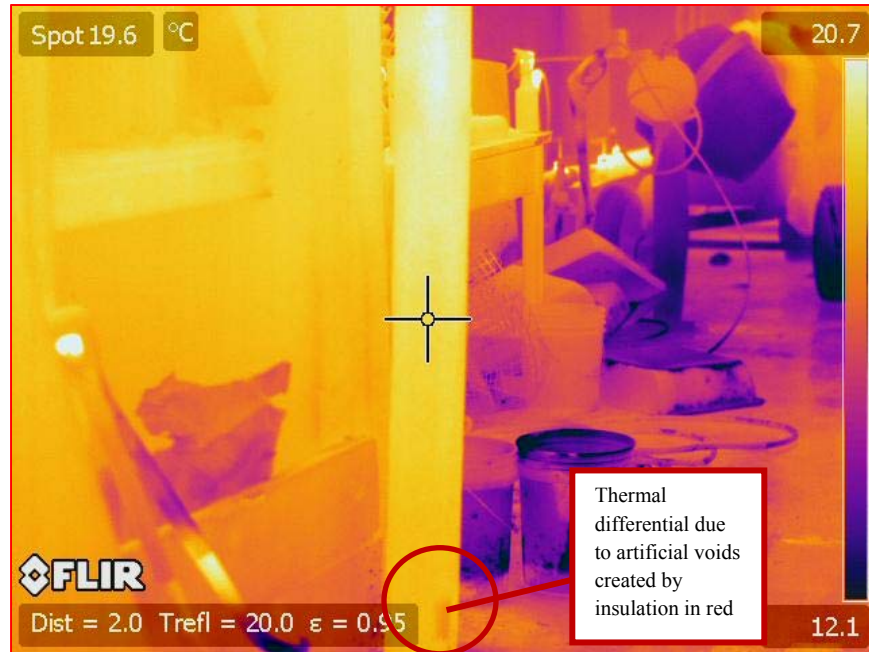
Figure 20: Partially filled Tube K, 12:24, time since filling ~30 minutes

Images are shown for one placement. Tube K was partially filled by hand starting at 11:40 on April 6, 2012. A series of images was taken after filling starting at 12:24 and continuing for roughly half an hour. The first is shown in Figure 20 and the last in Figure 21.

The IR thermography successfully detected the artificial void during filling, and was able to be detected in images ranging from half an hour after filling to an hour after filling. The ability to see the void was greatly diminished roughly an hour after concrete placement, but is still detectible as Figure 21 shows. Based on this experimentation, IR thermography could be used during concrete placement to successfully detect voids before the concrete has cured. This ability could be used to consolidate the concrete causing the void before curing, thus allowing defects to be removed while there is still opportunity to do very simply cost effectively.

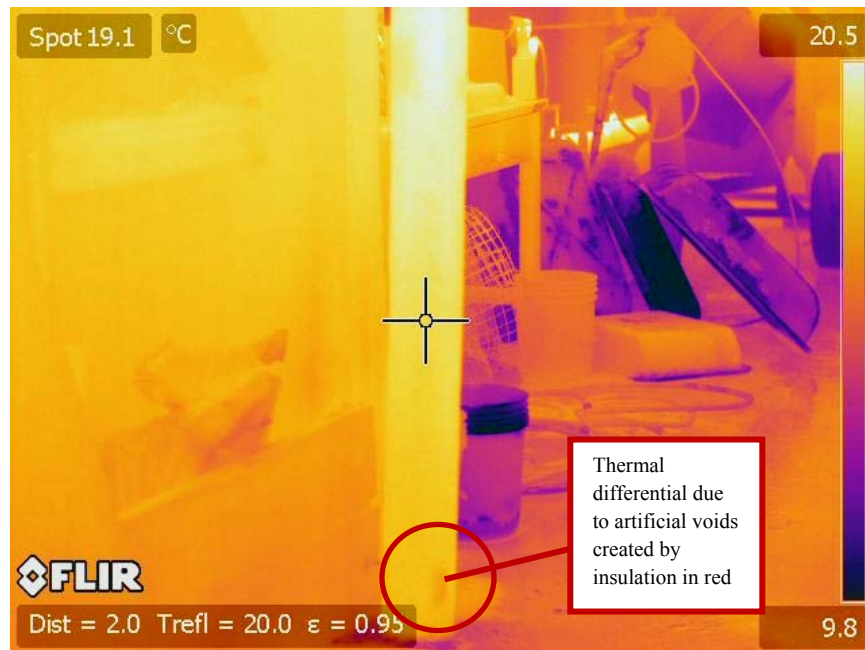
Figure 21: Partially filled Tube K at 12:49, time since filling ~55 minutes

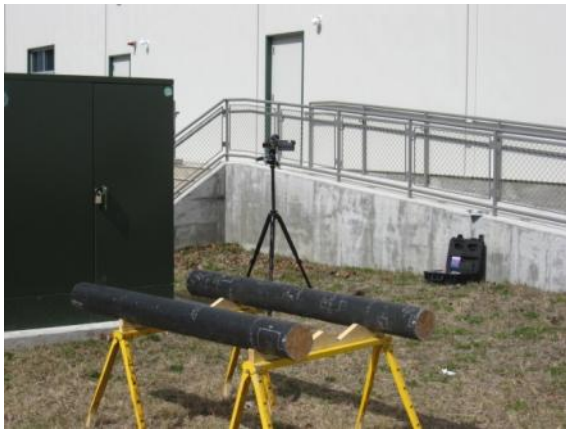
**Figure 22: Tubes outside of lab**

Concrete filled tubes were placed outside on several occasions for inspection with IR thermography. This simulated in place conditions for BiaB inspections. Various environmental conditions were evaluated including direct sunlight, overcast conditions and early and late day conditions with relatively rapid changes in ambient air temperature. Figure 22 shows the CFFTs outside of the laboratory for inspection. Tubes were checked for effects of thermal changes in air temperatures and direct radiation heating from the sun. As can be seen from the thermal photo in Figure 23, 2 voids were seen by their darker color indicating a temperature variance.

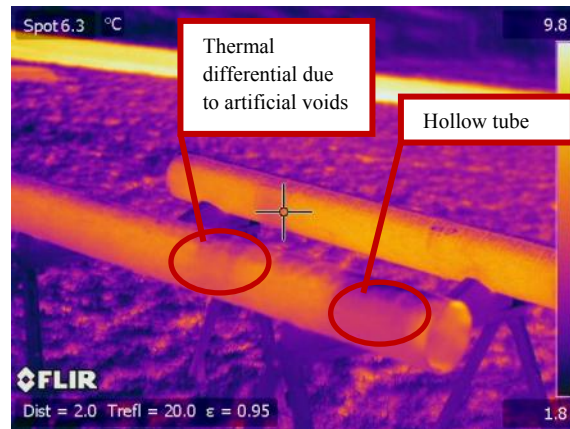
**Figure 23: Tubes inspected with IR**

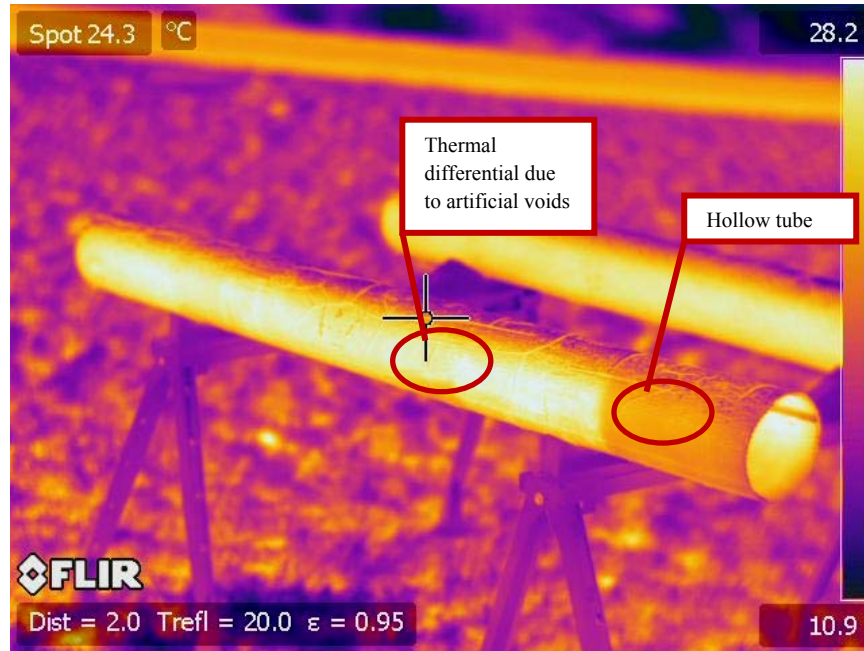
It was difficult to detect the voids on sunny days where there was direct heating of the surface of the FRP as is shown in Figure 24.

Figure 24: Tubes in direct sunlight

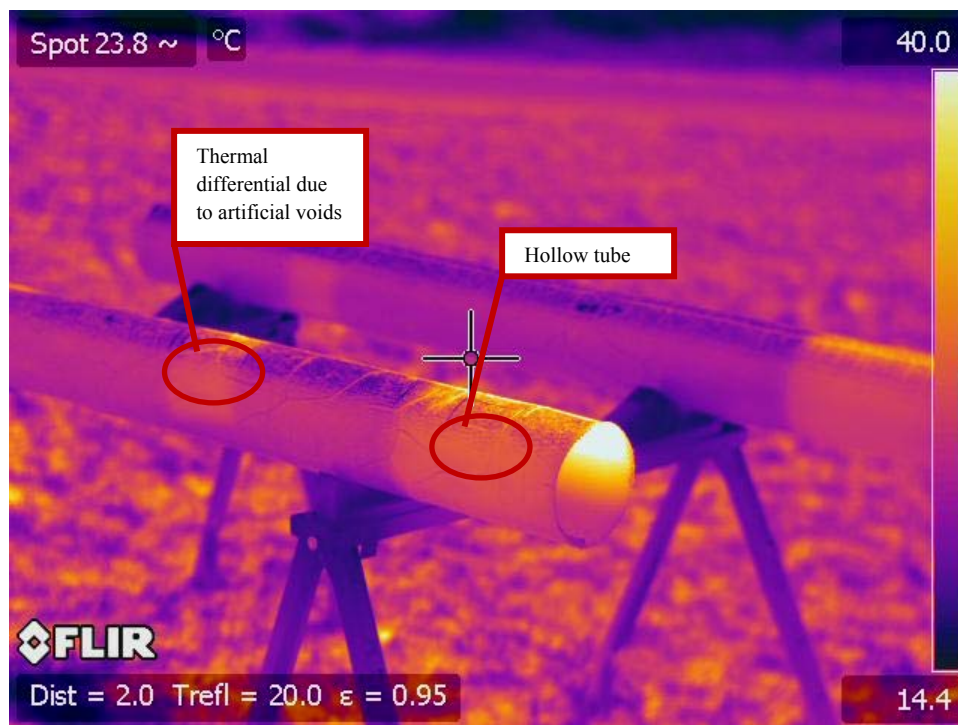
The best results for finding the voids came on overcast days with higher temperature variance from overnight to the mid-day as is shown in Figure 25.

Figure 25: Tubes in cloudy skies

This experimentation IR thermography on CFFTs in exterior conditions shows the ability of the inspection methodology to detect voids in large field in various environmental conditions. The best detection occurred when large temperature differentials were present between the thermal mass of the concrete and exterior ambient temperature.
