MASH EVALUATION OF TxDOT HIGH-MOUNTING-HEIGHT TEMPORARY WORK ZONE SIGN SUPPORT SYSTEM

Test Report 9-1002-15-8

**TEXAS A&M TRANSPORTATION INSTITUTE
COLLEGE STATION, TEXAS**

TEXAS DEPARTMENT OF TRANSPORTATION

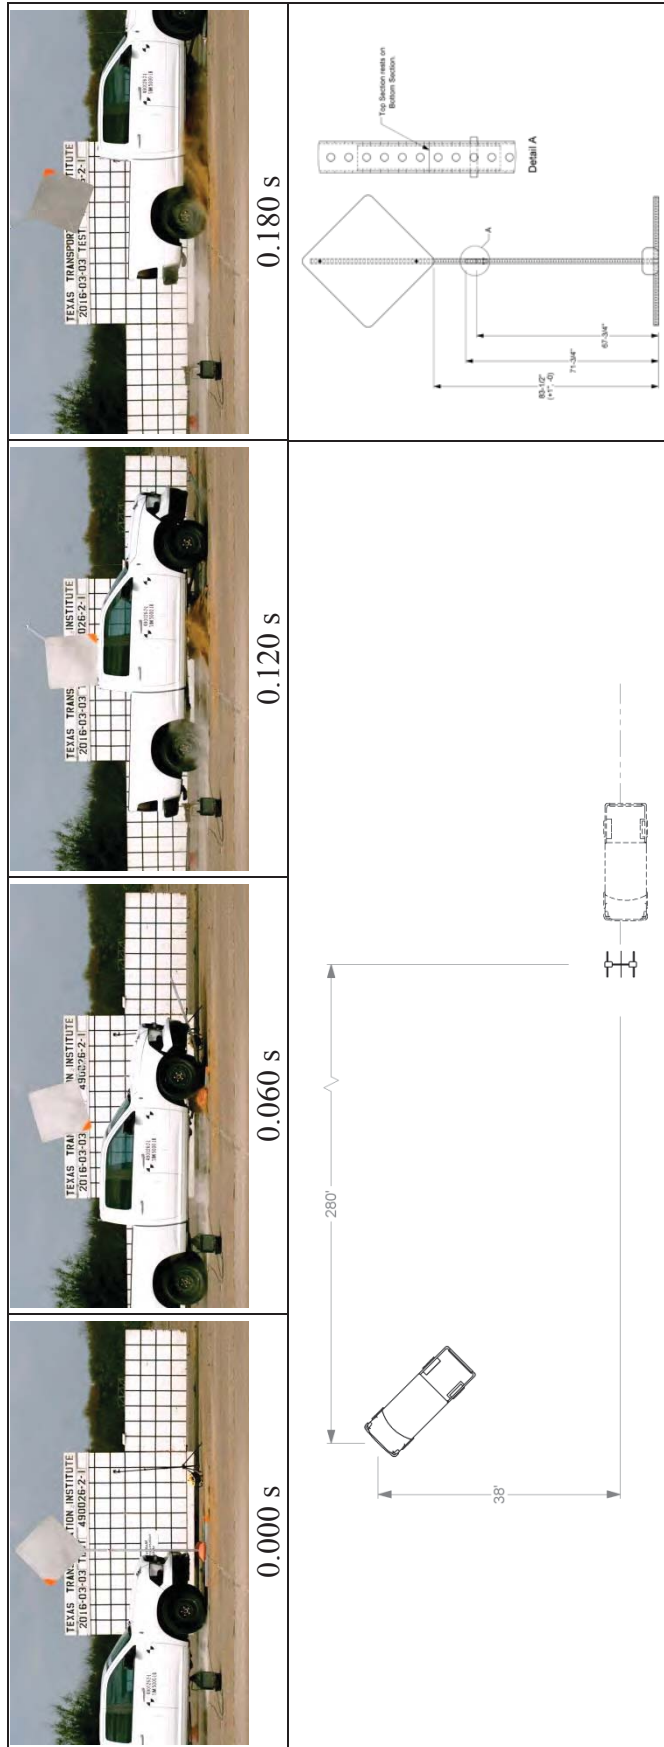
Figure 5.7. Summary of Results for MASH Test 3-72 at 90 Degrees on the Option A Temporary Work Zone Sign Support.

General Information		Test Vehicle		Test Article Debris Scatter	
Test Agency	Texas A&M Transportation Institute (TTI)	Type/Designation	2270P	Longitudinal	98 ft downstream
Test Standard	MASH Test 3-72	Make and Model	2010 Dodge Ram 1500	Lateral	12 ft left of center
TTI Test No.	490026-2-1	Curb	4898 lb	Post-Impact Trajectory	
Test Date	2016-03-03	Test Inertial	5014 lb	Stopping Distance	280 ft downstream
		Dummy	No dummy		38 ft right of center
		Gross Static	5014 lb	Vehicle Stability	
Test Article		Impact Conditions		Maximum Yaw Angle	Vehicle remained upright
Type	Temporary Work Zone Sign Support	Speed	62.9 mi/h	Maximum Pitch Angle	Vehicle remained upright
Name	Option A Temporary Work Zone Sign Support	Angle	90 degrees	Maximum Roll Angle	No
Installation Height	83½ inches to bottom of sign; 132 ¾ to top	Location/Orientation	10 inches right of centerline	Vehicle Snagging	No
Material or Key Elements		Kinetic Energy		Vehicle Pooketing	No

Upper & lower sections connected with 8-inch long insert sleeve of 1½-inch, 12-gauge perforated square steel tubing secured with ¾-inch diameter x 2½-inch long smooth pin located in holes 2½ inches below joint		Exit Conditions		Vehicle Damage	
Placed on dry concrete surface		Speed	663 kip-ft	VDS	12FR1
		Angle	61.8 mi/h	CDC	12FREN1
		Occupant Risk Values		Max. Exterior Deformation	2.5 inches
				OCDI	RR0000000
				Max. Occupant Compartment Deformation	1 inch

Figure 5.7 provides a summary of the results of the test. The slip connection incorporated into the vertical support post of the Option A temporary work zone sign support allowed the top of the system to release from the lower section of the vertical support post and base as intended. The corner of the sign panel impacted the vehicle roof, and no tear occurred with this first impact. However, as the vehicle continued forward, the sign panel continued to rotate and impacted the rear of the roof causing a 5-inch long tear in the exterior of the roof. The tear did not extend into the occupant compartment, but did cause a 1-inch dent in the interior roof panel at this location of the right rear passenger compartment. Due to the extent of the external roof tear, the Option A temporary work zone sign support was judged to have potential for intrusion into the occupant compartment.

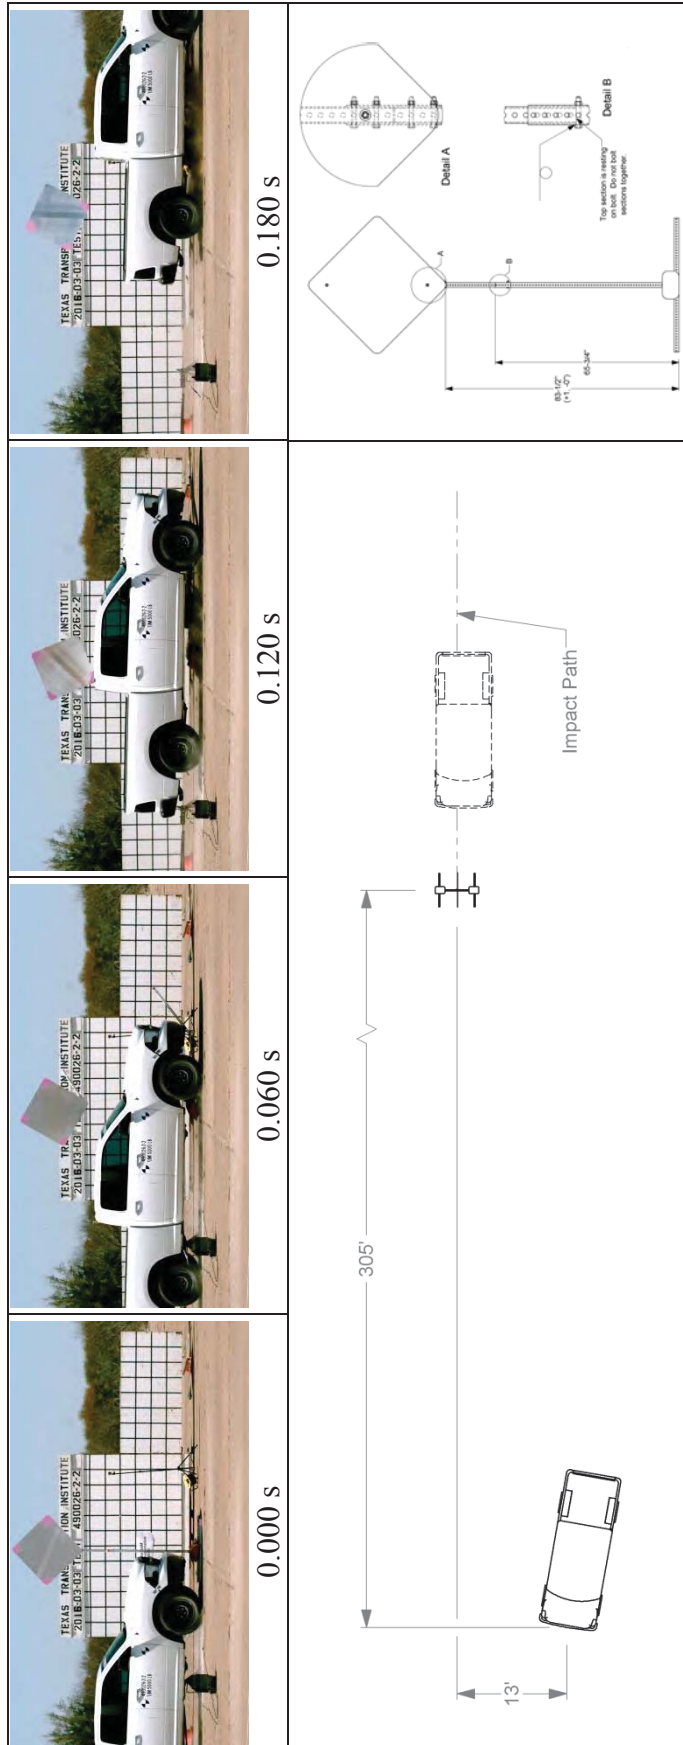
Figure 6.7. Summary of Results for MASH Test 3-72 at 90 Degrees on the Option B Temporary Work Zone Sign Support.

General Information	
Test Agency.....	Texas A&M Transportation Institute (TTI)
Test Standard Test No.....	MASH Test 3-72
TTI Test No.....	490026-2-2
Test Date.....	2016-03-03
Test Article	
Type	Temporary Work Zone Sign Support
Name	Option B Temporary Work Zone Sign Support
Installation Height	83½ inches to bottom of sign; 132% to top
Material or Key Elements	Upper & middle sections joined with two opposing fuse plates; smaller 1½ inch middle section had telescopic slip joint inside 1 ¼ inch lower section of vertical support
Soil Type and Condition Placed on dry concrete surface	
Test Vehicle	
Type/Designation	2270P
Make and Model	2010 Dodge Ram 1500
Curb	4898 lb
Test Inertial	5014 lb
Dummy	No dummy
Gross Static.....	5014 lb
Impact Conditions	
Speed	62.6 mi/h
Angle.....	90 degrees
Location/Orientation	10 inches left of centerline 655 kip-ft
Kinetic Energy

61.6 mi/h	
Exit Conditions	
Speed	NA
Angle.....	Assessment of occupant risk factors not required for test articles
Occupant Risk Values	
of 58 lb	
Test Article Debris Scatter	
Longitudinal	108 downstream
Lateral.....	2 ft left – 6 ft right
Post-Impact Trajectory	
Stopping Distance.....	305 ft downstream 13 ft left of center
Vehicle Stability	
Maximum Yaw Angle	Vehicle remained upright
Maximum Pitch Angle	No
Maximum Roll Angle	No
Vehicle Snagging	No
Vehicle Pocketing	No
Vehicle Damage	
VDS	12FL1
CDC.....	12FLEN1
Max. Exterior Deformation.....	2.5 inches
OCDI.....	RR0000000
Max. Occupant Compartment Deformation	None

Figure 6.7 provides a summary of the results of the test. The slip connection between the bottom and middle sections of the vertical support performed as designed and released the middle and upper sections and sign panel from the lower section and base. The fuse plate between the upper and middle sections of the vertical support activated as designed. Although the sign panel impacted the roof, this contact did not result in any tear or penetration of the roof. The slight roof deformation that occurred was within *MASH* criteria.

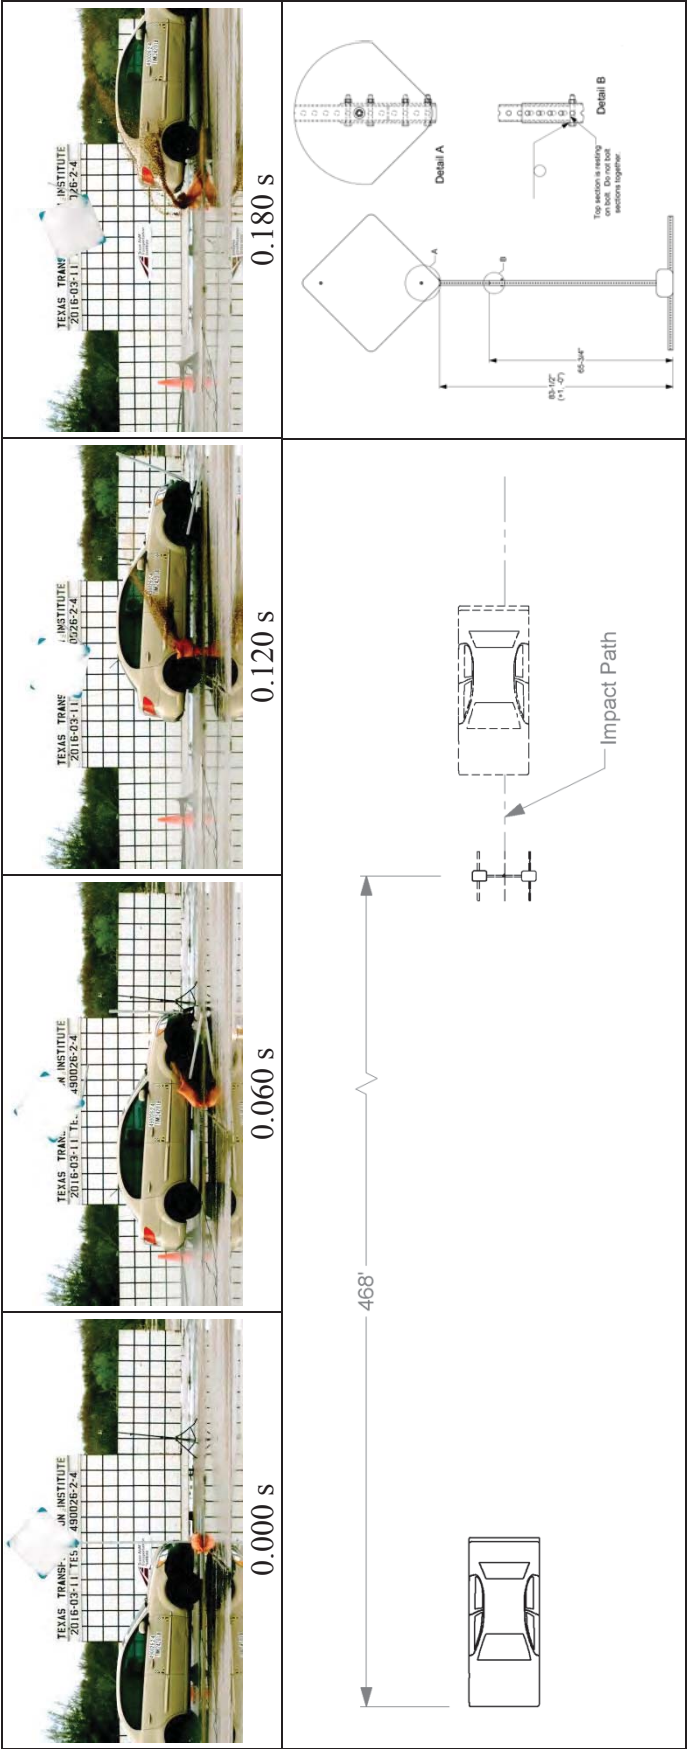
Figure 6.13. Summary of Results for MASH Test 3-71 at 90 Degrees on the Option B Temporary Work Zone Sign Support.

General Information		Test Vehicle		Test Article Debris Scatter	
Test Agency.....	Texas A&M Transportation Institute (TTI)	Type/Designation.....	1100C	Longitudinal.....	483 downstream
Test Standard Test No.....	MASH Test 3-71	Make and Model.....	2011 Kia Rio	Lateral.....	Centerline
TTI Test No.....	490026-2-4	Curb.....	2479 lb	Post-Impact Trajectory	
Test Date.....	2016-03-11	Test Inertial.....	2443 lb	Stopping Distance.....	468 ft downstream
		Dummy.....	165 lb	Centerline	
		Gross Static.....	2608 lb	Vehicle Stability	
		Speed.....	60.9 mi/h	Maximum Yaw Angle.....	Vehicle remained
		Angle.....	90 degrees	Maximum Pitch Angle.....	upright
		Location/Orientation.....	10 inches right of centerline 303 kip-ft	Maximum Roll Angle.....	No
		Kinetic Energy.....	58.8 mi/h	Vehicle Snagging.....	No
		Exit Conditions.....	NA	Vehicle Pooketing.....	No
		Speed.....	Assessment of occupant risk factors not required	Vehicle Damage

Angle.....	for test articles of 58 lb	VDS.....	12FR1
		Occupant Risk Values.....		CDC.....	12FREN1
				Max. Exterior Deformation.....	None
				OCDI.....	RF0000000
				Max. Occupant Compartment Deformation.....	None
Soil Type and Condition		Placed on dry concrete surface

Figure 6.13 provides a summary of the results of the test. The slip connection between the bottom and middle sections of the vertical support performed as designed and released the middle and upper sections and sign panel from the lower section and base. The fuse plate between the upper and middle sections of the vertical support activated as designed. There was no secondary contact between the sign panel and the roof of the vehicle.

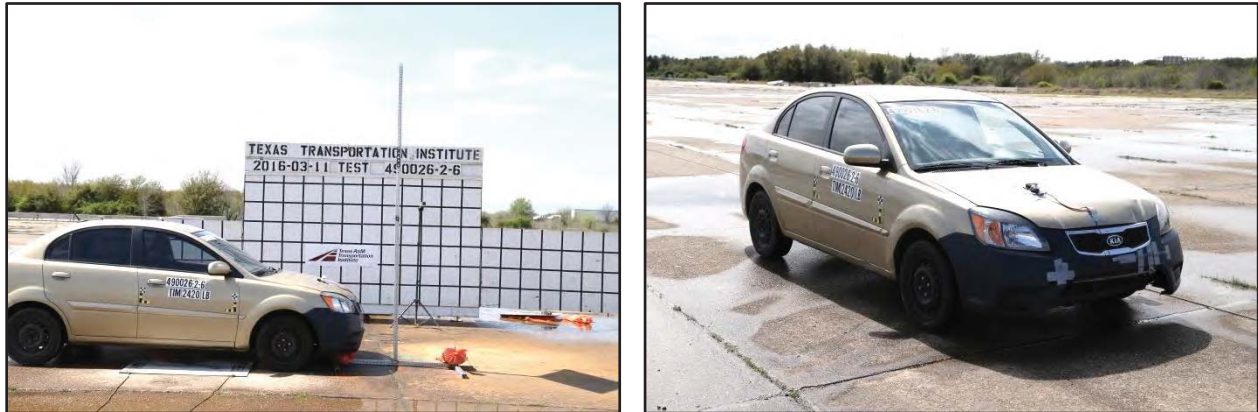
Figure 6.15. Test Vehicle before Test No. 490026-2-6.

The 2011 Kia Rio used in the previous test 490026-2-4, shown in Figure 6.15, was used for the crash test. The vehicle's test inertia weight was 2443 lb, and its gross static weight was 2608 lb. The height to the lower edge of the vehicle bumper was 8.0 inches, and the height to the upper edge of the vehicle bumper was 21.5 inches. Table D.1 in Appendix D1 gives additional dimensions and information on the vehicle. The vehicle was directed into the installation using a cable reverse tow and guidance system, and was released to be freewheeling and unrestrained just prior to impact.

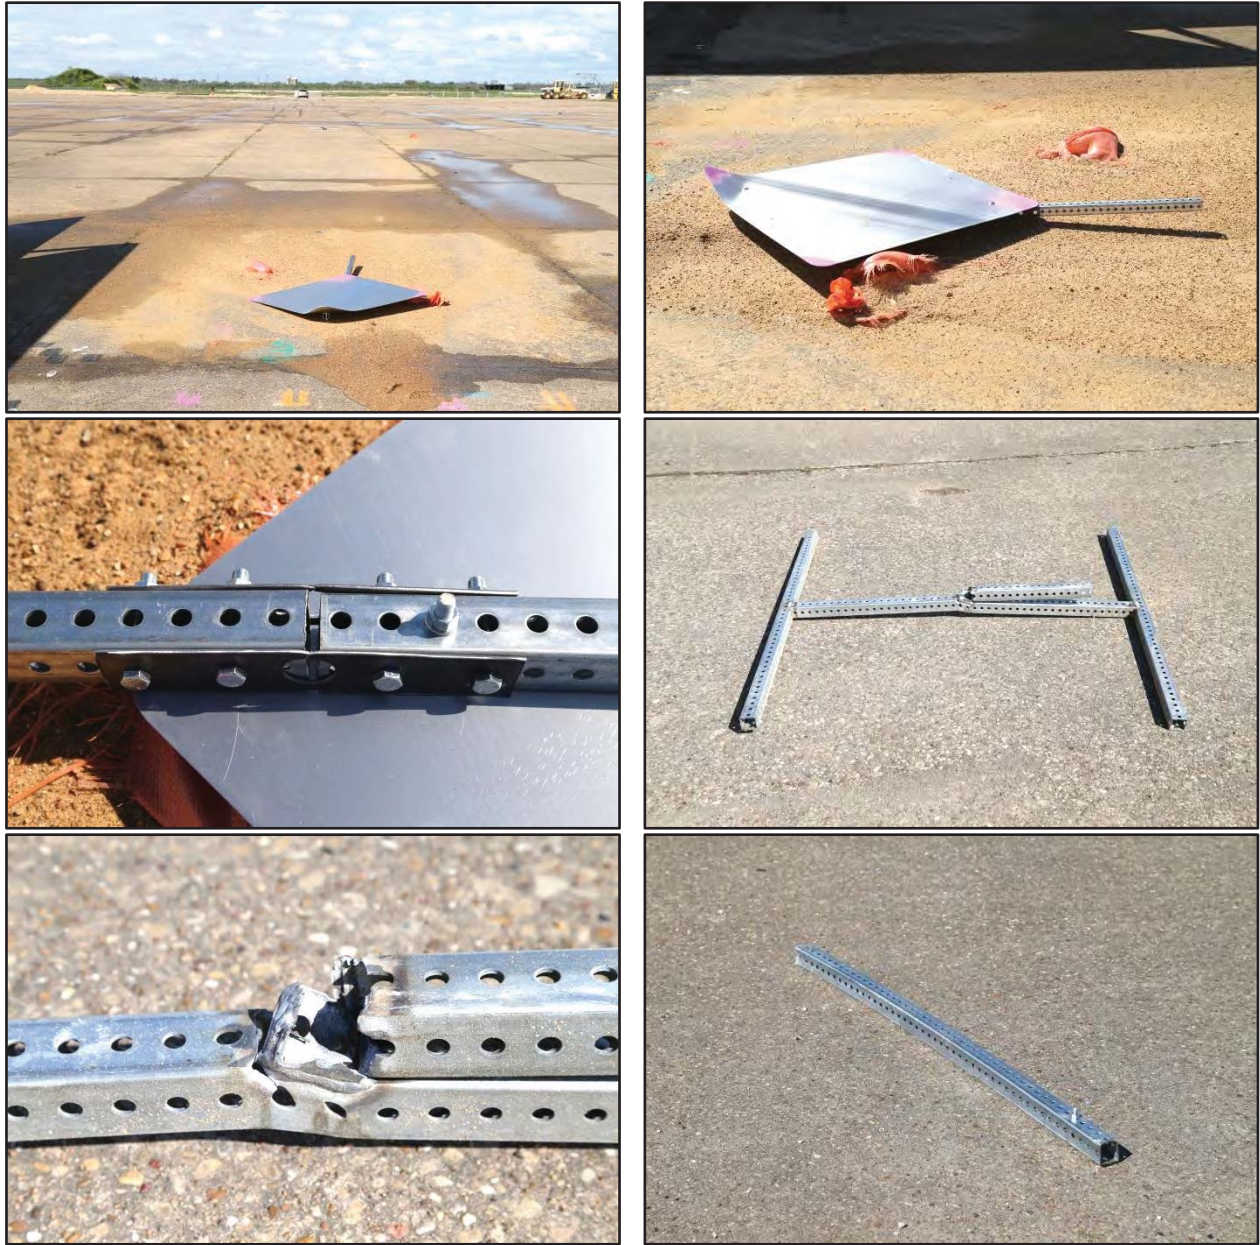
Figure 6.16. Option B Temporary Work Zone Sign Support after Test No. 490026-2-6.

Figure 6.16 shows the damage to the Option B temporary work zone sign support. The sign panel and the attached upper and middle sections of the vertical support came to rest 3 ft downstream of impact. The lower section of the vertical support fractured into two pieces 16 inches above ground level. The upper fractured piece came to rest 185 ft downstream of impact and 12 ft to the right of centerline of the vehicle path. The remaining lower portion and H-base of the temporary work zone sign support came to rest 83 ft downstream of impact.

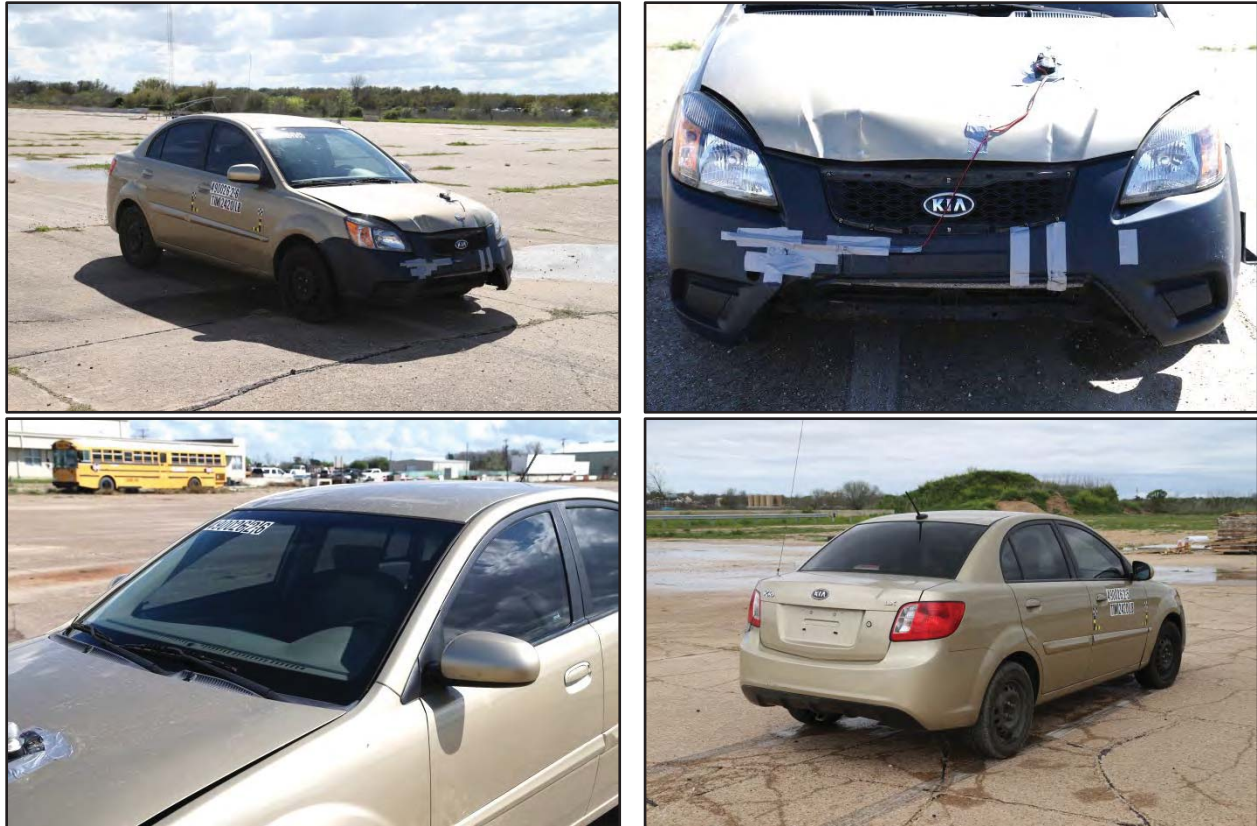
Figure 6.17. Test Vehicle after Test No. 490026-2-6.

Figure 6.17 shows the damage sustained by the vehicle. The 1100C vehicle sustained only scrapes to the bumper and hood with no measureable exterior vehicle deformation. Figure 6.18 shows the interior of the vehicle. No occupant compartment penetration, deformation, or intrusion was noted. Tables D.2 and D.3 in Appendix D1 provide exterior crush and occupant compartment measurements.

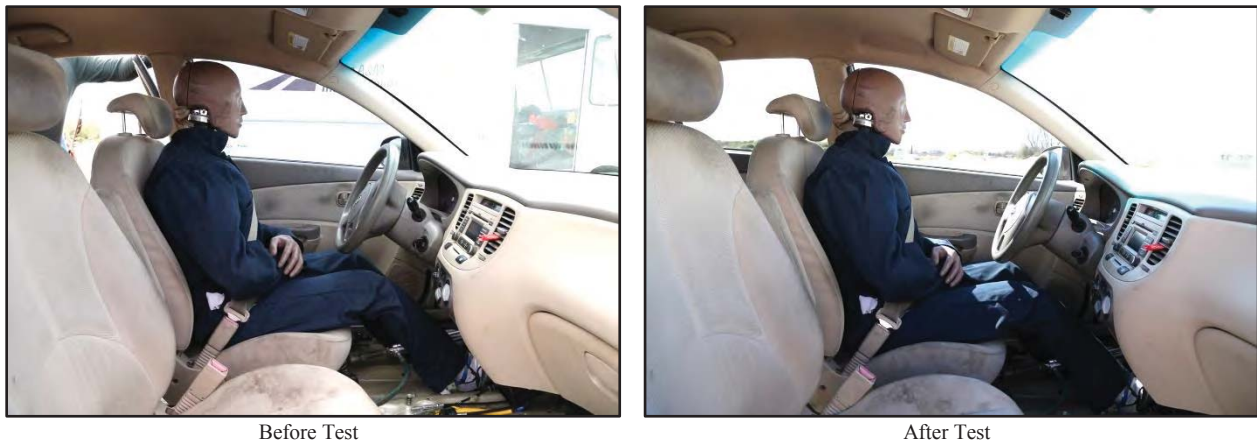
Figure 6.18. Interior of Test Vehicle for Test No. 490026-2-6.

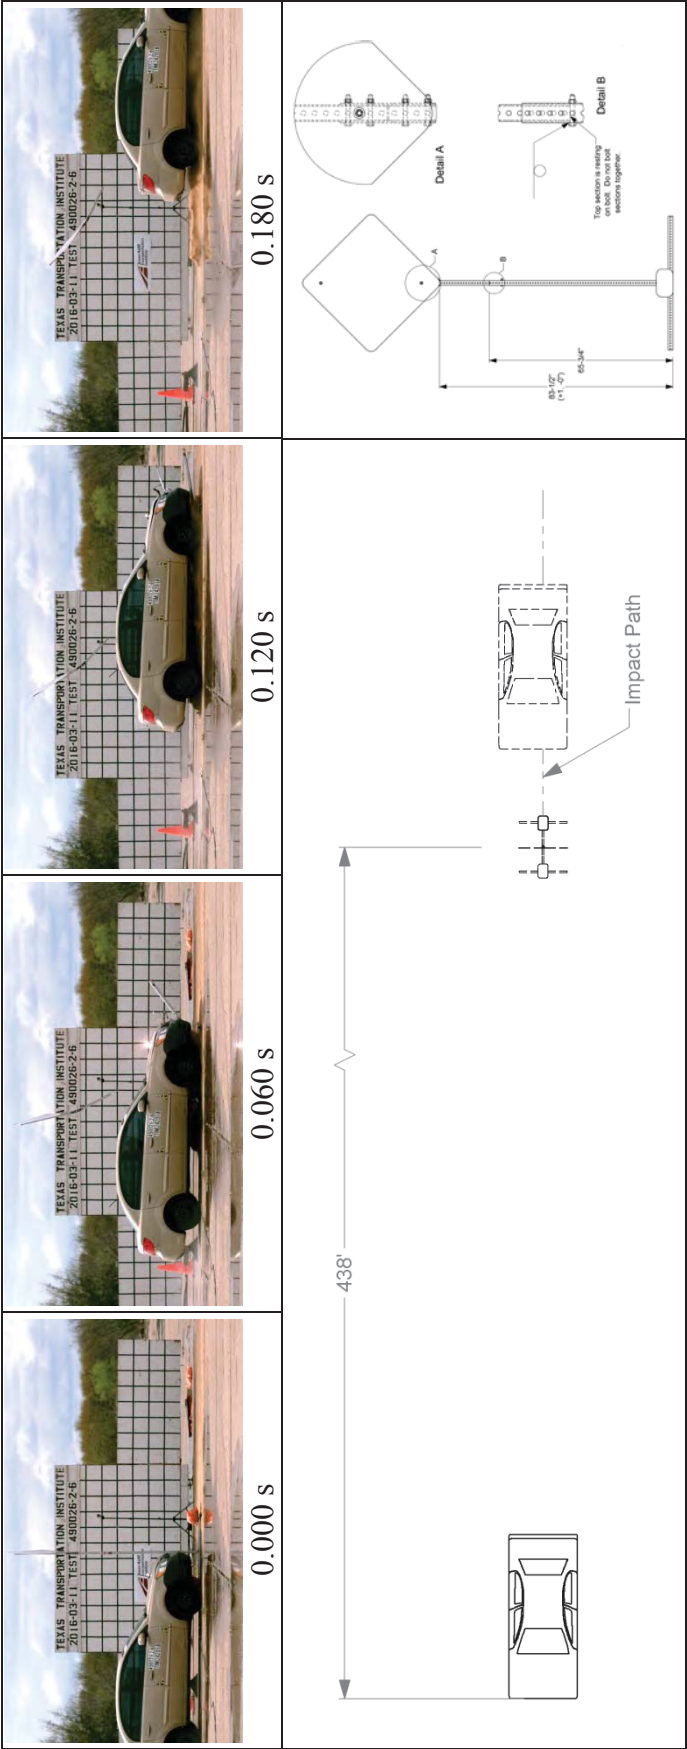
Figure 6.19. Summary of Results for MASH Test 3-71 at 0 Degrees on the Option B Temporary Work Zone Sign Support.

Figure 6.19 provides a summary of the results of the test. The slip connection of Option B temporary work zone sign support performed as designed and permitted the top of the system to release from the lower section. There was no secondary contact between the sign panel and the roof of the vehicle.

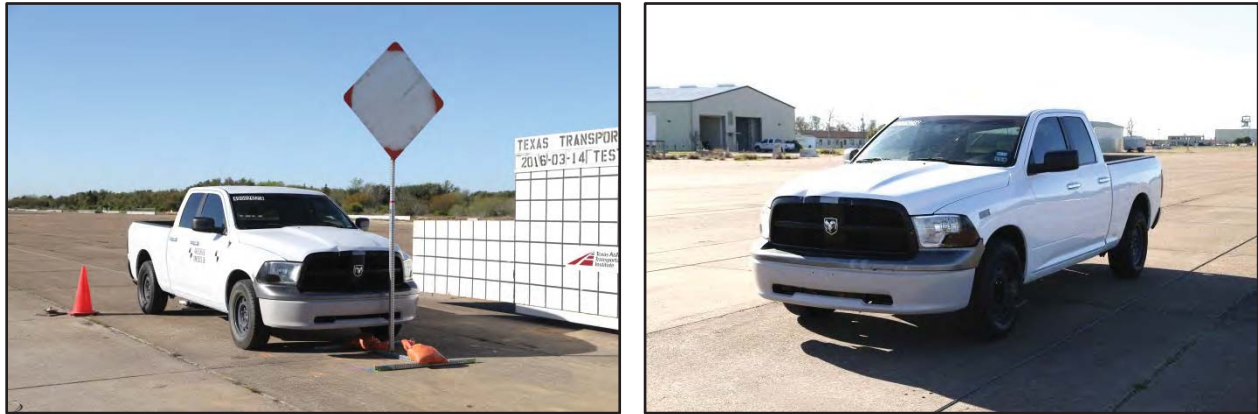
Figure 6.21. Test Vehicle before Test No. 490026-2-8.

The 2010 Dodge Ram 1500 pickup, shown in Figure 6.21, was used for the crash test. The vehicle's test inertia weight was 5014 lb, and its gross static weight was 5014 lb. The height to the lower edge of the vehicle bumper was 12.5 inches, and the height to the upper edge of the vehicle bumper was 27.5 inches. The height to the vehicle's center of gravity was 28.4 inches. Tables E.1 and E.2 in Appendix E1 give additional dimensions and information on the vehicle. The vehicle was directed into the installation using a cable reverse tow and guidance system, and was released to be freewheeling and unrestrained just prior to impact.

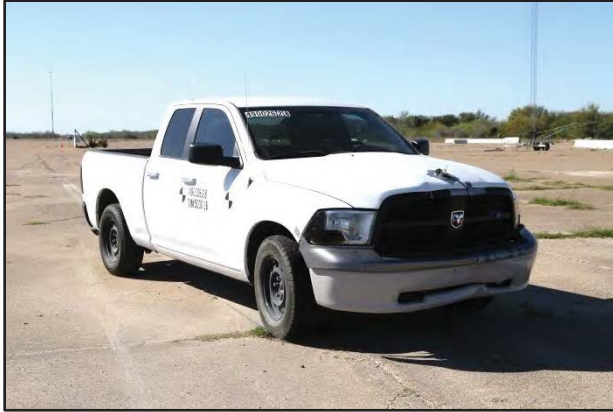
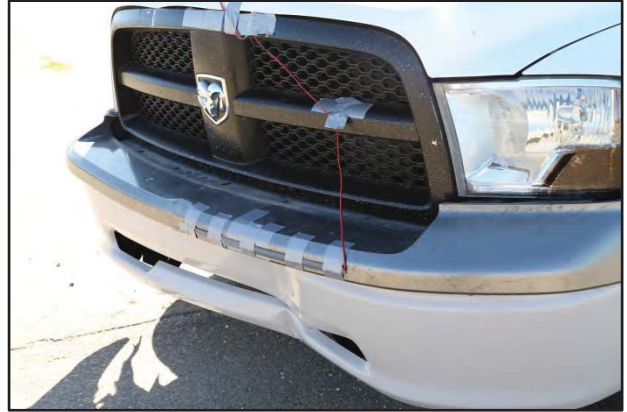
Figure 6.23. Test Vehicle after Test No. 490026-2-8.

Figure 6.23 shows the damage sustained by the vehicle. The bumper and hood were damaged. Maximum exterior crush to the vehicle was 4.0 inches in the front plane at the left quarter point at bumper height. Figure 6.24 shows the interior of the vehicle. No occupant compartment deformation or intrusion was noted. Tables E.3 and E.4 in Appendix E1 provide exterior crush and occupant compartment measurements.

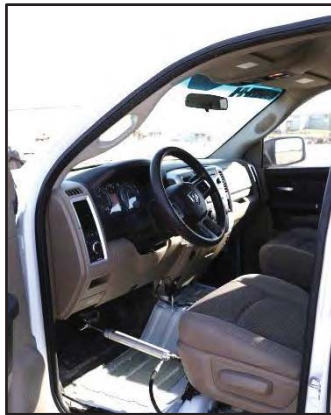
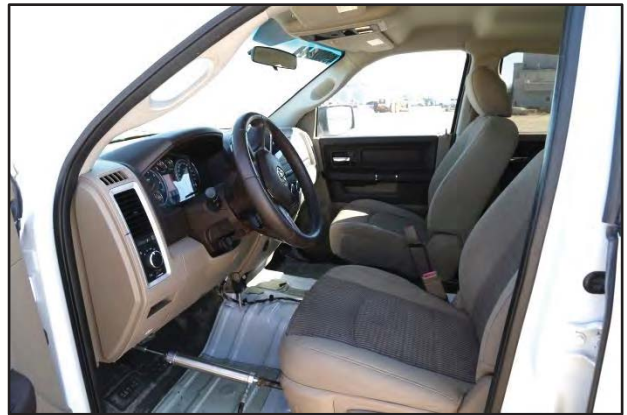
Figure 6.24. Interior of Test Vehicle after Test No. 490026-2-8.

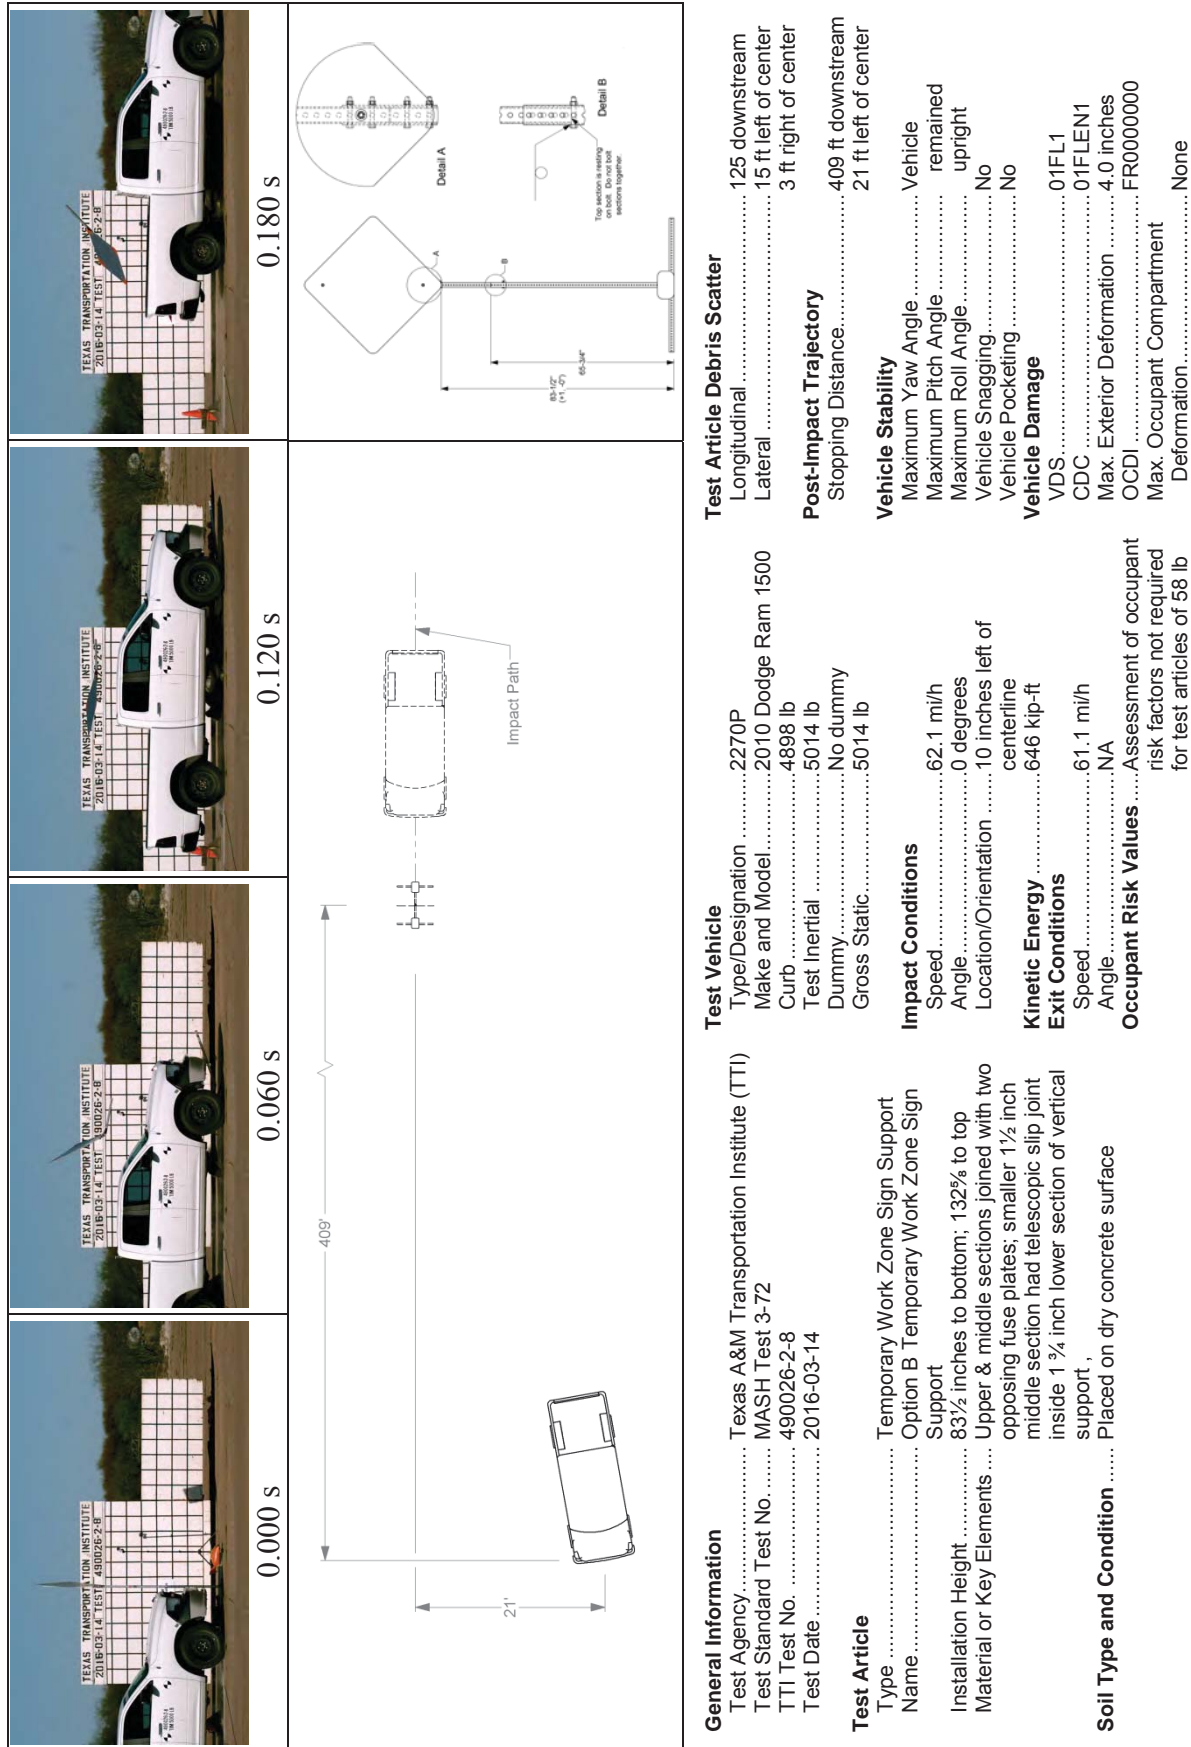
Figure 6.25. Summary of Results for MASH Test 3-72 at 0 Degrees on the Option B Temporary Work Zone Sign Support.

Figure 6.25 provides a summary of the results of the test. The slip connection of Option B temporary work zone sign supports performed as designed and the top of the system released from the lower section. The lower section of the vertical support fractured but did not penetrate or show potential for penetrating the vehicle. No occupant compartment deformation or intrusion was noted. The fractured pieces of the Option B temporary work zone sign support did not block the driver's view and would not cause the driver to lose control of the 2270P vehicle. The 2270P vehicle remained upright during and after the collision event. The 2270P vehicle came to rest 409 ft behind the installation.

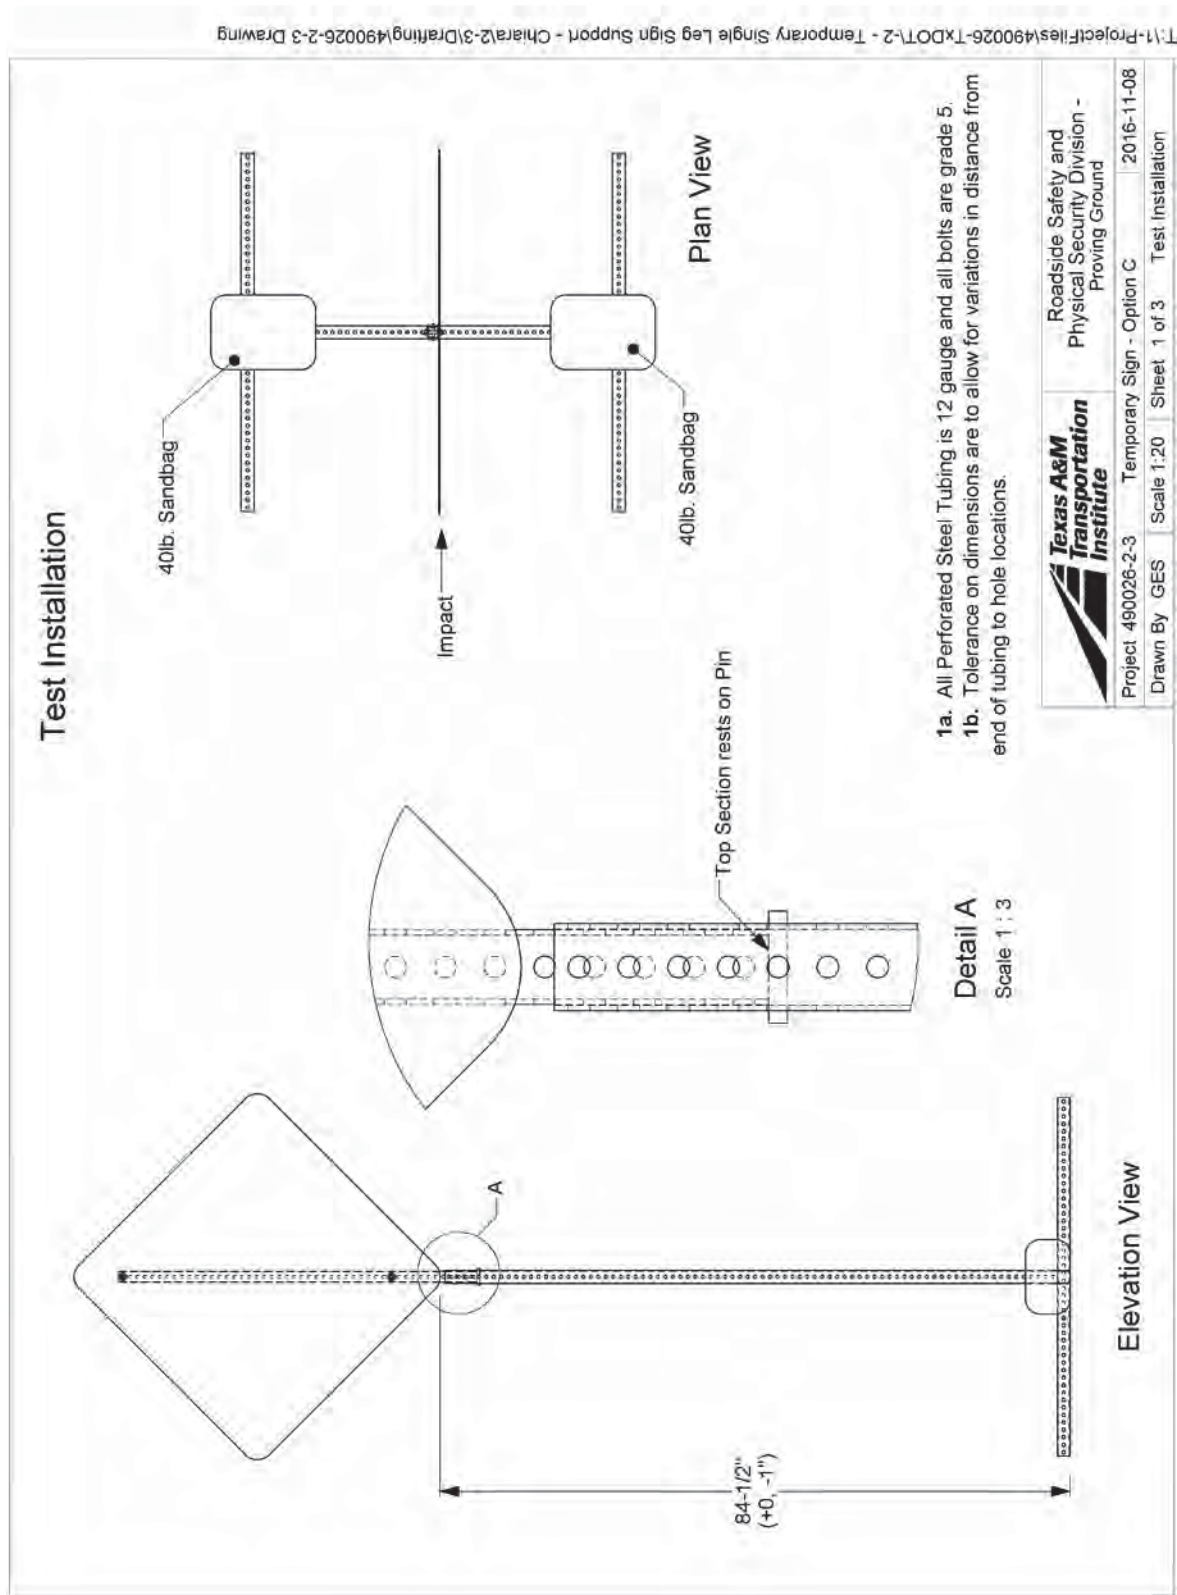
Figure 7.1. Details of the Option C Temporary Work Zone Sign Support.

Figure 7.1 shows details of the Option C temporary work zone sign and post installation. Figure 7.2 provides photographs of the completed installation.

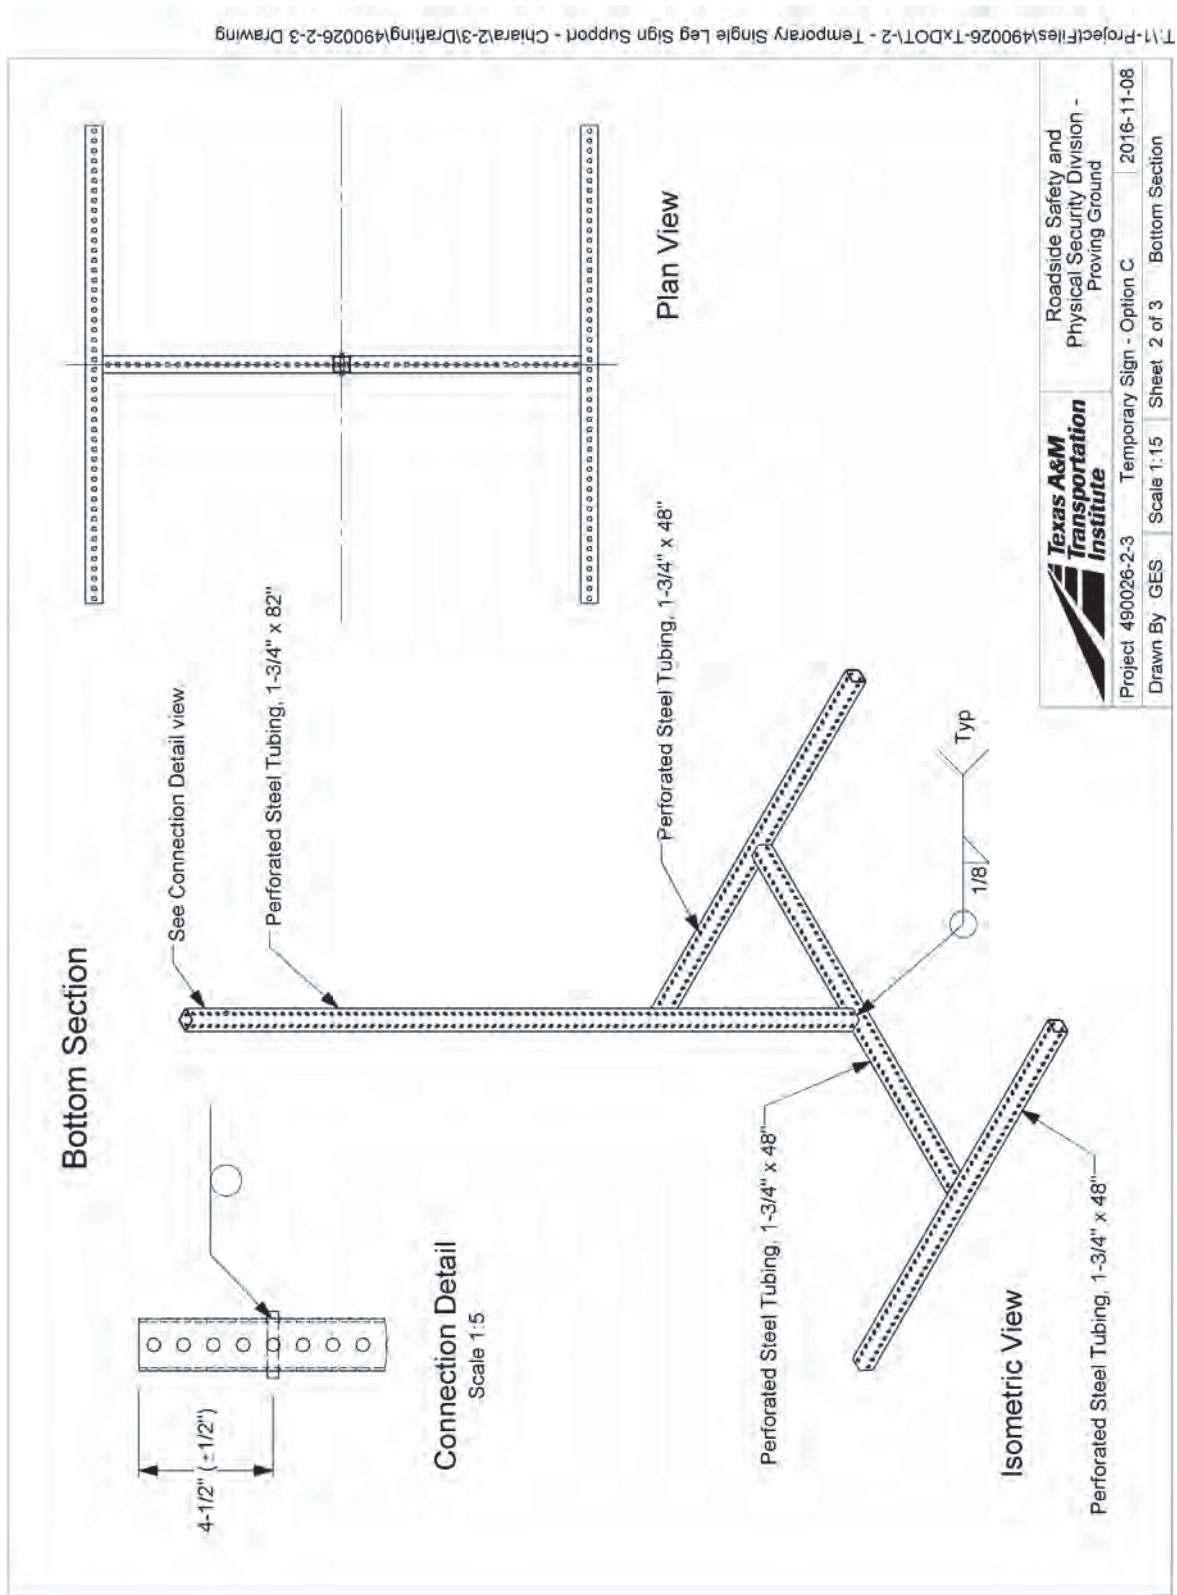
Figure 7.1. Details of the Option C Temporary Work Zone Sign Support (Continued).

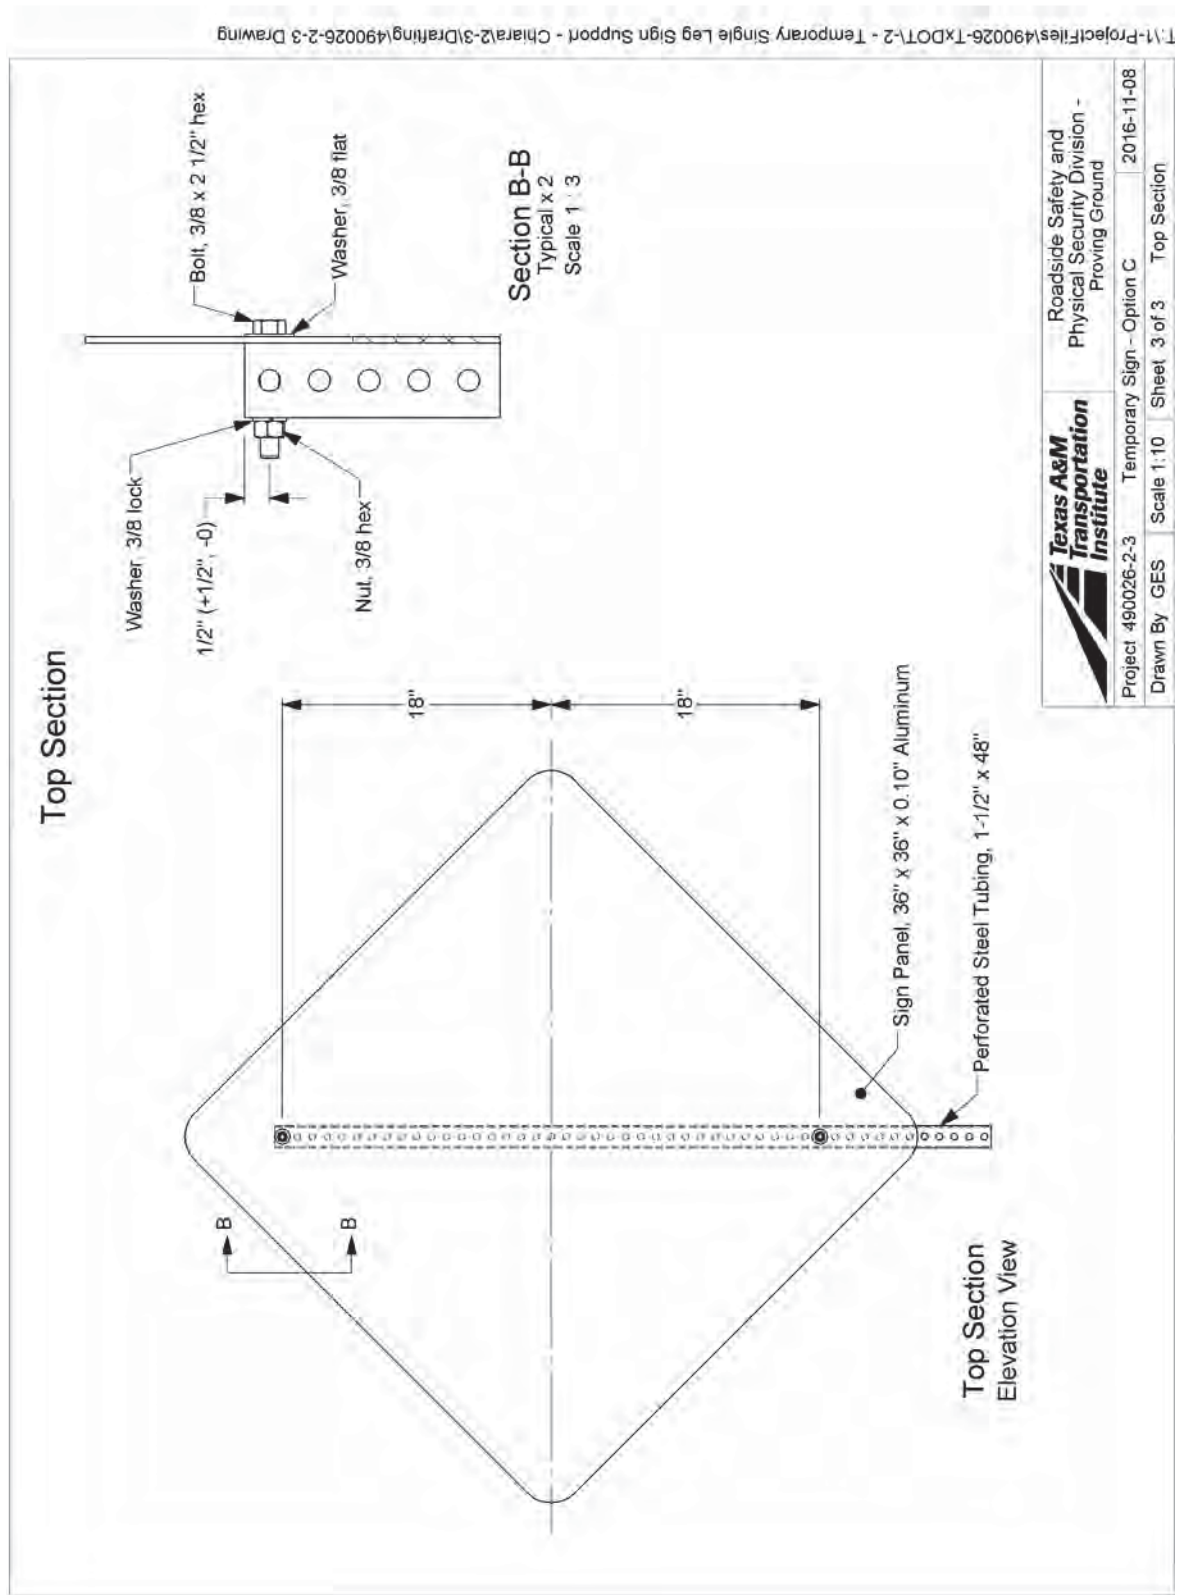
Roadside Safety and Physical Security Division - Proving Ground		
	Project 490026-2-3	Temporary Sign - Option C	2016-11-08
	Drawn By GES	Scale 1:10 Sheet 3 of 3	Top Section

Figure 7.1. Details of the Option C Temporary Work Zone Sign Support (Continued).

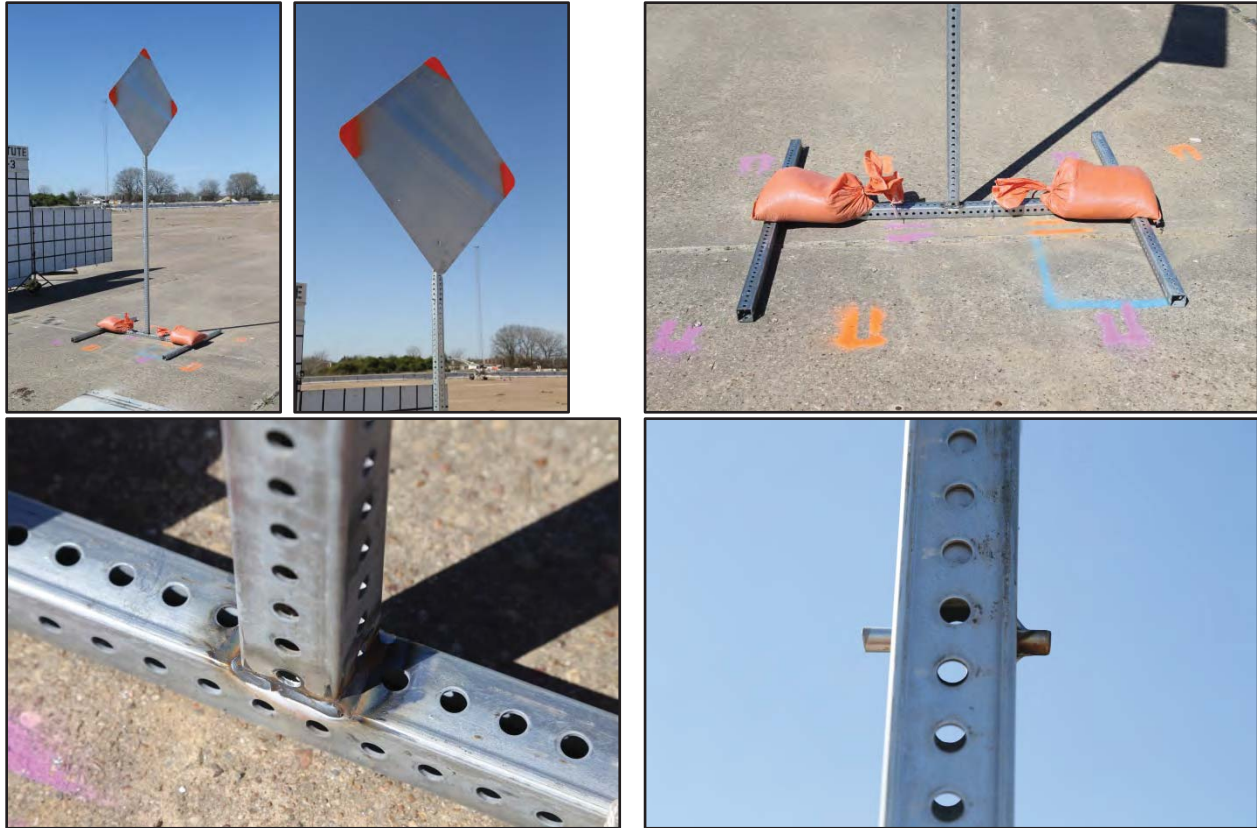
Figure 7.2. Option C Temporary Work Zone Sign Support Used for Test No. 490026-2-3.

MASH Test 3-72 involves a 2270P vehicle weighing 5000 lb \pm 110 lb impacting the Option C temporary work zone sign support at an impact speed of 62.2 mi/h \pm 2.5 mi/h and CIA \pm 1.5 degrees. The CIA for MASH Test 3-72 on the temporary work zone sign support was 90 degrees. The 2010 Dodge Ram 1500 pickup truck used in the test weighed 5014 lb, and the actual impact speed and angle were 62.5 mi/h and 90 degrees, respectively. The actual impact point was the centerline of the front of the vehicle. The target KE was \geq 594 kip-ft, and the actual KE at impact was 653 kip-ft. Figure 7.2 shows the installation before the test.

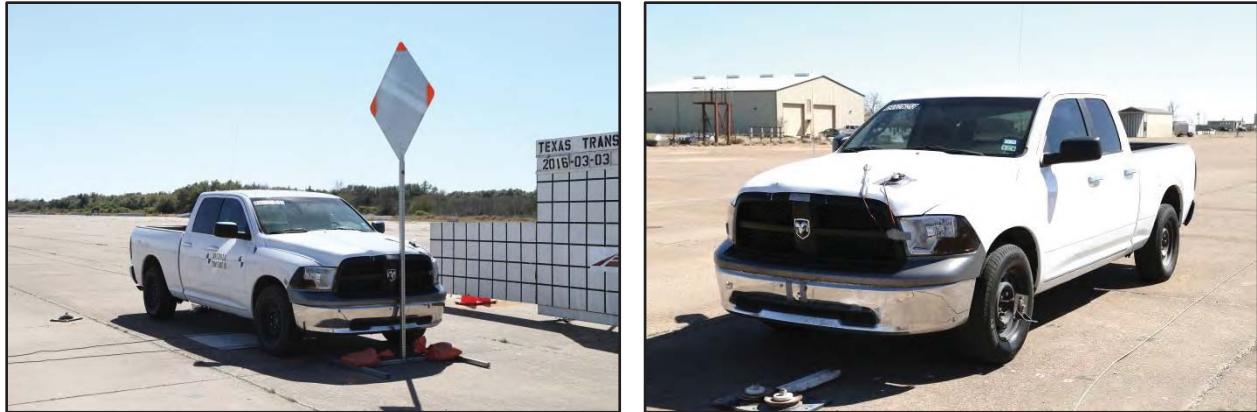
Figure 7.3. Test Vehicle before Test No. 490026-2-3.

The 2010 Dodge Ram 1500 pickup, shown in Figure 7.3, was used for the crash test. The vehicle's test inertia weight was 5014 lb, and its gross static weight was 5014 lb. The height to the lower edge of the vehicle bumper was 12.5 inches, and the height to the upper edge of the vehicle bumper was 27.5 inches. The height to the vehicle's center of gravity was 28.4 inches. Tables F.1 and F.2 in Appendix F1 give additional dimensions and information on the vehicle. The vehicle was directed into the installation using the cable reverse tow and guidance system, and was released to be freewheeling and unrestrained just prior to impact.
