MASH EVALUATION OF TxDOT HIGH-MOUNTING-HEIGHT TEMPORARY WORK ZONE SIGN SUPPORT SYSTEM

Test Report 9-1002-15-8

**TEXAS A&M TRANSPORTATION INSTITUTE
COLLEGE STATION, TEXAS**

TEXAS DEPARTMENT OF TRANSPORTATION

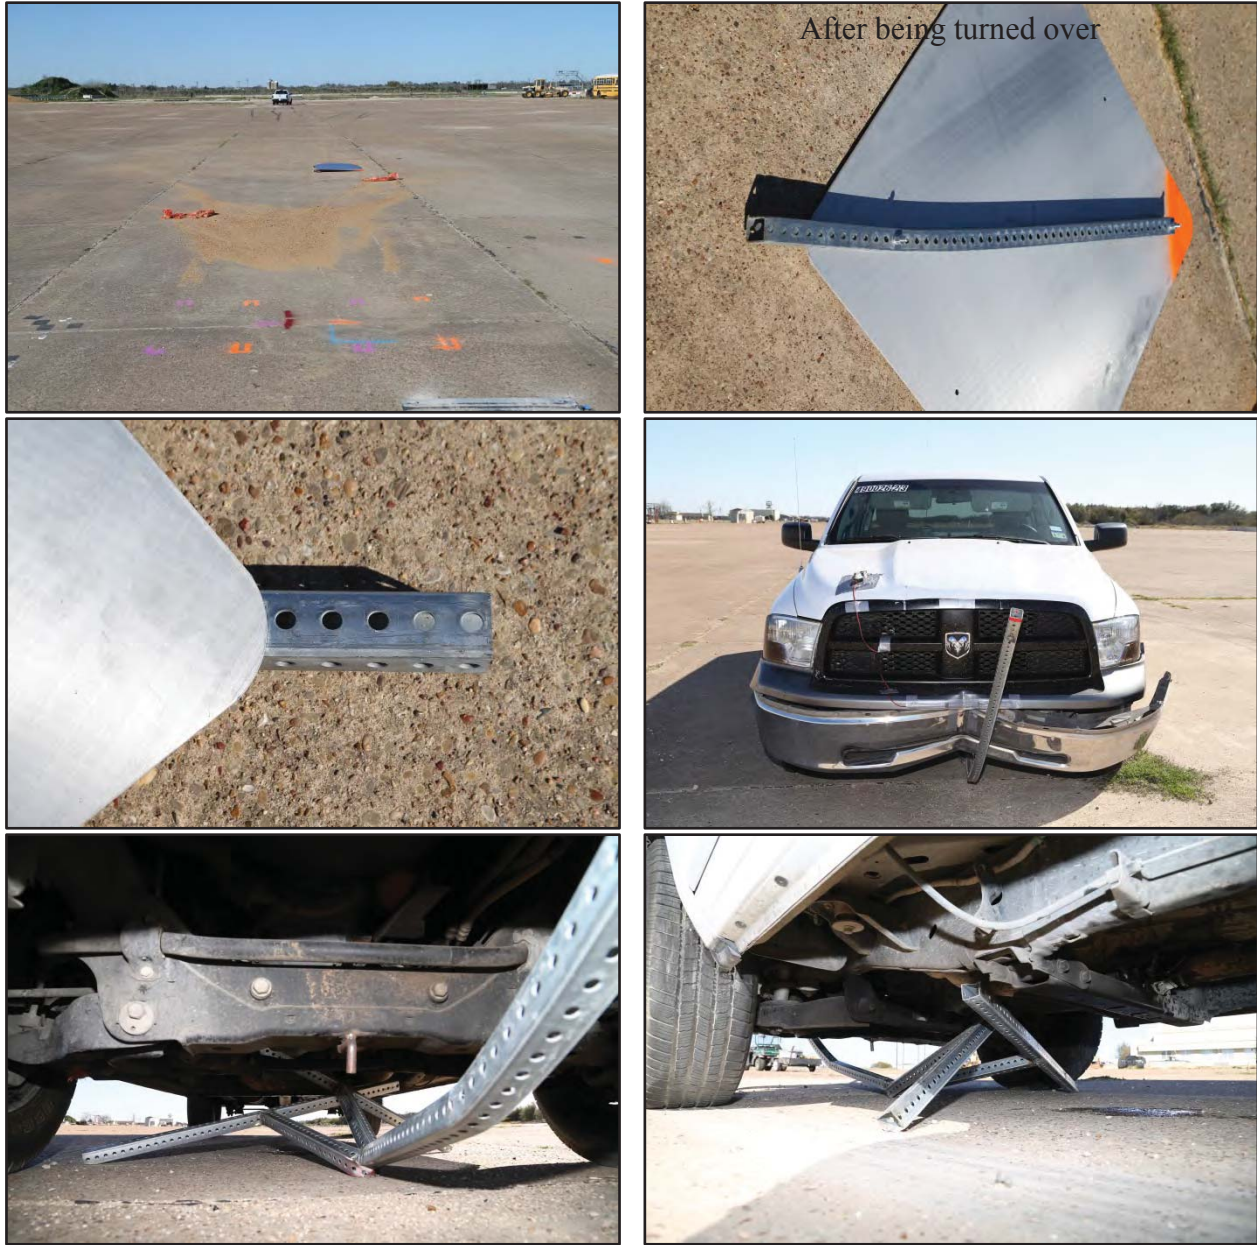
Figure 7.4. Option C Temporary Work Zone Sign Support after Test No. 490026-2-3.

Figure 7.4 shows the damage to the Option C temporary work zone sign support. The sign panel and the attached upper section of the vertical support came to rest 35 ft downstream of impact and 3 ft to the right of centerline of the impact path. The remainder of the temporary work zone sign support became lodged under the 2270P vehicle and traveled along with the vehicle, which came to rest 347 ft downstream of impact and on the centerline of the impact path.

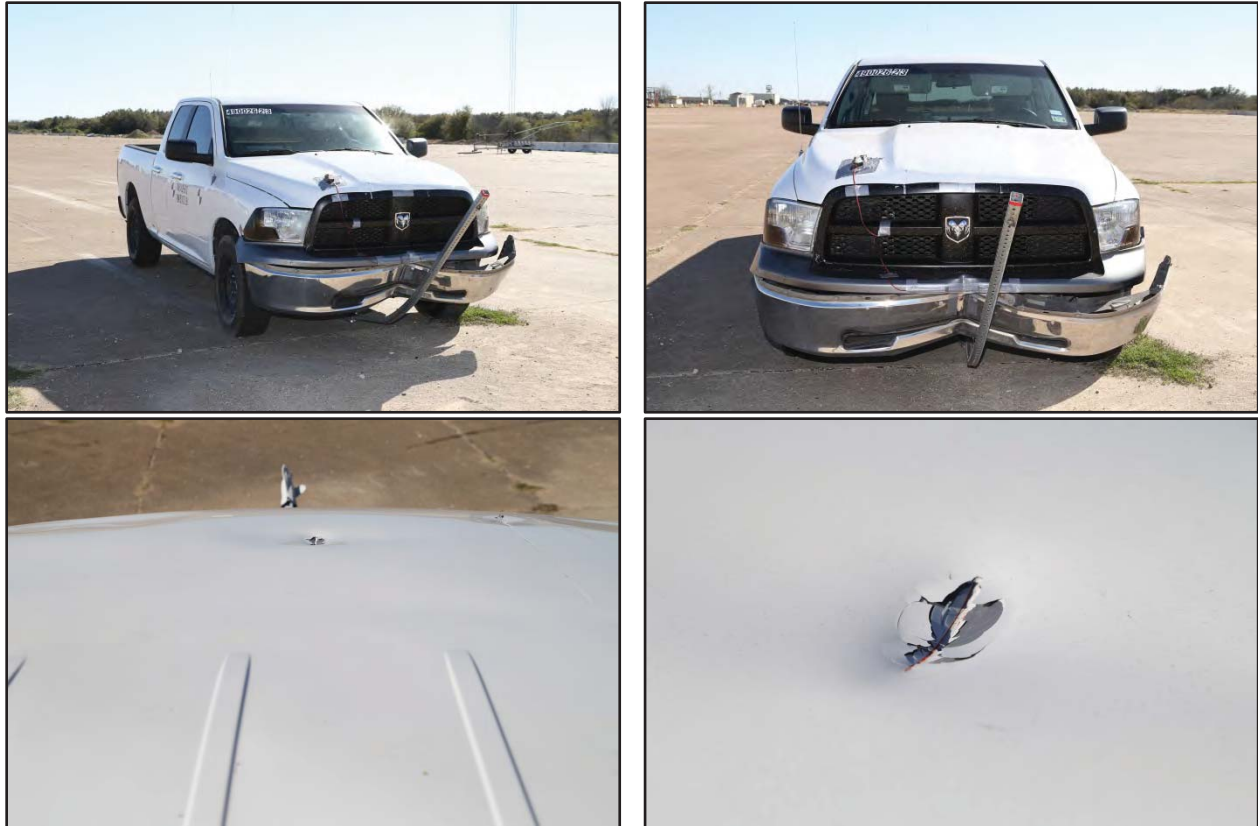
Figure 7.5. Test Vehicle after Test No. 490026-2-3.

Figure 7.5 shows the damage sustained by the vehicle. The bumper, hood, and roof were scraped. Maximum exterior crush to the vehicle was 6 inches in the front plane at the centerline at bumper height. There was a 3-inch long dent on the outer surface of the front of the roof of the cab, but it did not extend into the passenger compartment. Figure 7.6 shows the interior of the vehicle. No occupant compartment deformation or intrusion was noted. Tables F.3 and F.4 in Appendix F1 provide exterior crush and occupant compartment measurements.

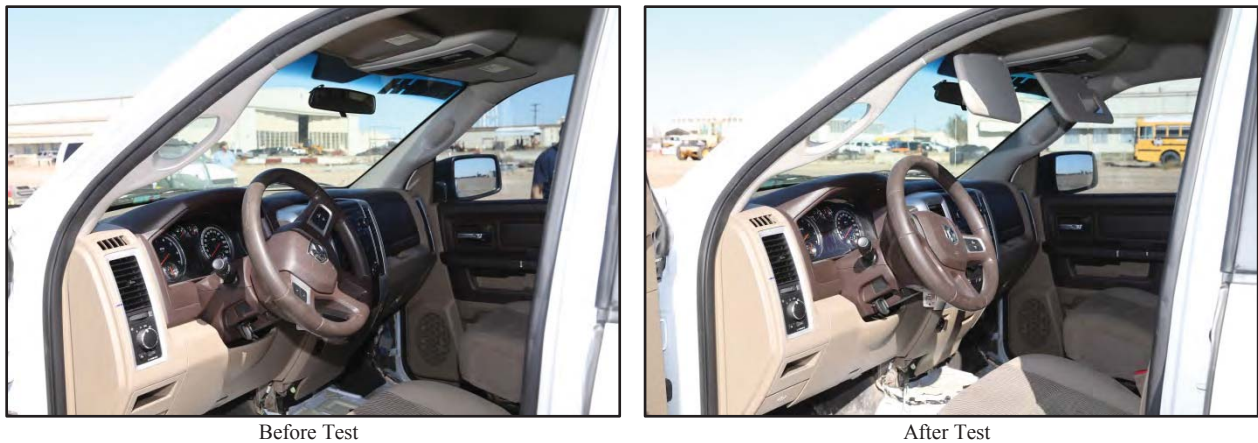
Figure 7.6. Interior of Test Vehicle for Test No. 490026-2-3.

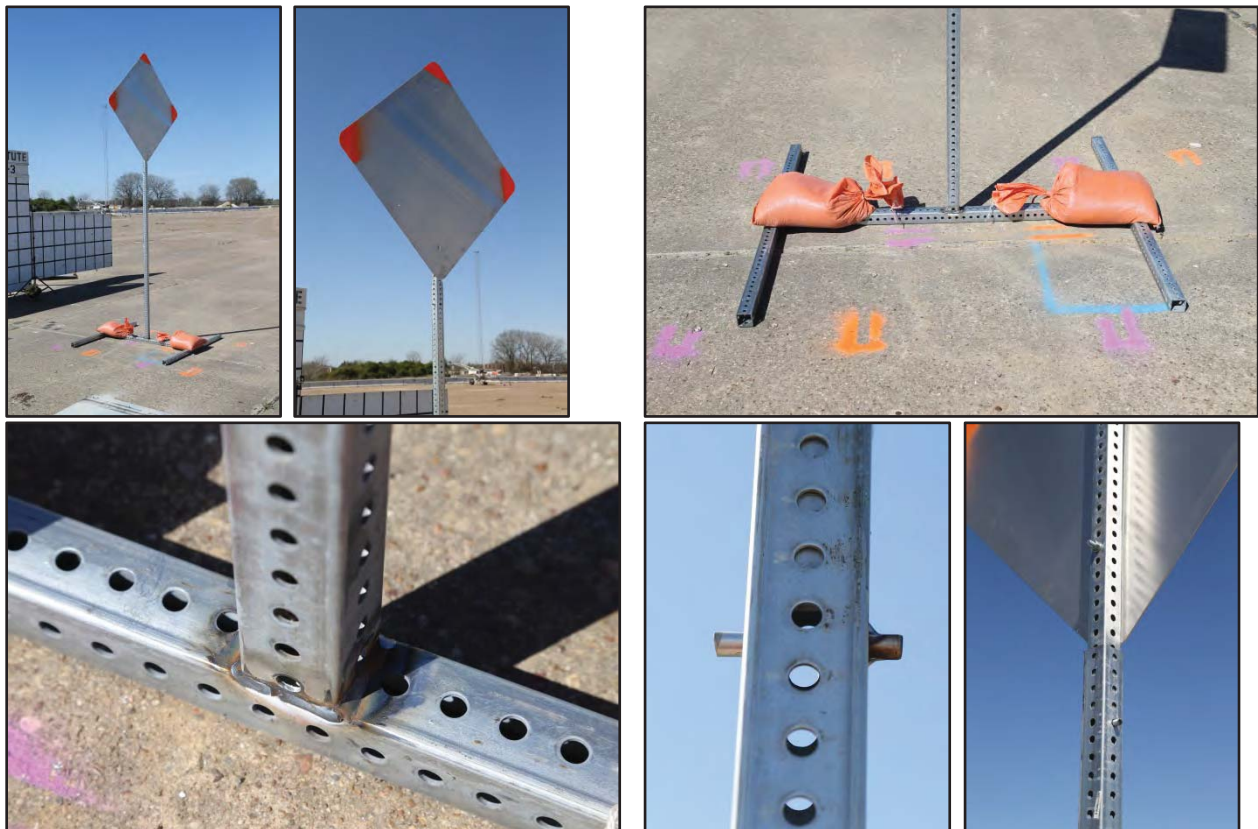
Figure 7.8. Option C Temporary Work Zone Sign Support Used for Test No. 490026-2-5.

MASH Test 3-71 involves an 1100C vehicle weighing 2425 lb \pm 55 lb impacting the Option C temporary work zone sign support at an impact speed of 62.2 mi/h \pm 2.5 mi/h and CIA \pm 1.5 degrees. The CIA for MASH Test 3-71 on the temporary work zone sign support was 90 degrees. The 2011 Kia Rio used in the test weighed 2443 lb, and the actual impact speed and angle were 61.5 mi/h and 90 degrees, respectively. The actual impact point was 10 inches to the left of centerline of the vehicle. The target KE was \geq 288 kip-ft, and the actual KE at impact was 309 kip-ft. Figure 7.8 shows the installation before the test.

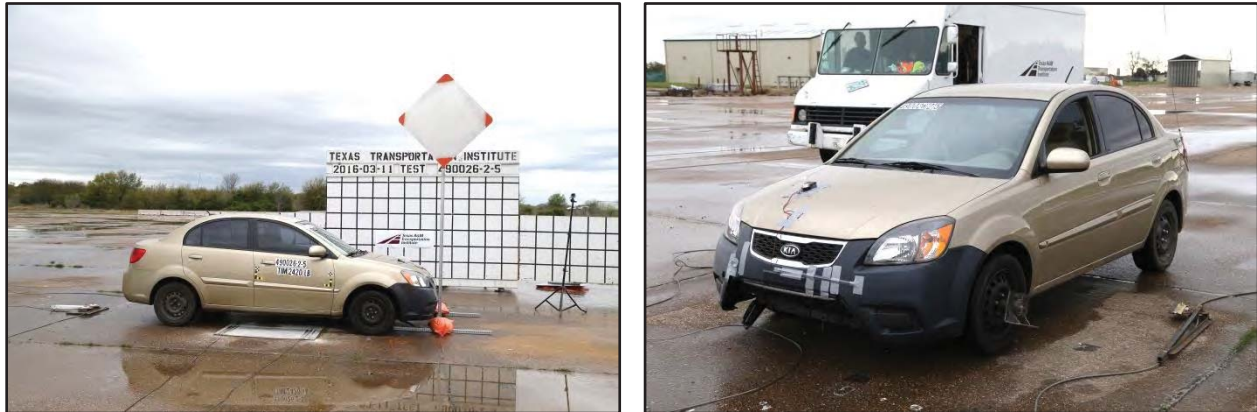
Figure 7.9. Test Vehicle before Test No. 490026-2-5.

The 2011 Kia Rio for the previous test (test 490026-2-4), shown in Figure 7.9, was used for the crash test. The vehicle's test inertia weight was 2443 lb, and its gross static weight was 2608 lb. The height to the lower edge of the vehicle bumper was 8.0 inches, and the height to the upper edge of the vehicle bumper was 21.5 inches. Table G.1 in Appendix G1 gives additional dimensions and information on the vehicle. The vehicle was directed into the installation using the cable reverse tow and guidance system, and was released to be freewheeling and unrestrained just prior to impact.

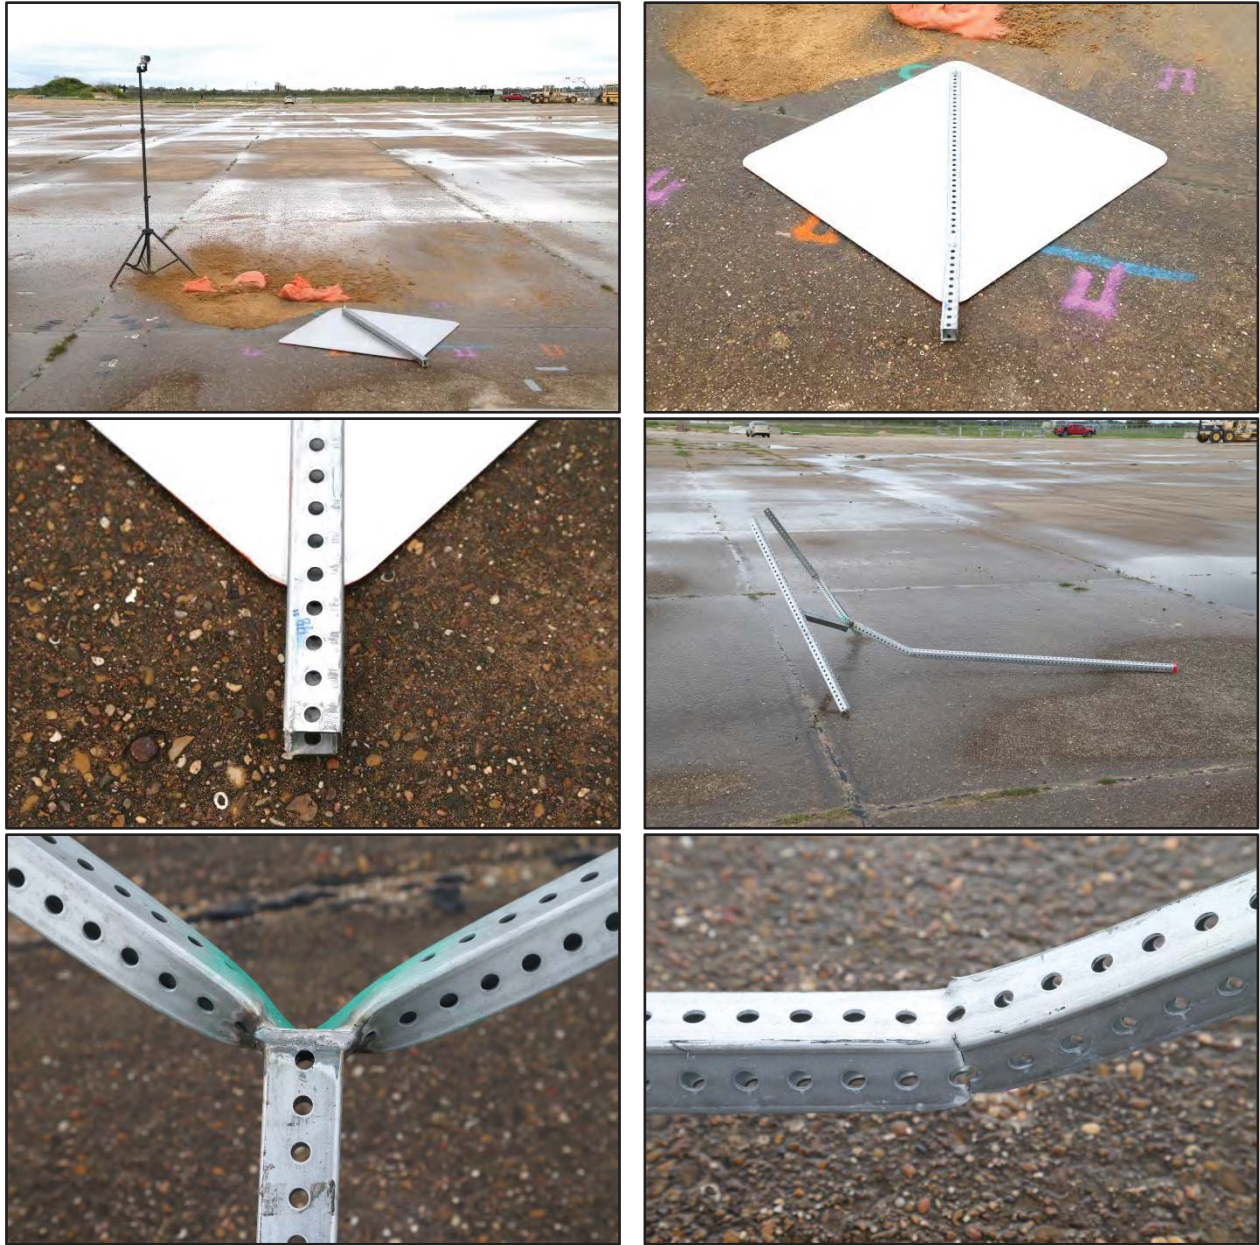
Figure 7.10. Option C Temporary Work Zone Sign Support after Test No. 490026-2-5.

Figure 7.10 shows the damage to the Option C temporary work zone sign support. The sign panel and attached upper section of the vertical support came to rest at the point of impact. The remainder of the temporary work zone sign support rode along with the 1100C vehicle for a distance and then came to rest 230 ft downstream of impact and 25 ft to the left of centerline of the impact path.

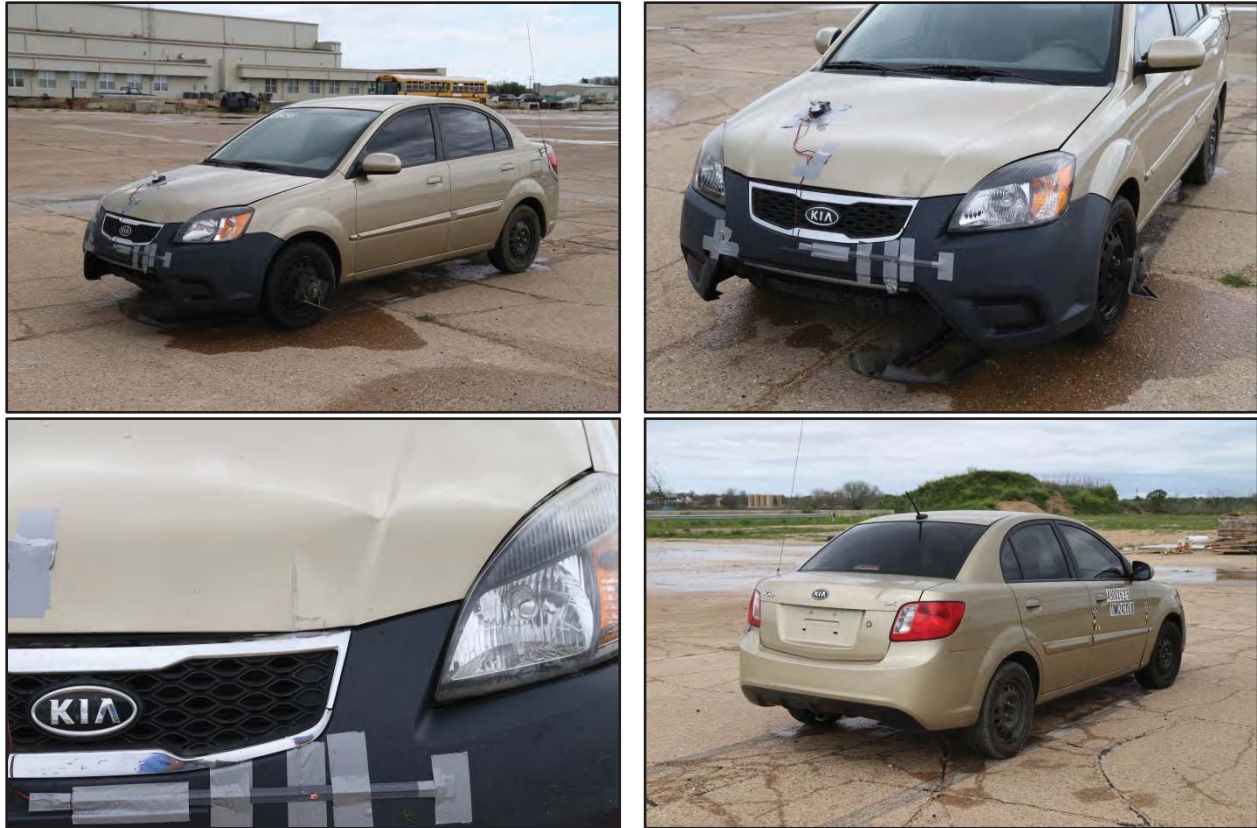
Figure 7.11. Test Vehicle after Test No. 490026-2-5.

Figure 7.11 shows the damage sustained by the vehicle. The 1100C vehicle sustained only scrapes to the bumper and hood with no measureable exterior vehicle deformation. Figure 7.12 shows the interior of the vehicle. No occupant compartment deformation or intrusion was noted. Tables G.2 and G.3 in Appendix G1 provides exterior crush and occupant compartment measurements.

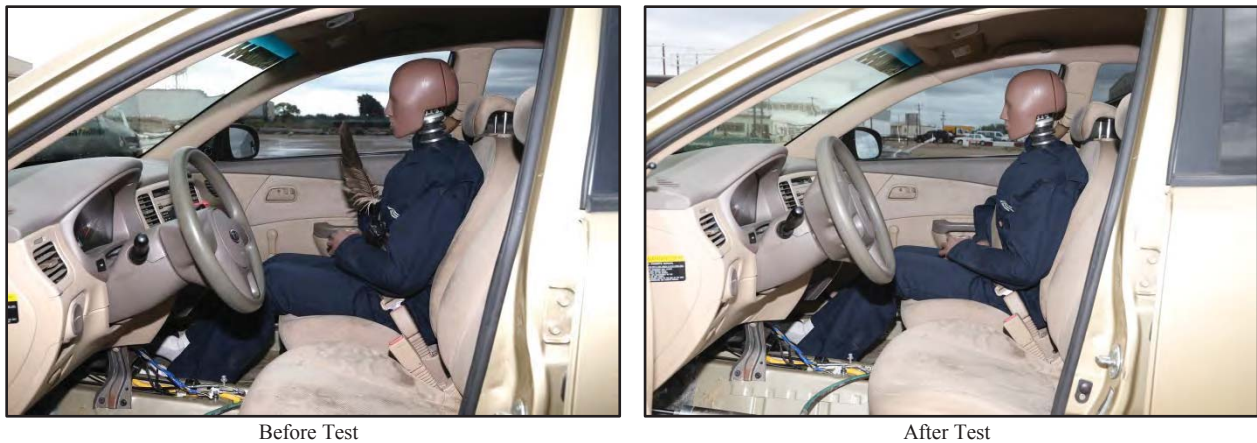
Figure 7.12. Interior of Test Vehicle for Test No. 490026-2-5.

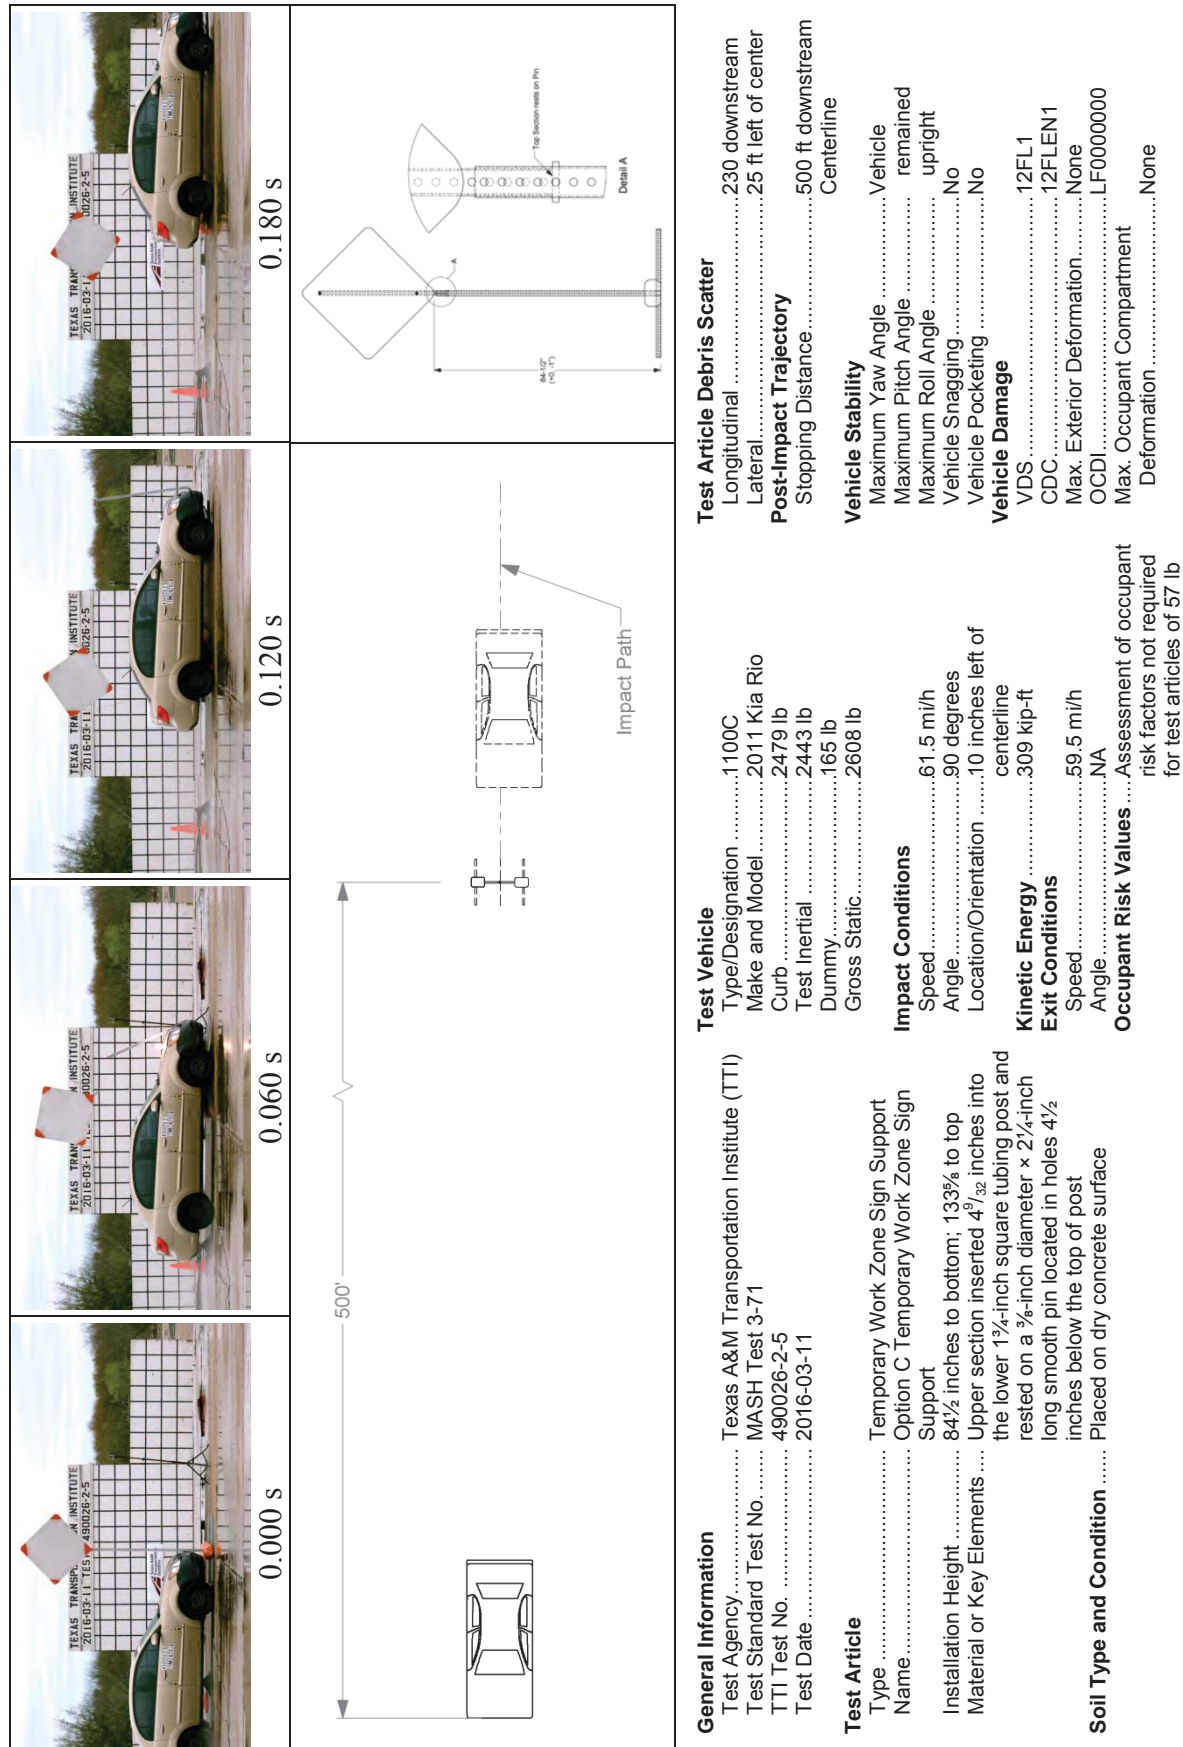
Figure 7.13. Summary of Results for MASH Test 3-71 at 90 Degrees on the Option C Temporary Work Zone Sign Support.

Figure 7.13 provides a summary of the results of the test. The slip connection of Option C temporary work zone sign support performed as designed and the top of the system released from the lower section at vehicle impact. The support structure contacted the bumper and hood, but the sign panel did not contact the roof of the vehicle.

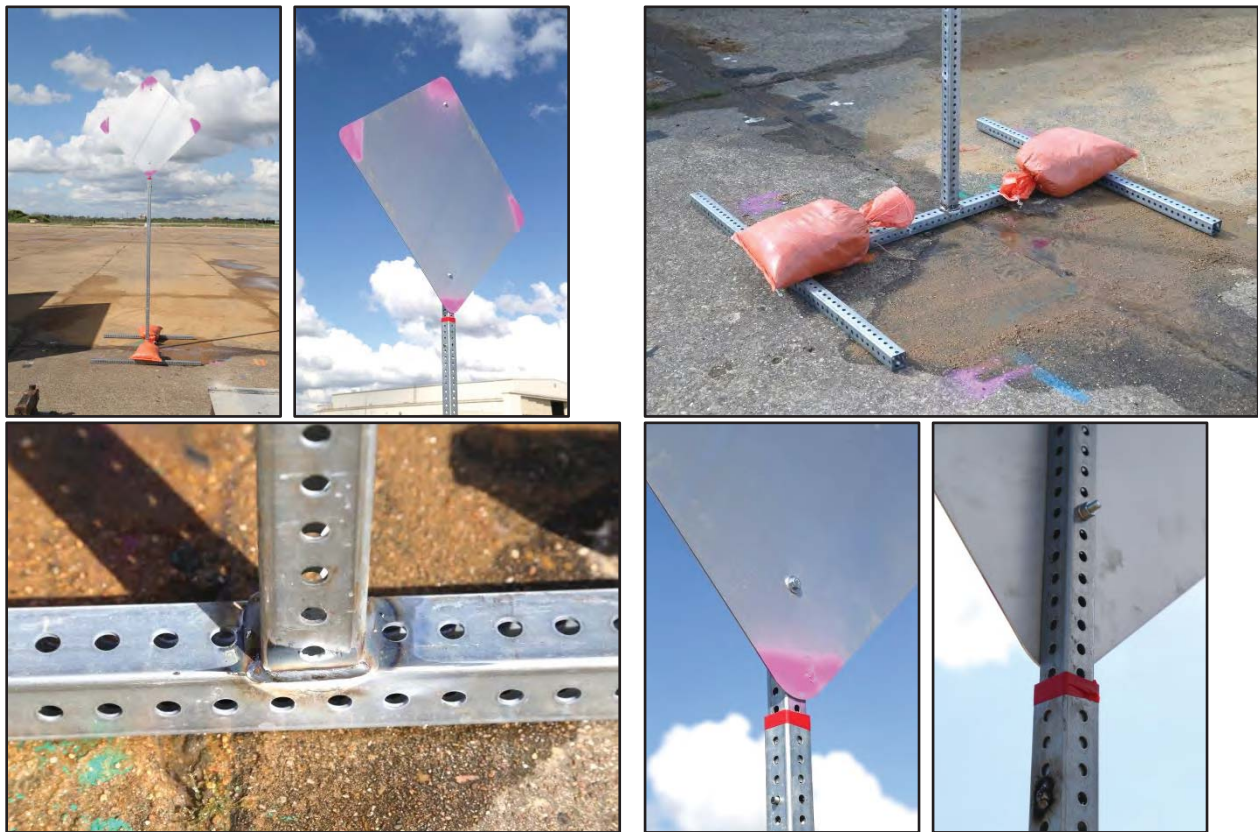
Figure 7.14. Option C Temporary Work Zone Sign Support Used for Test No. 490026-2-7.

MASH Test 3-71 involves an 1100C vehicle weighing 2425 lb \pm 55 lb and impacting the Option C temporary work zone sign support at an impact speed of 62.2 mi/h \pm 2.5 mi/h and CIA \pm 1.5 degrees. The CIA for MASH Test 3-71 on the temporary work zone sign support was 0 degrees. The 2011 Kia Rio used in the test weighed 2443 lb, and the actual impact speed and angle were 61.9 mi/h and 90 degrees, respectively. The actual impact point was 10 inches to the left of centerline of the vehicle. Target KE was \geq 288 kip-ft, and actual KE was 313 kip-ft. Figure 7.14 shows the installation before the test.

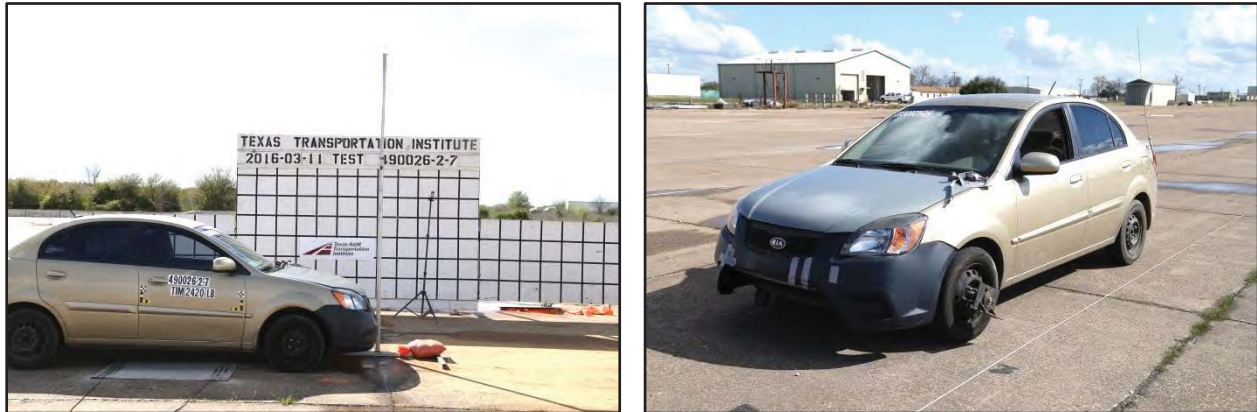
Figure 7.15. Test Vehicle before Test No. 490026-2-7.

The 2011 Kia Rio used in the tests 490026-2-4 and 2-5, shown in Figure 7.15, was used for the crash test. The vehicle's test inertia weight was 2443 lb, and its gross static weight was 2608 lb. The height to the lower edge of the vehicle bumper was 8.0 inches, and the height to the upper edge of the vehicle bumper was 21.5 inches. Table H.1 in Appendix H1 gives additional dimensions and information on the vehicle. The vehicle was directed into the installation using the cable reverse tow and guidance system, and was released to be freewheeling and unrestrained just prior to impact.

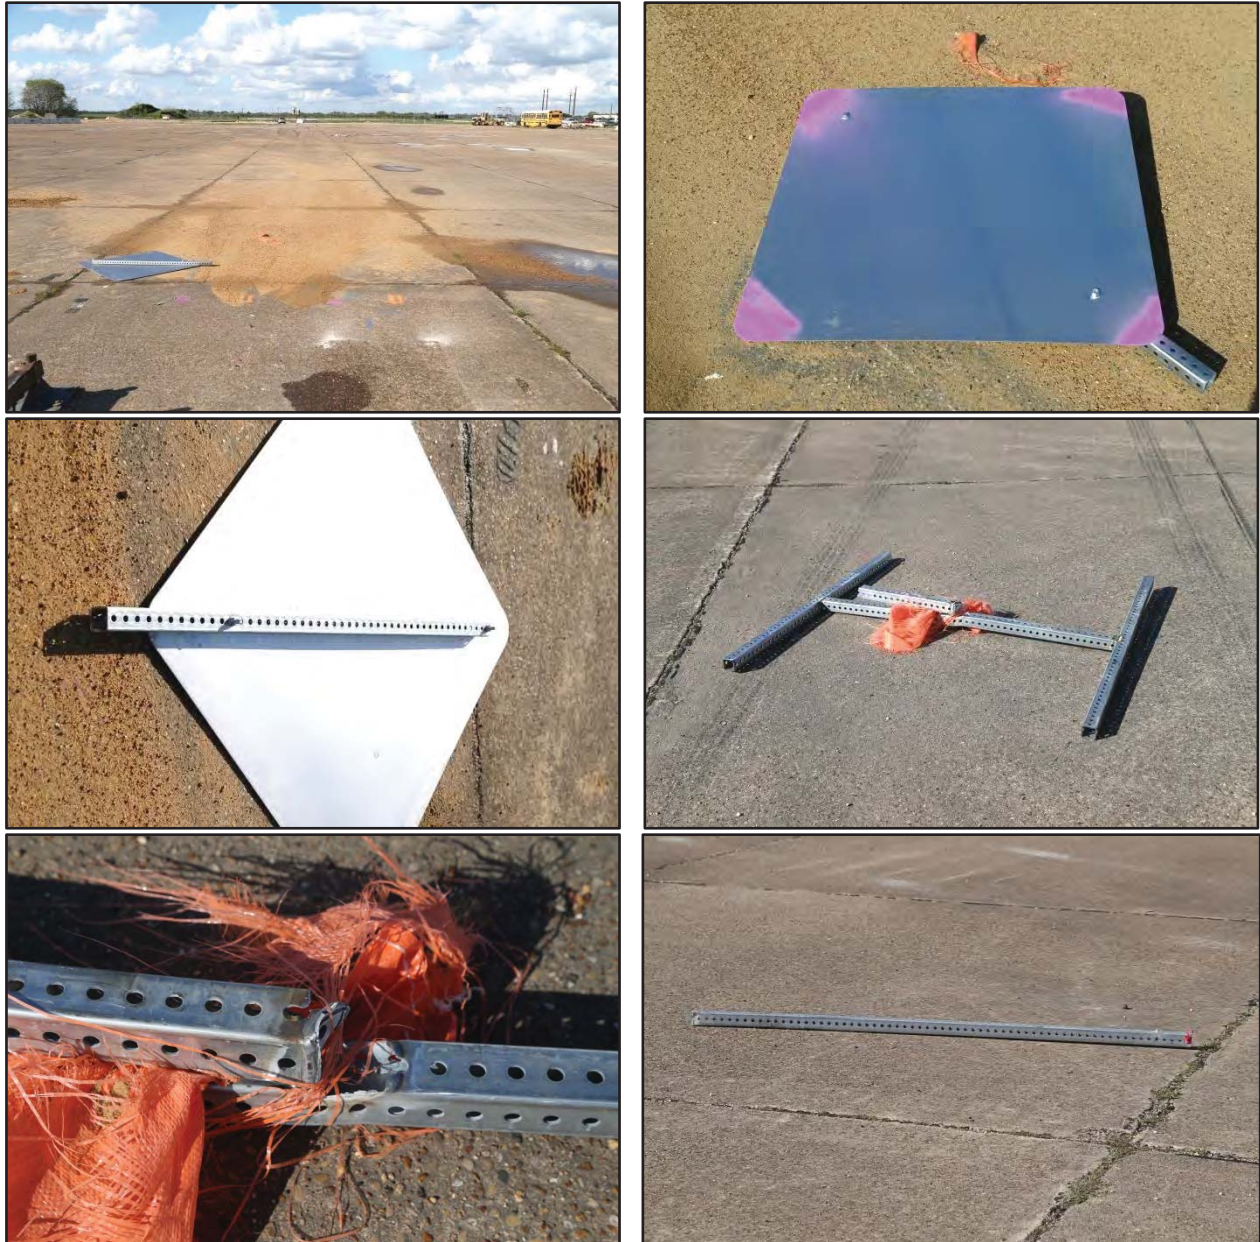
Figure 7.16. Option C Temporary Work Zone Sign Support after Test No. 490026-2-7.

Figure 7.16 shows the damage to the Option C temporary work zone sign support. The sign panel and attached upper section of the vertical support came to rest 2 ft downstream of impact and 2 ft to the left of centerline of the vehicle path. The lower portion of the temporary work zone sign support came to rest 143 ft downstream of impact and 9 ft to the right of centerline of the impact path, and was deformed 85 degrees. A piece of the vertical section fractured away from the lower support 18 inches above ground level, and came to rest 275 ft downstream of impact and 18 ft to the right of centerline of the vehicle path.

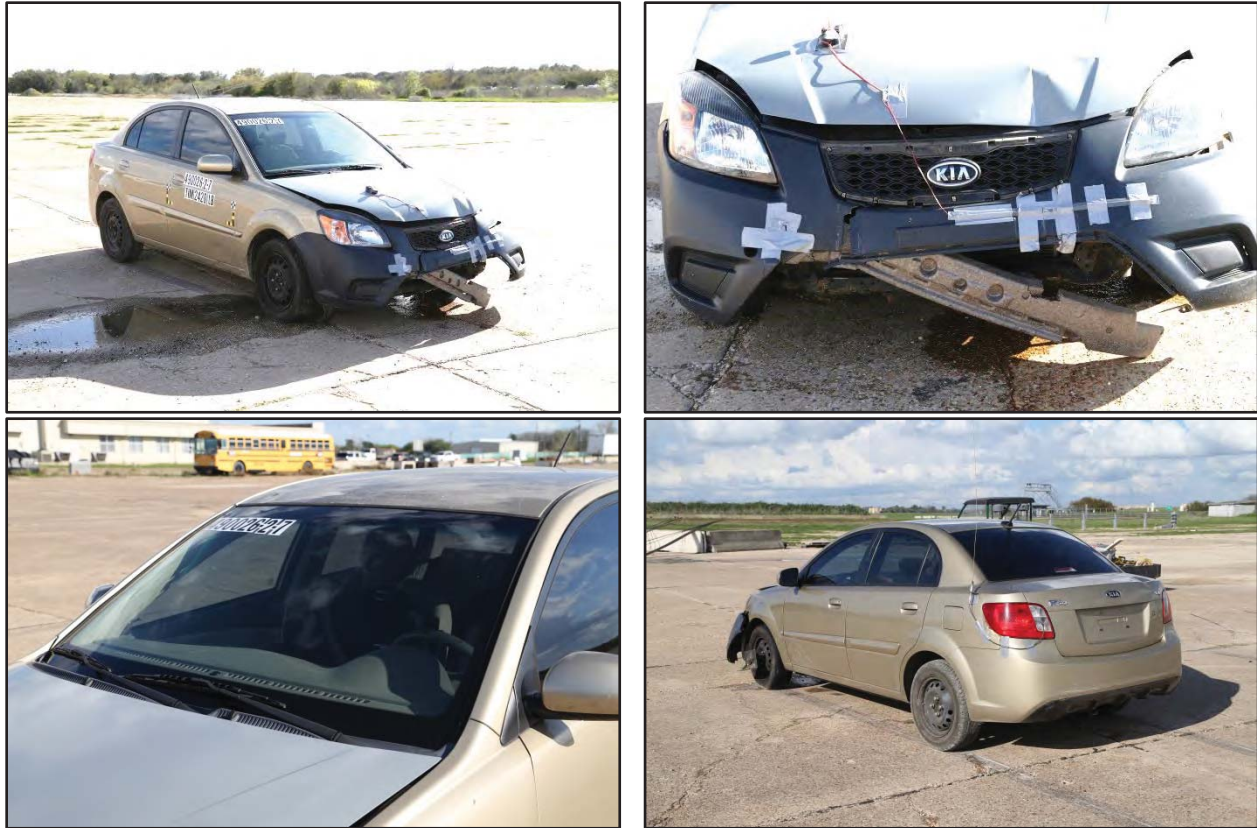
Figure 7.17. Test Vehicle after Test No. 490026-2-7.

Figure 7.17 shows the damage sustained by the vehicle. The 1100C vehicle sustained only scrapes to the bumper and hood with no measureable exterior vehicle deformation. Figure 7.18 shows the interior of the vehicle. No occupant compartment deformation or intrusion was noted. Tables H.2 and H.3 in Appendix H1 provides exterior crush and occupant compartment measurements.

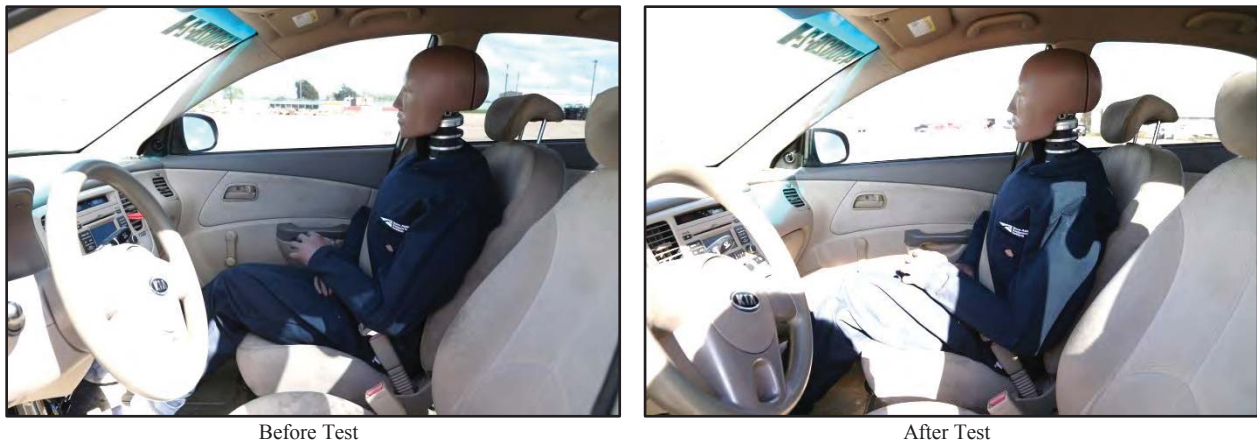
Figure 7.18. Interior of Test Vehicle for Test No. 490026-2-7.

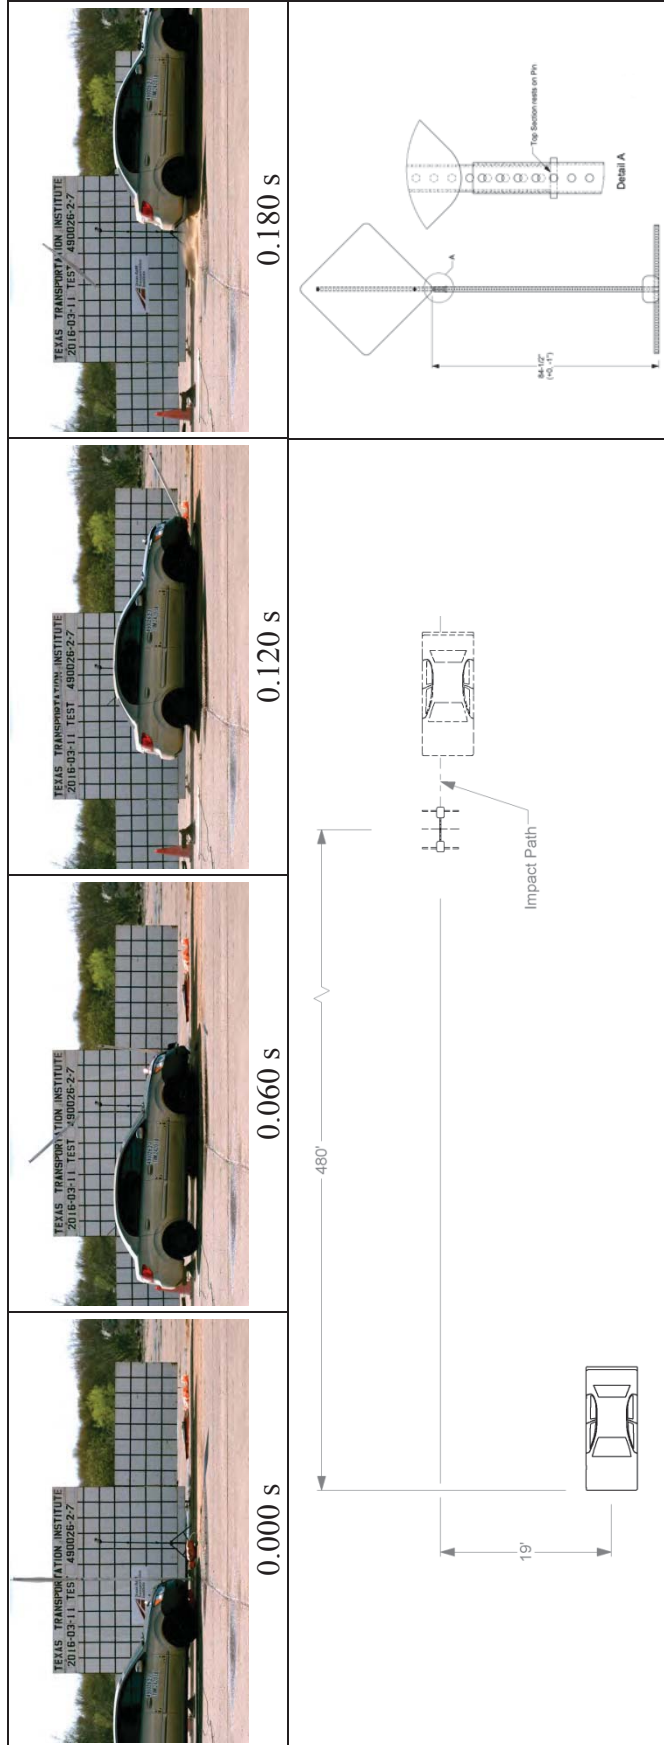
Figure 7.19. Summary of Results for MASH Test 3-71 at 0 Degrees on the Option C Temporary Work Zone Sign Support.

Figure 7.19 provides a summary of the results of the test. The slip connection of Option C temporary work zone sign support performed as designed and the top of the system released from the lower section. The support structure contacted the bumper and hood, but the sign panel did not contact the roof of the vehicle.

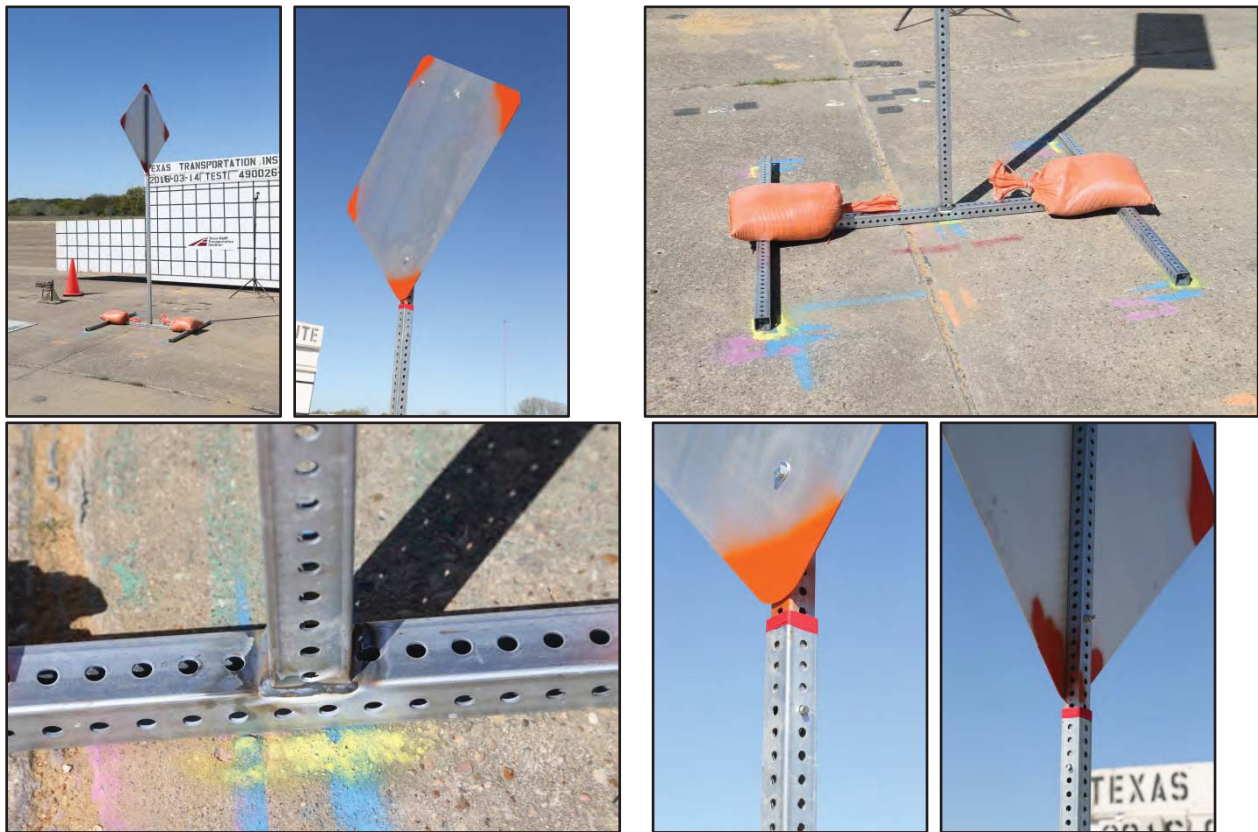
Figure 7.20. Option C Temporary Work Zone Sign Support Used for Test No. 490026-2-9.

MASH Test 3-72 involves a 2270P vehicle weighing 5000 lb \pm 110 lb impacting the Option C temporary work zone sign support at an impact speed of 62.2 mi/h \pm 2.5 mi/h and CIA \pm 1.5 degrees. The CIA for MASH Test 3-72 on the temporary work zone sign support was 0 degrees. The 2010 Dodge Ram 1500 pickup truck used in the test weighed 5014 lb, and the actual impact speed and angle were 62.9 mi/h and 0 degrees, respectively. The actual impact point was 10 inches to the left of centerline of the vehicle. The target KE was \geq 594 kip-ft, and the actual KE at impact was 663 kip-ft. Figure 7.20 shows the installation before the test.

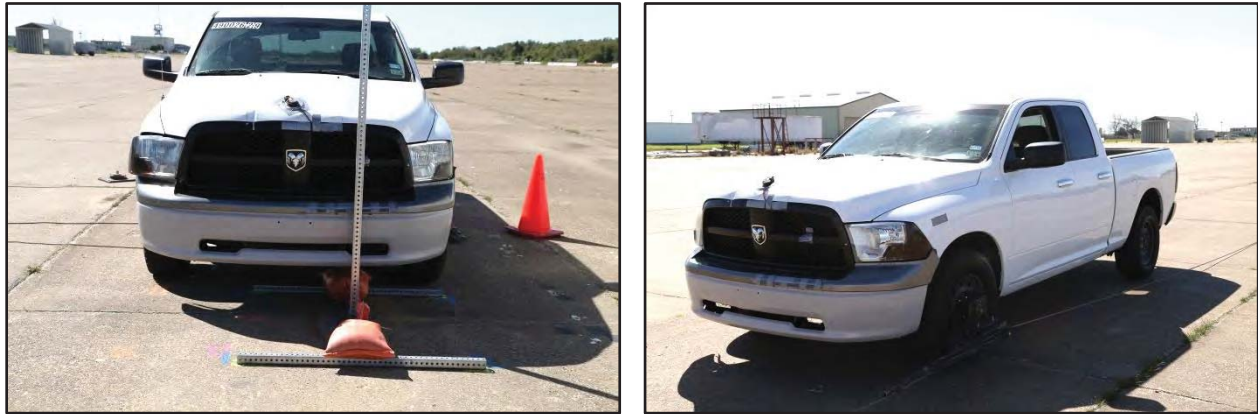
Figure 7.21. Test Vehicle before Test No. 490026-2-9.

The 2010 Dodge Ram 1500 pickup, shown in Figure 7.21, was used for the crash test. The vehicle's test inertia weight was 5014 lb, and its gross static weight was 5014 lb. The height to the lower edge of the vehicle bumper was 12.5 inches, and the height to the upper edge of the vehicle bumper was 27.5 inches. The height to the vehicle's center of gravity was 28.4 inches. Tables I.1 and I.2 in Appendix I1 give additional dimensions and information on the vehicle. The vehicle was directed into the installation using a cable reverse tow and guidance system, and was released to be freewheeling and unrestrained just prior to impact.

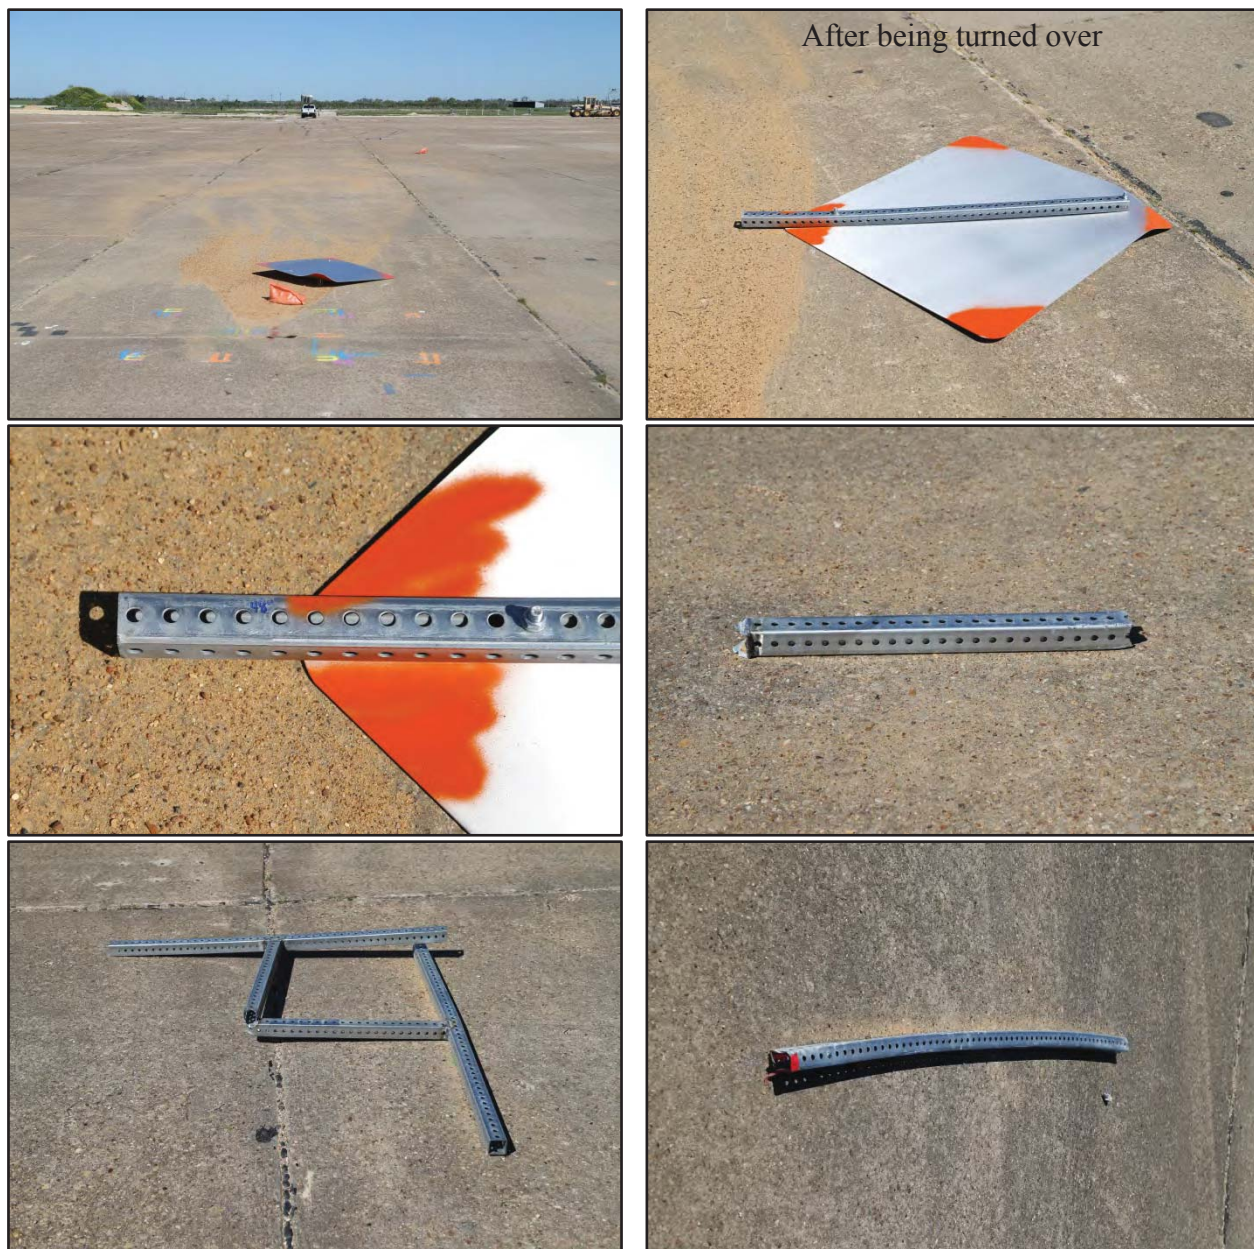
Figure 7.22. Option C Temporary Work Zone Sign Support after Test No. 490026-2-9.

Figure 7.22 shows the damage to the Option C temporary work zone sign support. The sign panel and the attached upper section of the vertical support came to rest 7 ft downstream of impact. A vertical piece fractured from the lower section of the support at 24 inches above ground and came to rest 125 ft downstream of impact. The remainder of the temporary work zone sign support came to rest 120 ft downstream of impact and 10 ft to the right of centerline of the impact path.

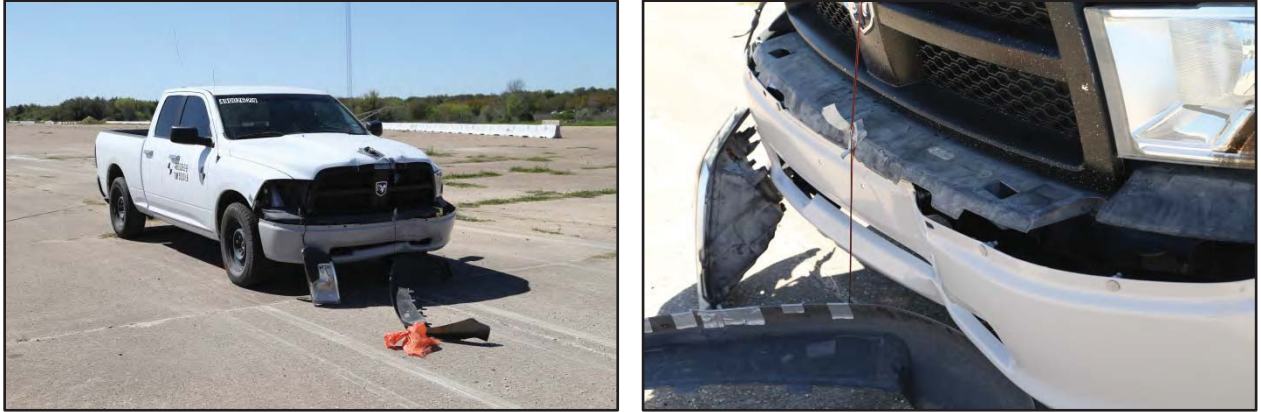
Figure 7.23. Test Vehicle after Test No. 490026-2-9.

Figure 7.23 shows the damage sustained by the vehicle. The bumper and hood were scraped. Maximum exterior crush to the vehicle was 3.5 inches in the front plane at the left quarter point at bumper height. Figure 7.24 shows the interior of the vehicle. No occupant compartment deformation or intrusion was noted. Tables I.3 and I.4 in Appendix I1 provides exterior crush and occupant compartment measurements.

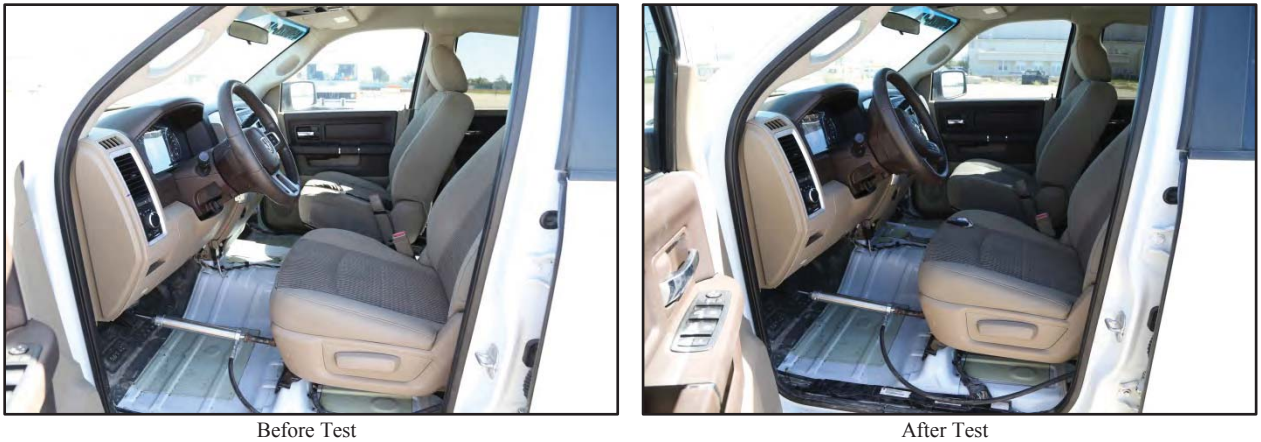
Figure 7.24. Interior of Test Vehicle for Test No. 490026-2-9.
