MASH EVALUATION OF TxDOT HIGH-MOUNTING-HEIGHT TEMPORARY WORK ZONE SIGN SUPPORT SYSTEM

Test Report 9-1002-15-8

**TEXAS A&M TRANSPORTATION INSTITUTE
COLLEGE STATION, TEXAS**

TEXAS DEPARTMENT OF TRANSPORTATION

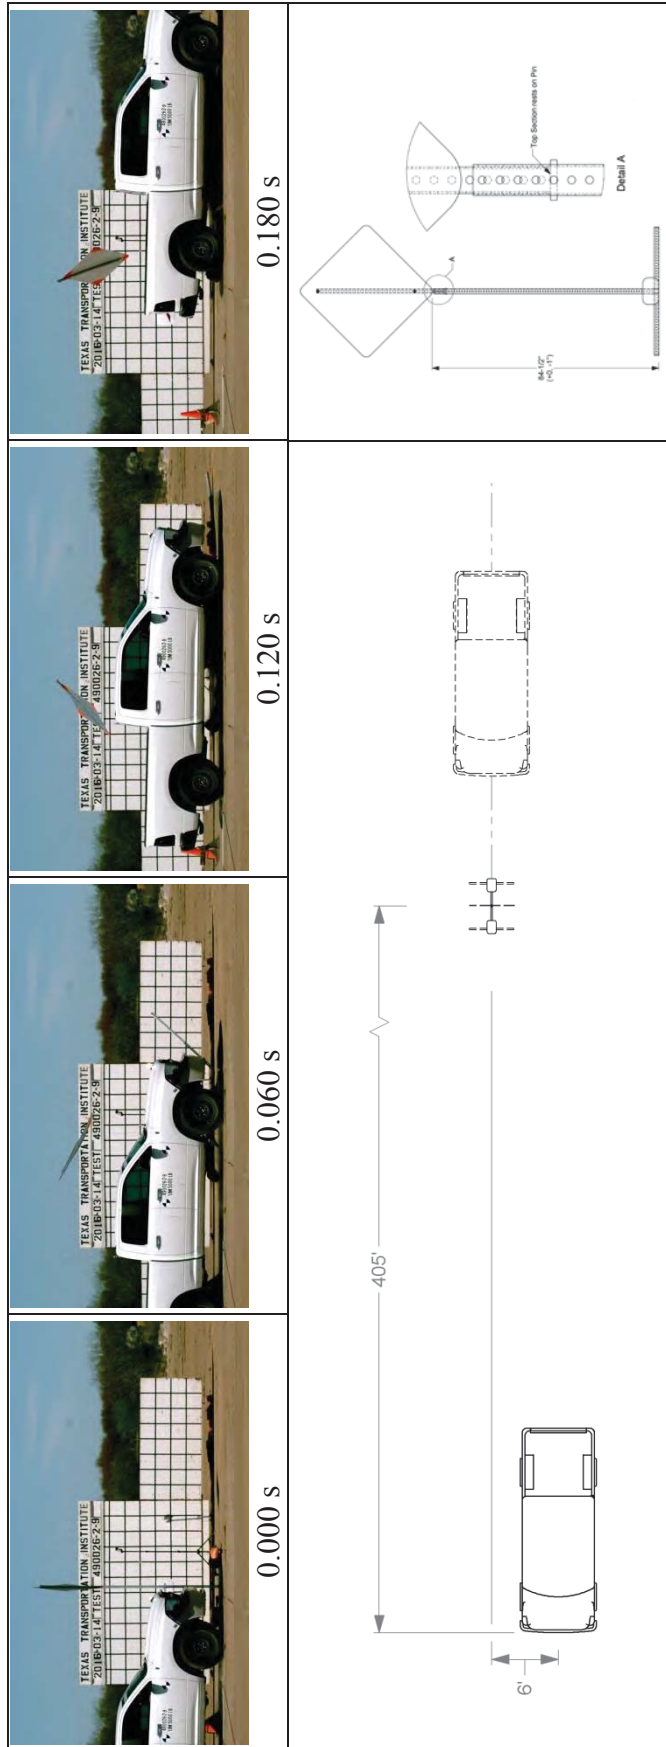
Figure 7.25. Summary of Results for MASH Test 3-72 at 0 Degrees on the Option C Temporary Work Zone Sign Support.

Figure 7.25 provides a summary of the results of the test. The slip connection for Option C temporary work zone sign support performed as designed, and the top of the system released from the lower section at vehicle impact. The released and fractured pieces gave no concern for penetration or intrusion into the vehicle. The sign panel did not contact the roof. The 2270P vehicle remained upright during and after the collision event. The 2270P vehicle came to rest 405 ft behind the Option C temporary work zone sign support.

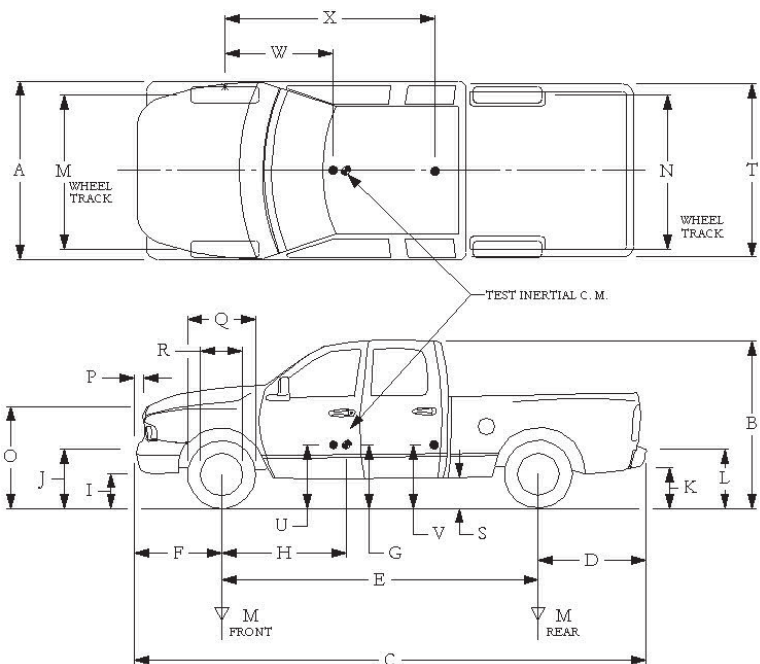
Table A.2. Measurements of Vehicle Vertical CG for Test No. 490026-2-1 through 490026-2-3.

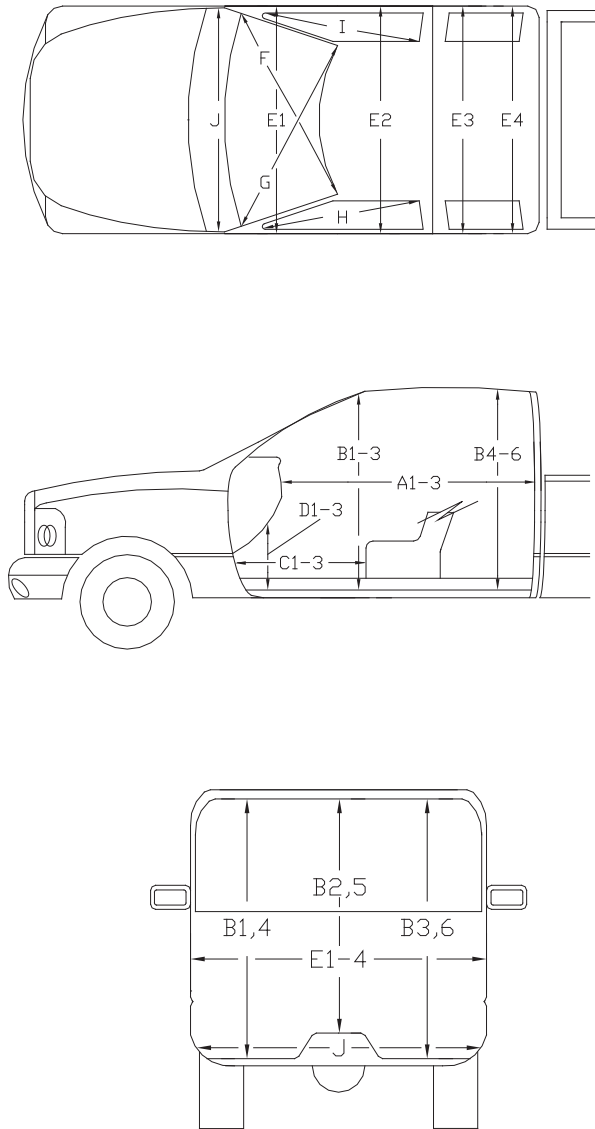
**OCCUPANT COMPARTMENT
DEFORMATION MEASUREMENT**

Before (inches)	After (inches)
A1	65.50	65.50
A2	63.50	63.50
A3	65.50	65.50
B1	45.00	45.00
B2	37.75	37.75
B3	45.00	45.00
B4	39.50	39.50
B5	41.00	41.00
B6	39.50	39.50
C1	26.50	26.50
C2	-----	-----
C3	26.00	26.00
D1	11.25	11.25
D2	-----	-----
D3	11.25	11.25
E1	58.50	58.50
E2	63.50	63.50
E3	63.50	63.50
E4	63.25	63.25
F	59.00	59.00
G	59.00	59.00
H	37.50	37.50
I	37.50	37.50
J*	23.00	23.00

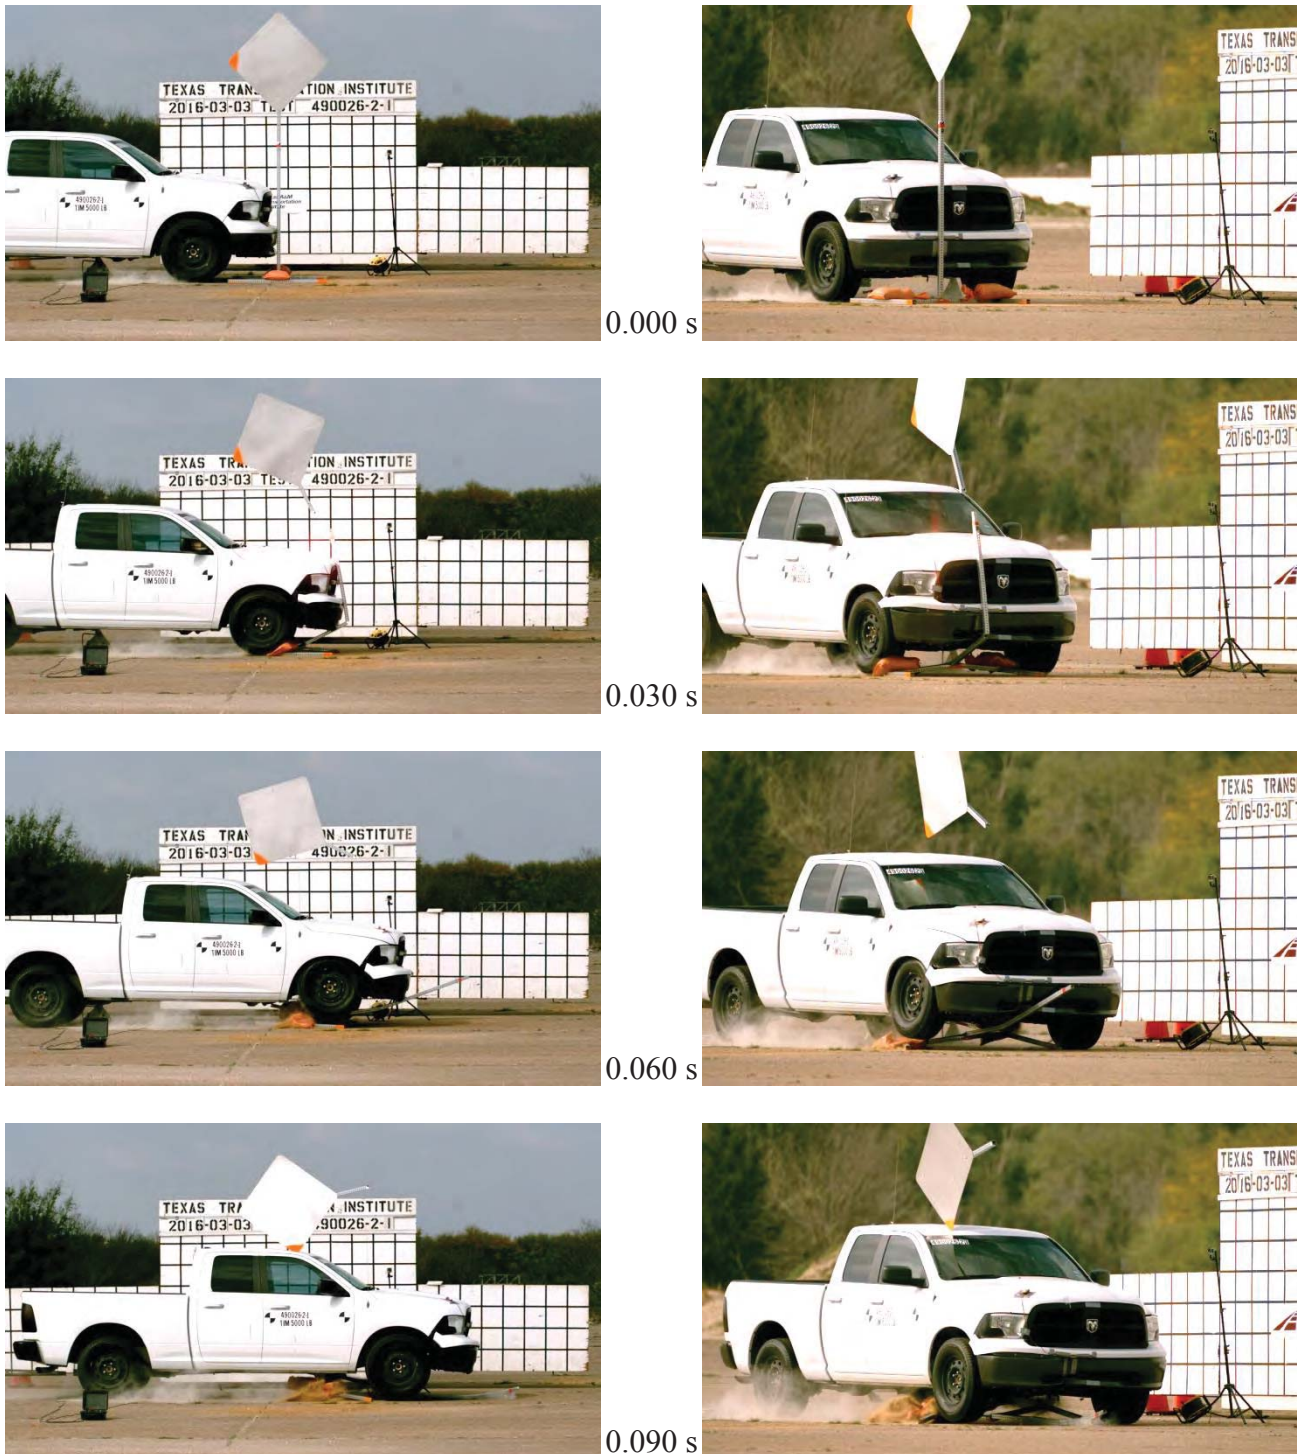
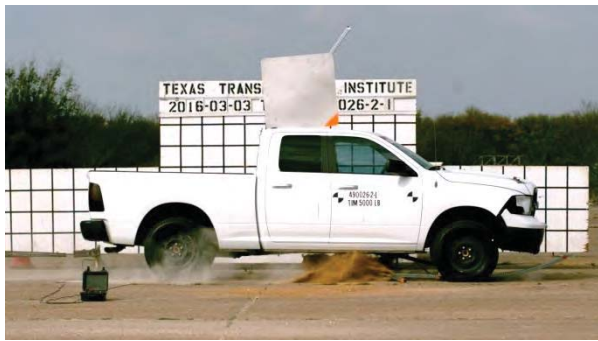
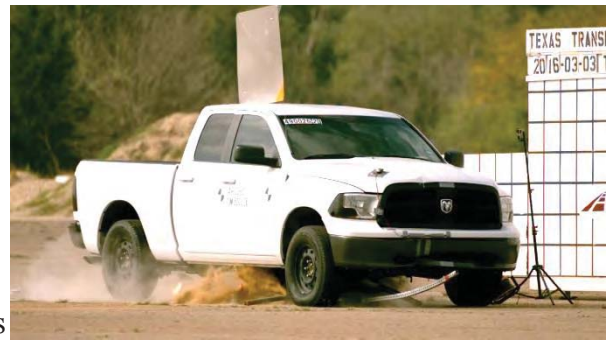
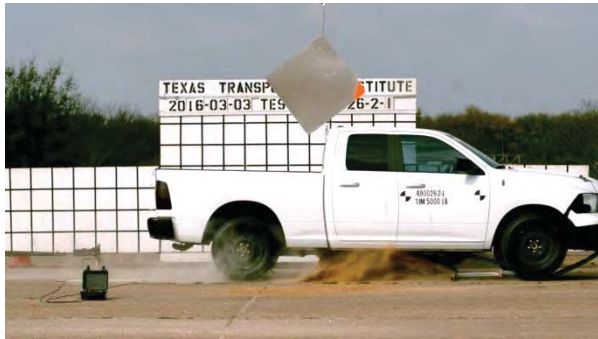
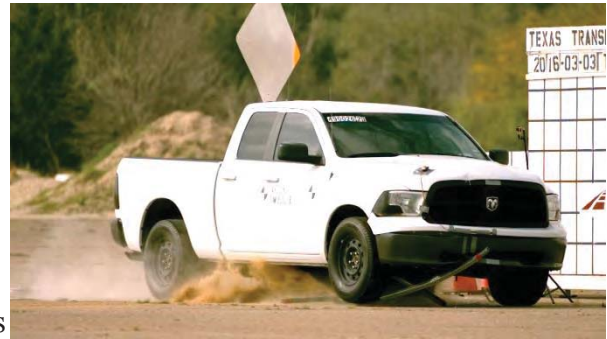
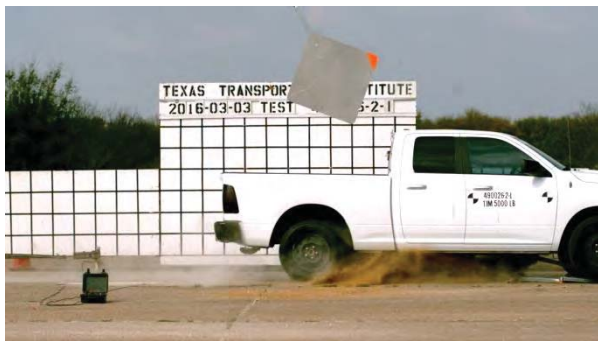
Figure A.1. Sequential Photographs for Test No. 490026-2-1 (Perpendicular and Oblique Views).

Figure A.1. Sequential Photographs for Test No. 490026-2-1 (Perpendicular and Oblique Views) (Continued).

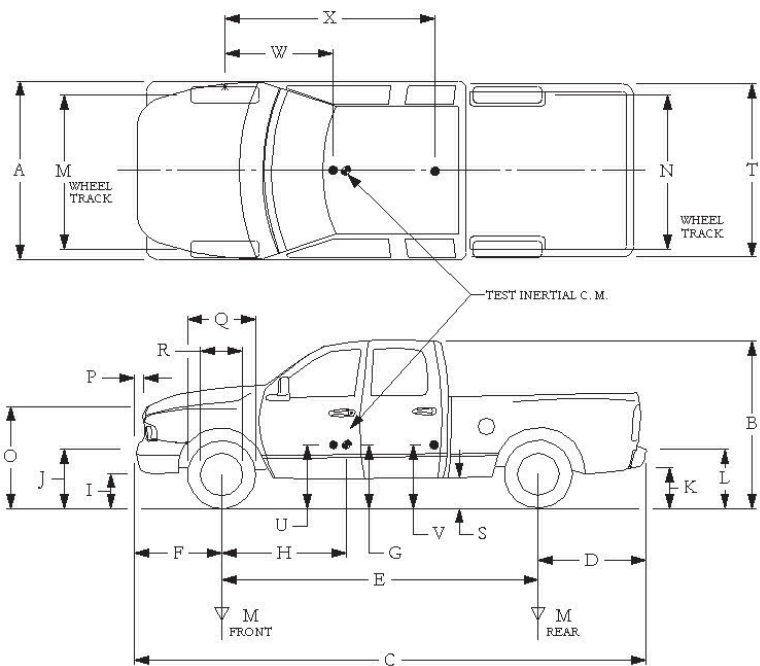
Table B.2. Measurements of Vehicle Vertical CG for Test No. 490026-2-2.

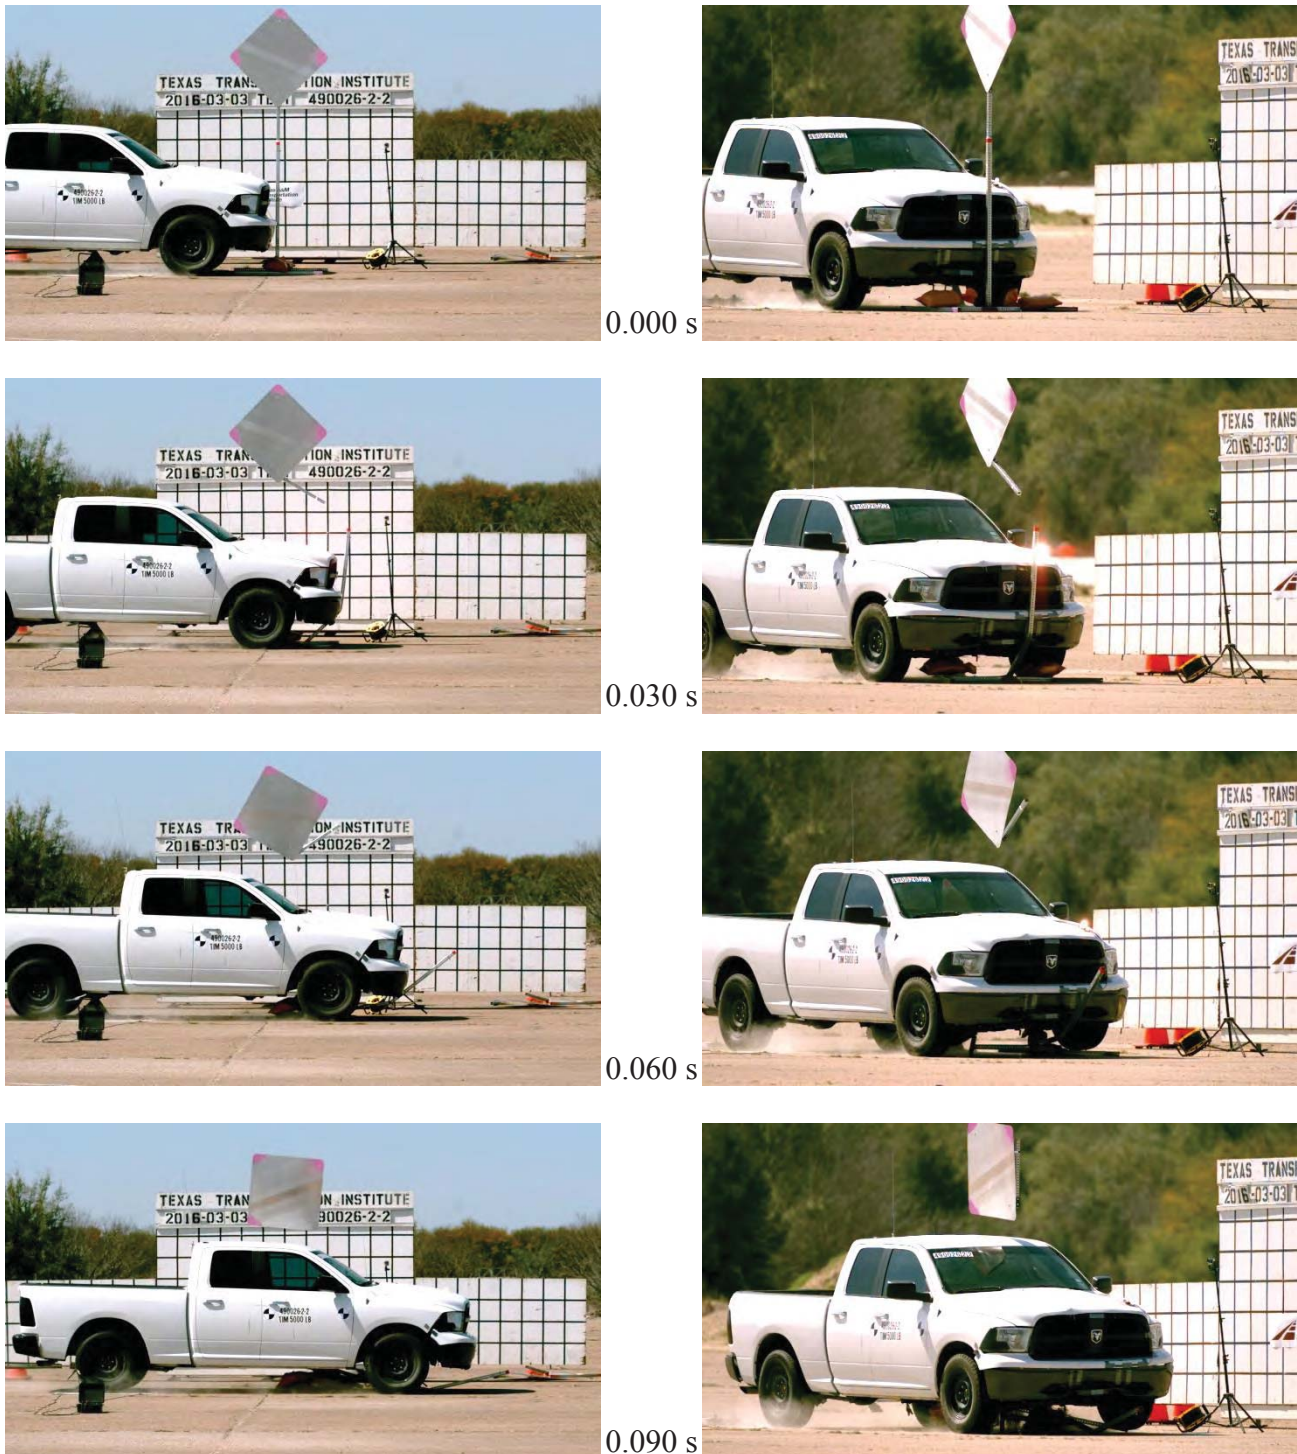
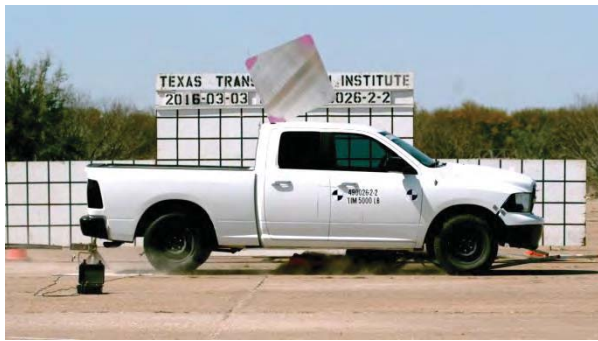
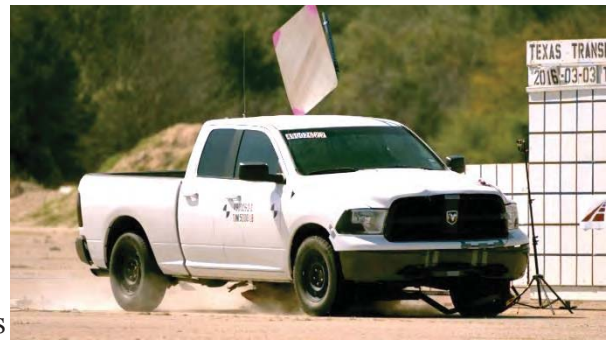
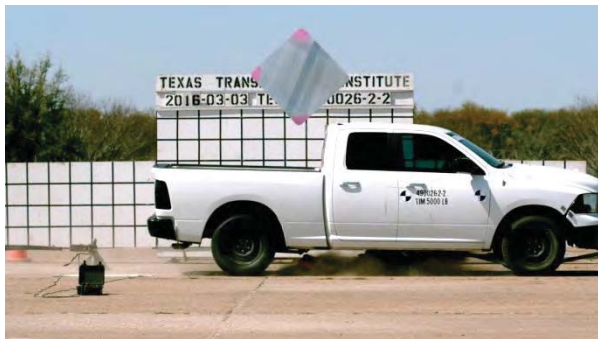
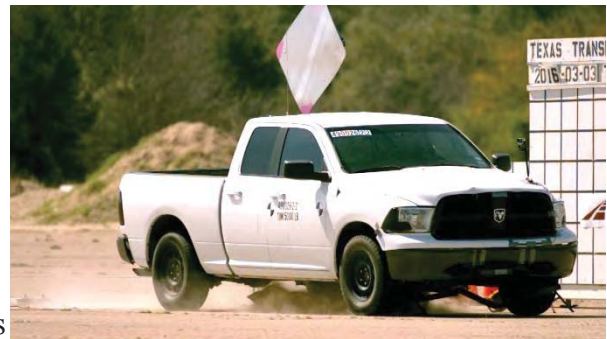
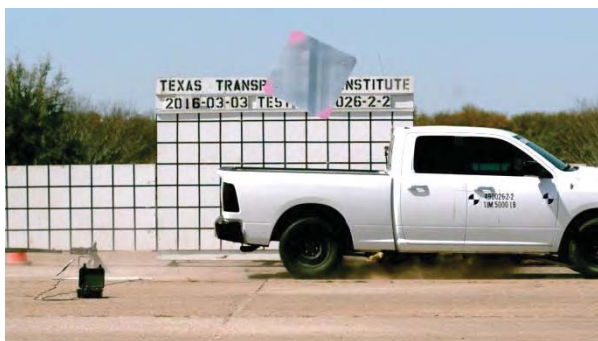
Figure B.1. Sequential Photographs for Test No. 490026-2-2 (Perpendicular and Oblique Views).

Figure B.1. Sequential Photographs for Test No. 490026-2-2 (Perpendicular and Oblique Views) (Continued).

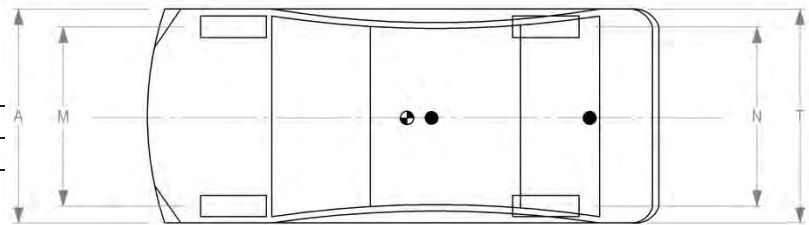
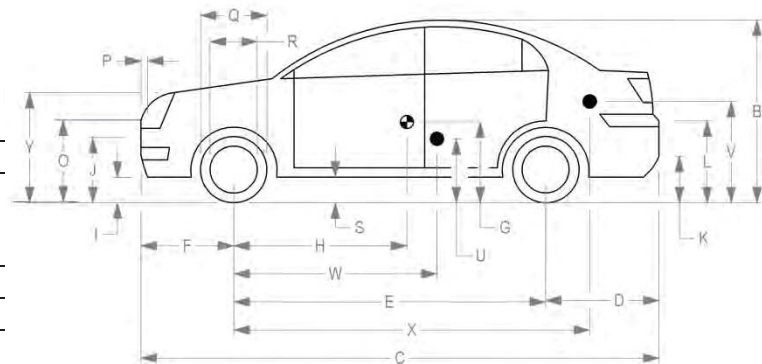
Geometry: inches

A	66.38	F	33.00	K	12.20	P	4.12	U	NA
B	58.00	G	-----	L	25.00	Q	22.50	V	NA
C	165.75	H	35.93	M	57.75	R	15.50	W	NA
D	34.00	I	8.00	N	57.10	S	7.25	X	NA
E	98.75	J	21.50	O	28.25	T	66.20	Y	27.00
Wheel Center Ht Front			11.00	Wheel Center Ht Rear			11.00	W-H	NA

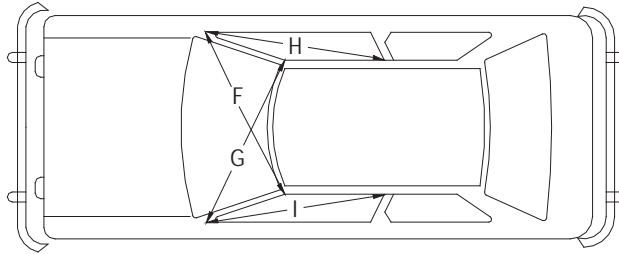
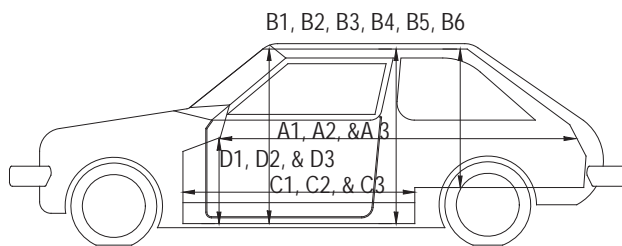
**OCCUPANT COMPARTMENT
DEFORMATION MEASUREMENT**

Before (inches)	After (inches)
A1	67.50	67.50
A2	67.25	67.25
A3	67.75	67.75
B1	40.50	40.50
B2	35.75	35.75
B3	40.50	40.50
B4	36.00	36.00
B5	32.50	32.50
B6	36.00	36.00
C1	27.25	27.25
C2	-----	-----
C3	27.00	27.00
D1	9.50	9.50
D2	-----	-----
D3	9.25	9.25
E1	51.50	51.50
E2	51.00	51.00
F	51.00	51.00
G	51.00	51.00
H	37.50	37.50
I	37.50	37.50
J*	51.00	51.00

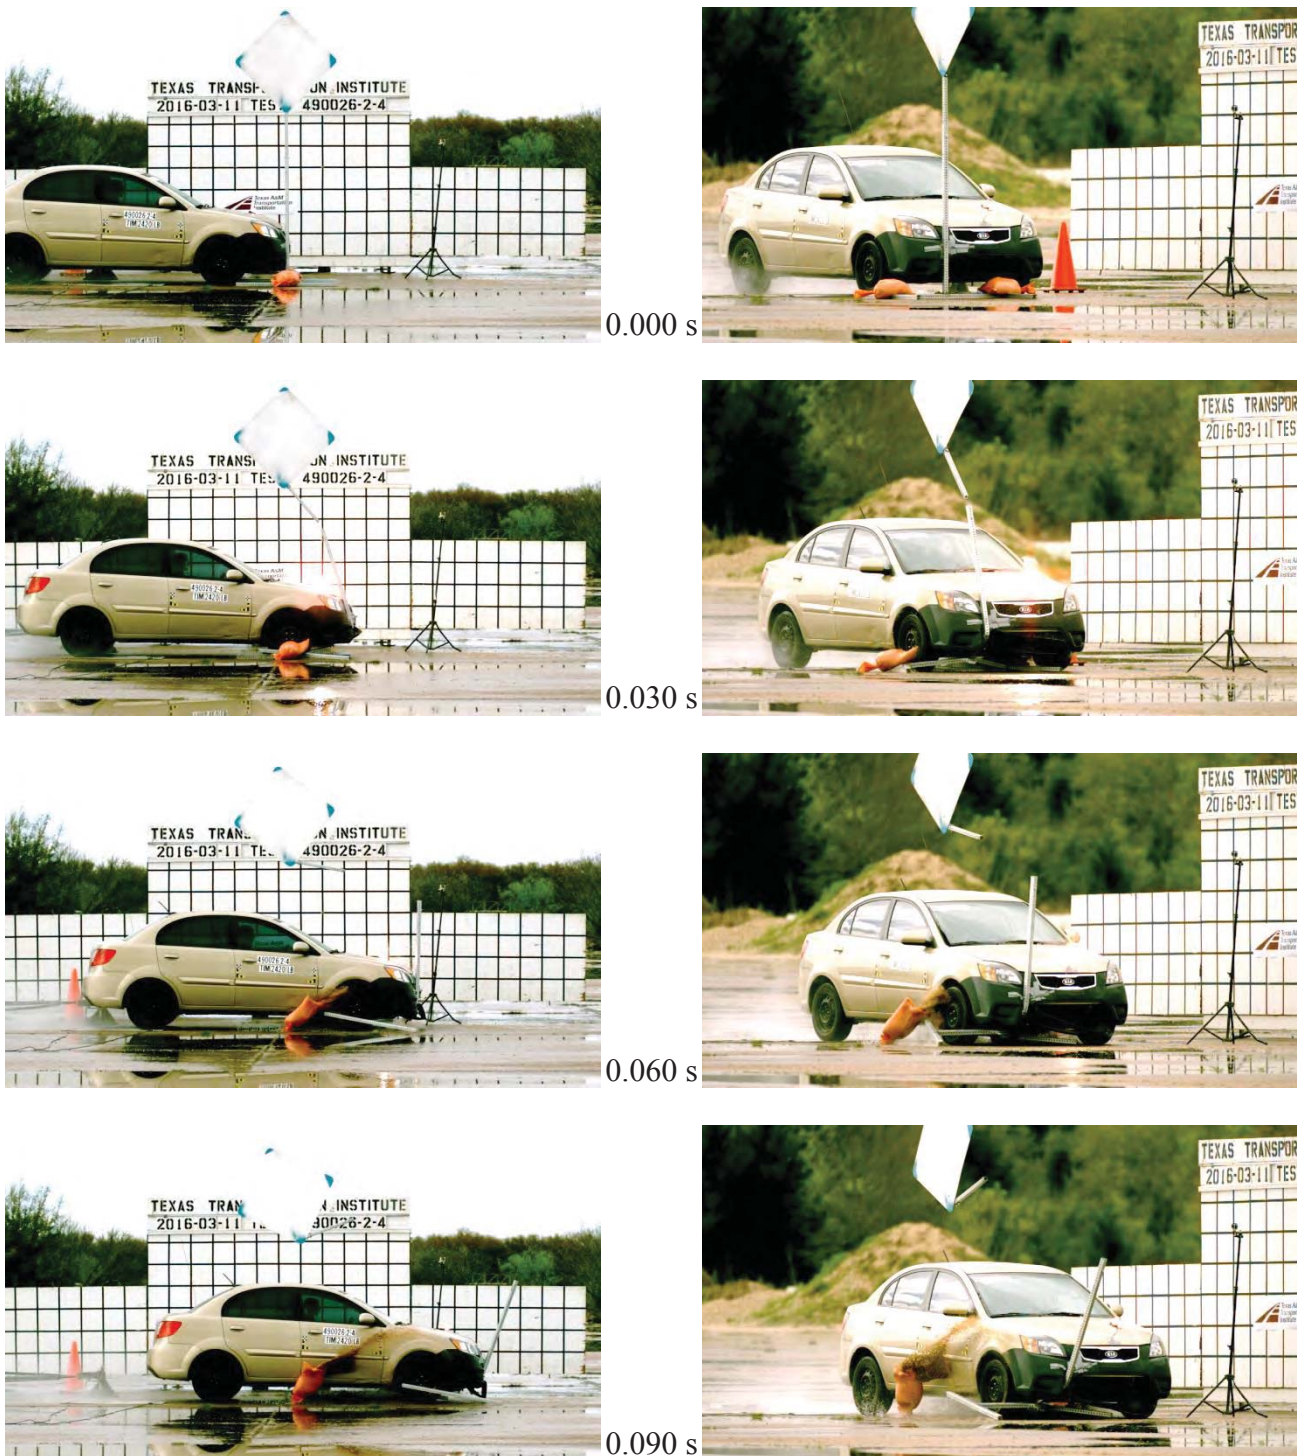
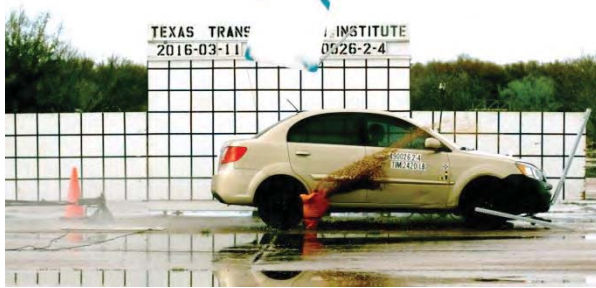
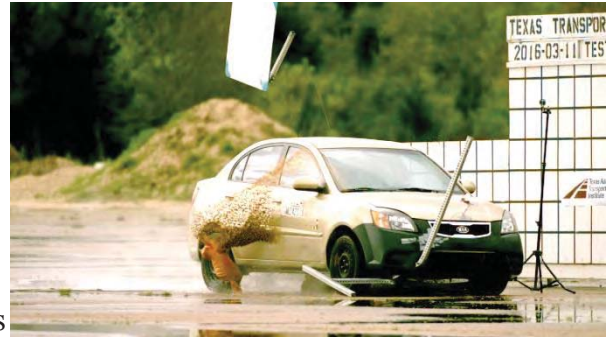
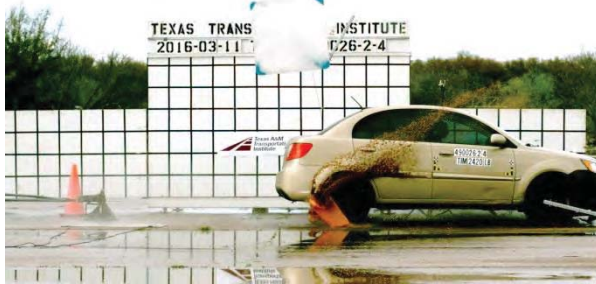
Figure C.1. Sequential Photographs for Test No. 490026-2-4 (Perpendicular and Oblique Views).

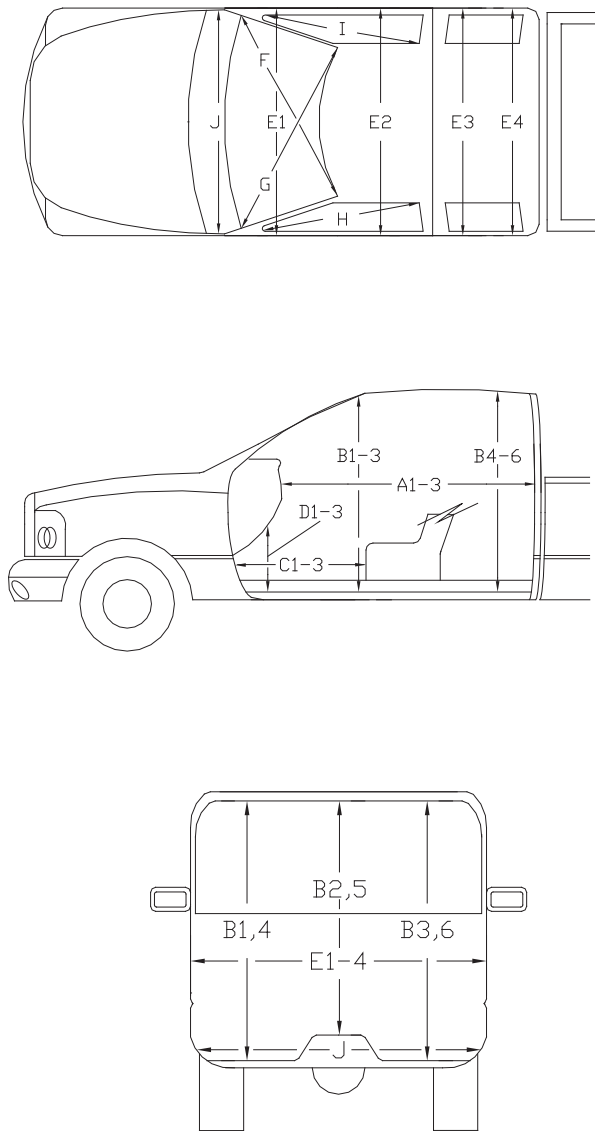
Table E.4. Occupant Compartment Measurements for Test No. 490026-2-8.

**OCCUPANT COMPARTMENT
DEFORMATION MEASUREMENT**

Before (inches)	After (inches)
A1	65.50	65.50
A2	63.50	63.50
A3	65.50	65.50
B1	45.00	45.00
B2	37.75	37.75
B3	45.00	45.00
B4	39.50	39.50
B5	41.00	41.00
B6	39.50	39.50
C1	26.50	26.50
C2	-----	-----
C3	26.00	26.00
D1	11.25	11.25
D2	-----	-----
D3	11.25	11.25
E1	58.50	58.50
E2	63.50	63.50
E3	63.50	63.50
E4	63.25	63.25
F	59.00	59.00
G	59.00	59.00
H	37.50	37.50
I	37.50	37.50
J*	23.00	23.00

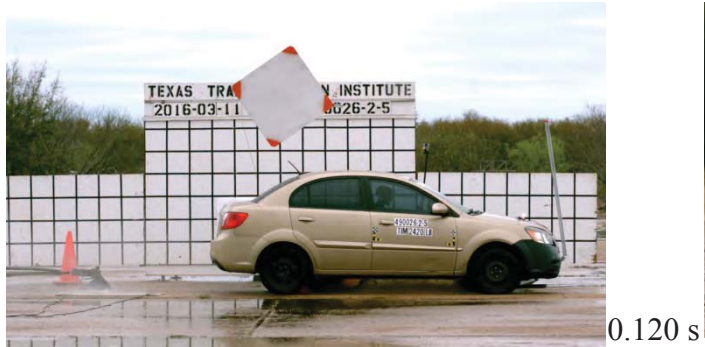
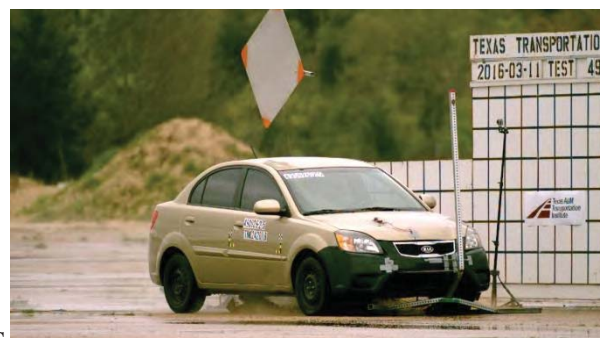
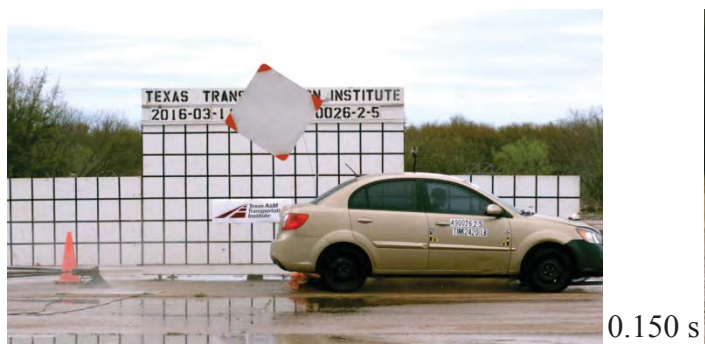
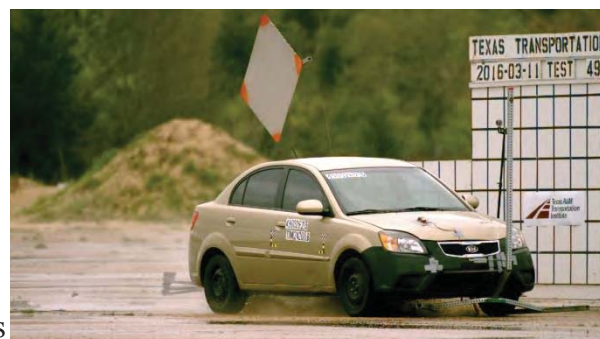
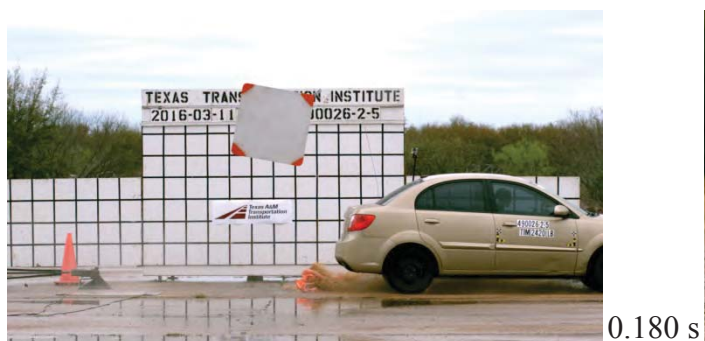
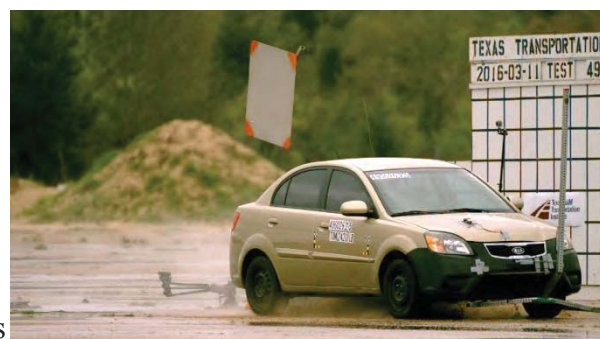
Figure G.1. Sequential Photographs for Test No. 490026-2-5 (Perpendicular and Oblique Views) (Continued).

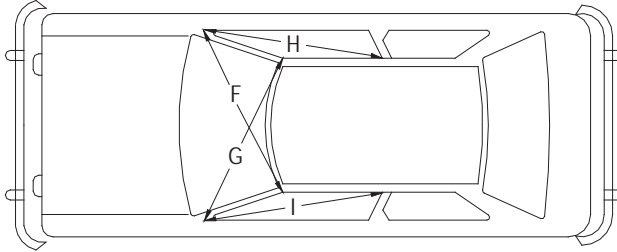
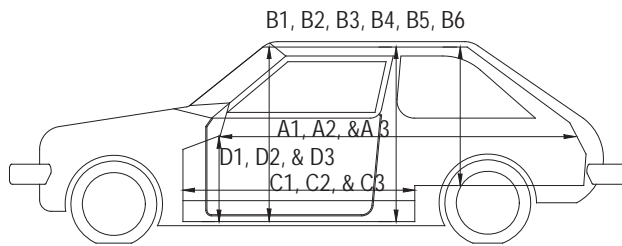
**OCCUPANT COMPARTMENT
DEFORMATION MEASUREMENT**

Before (inches)	After (inches)
A1	67.50	67.50
A2	67.25	67.25
A3	67.75	67.75
B1	40.50	40.50
B2	35.75	35.75
B3	40.50	40.50
B4	36.00	36.00
B5	32.50	32.50
B6	36.00	36.00
C1	27.25	27.25
C2	-----	-----
C3	27.00	27.00
D1	9.50	9.50
D2	-----	-----
D3	9.25	9.25
E1	51.50	51.50
E2	51.00	51.00
F	51.00	51.00
G	51.00	51.00
H	37.50	37.50
I	37.50	37.50
J*	51.00	51.00

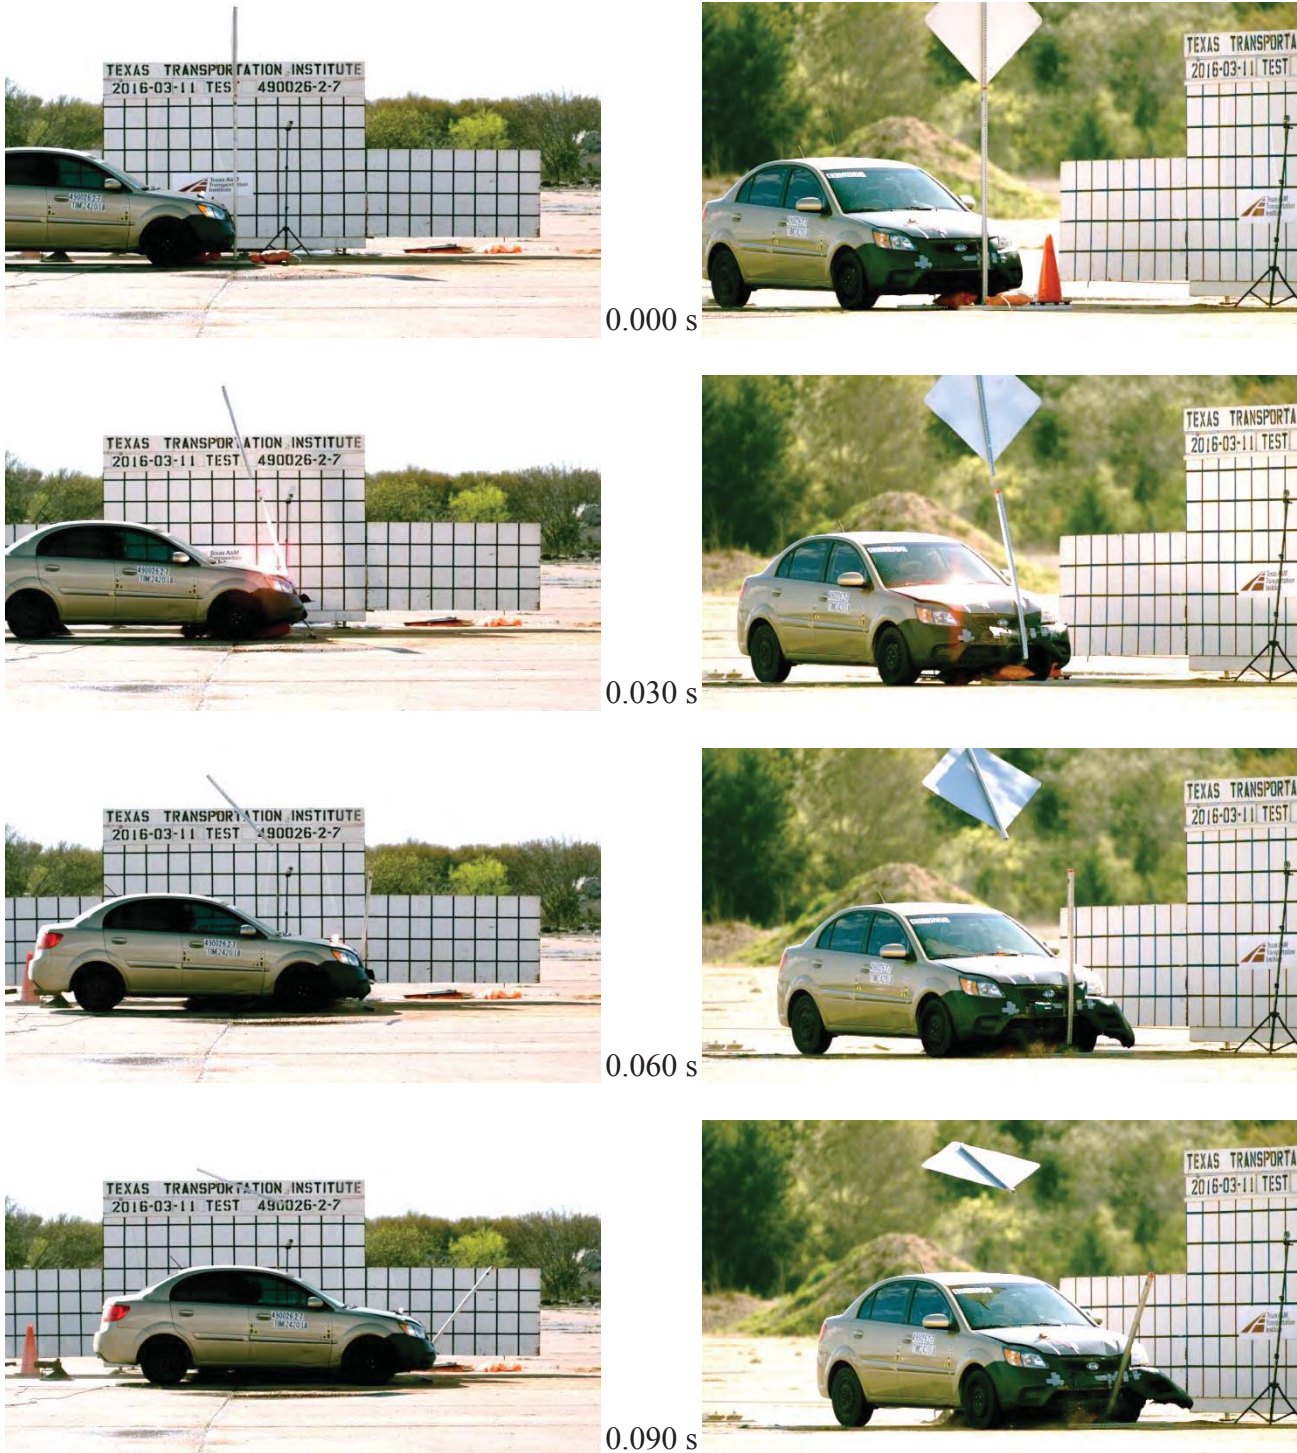
Figure H.1. Sequential Photographs for Test No. 490026-2-7 (Perpendicular and Oblique Views).

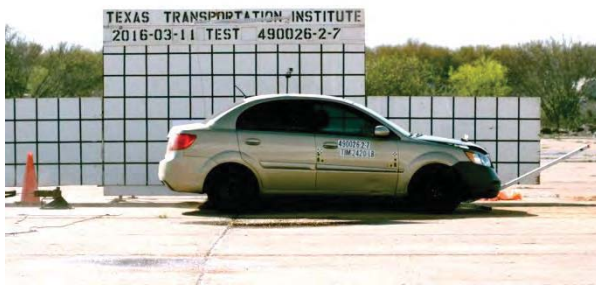
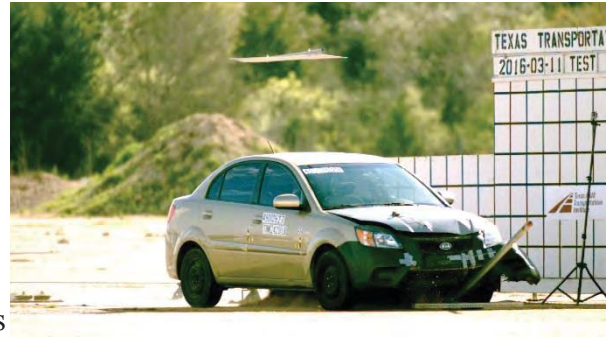
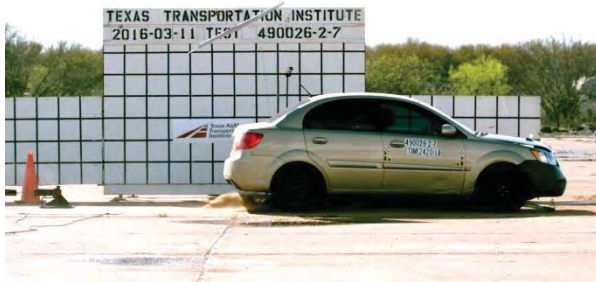
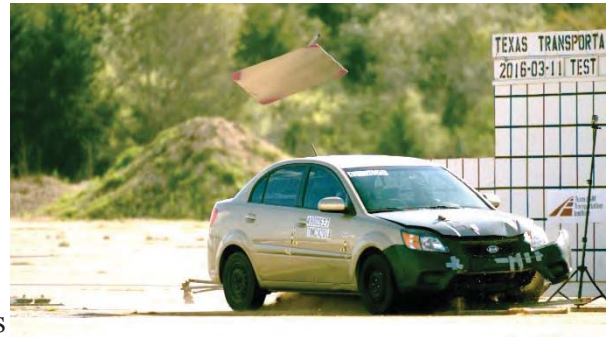
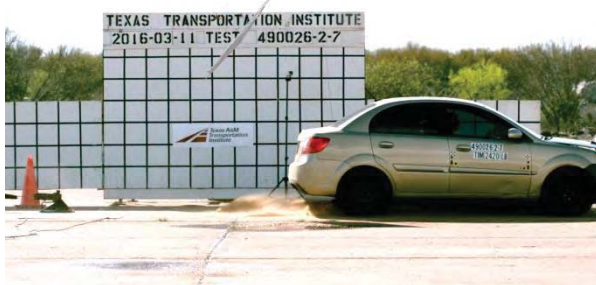
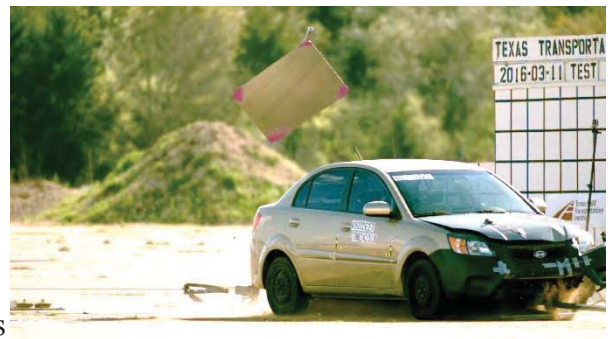
Figure H.1. Sequential Photographs for Test No. 490026-2-7 (Perpendicular and Oblique Views) (Continued).

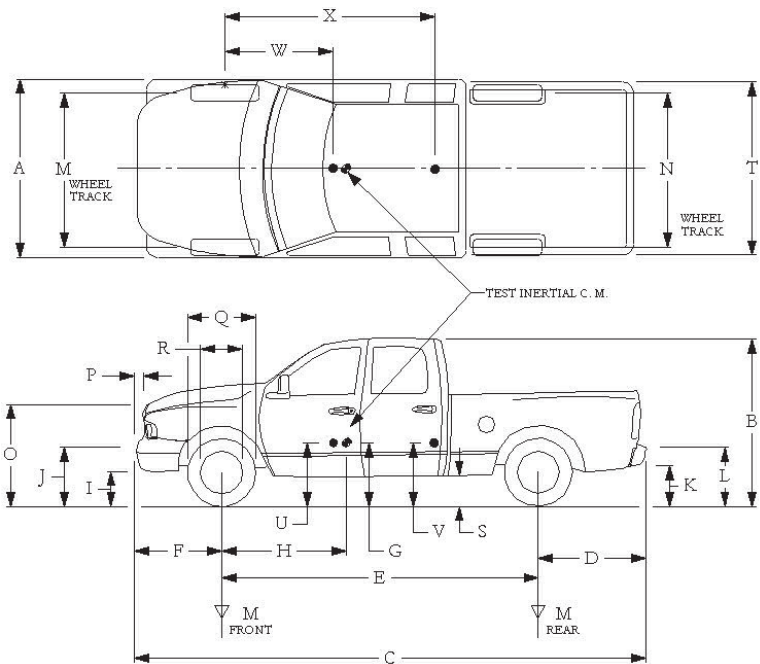
Table I.2. Measurements of Vehicle Vertical CG for Test No. 490026-2-9.

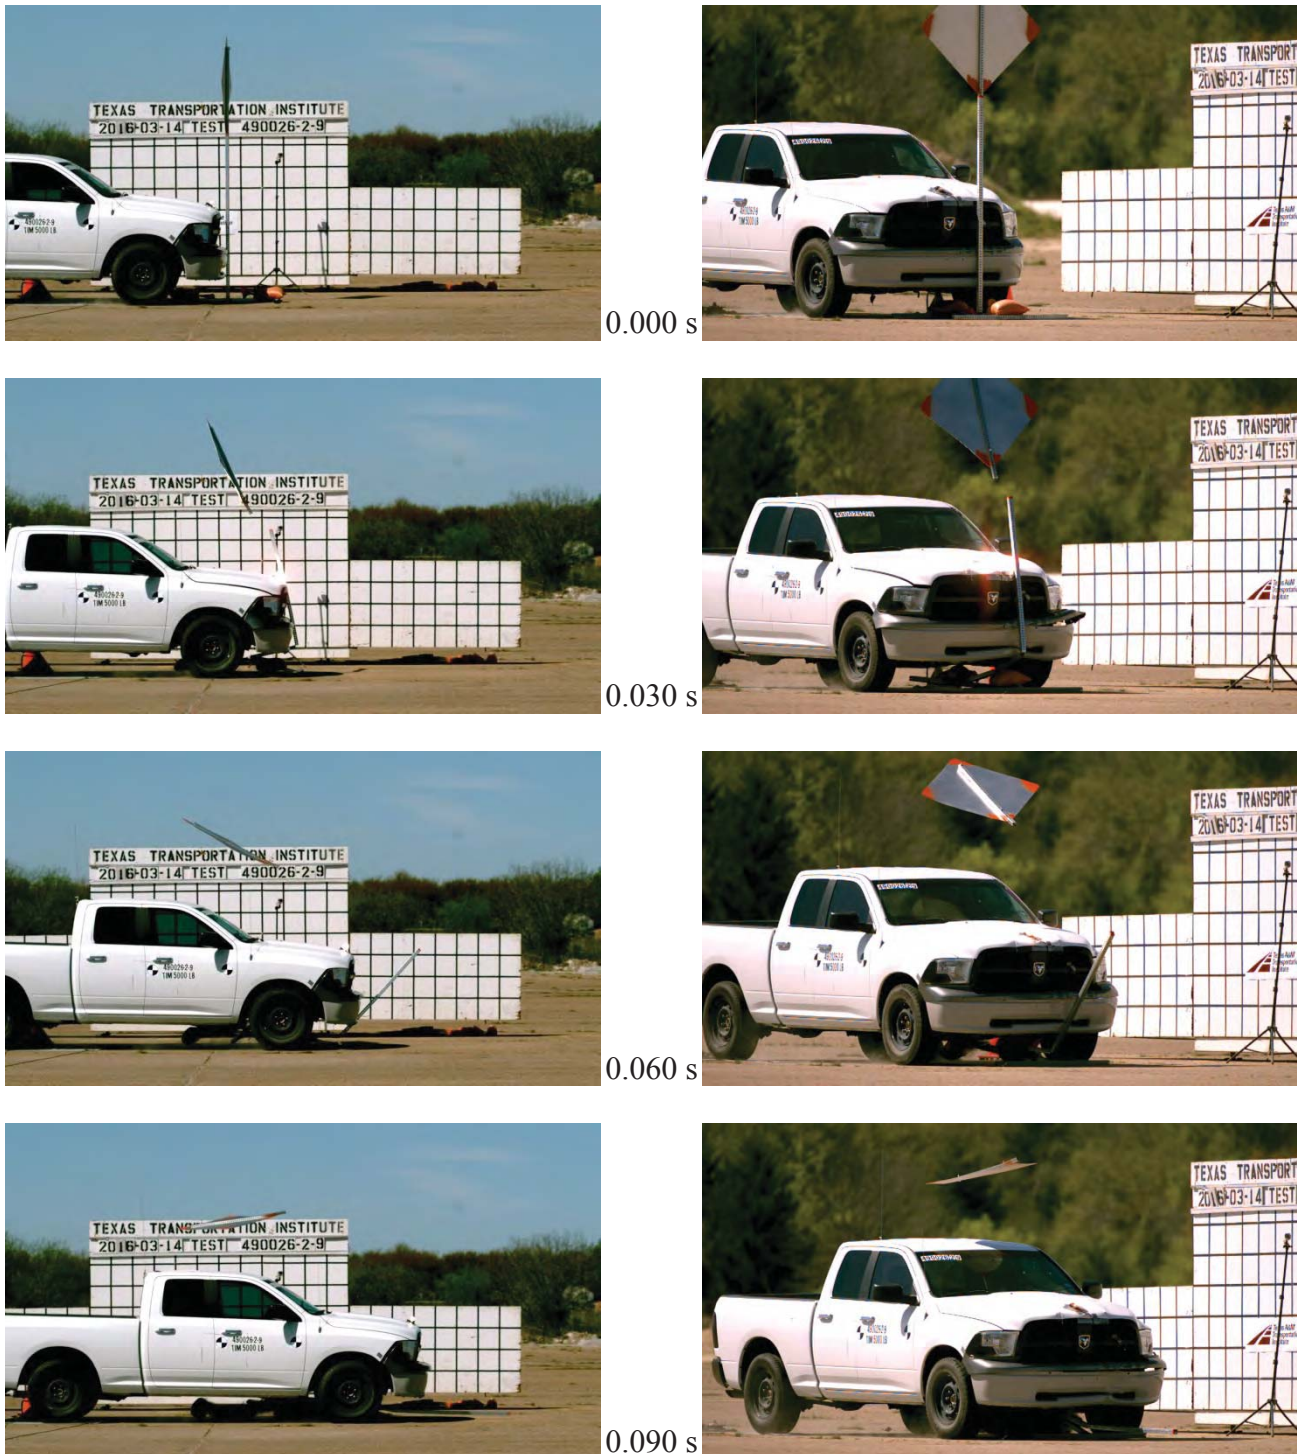
Figure I.1. Sequential Photographs for Test No. 490026-2-9 (Perpendicular and Oblique Views).

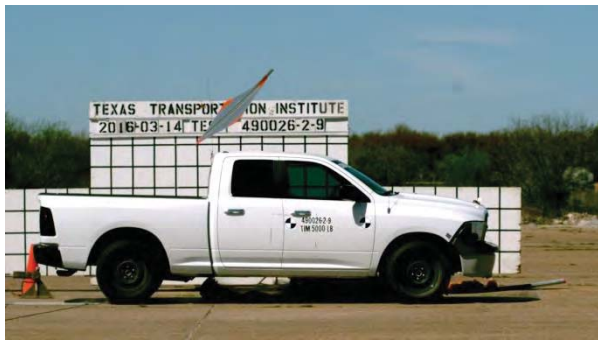
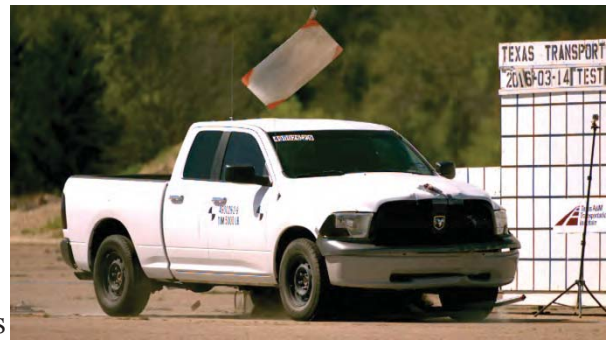
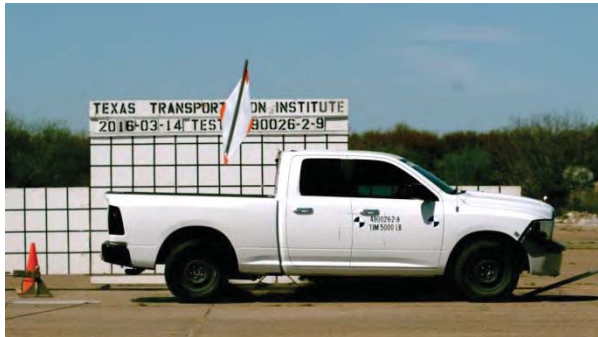
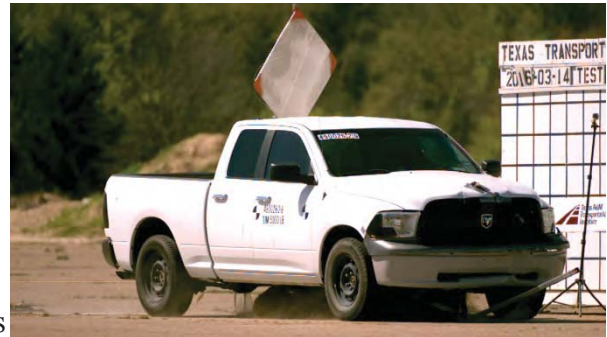
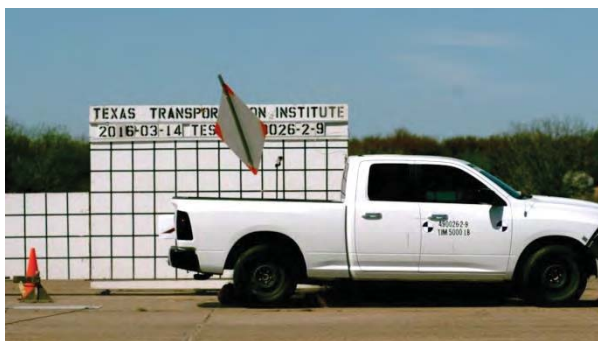
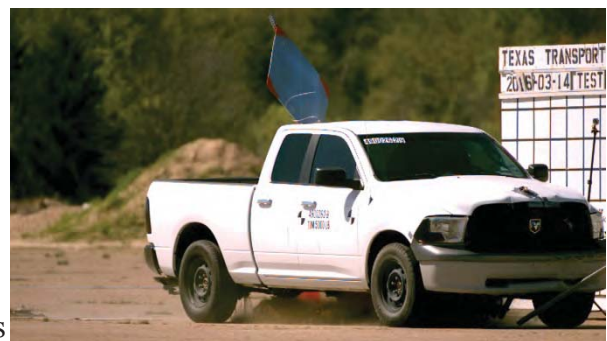
Figure I.1. Sequential Photographs for Test No. 490026-2-9 (Perpendicular and Oblique Views) (Continued).
