CIVIL AERONAUTICS BOARD

ACCIDENT INVESTIGATION REPORT

EASTERN AIR LINES, INC. AND P-38 AIR COLLISION—NEAR WASHINGTON NATIONAL AIRPORT, WASHINGTON, D. C., NOVEMBER 1, 1949**THE ACCIDENT**

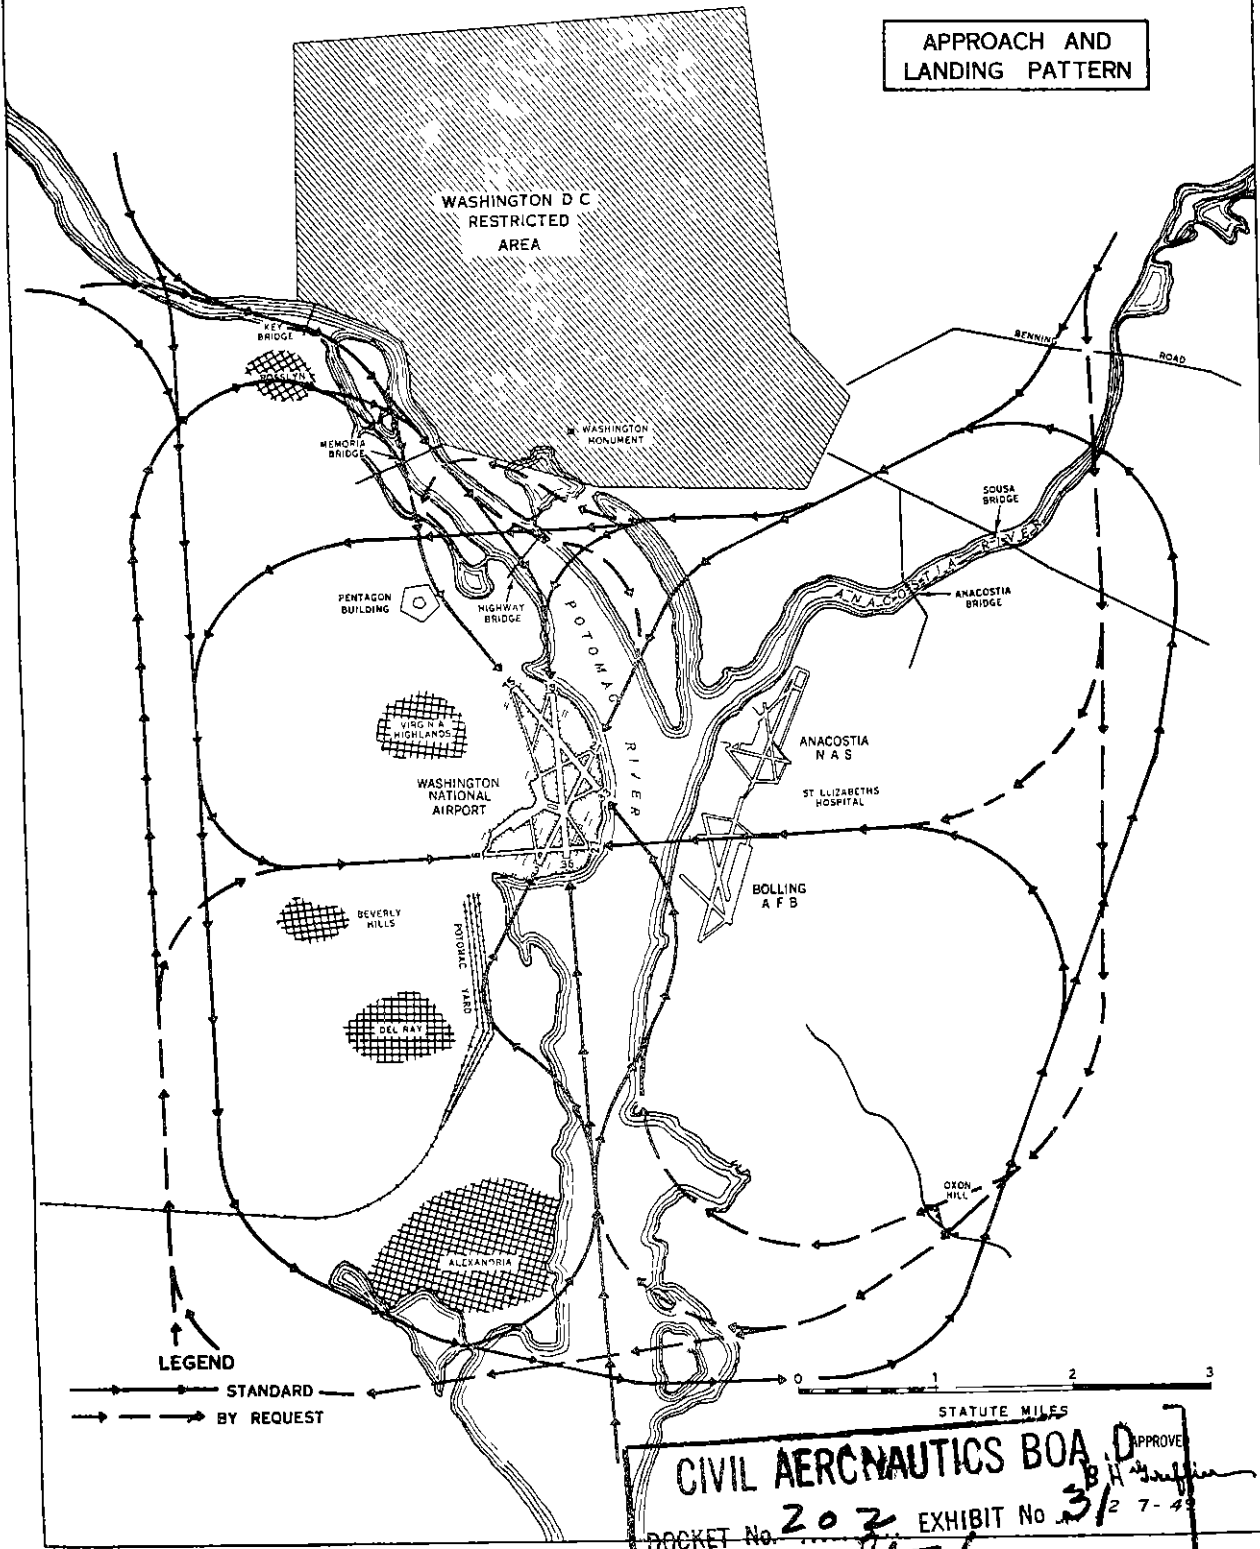
WASHINGTON NATIONAL AIRPORT

APPROACH AND LANDING PATTERN

Patterns are designed for landings on each runway under VFR conditions (Caution Note) Heavy traffic at Anacostia, Bolling, and Andrews Field, and the area between them
