CIVIL AERONAUTICS BOARD

ACCIDENT INVESTIGATION REPORT

UNITED AIR LINES, INC. - NEAR REDWOOD CITY, CALIFORNIA, SEPTEMBER 12, 1951

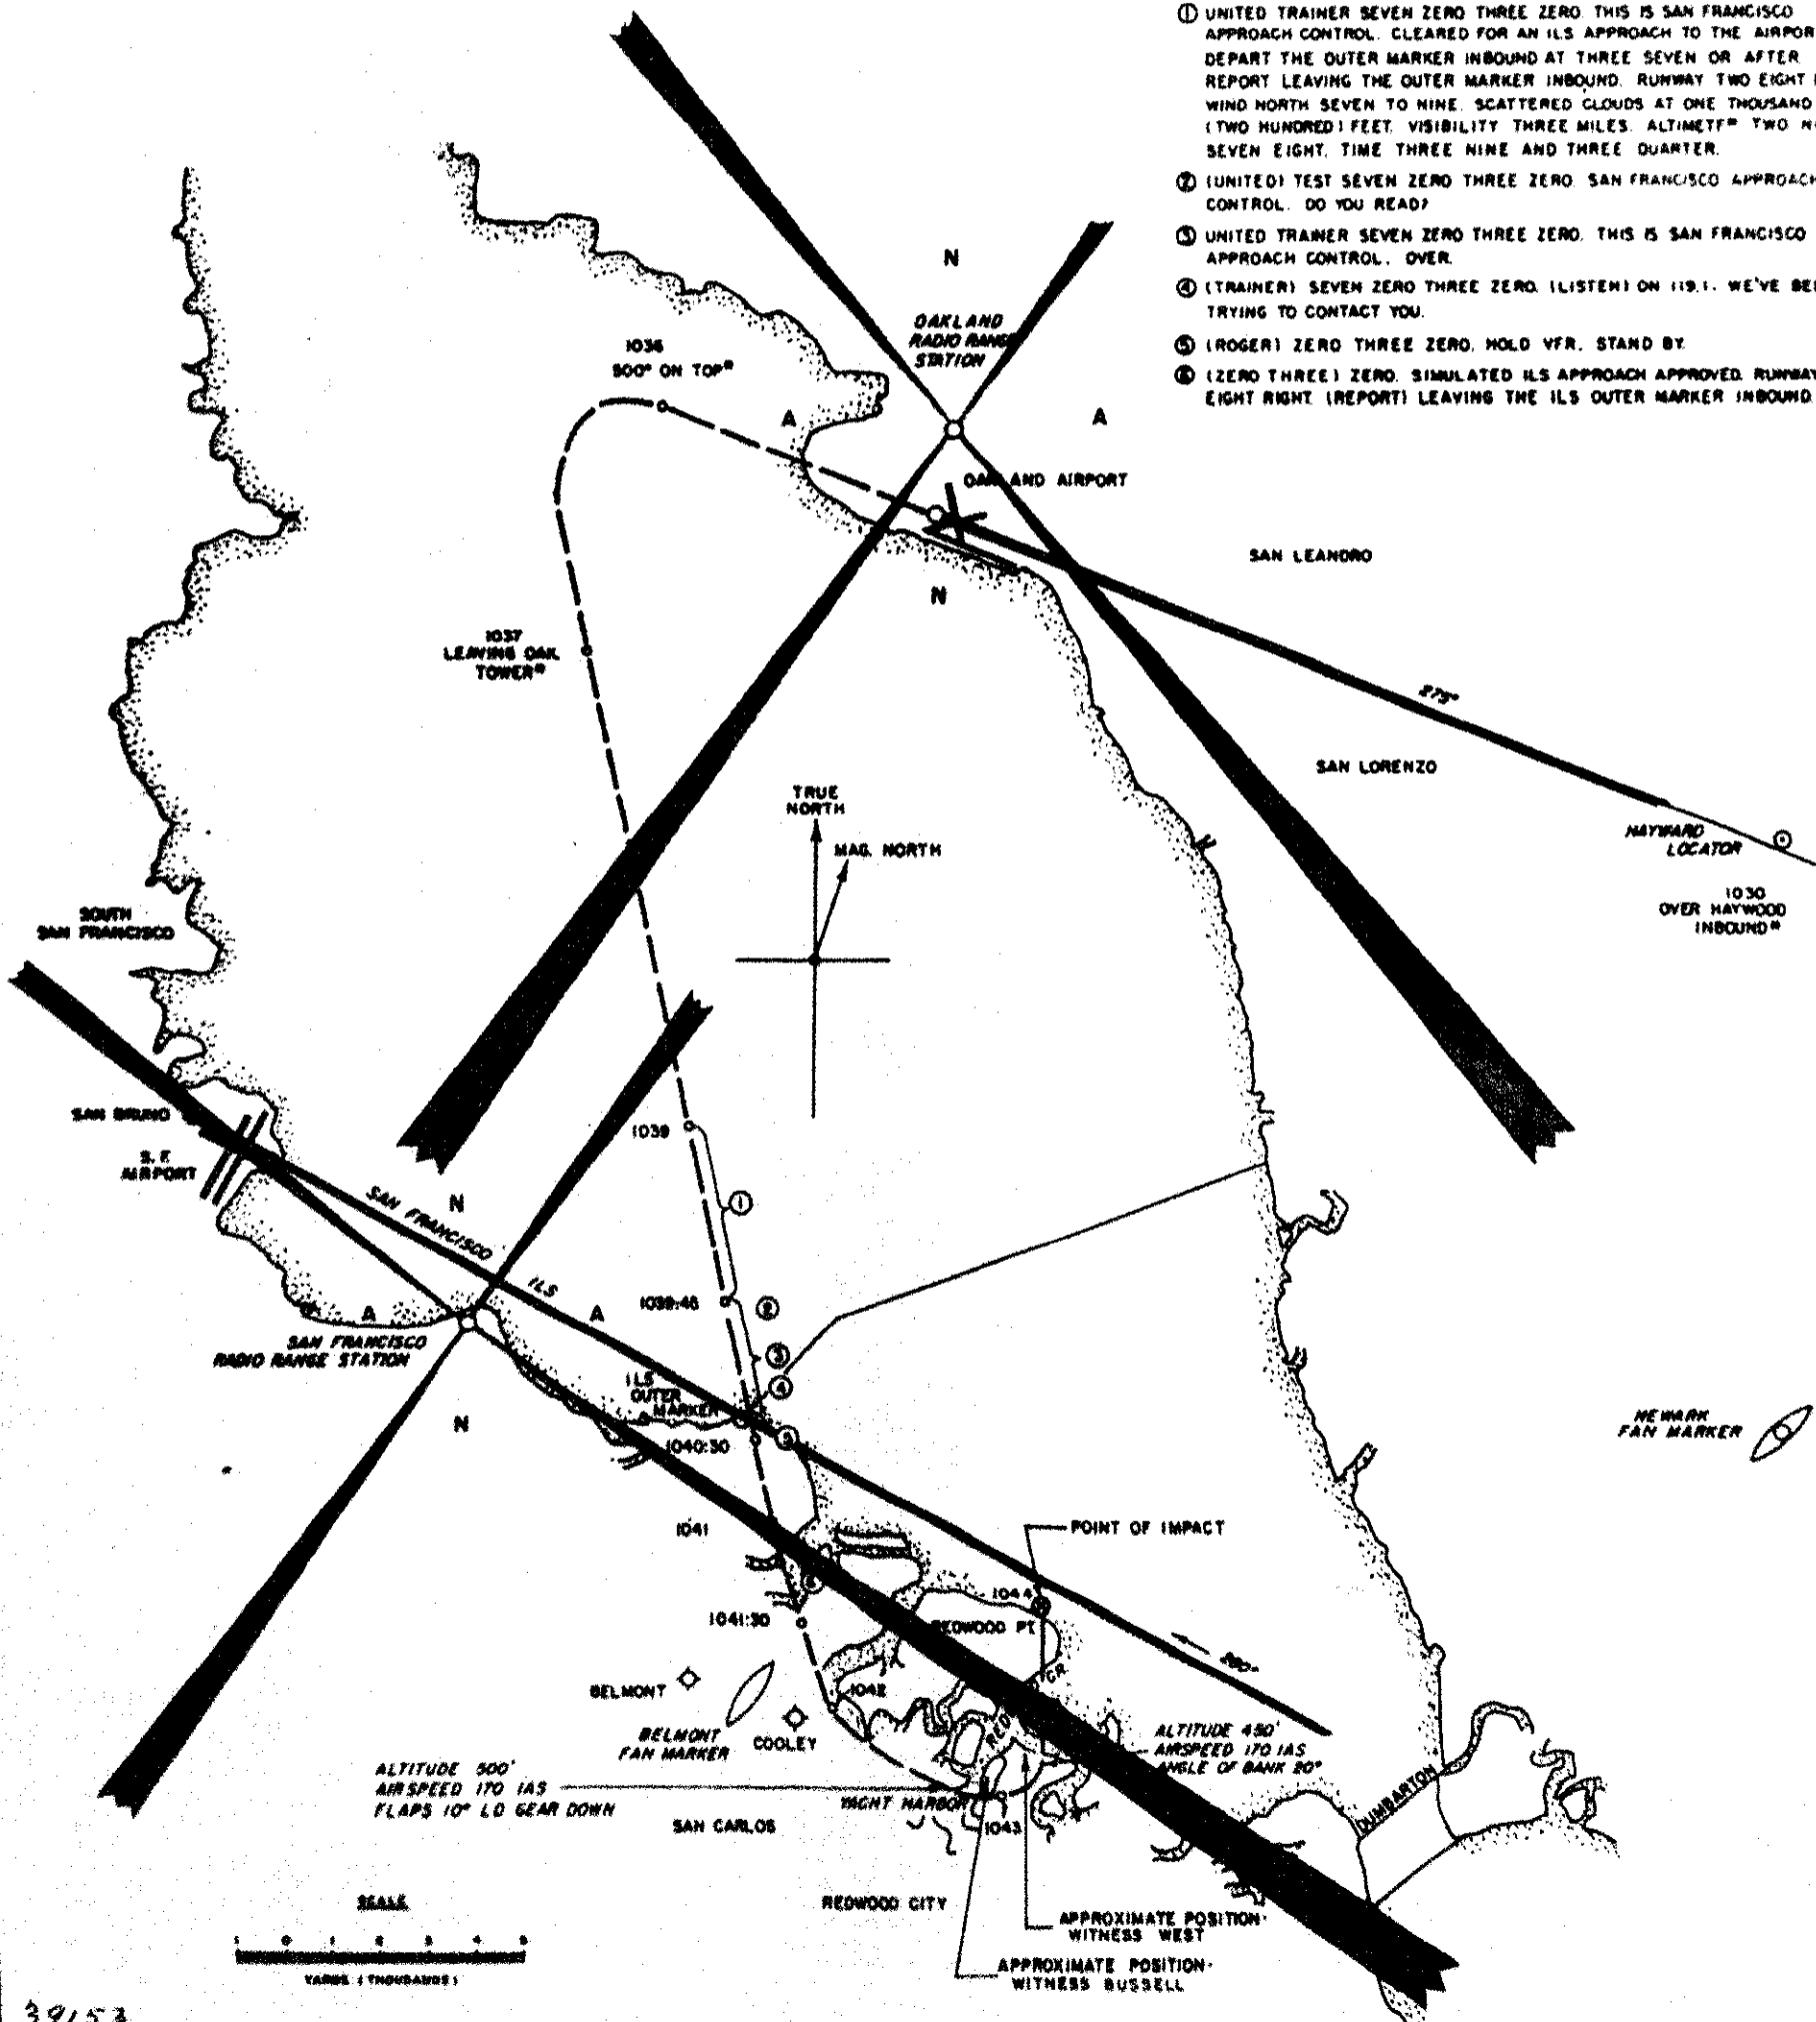
1. ACCIDENT INVOLVING BOEING MODEL B-377, REGISTRATION NO. N31230, REDWOOD CITY, CALIFORNIA, ON SEPTEMBER 12, 1951.
2. ASSUMED FLIGHT PATH INDICATED BY DASH LINE.
3. POSITIONS OF AIRCRAFT ALONG FLIGHT PATH AT TIMES SHOWN ARE BASED ON ASSUMED GROUND SPEED OF 160 MPH.
4. TIMES SHOWN ARE PACIFIC STANDARD TIME.
5. "INDICATES TRANSMISSIONS FROM FLIGHT TO OAKLAND TOWER - NOT VERBATIM.
6. CIRCLED NUMBERS ALONG FLIGHT PATH REFER TO FOLLOWING TRANSMISSIONS FROM SAN FRANCISCO TOWER RADIO TRANSCRIPTION:

- ① UNITED TRAINER SEVEN ZERO THREE ZERO. THIS IS SAN FRANCISCO APPROACH CONTROL. CLEARED FOR AN ILS APPROACH TO THE AIRPORT. DEPART THE OUTER MARKER INBOUND AT THREE SEVEN OR AFTER REPORT LEAVING THE OUTER MARKER INBOUND. RUNWAY TWO EIGHT RIGHT. WIND NORTH SEVEN TO NINE. SCATTERED CLOUDS AT ONE THOUSAND (TWO HUNDRED) FEET. VISIBILITY THREE MILES. ALTIMETER TWO NINE SEVEN EIGHT. TIME THREE NINE AND THREE QUARTER.
- ② (UNITED) TEST SEVEN ZERO THREE ZERO. SAN FRANCISCO APPROACH CONTROL. DO YOU READ?
- ③ UNITED TRAINER SEVEN ZERO THREE ZERO. THIS IS SAN FRANCISCO APPROACH CONTROL. OVER.
- ④ (TRAINER) SEVEN ZERO THREE ZERO. (LISTEN) ON 119.1. WE'VE BEEN TRYING TO CONTACT YOU.
- ⑤ (ROGER) ZERO THREE ZERO. HOLD VFR. STAND BY.
- ⑥ (ZERO THREE) ZERO. SIMULATED ILS APPROACH APPROVED. RUNWAY TWO EIGHT RIGHT. (REPORT) LEAVING THE ILS OUTER MARKER INBOUND.
