AIRCRAFT ACCIDENT REPORT

EASTERN AIR LINES, INC., LOCKHEED ELECTRA L-188, N 5533,
LOGAN INTERNATIONAL AIRPORT, BOSTON, MASSACHUSETTS, OCTOBER 4, 1960

SYNOPSIS

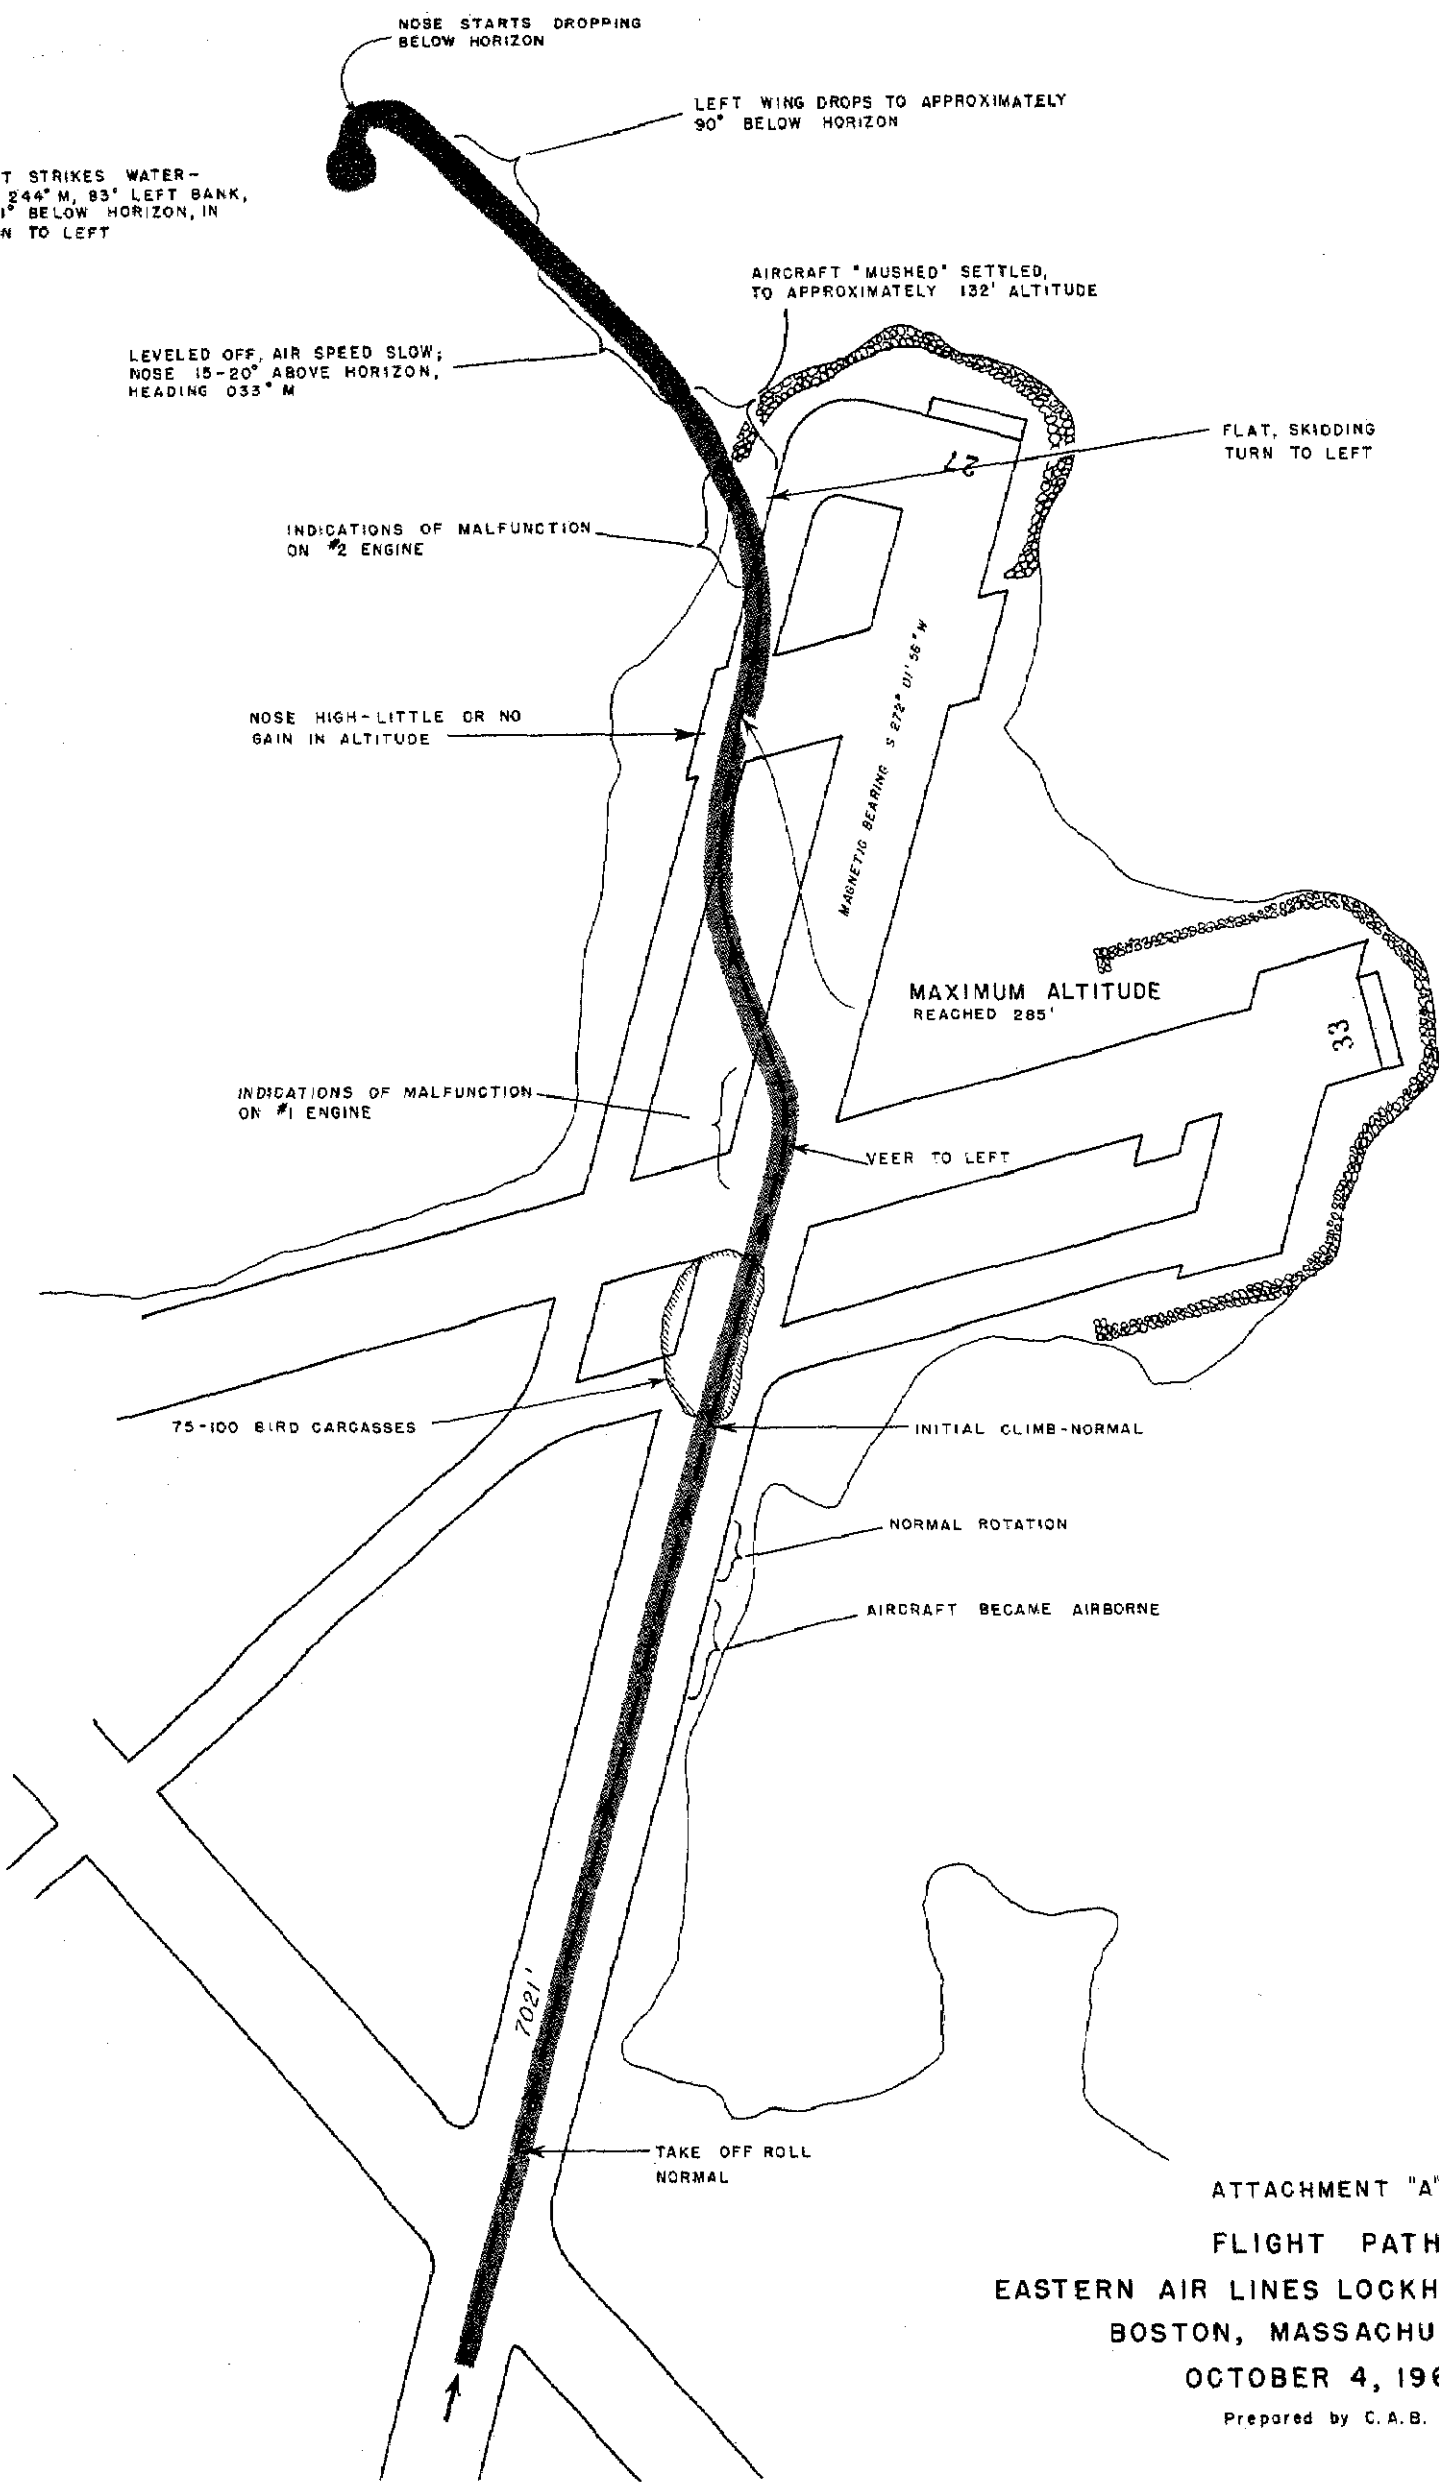
TAKE OFF ROLL
NORMAL

ATTACHMENT "A"
FLIGHT PATH
EASTERN AIR LINES LOCKHEED ELECTRA
BOSTON, MASSACHUSETTS
OCTOBER 4, 1960
Prepared by C.A.B.

First, the more complete loss of power on the left side than on the right started the aircraft turning to the left while its airspeed was decaying as a result of the overall power loss. The fact that the No. 1 propeller rather than an inboard propeller autofeathered, while not critical in itself, was more undesirable in that it increased the degree of asymmetry of any power combinations on the right side.

The No. 2 engine flameout, coupled with only a partial loss of power on No. 4, placed the aircraft in a condition of having no power on the left side and substantial power on the right. This produced a severe yaw to the left which was further aggravated by No. 4 engine recovering full power prior to the relight and recovery of No. 2.

The high yaw angle, as earlier described, produced a drag of such magnitude that the subsequent recovery of No. 2 engine could not arrest the rapid decrease in speed before the aircraft stalled. The recovery of No. 2 engine, while it reduced the degree of asymmetry, could not compensate for the high-power condition on the right side. With some degree of asymmetric power still producing left yaw and roll, coupled with the effects of roll due to yaw, and with the aircraft rapidly entering a stall regime, roll control effectiveness degenerated and the aircraft rolled farther to the left, stalled, and entered a spin. The only recovery from such a situation prior to the spin would have been to reduce power and lower the nose to regain control and airspeed. Recovery in this case was impossible since the 100-to 150-foot altitude was insufficient in an aircraft of the Electra's dimensions and speed requirements.
