**A COMPARISON OF PRESSURE  
TREATED WOOD AND CEDAR  
SIGNPOSTS**

**Final Report**

**STATE RESEARCH PROJECT #549**

*Oregon Department of Transportation*

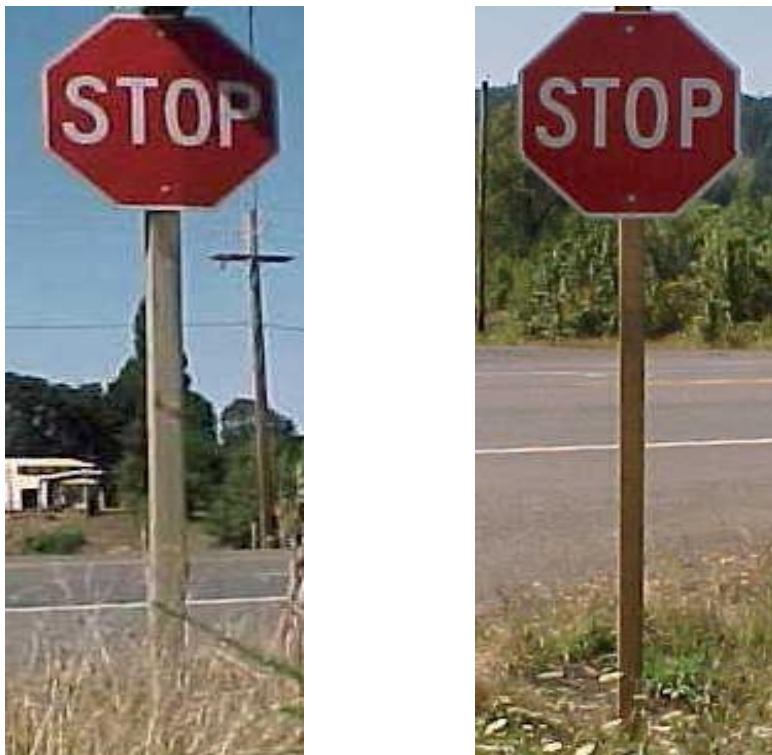
Figure 1.1: A Pressure Treated (left) and a Port Orford Cedar Signpost (right)

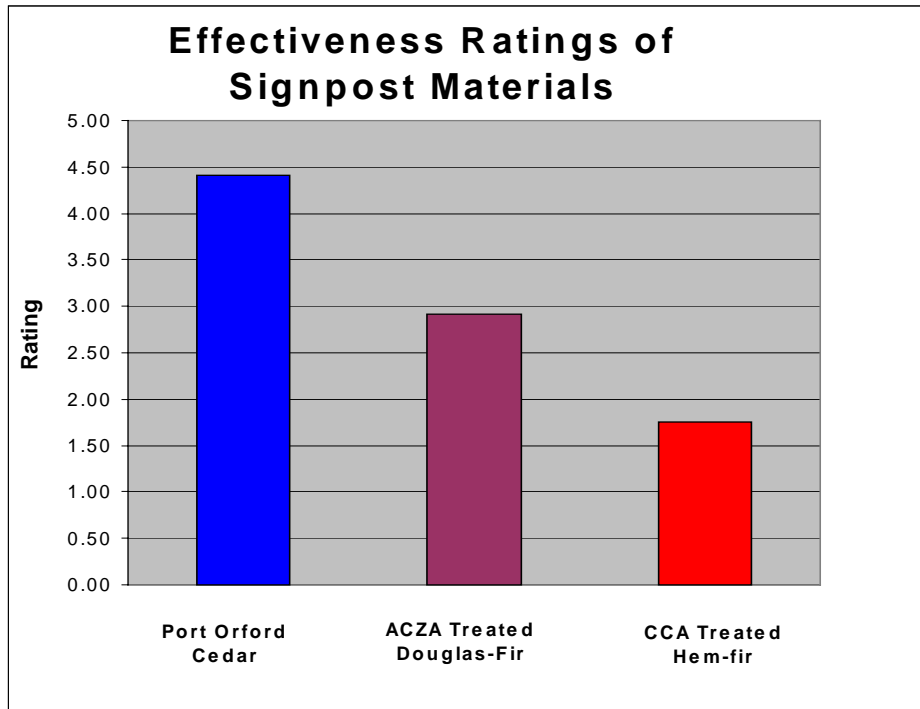
The sign crews were also asked to rate on a scale from one to five the effectiveness (ease in installation, amount of defects, durability, etc.) of each sign post material they use or have used in the past. A score of five was regarded as highly favorable and one was considered the least favorable. The results are presented in Figure 6.1.

Figure 6.1: Effectiveness Rating of Signpost Materials

Port Orford cedar received the highest rating at 4.4 and treated Douglas-fir posts were rated next higher at 2.9.
