Dowel Bar Retrofit – Do's and Don'ts

WA-RD 576.2

March 2009

16. ABSTRACT This report documents construction and inspection guidelines for the successful construction of a dowel bar retrofit project.			
17. KEY WORDS Dowel bar retrofit, concrete rehabilitation, construction techniques		18. DISTRIBUTION STATEMENT No restrictions. This document is available to the public through the National Technical Information Service, Springfield, VA 22616

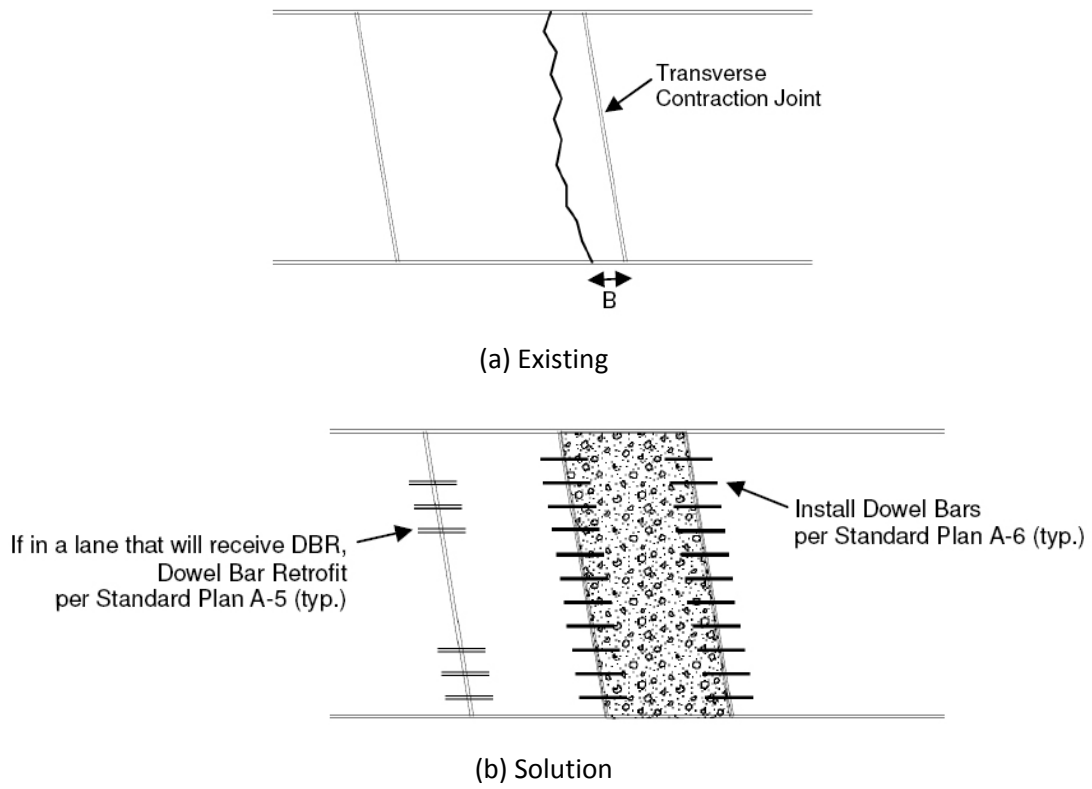
Figure 2 Existing transverse crack (B < three feet).

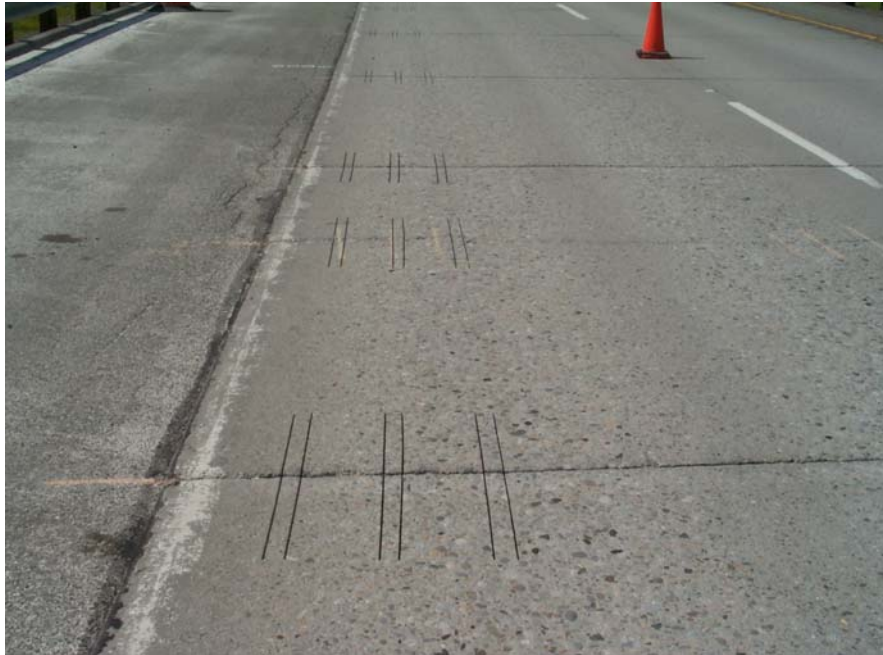
Figure 12 Cut dowel bar slots on non-skewed transverse joint.

Figure 12 illustrates the completed product from the sawcutting operation.

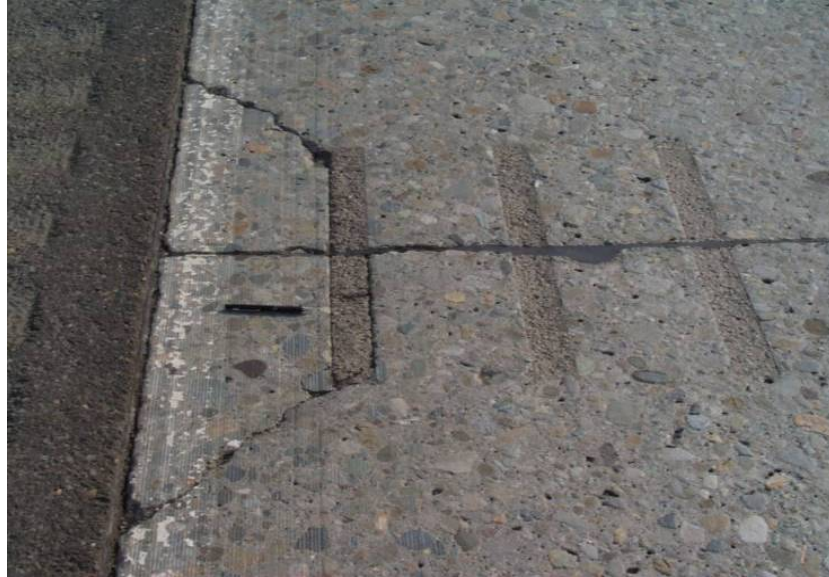
Figure 15 Distress due to dowel bar slot cut and/or chipped too deep.

Slots cut deeper than necessary can contribute to corner cracking (Figure 15). Patching material failure and the potential of the jackhammer punching through the bottom of the dowel bar slot may also occur. The Contractor/Inspector should physically measure (Figure 16) the dowel bar retrofit assembly height (including chairs) to ensure proper sawcut depth.

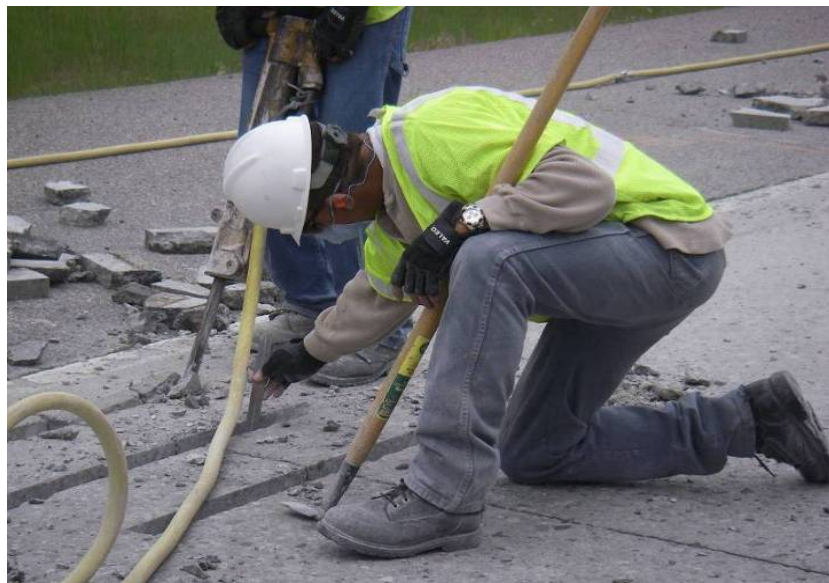
Figure 16 Check depth of dowel bar slot.

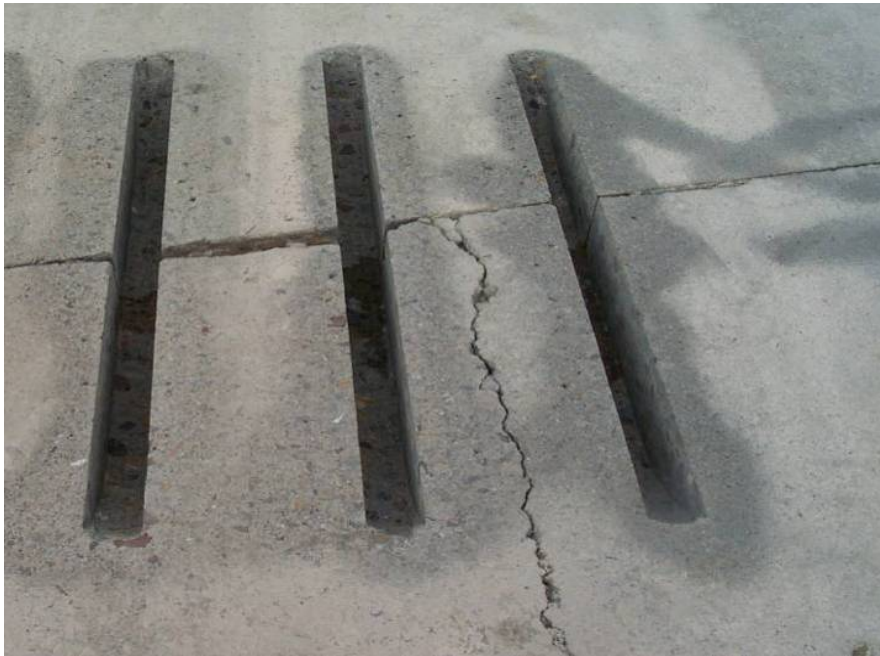
Figure 17 Dowel bar slots aligned to miss an existing longitudinal crack.

Dowel bar slots should be aligned to miss (Figure 17) any existing longitudinal crack. Depending on the wander of the longitudinal crack, dowel bar slots could also be eliminated (Figure 18). If the longitudinal crack was located in the right wheelpath, completely eliminating all dowel bar slots would not be recommended. In this instance, it may be best to place as many dowel bar slots as possible without intersecting the longitudinal crack.

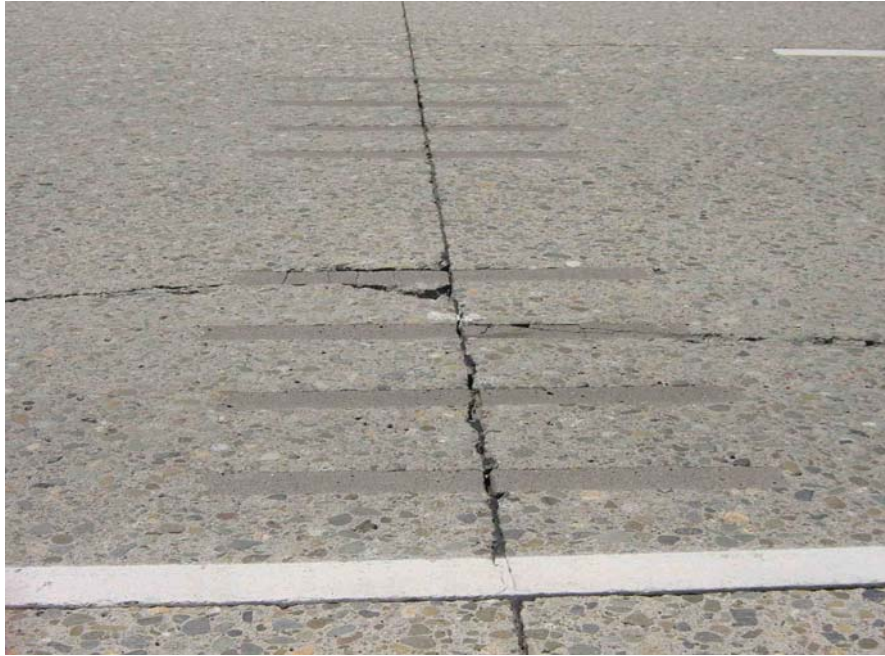
Figure 19 Failure of dowel bar slot placed over existing longitudinal crack.

Figure 19 and Figure 20 illustrate instances where the dowel bar slot was not placed to miss the existing longitudinal crack resulting in failure of the patching material. Dowel bar slots placed over a longitudinal crack will fail within a very short period of time (< 12 months). The failure mechanism is typically debonding, cracking and spalling of the concrete patching material. Shifting dowel bar slots, three to four inches, will prevent this distress while still providing the required load transfer. If a gang saw is used, dowel bar slots may be sawed but not retrofitted, any non-retrofitted sawcuts should be cleaned and sealed with an epoxy resin.

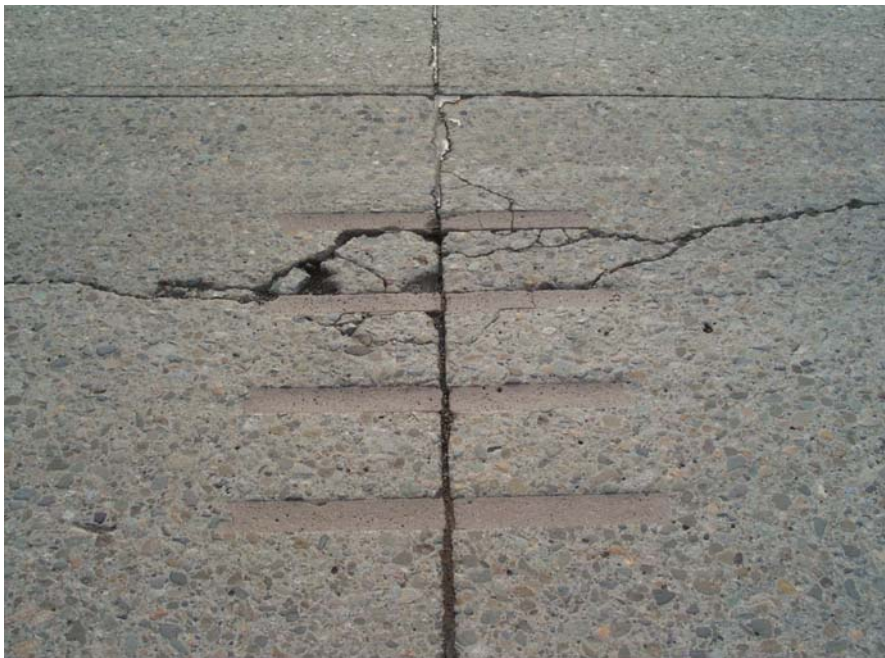
Figure 20 Severe failure of dowel bar slot placed over existing longitudinal crack.

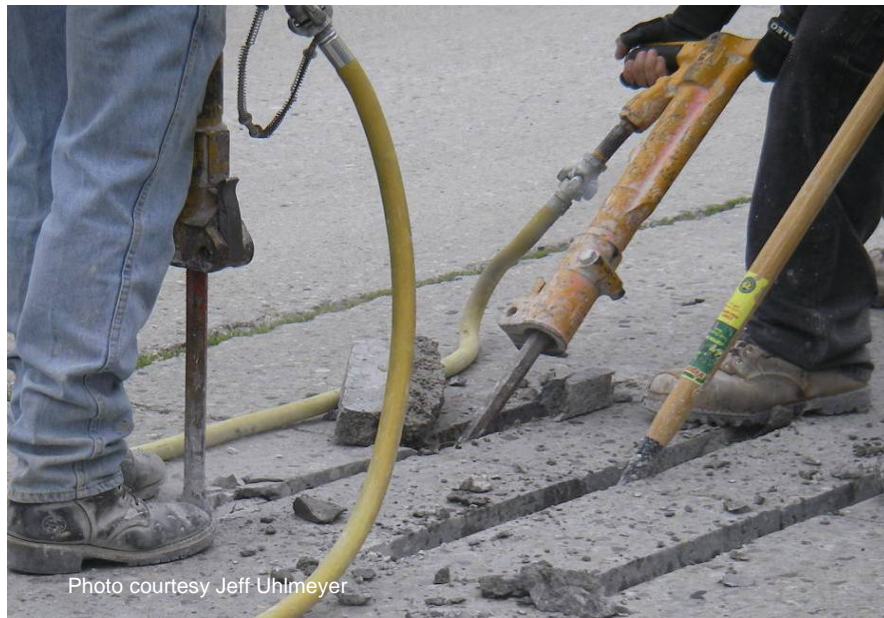
Figure 24 Removing concrete within dowel bar slot.

The existing concrete should be removed from the dowel bar slot using jackhammers weighing 30 pounds or less. Jackhammers should be operated at a 45 degree angle or less (Figure 22 through Figure 24). Jackhammers operated in a vertical position can punch through the bottom of the dowel bar slot.

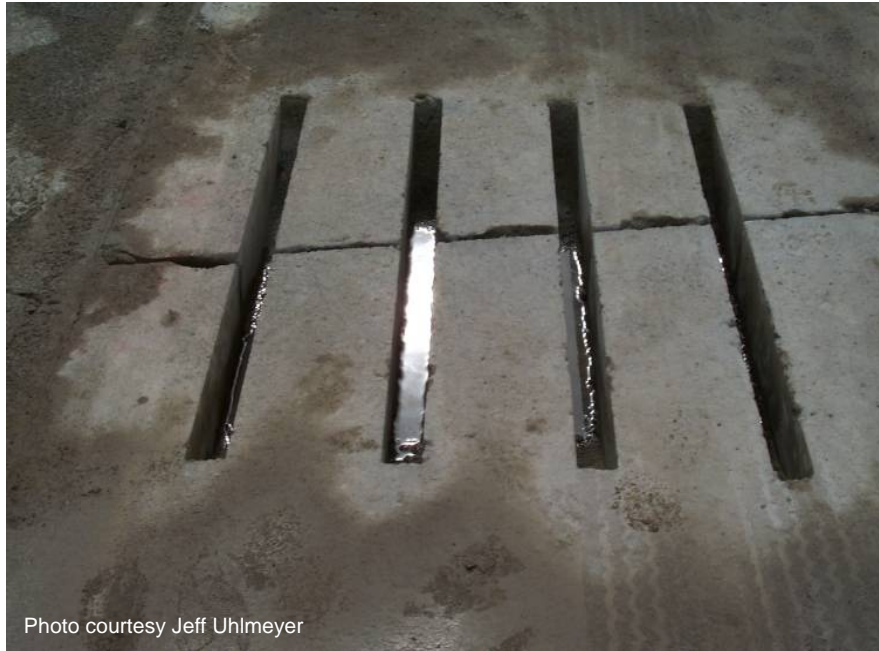
Removal of debris and slurry residue can be challenging if water is present in the dowel bar slot. If water is present (Figure 42), slurry residue is redistributed to the bottom or sides of the dowel bar slots and should be removed by sandblasting or compressed air. More than one attempt at cleaning the dowel bar slot may be required to obtain the desired cleanliness.

Figure 42 Water must be removed prior to placement of patching material.

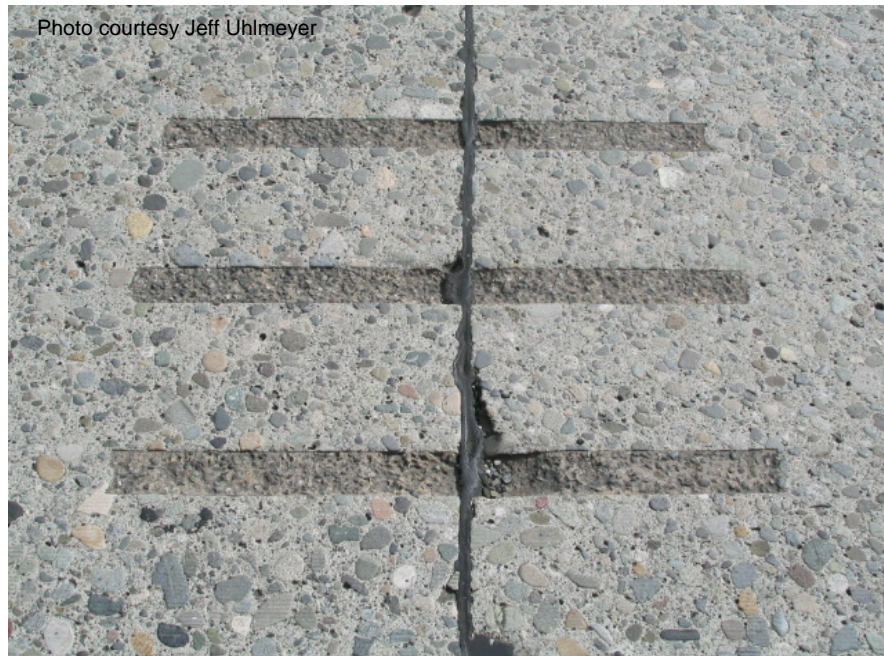
Figure 45 illustrates spalling of the patching material. Potential causes of this distress can be related to consolidation, lack of sufficient aggregate or opening too early to traffic. Figure 46

Figure 45 Spalling of patching material.

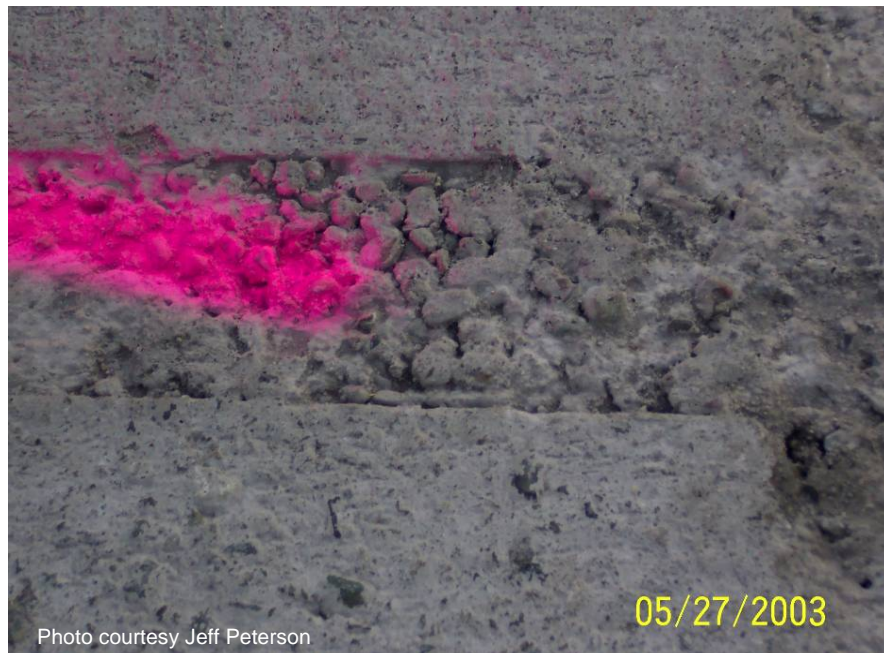
illustrates insufficient consolidation in the patching material. Repair, for both instances would include removal and replacement of two to three inches of the patching material.

Figure 46 Insufficient consolidation of patching material.

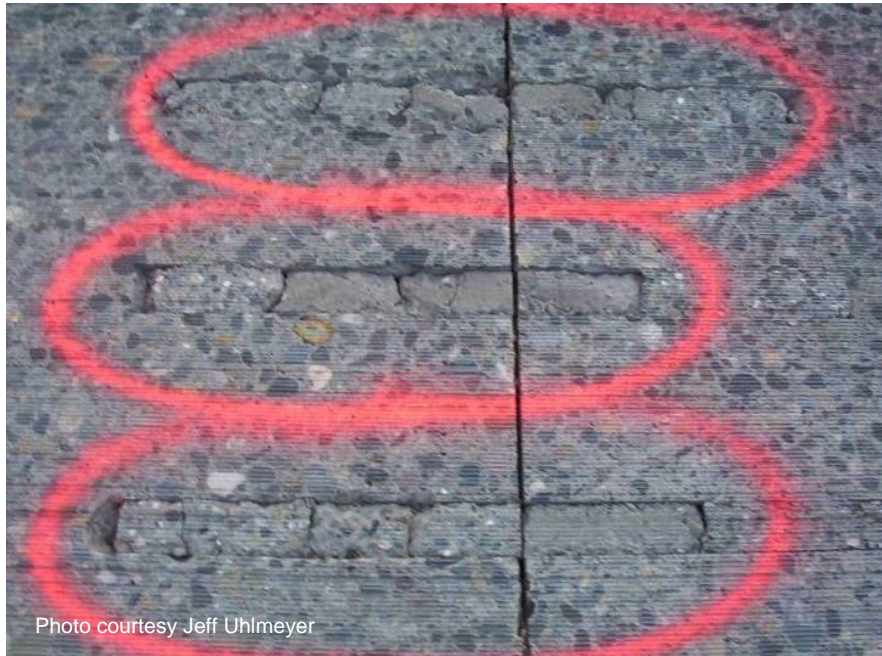
Figure 47 illustrates shrinkage cracking of the patching material. This type of cracking is repaired by removal and replacement of distressed patching material.

Figure 47 Shrinkage cracks of pour back material.

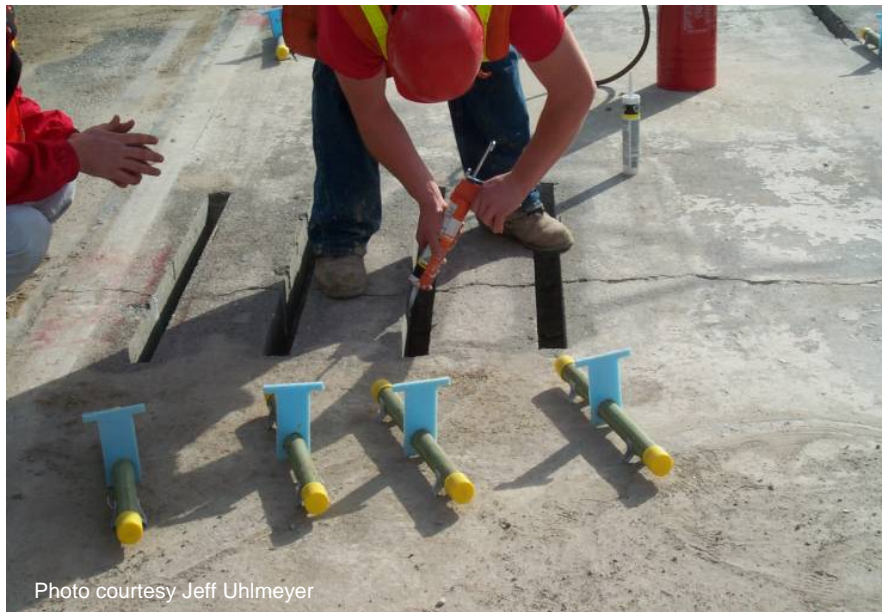
Transverse joints and cracks must be caulked (Figure 49 and Figure 50) within the dowel bar slot. Caulking material should not extend more than $\frac{1}{2}$ inch beyond either side of the joint or crack. The caulking material will prevent patching material from entering the joint/crack.

Figure 49 Caulking dowel bar slot sides and bottom.

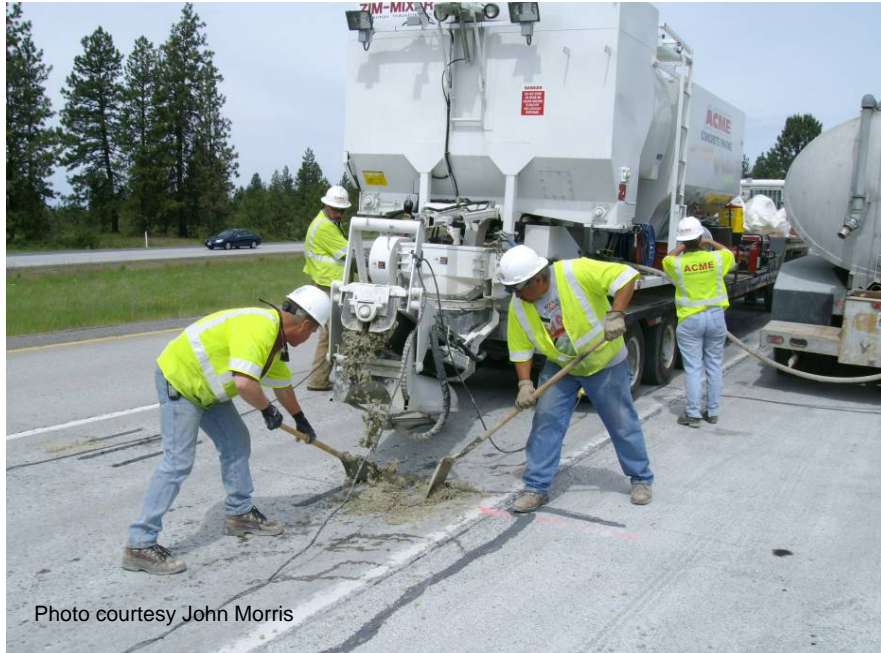
Patching material should not be dumped directly into the dowel bar slot; the impact of the patching material falling directly into the dowel bar slot will cause movement of the dowel bar retrofit assembly. The patching material should be placed adjacent (Figure 62 and Figure 63) to and spread with shovel (Figure 64) toward and into the dowel bar slot.

Figure 62 Placement of patching material.

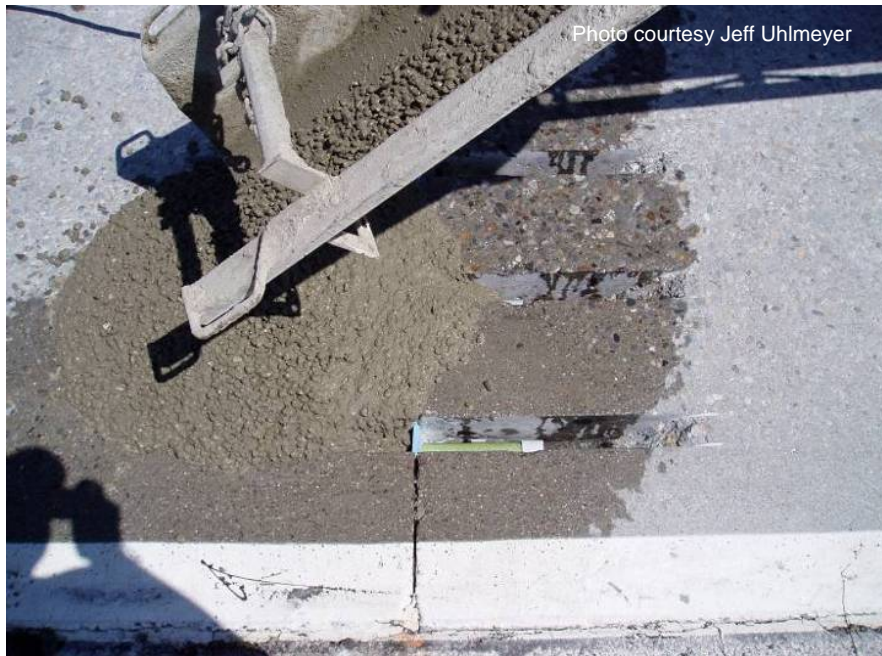
Figure 63 Placing patching material adjacent to dowel bar slots.

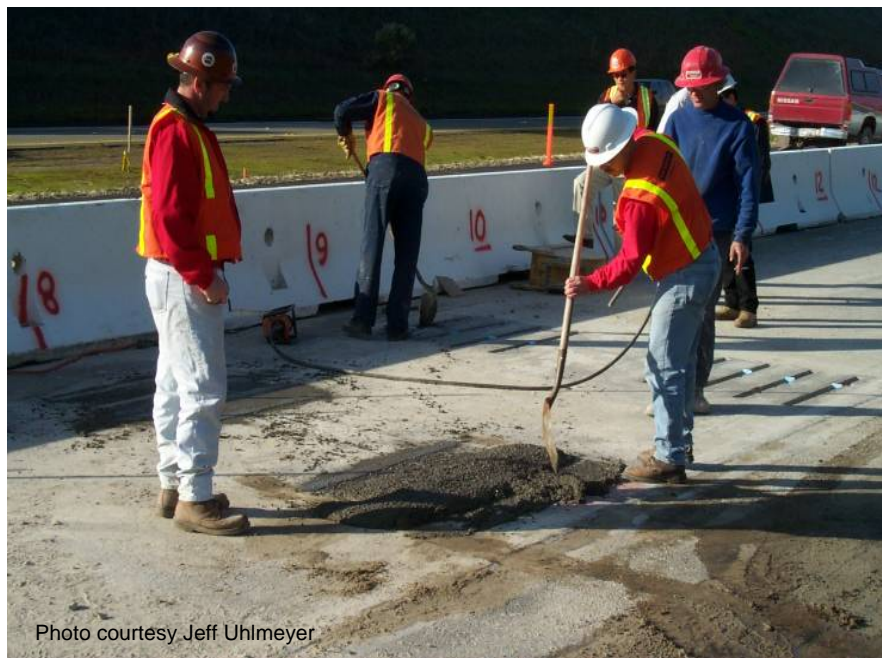
Figure 64 Moving patching material into dowel bar slots.

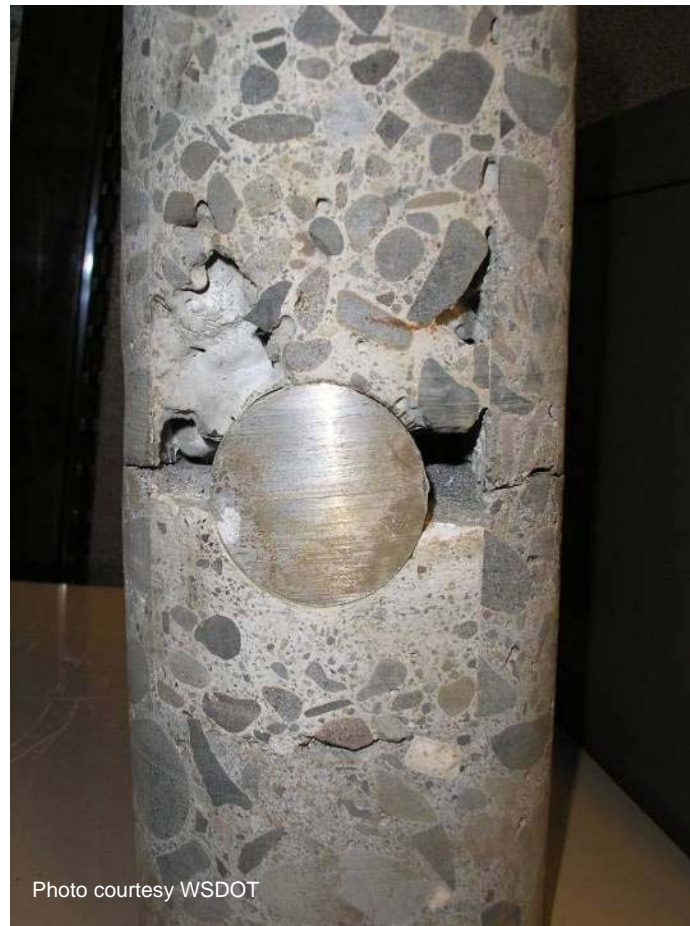
Figure 68 and Figure 69 illustrate patching material voids in the vicinity of the dowel bar. The core shown in Figure 68 was taken from the first dowel bar retrofit project and illustrates lack of consolidation beneath the dowel bar, which could be due to aggregate size and the inability to move the aggregate around the dowel bar or lack of consolidation. Figure 69, on the other hand, was taken from a more recent project (2006) and shows lack of consolidation around and above the bar. In this case, it was determined that the aggregate gradation was too large to adequately fit around the bar and WSDOT modified specifications to allow only AASHTO Grading No. 8 (prior to this project, either AASHTO Grading No. 7 or 8 was allowed).

Figure 69 Poor consolidation around bar.

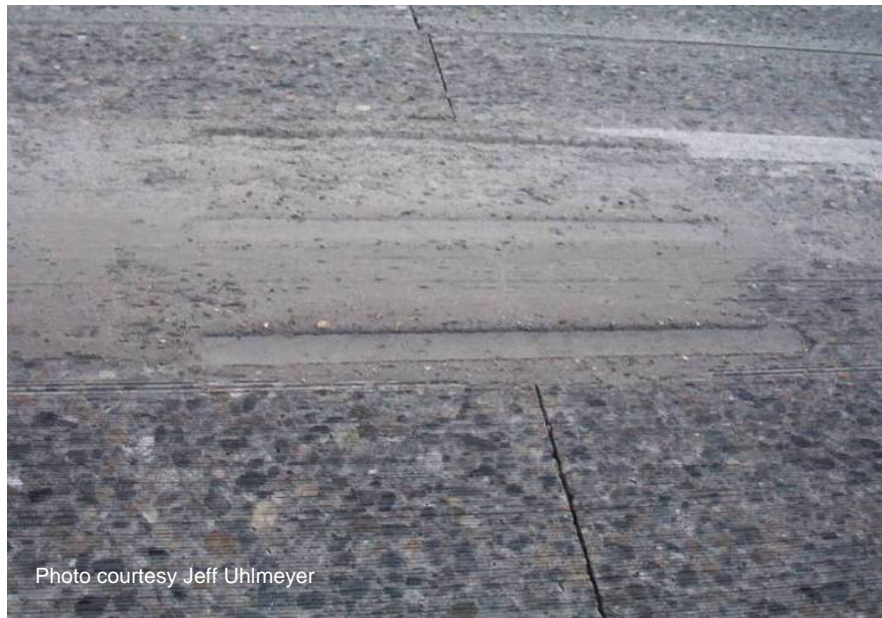
Figure 77 illustrates damage caused by mechanically sweeping the roadway prior to the patching material reaching the required strength. As before, the methodology for repairing this distress is to saw cut, remove and replace two to three inches of the distressed material.

Figure 77 Mechanical sweeping prior to patching material reaching strength.

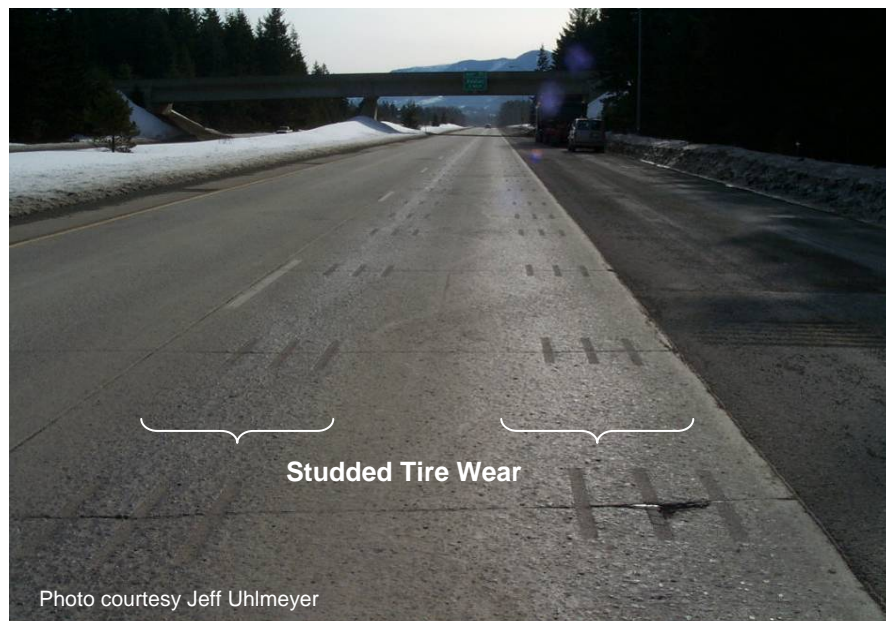
Studded tire wear is one of the more predominant distresses affecting pavement (both HMA and concrete) performance in Washington State. For dowel bar retrofit, the largest impact of studded tires is wear in the dowel bar slot (Figure 78 and Figure 79).

Figure 78 Wear due to studded tires.

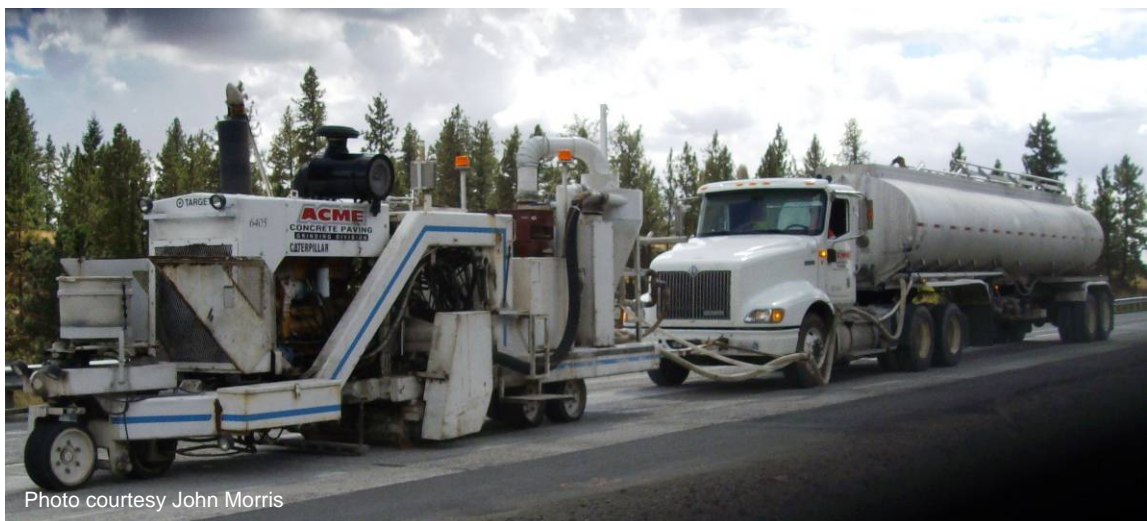
Figure 80 Diamond grinding equipment.

Diamond grinding (Figure 80 through Figure 82) should begin within 10 working days of placing dowel bar retrofit patching materials. The primary reason for this specification is to minimize traveler complaints related to intentionally leaving dowel bar patching material high.

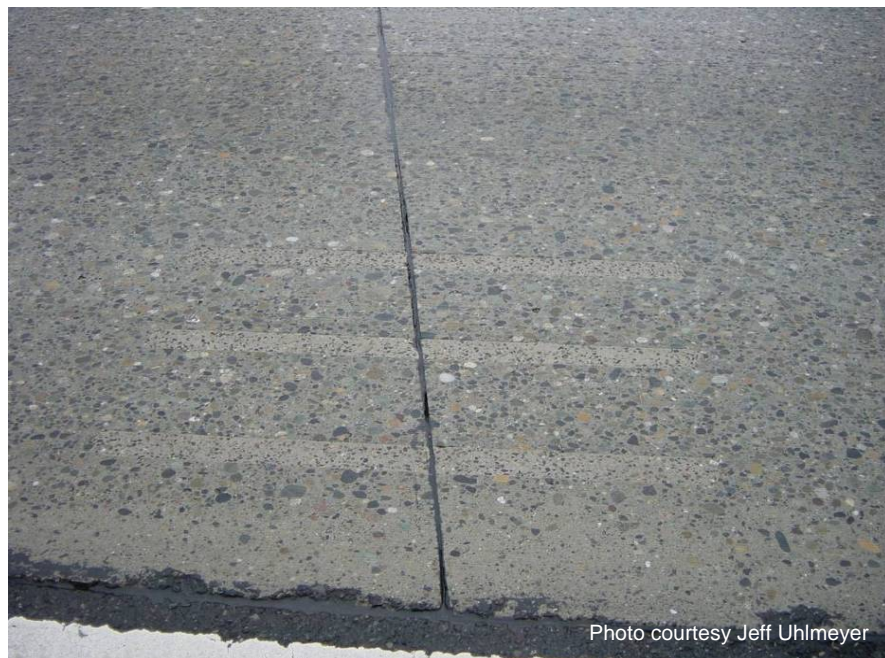
Figure 84 Close-up of completed dowel bar retrofit.

Figure 83 and Figure 84 illustrate successful completion of the dowel bar retrofit process.
