Improving Infrastructure Sustainability 2: Repairing Existing Fatigue Cracks in Steel Bridges Using Carbon Fiber Reinforced Polymer Materials

1 Report No. K-TRAN: KU-11-5	2 Government Accession No.	3 Recipient Catalog No.	
4 Title and Subtitle Improving Infrastructure Sustainability 2: Repairing Existing Fatigue Cracks in Steel Bridges Using Carbon Fiber Reinforced Polymer Materials		5 Report Date January 2016	6 Performing Organization Code
		7 Performing Organization Report No.	
7 Author(s) Say Hak Bun, M.S., Eric Bonet, M.S., Adolfo Matamoros, Ph.D., P.E., Caroline Bennett, Ph.D., P.E., Ron Barrett-Gonzalez, Ph.D., Jian Li, Ph.D., Stan Rolfe, Ph.D., P.E.		10 Work Unit No. (TRAIS)	
9 Performing Organization Name and Address The University of Kansas Department of Civil, Environmental and Architectural Engineering 1530 West 15th St Lawrence, Kansas 66045-7609		11 Contract or Grant No. C1879	
		13 Type of Report and Period Covered Final Report July 2010–February 2015	
12 Sponsoring Agency Name and Address Kansas Department of Transportation Bureau of Research 2300 SW Van Buren Topeka, Kansas 66611-1195		14 Sponsoring Agency Code RE-0556-01

Final Report

The University of Kansas

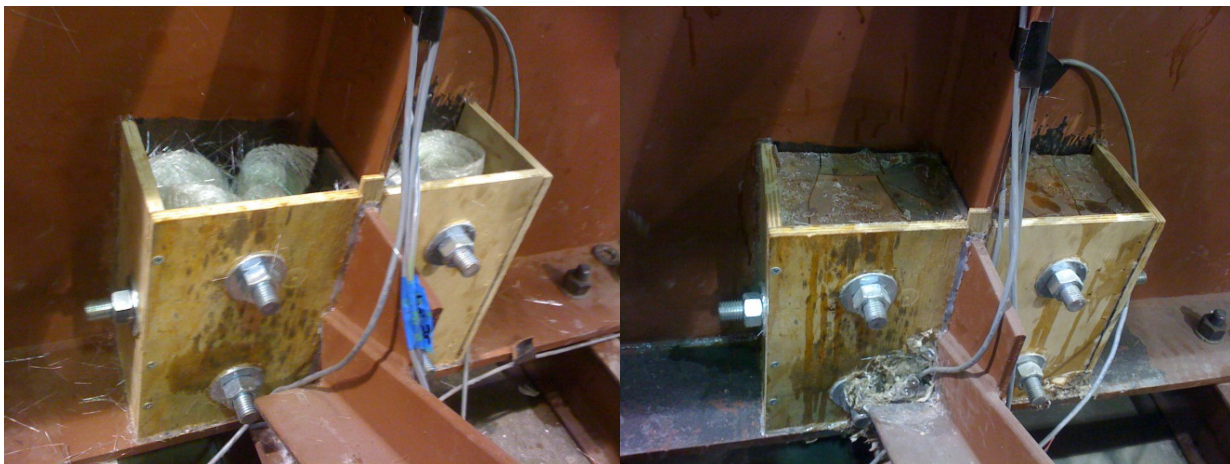
Figure 3: GFRP Repair Block for Girder Subassembly 1 Prior to Casting the West System™ Resin and After Curing

Prior to casting the GFRP composite blocks, the paint was removed from the areas that would be bonded to the block through sandblasting. After the paint was removed, the steel surface was cleaned using a degreaser and wooden forms were placed on each side of the connection plate to form two rectangular molds, each with dimensions of $165 \times 121 \times 254$ mm ($6\frac{1}{2} \times 4\frac{3}{4} \times 10$ in.). The forms were firmly held in position through the use of 19-mm ($\frac{3}{4}$ -in.) threaded rods (Figure 3). The threaded rods were tightened to the snug-tight condition, the mat fiberglass was placed inside the wooden forms, and the resin was cast. The resin used in the GFRP blocks was a West System™ 105 Epoxy Resin and West System™ 206 Slow Hardener, with a pot life of 25 minutes, mixed at a ratio of 5:1. The West System™ epoxy and mat fiberglass were combined to make 0.0102 m^3 (0.36 ft^3) of composite with approximately 30% mat fiberglass and 70% West System™ epoxy resin. Finally, the GFRP blocks were cured at room temperature for 24 hours before testing. It should be noted that while the threaded rods provided mechanical anchorage between the GFRP blocks, the connection plate, and the girder web, no connection beyond that of naturally-occurring adhesion during the curing process was provided between the GFRP blocks and the bottom flange of the girder subassembly.

The first girder subassembly was tested under cyclic loading, ranging from 2.2 kN (0.5 kips) to 25.3 kN (5.7 kips). The test was divided into two trials: Trial G1.1 was performed on the girder subassembly without any retrofit measure, followed by Trial G1.2 in which the girder subassembly was repaired with the GFRP composite blocks. The main objective of Trial G1.1, in which the girder subassembly was subjected to cyclic loading in the unretrofitted condition, was to allow cracking to initiate and propagate. The first crack formed along the connection plate-to-web weld and was allowed to propagate to a length of 57 mm (2¼ in.) while being inspected every thousand cycles using UV light and dye penetrant. After Trial G1.1 was completed, the GFRP composite block retrofit measure was cast in the interior face of the girder on both sides of the connection plate (Figure 3).

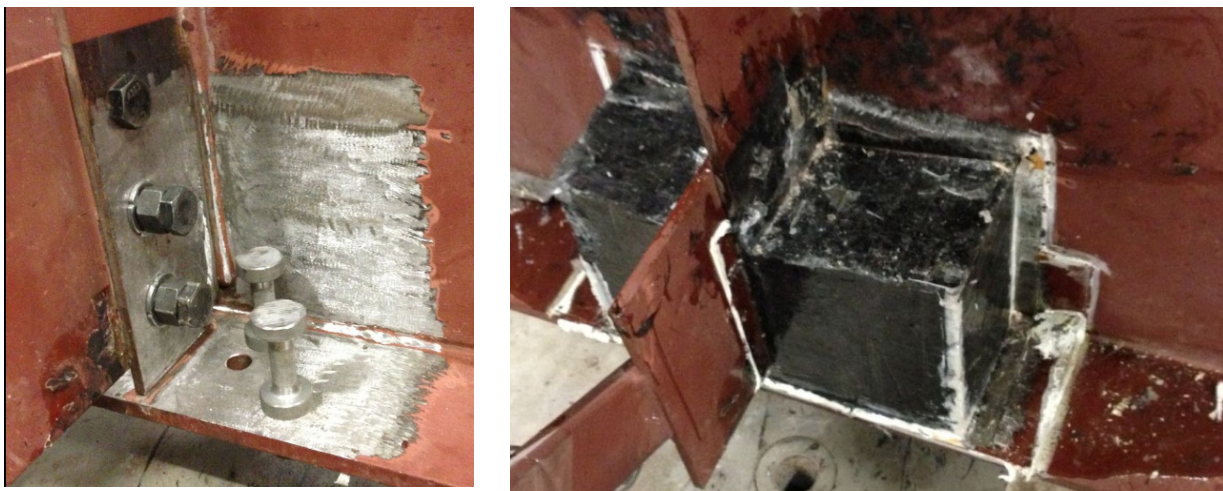
Figure 4: Repair for Girder Subassembly 2 Prior To and After Casting CFRP Block

A second girder subassembly was retrofitted using CFRP blocks. For the second subassembly, the surface was prepared by grinding the paint off the specimen in the region where the retrofit would be installed. Steel anchors were installed in the girder flange by drilling and tapping to provide mechanical anchorage for the CFRP blocks (Figure 4). Longer bolts were installed between the connection plate and the cross frame to improve the anchorage of the CFRP blocks to the cross frame. The resin system used in the CFRP blocks was a West System™ 105 Epoxy Resin and West System™ 209 Extra Slow Hardener mixed at a ratio of 3:1. The blocks had a 15% graphite fiber volume ratio. The blocks were fabricated according to the following sequence: first, the resin and the hardener were mixed together for 30 seconds with a drill-attached paint mixer. After mixing of the liquids, the fibers were slowly added and the composite was blended with a paint stick for a period of 5 minutes. After mixing, the composite was placed in the wooden forms with mold dimensions of 127 × 152 × 178 mm (5 × 6 × 7 in.). A 51 × 102-mm (2 × 4-in.) piece of timber was used to apply pressure on the block and compact it. Additional details regarding the fabrication technique are provided in Appendix B.

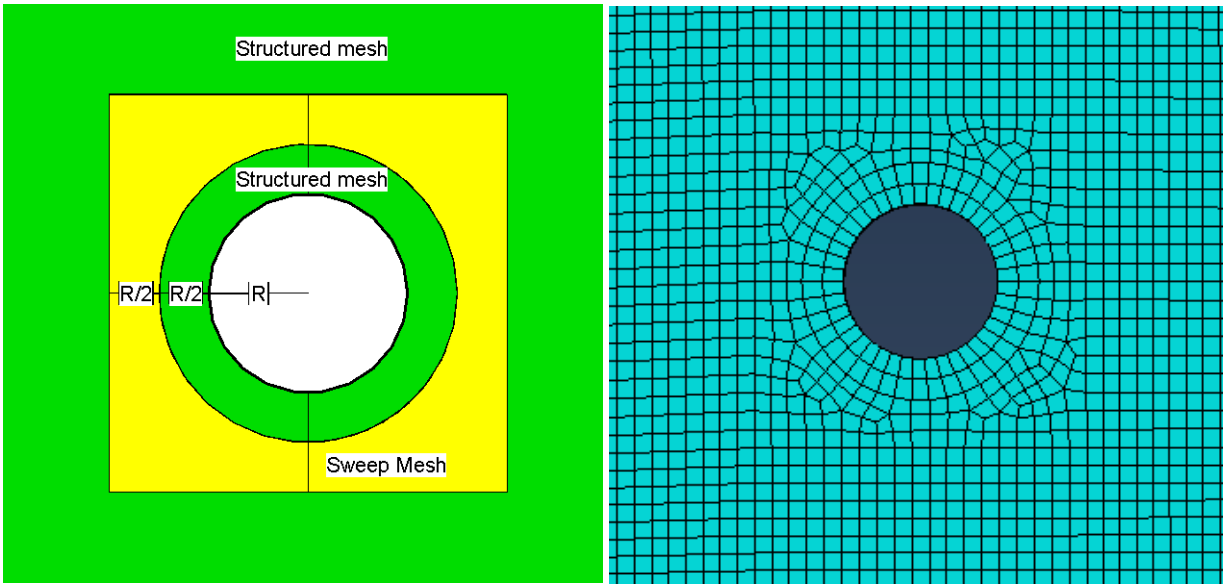
Figure A.2: Bolt Hole Meshing Technique

Special consideration were taken to ensure the model would be constructed out of 8-node hexahedral elements, only using other element types when absolutely necessary. A meshing technique was developed for bolt holes to allow for a clean mesh. Figure A.2 shows the generic bolt hole meshing technique.

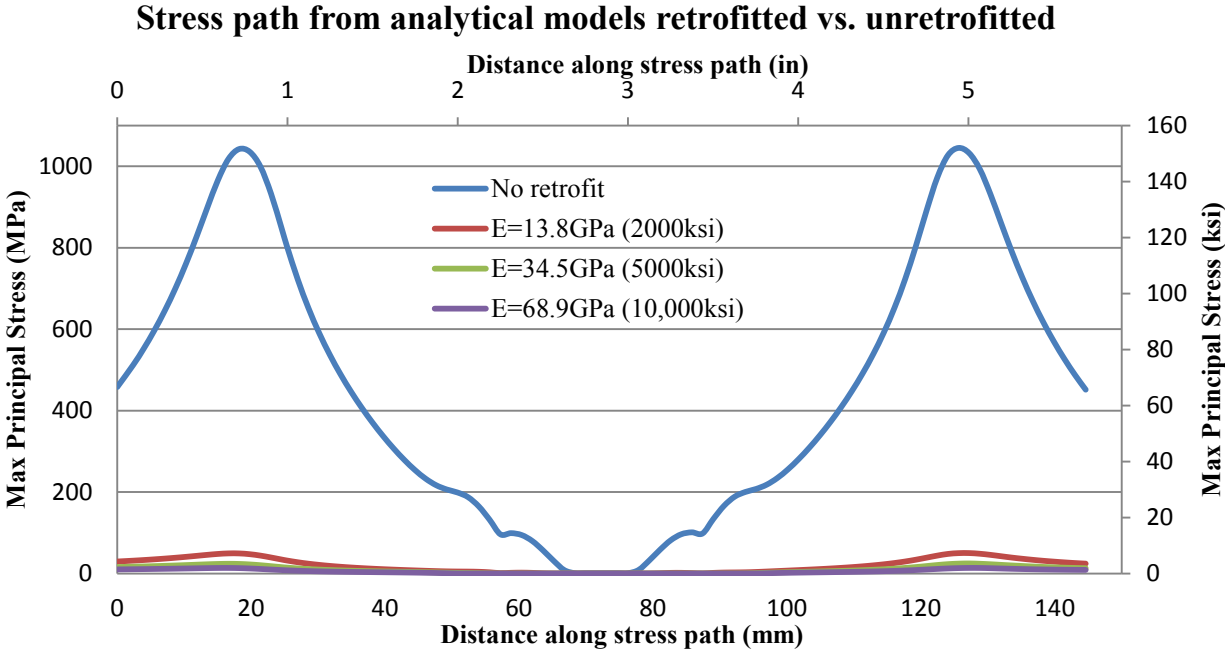
Figure A.11: Retrofitted Specimen Using the Composite Block Retrofit with Varying Modulus of Elasticity vs. Unretrofitted Specimen

Figure A.11 presents a comparison of maximum principal stresses from the path in the unretrofitted and retrofitted models. The retrofit geometry in each retrofitted model was exactly the same, and the differences in the models are the composite material properties used; the modulus of elasticity for each retrofitted model was varied. Increasing the modulus of elasticity of the composite block did not have a significant effect on the magnitude of stress reduction.

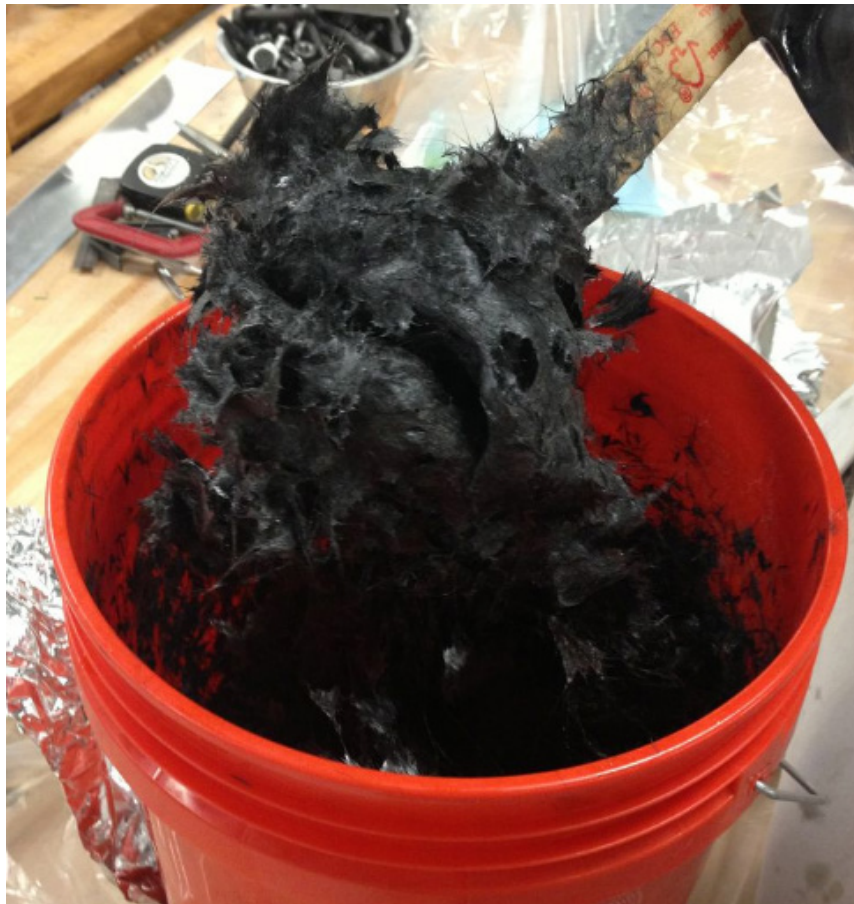
Figure B.4: CFRP Mixture After Mixing

After all materials were weighed out and the resin and hardener was mixed together, a drill attached paint mixer was used to mix the two liquids together for 30 seconds. After the liquids were mixed, the fibers were slowly added. A paint stick was used to mix the fibers and the epoxy together. After all fibers were added, the composite was mixed for 5 minutes. Figure B.4 shows the composite mixture after five minutes of mixing.

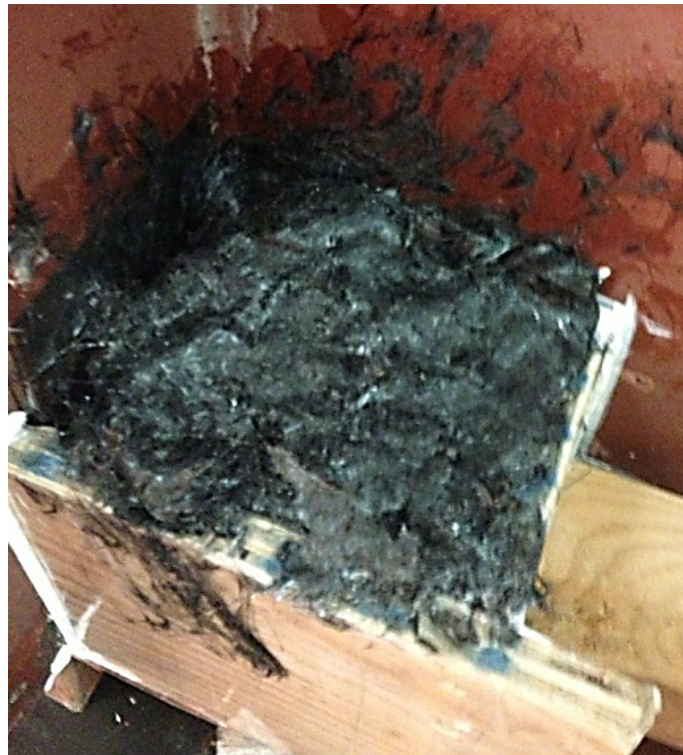
Figure B.5: CFRP Material Inside Mold

The CFRP mixture was then put into the mold at the web-gap region. The experimenter took handfuls of the composite and placed it into the mold until the composite was flush with the top of the box as shown in Figure B.5. A 127×152 -mm (5×6 -in.) piece of 16-mm ($5/8$ -in.) thick plywood wrapped in packing tape was placed on the top of the box. A 667-mm ($26\frac{1}{4}$ -in.) long 51×102 -mm (2×4 -in.) board was wedged up against the underside of the girder's top flange. This 51×102 -mm (2×4 -in.) board was used to push the plywood piece on top of the box into the form in order to compact the composite and ensure there wouldn't be any air pockets present in the block. Clear epoxy then began to leak through the form ensuring that the block was under pressure, as shown in Figure B.6. The temperature in the lab when the block was casted was $24.3\text{ }^{\circ}\text{C}$ ($75.7\text{ }^{\circ}\text{F}$).

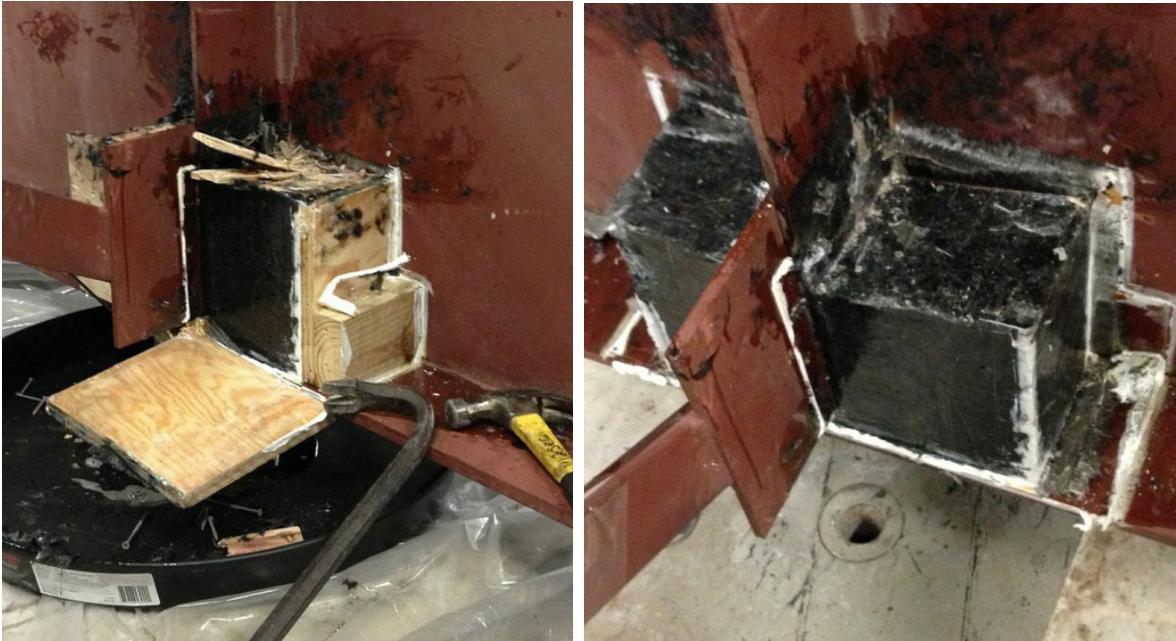
Figure B.7: Cured Composite Block

The block was given nine full days to cure. On the 10th day of curing, the plywood mold was removed. A crowbar and hammer was used to remove the mold from the block. Figure B.7 shows the mold being removed and the fully cured composite block. Testing of the composite
