DOT/FAA/AR-00/13

Benefit Analysis for Aircraft 16-g Dynamic Seats

April 2000

Final Report

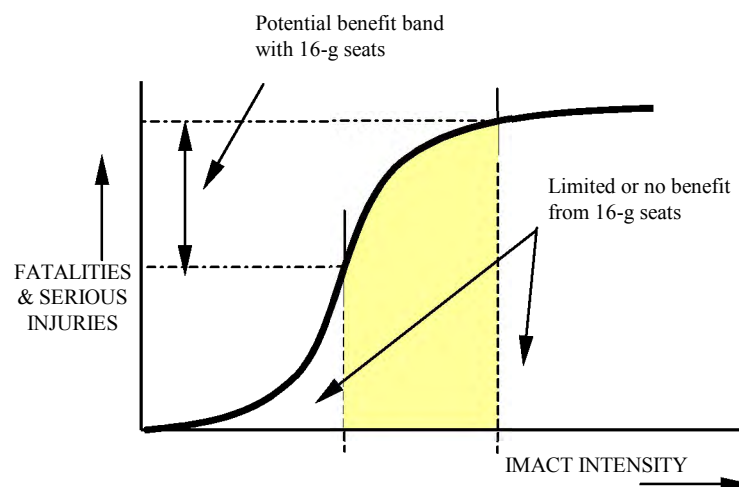
FIGURE 4. POTENTIAL LIVES SAVING WITH 16-g SEATS

From a previous study [1], it was suggested that the proportion of fatal and serious injuries in an accident scenario was of a form similar to that shown in figure 4. It is evident that there will not be any benefit from the introduction of 16-g seats when the impact intensity is beyond their level of resilience. Furthermore, at impact intensities below those sustainable by 9-g seats, there would be little benefit beyond that afforded by improvements to seat design associated with the enhanced Head Injury Criteria.

This limits the number of ground impact related accidents that would benefit from the introduction of 16-g seats.

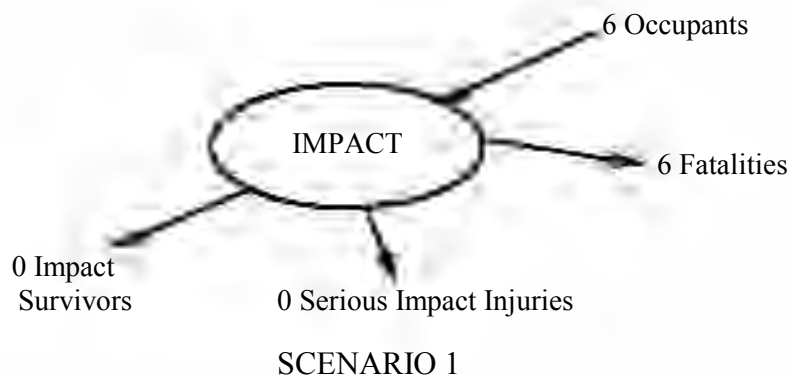
Scenario 1 is the area occupied by the flight and cabin crew. It is assumed that all perished as a direct result of the impact.

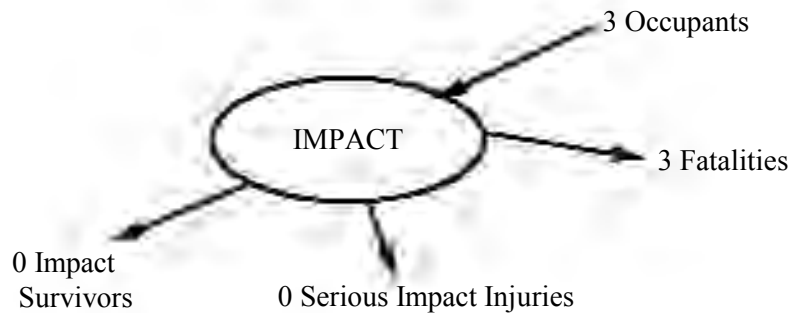
SCENARIO 1

Scenario 1 represents the cockpit area containing three flight crewmembers. Since fire was reported only in the mid-section, it has been assumed that the flight crew suffered fatal injuries in the impact.

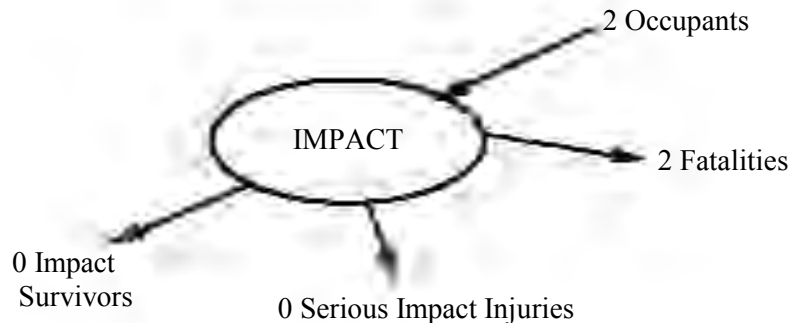
SCENARIO 2

Scenario 2 represents the area occupied by the two forward flight attendants. Since fire was reported only in the mid-section, it has been assumed that the forward flight attendants suffered fatal injuries in the impact.

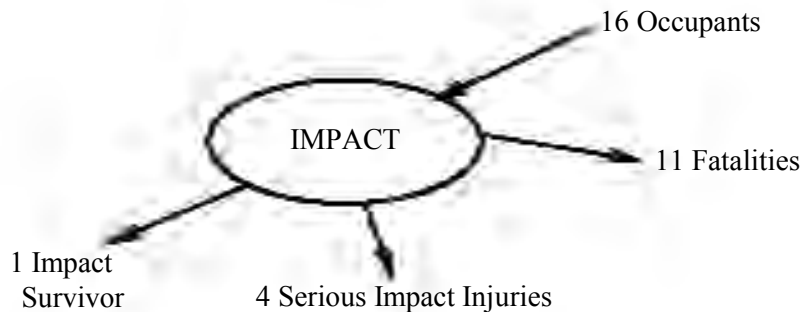
SCENARIO 4

Scenario 4 represents seat row 34 to seat row 40, located at the front of the rear section and subjected to massive disruption of cabin floor, walls, and ceiling. Full details of occupant injury are not known but due to the extent of the cabin disintegration there is unlikely to be any benefit from the introduction of 16-g seats. Therefore the breakdown of injuries will have no bearing on the outcome of this analysis and all fatalities have been assumed to be from impact forces.

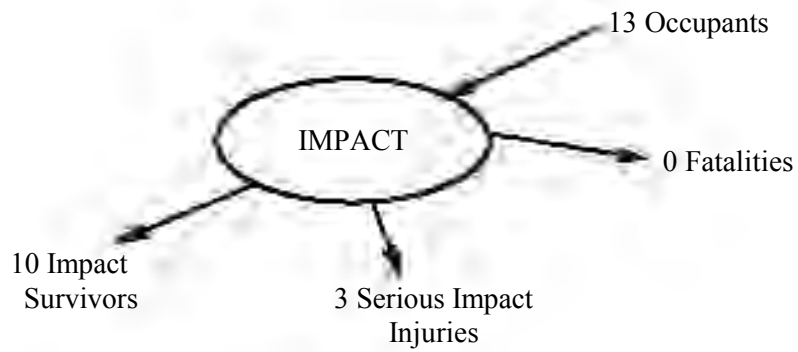
SCENARIO 5

Scenario 5 represents the middle and right side sections of seat rows 41 to 45, which were relatively undamaged. Three occupants could not escape due to their impact injuries and were removed by fellow passengers and rescue personnel. Ten occupants reported minor or no injuries.

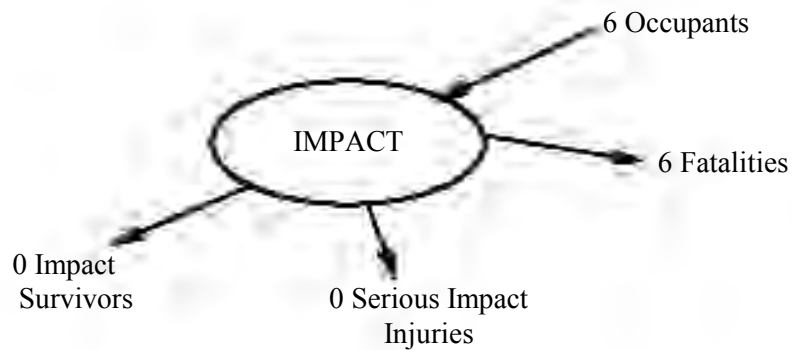
SCENARIO 6

Scenario 6 represents the left side of seat rows 41 to 45. The left wall was missing and the six occupants who were seated next to the wall suffered fatal injuries and these have assumed to have been caused by the impact forces that removed the wall.

The six fatalities located against the missing side wall are assumed to have been killed by the impact that removed the wall and therefore no benefit was assessed for the use of 16-g seats in this area.

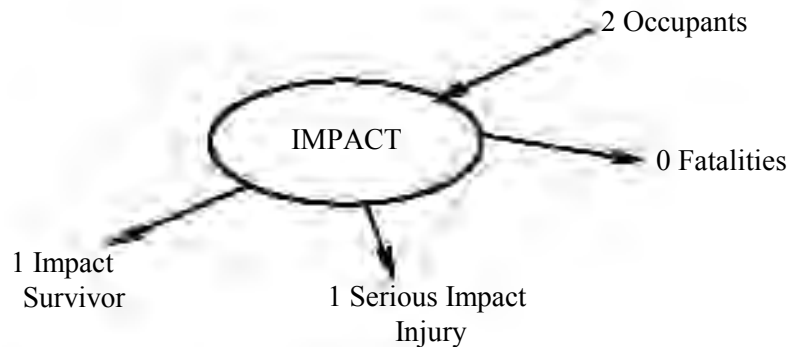
SCENARIO 7

Scenario 7 represents the area containing the two rear flight attendants. One suffered serious injuries due to the impact and the other escaped with minor or no injuries.

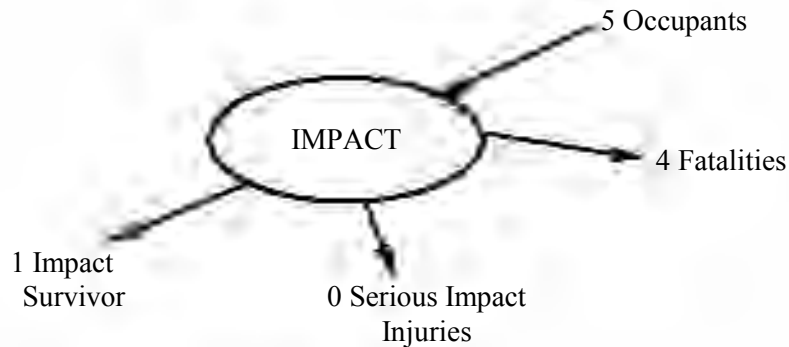
SCENARIO 8

Scenario 8 contains the five occupants for which seat location and injury were unknown. Absence of information results in the following simplified survivability chain. It was reported that 26 passengers and 3 cabin attendants survived the accident. However in figure A-1 the injury location diagram only identified 25 passengers and 3 cabin attendants. Therefore, 1 of the unknown seat location passengers must have received minor or no injuries since it was not significant enough to be reported officially.

The four unknown seat location passengers have been assumed to have died from the impact. This is consistent with the destruction of the aircraft.

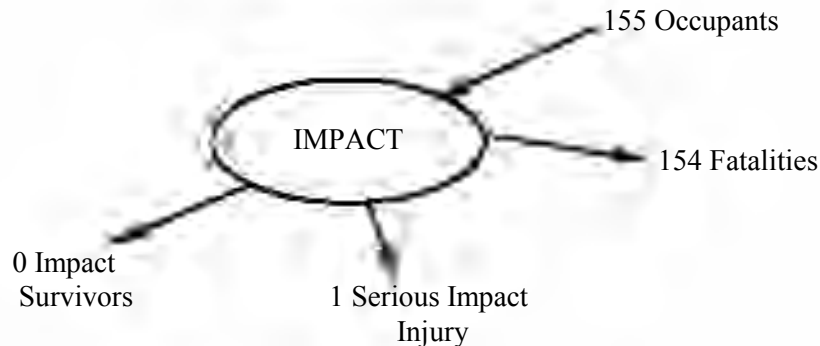
Due to the massive disintegration of the fuselage structure, this accident was considered as a single scenario, encompassing the whole cabin.

This accident involved a considerable impact and the cabin area disintegrated during the crash sequence. It was reported that all of the passenger seats were separated from the fuselage and were scattered along the wreckage path. In addition, external examination of the occupants showed that all had sustained multiple injuries. Therefore, due to this large amount of structural disruption, it is assessed that the introduction of 16-g seats would not have provided any additional benefit in this accident.

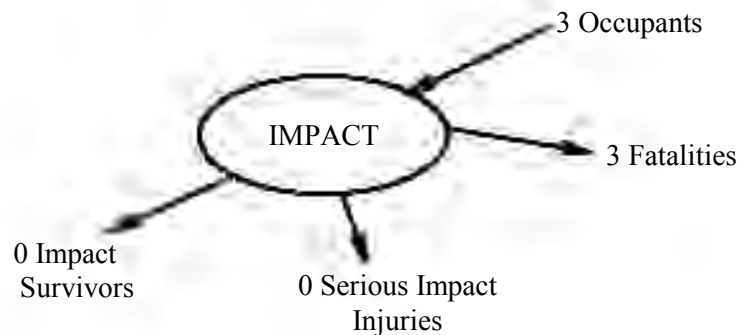
SCENARIO 1

Scenario 1 contains the flight deck and the vestibule where two flight crew and one cabin attendant died from impact injuries.

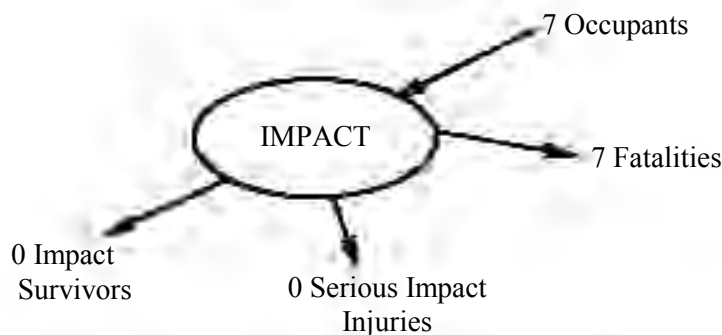
SCENARIO 2

Scenario 2 contains the forward left side of the fuselage, seats 2A to 9A and 9C, where there were seven impact fatalities. Conditions for passengers seated in these seats are considered nonsurvivable due to the severe damage in this area. The forward fuselage came to rest on its left side and it was badly damaged. This included loss of some areas of the floor and ceiling. Much of the exterior skin and underlying structure was torn away and found along the wreckage path.

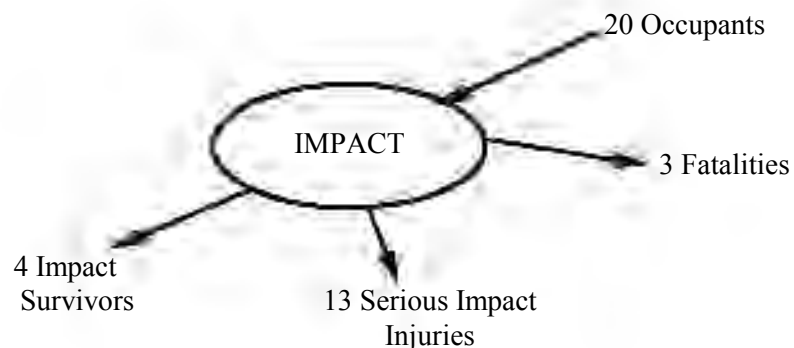
SCENARIO 3

Scenario 3 contains rows 2 to 9 on the right side and seats 2B to 8B. The right side of the fuselage was distorted and dented in several places near the forward baggage door. Some passengers were thrown out of the cabin. There were 20 passengers in this section and 2 died from impact injuries, 13 suffered serious impact injuries, and 4 received minor or no injuries.

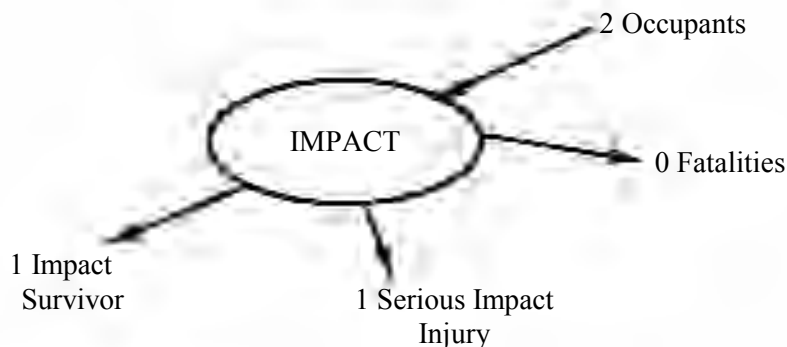
SCENARIO 6

Scenario 6 contains the two flight attendants stationed at the rear of the aircraft. One flight attendant sustained serious impact injuries and the other received minor or no injuries.

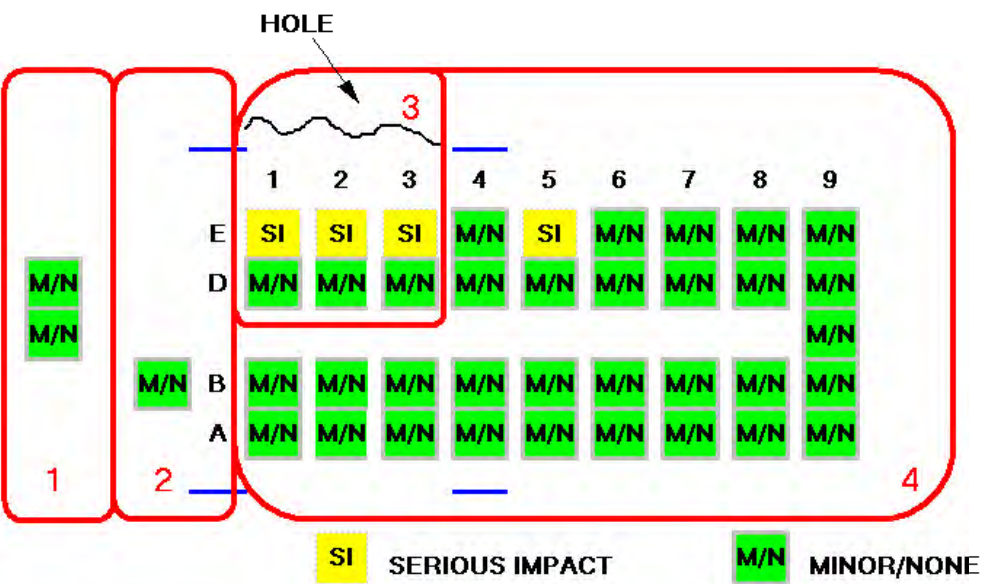
FIGURE A-3. LOCATION OF INJURIES AND SCENARIOS

This accident is considered as having three scenarios, as shown in figure A-3.

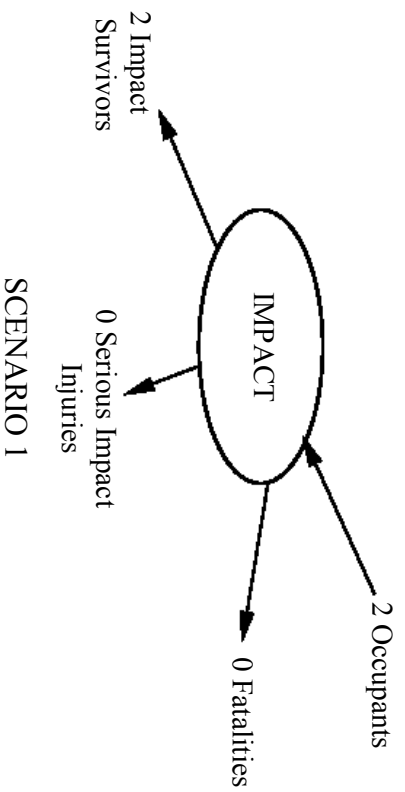
Scenario 1 represents the cockpit area where the two flight crewmembers were located. Both flight crewmembers sustained minor or no injuries.

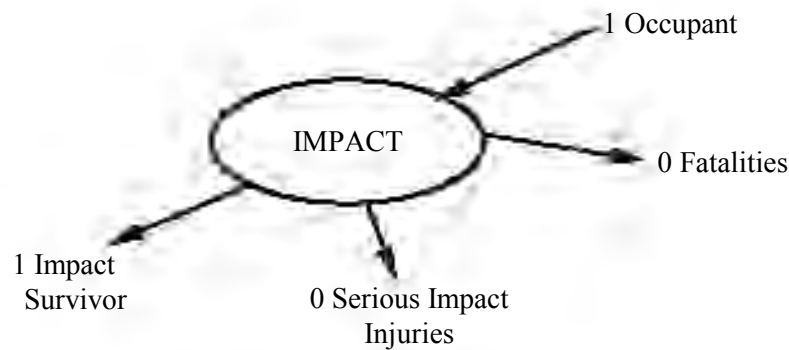
SCENARIO 1

Scenario 2 represents the forward vestibule area occupied by a flight attendant who sustained minor or no injuries.

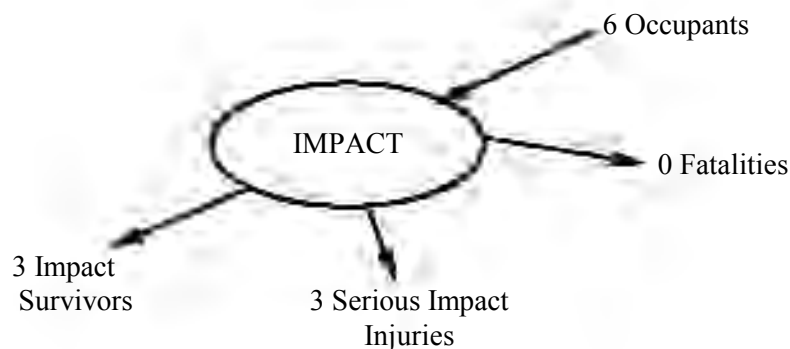
SCENARIO 2

Scenario 3 represents that portion of the passenger cabin containing seats 1DE, 2DE, and 3DE. This was reported to be the most heavily damaged area during impact with ground equipment. There were six occupants in this area, three sustained serious injuries, and three were uninjured. The survivability chain for this area is:

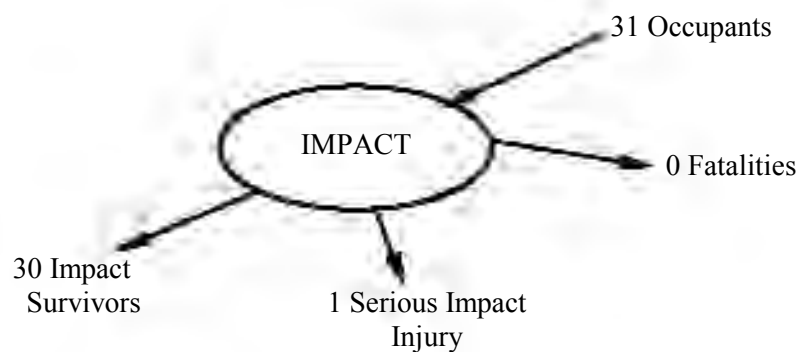
SCENARIO 4

Scenario 4 represents the remainder of the passenger cabin. There were thirty-one occupants in this area, one sustained serious injuries, and thirty were uninjured. The survivability chain for this area is:

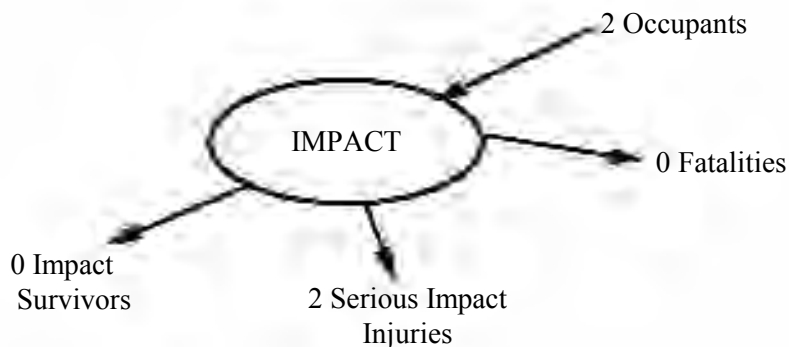
SCENARIO 1

Scenario 1 represents the flight deck area containing two-flight crew, both of whom were seriously injured. The survivability chain for this area is:

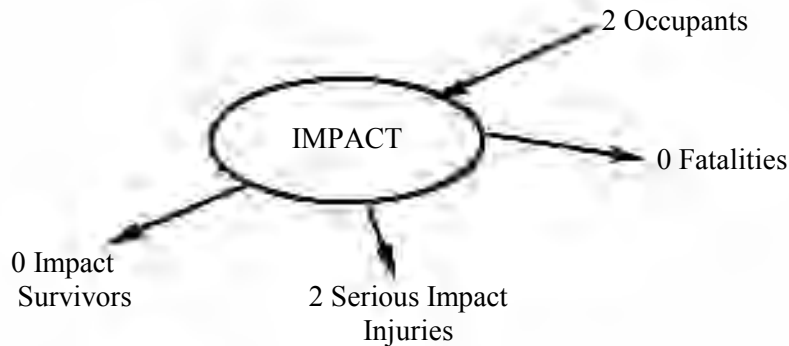
SCENARIO 2

Scenario 2 represents that area of the cabin in which the two forward flight attendants were located, both of whom were seriously injured. The survivability chain for this area is:

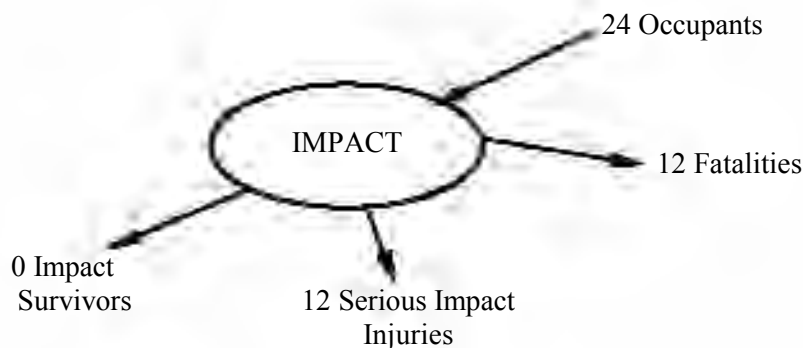
SCENARIO 3

Scenario 3 represents that portion of the passenger cabin between seat rows 1 and 5 inclusive. There were 24 passengers in this area, 12 sustained fatal injuries and 12 were seriously injured. The survivability chain for this area is:

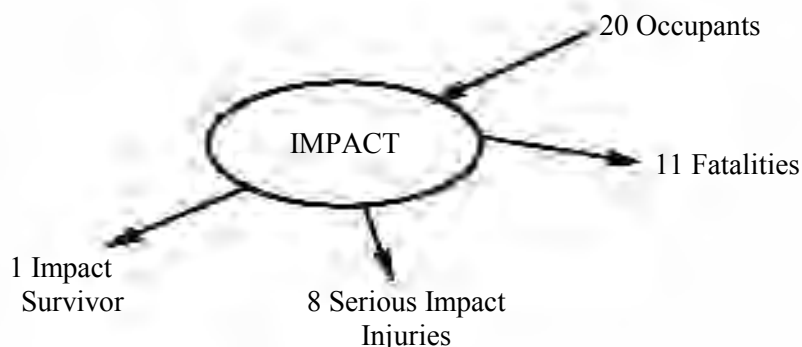
SCENARIO 4

Scenario 4 represents that portion of the passenger cabin between seat rows 6 and 9 inclusive. There were 20 occupants in this area, 11 sustained fatal injuries, and 8 were seriously injured. The survivability chain for this area is:

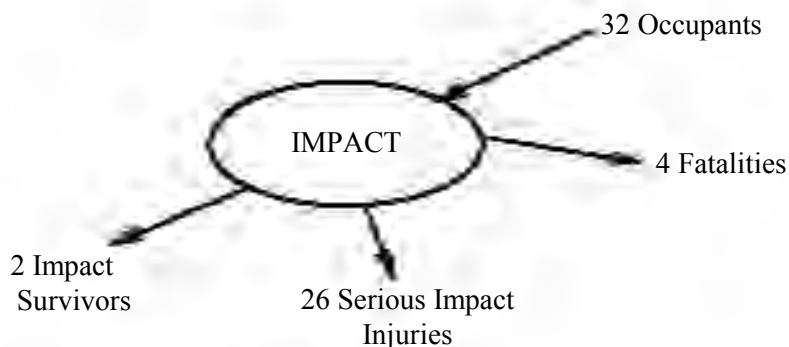
SCENARIO 5

Scenario 5 represents that portion of the passenger cabin between seat rows 10 and 17 inclusive. There were 32 occupants in this area, 4 sustained fatal injuries, and 26 were seriously injured. The survivability chain for this area is:

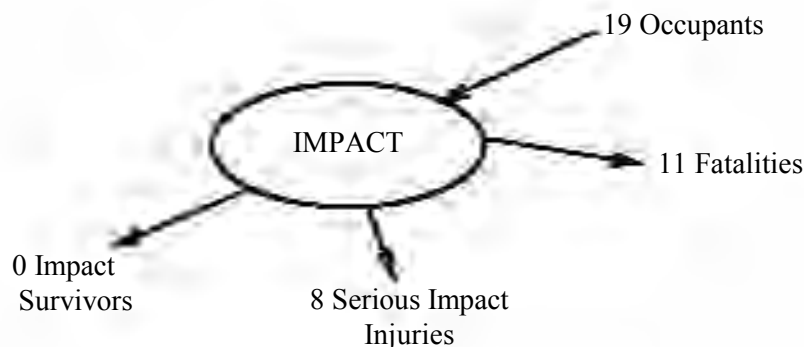
SCENARIO 6A

Scenario 6A represents that portion of the passenger cabin between seat rows 18 to 24 inclusive on the starboard side of the aircraft and the aisle seats on the port side in rows 19 to 23 inclusive. There were 19 occupants in this area, 11 sustained fatal injuries, and eight were seriously injured. The survivability chain for this area is:

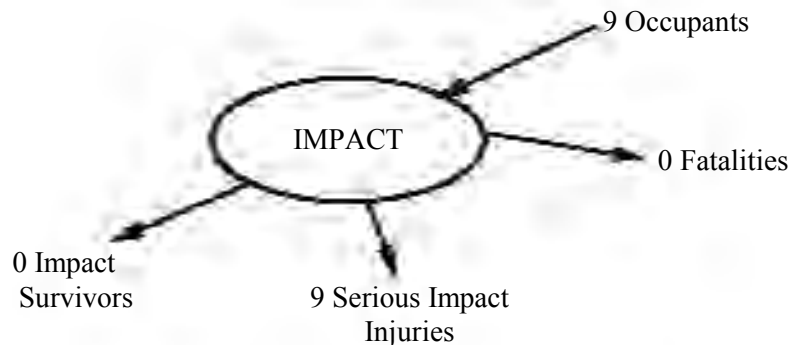
SCENARIO 6B

Scenario 6B represents that portion of the passenger cabin containing the port triple seat in row 18 and the port centre and window seats in rows 18 to 23 inclusive. There were nine occupants in this area all of who were seriously injured. The survivability chain for this area is:

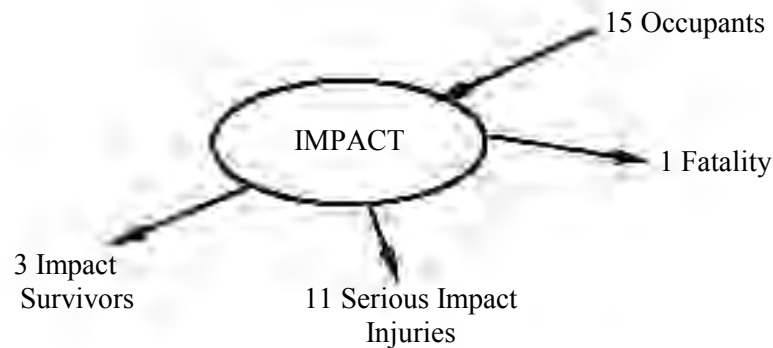
SCENARIO 7

Scenario 7 represents that portion of the passenger cabin from seat rows 25 to 27 on the starboard side and seat rows 24 to 27 on the port side. There were 15 passengers in this area, 1 of whom sustained fatal injuries, and 11 were seriously injured. The survivability chain for this area is:

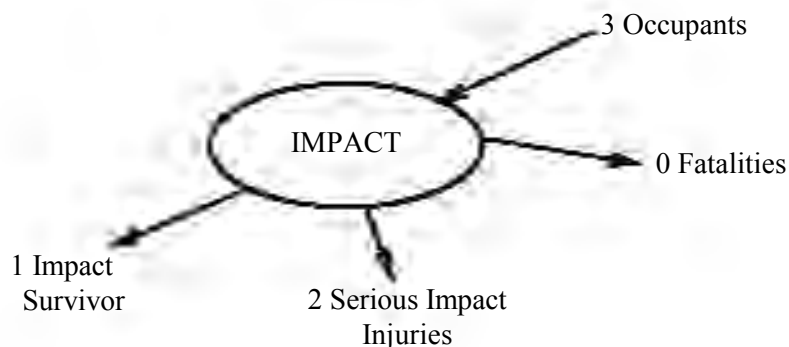
SCENARIO 8

Scenario 8 represents that area of the cabin in which the three aft flight attendants were located, two of who were seriously injured and one survived uninjured. The survivability chain for this area is:

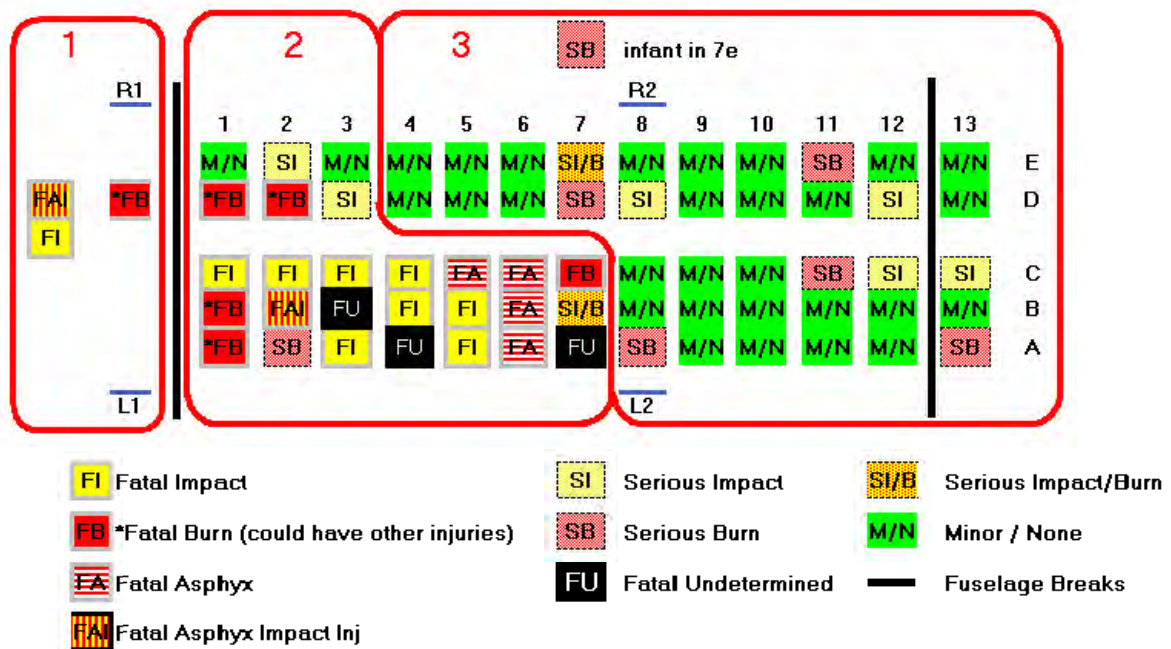
FIGURE A-5. LOCATION OF INJURIES AND SCENARIOS

It should be noted that since the g levels in this area were assessed to have exceeded 16 g's, no benefit is assigned from an improved seat standard. If these were not the case, scenario 2 would have been divided into smaller scenarios.

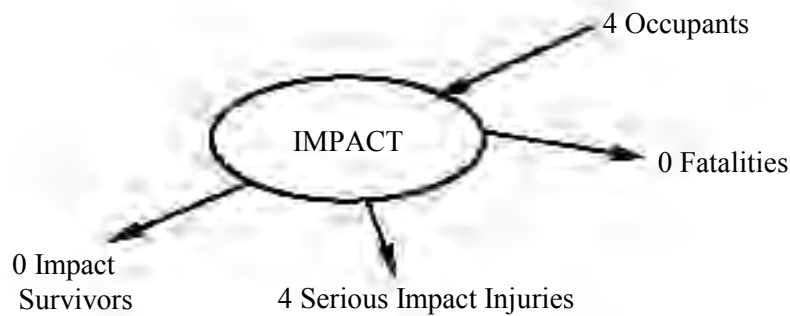
SCENARIO 1

Scenario 1 represents the cockpit area where it is assessed that the three flight crewmembers and the occupant of the jump seat were located—all of whom survived although serious impact injuries were encountered.

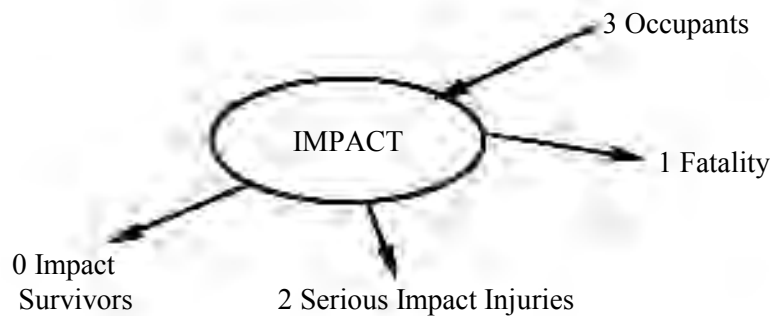
SCENARIO 2

Scenario 2 represents the area occupied by the forward flight attendants, one of whom sustained fatal impact injuries and the remaining two sustained serious impact injuries.

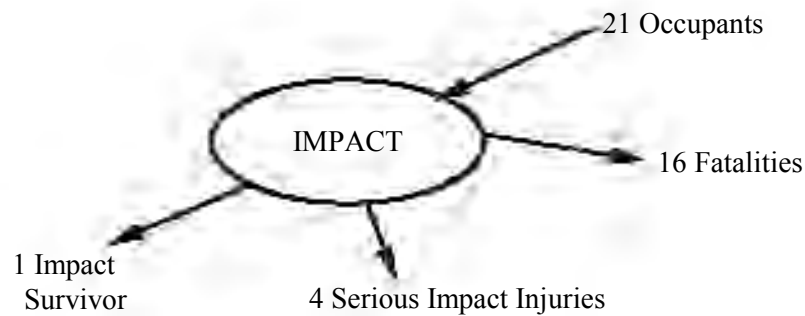
SCENARIO 4

Scenario 4 represents the remainder of the first-class cabin. It is assessed that this portion of the cabin contained 21 occupants of whom 16 sustained fatal injuries as a result of impact trauma.

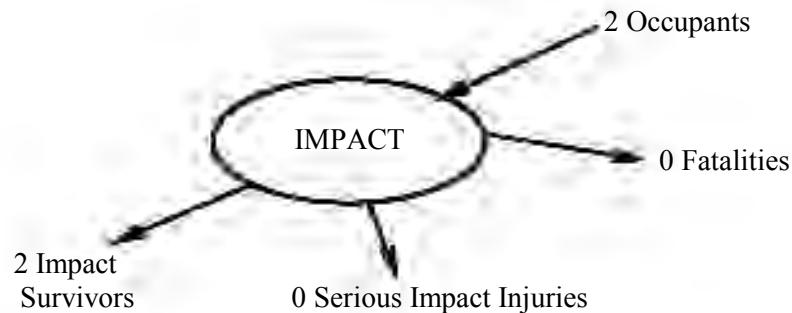
SCENARIO 5

Scenario 5 represents the area occupied by the R2 and L2 flight attendants, both of whom escaped serious injury.

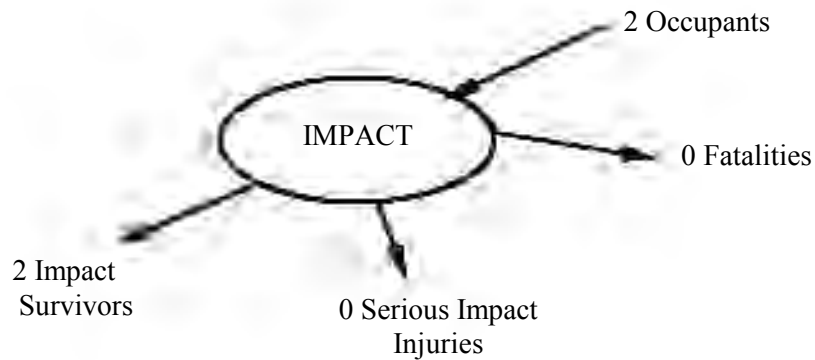
SCENARIO 8

Scenario 8 represents the area occupied by the R3 and L3 flight attendants, both of whom escaped serious injury.

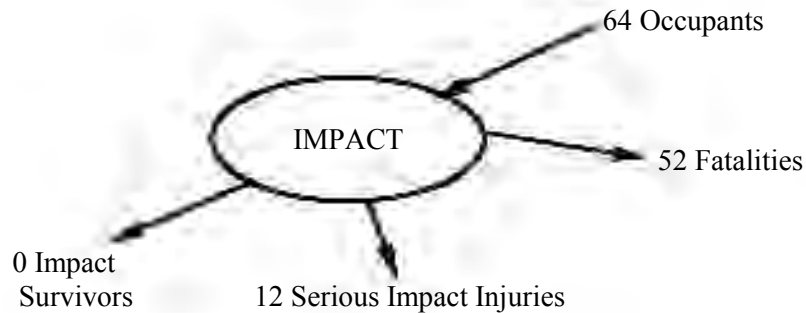
SCENARIO 11

Scenario 11 represents the remainder of the passenger cabin aft to seat rows 36. It is assessed that this portion of the cabin contained 64 occupants of which 52 sustained fatal injuries as a result of impact trauma.

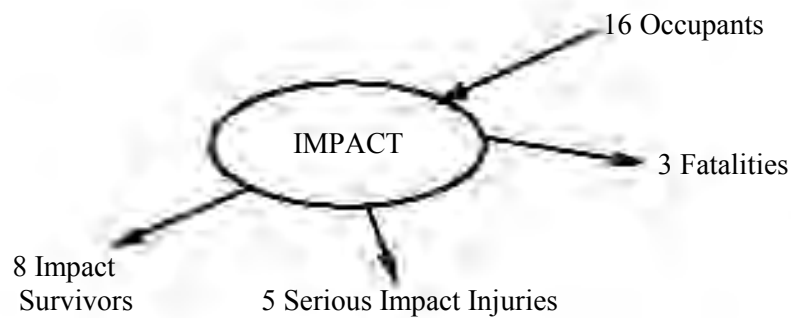
SCENARIO 12

Scenario 12 represents the passenger cabin aft of seat row 36. It is assessed that this portion of the cabin contained 16 occupants of which 3 sustained fatal injuries as a result of impact trauma.

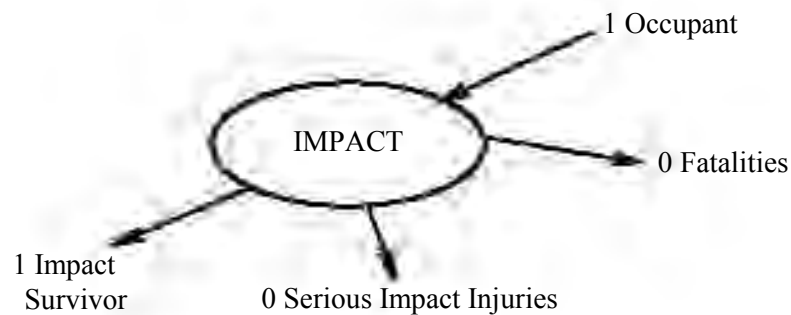
SCENARIO 13

Scenario 13 represents the area occupied by the aft flight attendant, who escaped serious injury.

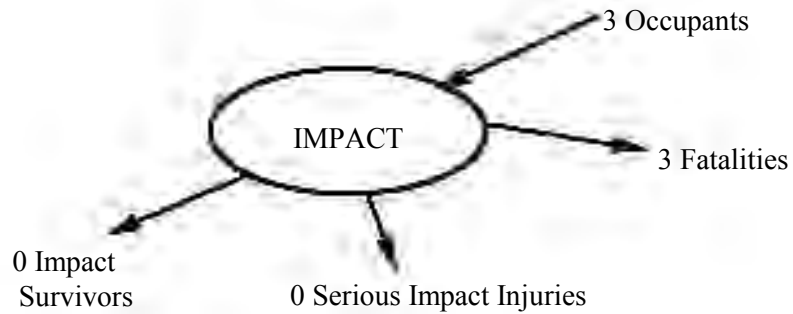
SCENARIO 1

Scenario 1 represents the cockpit area where the three flight crewmembers were located.

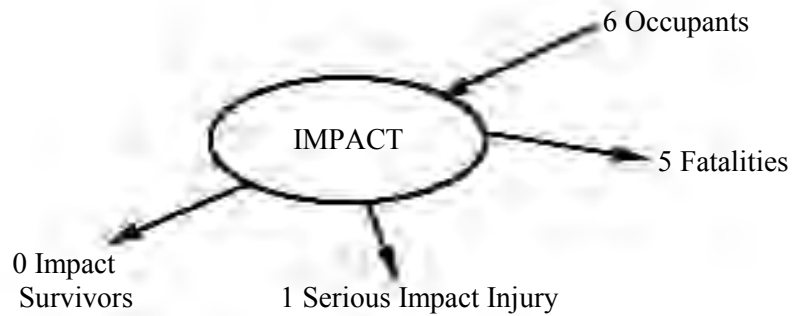
SCENARIO 2

Scenario 2 represents the areas occupied by the flight attendants.

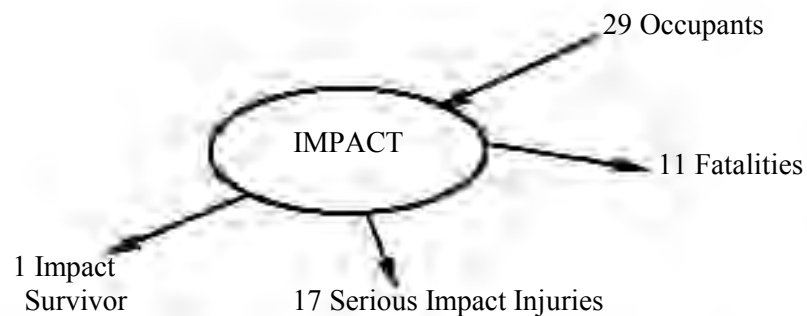
SCENARIO 3

Scenario 3 represents passenger seat rows 1 through 8, which were located in the forward separated fuselage section.

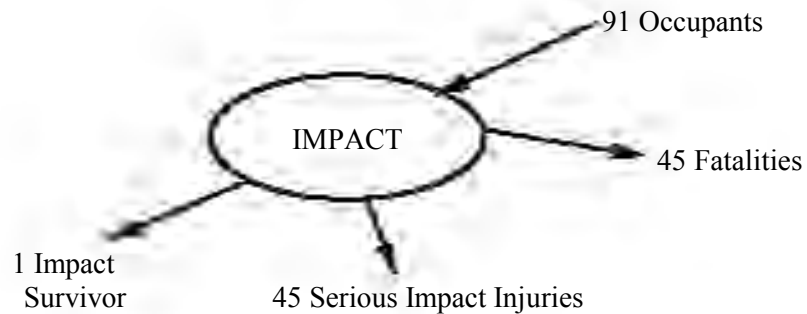
SCENARIO 4

Scenario 4 represents passenger seat rows 9 through 24, located in the middle separated fuselage section.

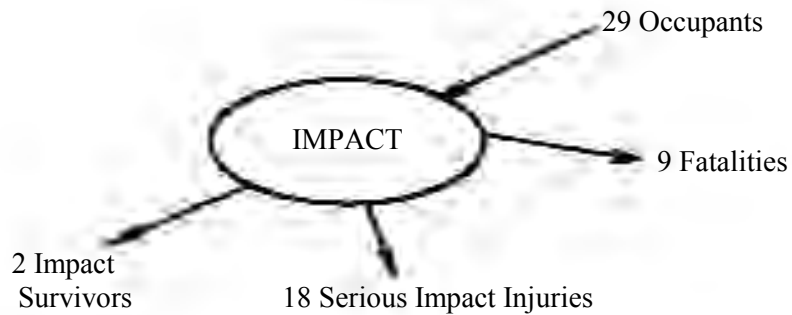
SCENARIO 5

Scenario 5 represents passenger seat rows 25 through 29, located in the rear separated fuselage section.

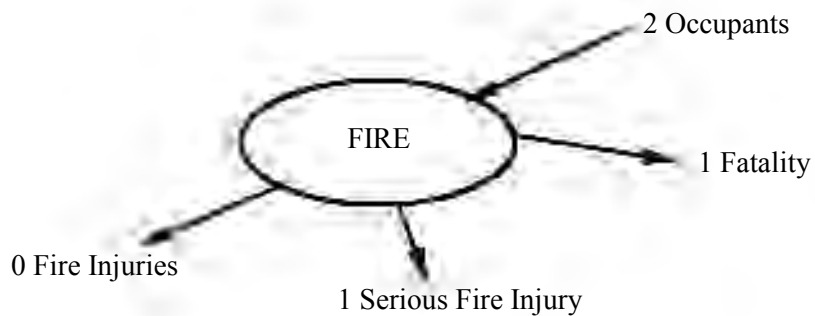
SCENARIO 2

Scenario 2 represents the forward flight attendant area. One flight attendant died of asphyxia due to smoke inhalation and the other suffered serious fire burns.

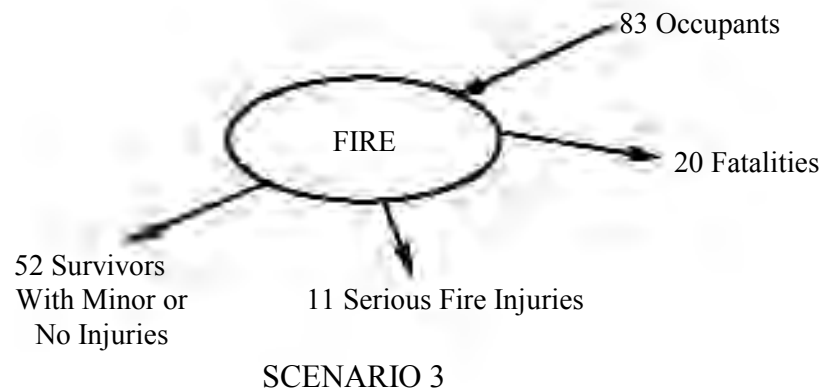
Scenario 3 represents the entire passenger cabin containing seat rows 1 to 22. This scenario contains 83 passengers. Nineteen passengers died of asphyxia due to smoke inhalation. One passenger died due to thermal burns. Eleven passengers suffered serious fire burns.

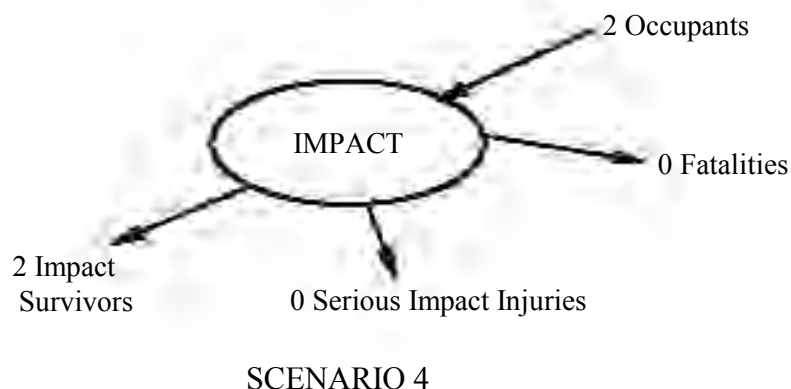
Scenario 4 represents the aft cabin attendant area, which contains two flight attendants. Both of them suffered minor or no injuries.

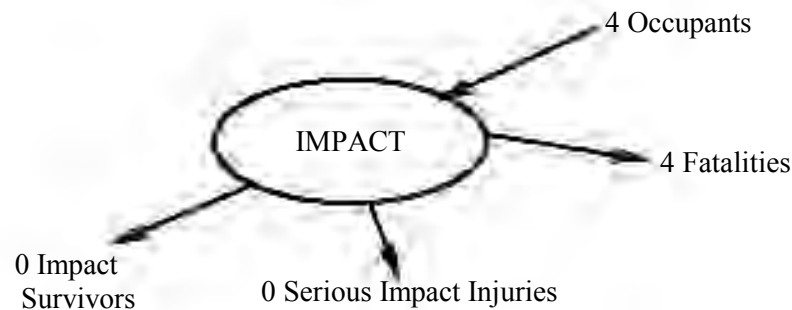
SCENARIO 1

Scenario 1 represents the flight deck and the vestibule area containing two flight crew and two cabin crew. All four crewmembers sustained fatal impact injuries in the impact.

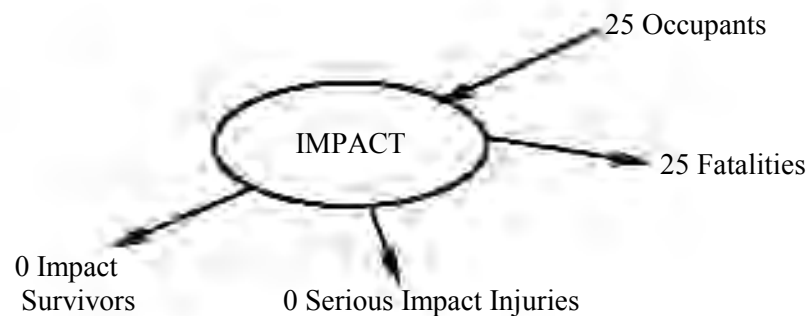
SCENARIO 2

Scenario 2 represents seat rows 1 to 8. It is assumed that there were 25 passengers in this section and all died as a result of the impact.

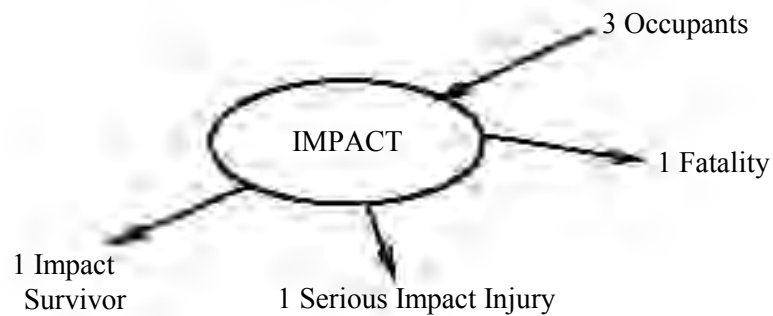
SCENARIO 1

Scenario 1 contains the flight deck and the forward galley area which was subjected to impact damage. The scenario contains two flight crew and one flight attendant. Due to absence of detailed documentary evidence on the location of injuries, it is assumed that the captain died of blunt force trauma and the flight attendant sustained serious impact-related injuries. This is based on the fact that the left side and bottom of this section were crushed by impact forces. A hole was in the fuselage skin to the left of the captain's seat. The floor on the left side of the cockpit and the captain's seat pedestal were displaced upward. The right side of the forward fuselage near the roof exhibited compression wrinkles. There was no sign of any fire damage in this section.

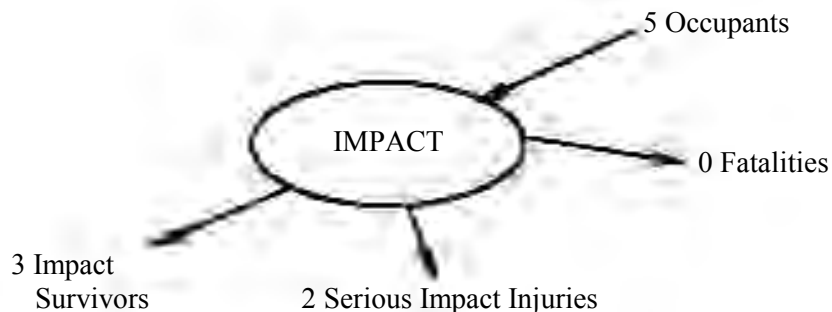
SCENARIO 2

Scenario 2 contains passenger seat rows 1 and 2 which were subjected to impact damage. The scenario contains five passengers, three of whom suffered minor or no injuries and two suffered serious injuries.

Due to the absence of detailed documentary evidence on the location of injuries, it is assumed that the two injured passengers sustained serious impact-related injuries. This section suffered impact damage and the right side of the forward fuselage near the roof exhibited compression wrinkles. There was no sign of any fire damage in this section.

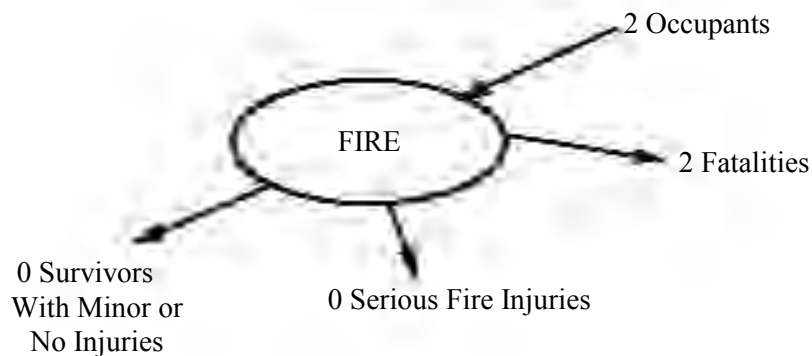
CHAIN 3

Scenario 3 – Chain 3 represents the two occupants seated between rows 3 to 14 who were killed by the postaccident fire.

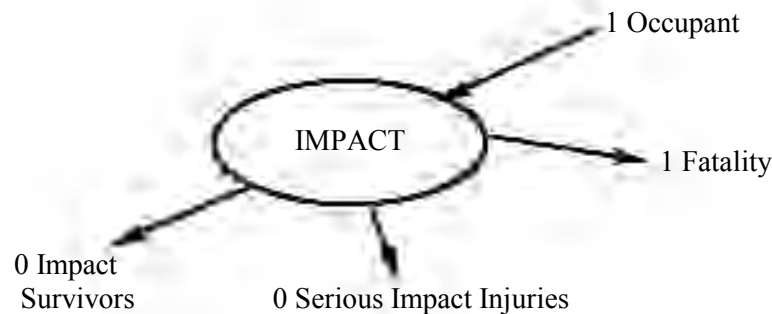
SCENARIO 4

Scenario 4 represents the rear flight attendant's area which contains one flight attendant. Due to absence of detailed documentary evidence on the location of injuries, it is assumed that the flight attendant died of blunt force trauma.

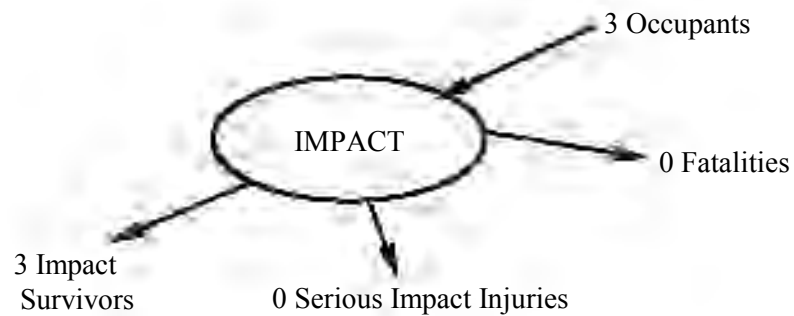
SCENARIO 1

Scenario 1 contains the flight deck area which was subjected to the impact and was not fire damaged. The scenario contains the three flight crew.

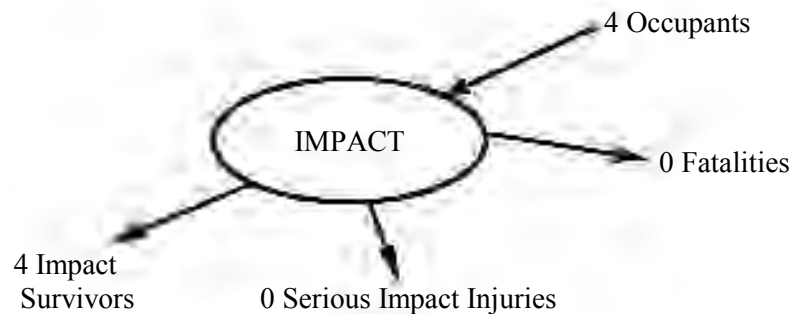
SCENARIO 2

Scenario 2 contains the forward flight attendant area and encompasses four flight attendants, none of whom sustained serious or fatal injuries.

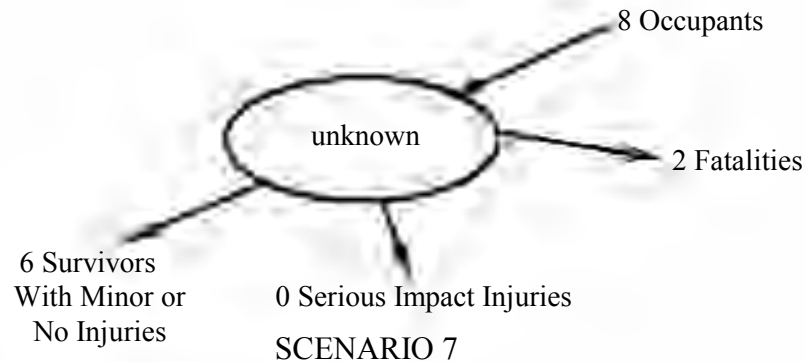
Scenario 7 contains the eight occupants for which seat location and injuries were unknown. Absence of information results in the following simplified survivability chain. The six unknown injuries have been assumed minor or none since they were not significant enough to be reported officially. It is not possible to determine the cause of death for the two fatalities.

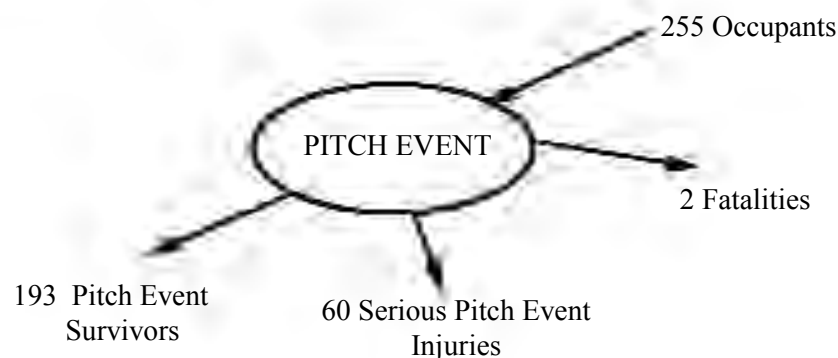
SCENARIO 1

Due to the lack of information on occupant location during the event, the aircraft has been considered as one scenario containing all occupants.

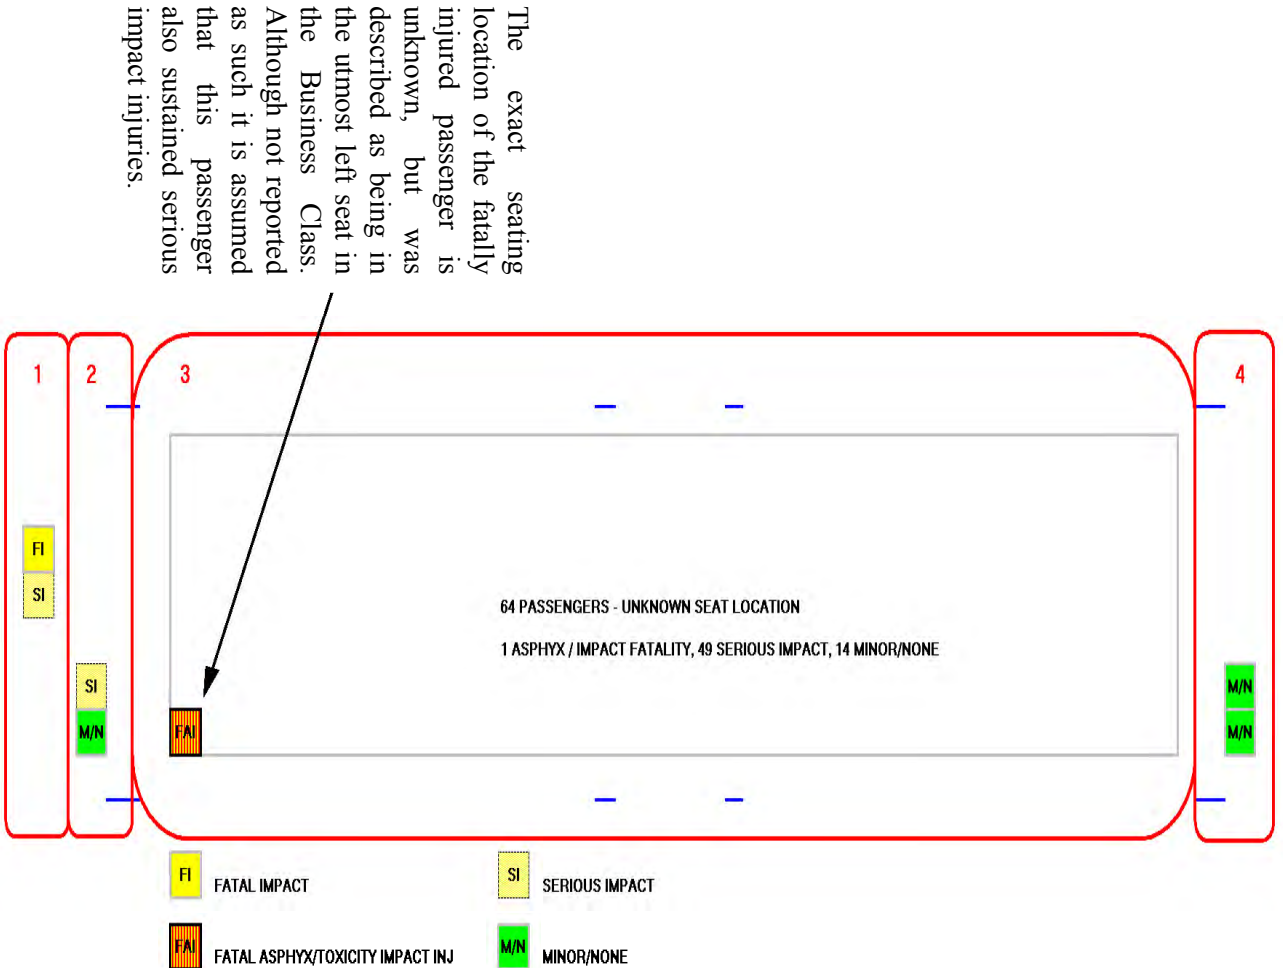
FIGURE A-13. LOCATION OF INJURIES AND SCENARIOS

The only information available regarding the location of occupants is the statement that they were uniformly distributed throughout the cabin. Therefore, this accident is considered as four scenarios, the largest encompassing the aircraft cabin occupied by all of the passengers.

This accident is divided into four separate scenarios, as shown in figure A-13.

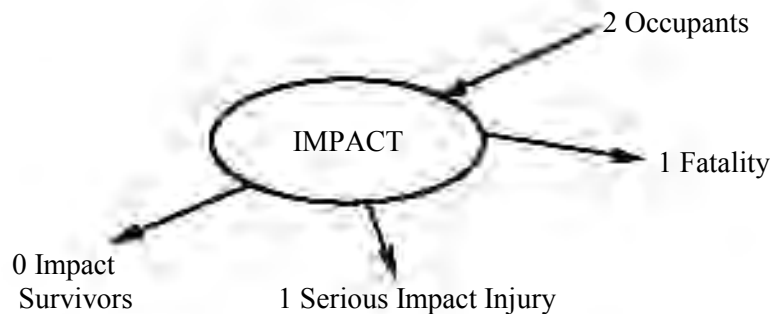
SCENARIO 1

Scenario 1 contains the flight deck area where one flight crewmember died and the other sustained serious injuries from the impact.

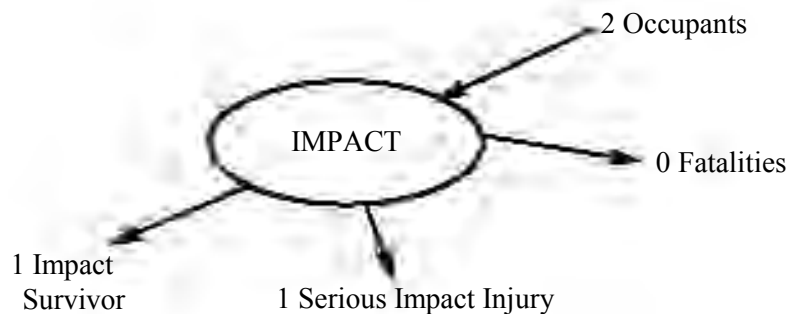
SCENARIO 2

Scenario 2 contains the forward flight attendant area where only the chief steward sustained serious injuries from the impact. The scenario contains two flight attendants.

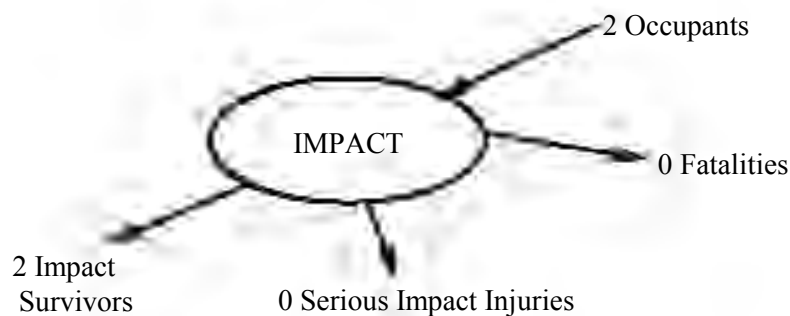
SCENARIO 4

Scenario 4 contains the rear flight attendant area where the two flight attendants received minor or no injuries from the impact.

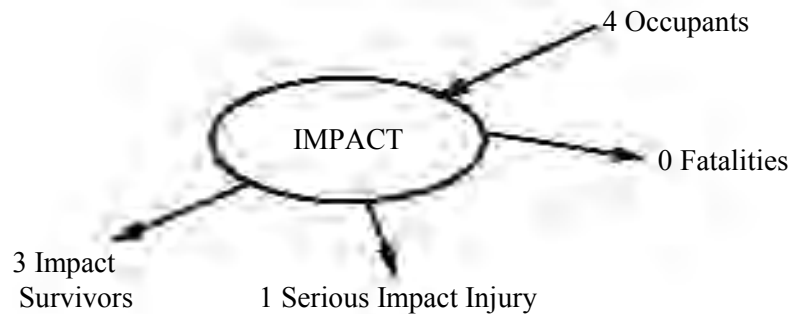
SCENARIO 1

Scenario 1 represents the flight deck and the vestibule area containing two flight crew and two cabin crew. One cabin crewmember sustained serious injuries and the others received minor or no injuries in the impact.

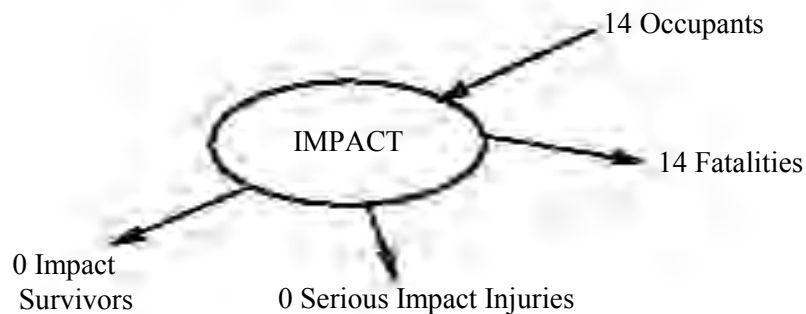
SCENARIO 2

Scenario 2 represents the first class and part of the coach cabin area (rows 1 to 8) containing 12 fatally injured passengers. This section impacted two large hardwood trees and passenger seats were crushed against them. Due to the destruction of the fuselage in this section, it is assumed that the two impact fatalities of unknown seat location (originally assigned seats 17D and 17E) had moved to this part of the aircraft, since there were more unoccupied seats available in this section. Therefore, the total number of impact fatalities in this scenario is assessed to be 14.

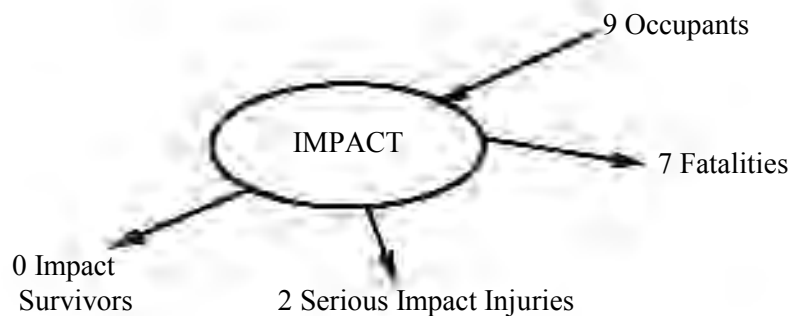
SCENARIO 3

Scenario 3 represents passenger seat rows 9 and 10 and seats 11A and C and 14D, E, and F, which suffered impact damage and postaccident fire. Seven passengers suffered fatal impact injuries and two passengers suffered serious impact injuries. There were no fire injuries.
