DOT/FAA/AR-00/13

Benefit Analysis for Aircraft 16-g Dynamic Seats

April 2000

Final Report

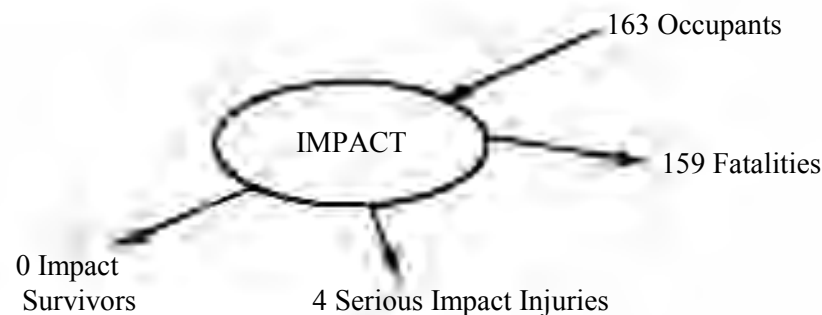
Due to the massive destruction of the aircraft, this accident was considered as a single scenario encompassing the whole cabin.

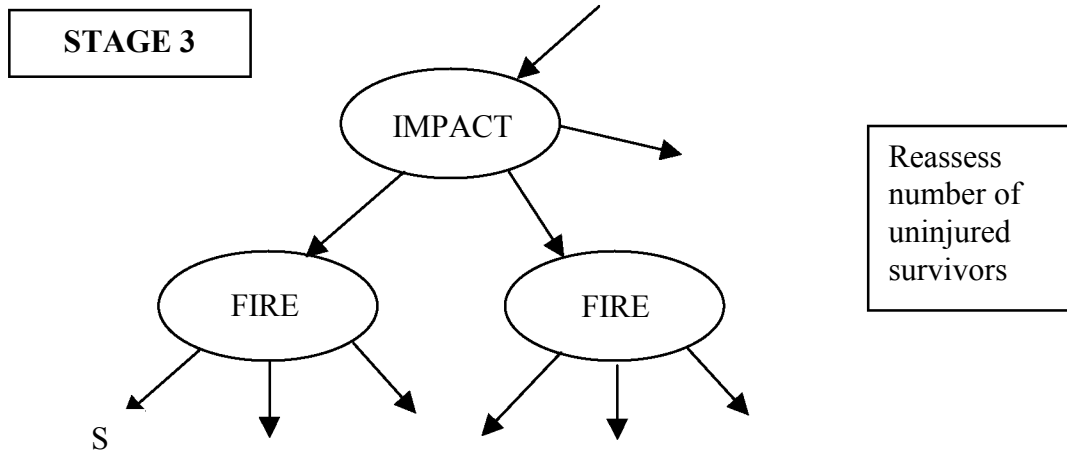
FIGURE B-3. STATISTICAL MODELLING PROCESS, STAGE 3

Evaluate injury rate improvement using:

$$S_F = \frac{S - S_B}{T}$$

A similar technique is used for fatality rate improvement.
