# CRASH TEST AND EVALUATION OF TL-2 SHORT RADIUS GUARDRAIL TREATMENT

**Test Report 0-6913-R1**

**TEXAS A&M TRANSPORTATION INSTITUTE  
COLLEGE STATION, TEXAS**

**TEXAS DEPARTMENT OF TRANSPORTATION**

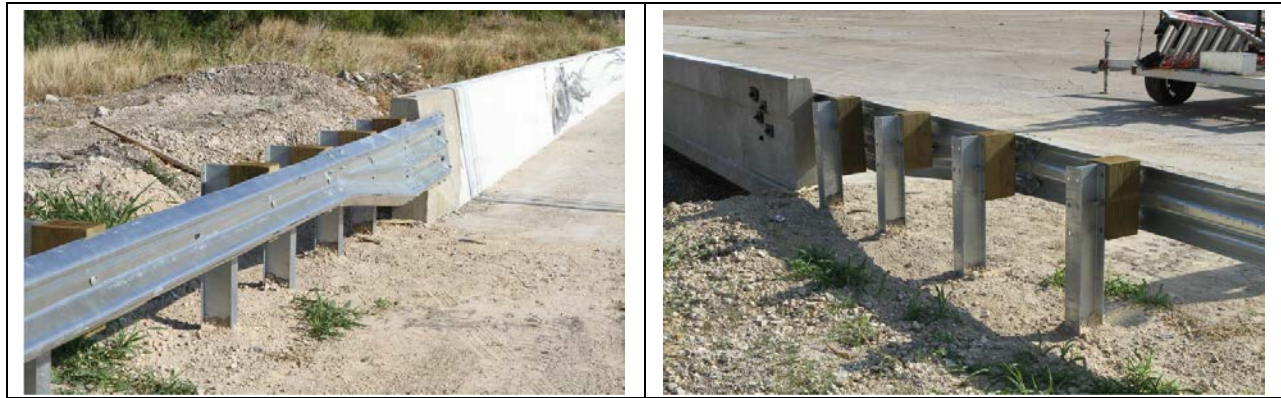
**Figure 2.1. *MASH* TL-2 Transition before Test No. 420021-4.**

The first W6×9 steel post is located 29 inches from the end of the parapet with a 6-inch × 8-inch × 22-inch routed wood blockout. The post included a 10-inch long button head bolt with recessed guardrail nut only on the top hole. The next two posts were spaced 37.5 inches on center. A 10-gauge thrie beam rail, 37.5 inches long, spanned the space between the parapet and post 11.

The new *MASH* TL-2 transition was developed and successfully crash tested. The results showed that the new *MASH* TL-2 transition met all the requirements of *MASH* for all crash tests. The vehicles remained stable and the occupant risk indices were below the preferred limits recommended in *MASH*. Figure 2.1 shows the described transition design tested. This transition system design was modeled as a point of reference for new design concepts that are incorporated in the TL-2 short radius system design.

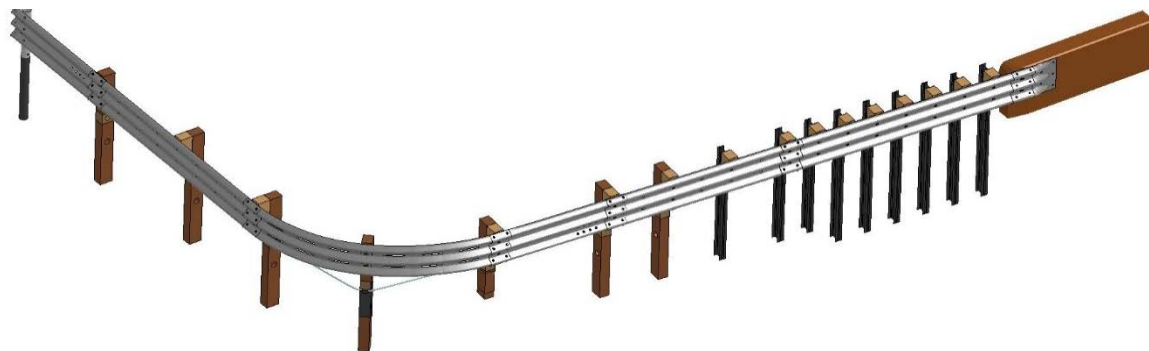
**Figure 2.2. Entire System with Cable.**

A guardrail system design was evaluated in a simulation. Figure 2.2 depicts the whole guardrail system. This system includes a long tension cable behind the curved section of the rail. The vehicle impacted this system at the center of the radius at a 25° angle. The vehicle was approaching the system at a speed of 45 mph.

A single three beam system design was evaluated through simulations. The guardrail system consists of a 31-inch tall guardrail system with a 36-ft long primary-road from end of nose to end of parapet, and a 20-ft long secondary-road after the nose. The nose, curved section, has a radius of 8 ft-4 inches.

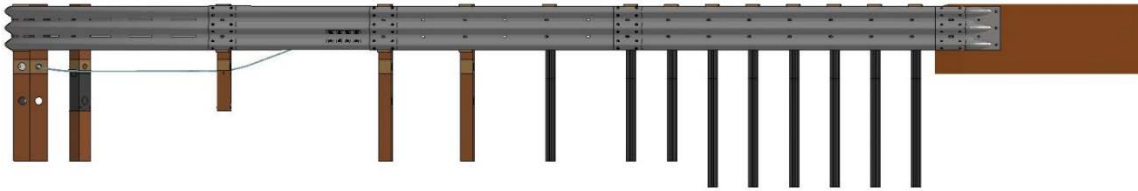
**Figure 2.3. Side View of Primary Roadway.**

Figure 2.3 shows the side view of the primary roadway. The primary roadway consists of nine steel posts and three controlled release timber (CRT) posts. Figure 2.4 represents the side view of the secondary roadway. The secondary roadway has three CRT posts with only two CRT post with blockouts. A rigid post in the simulation anchored this end. The curved section has one CRT timber post, and the post includes a sheath. The simulated parapet section represents the stiff

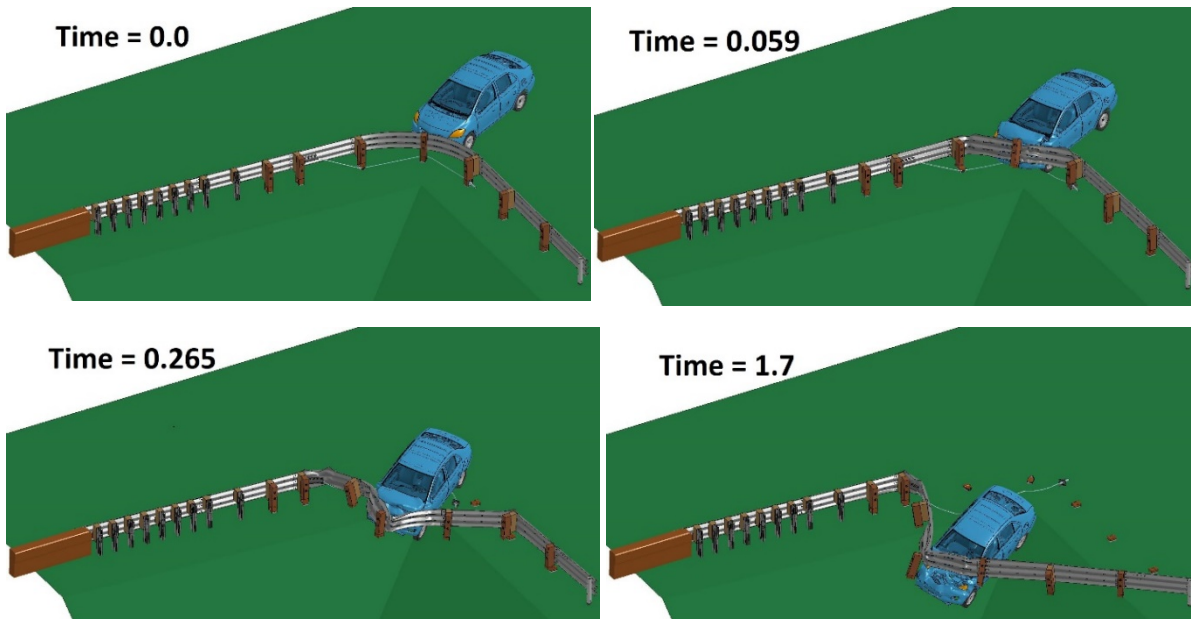
**Figure 2.5. Sequential Images of Car Simulation with Cable.**

Figure 2.5 presents the progression of the small car in this simulation. Upon impact, the rail and deformation of the front of the car progress into the windshield of the car, which is an undesirable behavior for the system.

The first simulation case was for the TL-3 short radius system but without the sand barrels. The simulation results show that the car was damaged up to the windshield and truck was overriding the system making it undesirable. The second simulation is an extended short radius system that did not include a cable, was extended from the secondary roadway, and had less post on the primary roadway. This simulation also resulted in the vehicle overriding the system.

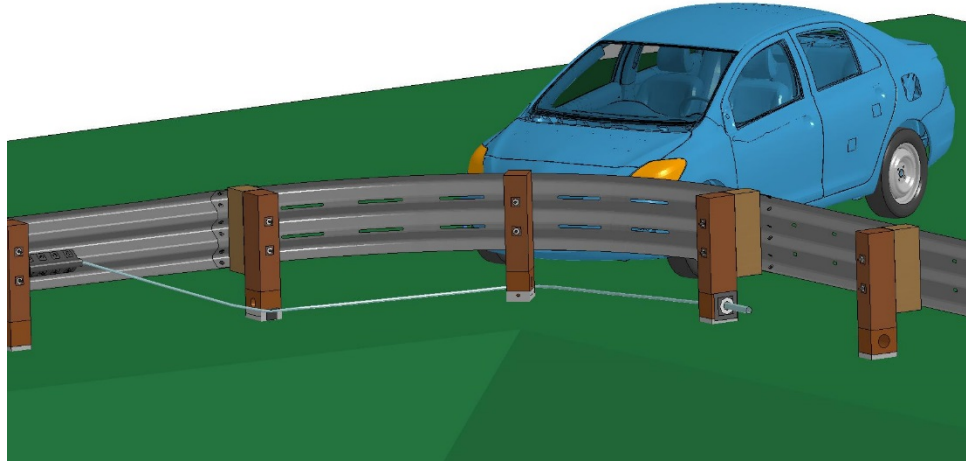
**Figure 2.6. Initial State of the Simulation.**

Figures 2.6 and 2.7 show images of the initial and end state of the simulation, respectively. Figure 2.7 shows a close up image of the car going under the guardrail damaging the front of the car and windshield. It is also noticed that the tires rolled over the cable without much effect.

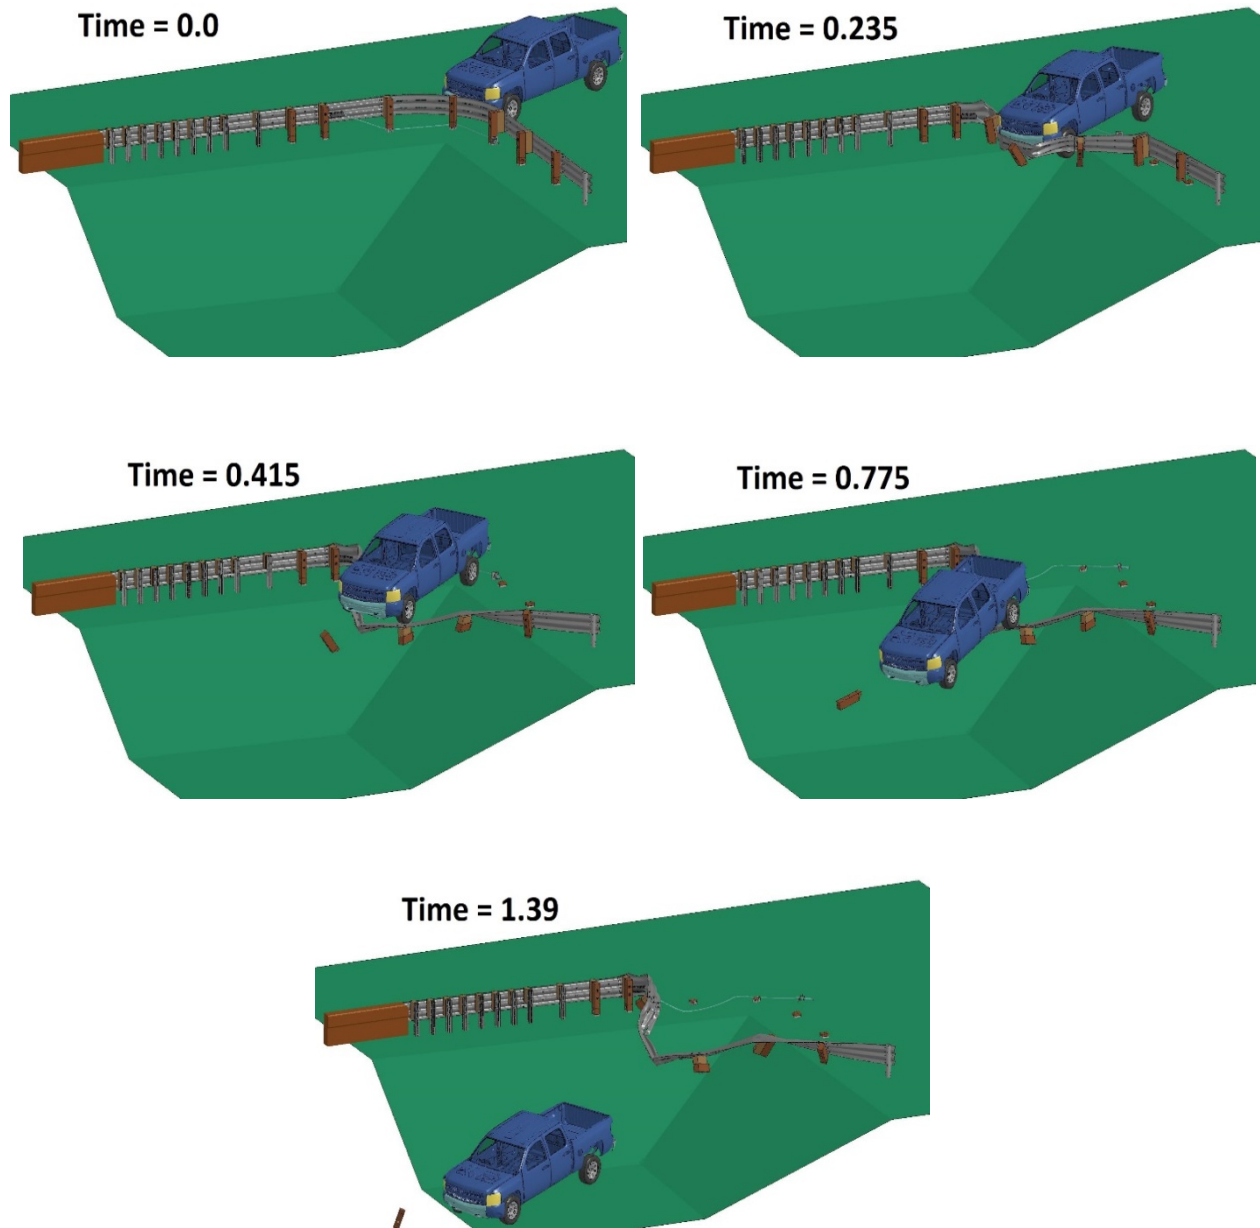
**Figure 2.8. Sequential Images of Truck Simulation with Flare.**

Figure 2.8 shows sequential images of the simulation of the truck upon impact. The first image shows the initial position of the system and is followed by three images of the truck interacting with the rail. The guardrail system is already deforming by the time of 0.235 s. At time 0.415 s, the truck begins to override the guardrail system, and by 0.775 s, the truck has completely overridden the system. The truck was not contained by the guardrail system.

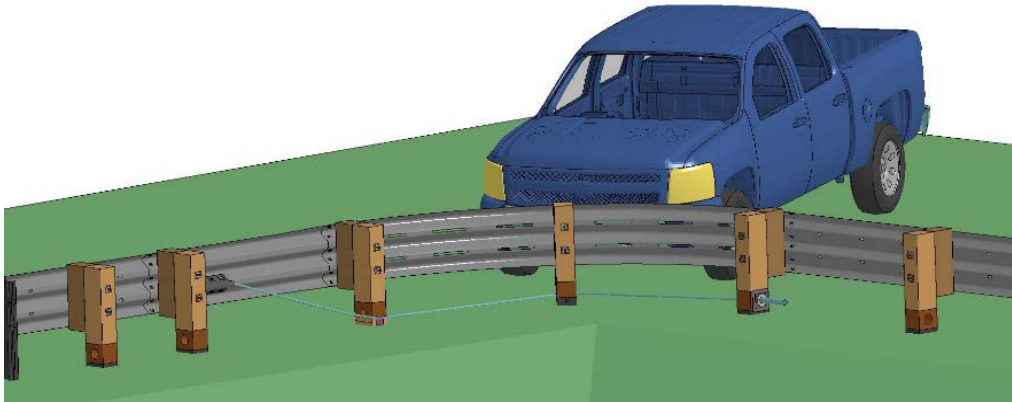
**Figure 2.9. Initial State of Simulation.**

Figures 2.9 and 2.10 show the initial and final state images of the simulation of the truck with cable, respectively. Figure 2.10 shows the deformation of the guardrail system and the truck. Five posts from the system broke while the remaining posts stayed intact. The truck was bent from the front, and the right front tire was deformed as well.

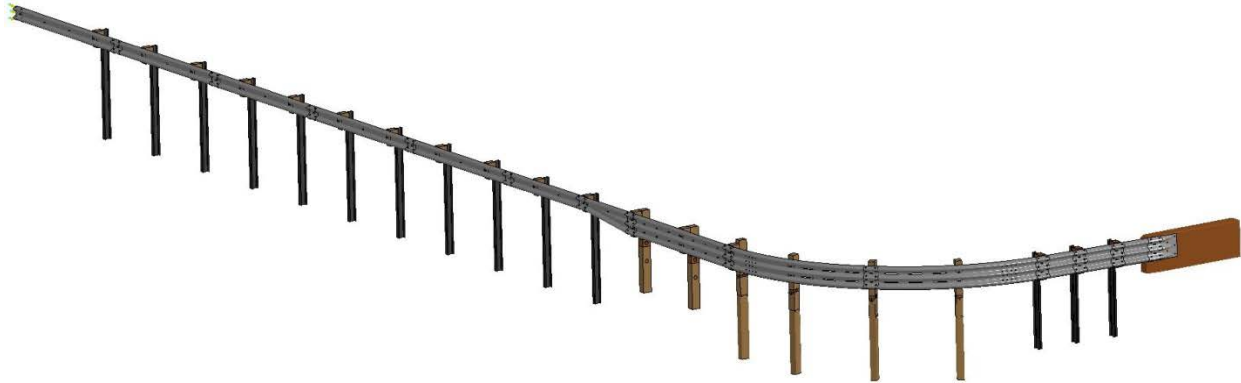
**Figure 2.11. Extended Short Radius System with No Flare.**

The following simulation includes a different guardrail system design from the first simulation. Figure 2.11 depicts the whole guardrail system. It has no energy-absorbing systems behind the curved section of the rail. It is a longer guardrail system. The vehicle impact to the system has the same impact angle and speed from the first simulation, 45 mph at a 25° angle.

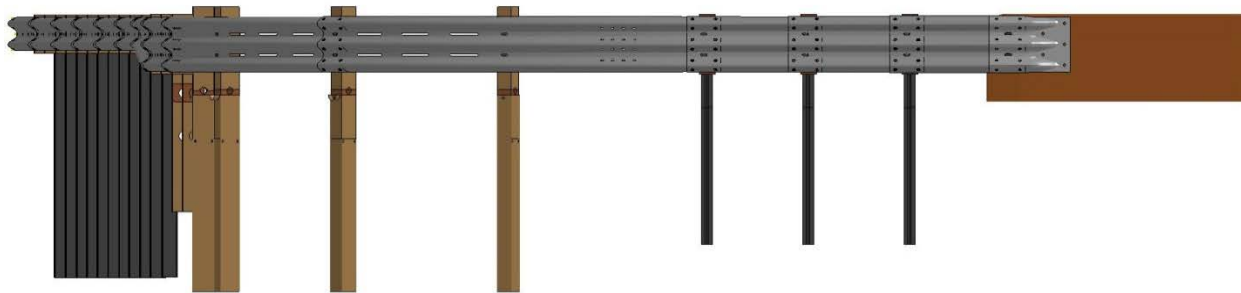
**Figure 2.12. Primary Roadway Side View.**

Figure 2.12 shows the side view of the primary roadway. The primary roadway consists of three steel posts. Figure 2.13 represents the side view of the secondary roadway. The

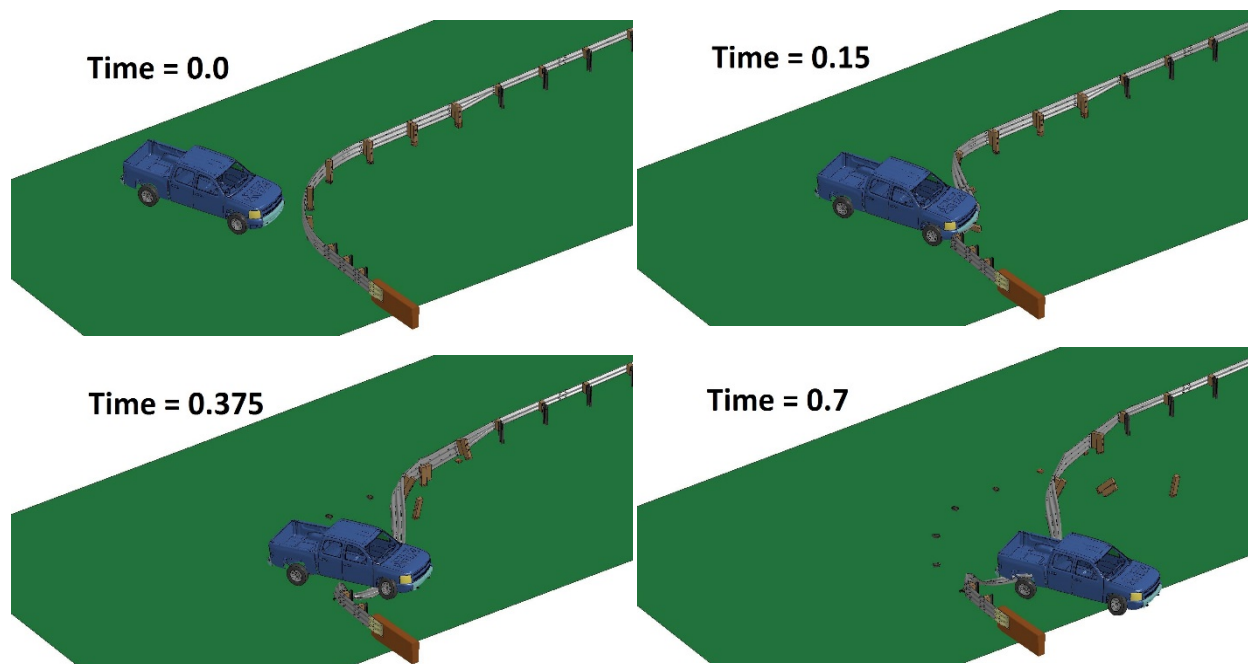
**Figure 2.14. Sequential Images of Simulation with No Cable.**

Figure 2.14 presents the sequential images of the motion of the truck as it impacts the nose section of the system. The truck remains stable during the simulation. The first image shows the initial position of the system and is followed by three images of the truck interacting with the rail. At time 0.375 s, the truck has overridden the system. The last image displays the end state of the simulation and shows that the truck has completely gone over the system. The simulation of the system shows that the system is not adequate to contain the truck.

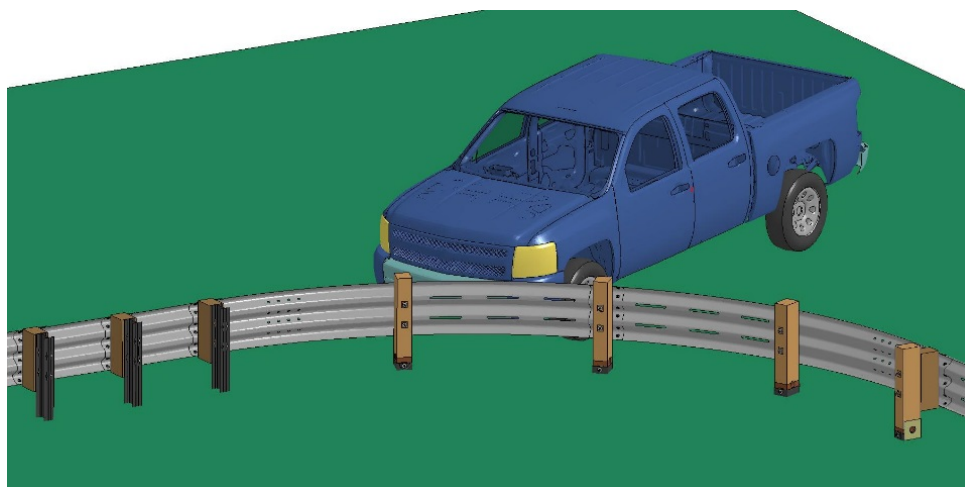
**Figure 2.15. Initial State of Simulation.**

Figures 2.15 and 2.16 show the initial and final state of the simulation of the truck, respectively. In the final frame of the simulation, the guardrail system has deformed and seven of the posts broke while two steel posts to the right of the thrie beam end shoe appear to remain intact.

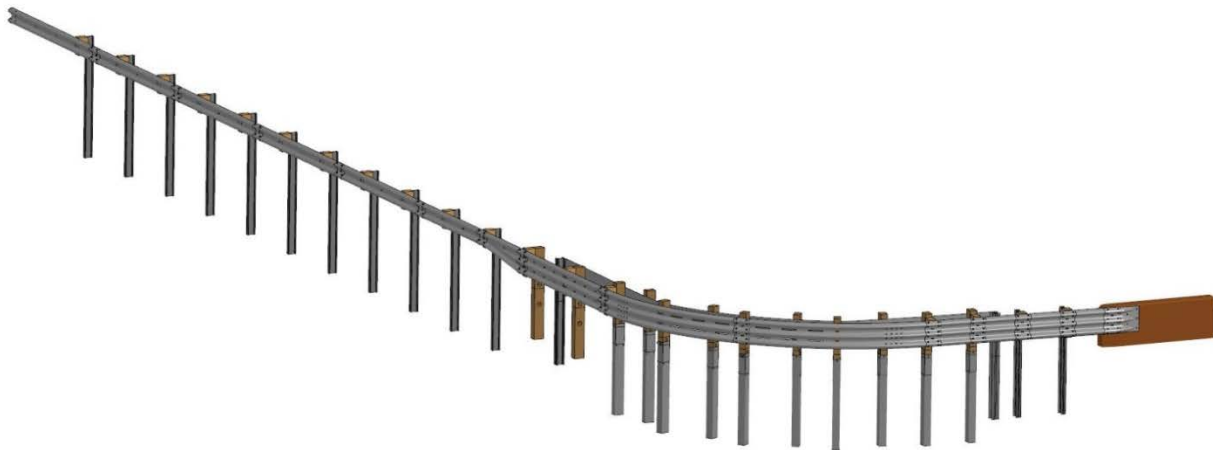
**Figure 2.17. Extended Short Radius with Strap.**

Figure 2.17 presents the system layout for this simulation. This system is surrounding a ditch. As previously concluded, since the system did not contain the truck, a strap was added to the back of the guardrail, as shown in Figure 2.18. To make the strap stand out, it has been colored red. The strap has a height of 12 inches and starts 7 ft from the end of the parapet. It goes along the guardrail to the secondary roadway and stops 9 ft-3 inches from the end of nose. Six new posts were included in the system that run along the strap.

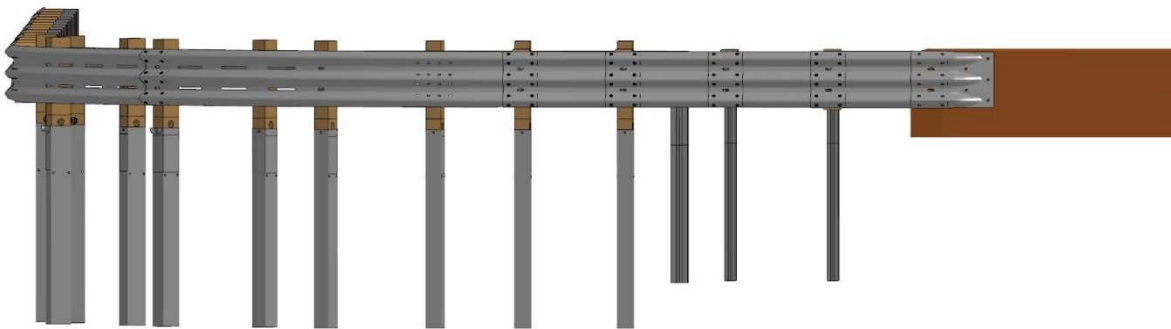
**Figure 2.19. Primary Roadway Side View.**

Figure 2.19 shows the side view of the primary roadway. The primary roadway consists of two steel posts and two CRT posts with blockouts. It also includes one steel post that is attached to the beginning of the strap. Figure 2.20 represents the side view of the secondary roadway. The secondary roadway has three CRT posts with a blockout, one steel post attached to the end of the strap, and 11 steel posts. The curved section has three CRT posts and four CRT posts running along the strap. The simulated parapet section represents the stiffer portion of the rail.

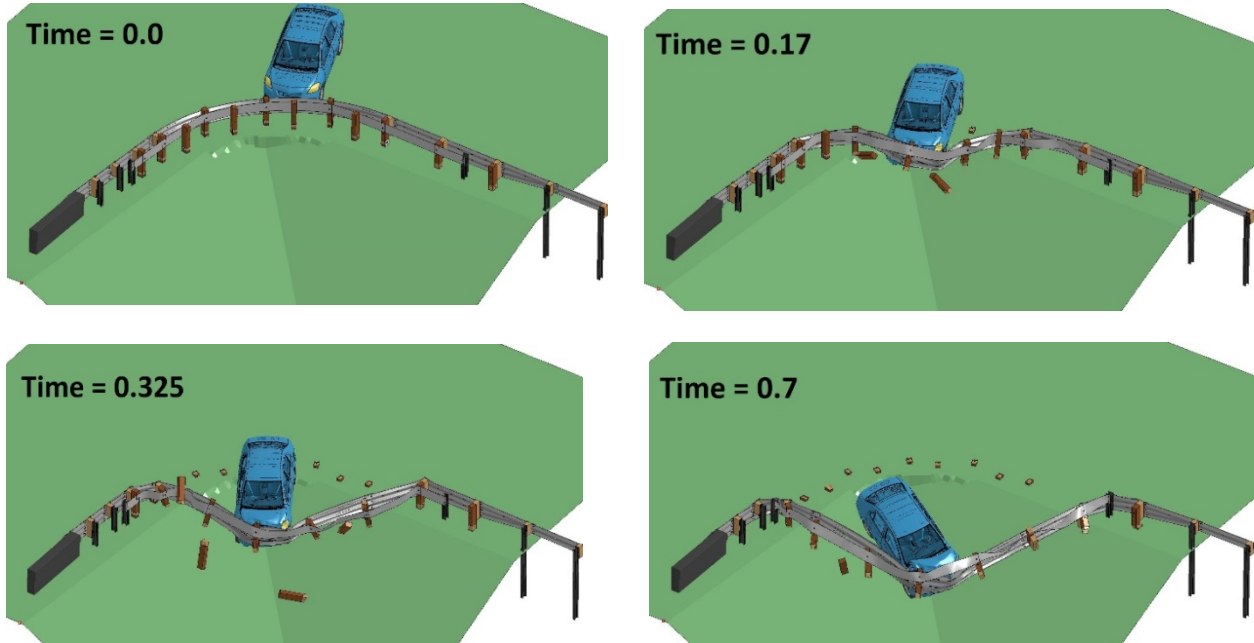
**Figure 2.21. Sequential Images of Car Simulation with Strap.**

Figure 2.21 presents the sequential frames of the simulation of the car and the system. The first frame shows the initial state of the system and the car. It is followed by two images displaying the interaction of the car with the system. Just after the car interacts with the guardrail, the wood posts supporting both the guardrail and the strap break sequentially until the system goes to rest. During this process, the strap successfully contains the car from overriding

the guardrail and also plays a modest role in absorbing and releasing the impact energy of the system. The last frame depicts the end state of the simulation, showing car deformation at the front of car. The car remains stable throughout the simulation with the inclusion of the strap.

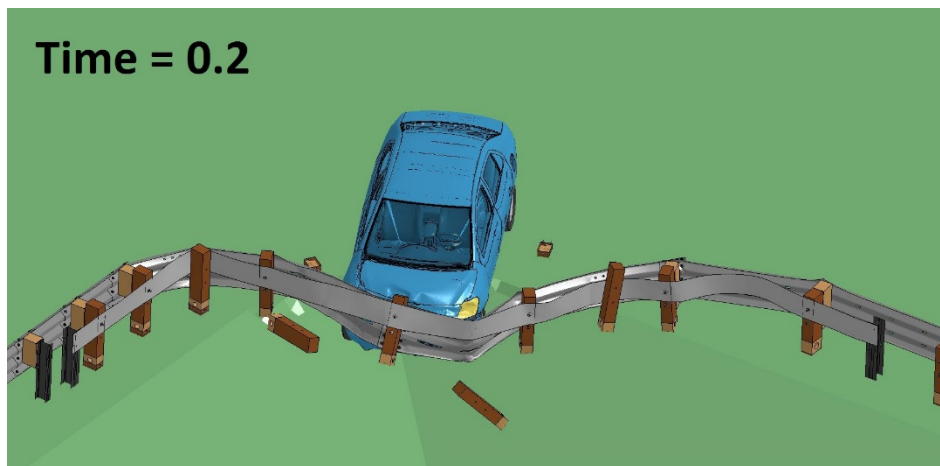
**Figure 2.22. Interaction of Car with System.**

Below are shown two significant frames of the simulation that give a closer look to the impact process. Figures 2.22 and 2.23 show the interaction in development and the end state of the simulation, respectively. In these figures, the containment ability of the strap is clearly seen. Also, the two steel posts attached to the strap ends appear to remain solid by the end of this simulation.

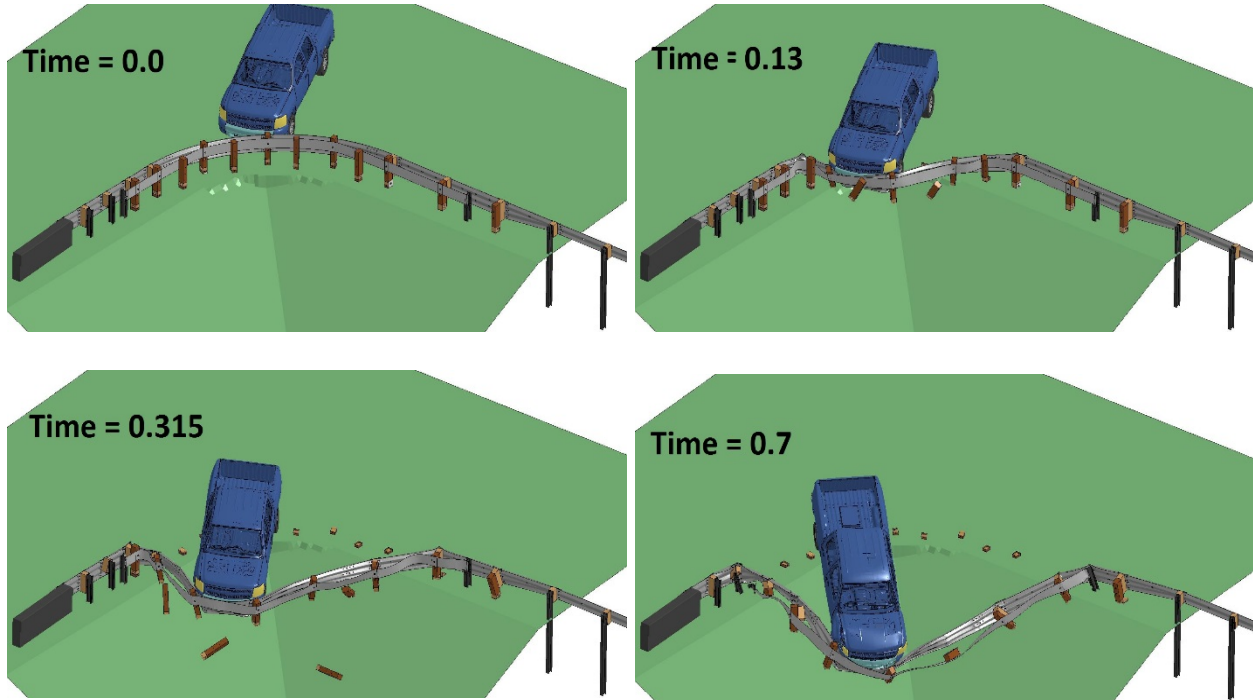
**Figure 2.27. Sequential Images of Truck Simulation with Strap.**

Figure 2.27 represents the chronological images of the movement of the truck in this simulation. The first image shows the initial position of the system and is followed by three images of the truck interacting with the guardrail. The simulation shows that the new system with the strap was able to contain the truck from overriding the guardrail.

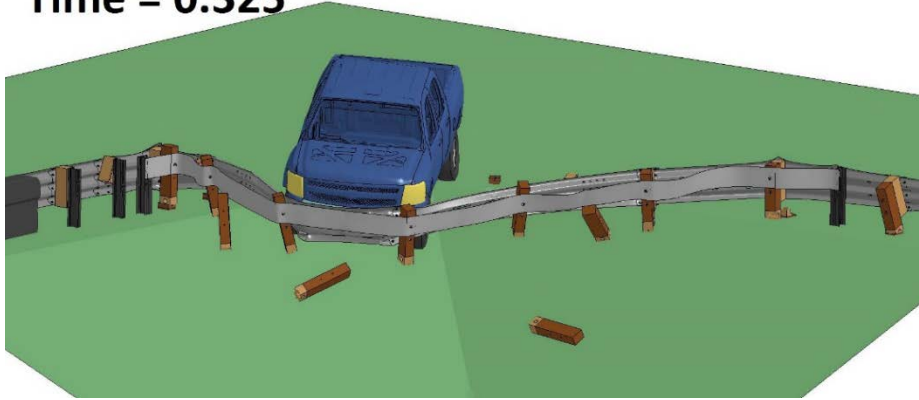
Figure 2.28. Interaction of Car with System.

Figures 2.28 and 2.29 show the interaction in development and final state of the simulation of the truck, respectively. In both figures, it is seen that the strap supports and holds the guardrail in a position that prevents the truck from overriding it. Also, by the end of the simulation, the support steel post of the strap close to the thrie beam end shoe appears to break. Meanwhile, the support steel post on the other end of the strap, despite significant bending, it still remains solid.

Time = 0.325

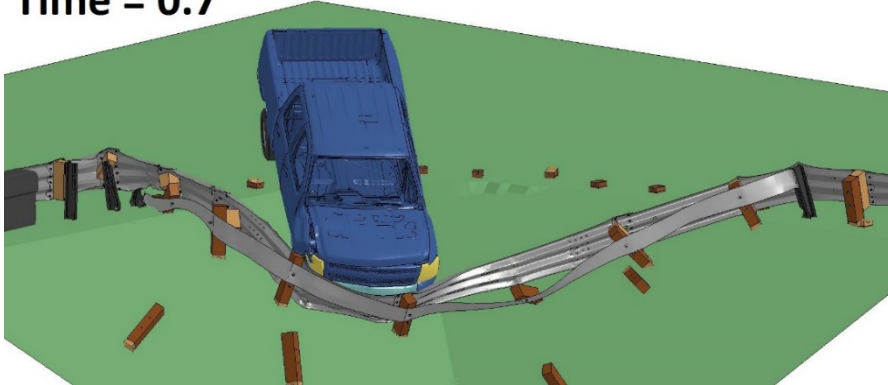
Figure 2.29. Final State of Simulation.

Time = 0.7

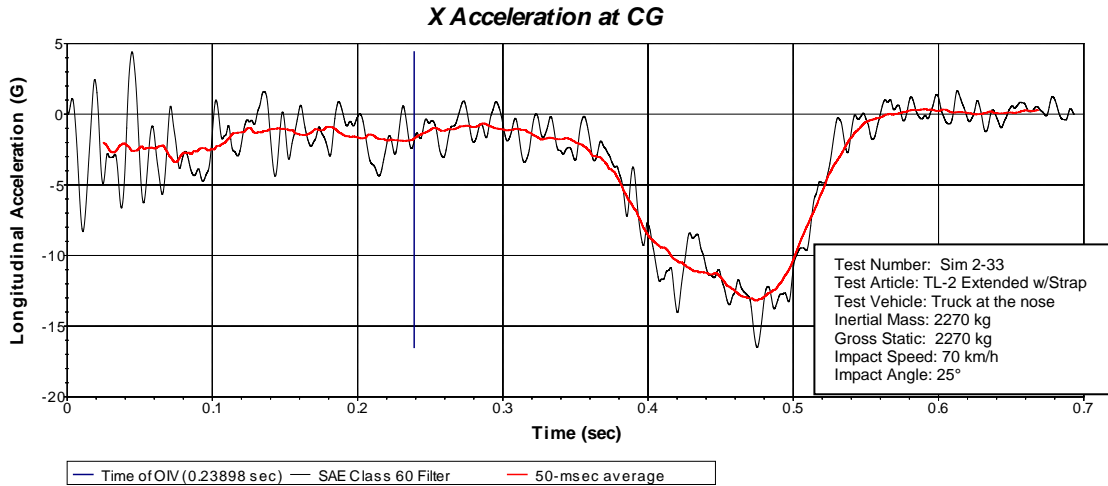
**Figure 2.30. Longitudinal Accelerations for Truck Simulation.**

Shown next are the graph results of the truck simulation. Figure 2.30 shows the longitudinal accelerations, Figure 2.31 shows the lateral accelerations, and Figure 2.32 shows the roll, pitch, and yaw angles.

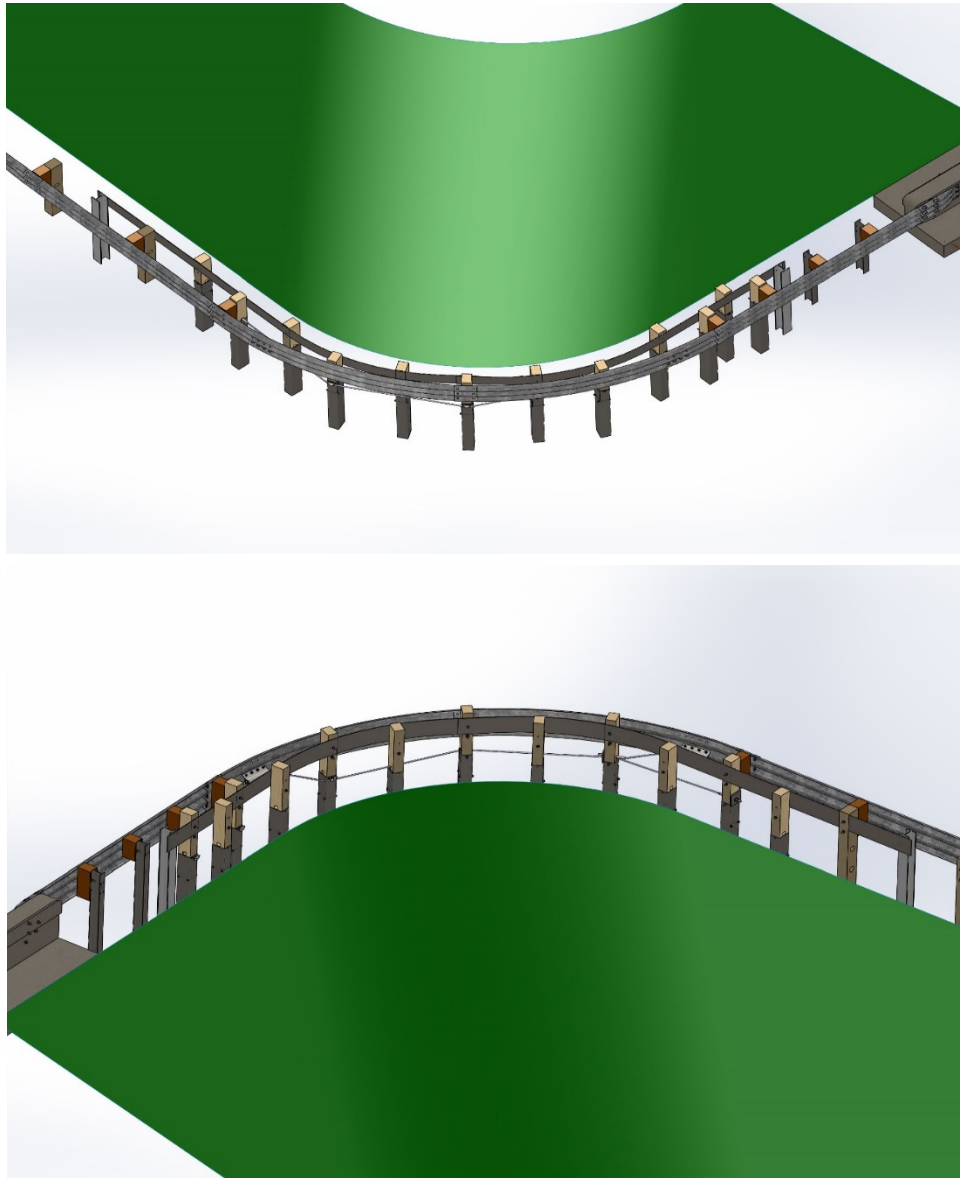
**Figure 2.33. Short Radius System with Back Plate.**

A new design of the short radius guardrail system was created using Solidworks with the appropriate measurements. Figure 2.33 shows the system design surrounding a ditch. The design was based on the system simulation discussed above. As mentioned before, the system consists of a strap running behind the guardrail system with six CRT posts and two steel posts. The design includes two cables, a primary cable attached to the thrie beam running from the primary roadway to the secondary roadway and a secondary short cable on the secondary roadway.

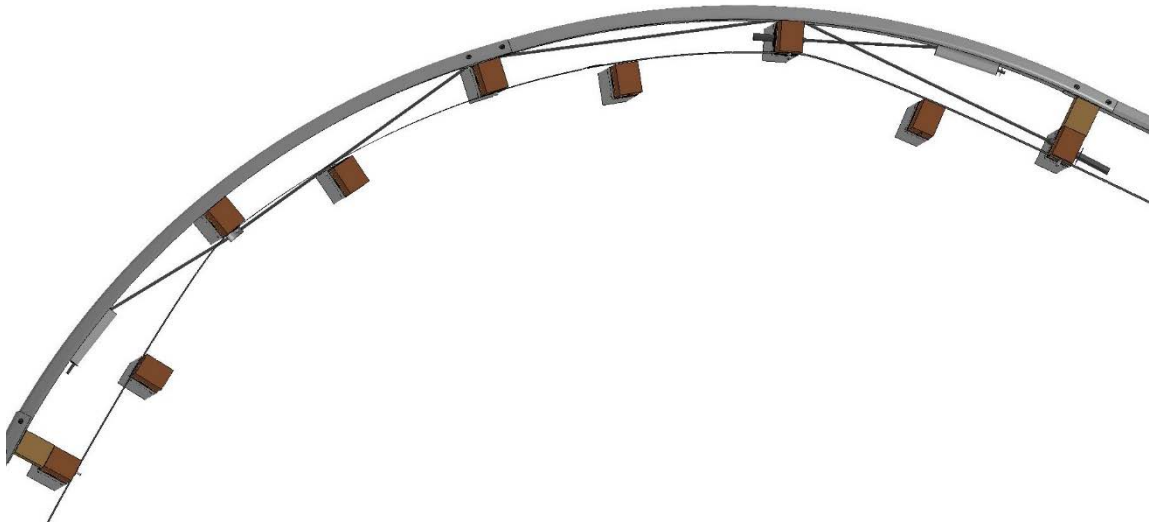
**Figure 2.34. Amplified View of Guardrail System with Strap and Two Cables.**

The following simulation includes the updated guardrail system. This new design includes two new cables, a primary cable and a secondary cable. The primary cable is attached to the thrie beam and is oriented to get to the ground by the third CRT post on the primary roadway. The cable runs under the cable shelf attached at ground level to the post on the primary roadway. The cable then runs along the ground and under the cable shelf attached to the two posts at the center of the radius. It passes along the ground and terminates at the post on the secondary roadway. The secondary cable is attached to the thrie beam and terminates at the post before the post on the secondary roadway.

Figure 2.34 depicts the new cable design that is described above. Figures 2.35 and 2.36 provide a front and back view, respectively, of the long tension cable from the simulation.

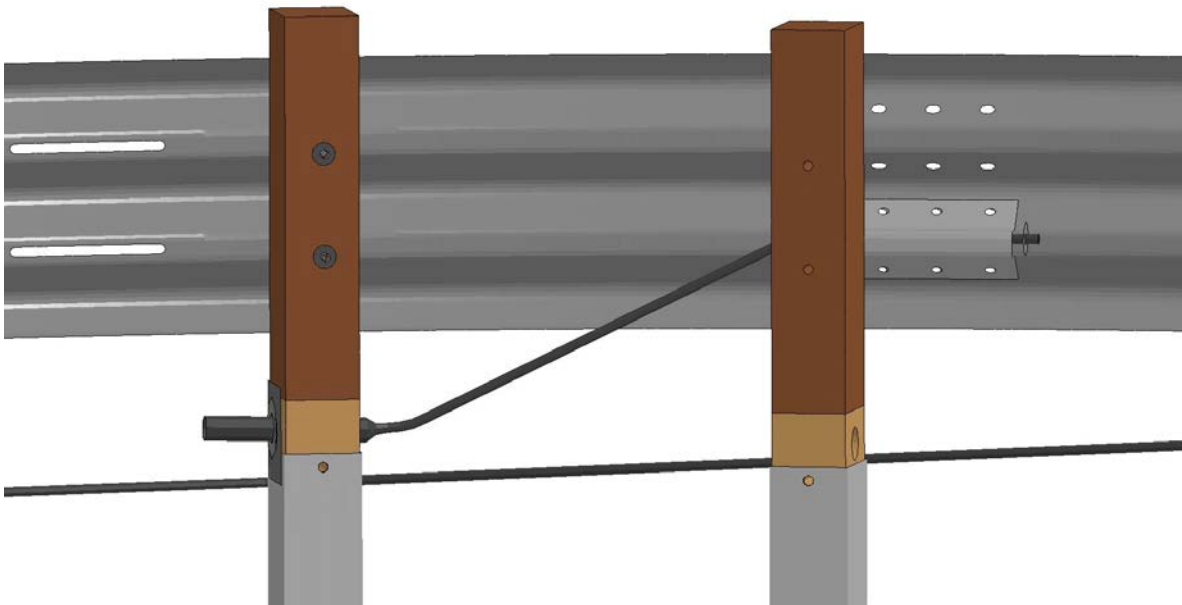
**Figure 2.37. Back View of Secondary Cable (Strap Hidden).**

Figure 2.37 provides the back view of the short tension cable from the simulation. The back strap is hidden from the figures for clarity.

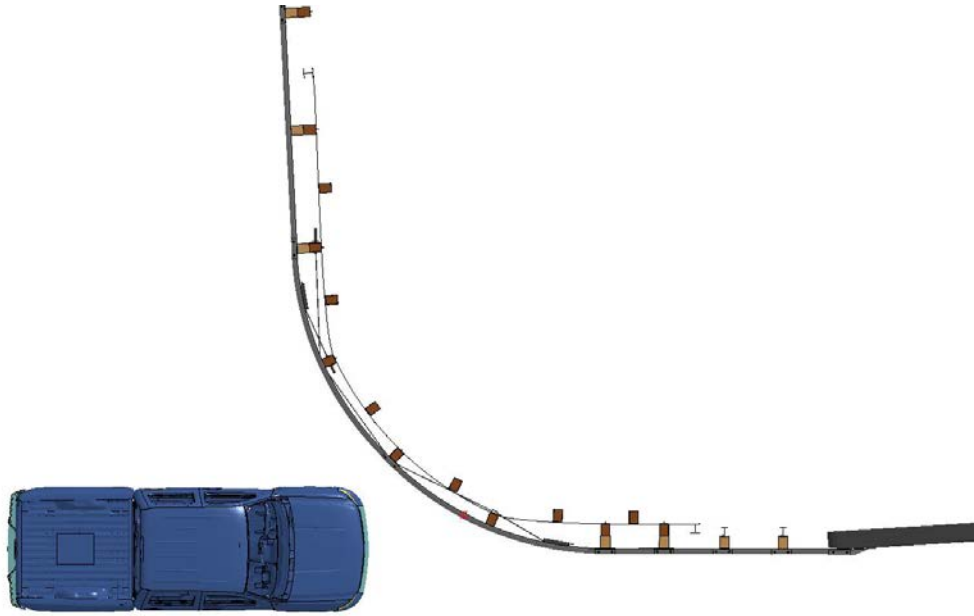
**Figure 2.38. Alignment of Truck with System.**

Figure 2.38 depicts the truck alignment with the system. The centerline of the truck is aligned with the traffic face of the concrete parapet located on the primary roadway.

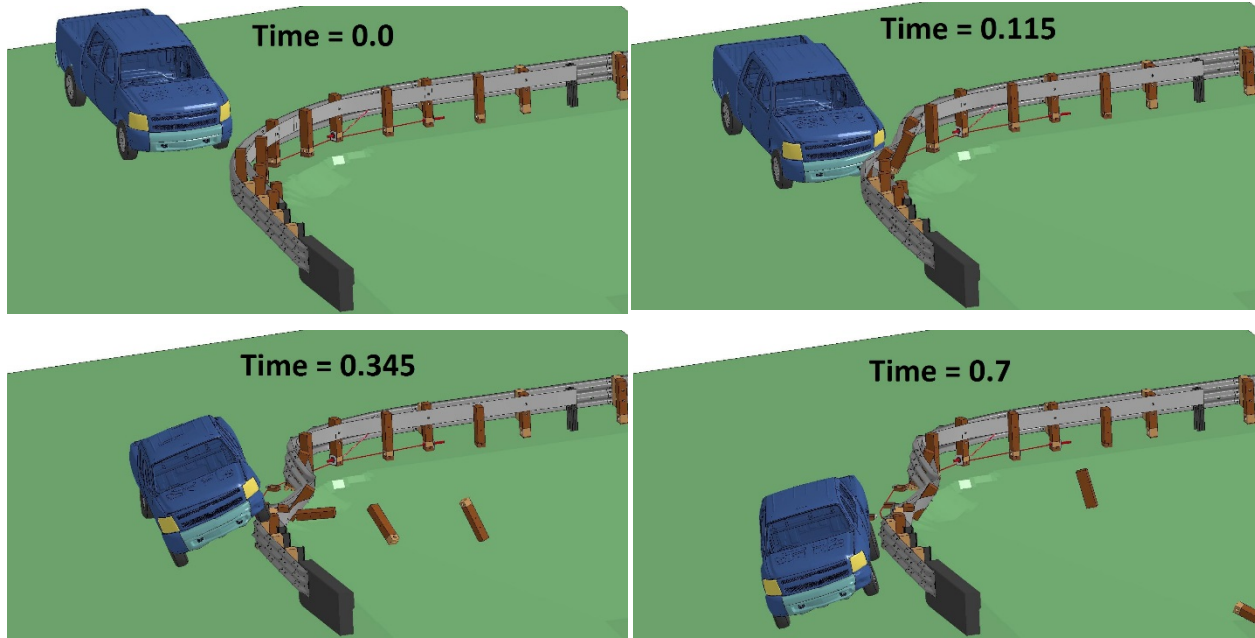
**Figure 2.39. Sequential Images of Simulation of Truck from Front of Rail, with Strap and Cables.**

Figure 2.39 shows sequential images depicting the performance of the system. The first contact with the guardrail happens at 0.065 s from the start of the simulation. The three wood posts surrounding the impact area seem to break simultaneously at 0.1 s. The primary cable maintains tension capacity and continues to be attached under the initial angle until the truck reaches the bracket, and consequently, the wood post behind it breaks. At 0.125 s, the front left tire begins to ride along the cable. By 0.215 s, the tire has passed from riding along the cable to riding up the rail. The front left truck tire appears to detach from the rail before 0.35 s, and the truck is unstable. By the end of the simulation, only six wood posts break, while the others remain intact, including the steel posts that hold the strap. The secondary cable maintains tension capacity and remains attached under the initial angle throughout the simulation.

The first frame shows the initial state of the system and the truck, followed by two frames depicting the initial and last state of the interaction progress. The conclusion that the system has an undesirable outcome is seen in these two images. The last frame of Figure 2.39 represents the last state of the simulation. To make them stand out, the cables have been colored red.

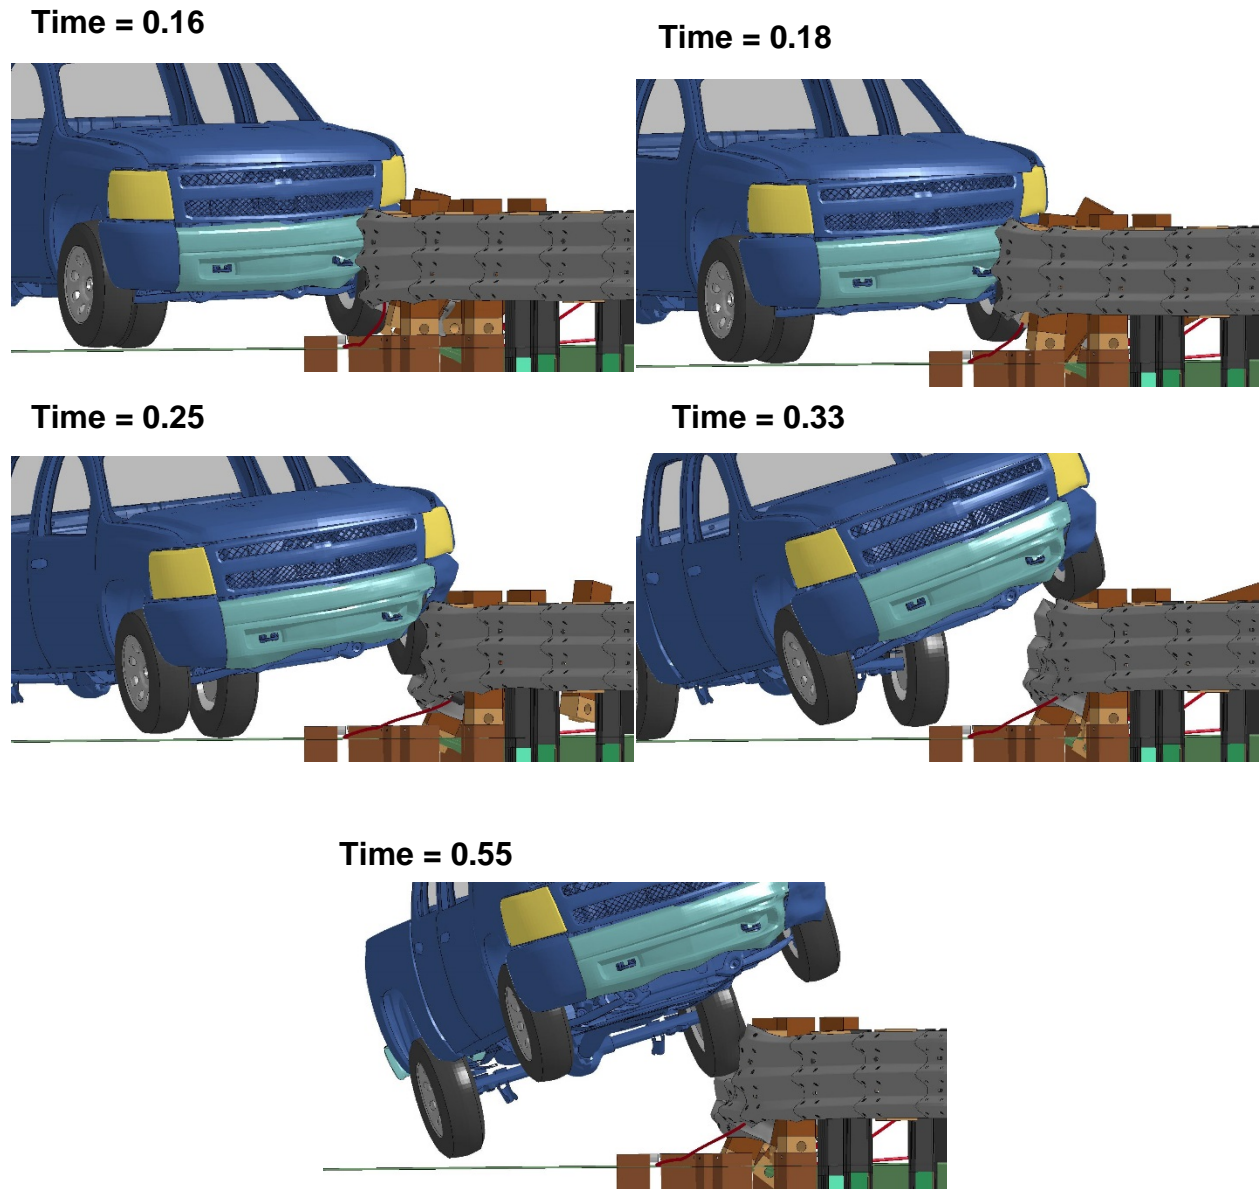
**Figure 2.40. Sequential Images of Tire with System Interaction.**

Figure 2.40 shows how the truck tires interact with the cable initially and then with the rail. The front left truck tire rides up the cable onto the rail, followed by the back left tire riding up the rail, eventually causing the truck to be unstable. Figure 2.41 zooms in on the moment the left truck front tire rides along the cable, at 0.18 s, in two different angled views. Notice how the rail is pushed into the ditch of the system as the tire rides along the cable.

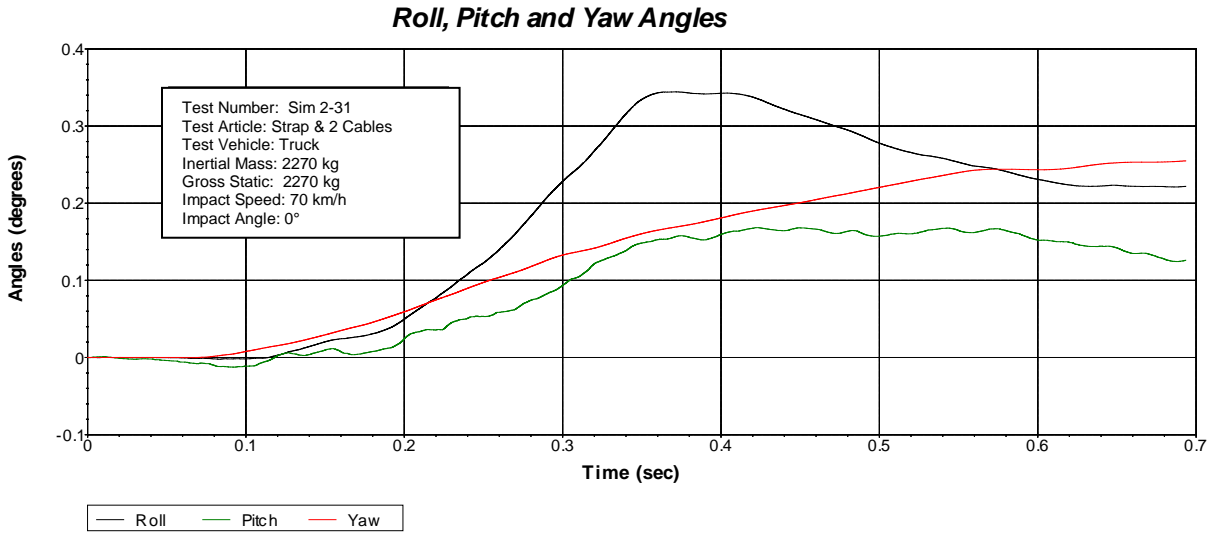
**Figure 2.42. Roll, Pitch, and Yaw Angles.**

Figure 2.42 shows the graph results of the truck simulation for the roll, pitch, and yaw angles. The roll angle shown in the black solid line has a peak at 0.37 s, with an angle of  $0.35^\circ$ . The peak can be explained by analyzing the above simulating images, where it is observed that the moment that the truck rides up the rail matches with the time, the peak is represented in the graph.

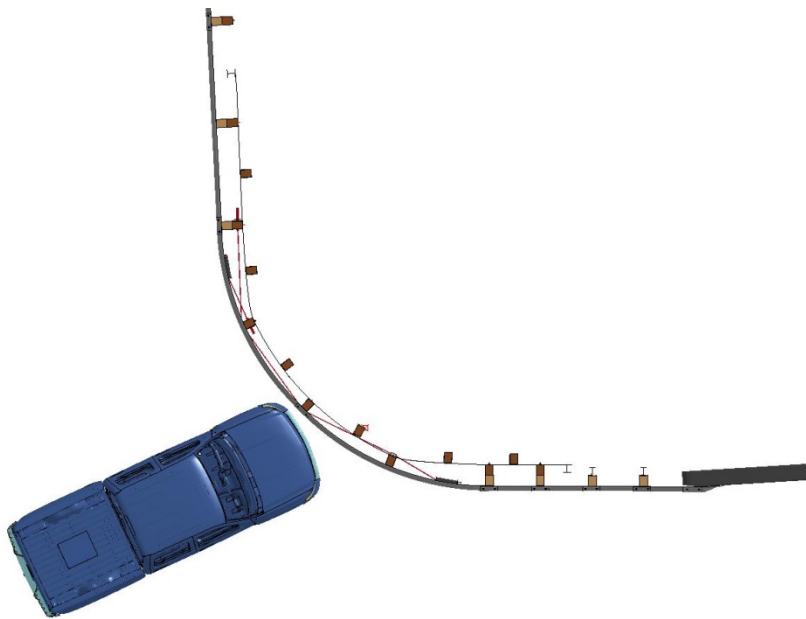
**Figure 2.43. Alignment of Truck with System.**

Test 2-33 was simulated to determine the rail’s capacity of containing or redirecting the truck. The same guardrail system design was used from test 2-31. The truck impacted the system at a 25° angle at the center of the radius. Figure 2.43 shows the alignment of the truck with the system.

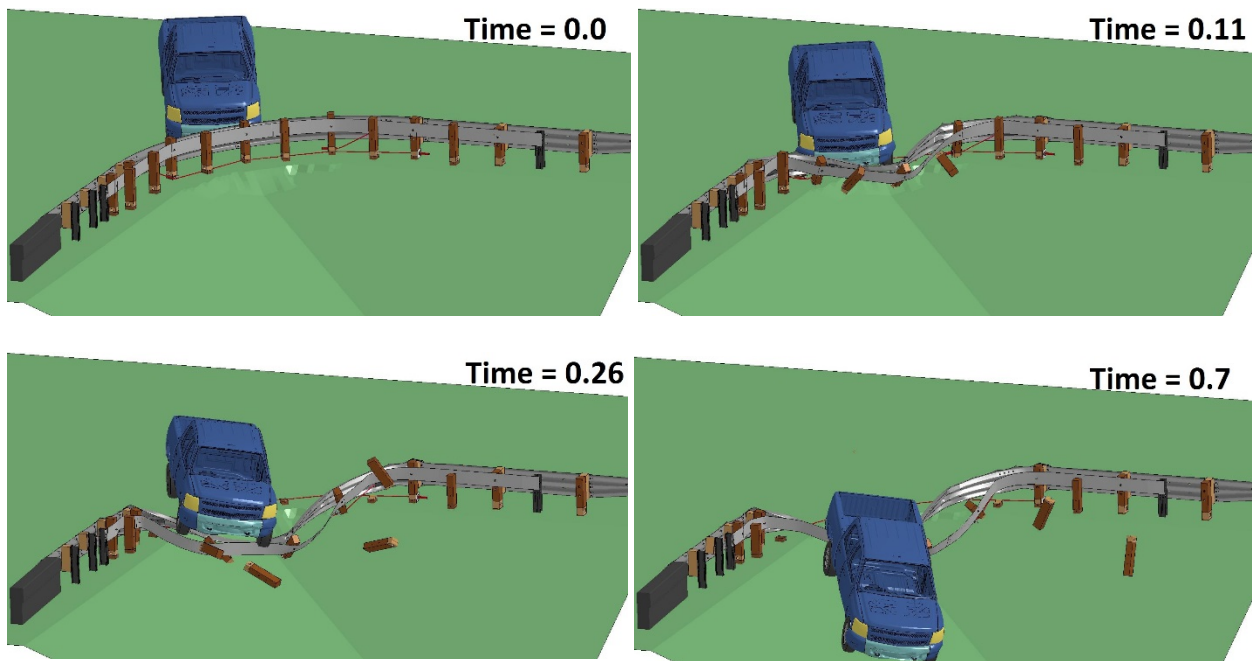
**Figure 2.44. Sequential Images of Simulation with Strap and Cables.**

Figure 2.44 shows sequential images of the simulation of the truck interacting with the system. The initial contact with the rail happens at 0.015 s. The wood post in the middle of the radius breaks first at 0.035 s. Then, before 0.04 s the other two wood posts of the radius break. The next to break is the wood post holding the secondary cable before 0.05 s. The secondary cable maintained tension capacity and was attached under the initial angle until this point. From impact, the rail area holding the primary cable's bracket is pushed into the ditch side moving along with the cable. The cable first escapes from one the shelves at 0.105 s and consequently changes the angle of attachment. Before 0.14 s, the right truck front tire begins to run along the cable. Before 0.18 s, the tire has passed from riding along the cable to riding up the rail. By this point, also the left front tire is riding up the rail. The back truck tires follow and by 0.47 s they are up the rail. Before 0.5 s, the truck has completely detached from the system and is going down the ditch.

The first frame shows the initial state of the simulation, followed by two frames representing the interaction between the truck and the system. The last frame is the last state of the simulation. This figure clearly draws the conclusion that the system is not adequate to contain the truck.
