# CRASH TEST AND EVALUATION OF TL-2 SHORT RADIUS GUARDRAIL TREATMENT

**Test Report 0-6913-R1**

**TEXAS A&M TRANSPORTATION INSTITUTE  
COLLEGE STATION, TEXAS**

**TEXAS DEPARTMENT OF TRANSPORTATION**

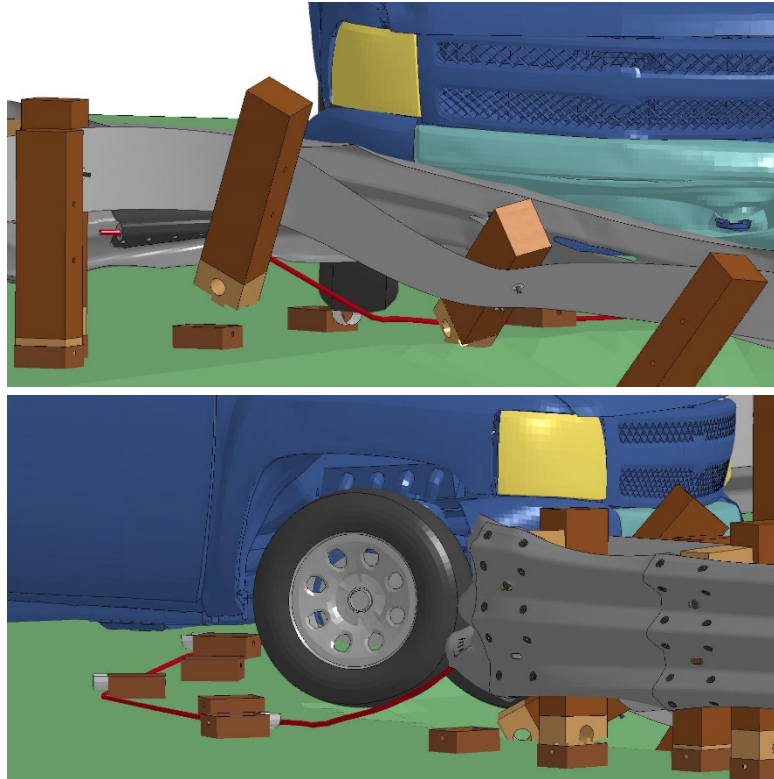
**Figure 2.45. Interaction of Truck with System.**

Figure 2.45 shows two amplified images on the moment the right front tire rides along the cable initially and then up the rail. Notice how the rail is pushed toward the ditch as the tire starts to ride along the cable. The tire rides along the cable from 0.14 s to 0.17 s. The cables have been colored red to make them stand out.

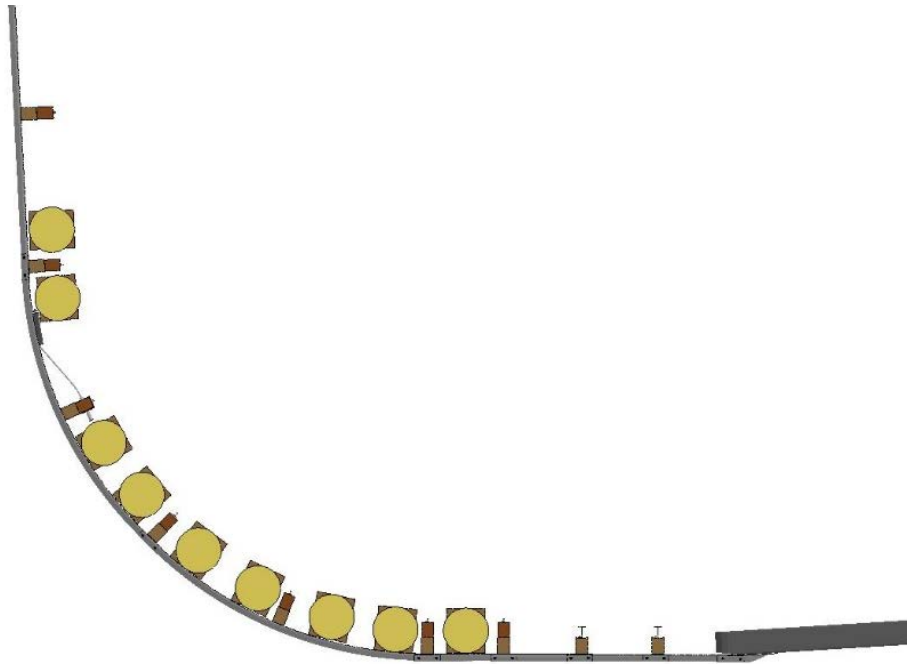
**Figure 2.46. Flare and 18-lb Sand Drums behind Radius.**

Since the previous system was overridden by the truck, the guardrail system was updated. The new system is shown in Figure 2.46. The system design includes drums filled with sand placed between posts. Each of the nine drums were raised by wood blockouts from the ground. From the primary roadway, the first drum is placed between posts 3 and 4, two drums are placed between posts 4 and 5, 5 and 6, and 6 and 7. One drum is placed between the ends of the secondary cable to post 8. The last drum is placed between 8 and 9. Since the ditch is really close to the system the drums were set as close as possible the guardrail. The strap and primary cable were removed from the system design.

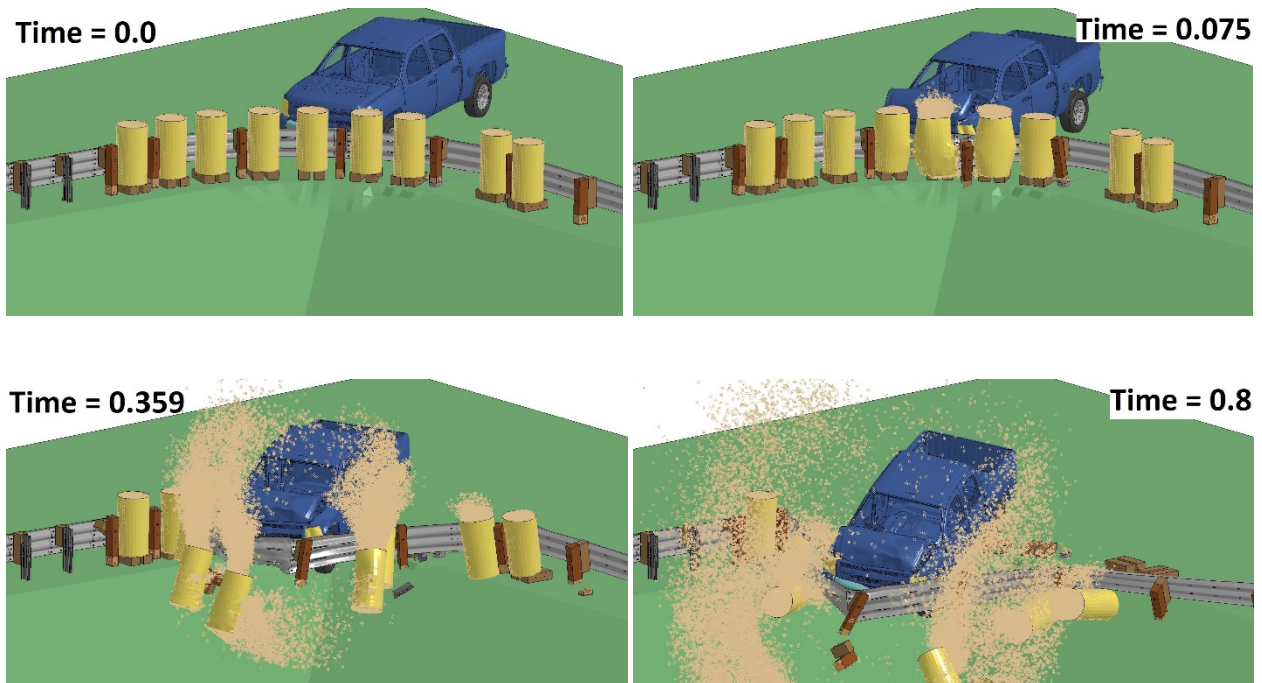
**Figure 2.47. Sequential Images of Truck Simulation, with Flare and 18-lb Sand Drums.**

Figure 2.47 shows the sequential images of the simulation of system with the truck. The truck remains stable during the simulation. The first image shows the initial position of the truck and the system, and is followed by two images that depict the interaction of the truck with the guardrail system and the drums. The last image is the last state of the simulation. The drums and the guardrail system engage to absorb the kinetic energy of the vehicle and successfully contain the truck.

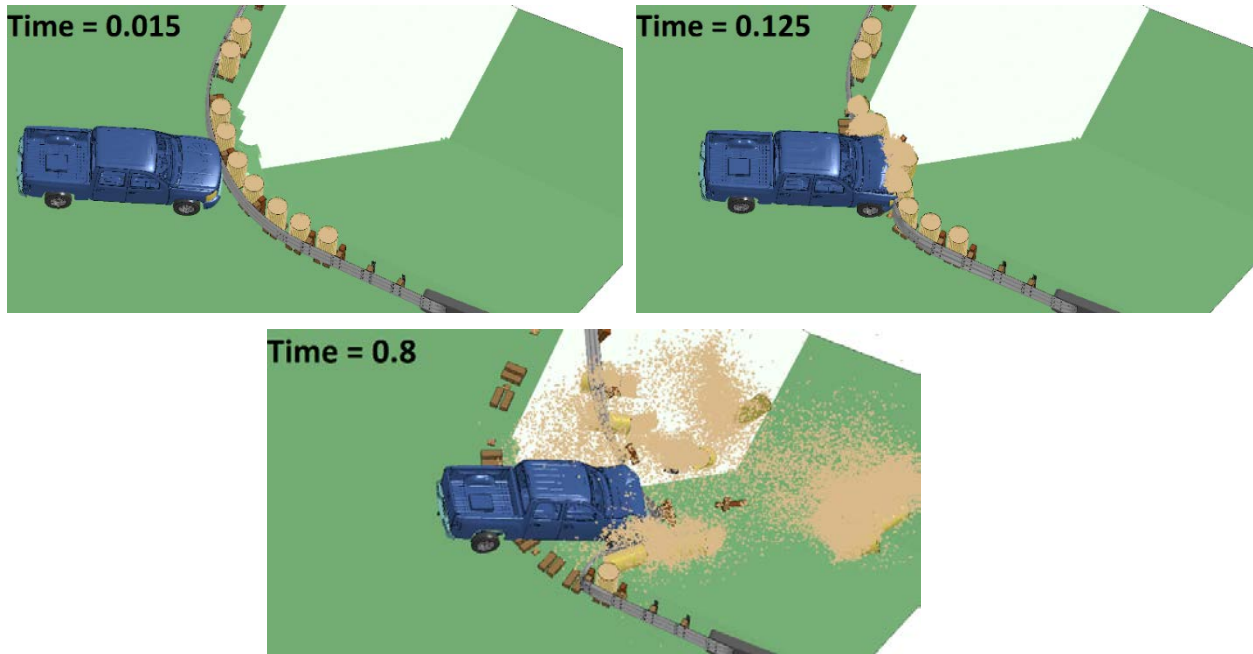
**Figure 2.48. Interaction of Truck with System.**

Figure 2.48 offers alternate views of three key moments of the simulation. The first frame shows when the first impact occurs. The second one displays the moment after the drums have had their greatest impact. The third frame is the moment after the guardrail system has had its

impact and the truck reaches zero velocity. The third frame is also the last frame of the simulation.

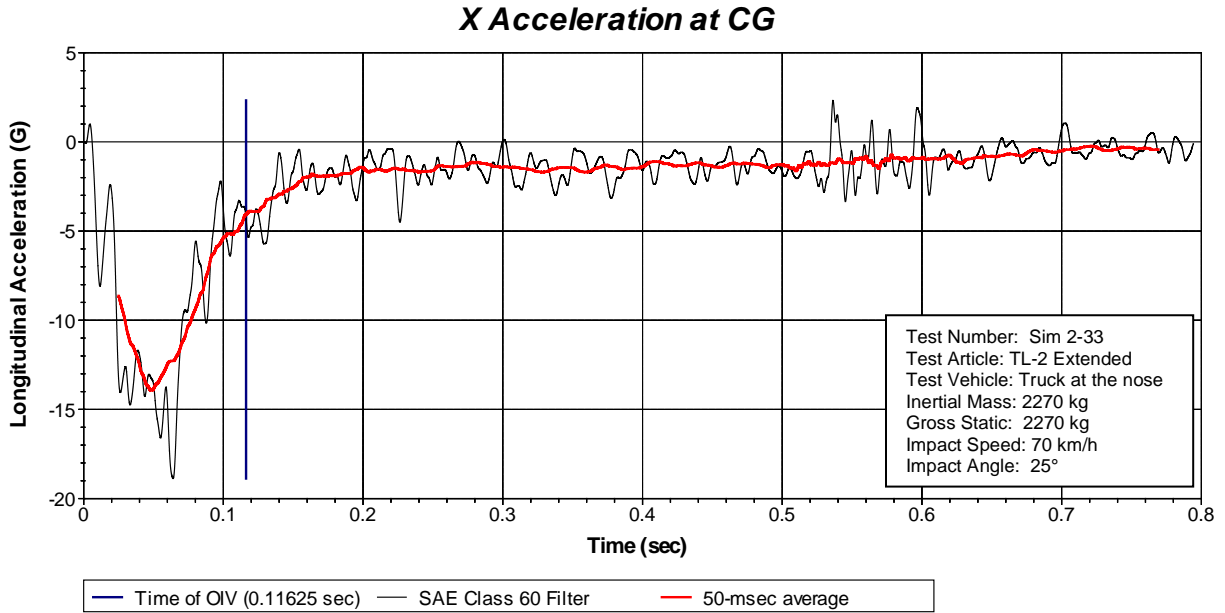
**Figure 2.49. Longitudinal Accelerations for Truck Simulation.**

Figures 2.49, 2.50, and 2.51 are the results for the longitudinal accelerations, lateral accelerations, and vertical accelerations, respectively. Figure 2.52 shows the results of the roll, pitch, and yaw angles.

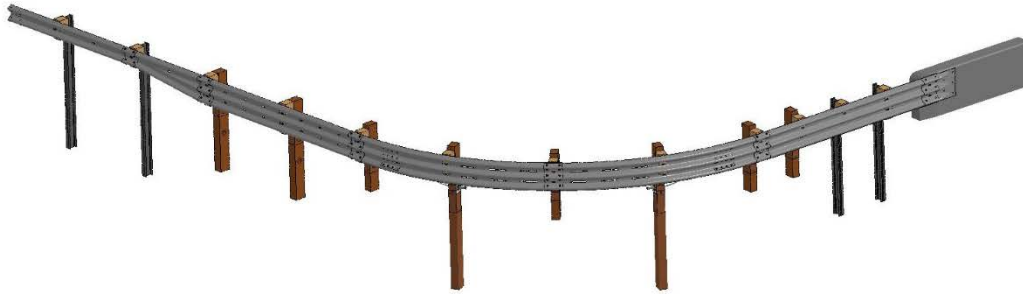
**Figure 3.1. Guardrail System.**

The short radius system used for these test simulations starts with a transition between a guardrail to a concrete bridge rail on the primary road. This transition included a 31-inch tall strong post thrie beam approach guardrail to a rigid concrete bridge parapet. The primary roadway consisted of two steel posts, two controlled release timber (CRT) posts, and a 12.5-ft thrie beam on the primary roadway. The first two posts are W6×9 steel post starting 29 inches from the end of the parapet with a 6-inch × 8-inch × 21-inch routed wood blockout. The next two posts were the CRT posts with a 6-inch × 8-inch × 14-inch. All posts included one bolt on the top hole shown on the thrie beam. The following thrie beam was the curved section with a radius of 16-ft; this section of the guardrail consisted of three CRT wood posts. Continuing to the secondary roadway, a 12.5-ft thrie beam connected with the curved section. The secondary roadway consisted of a 7 ft-3 inch taper transition from a thrie-beam to W-beam, three CRT wood posts, and two steel posts. Figures 3.1 and 3.2 show the described system from the front and back view. The guardrail system was set as a reference for the following simulations.

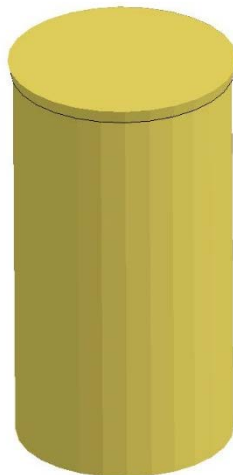
**Figure 3.3. Sand Drum Used in Simulations.**

The sand drums developed for the simulations were based on Eagle models, model number 1656, with a height of  $36\frac{3}{8}$ -inches and 21-inch diameter. The drums were filled with sand and weighed approximately 700 lb. Figure 3.3 shows the drum used for the simulations.

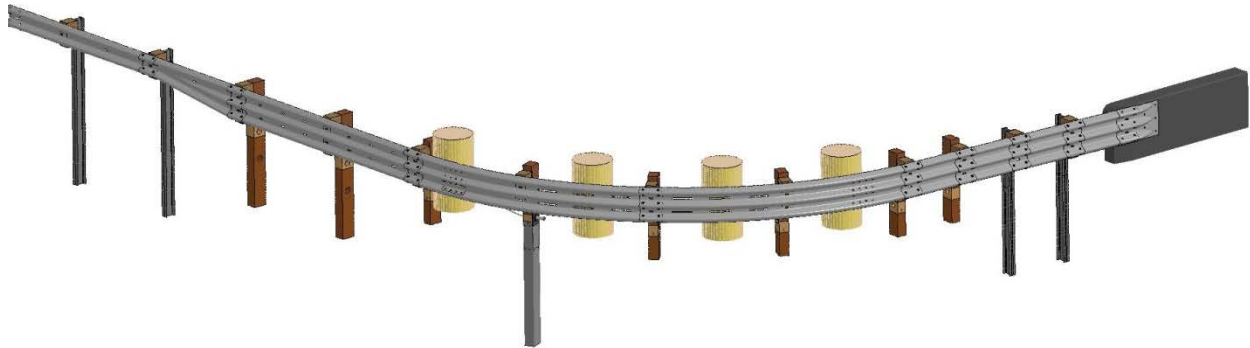
**Figure 3.4. Entire System with Tension Cable and Four 700-lb Sand Drums.**

A guardrail system design was evaluated in a simulation. This system includes only four drums and a tension cable. There are four 700-lb sand drums in the system used in this simulation, spread along the curved section of the rail. The drums are placed between posts, from posts 4 through 8. The goal of this simulation is to affirm that the truck is adequately captured within an acceptable distance behind the rail. The vehicle impacted the system at the center of the radius at a 25° angle. Figure 3.4 illustrates the whole guardrail system.

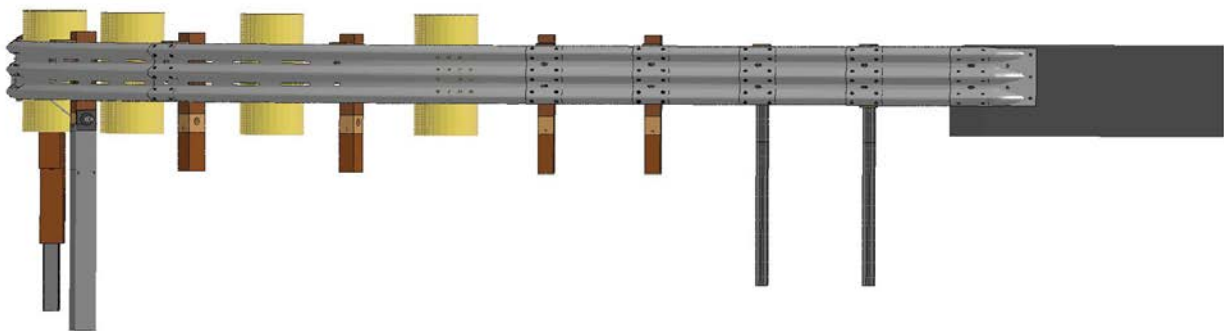
**Figure 3.5. Side View of Primary Roadway.**

Figure 3.5 shows the side view of the primary roadway. The primary roadway consists of two steel posts and two CRT posts. All four posts only contained one bolt. Figure 3.6 shows the side view of the secondary roadway. The secondary roadway consists of three CRT posts with blockouts and two steel posts. The curved section of the system consists of three CRT timber posts. The simulated parapet section represents the stiffer portion of the rail.

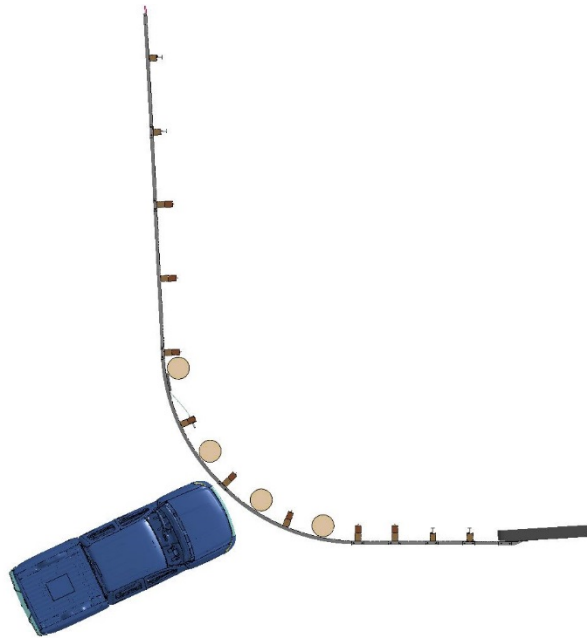
**Figure 3.7. Alignment of Truck with System.**

The spacing for posts 1 to 4 is 3-ft and spacing for posts 4 to 12 is 6-ft 3-in. measured along the arc of the curved thrie beam. Figure 3.7 depicts the truck alignment with the system for this simulation.

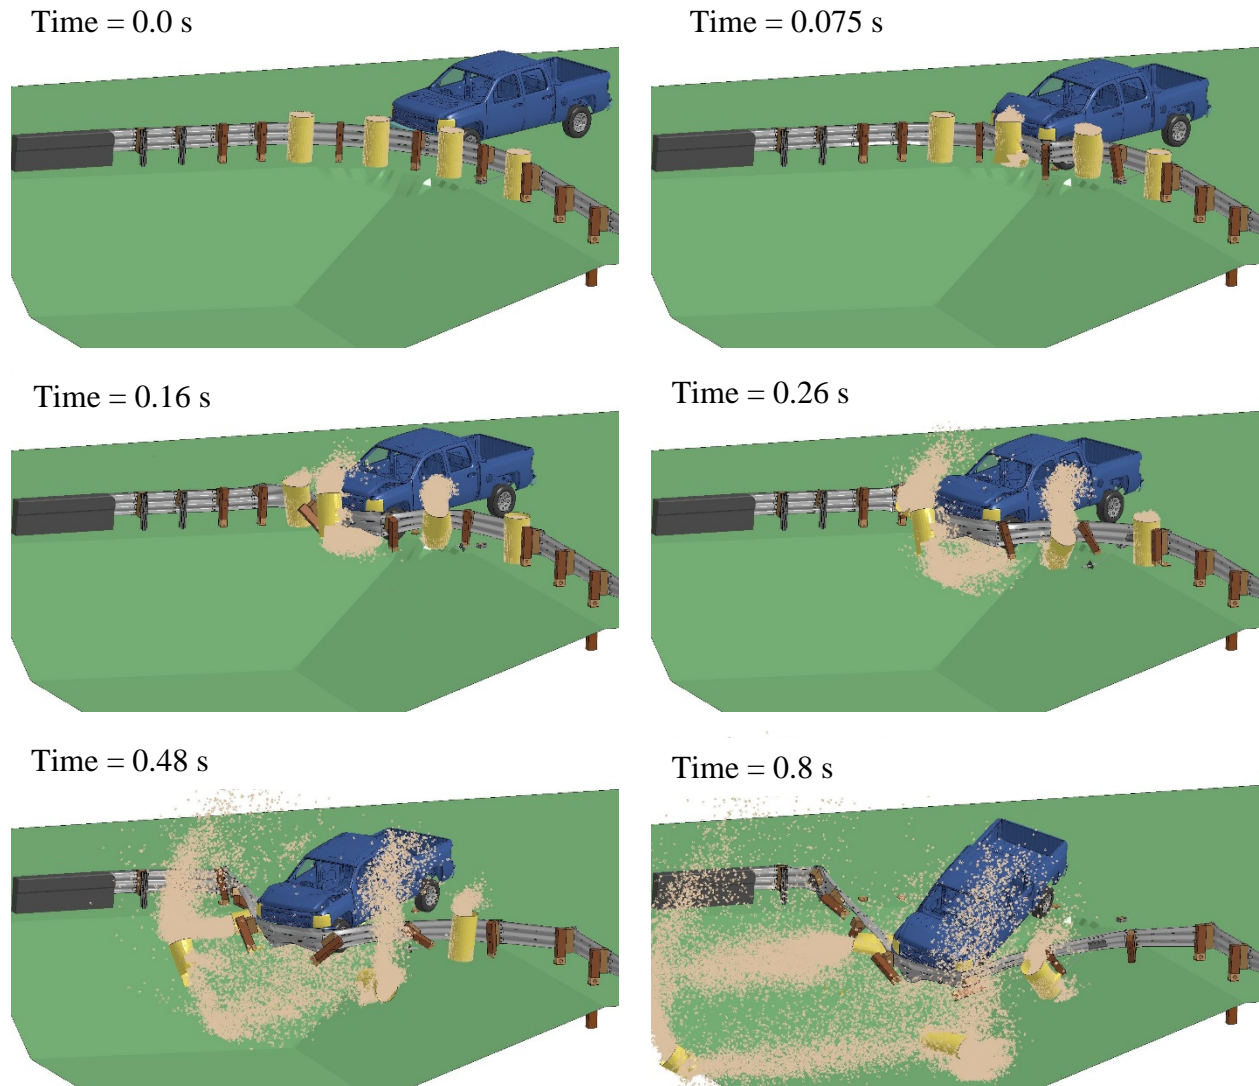
**Figure 3.8. Sequential Images of Truck Simulation with Tension Cable and Four 700-lb Sand Drums.**

Figure 3.8 shows the sequential images of the simulation of the system with the truck. The first image shows the initial position of the truck and the system, and is followed by four images that depict the interaction of the truck with the guardrail system and the drums. By 0.075 s, the hood of the truck had deformed but had not passed into the windshield. At 0.26 s, three of the drums broke and the sand dispersed. The fourth drum was placed closer to the secondary roadway did not move from its place until 0.3 s. The last image displays the last state of the simulation. The drums and the guardrail system engaged to absorb the kinetic energy of the vehicle and successfully contain the truck.

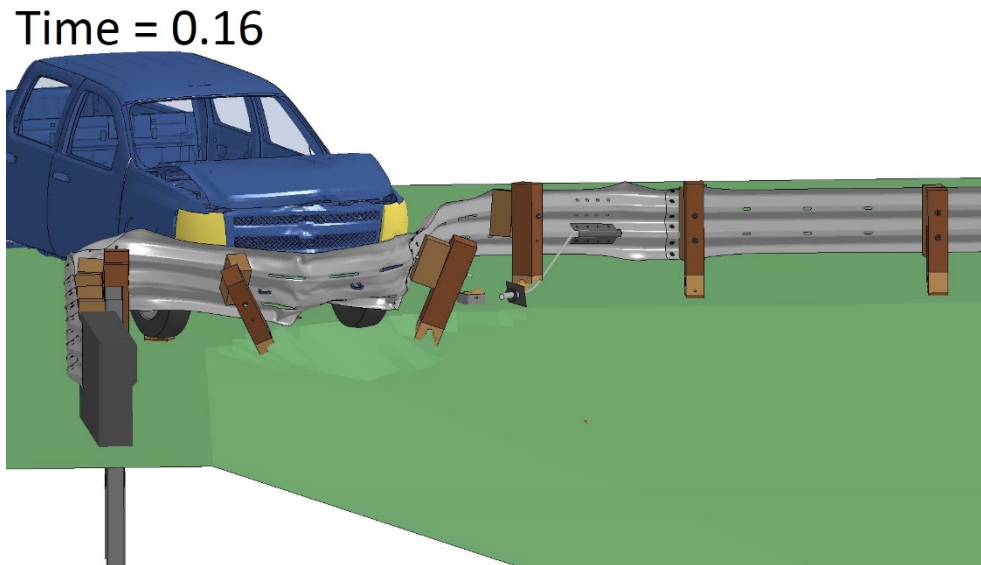
**Figure 3.9. Interaction of Truck with System.**

Figures 3.9 and 3.10 show the interaction in the development and final state of the simulation of the truck, respectively. The drums have been hidden from the following images to better show the deformation happening between the vehicle and the system.

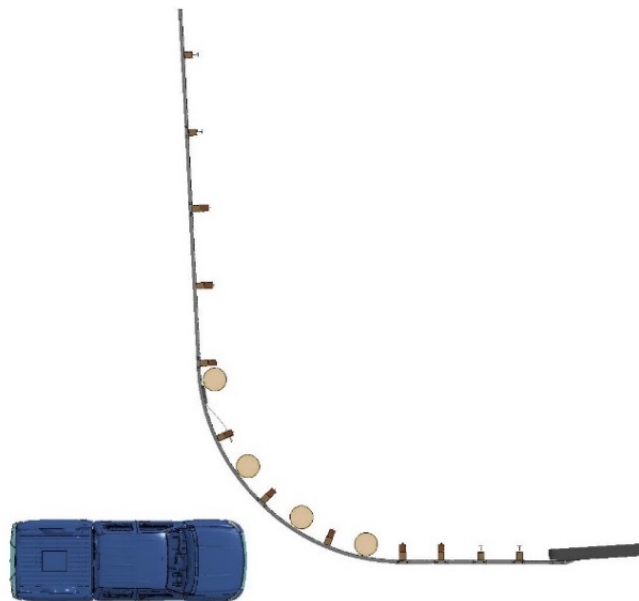
**Figure 3.11. Alignment of Truck with System.**

This simulation case aligns the truck parallel with the primary roadway. Figure 3.11 shows the system used in this simulation and the alignment of the truck within the system. The system contains the four 700-lb sand drums spread along the curved section of the rail and the tension cable placed on the secondary roadway.

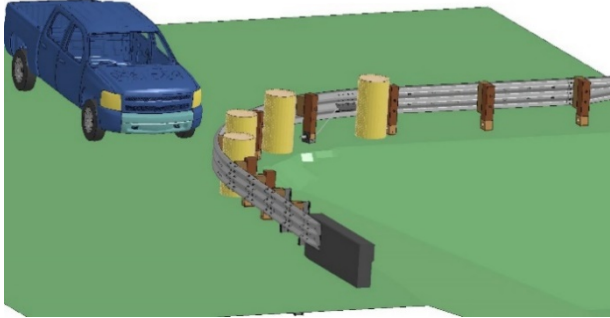
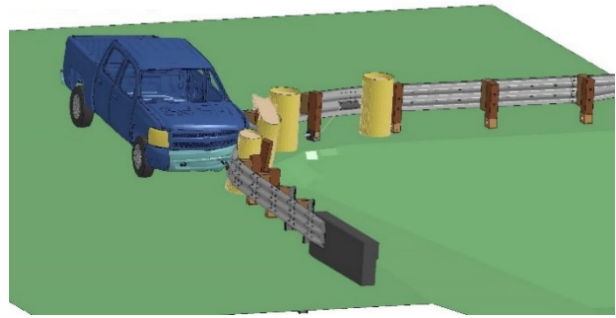
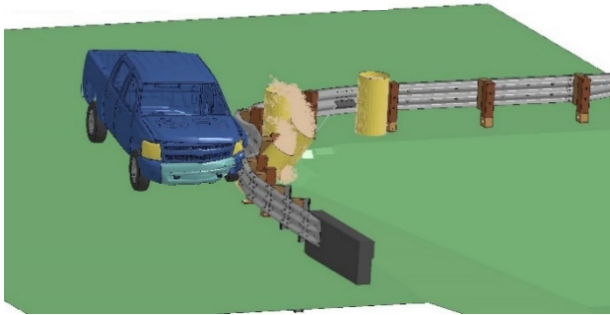
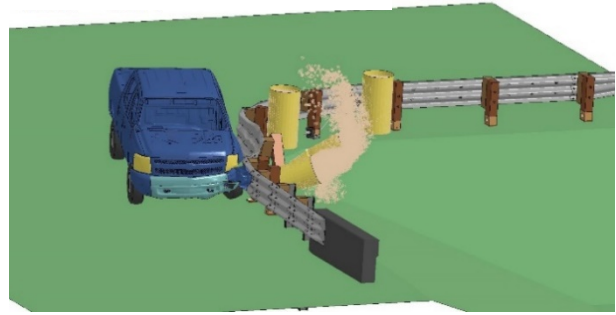
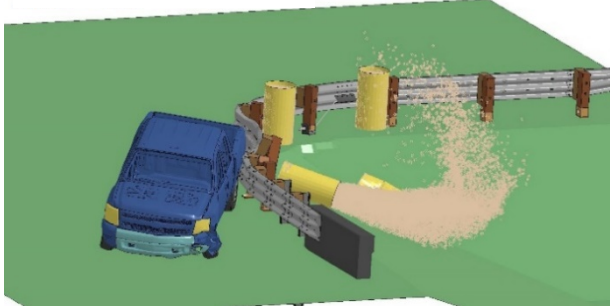
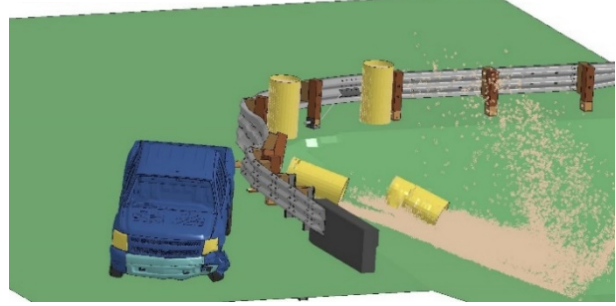
**Figure 3.12. Sequential Images of Truck Simulation with Tension Cable and Four 700-lb Sand Drums.**

Figure 3.12 displays the truck in sequential images throughout the simulation. The truck remained stable throughout the impact. At 0.15 s, there is damage to the front left corner of truck and the rail has been pushed into the interior of the system. At 0.3 s, the truck begins to be redirected away from the guardrail system. By the end of the simulation, the truck has been redirected and its interaction with the system is complete. At this point in the simulation, two posts and two drums have broken, while the other remaining drums are still standing. The front corner and tire on the driver's side and the back corner on the same side were damaged.

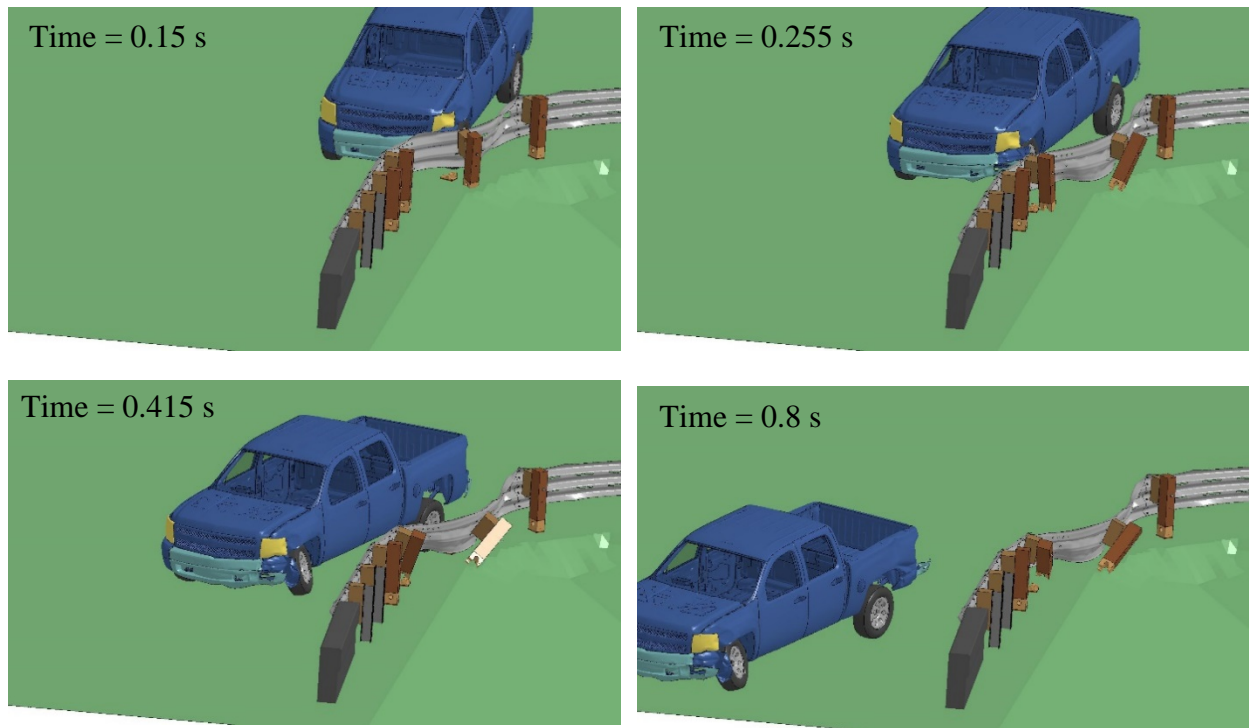
**Figure 3.13. Sequential Images of Truck Simulation from Back of Rail (No Drums Visible).**

The sequential images in Figure 3.13 show a closer view of the interaction between the guardrail and vehicle from the back of the system. The sand and the drums have been removed from these images to show the interaction of the rail and vehicle clearly. Figure 3.14 shows a closer view of the interaction.

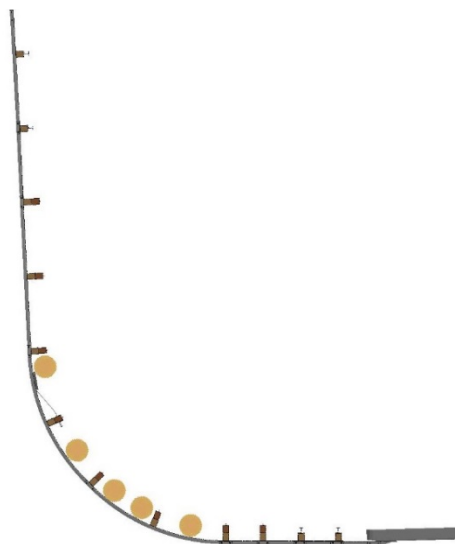
**Figure 3.15. Tension Cable and Five 700-lb Sand Drums.**

Figure 3.15 shows the system used for the simulation. The changes made to the system included an extra drum, placed between posts 11 and 12. A total of five drums are placed along the rail from posts 9 to 13. Two drums are placed between posts 11 and 12. The drum placed between posts 9 and 10 is placed 17 inches from center of drum to center of post 9. The same short cable placed on the secondary roadway between posts 9 and 10 is also included in the system. The cable is attached to the thrie beam and terminates at post 10 at an angle.

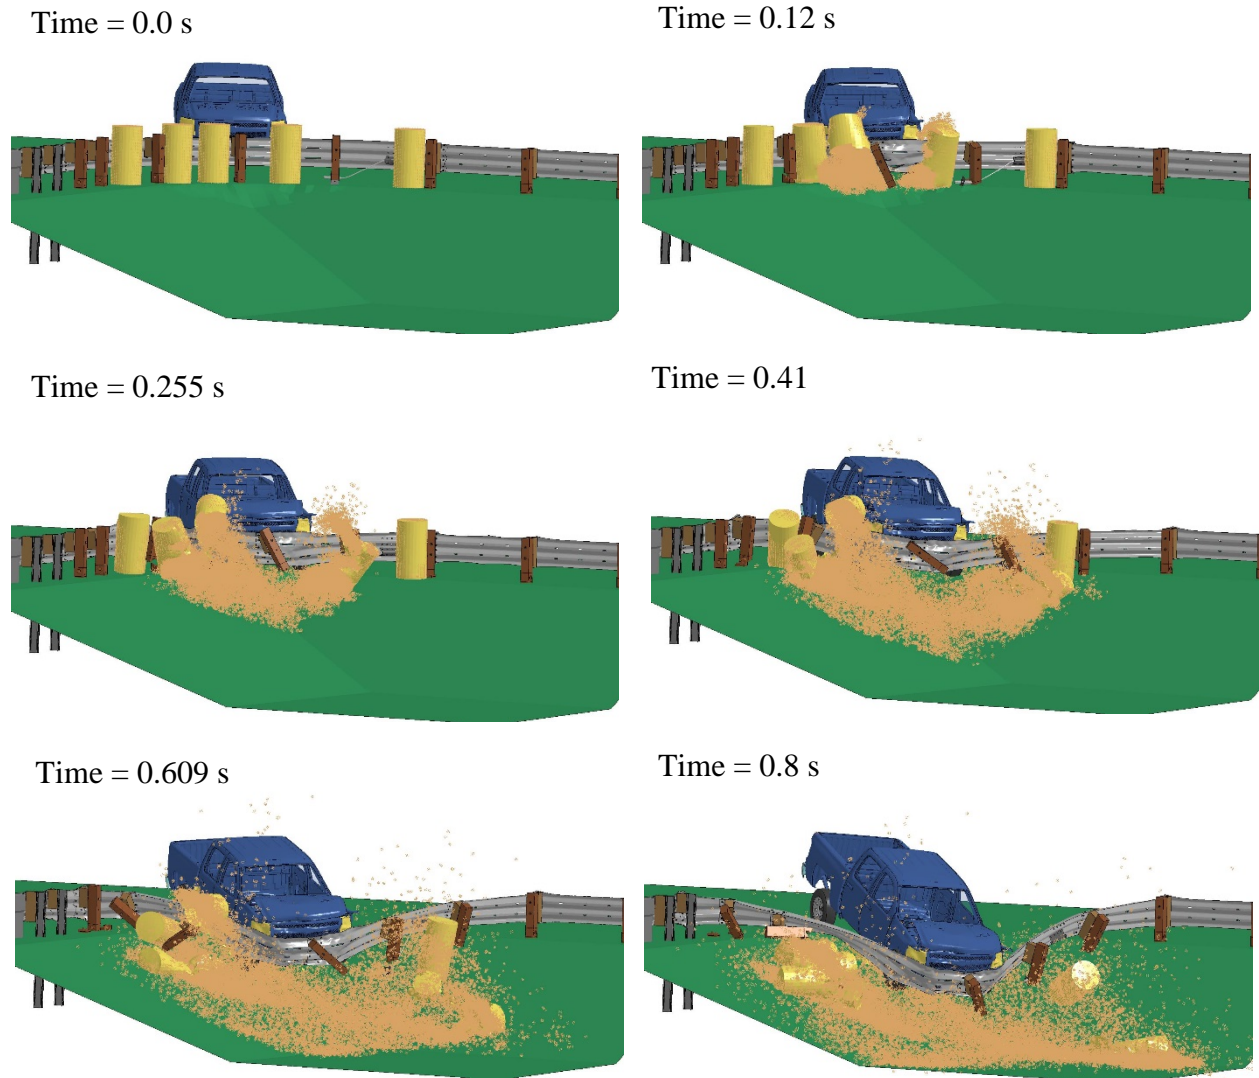
**Figure 3.16. Sequential Images of Truck Simulation with Tension Cable and Five 700-lb Sand Drums.**

Figure 3.16 demonstrates the progression of the simulation to summarize the behavior of the vehicle. The rail and the deformation of the front of the truck did not pass as far into the windshield as on previous simulations. The back tires of the truck were in the air by 0.609 s. Six of the wood posts broke at the end of the simulation and all six drums broke and dispersed the sand.

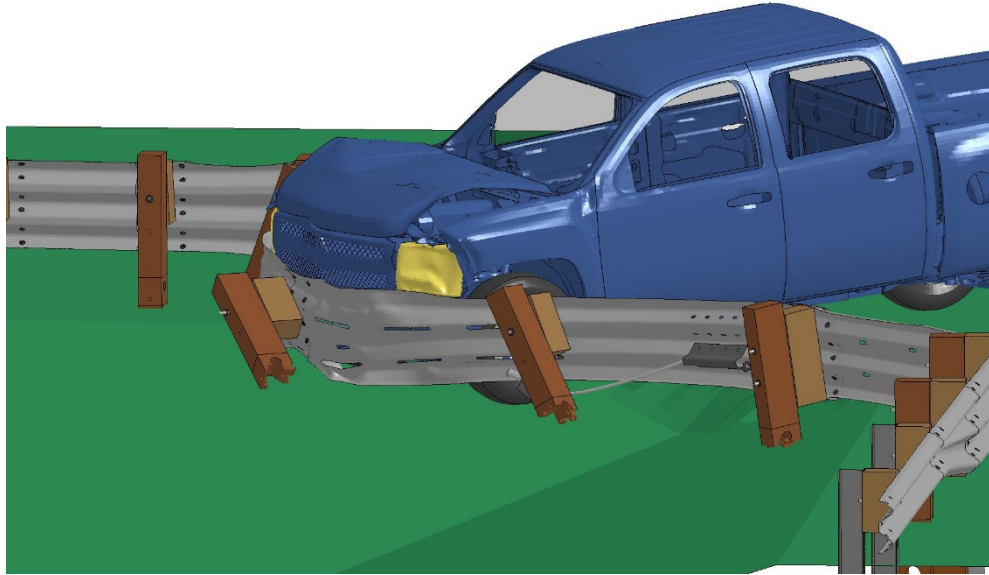
**Figure 3.17. Interaction of Truck with System (No Drums Visible).**

Figures 3.17 and 3.18 display images of a closer view of the interaction between the truck and the system. The drums were removed from the images to have a clear view of the interaction.

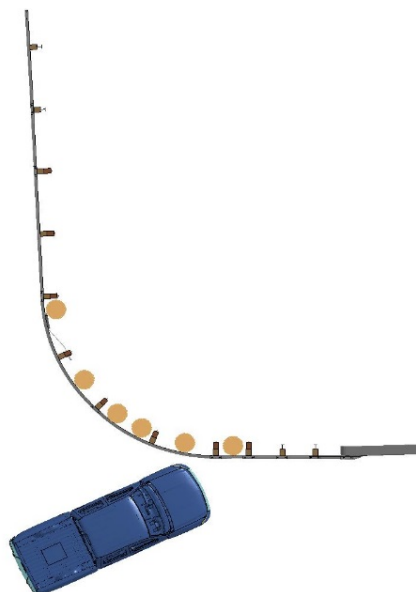
**Figure 3.19. Alignment of Truck with System.**

Figure 3.19 shows the system used for this simulation and the alignment of the truck to the system. For this simulation, the same layout was used with an additional drum. The system includes one short cable and a total of six drums spread along the rail. The drums are placed between posts 9 through 14. The short cable is on the secondary roadway placed between posts 9 and 10. It is attached to the thrie beam and terminates at post 10 at an angle.

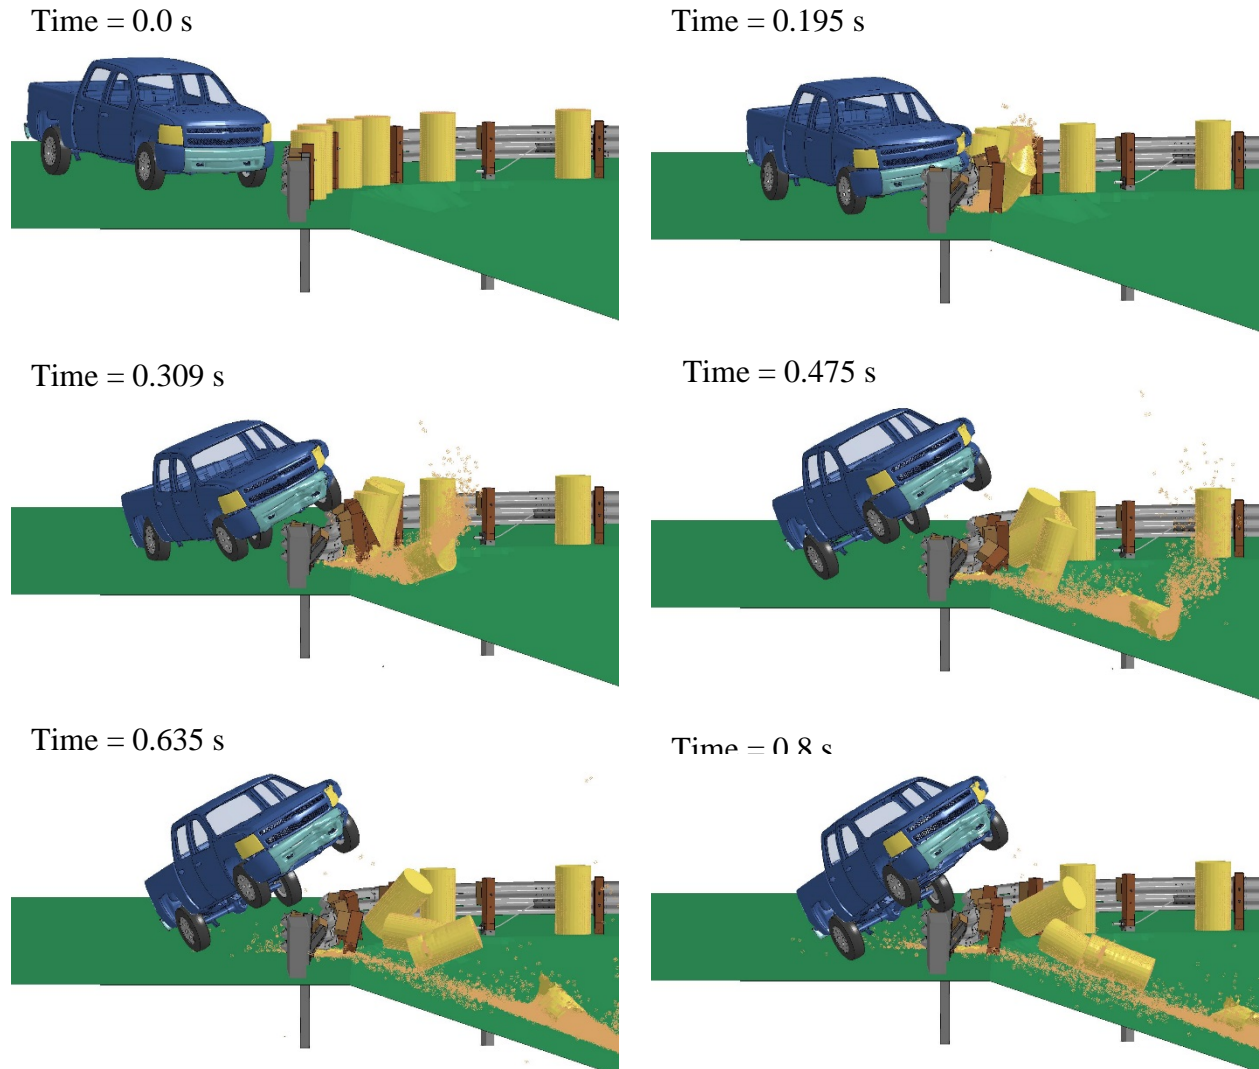
**Figure 3.20. Sequential Images of Truck Simulation with Tension Cable and Six 700-lb Sand Drums.**

Figure 3.20 presents the simulation of the truck. The first CRT post along the primary roadway broke, and by the end of the simulation three CRT posts were broken, one steel post was deformed, and the other stayed stable through the simulation. By 0.309 s, the driver side front wheel of the truck began to ride up onto the rail. The truck becomes unstable as early as 0.35 s.

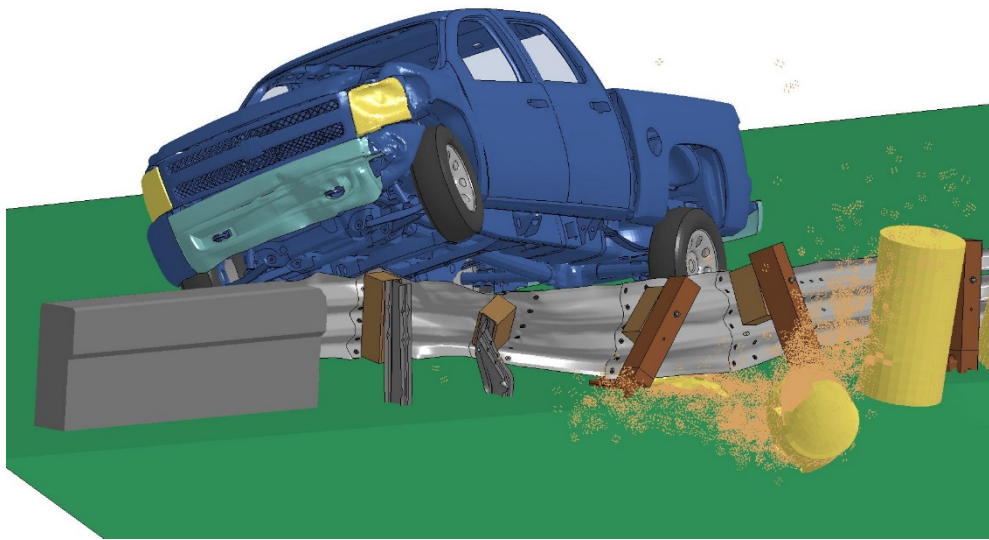
**Figure 3.21. Interaction of Truck with System.**

Figures 3.21 and 3.22 display a closer view of the interaction. The drums were removed to show the deformation between the car and the rail.

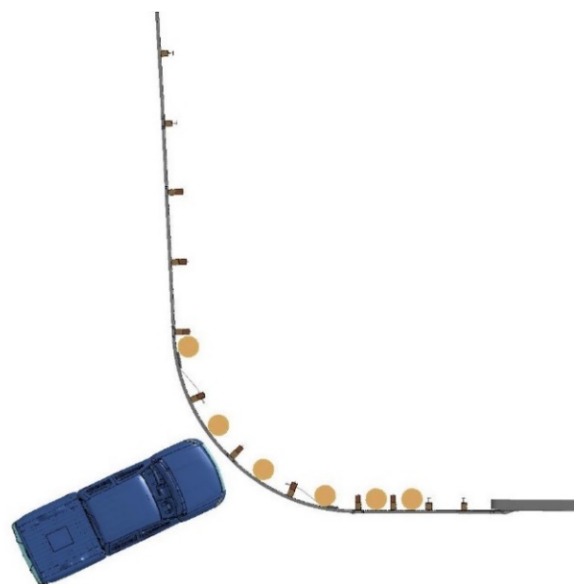
**Figure 3.23. Alignment of Truck with System.**

Figure 3.23 presents the system layout used for the following simulation. The system includes two short cables and six drums spread along the rail. One of the cables is placed on the primary roadway between posts 12 and 13. It is attached to the thrie beam and terminates at post 12 at an angle. The second short cable is placed on the secondary roadway between posts 9 and 10. It is attached to the thrie beam and terminates at post 10. The six drums are placed between posts 9 through 15. Only one drum is placed between each post.

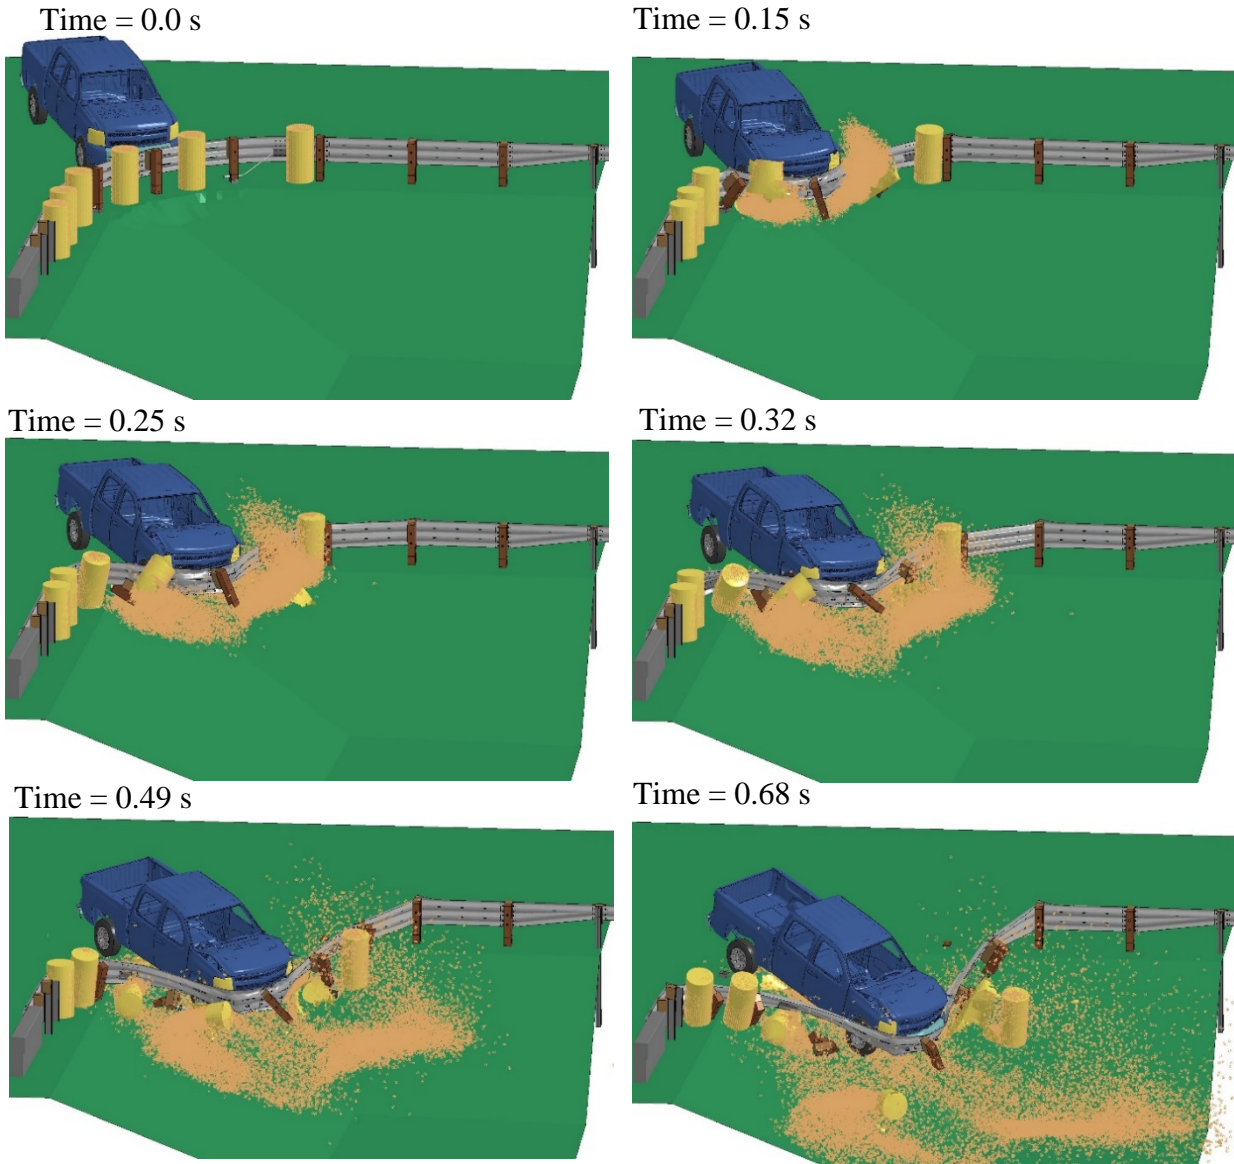
**Figure 3.24. Sequential Images of Truck Simulation with Two Tension Cables and Six 700-lb Sand Drums.**

Figure 3.24 shows the sequential images of the simulation. In this simulation, the truck did not override the system. At 0.68 s, six of the wood posts broke and most of the drums dispersed the sand they were containing.

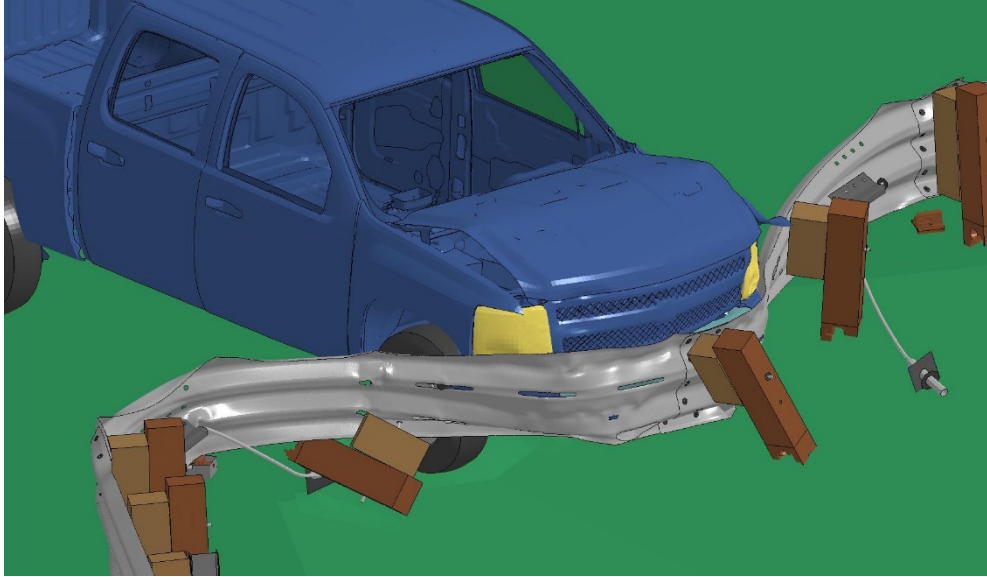
**Figure 3.25. Interaction of Truck with System (No Drums Visible).**

Figures 3.25 and 3.26 are a closer view of the simulation. The drums were removed to show the deformation of the car and guardrail.

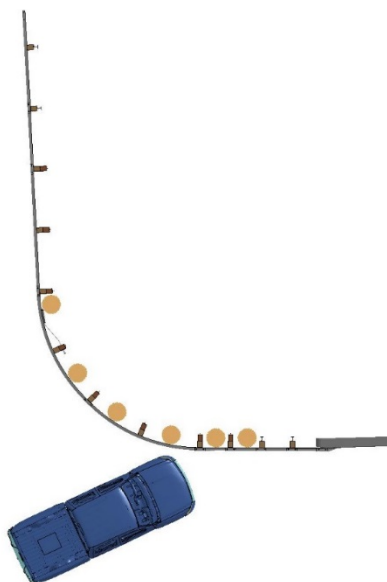
**Figure 3.27. Alignment of Truck with System.**

For the following simulation, the truck was placed at a different position in the system. Figure 3.27 displays the system used and the alignment of the truck to the system. For this system, the cable from the previously described system was removed. The truck is still at a 25° angle from the guardrail system, but this time it is impacting the guardrail system on the primary roadway.

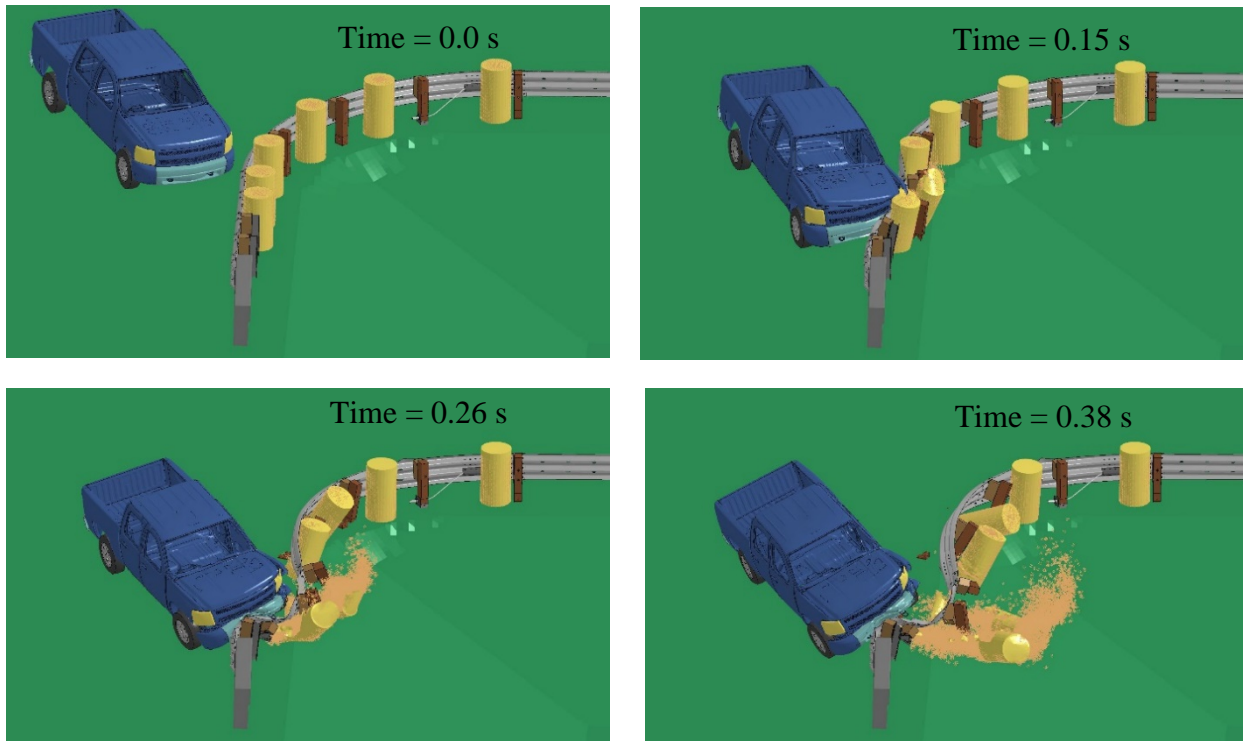
**Figure 3.28. Sequential Images of Truck Simulation with Tension Cable and Six 700-lb Sand Drums.**

Figure 3.28 shows the sequential images of the simulation. At 0.15 s, the truck has impacted the rail. The last image shows that the truck was not redirected away from the system. Instead, the front of the truck began to override the rail.

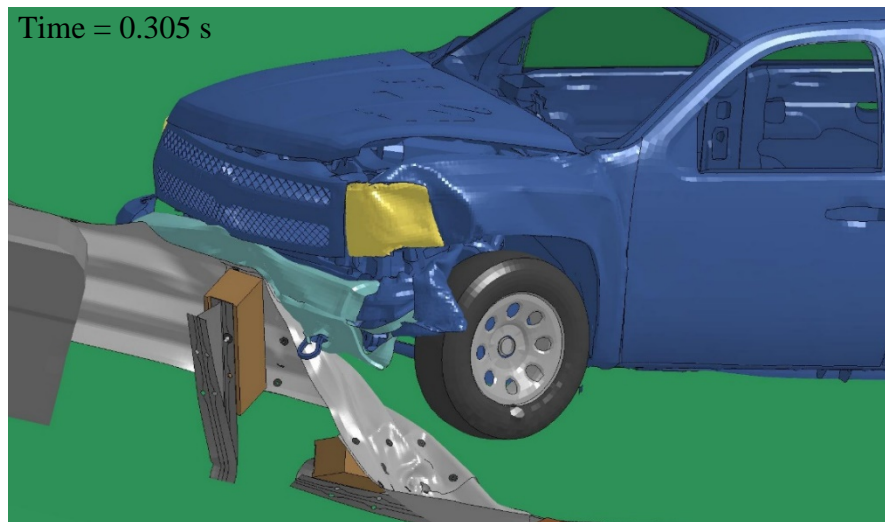
**Figure 3.29. Interaction of Truck with System (No Drums Visible).**

Figures 3.29 and 3.30 show a close view of the deformation between the truck and the guardrail system. These two figures show different views of the truck at certain points in the simulation. As seen below, at approximately 0.3 s the front of the truck is lifted up. The drums were removed for clarity.

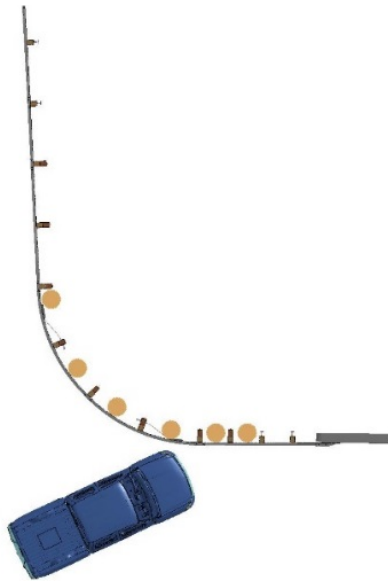
**Figure 3.31. Alignment of Truck with System.**

Figure 3.31 displays the following system and position of the truck used for this simulation. Since the simulation described above did not satisfy the requirements, the cable was added back to the primary roadway.
