# CRASH TEST AND EVALUATION OF TL-2 SHORT RADIUS GUARDRAIL TREATMENT

**Test Report 0-6913-R1**

**TEXAS A&M TRANSPORTATION INSTITUTE  
COLLEGE STATION, TEXAS**

**TEXAS DEPARTMENT OF TRANSPORTATION**

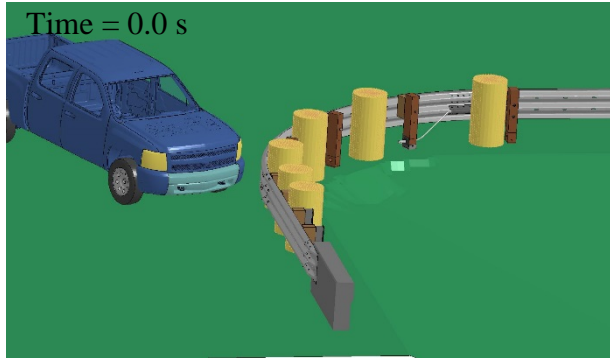
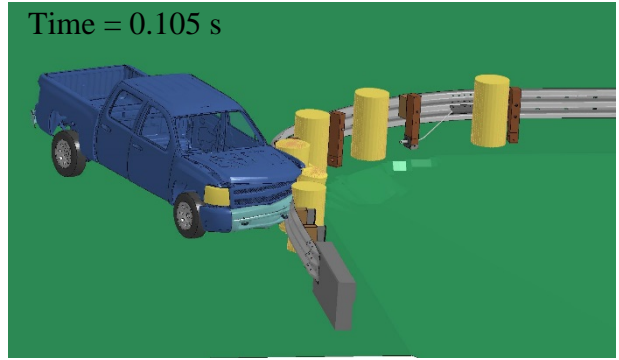
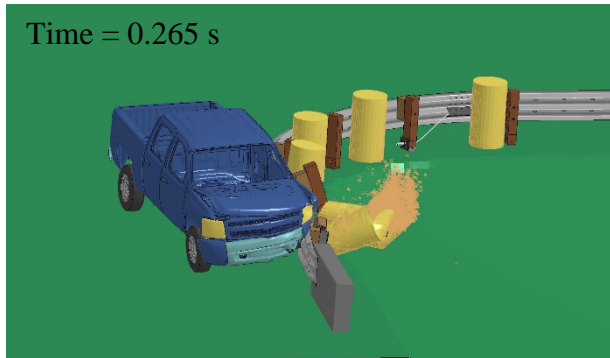
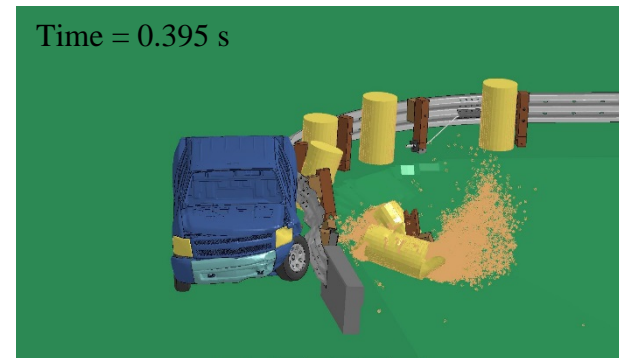
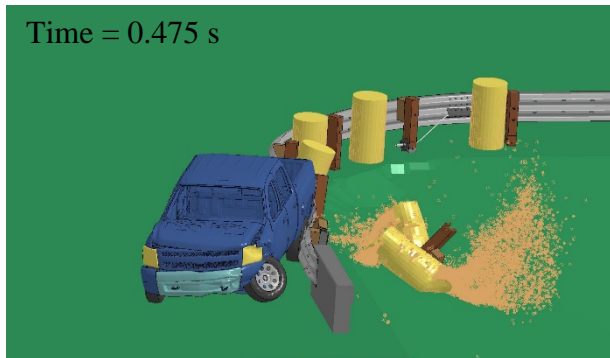
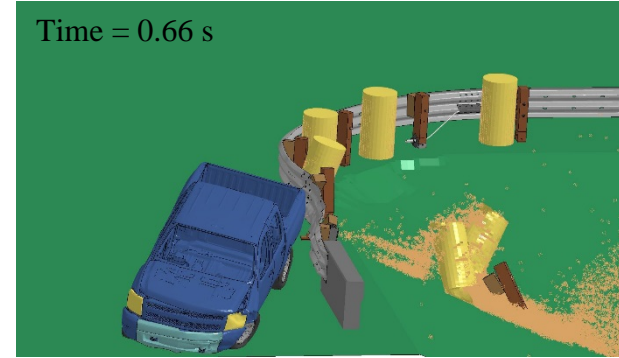
**Figure 3.32. Sequential Images of Truck Simulation with Two Tension Cables and Six 700-lb Sand Drums.**

Figure 3.32 shows the sequential images of this simulation. At 0.105 s, the truck pushed the rail into the interior of the system and the front left side of the truck deformed. The cable maintained tension capacity. By 0.4 s, the truck had been redirected. At 0.475 s, the left side corner of the truck interacted with the system. The last image displays the redirected truck after its interaction with the system was complete.

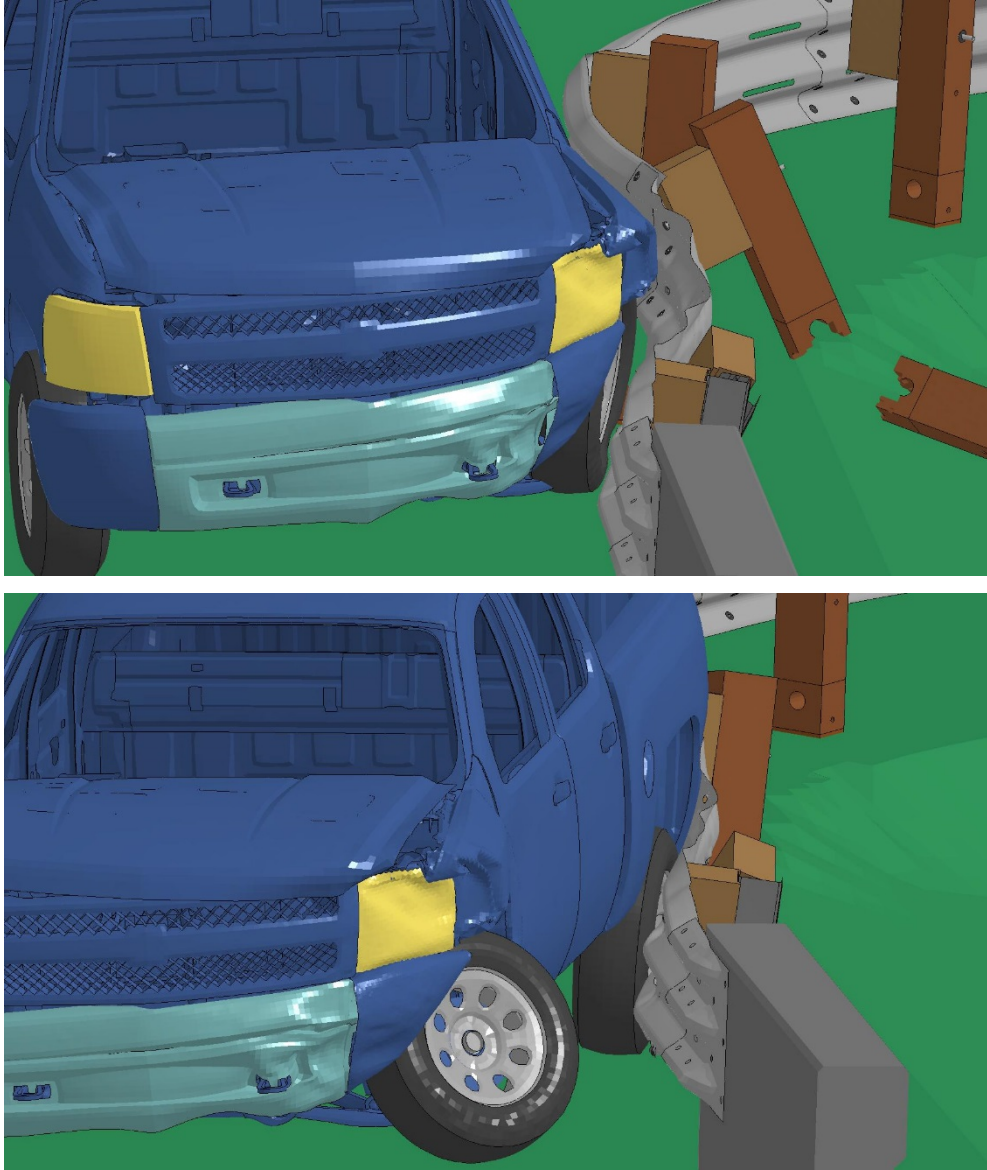
**Figure 3.33. Interaction of Truck with System (No Drums Visible).**

Figure 3.33 presents a closer view of the interaction. Deformation has occurred for both the truck and rail, leaving two broken CRT posts and one deformed steel post. The sand has been hidden from these images to better see the rail and truck.

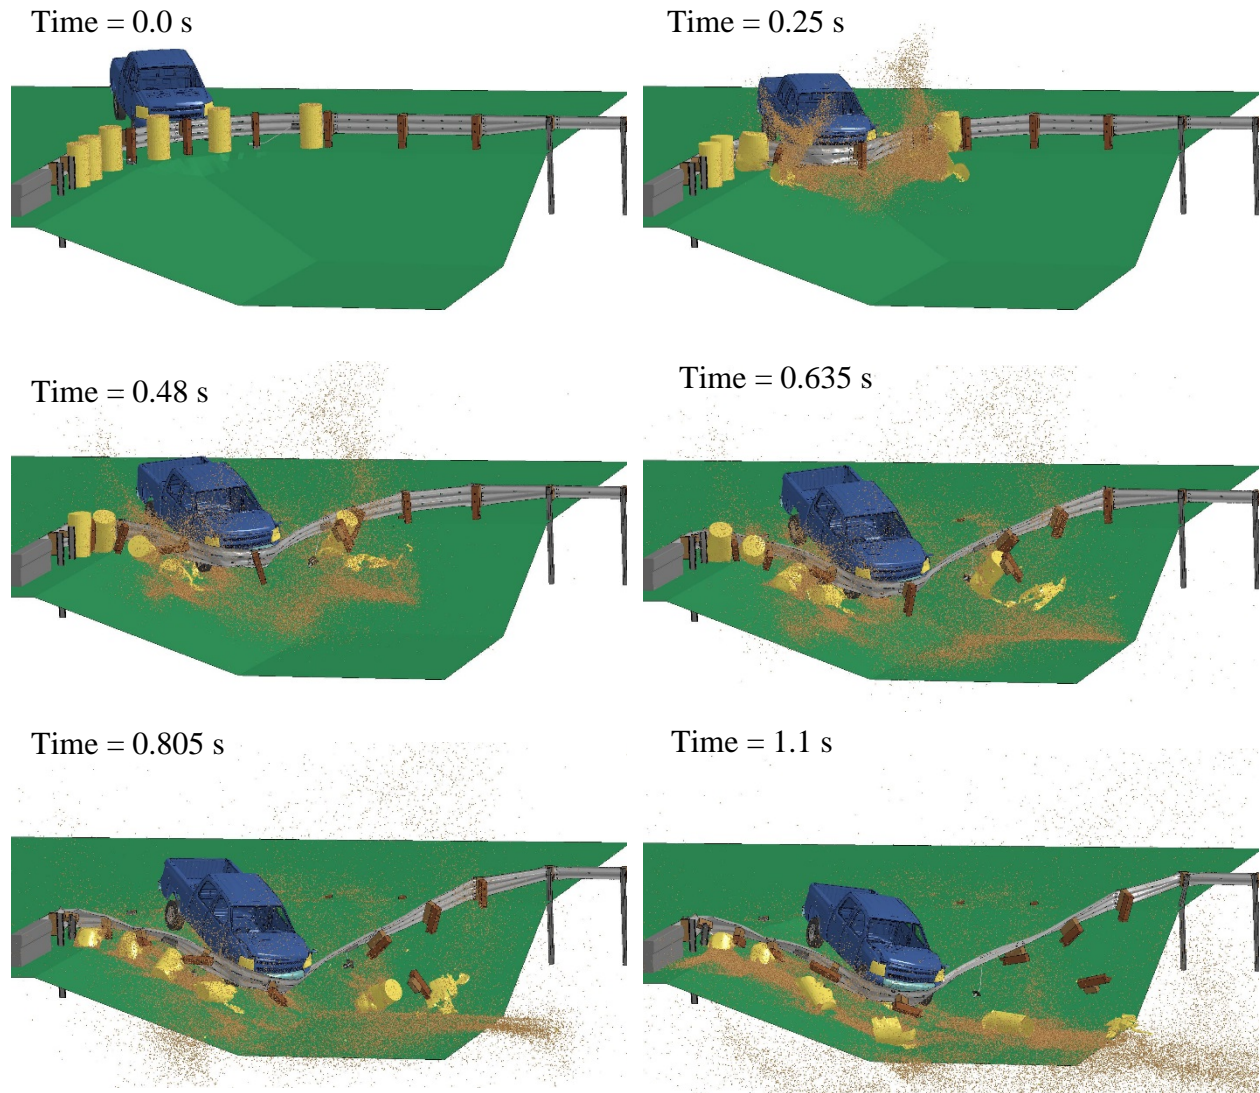
**Figure 3.34. Sequential Images of Truck Simulation with Two Tension Cables and Six 700-lb Sand Drums.**

Figure 3.34 presents the sequential images depicting the performance of the system. The first image shows the initial position of the system. At 0.25 s, four wood posts surrounding the impact area broke. The wood posts continued to break consecutively. By the end of the simulation, all of the wood posts broke and one of steel posts had significant bending while the other one still remained intact.

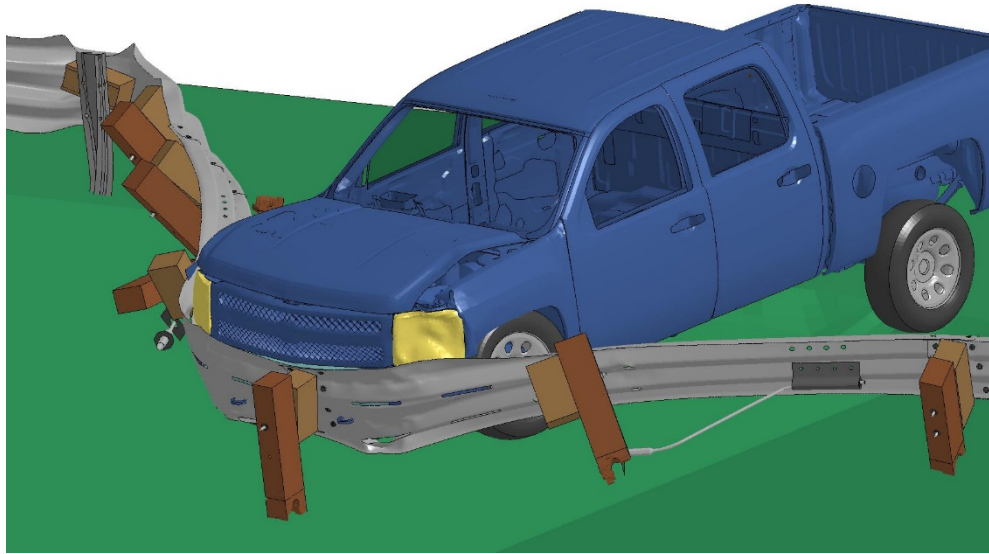
**Figure 3.35. Interaction of Simulation with System (No Drums Visible).**

Figures 3.36 and 3.36 show a closer view of the impact during the simulation and at the final state of the simulation. The drums were removed to have a clear view. Figure 3.36 displays a clear view of how the rail started to go under the front of the truck.

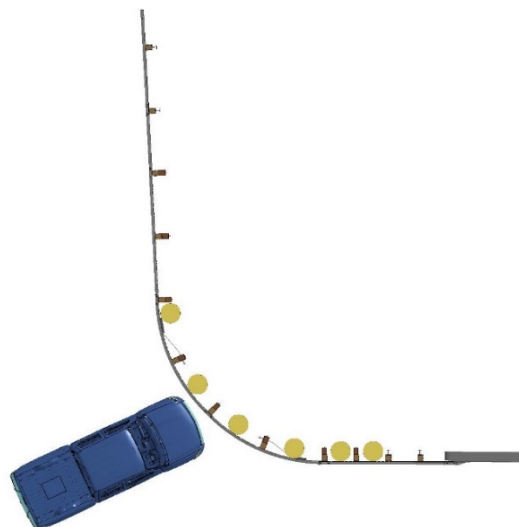
**Figure 3.37. Two Tension Cables and 700-lb Sand Drums behind Radius.**

The same guardrail system of the truck presented above is used for this simulation. The goal of this simulation is to affirm that the truck is adequately captured within an acceptable distance behind the rail. Figure 3.37 shows the guardrail system and position of the truck for the simulation.

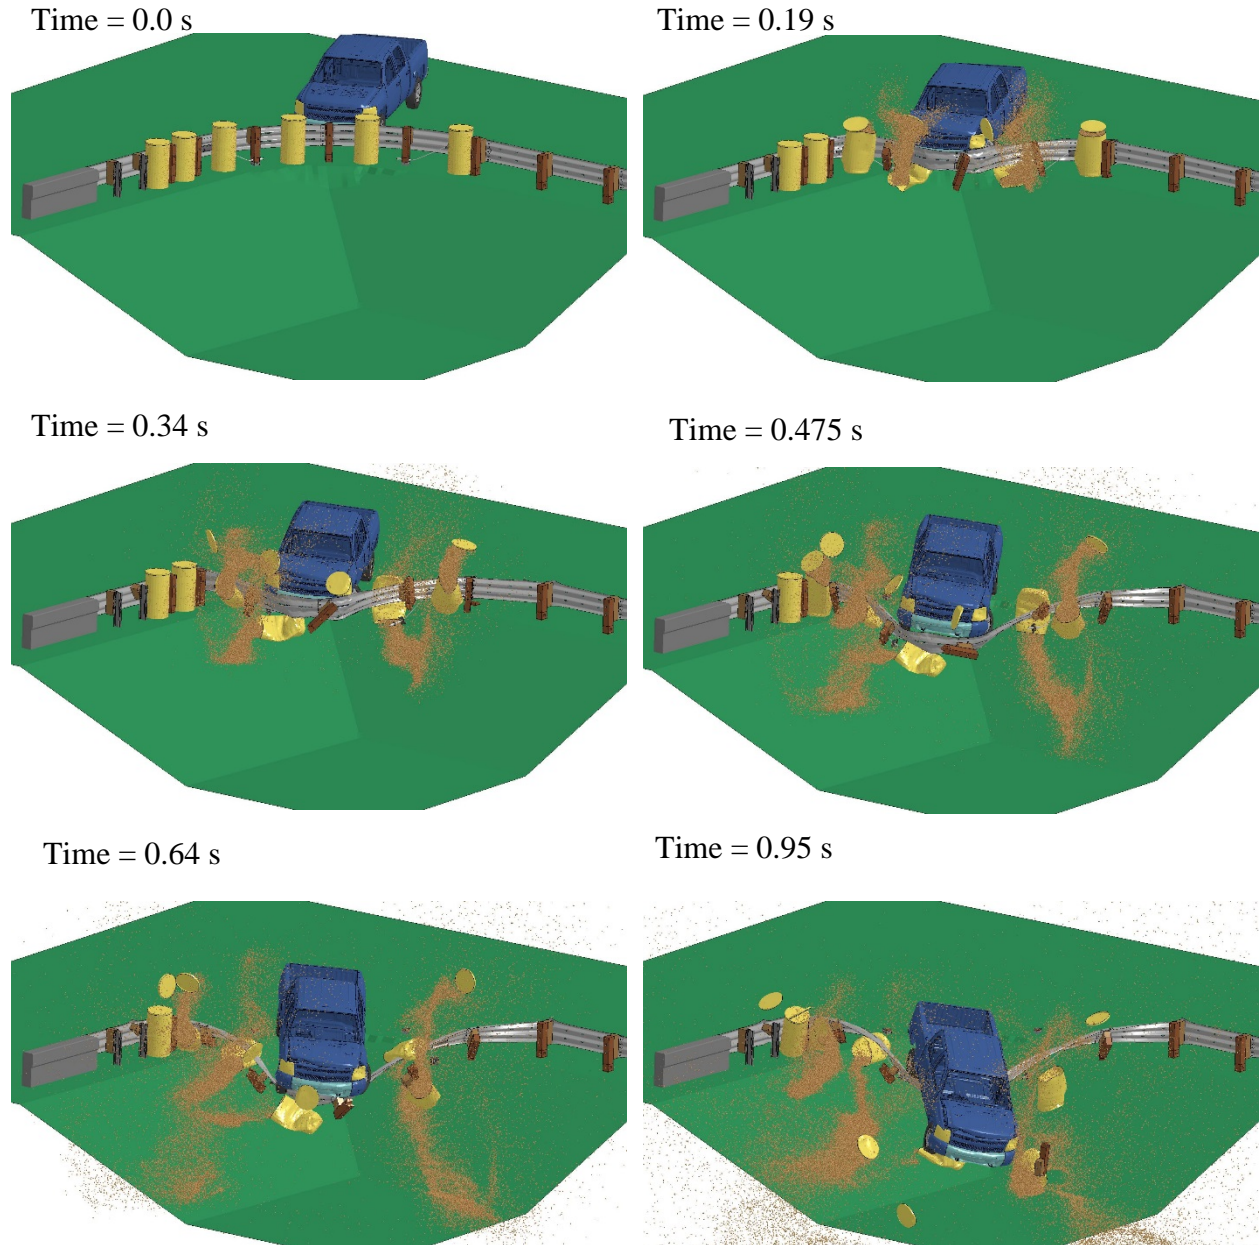
**Figure 3.38. Sequential Images of Truck Simulation with Two Tension Cables and Six 700-lb Sand Drums.**

Figure 3.38 depicts the truck throughout the simulation. The initial contact with the rail happened at 0.019 s. Before 0.20 s, two drums had dispersed the sand and two more drums were about to break as well. At approximately 0.45 s, the truck was riding up the rail. By 0.645 s, the

front two tires had completely gone over the rail. The last image shows the last state for the simulation where the truck had overridden the system.

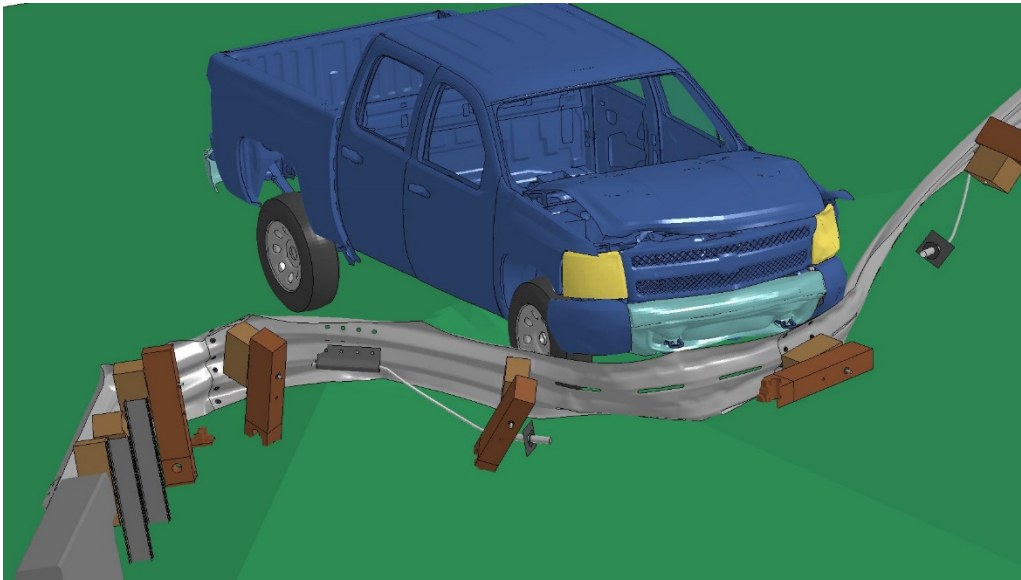
**Figure 3.39. Interaction of Truck with System (No Drums Visible).**

Figures 3.39 and 3.40 demonstrates a closer view of the truck impacting the rail. The drums were removed from the simulation to have a clear view of the deformation of the truck and the guardrail. Figure 3.39 shows approximately the time before the truck begins to ride over the rail. Figure 3.40 shows the final state of the simulation.

Time = 0.45 s

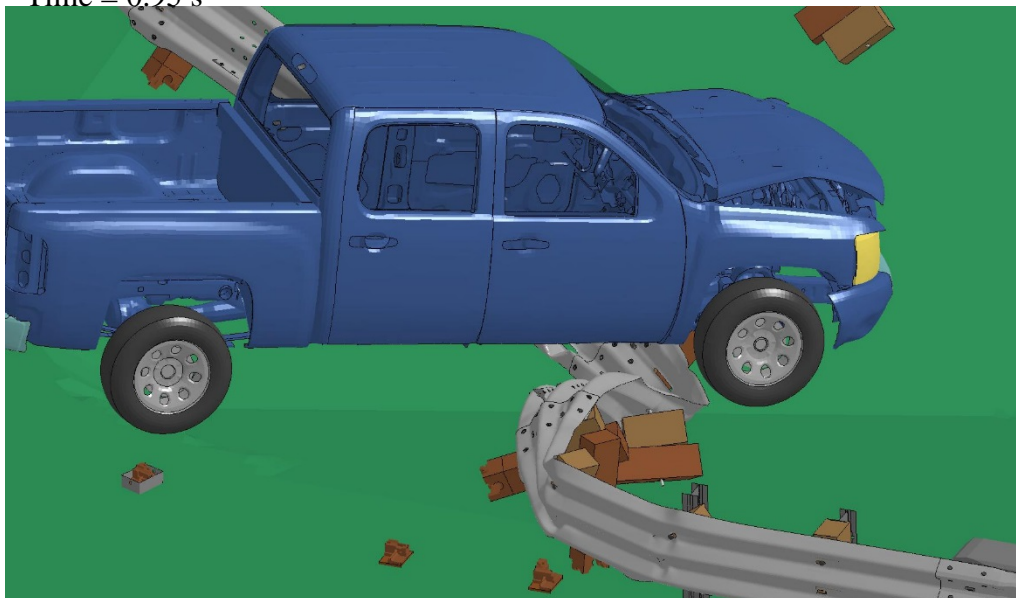
**Figure 3.40. Final State of Simulation (No Drums Visible).**

Time = 0.95 s

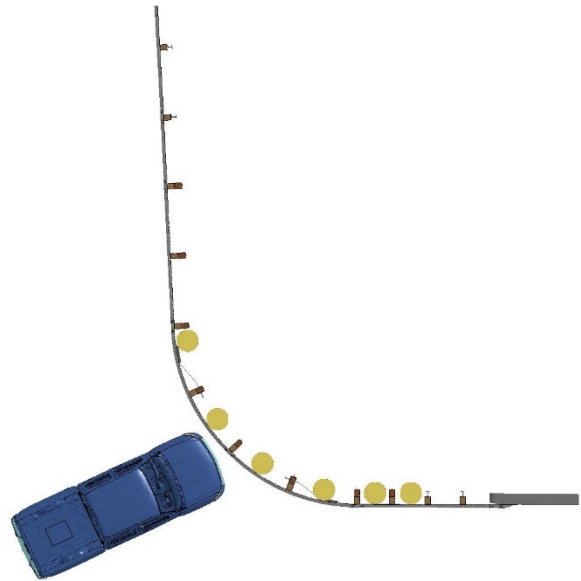
**Figure 3.41. Alignment of Truck with System.**

The same system from the above simulations of the car was used for this simulation. It includes two short cables, one on the primary roadway and the other cable on the secondary roadway. Six drums were placed between posts 9 to 15. For this case, a truck was used instead of a small car. The goal of this simulation was to affirm that the truck is adequately captured within an acceptable distance behind the rail. Figure 3.41 shows the system and position of the truck used for this case.

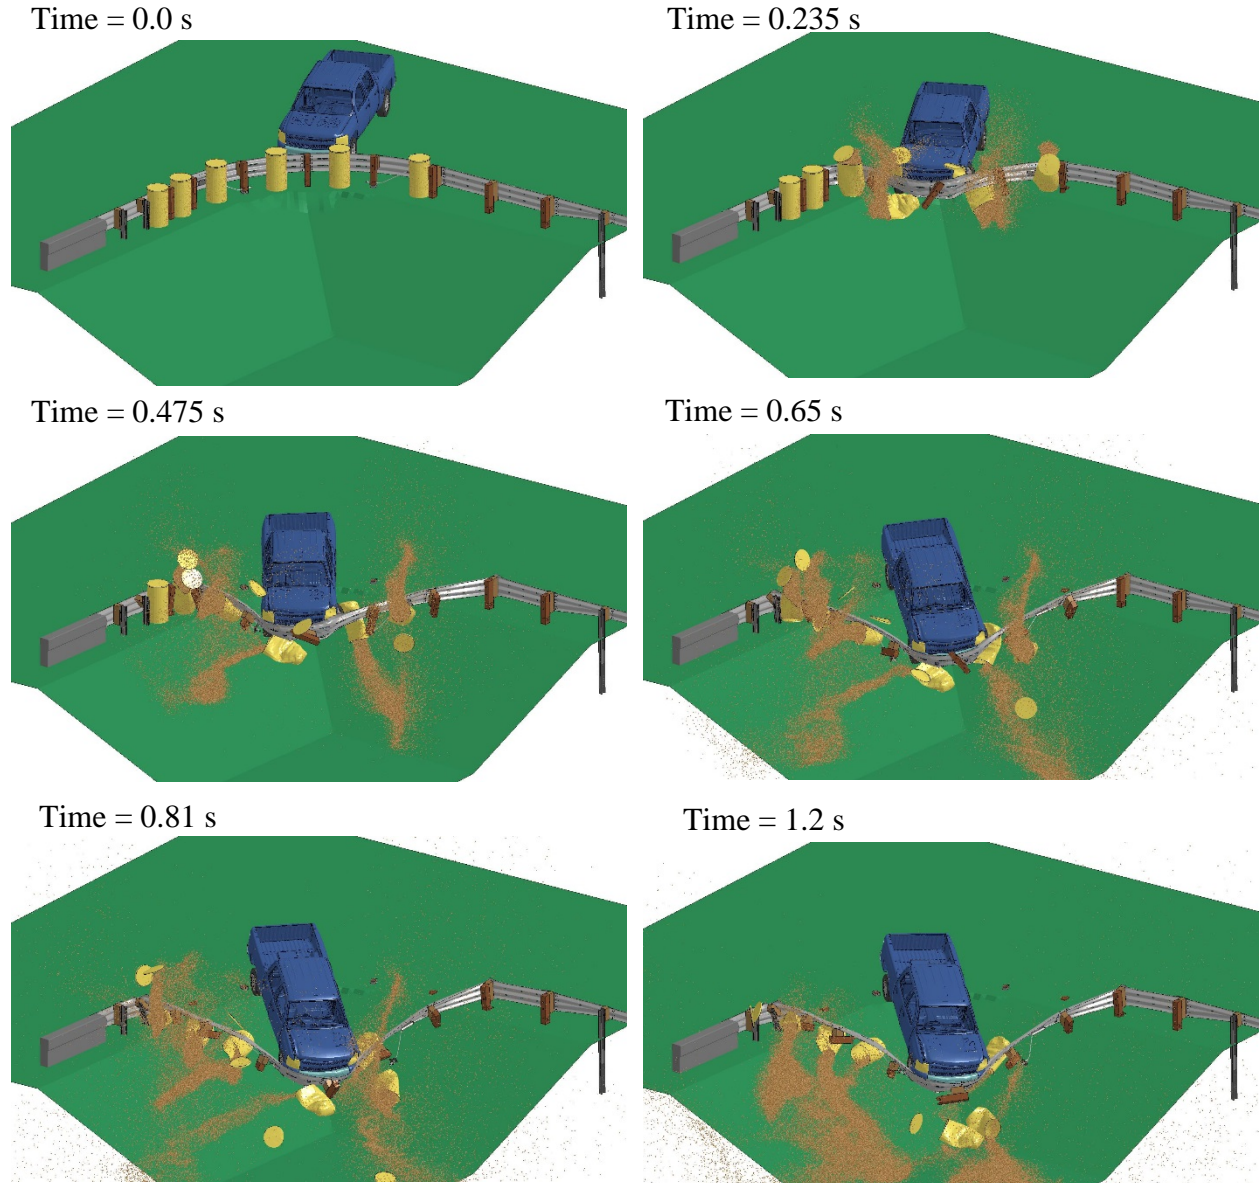
**Figure 3.42. Sequential Images of Truck Simulation with Two Tension Cables and Six 700-lb Sand Drums.**

Figure 3.42 shows the sequential images of the simulation. The first image shows the initial position of the system and is followed by four images of the truck interacting with the rail. Before 0.235 s, the guardrail system was already deforming into the ditch. The last image of the simulation shows the truck being captured by the rail.

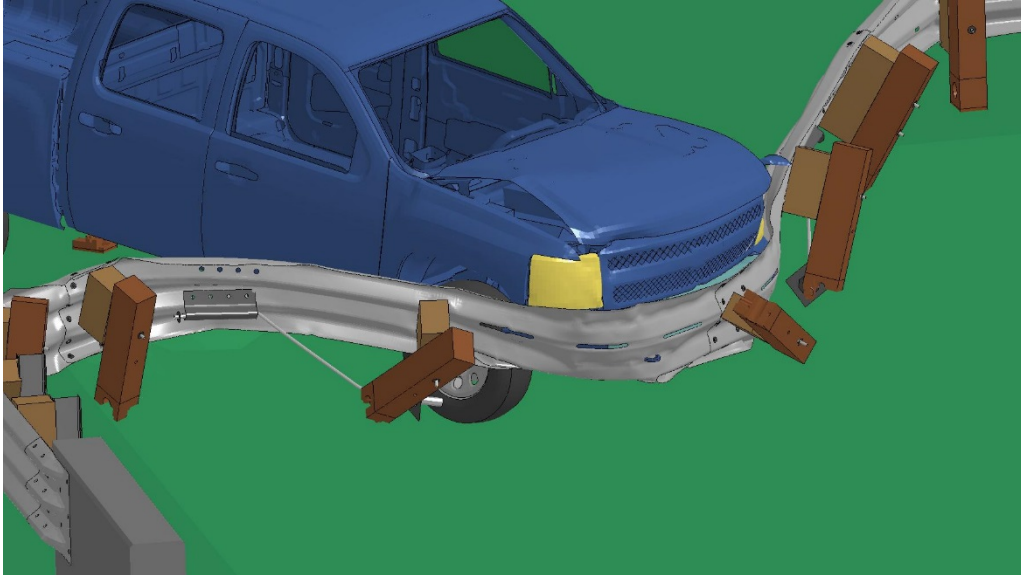
**Figure 3.43. Interaction of Truck with System (No Drums Visible).**

Figures 3.43 and 3.44 show a closer view of the deformation between the guardrail system and the truck. The drums were removed from the figures to have a clear view of the deformation.

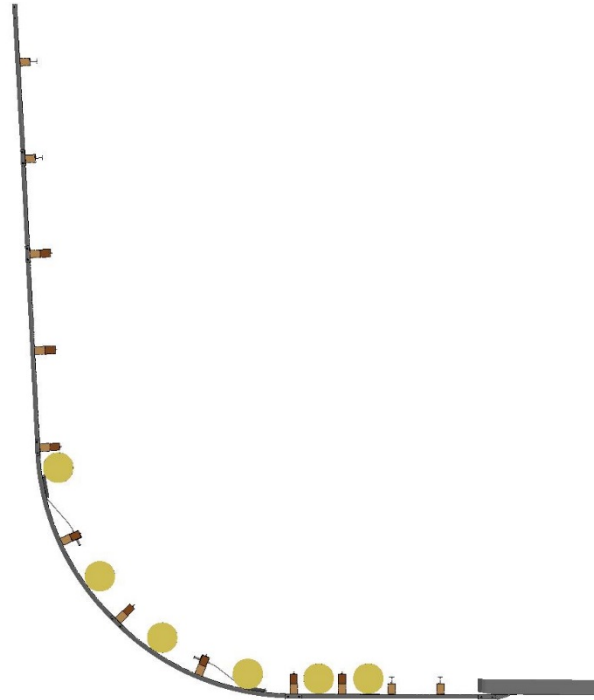
**Figure 3.45. Two Tension Cables and Six 700-lb Sand Drums behind Radius.**

Figure 3.45 presents the system layout for this simulation. The system includes two short cables and six drums spread along the rail. One of the cables was placed on the primary roadway between posts 12 and 13 at an angle; it is attached to the thrie beam and terminates at post 12. The second short cable is on the secondary roadway placed between posts 9 and 10. It is attached to the thrie beam and terminates at post 10. The drums are placed between posts 9 through 15. The drum placed between posts 9 and 10 is placed 17 inches from the center of drum to the center of post.

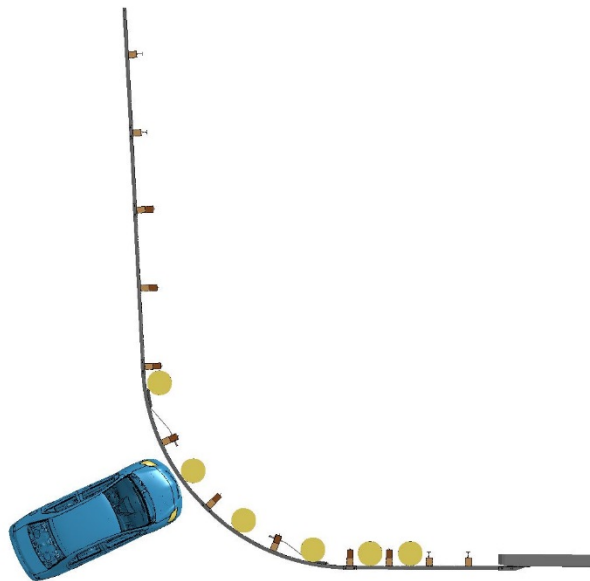
**Figure 3.46. Alignment of Car with System.**

Figure 3.46 shows the placement of the car to the guardrail system. It is set at a 25° angle heading straight toward a drum at the curved section.

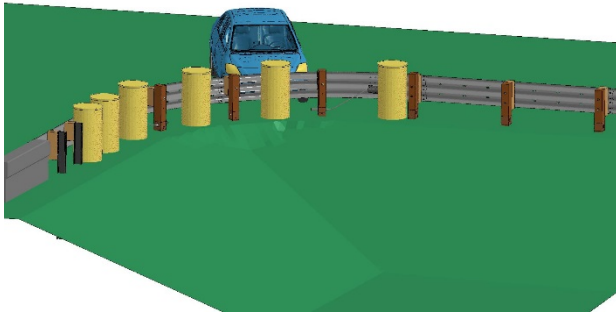
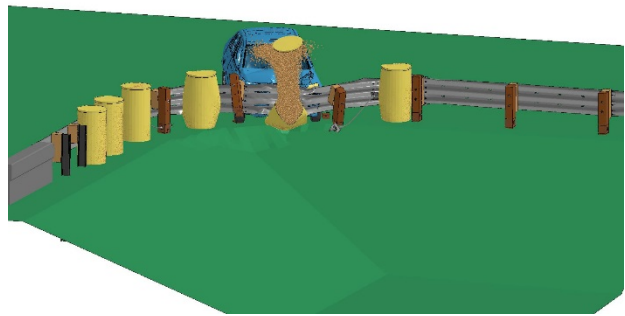
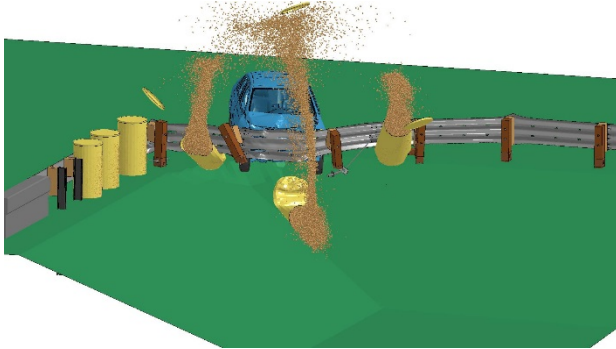
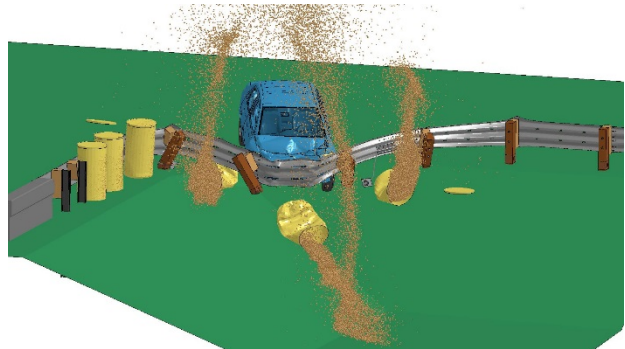
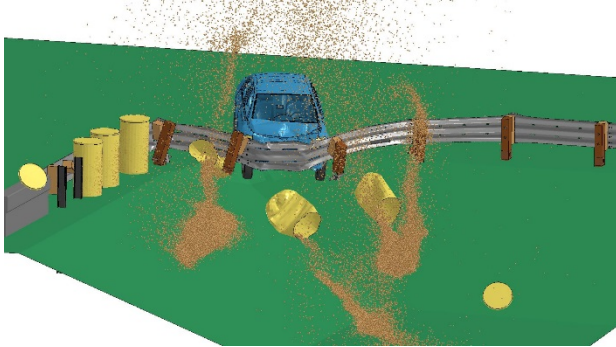
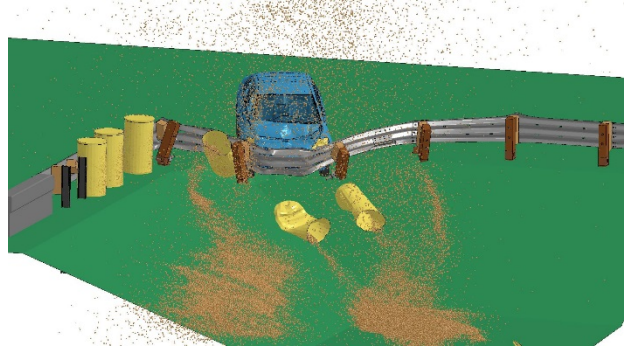
**Figure 3.47. Sequential Images of Car Simulation with Two Tension Cables and Six 700-lb Sand Drums.**

Figure 3.47 shows the sequential images throughout the simulation. The car remained stable during the simulation. The first image shows the initial position of the car and the system, and is followed by two images that depict the interaction of the car with the guardrail system and drums. At 0.27 s, the deformation from the car was present and three of the drums have broken and dispersed the sand. By 0.405 s, the car began to be captured by the rail. The last image displays the car being captured by the rail with three drums remaining intact and four out of the eight CRT posts broken.

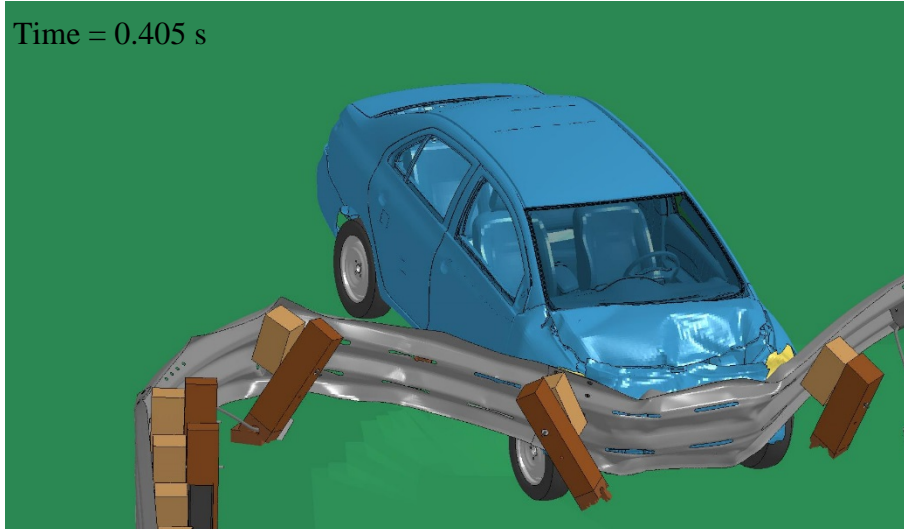
**Figure 3.48. Interaction of Car with System (No Drums Visible).**

Figures 3.48 and 3.49 display a closer view of the interaction of the car without the drums to have a clear view of the deformation between the car and the guardrail system.

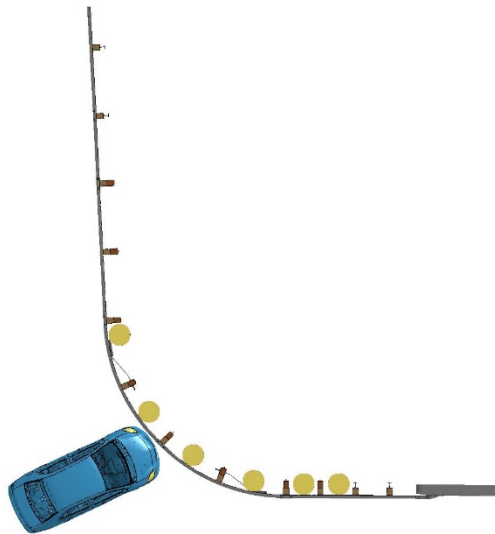
The same guardrail system from the above simulation was used. The difference in this simulation is the position of the car. It is set to hit the rail directly instead of directly into a drum. Figure 3.50 shows the system and position of the car used in this simulation.

**Figure 3.50. Alignment of Car with System.**

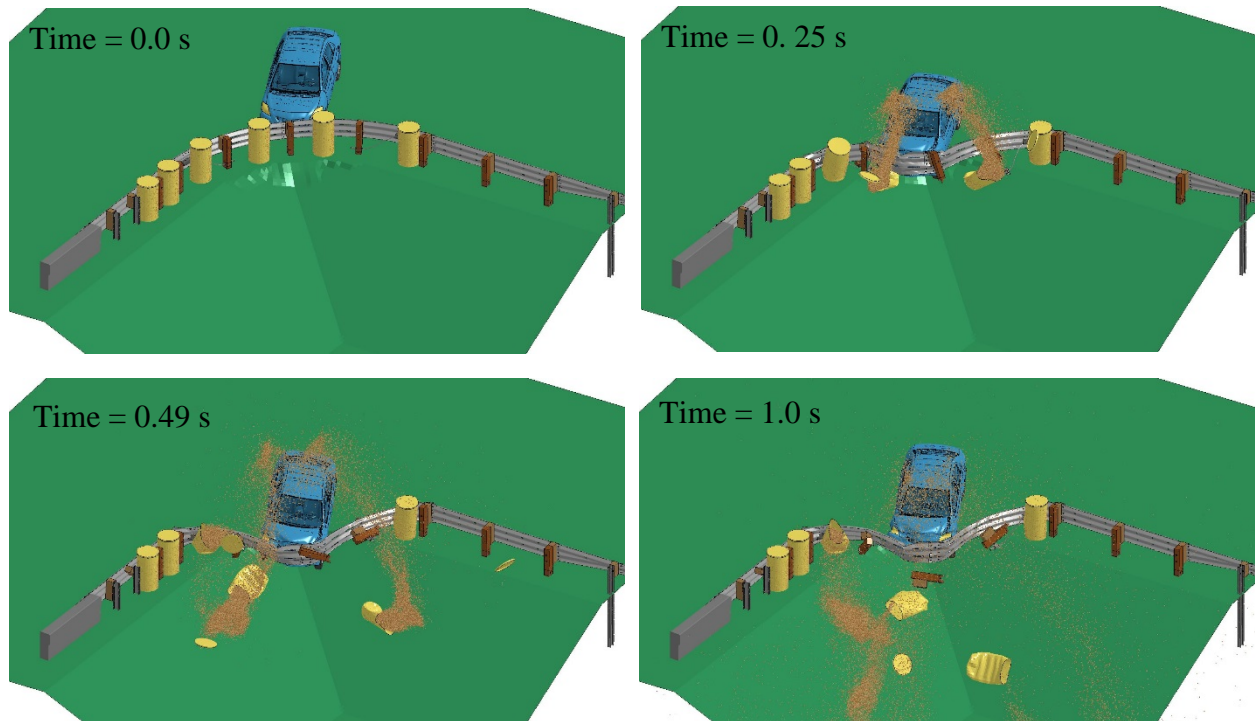
Figure 3.51 shows the sequential images of the simulation. At 0.25 s, the hood of the car impacted the rail and deformed. Also, two of the drums broke and dispersed the sand. By 0.49 s, a third sand barrel had dispersed the sand while the car was being captured by the rail. The car

reached zero velocity at approximately 0.43 s and then began to rebound. The last image displays the end state of the position of the car.

**Figure 3.51. Sequential Images of Car Simulation with Two Tension Cables and Six 700-lb Sand Drums.**

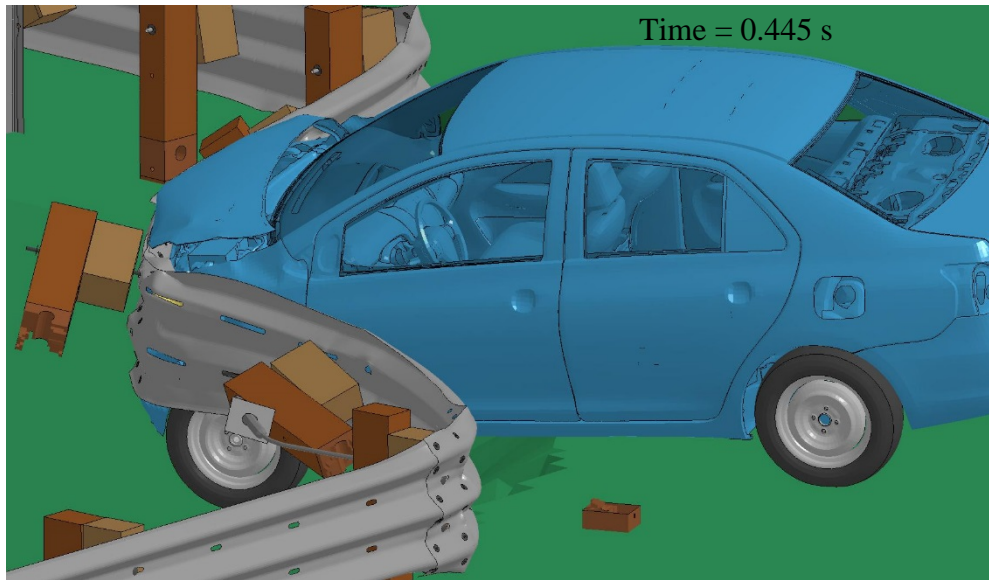
Figures 3.52 and 3.53 show a closer view of the impact between the guardrail and the car. The drums are removed to show a clear view of the deformation. Figure 3.52 shows the interaction of the rail with the car at 0.445 s, the approximate point at which the car reached zero velocity. Figure 3.53 shows the end state of the car in the simulation.

**Figure 3.52. Interaction of Car with System (No Drums Visible).**

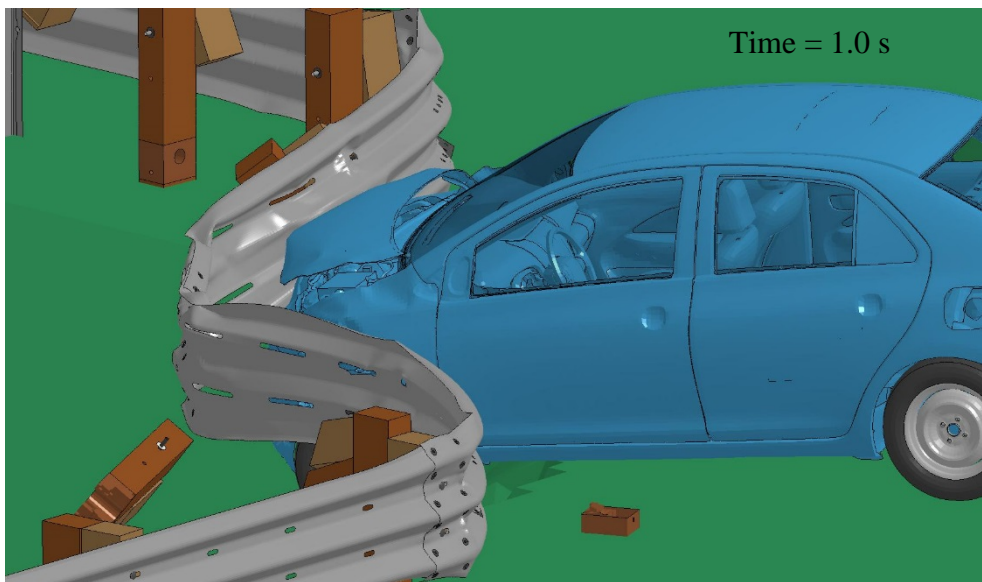
**Figure 3.53. Final State of Simulation (No Drums Visible).**

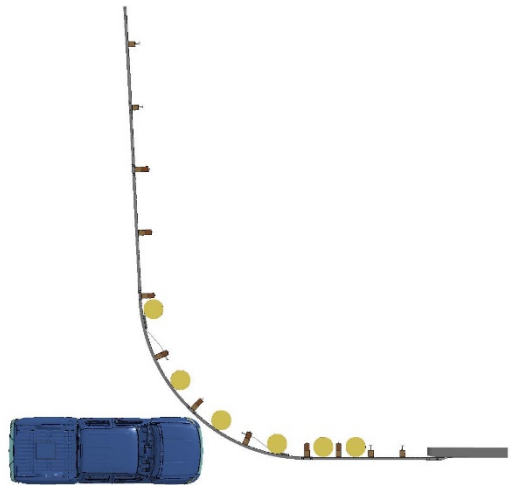
For the following test case, the truck is aligned parallel with the primary roadway. Figure 3.54 shows the system used in this simulation. The system contains two short cables and six 700-lb sand drums spread out.

**Figure 3.54. Alignment of System with Truck.**

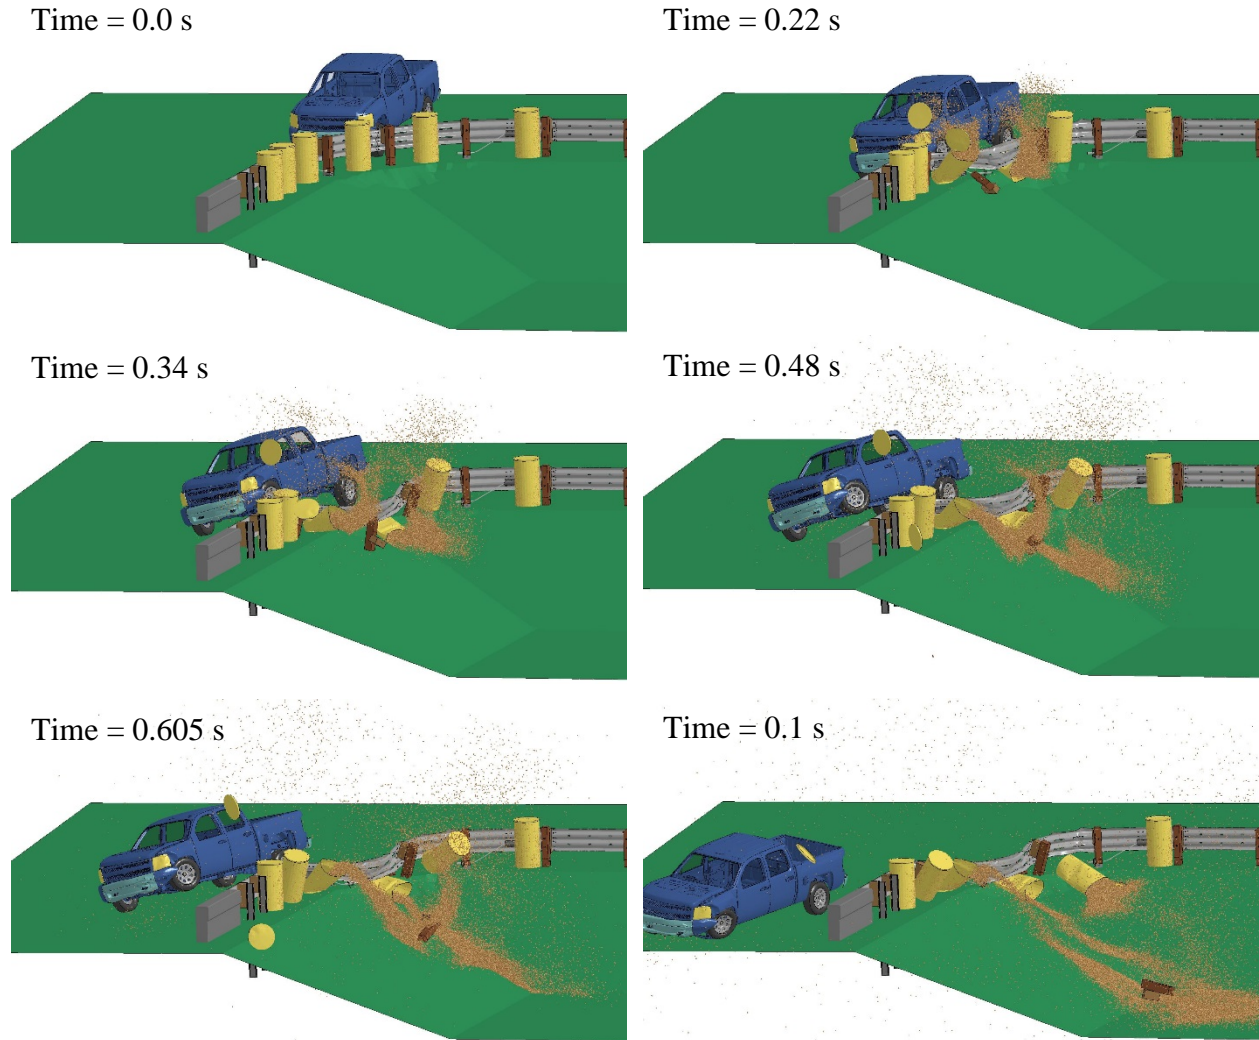
Figure 3.55 displays the truck in sequential images throughout the simulation. The first wood post at the center of the nose broke, as well as the CRT post on the primary roadway, at 0.075 s. At 0.155 s, the truck began to ride up the rail. The front left truck tire left the rail before 0.4 s, and the truck was unstable. By 0.88 s, all four tires were back on the ground.

**Figure 3.55. Sequential Images of Truck Simulation with Two Tension Cables and Six 700-lb Sand Drums.**

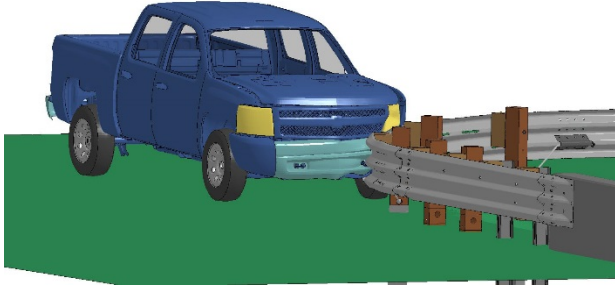
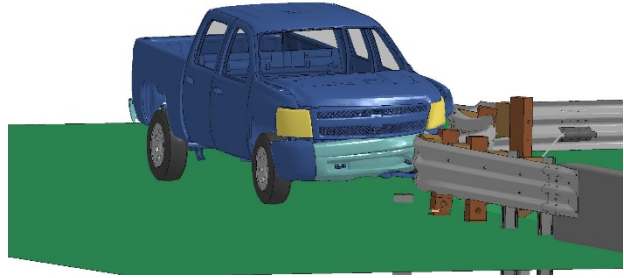
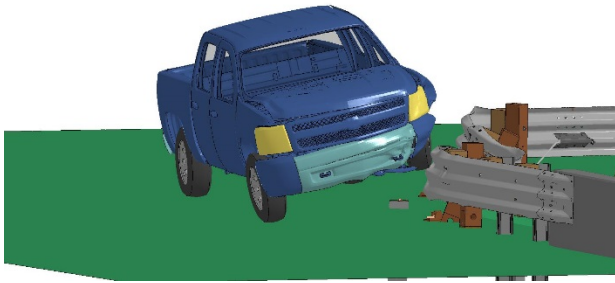
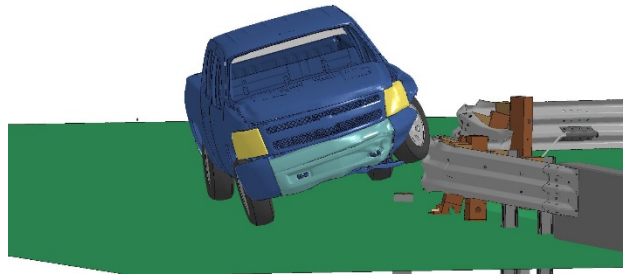
The sequential images in Figure 3.56 show the trucks interaction with the rail. The sand has been hidden from these images to better see the rail and truck interaction. Figure 3.57 displays a closer view of the interaction from the back of the rail. Figure 3.57 shows the time when the truck had already gone up the rail and its interaction with the system was complete.

**Figure 3.56. Sequential Images of Simulation from Front of Rail (No Drums Visible).**

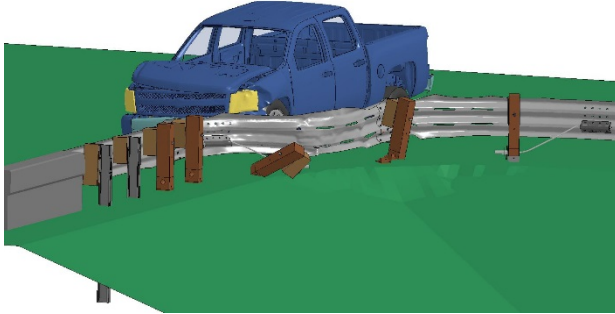
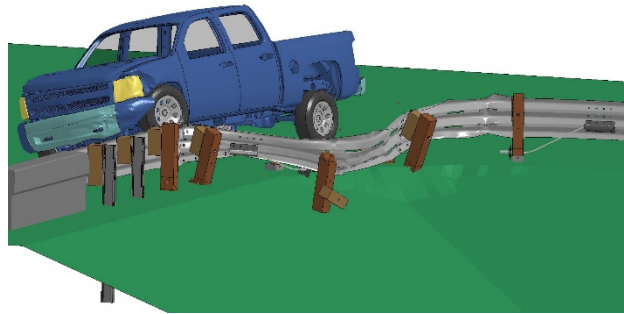
**Figure 3.57. Images of Simulation from Back of Rail (No Drums Visible).**

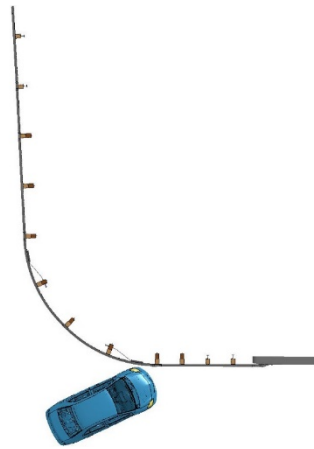
The next case involves a car impacting the same guardrail system. However, this case has the car positioned away from the center of the system and approximately 15-ft from the end of the parapet. Figure 3.58 shows the position of the car with the guardrail system. The car is still impacting the guardrail system at a 25° angle. This test was intended to evaluate the impact performance at a critical impact point where the car is being redirected. The impact point for this case is directly at a CRT post, post number 13 in the system.

**Figure 3.58. Alignment of Car with System (No Drums Visible).**

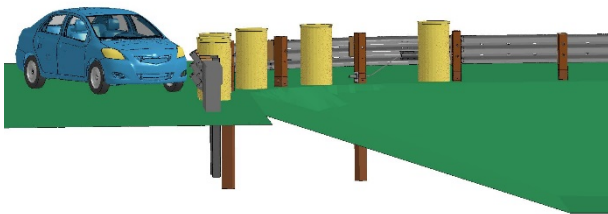
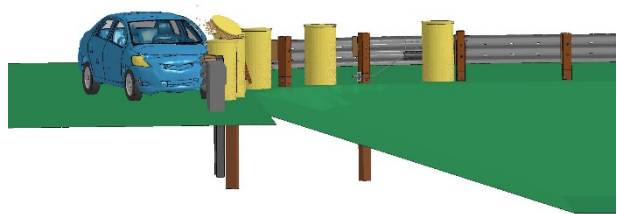
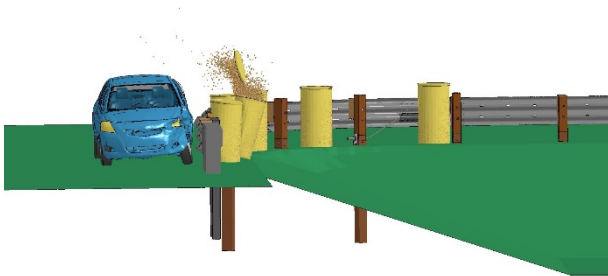
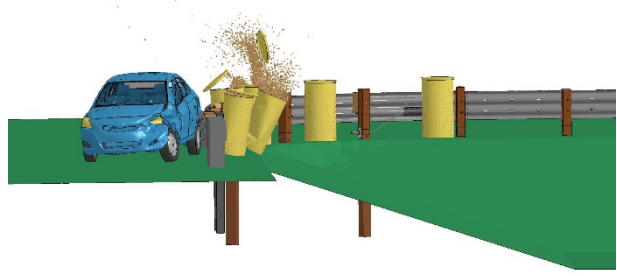
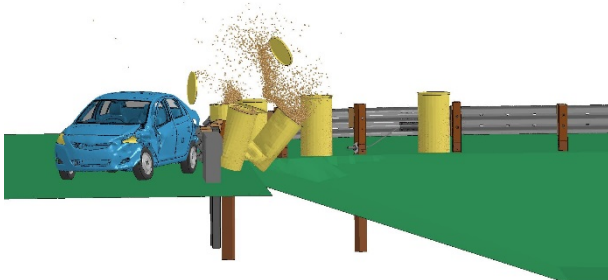
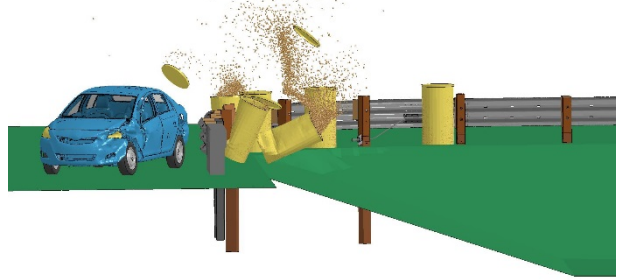
Figures 3.59 and 3.60 display the car in sequential images throughout the simulation. At 0.095 s, the driver's door had deformed and popped open when impacting with the rail. At 0.4 s, the rear right side of the car made contact with the system. After 0.43 s, the car was redirected and its interaction with the system was complete. At the end of the simulation, only two CRT post and three drums were broken. Figures 3.61 and 3.62 show a closer view of the impact between the car and the guardrail system. The drums have been removed to have a clear view. The first image shows a closer view of what is happening with the deformation. It can be seen that the door opened when impacting at this alignment.

**Figure 3.59. Sequential Images of Car Simulation with Two Tension Cables and Six 700-lb Sand Drums.**

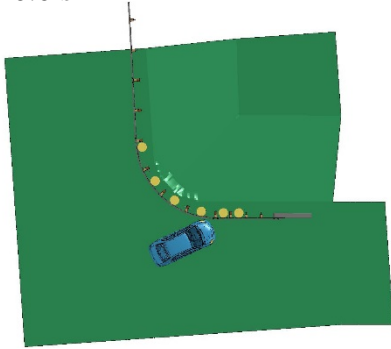
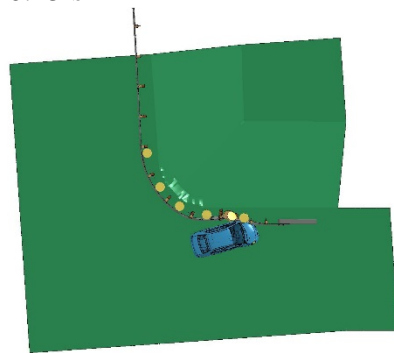
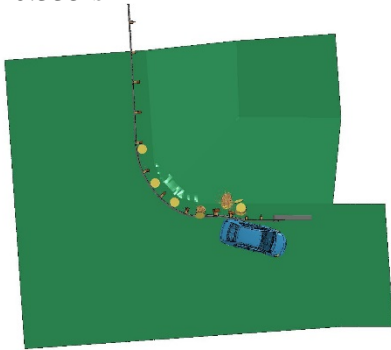
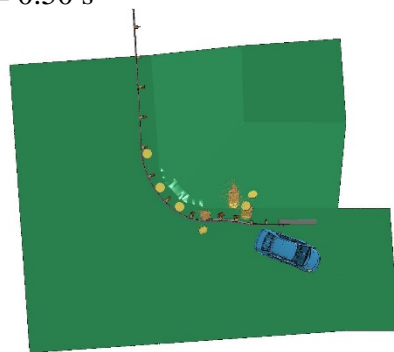
**Figure 3.60. Sequential Images of Simulation (Top View).**

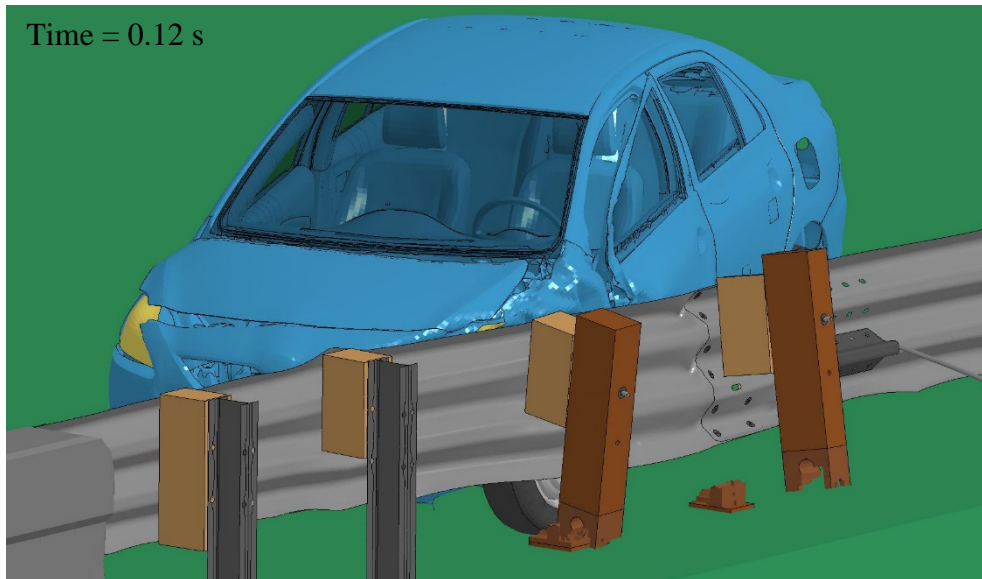
**Figure 3.61. Interaction of Car with System (No Drums Visible).**

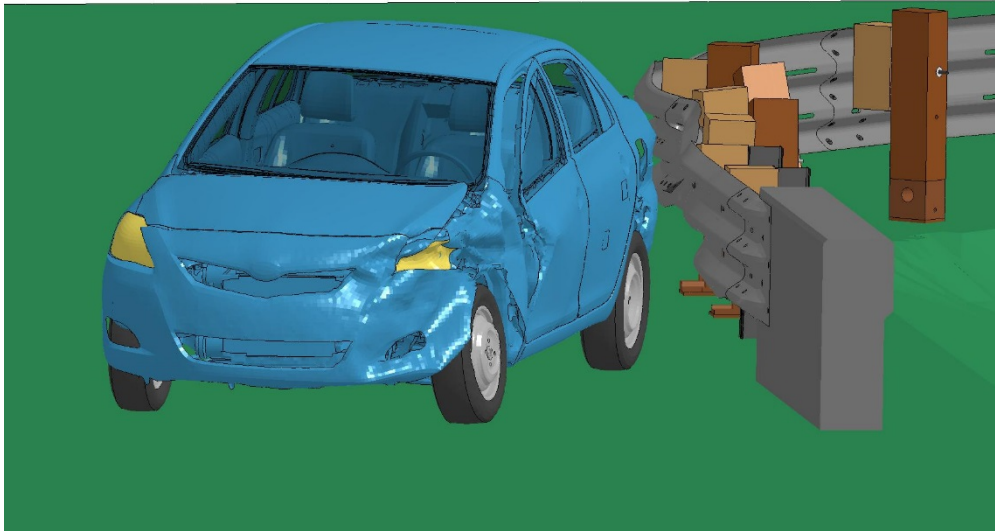
**Figure 3.62. Interaction of Car with System (No Drums Visible).**
