# CRASH TEST AND EVALUATION OF TL-2 SHORT RADIUS GUARDRAIL TREATMENT

**Test Report 0-6913-R1**

**TEXAS A&M TRANSPORTATION INSTITUTE  
COLLEGE STATION, TEXAS**

**TEXAS DEPARTMENT OF TRANSPORTATION**

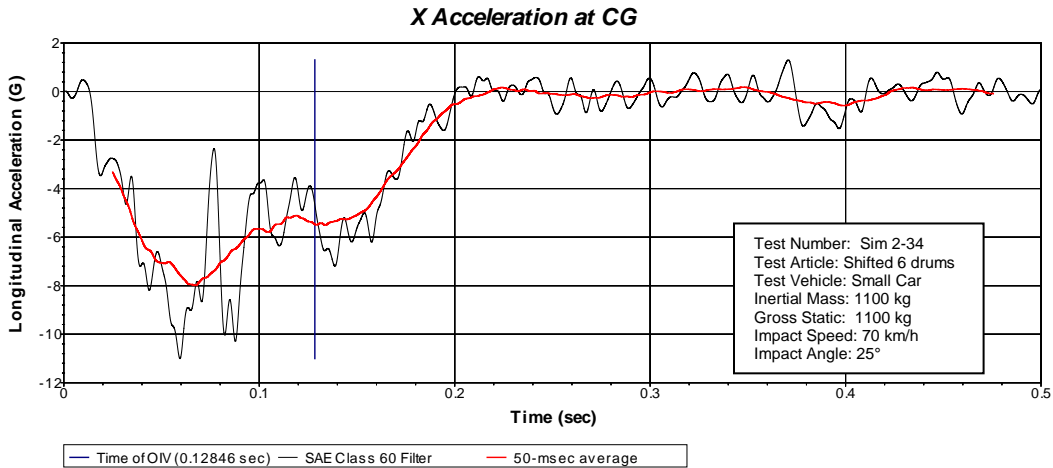
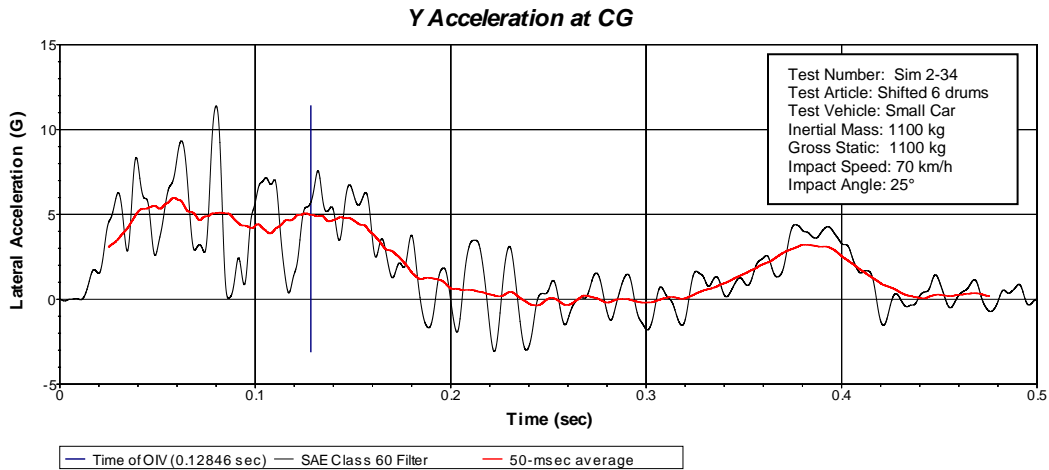
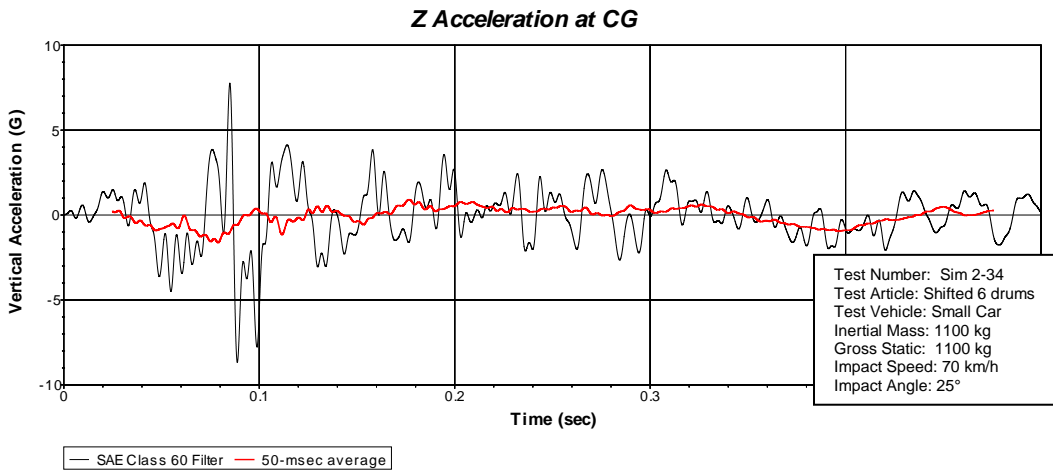
Table 3.14 shows the TRAP results of the occupant risk factor for the car simulation with two short cables and six spread out 700-lb sand drums. Figures 3.63, 3.64, and 3.65 show the longitudinal accelerations in the X, Y, and Z direction, respectively. Figure 3.66 shows the roll, pitch, and yaw angles for the simulation.

**Figure 3.63. Longitudinal Acceleration of Car Impacting Short Radius with Two Tension Cables and Six 700-Lb Sand Drums.**

**Figure 3.64. Longitudinal Acceleration of Car Impacting Short Radius with Two Tension Cables and Six 700-Lb Sand Drums.**

**Figure 3.65. Longitudinal Acceleration of Car Impacting Short Radius with Two Tension Cables and Six 700-Lb Sand Drums.**

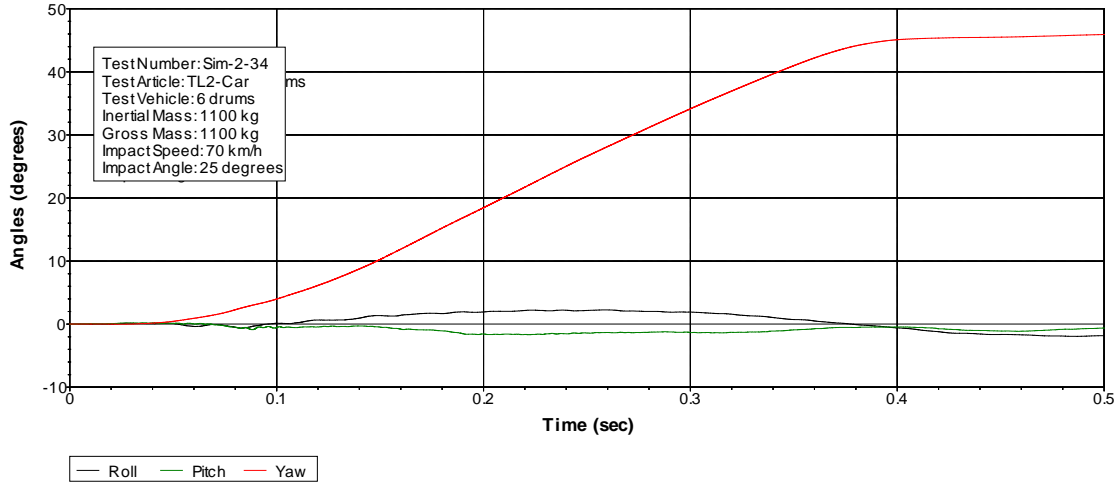
**Figure 3.66. Roll, Pitch, and Yaw Angles for the Simulation of Car Impacting Short Radius with Two Tension Cables and Six 700-Lb Sand Drums.**

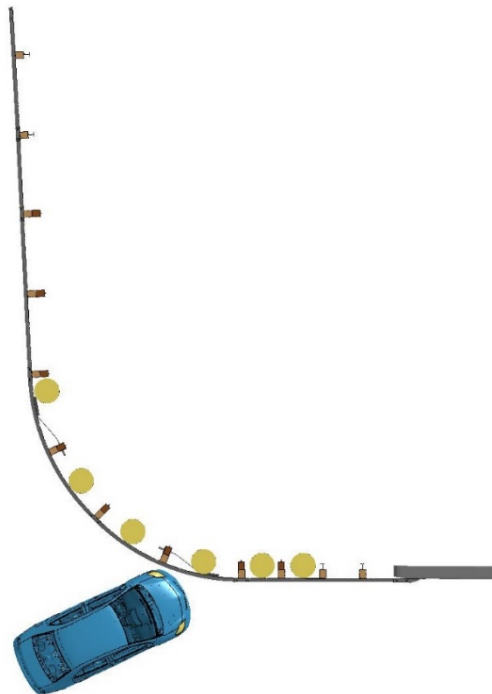
This simulation is also intended to evaluate the impact performance at a critical impact point where the car is being redirected. The only change made to this simulation is the position of the car, the guardrail system remains the same. The car was shifted 6-ft to the left from the simulation above, directly impacting the drum between posts 12 and 13. Figure 3.67 shows the alignment of the car with the system. The car impacts at a 25° angle and at a speed of 40 mph.

**Figure 3.67. Alignment of Car with System.**

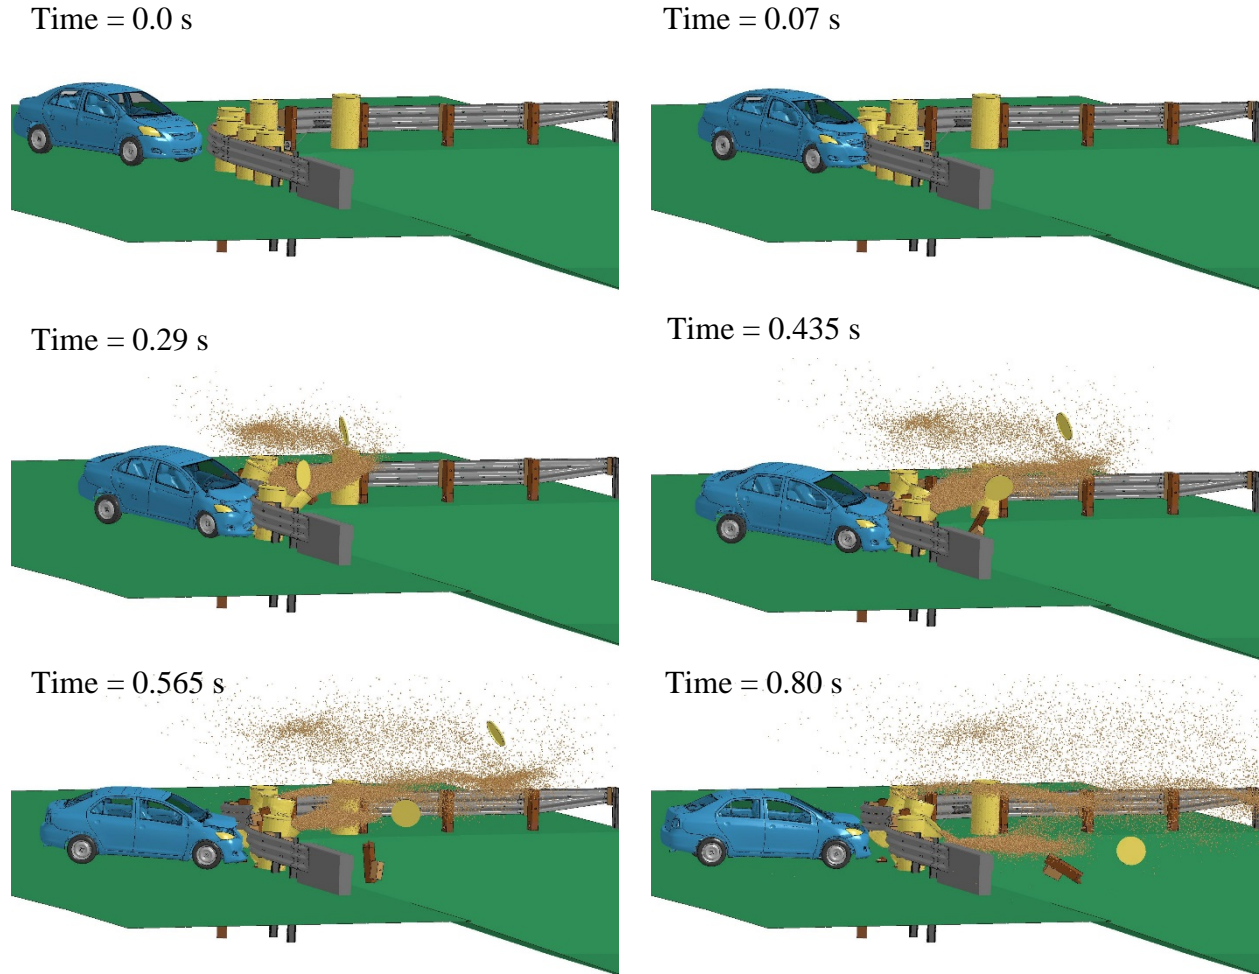
Figure 3.68 displays the sequential images for the simulation. At approximately 0.07 s, the front left corner of the car had deformed. The car continued to have contact with the rail and instead of being redirected away from the guardrail system, the car ended up perpendicular to the primary roadway.

**Figure 3.68. Sequential Images of Car Simulation with Two Tension Cables and Six 700-lb Sand Drums.**

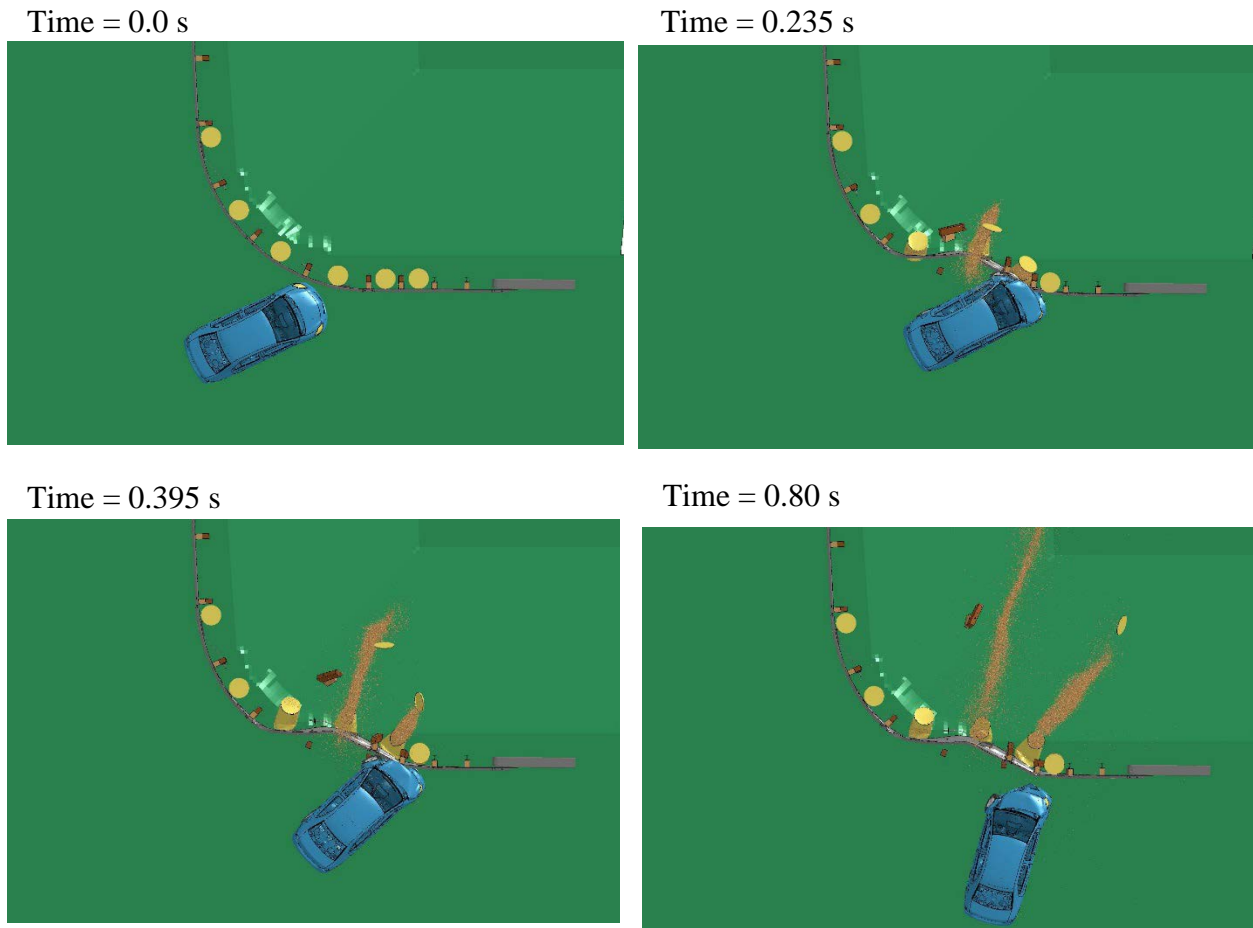
The following sequential images shown in Figure 3.69 display the top view. These images follow the position of the car from the beginning state to the final state. Figures 3.70 and 3.71 show a closer view of the deformation caused in this simulation. The drums were removed from the images to have a clear view. The first image shows that most of the damage in the car was on the front left corner of the car.

**Figure 3.69. Sequential Images of Simulation (Top View).**

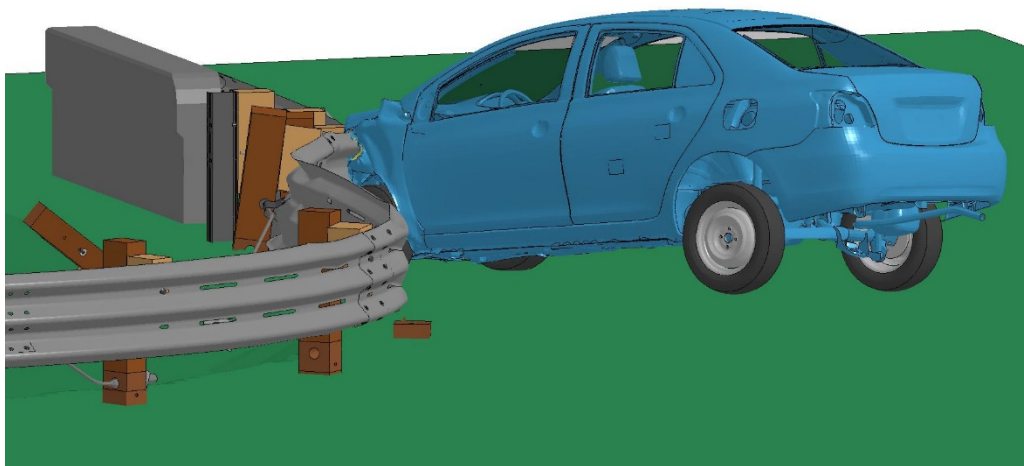
**Figure 3.70. Interaction of Car with System (No Drums Visible).**

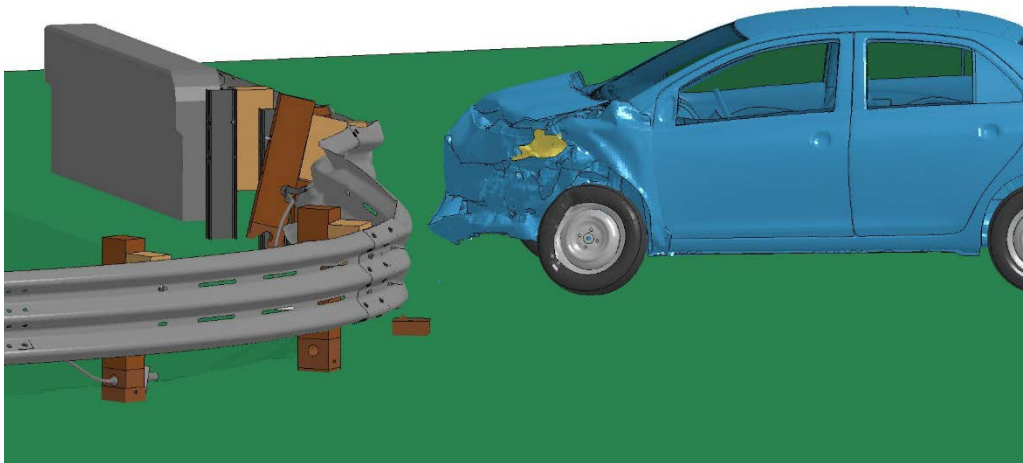
**Figure 3.71. Final State of Simulation (No Drums Visible).**

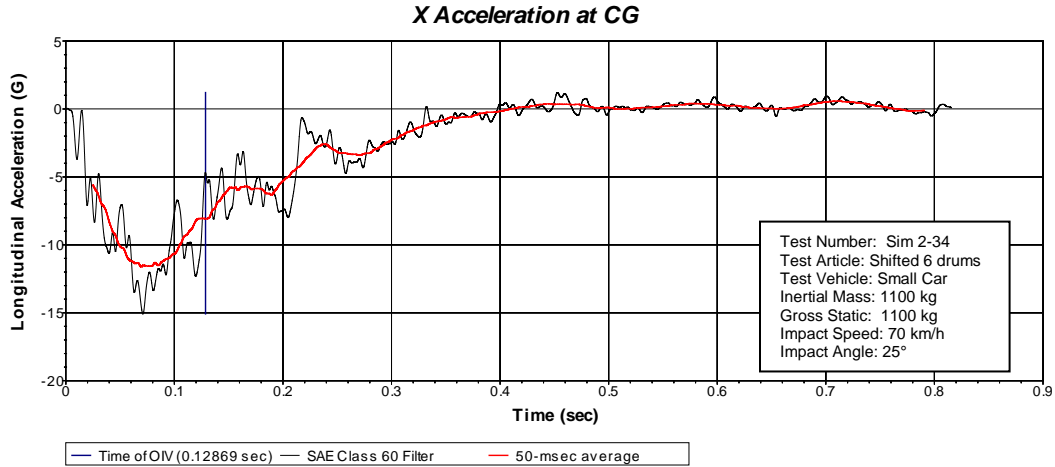
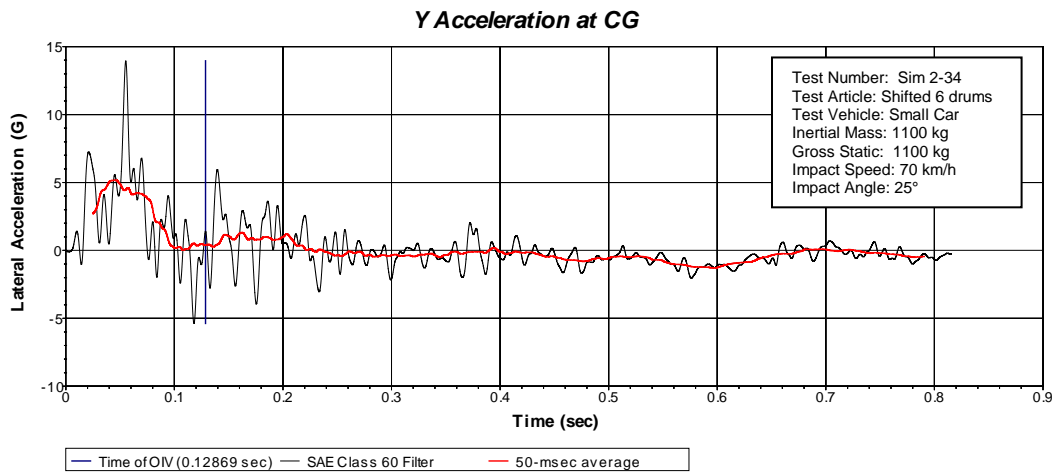
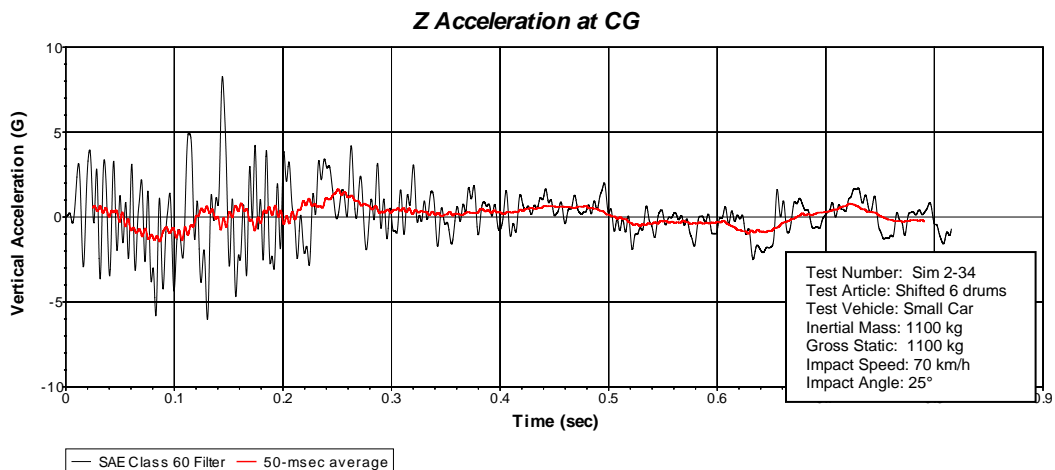
Table 3.15 shows the TRAP results of the occupant risk factor for the car simulation with two short cables and six spread out 700-lb sand drums. Figures 3.72, 3.73, and 3.74 show the longitudinal accelerations in the X, Y, and Z direction, respectively. Figure 3.75 shows the roll, pitch, and yaw angles for the simulation.

**Figure 3.72. Longitudinal Acceleration of Car Impacting Short Radius with Two Tension Cables and Six 700-Lb Sand Drums.**

**Figure 3.73. Longitudinal Acceleration of Car Impacting Short Radius with Two Tension Cables and Six 700-Lb Sand Drums.**

**Figure 3.74. Longitudinal Acceleration of Car Impacting Short Radius with Two Tension Cables and Six 700-Lb Sand Drums.**

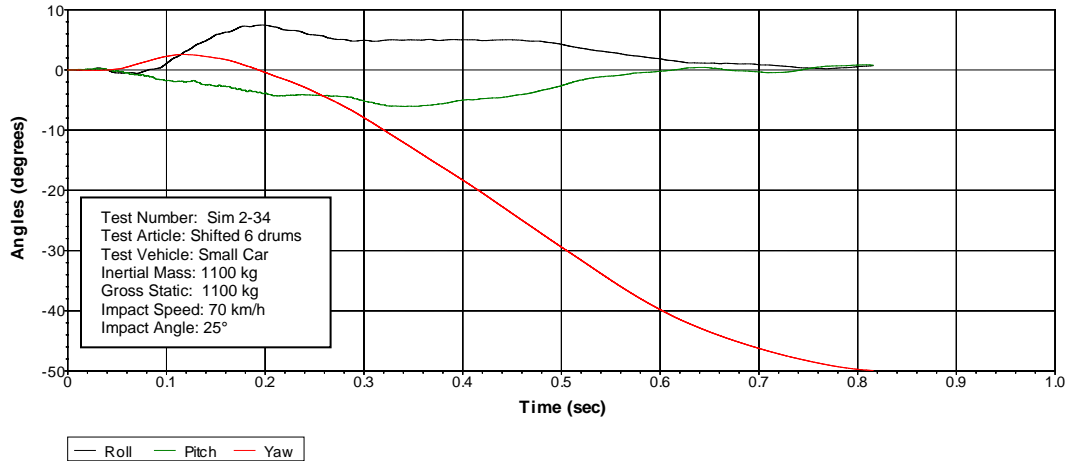
**Figure 3.75. Roll, Pitch, and Yaw Angle of Car Impacting Short Radius with Two Tension Cables and Six 700-Lb Sand Drums.**

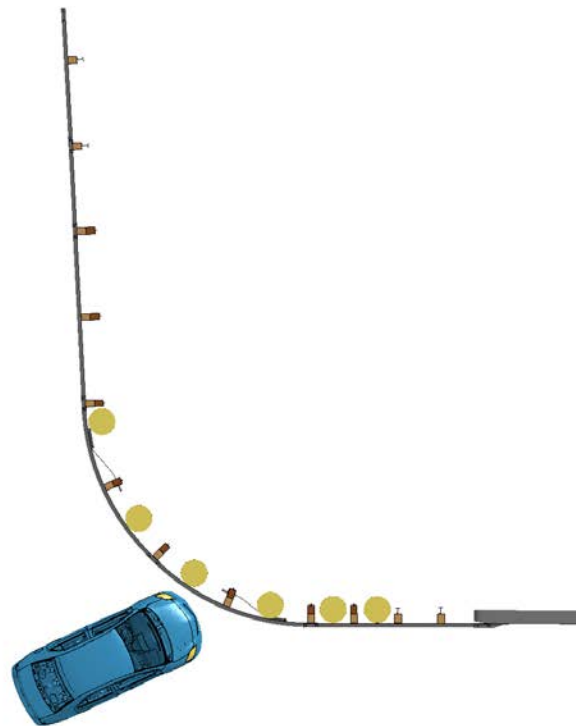
This simulation shared the intent of the previous two simulations: locating the critical impact point. The guardrail system was the same, but the car was shifted 6-ft to the left relative to the previous simulation. The front left corner of the bumper is positioned to impact the center of a drum, positioned between posts 11 and 12. Figure 3.76 shows the alignment of the car with the system. The car impacts at a 25° angle and at a speed of 40 mph.

**Figure 3.76. Alignment of Car with System.**

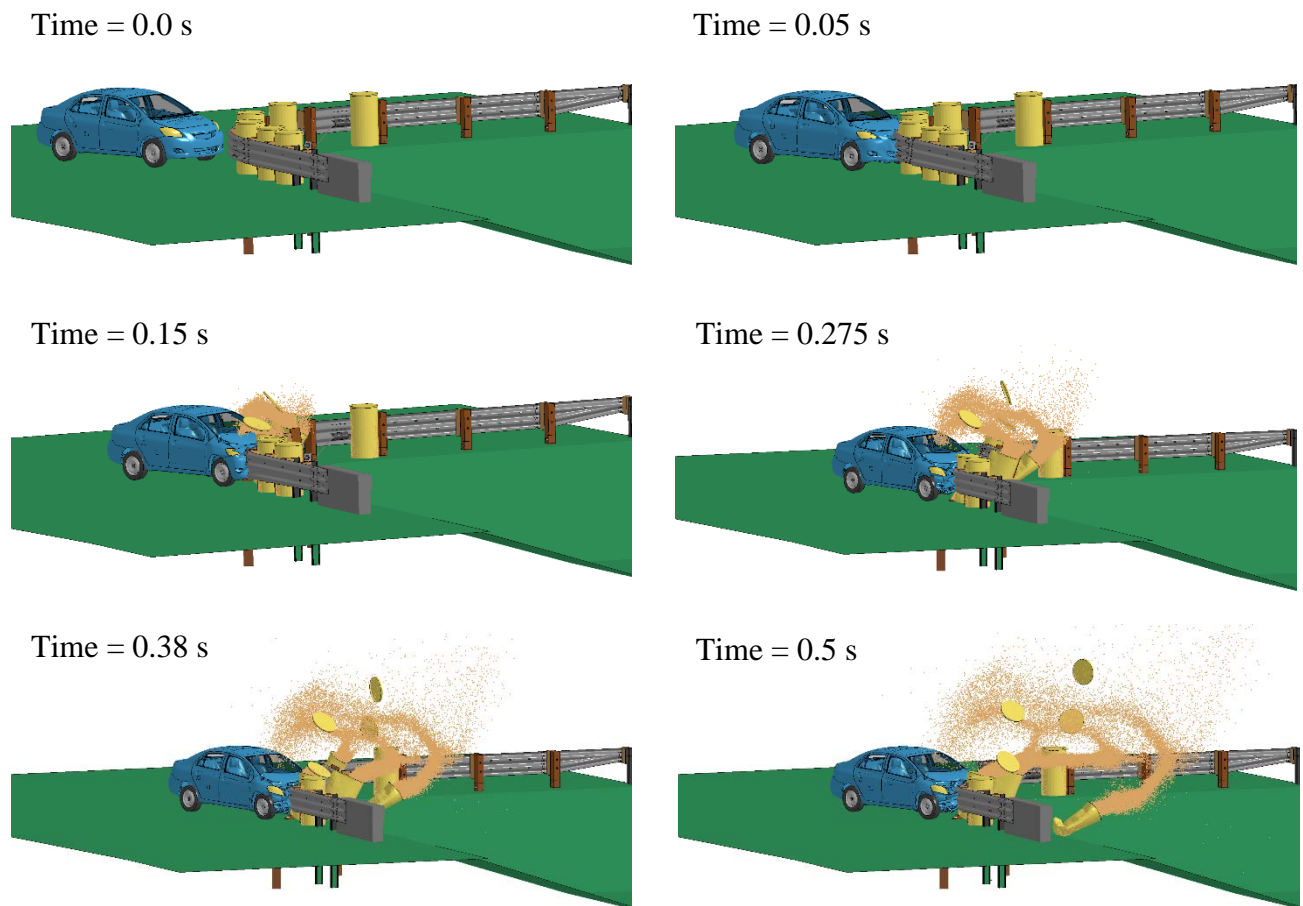
Figure 3.77 displays sequential images of the simulation. By 0.05 s, the front left bumper was significantly deformed. At approximately 0.15 s, the surface area of the car in contact with the guardrail was maximized. By this point, the drums had been impacted and were starting to release sand. By 0.275 s, the front of the car was entirely deformed, and the majority of the car's kinetic energy had been dissipated; almost all of the sand from the relevant drums had been released. After this point, the car slowly rolled backward until rest. Figure 3.78 follows the position of the car from beginning state to the final state.

**Figure 3.77. Sequential Images of Car Simulation with Two Tension Cables and Six 700-lb Sand Drums.**

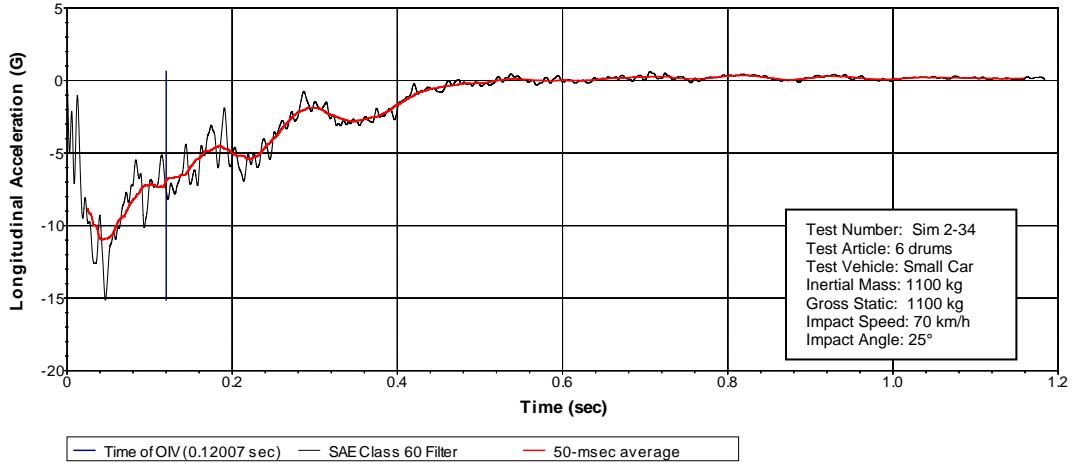
**Figure 3.79. Longitudinal Acceleration of Car Impacting Short Radius with Two Tension Cables and Six 700-Lb Sand Drums.**

Table 3.16 shows the TRAP results of the occupant risk factor for the car simulation with two short cables and six spread out 700-lb sand drums. Figures 3.79, 3.80, and 3.81 show the longitudinal accelerations in the X, Y, and Z direction, respectively. Figure 3.82 shows the roll, pitch, and yaw angles for the simulation.

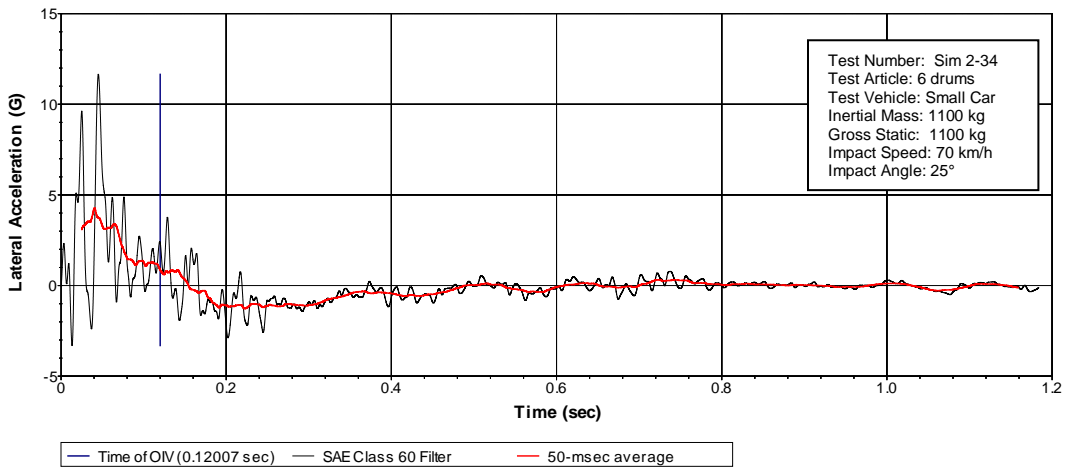
**Figure 3.80. Lateral Acceleration of Car Impacting Short Radius with Two Tension Cables and Six 700-Lb Sand Drums.**

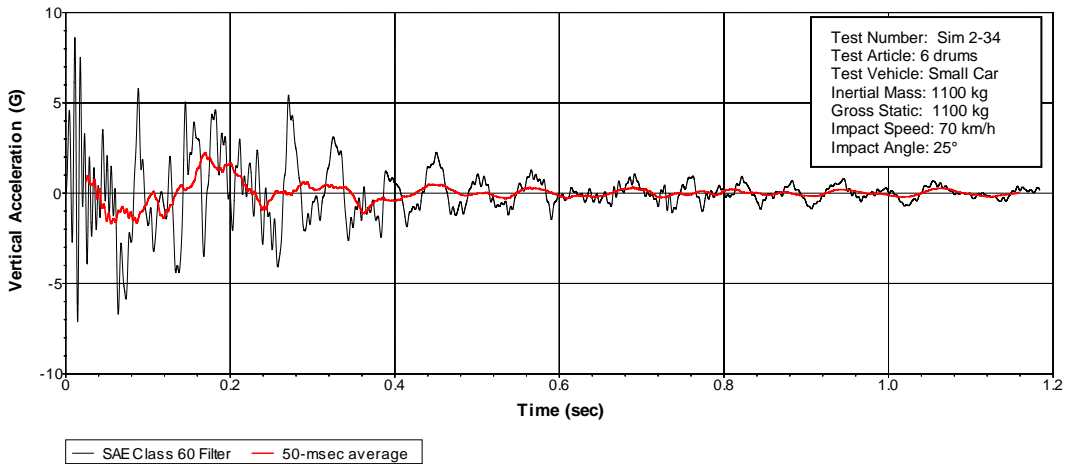
**Figure 3.81. Vertical Acceleration of Car Impacting Short Radius with Two Tension Cables and Six 700-Lb Sand Drums.**

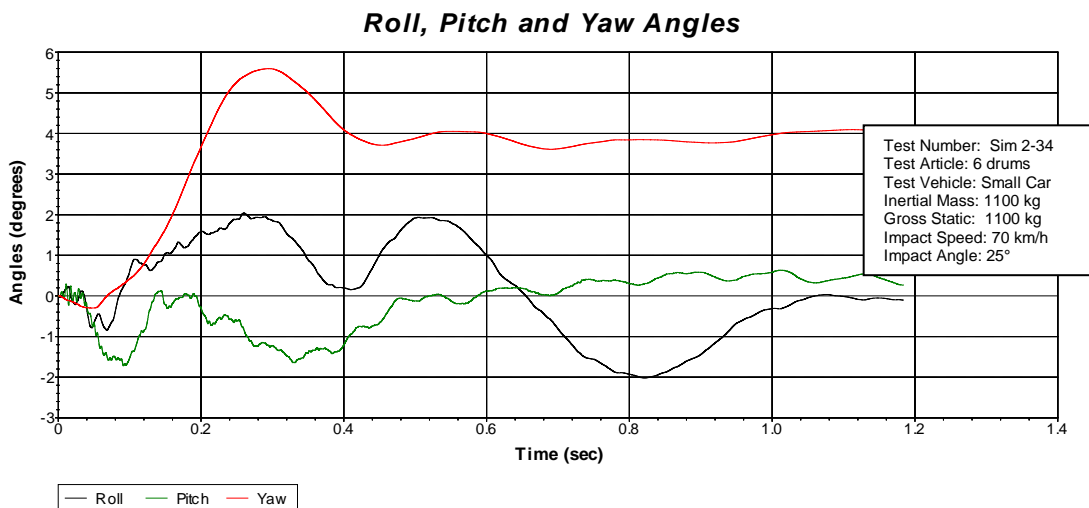
**Figure 3.82. Roll, Pitch, and Yaw Angles of Car Impacting Short Radius with Two Tension Cables and Six 700-Lb Sand Drums.**

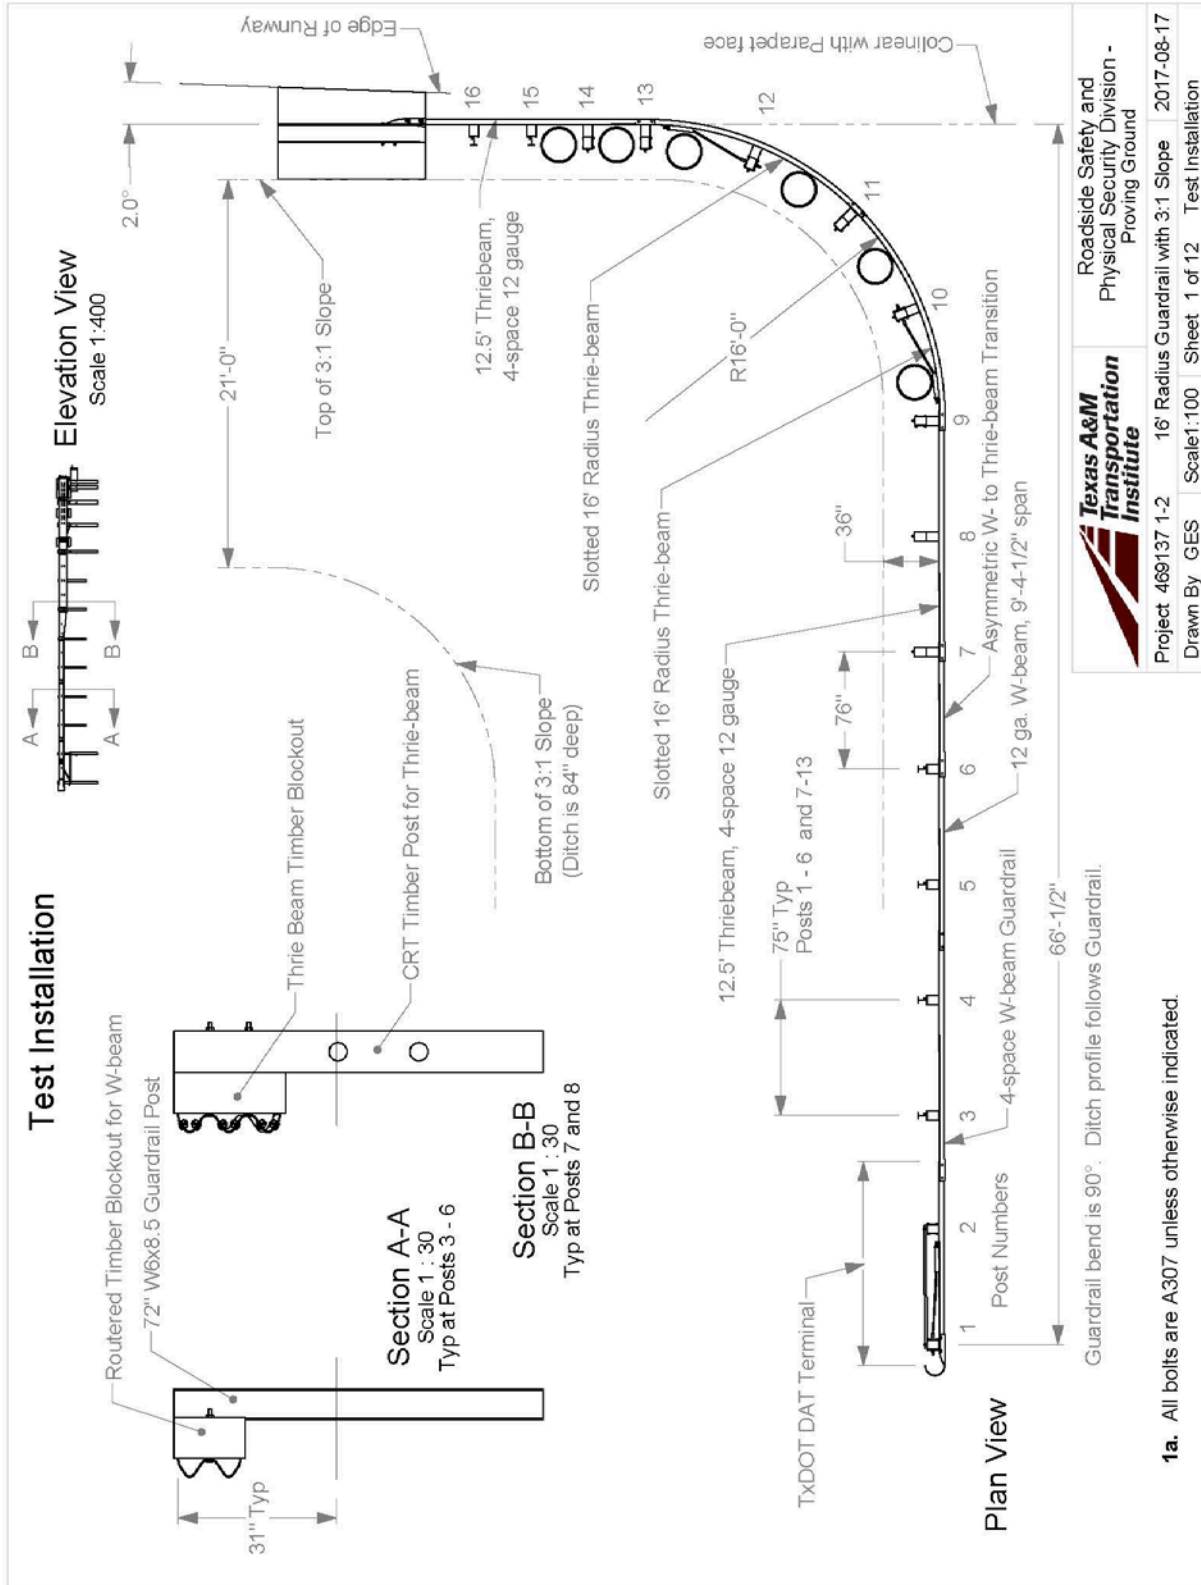
**Figure 4.1. Overall Details of the TxDOT Low-Speed Guardrail Treatment.**

Figure 4.1 presents overall information on the TxDOT low-speed short radius guardrail treatment, and Figure 4.2 provides photographs of the installation. Appendix A provides further details of the TxDOT low-speed short radius guardrail treatment.

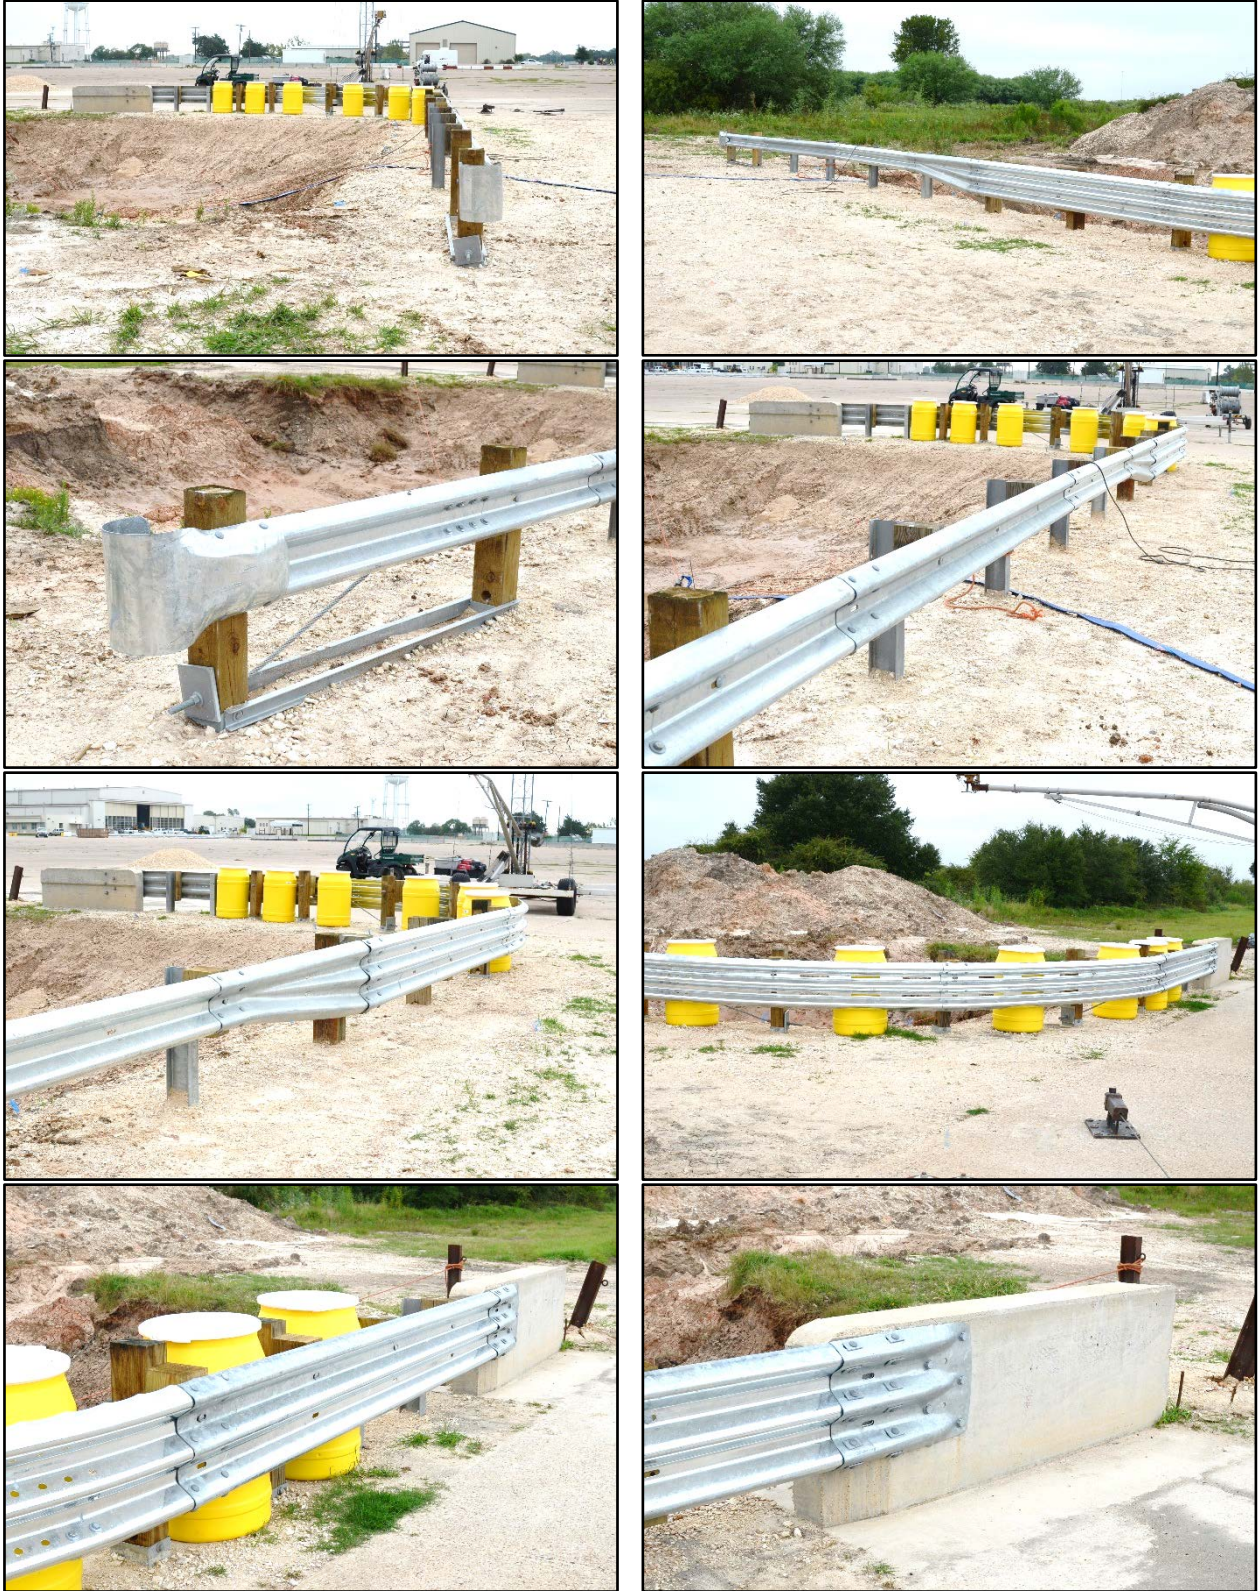
**Figure 4.2. TxDOT Low-Speed Short Radius Guardrail Treatment prior to Test Nos. 469137-3-1 and 469138-3-4.**

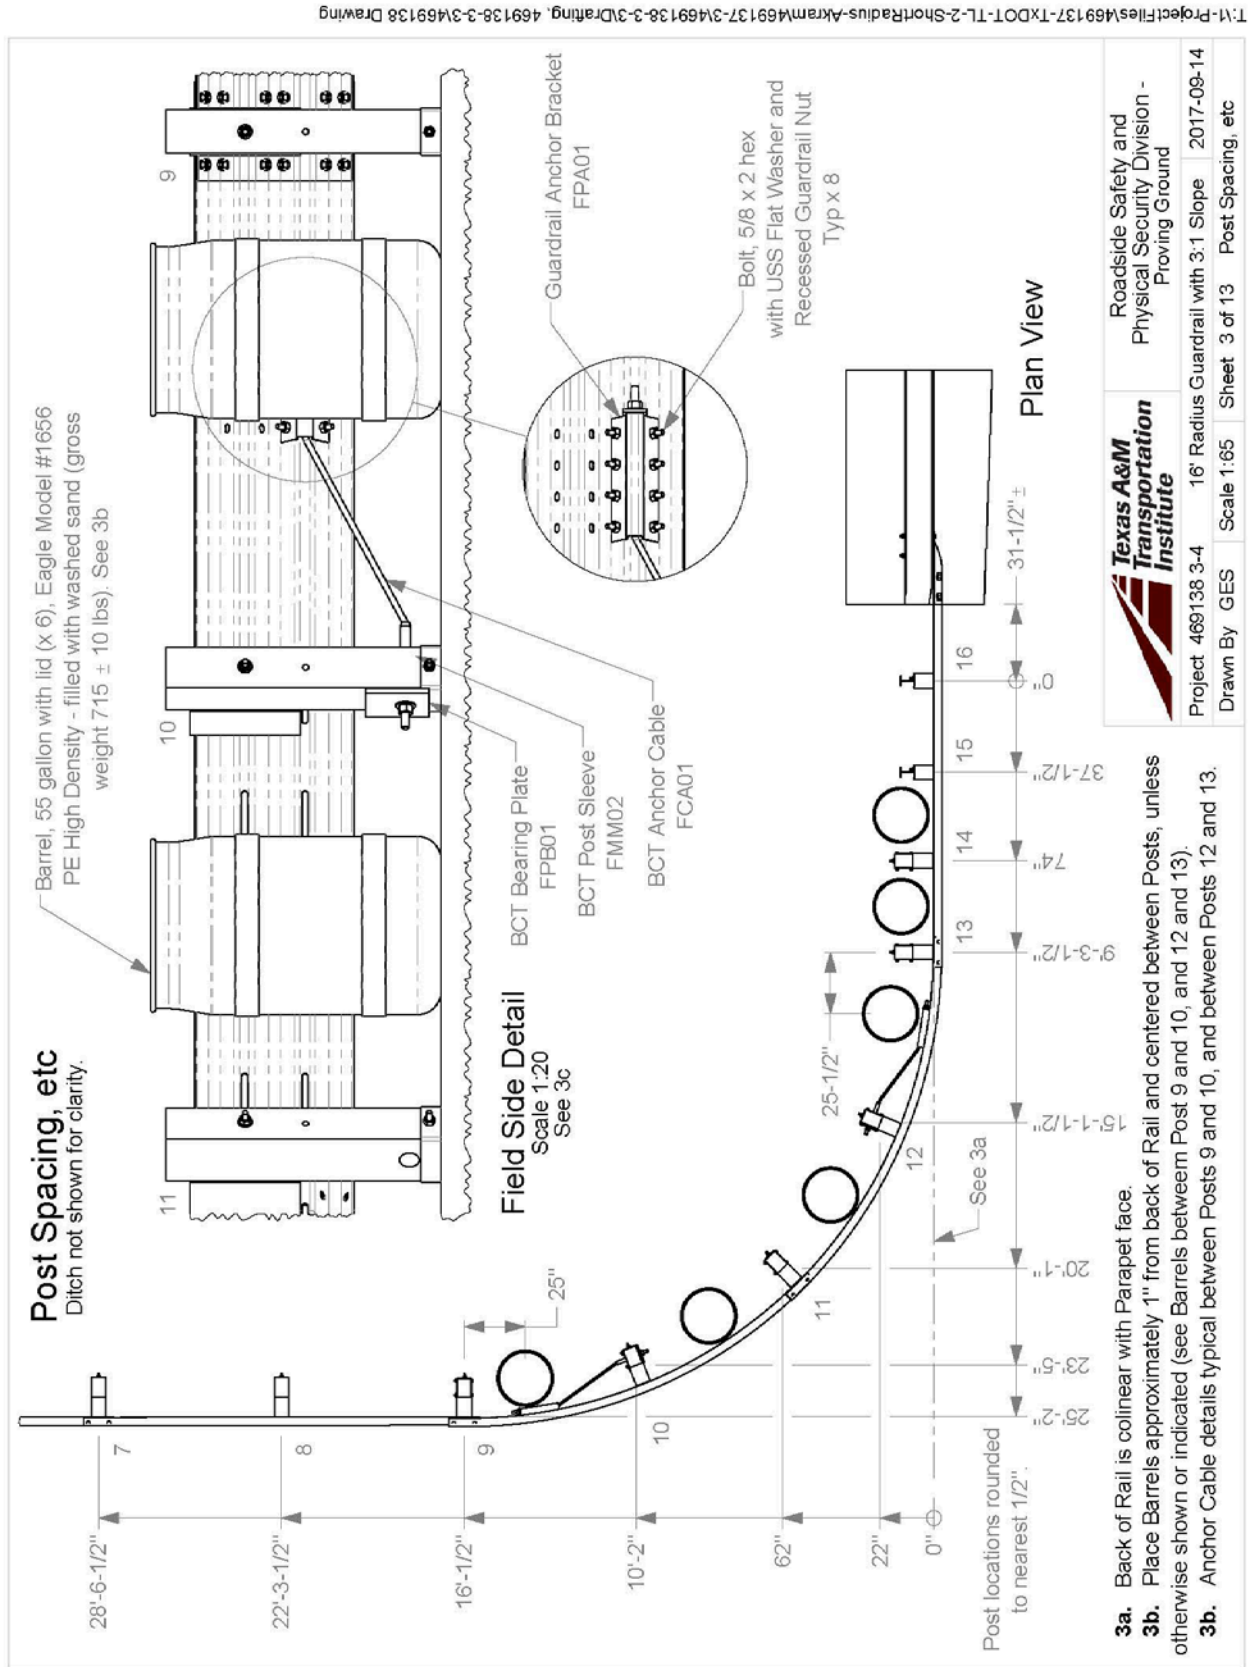
Roadside Safety and Physical Security Division - Proving Ground		
	Project 469138 3-4	16' Radius Guardrail with 3:1 Slope	2017-09-14
Drawn By GES	Scale 1:65	Sheet 3 of 13	Post Spacing, etc

**Figure 4.3. Details of the Cable used for Test Nos. 469138-3-3 and 469138-3-4.**

For Test Nos. 469138-3-3, -3-4, and 469138-3-5 (*MASH* 2-31, 2-35, and 2-34, respectively), modified BCT Anchor Cables measuring 5 ft-5 inches end to end, inclusive of terminal fittings, were used. These shortened cables allowed the Guardrail Anchor Brackets (FPA01) to attach to the thrie-beam with eight bolts. See Appendix B, Sheets 3 and 13 for details.

Figure 4.3 shows the changes to the TxDOT low-speed short radius guardrail treatment for Test Nos. 469138-3-3, -3-4, and 469138-3-5, and Figure 4.4 provides photographs of the installation. Appendix B provides further details of the TxDOT low-speed short radius guardrail treatment.

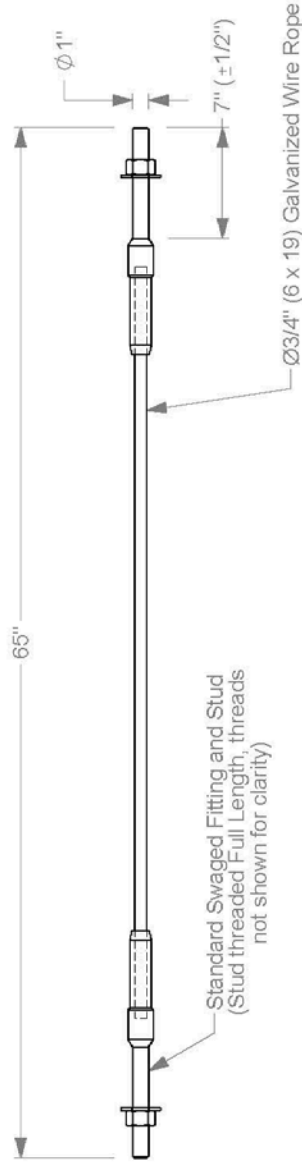
Roadside Safety and Physical Security Division - Proving Ground	
Project	469138-3-4	16' Radius Guardrail with 3:1 Slope	2017-09-14
Drawn By	GES	Scale 1:10	Sheet 13 of 13
		Anchor Cable

### Anchor Cable for Short Radius Rail

**13a.** The Stud shall conform to the requirements of ASTM A449 and shall be galvanized in accordance with ASTM A153. The threads shall have a Class 2A fit before galvanizing.

**13b.** The Wire Rope shall conform to the requirements of AASHTO M-30 and shall be Ø3/4" pre-formed, 6 x 19, wire strand core or independent wire rope core (WRC), galvanized, right regular lay, manufactured of improved plow steel with a minimum breaking strength of 46,000 lbs.

**Figure 4.3. Details of the Cable used for Test Nos. 469138-3-3 and 469138-3-4 (Continued).**

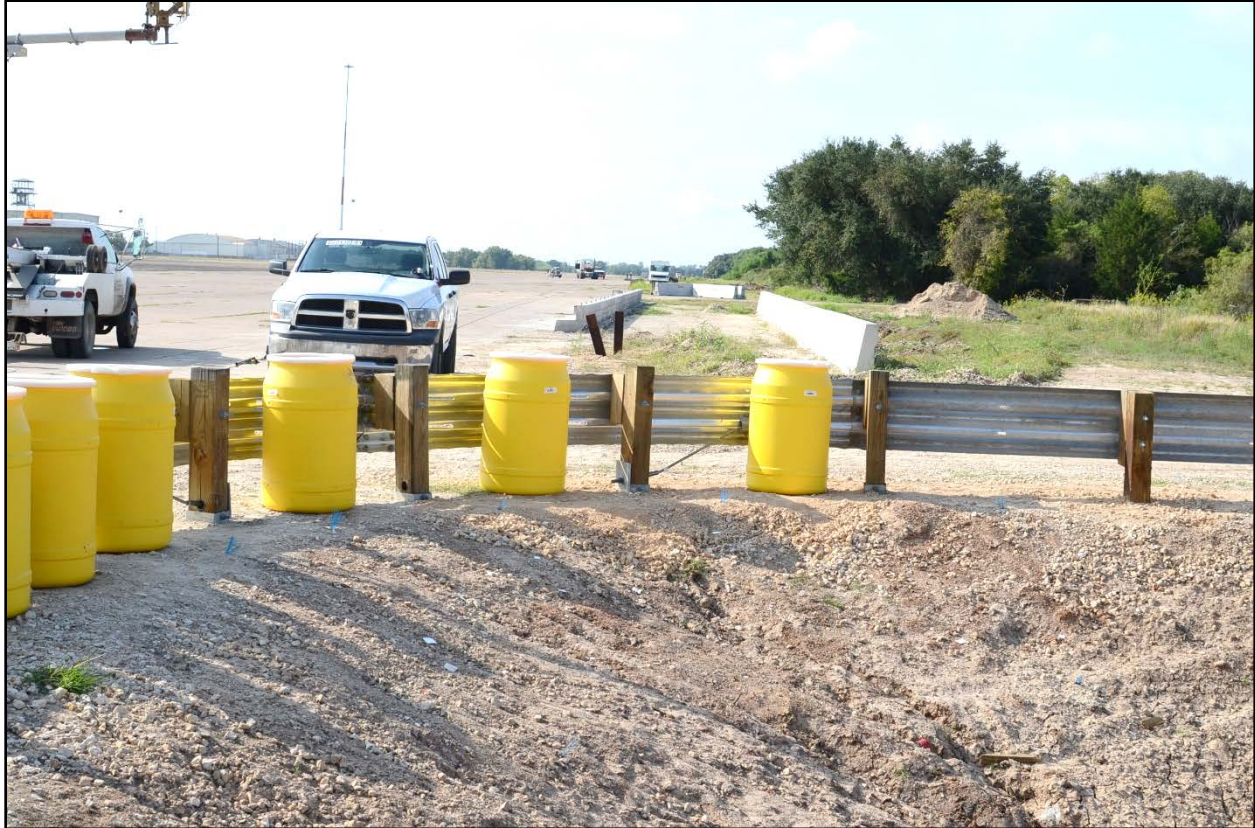
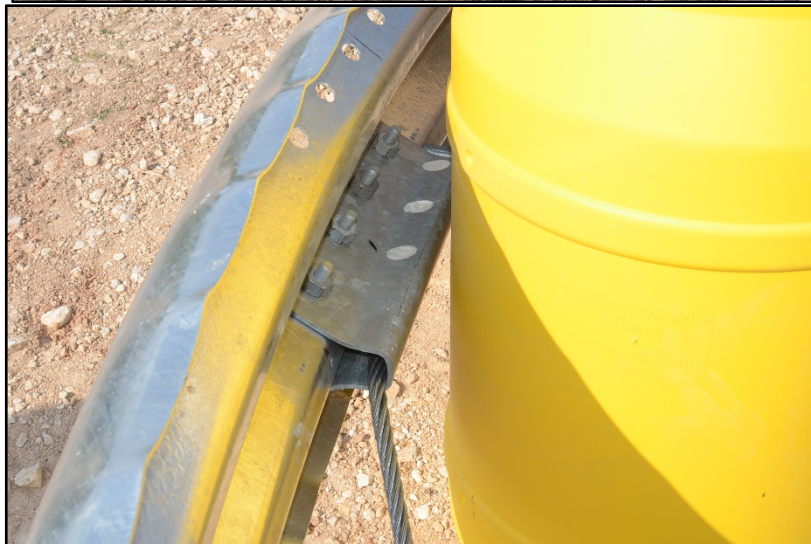
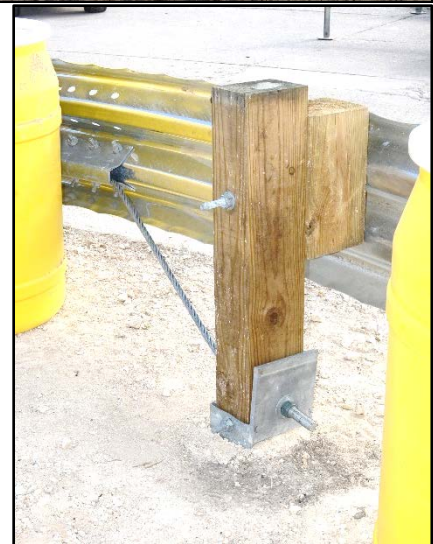
**Figure 4.4. Cable prior to Test Nos. 469138-3-3 and 469138-3-4.**

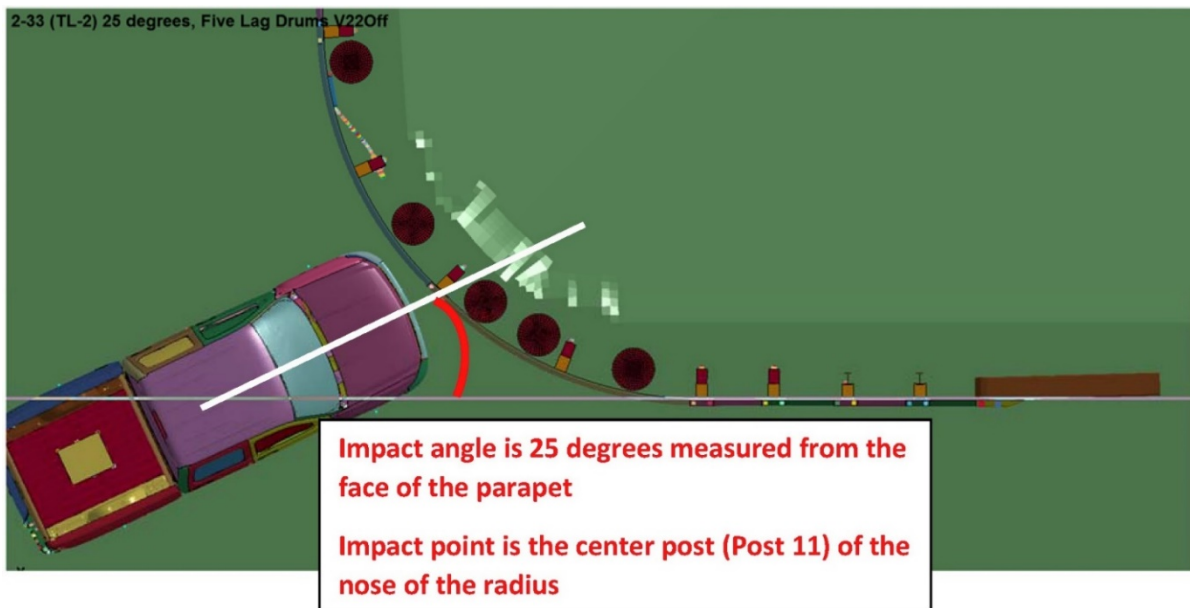
**Figure 5.1. Target CIP for *MASH* Test 2-33 on the TxDOT Low-Speed Short Radius Guardrail Treatment.**

Table 5.1 shows the test conditions and evaluation criteria for *MASH* TL-2 non-gating end treatments. The target CIPs selected for the tests were determined according to the information provided in *MASH* Section 2.3.3 and *MASH* Figure 2-3A. The target CIP selected for each test is shown in Figures 5.1 through 5.5.
