# CRASH TEST AND EVALUATION OF TL-2 SHORT RADIUS GUARDRAIL TREATMENT

**Test Report 0-6913-R1**

**TEXAS A&M TRANSPORTATION INSTITUTE  
COLLEGE STATION, TEXAS**

**TEXAS DEPARTMENT OF TRANSPORTATION**

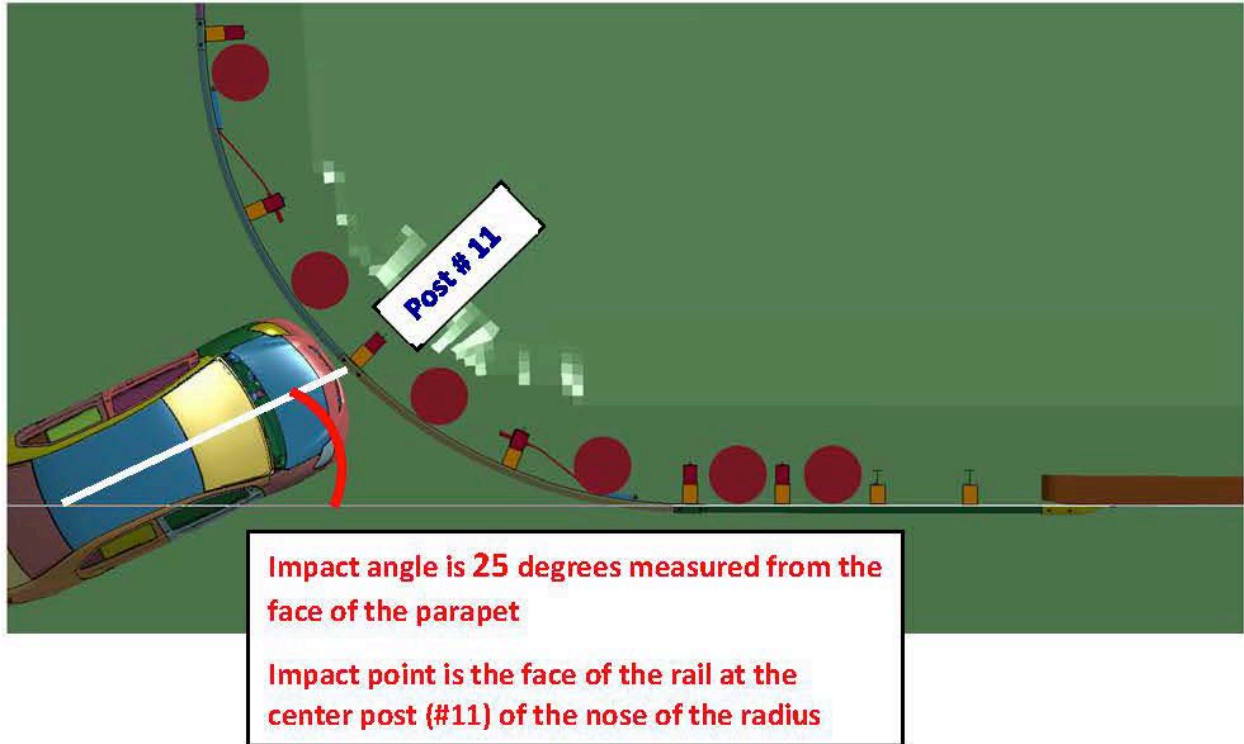
Figure 5.2. Target CIP for *MASH* Test 2-32 on the TxDOT Low-Speed Short Radius Guardrail Treatment.

Table 5.1 shows the test conditions and evaluation criteria for *MASH* TL-2 non-gating end treatments. The target CIPs selected for the tests were determined according to the information provided in *MASH* Section 2.3.3 and *MASH* Figure 2-3A. The target CIP selected for each test is shown in Figures 5.1 through 5.5.

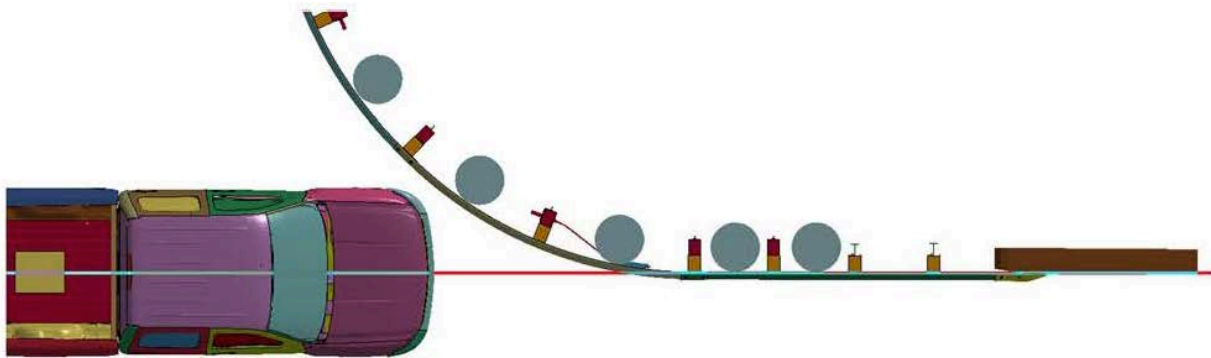
MASH TL 2 -31: The vehicle approaching parallel to the roadway (THE PARAPET ROADWAY). The centerline of the truck is aligned with the traffic face of the concrete parapet

Figure 5.3. Target CIP for *MASH* Test 2-31 on the TxDOT Low-Speed Short Radius Guardrail Treatment.

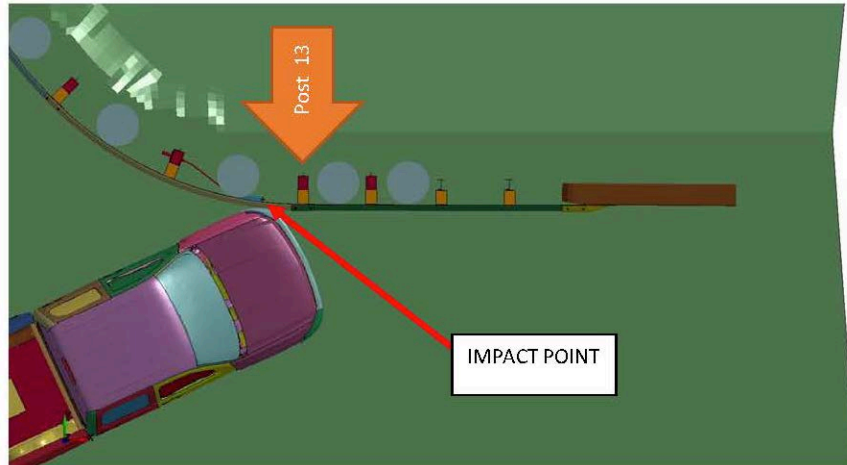
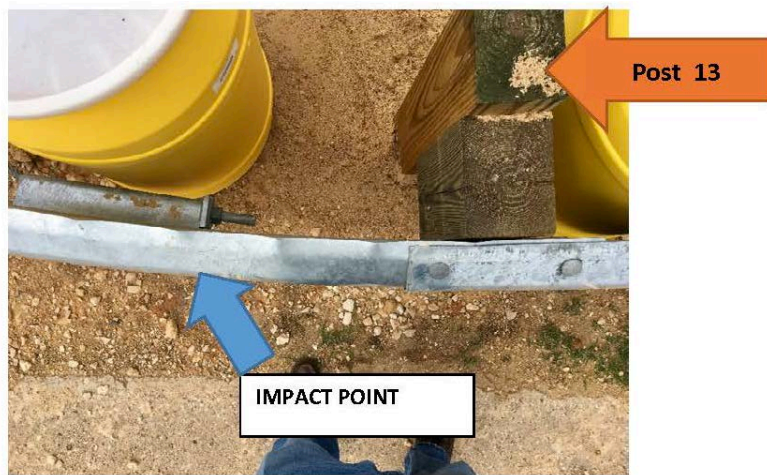
**Figure 5.4. Target CIP for *MASH* Test 2-35 on the TxDOT Low-Speed Short Radius Guardrail Treatment.**

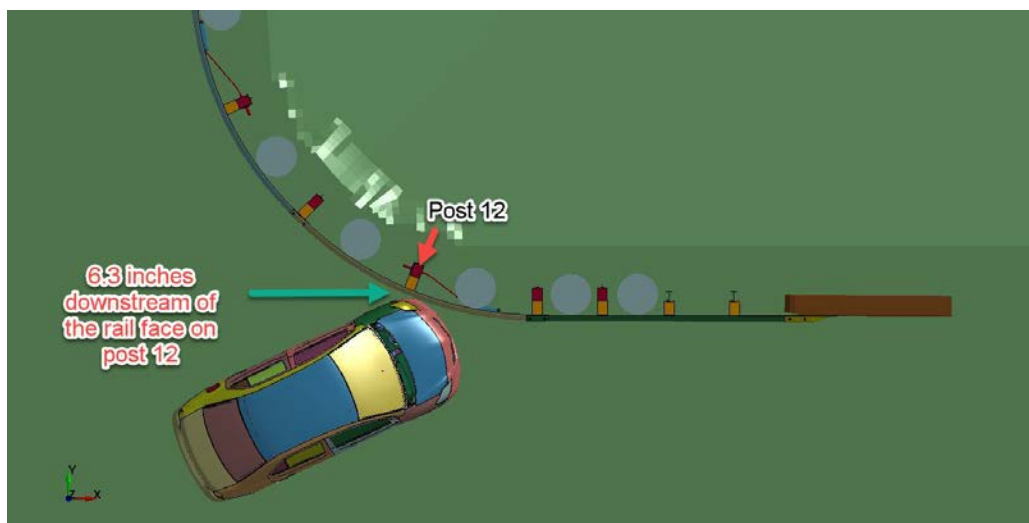
**Figure 5.5. Target CIP for Modified *MASH* Test 2-34 on the TxDOT Low-Speed Short Radius Guardrail Treatment.**

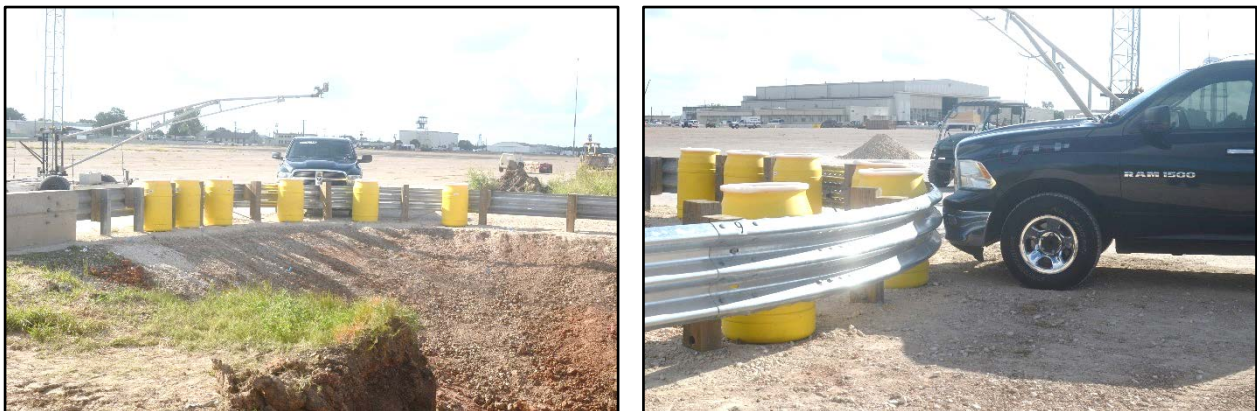
**Figure 7.1. TxDOT Low-Speed Short Radius Guardrail Treatment/Test Vehicle Geometrics for Test No. 469137-3-1.**

The 2011 Dodge RAM 1500 pickup truck, shown in Figures 7.1 and 7.2, was used for the crash test. The vehicle's test inertia weight was 5039 lb, and its gross static weight was 5039 lb. The height to the lower edge of the vehicle bumper was 11.0 inches, and height to the upper edge of the bumper was 26.5 inches. The height to the center of gravity of the vehicle was 28.38 inches. Tables D.1 and D.2 in Appendix D.1 give additional dimensions and information on the vehicle. The vehicle was directed into the installation using the cable reverse tow and guidance system, and was released to be freewheeling and unrestrained just prior to impact.

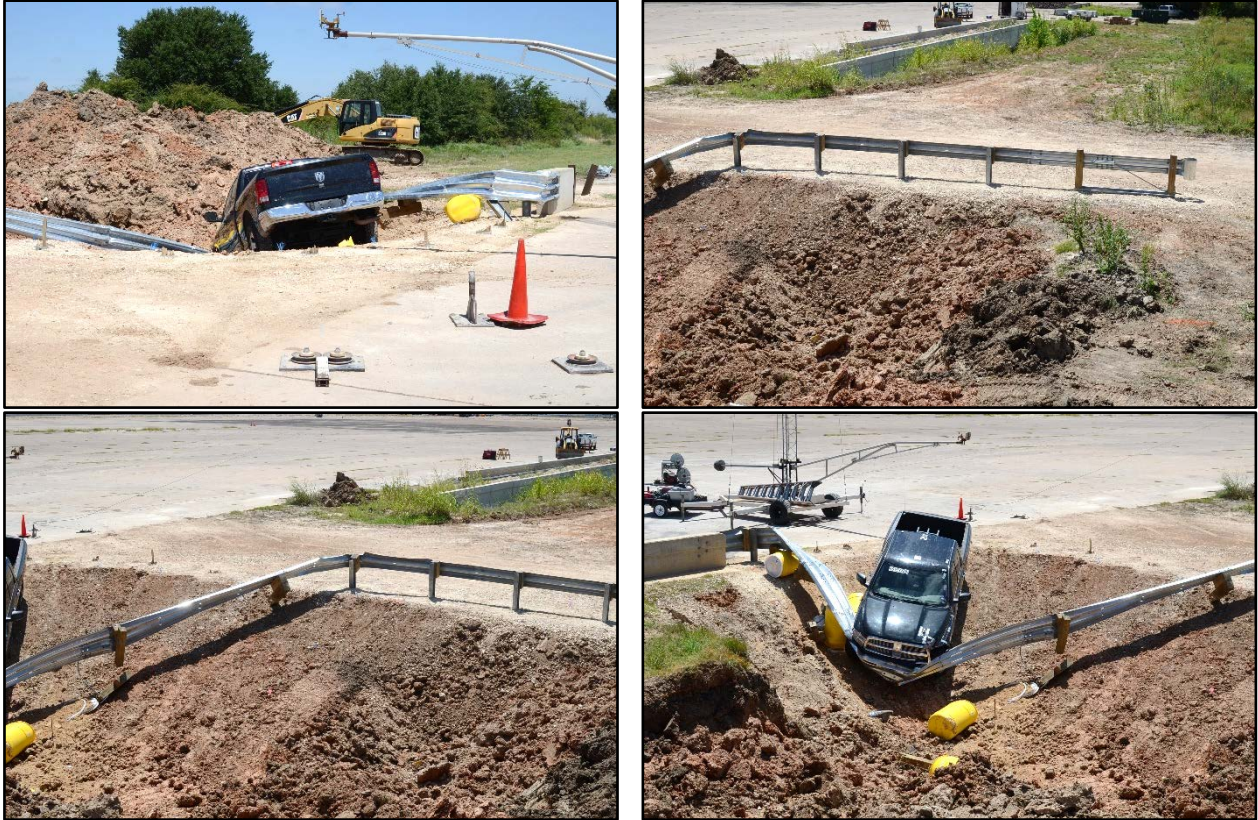
**Figure 7.3. TxDOT Low-Speed Short Radius Guardrail Treatment after Test No. 469137-3-1.**

Figures 7.3 through 7.6 show the damage to the TxDOT low-speed short radius guardrail treatment. The soil around post 1 was slightly disturbed. Post 5 was displaced 0.75 inch through the soil toward the field side. Post 6 was displaced 8.5 inches through the soil toward the field side. Posts 7, 9, and 13 fractured at ground level but remained attached to the rail element. Posts 8, 10, 11, 12, and 14 fractured at ground level and separated from the rail element. Post 15 was displaced through the soil 5.5 inches toward the field side and 6.0 inches toward the parapet. Post 16 was displaced 1.0 inch through the soil toward the field side. Maximum dynamic deflection during the test was 24.2 ft, and maximum permanent deformation was 20.5 ft.

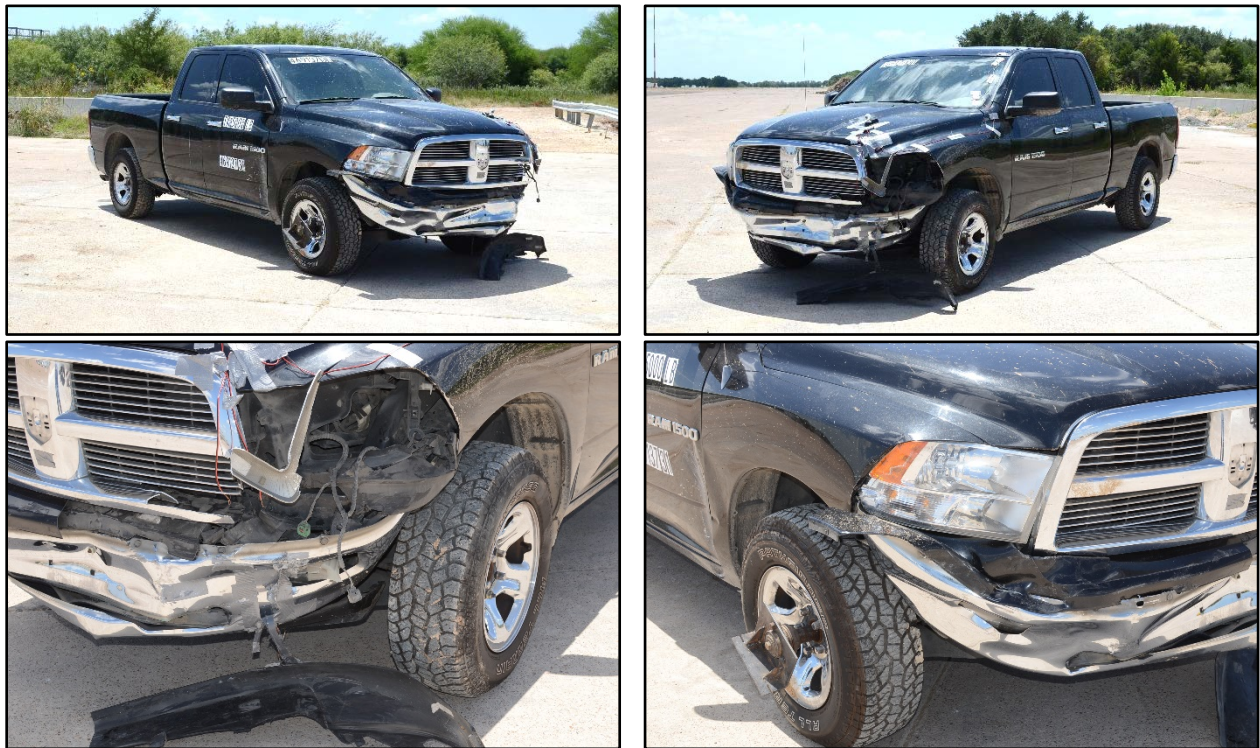
**Figure 7.7. Test Vehicle after Test No. 469137-3-1.**

Figure 7.7 shows the damage the vehicle sustained. The front bumper, grill, headlights, right and left front fenders, radiator support, and right front door were damaged. Maximum exterior crush to the vehicle was 6.0 inches in the front plane at the both front corners at bumper height. No occupant compartment deformation or intrusion occurred. Figure 7.8 shows the interior of the vehicle. Tables D.3 and D.4 in Appendix D.1 provides exterior crush and occupant compartment measurements.

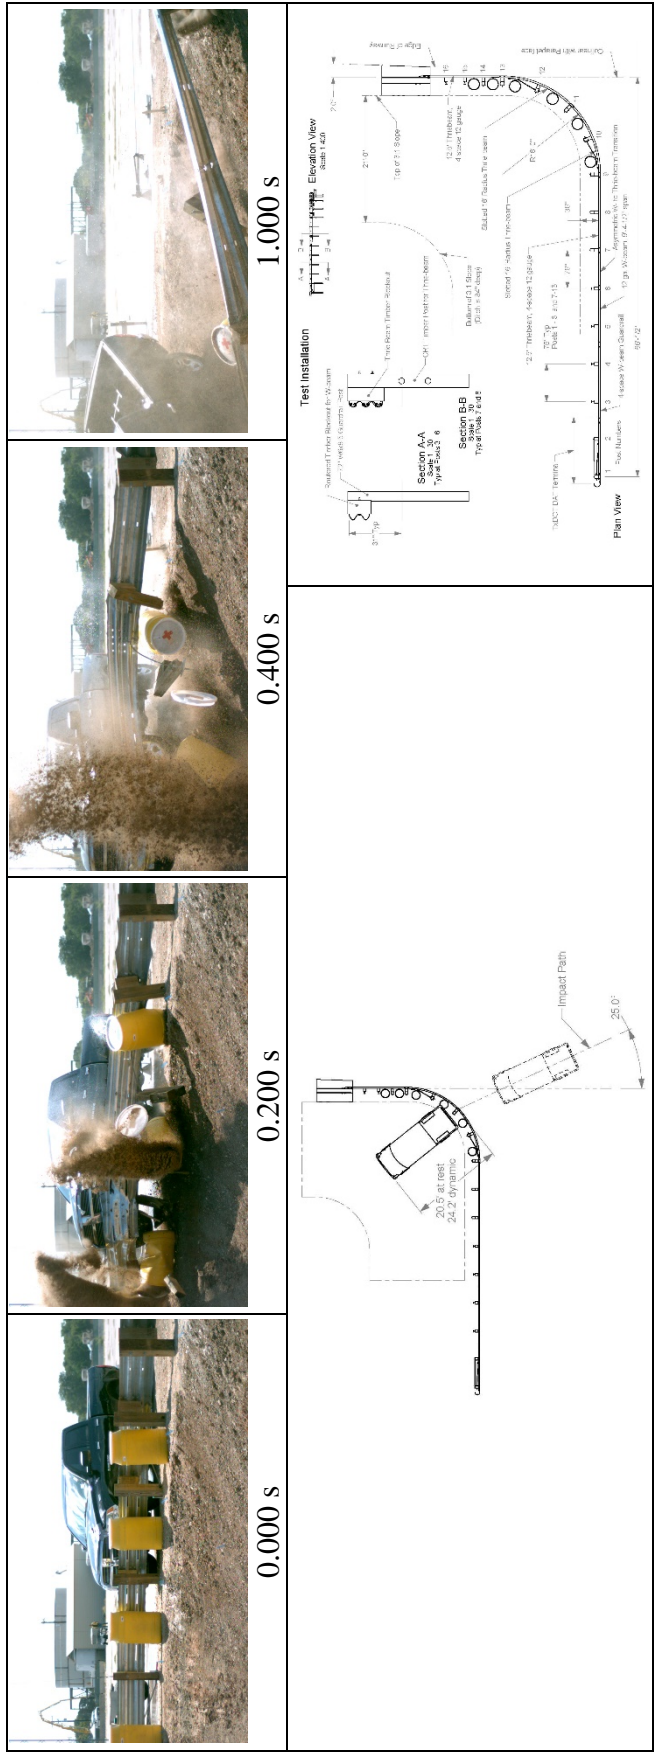
<b>General Information</b>		<b>Impact Conditions</b>	<b>Post-Impact Trajectory</b>
Test Agency.....	Texas A&M Transportation Institute (TTI)	Speed.....	Stopping Distance.....
Test Standard Test No.....	MASH Test 2-33	Angle.....	25 ft downstream
TTI Test No.....	469137-3-1	Location/Orientation.....	<b>Vehicle Stability</b>
Test Date.....	2017-08-18	Kinetic Energy.....	Maximum Yaw Angle.....
<b>Test Article</b>		Exit Conditions.....	Maximum Pitch Angle.....
Type.....	Short Radius Guardrail Treatment	Speed.....	Maximum Roll Angle.....
Name.....	TxDOT Low-Speed Short Radius	Angle.....	<b>Test Article Deflections</b>
Installation Length.....	66 ft-1/2 inch	Longitudinal Risk Values	Dynamic.....
Material or Key Elements .....	31-inch tall, 87-ft long, three-beam short radius guardrail system with curved 25-ft arc length three-beam section rolled to a 16-ft inside radius	Lateral OIV.....	Permanent.....
<b>Soil Type and Condition</b> .....	AASHTO M147-65(2004), grading B Soil (crushed limestone), Damp	Longitudinal Ridedown.....	<b>Vehicle Damage</b>

<b>Test Vehicle</b>		Lateral Ridedown.....	VDS.....
Type/Designation.....	2270P	THIV.....	CDC.....
Make and Model.....	2011 Dodge RAM 1500	PHD.....	Max. Exterior Deformation.....
Curb.....	5157 lb	ASI.....	OCDI.....
Test Inertial.....	5039 lb	Max. 0.050-s Average	Max. Occupant Compartment
Dummy.....	No dummy	Longitudinal.....	Deformation.....
Gross Static.....	5039 lb	Lateral.....	None
		Vertical.....

**Figure 7.9. Summary of Results for MASH Test 2-33 on the TxDOT Low-Speed Short Radius Guardrail Treatment.**

Data from the accelerometer, located at the vehicle center of gravity, were digitized for evaluation of occupant risk and are shown in Table 7.2. Figure 7.9 summarizes these data and other pertinent information from the test. Figure D.3 in Appendix D.3 shows the vehicle angular displacements, and Figures D.4 through D.9 in Appendix D.4 show accelerations versus time traces.

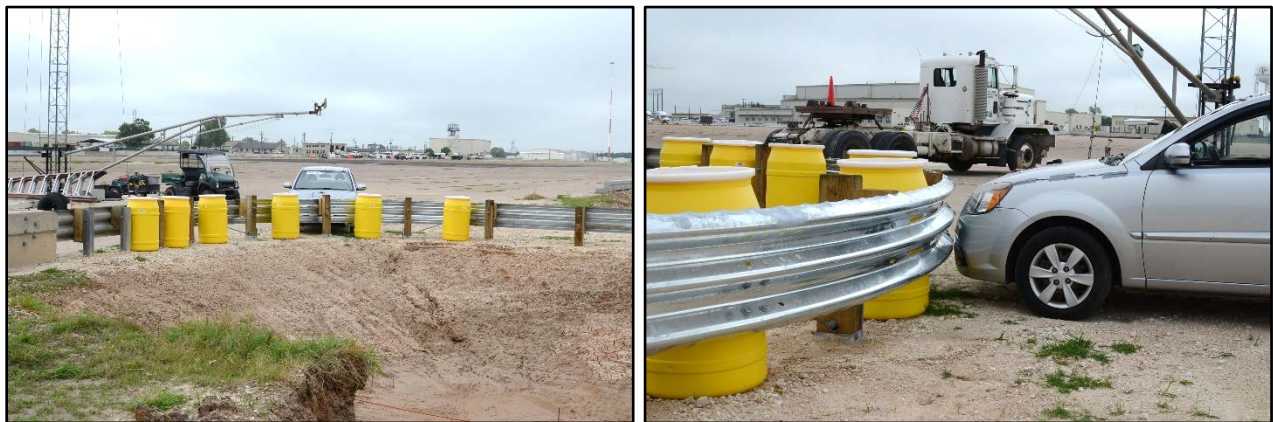
**Figure 8.1. TxDOT Low-Speed Short Radius Guardrail Treatment/Test Vehicle Geometrics for Test No. 469137-3-2.**

The 2011 Kia Rio, shown in Figures 8.1 and 8.2, was used for the crash test. The vehicle's test inertia weight was 2456 lb, and its gross static weight was 2621 lb. The height to the lower edge of the vehicle bumper was 7.75 inches, and height to the upper edge of the bumper was 21.00 inches. Table E.1 in Appendix E.1 gives additional dimensions and information on the vehicle. The vehicle was directed into the installation using the cable reverse tow and guidance system, and was released to be freewheeling and unrestrained just prior to impact.

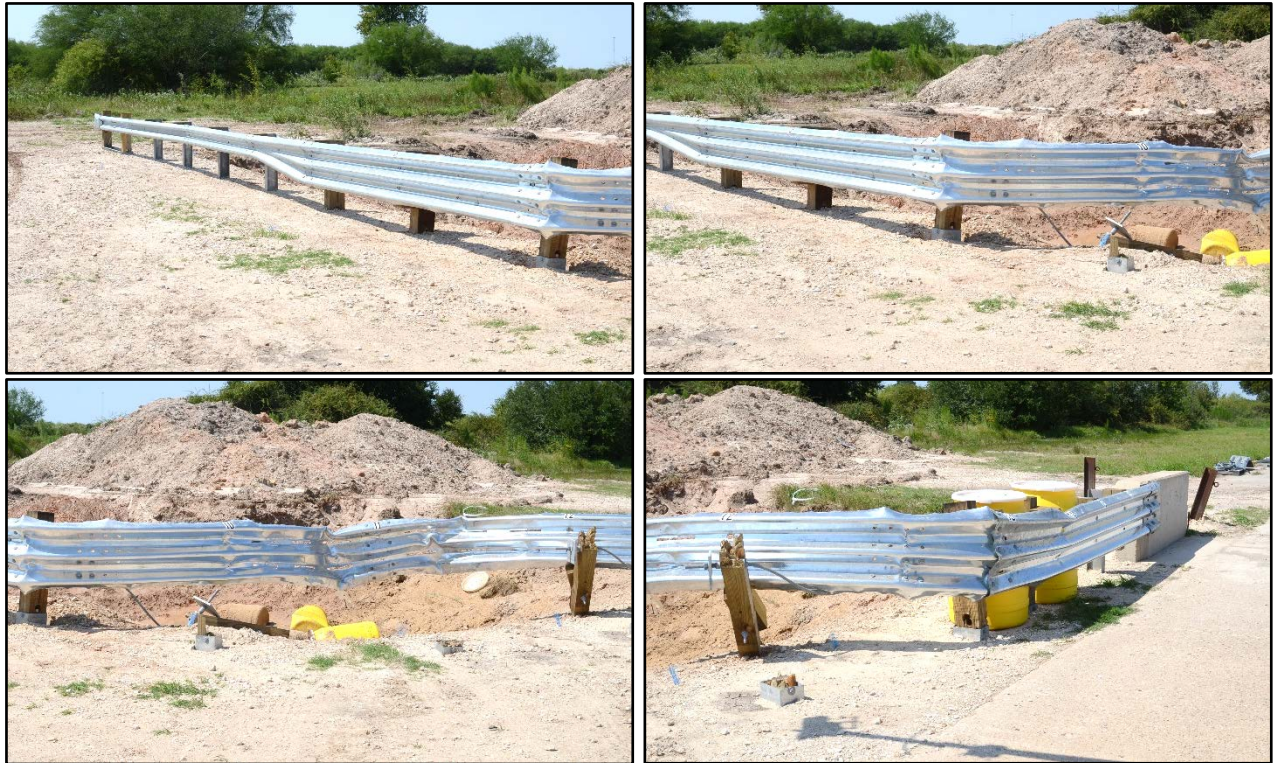
**Figure 8.4. Test Article after Test No. 469137-3-2.**

Figures 8.3 through 8.6 show the damage to the TxDOT low-speed short radius guardrail treatment. No disturbance of the soil around posts 1 through 6 was noted. Post 7 was displaced through the soil 1.0 inch toward field side. Post 8 was displaced through the soil 2.38 inches toward the field side and was leaning 85° toward the field side. Post 9 was displaced through the soil 9.25 inches toward the field side and was leaning 80° toward the field side. The ground tube for post 10 was displaced through the soil 3.75 inches, and the post fractured at the top of the ground tube. The ground tube for post 11 was displaced through the soil 0.25 inches, and the post fractured at the top of the ground tube. The ground tube for post 12 was displaced through the soil 0.38 inches, and the post fractured at the top of the ground tube. The ground tube for post 13 was displaced through the soil 0.12 inches, and the post fractured at the top of the ground tube. The soil was disturbed around post 14, and the rail element separated from the blockout. No disturbance of the soil around posts 15 and 16 was noted. Drums 1–4 were resting in the ditch, and drum 5 was pushed toward the field side 3.0 inches. Working width was 2.5 ft, and height of working width was below grade (vehicle in ditch). Maximum dynamic deflection during the test was 10.5 ft, and maximum permanent deformation was 10.5 ft.

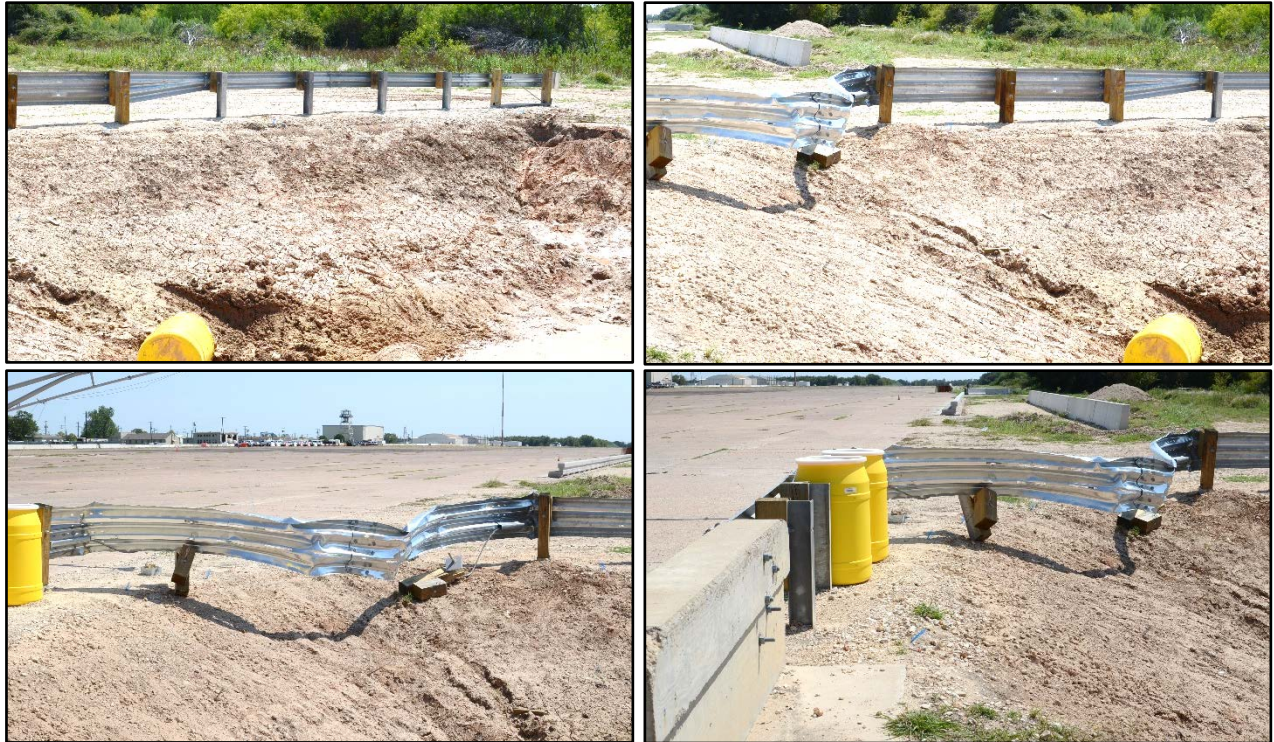
**Figure 8.5. Field Side of Test Article after Test No. 469137-3-2.**

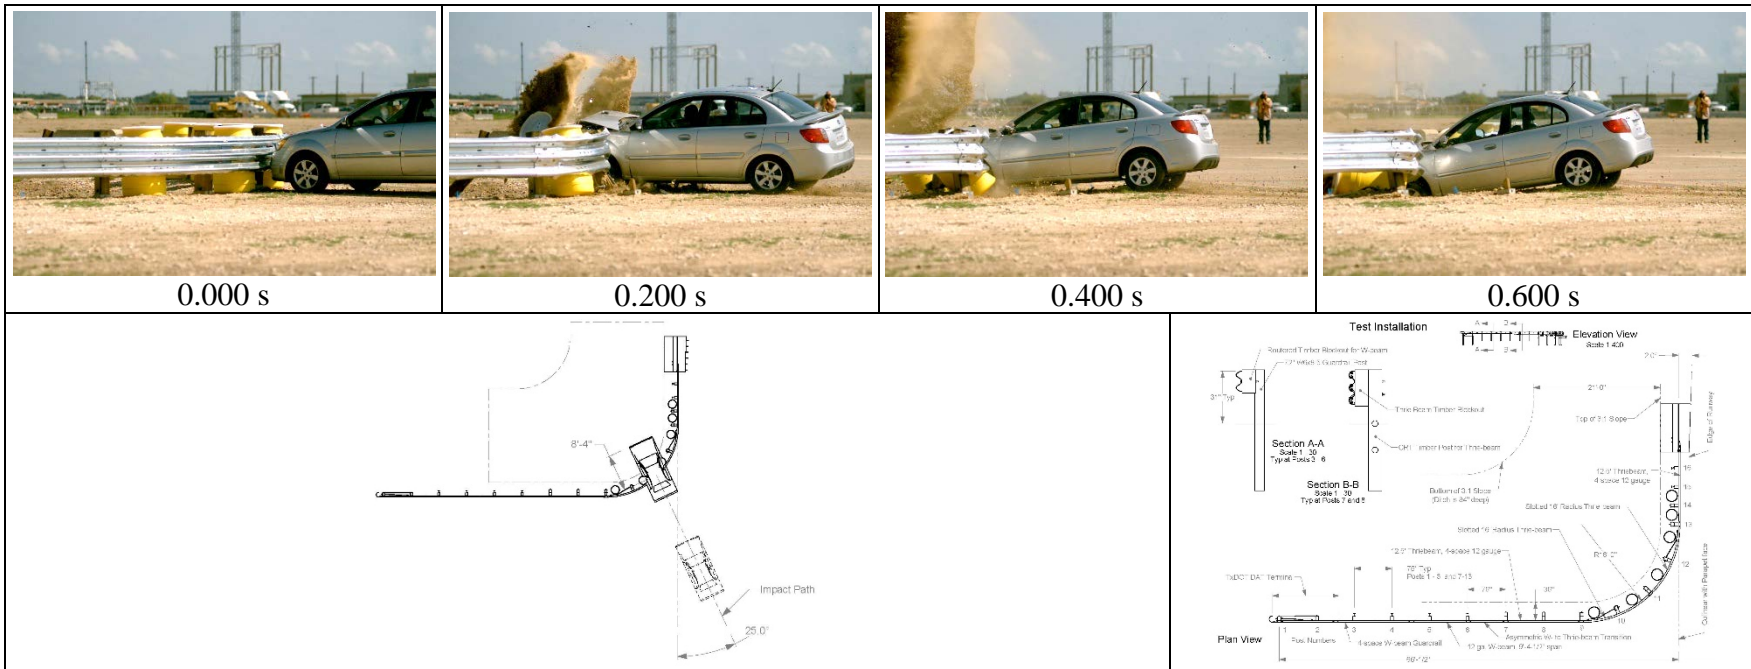
**General Information**

Test Agency..... Texas A&M Transportation Institute (TTI)  
 Test Standard Test No..... MASH Test 2-32  
 TTI Test No. .... 469137-3-2  
 Test Date ..... 2017-09-05

An assessment of the test based on the applicable safety evaluation criteria for *MASH* Test 2-32 is provided in Table 8.3.

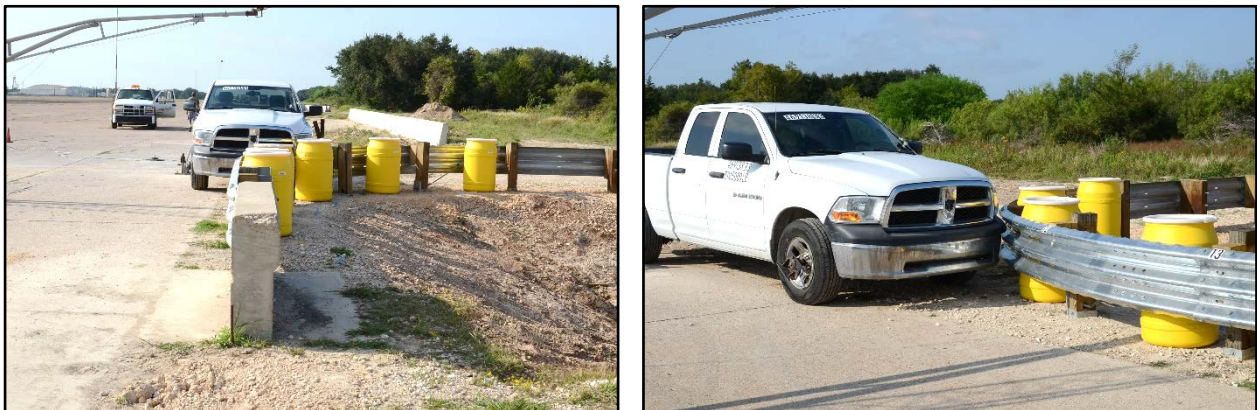
**Figure 9.1. TxDOT Low-Speed Short Radius Guardrail Treatment/Test Vehicle Geometrics for Test No. 469138-3-3.**

The 2012 Dodge RAM 1500 pickup truck, shown in Figures 9.1 and 9.2, was used for the crash test. The vehicle's test inertia weight was 5034 lb, and its gross static weight was 5034 lb. The height to the lower edge of the vehicle bumper was 11.0 inches, and height to the upper edge of the bumper was 26.5 inches. The height to the center of gravity of the vehicle was 28.25 inches. Tables F.1 and F.2 in Appendix F.1 give additional dimensions and information on the vehicle. The vehicle was directed into the installation using the cable reverse tow and guidance system, and was released to be freewheeling and unrestrained just prior to impact.

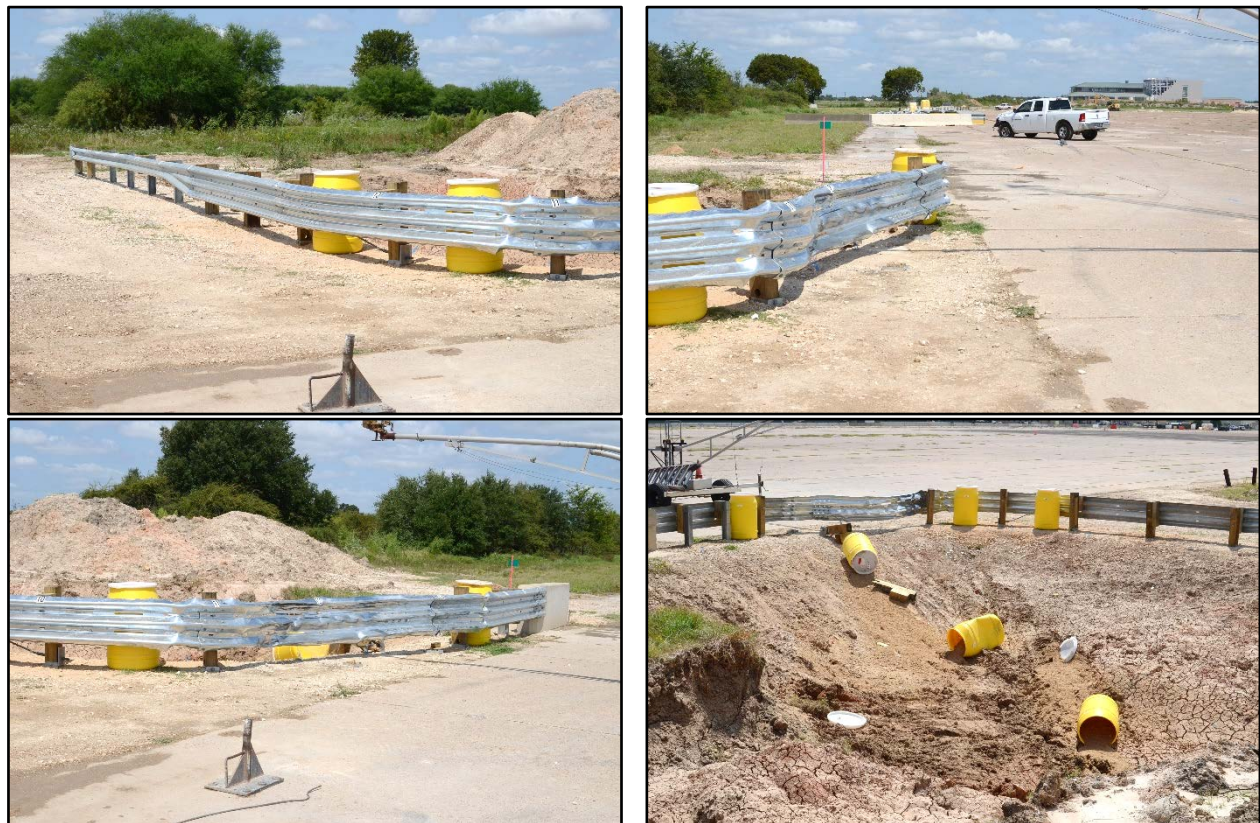
**Figure 9.3. TxDOT Low-Speed Short Radius Guardrail Treatment after Test No. 469138-3-3.**

Figures 9.3 through 9.6 show the damage to the TxDOT low-speed short radius guardrail treatment. The soil around posts 1 through 10 showed no signs of movement. Post 11 was displaced through the soil 0.62 inch toward the field side and leaning 86° toward the field side. Posts 12 and 13 fractured at the top of the foundation tube. Post 12 separated from the rail element and came to rest in the ditch. Post 13 separated from the rail but remained attached to the rail element. Post 14 was displaced through the soil 0.12 inch toward the field side. The soil around posts 15 and 16 showed no signs of movement. Working width was 1.5 ft, and the height of maximum working width was 2.5 ft. Maximum dynamic deflection during the test was 3.8 ft, and maximum permanent deformation was 2.9 ft.

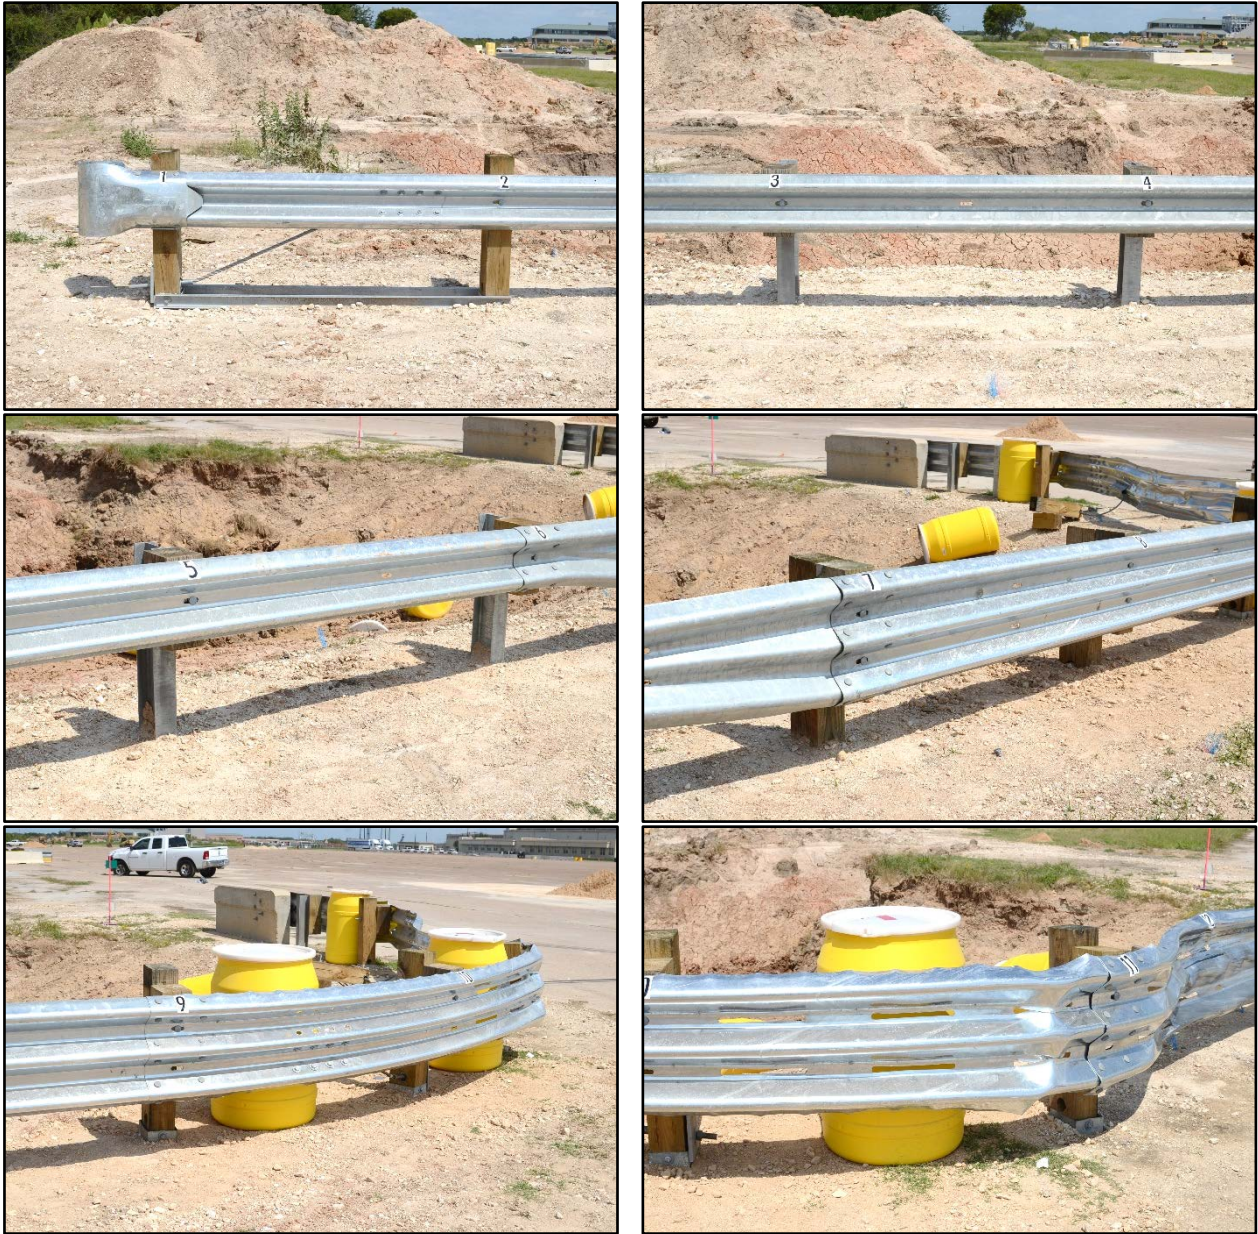
**Figure 9.4. Damage to Rail Section Perpendicular to Roadway after Test No. 469138-3-3.**

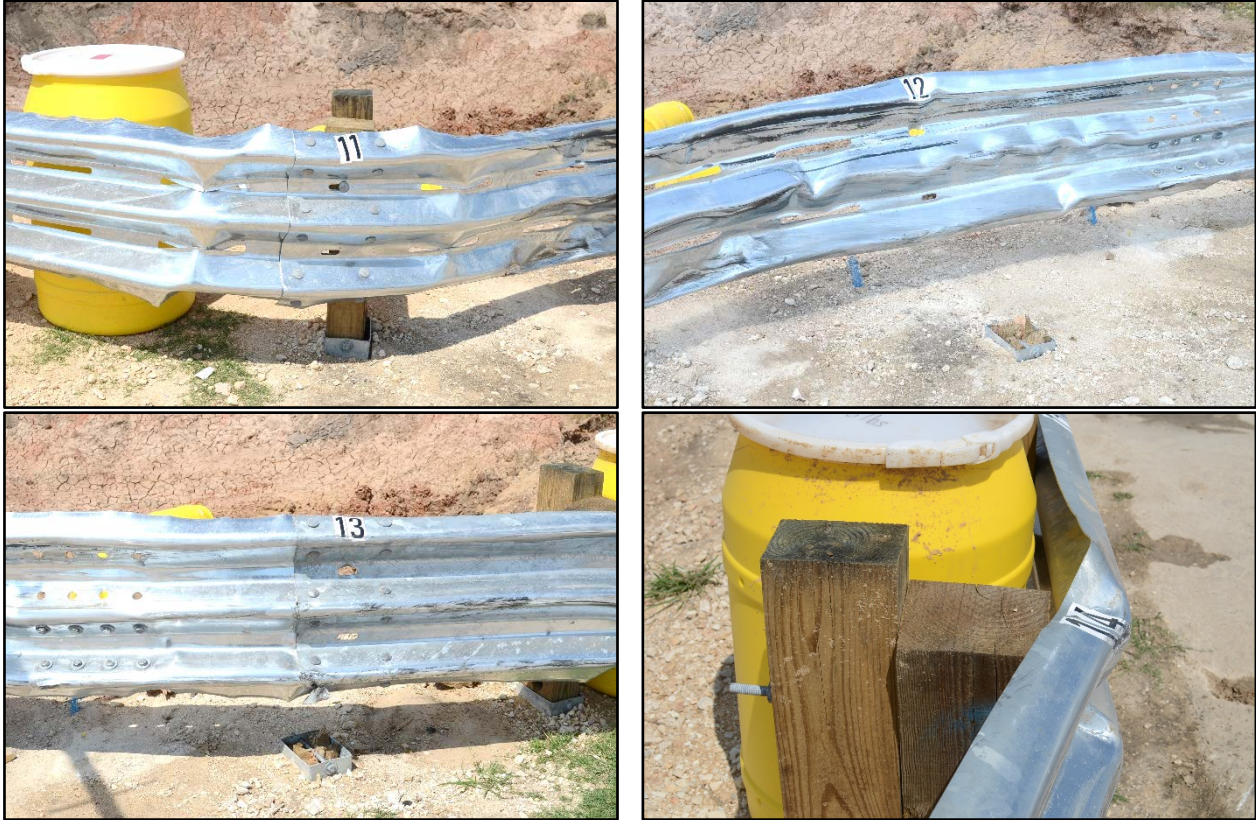
**Figure 9.5. Damage to Rail Section Parallel to Roadway after Test No. 469138-3-3.**

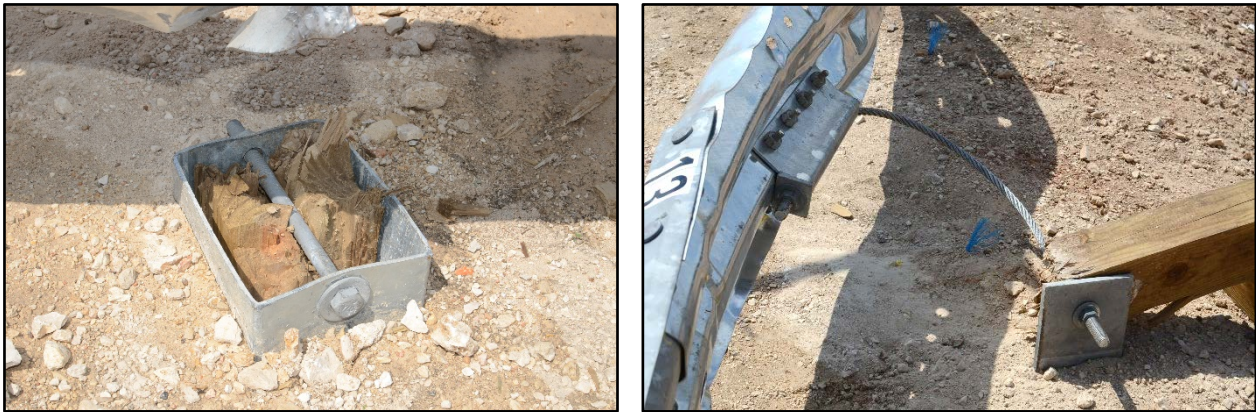
**Figure 9.6. Damage to Cable and Post 12 after Test No. 469138-3-3.**

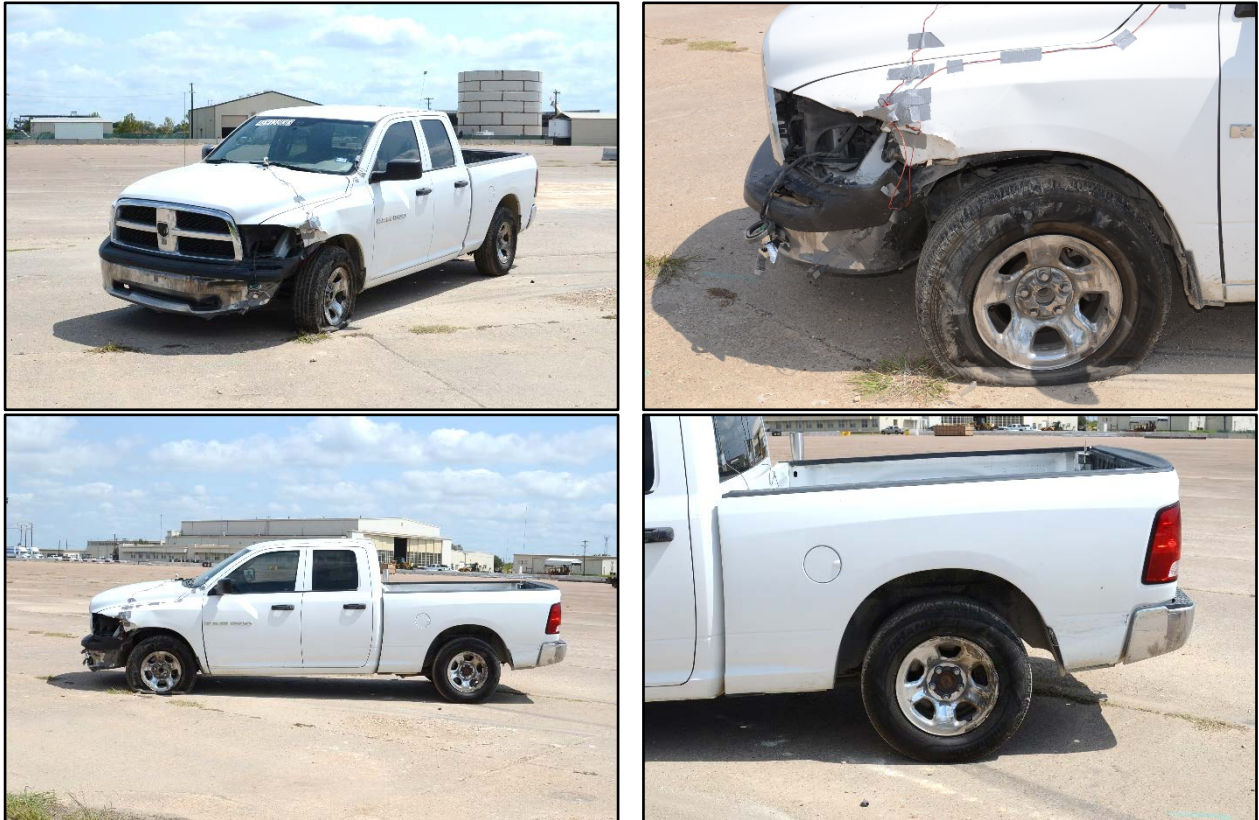
**Figure 9.7. Test Vehicle after Test No. 469138-3-3.**

Figure 9.7 shows the damage the vehicle sustained. The front bumper, grill, left front fender, left tire and rim, left rear rim, left rear exterior bed, and left rear bumper were damaged. Maximum exterior crush to the vehicle was 9.0 inches in the front plane at the left front corner at

bumper height. No occupant compartment deformation or intrusion occurred. Figure 9.8 shows the interior of the vehicle. Tables F.3 and F.4 in Appendix F.1 provide exterior crush and occupant compartment measurements.

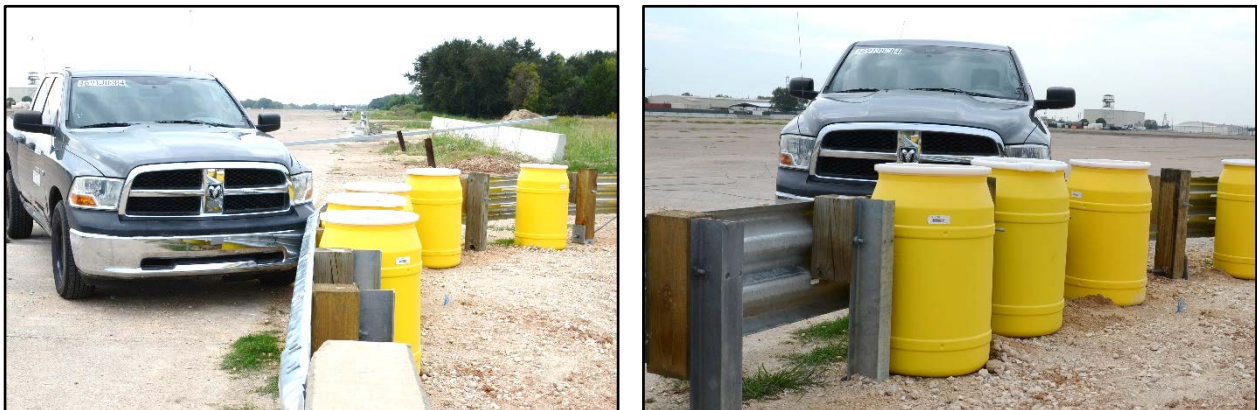
**Figure 10.1. TxDOT Low-Speed Short Radius Guardrail Treatment/Test Vehicle Geometrics for Test No. 469138-3-4.**

The 2012 Dodge RAM 1500 pickup truck, shown in Figures 10.1 and 10.2, was used for the crash test. The vehicle's test inertia weight was 5022 lb, and its gross static weight was 5022 lb. The height to the lower edge of the vehicle bumper was 11.25 inches, and height to the upper edge of the bumper was 26.5 inches. The height to the center of gravity of the vehicle was 28.62 inches. Tables G.1 and G.2 in Appendix G.1 give additional dimensions and information on the vehicle. The vehicle was directed into the installation using the cable reverse tow and guidance system, and was released to be freewheeling and unrestrained just prior to impact.

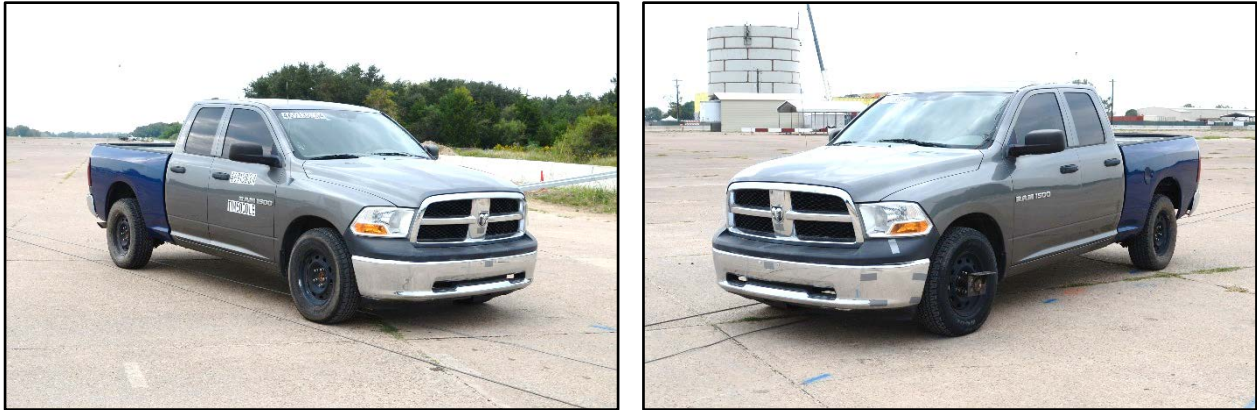
**Figure 10.2. Test Vehicle before Test No. 469138-3-4.**

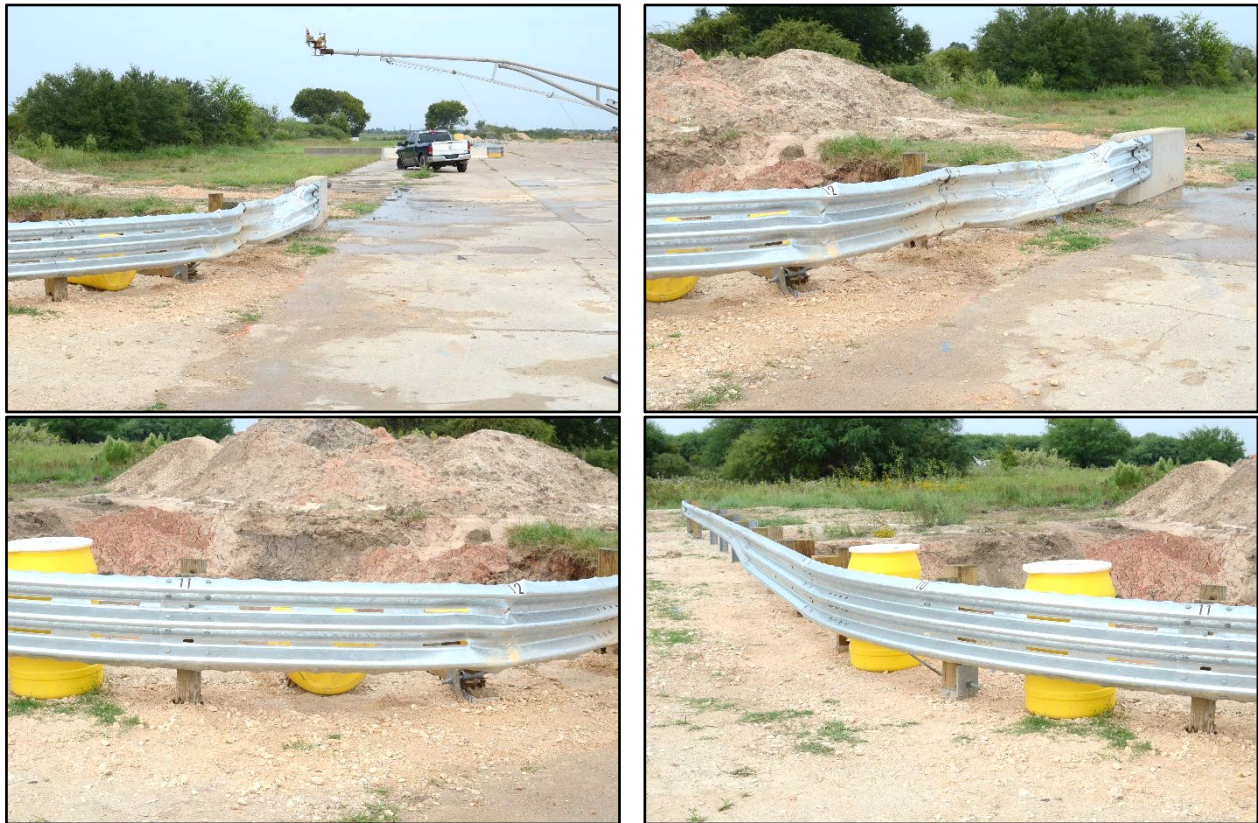
**Figure 10.3. TxDOT Low-Speed Short Radius Guardrail Treatment after Test No. 469138-3-4.**

Figures 10.3 through 10.6 show the damage to the TxDOT low-speed short radius guardrail treatment. The soil around posts 1 through 9 showed no signs of movement, and the soil around post 10 was disturbed. Post 11 fractured at the top of the foundation tube and leaning 83° toward the field side, but remained in place, and the tube was displaced through the soil 0.12 inch toward the field side. Posts 12 fractured at the top of the foundation tube, separated from the rail element, and resting toward the field side adjacent to the tube; the tube was displaced 0.5 inch toward the field side. Posts 13 fractured at the top of the foundation tube, remained attached to the rail element, and was resting 21.5 inches toward the field side. Post 14 fractured at the top of the foundation tube, separated from the rail element, and was resting 36 inches toward the field side. Post 15 was leaning 38° toward the parapet and 69° toward the field side. Post 16 was leaning 67° toward the parapet and 88° toward the field side and displaced through the soil 0.38 inch toward the field side. Working width was greater than 20 ft, and the height of maximum working width was 3.5 ft. Maximum dynamic deflection during the test was 2.6 ft, and maximum permanent deformation was 1.8 ft.

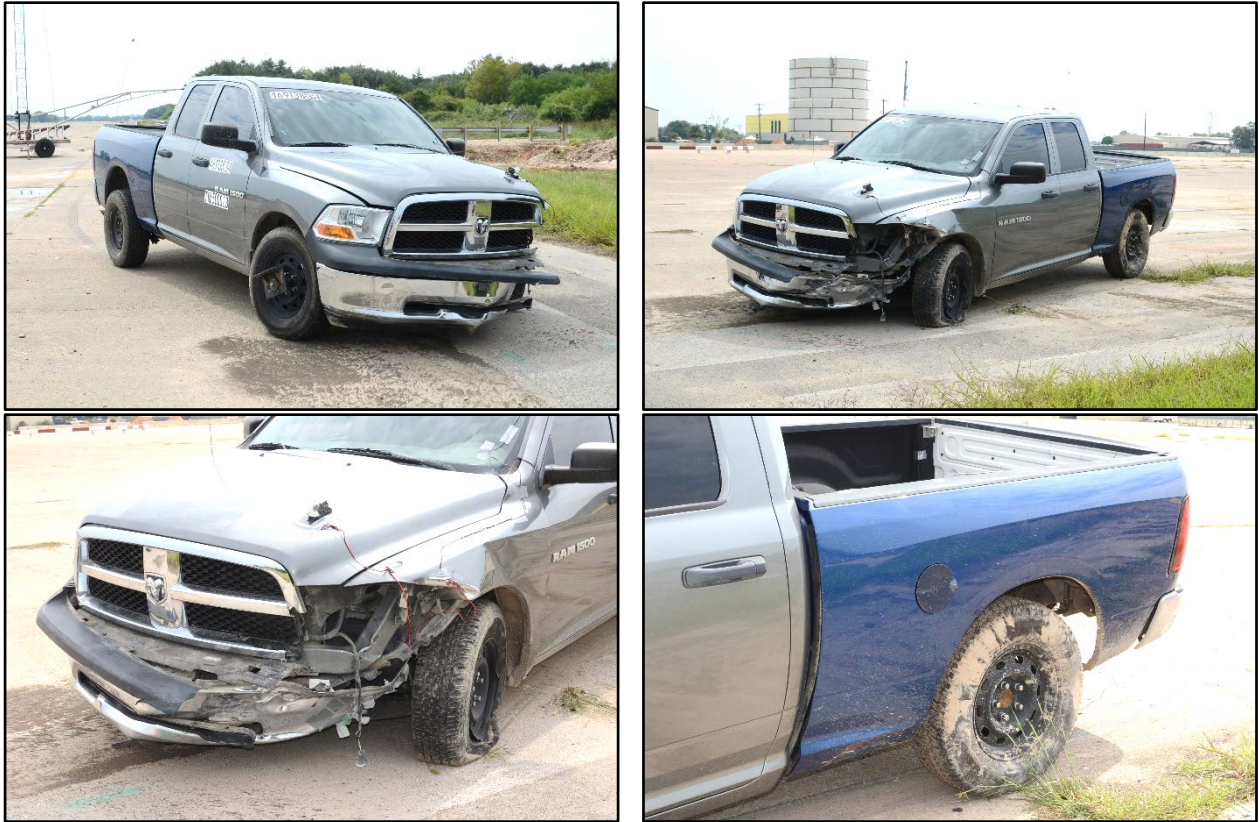
**Figure 10.6. Test Vehicle after Test No. 469138-3-4.**

Figure 10.6 shows the damage the vehicle sustained. The front bumper, grill, radiator support, left front fender, and left tire and rim were damaged. Maximum exterior crush to the vehicle was 10.0 inches in the front plane at the left front corner at bumper height. No occupant compartment deformation or intrusion occurred. Figure 10.7 shows the interior of the vehicle. Tables G.3 and G.4 in Appendix G.1 provide exterior crush and occupant compartment measurements.

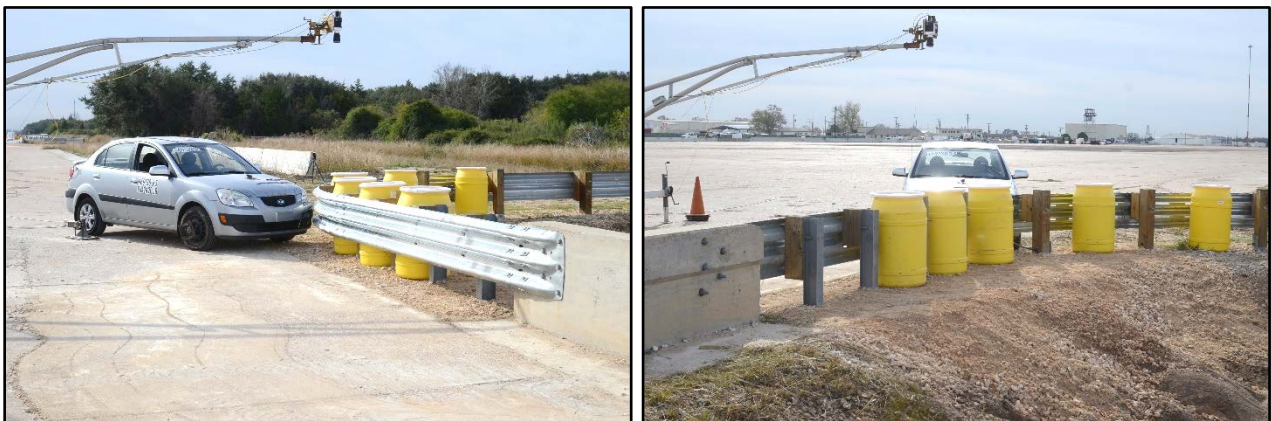
**Figure 11.1. TxDOT Low-Speed Short Radius Guardrail /Test Vehicle Geometrics for Test No. 469138-3-5.**

The 2009 Kia Rio, shown in Figures 11.1 and 11.2, was used for the crash test. The vehicle's test inertia weight was 2444 lb, and its gross static weight was 2609 lb. The height to the lower edge of the vehicle bumper was 7.75 inches, and height to the upper edge of the bumper was 21.0 inches. Table H.1 in Appendix H1 gives additional dimensions and information on the vehicle. The vehicle was directed into the installation using the cable reverse tow and guidance system, and was released to be freewheeling and unrestrained just prior to impact.
