# CRASH TEST AND EVALUATION OF TL-2 SHORT RADIUS GUARDRAIL TREATMENT

**Test Report 0-6913-R1**

**TEXAS A&M TRANSPORTATION INSTITUTE  
COLLEGE STATION, TEXAS**

**TEXAS DEPARTMENT OF TRANSPORTATION**

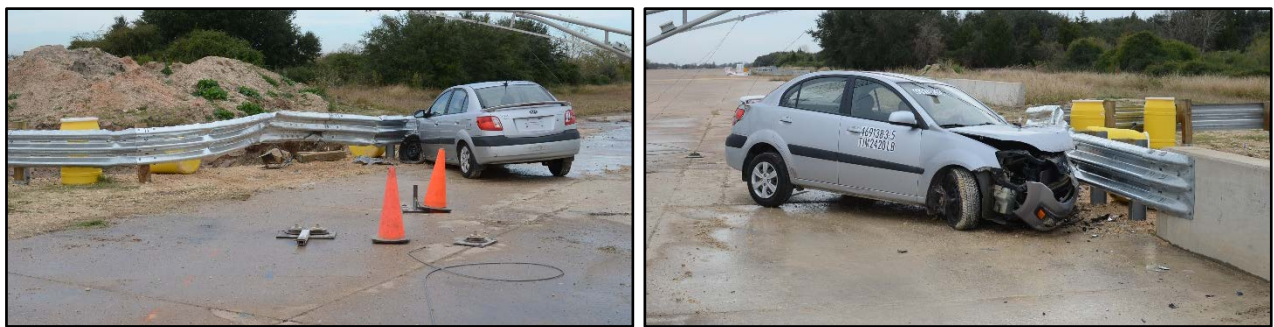
**Figure 11.3. TxDOT Low-Speed Short Radius Guardrail/Test Vehicle after Test No. 469138-3-5.**

Figure 11.3 shows the damage to the TxDOT low-speed short radius guardrail treatment. The soil around post 10 was disturbed, and post 11 was fractured near ground level and leaning 84° toward the field side. Posts 12–14 fractured at ground level and separated from the rail element. Posts 15 and 16 were pushed toward the field side 0.25 inch and 0.12 inch, respectively. Drums 1 and 2 were undisturbed, and drums 3 and 6 were overturned. Drums 4 and 5 were resting at the bottom of the slope. Working width was 5.8 ft at a height of 3.2 ft. Maximum dynamic deflection during the test was 5.0 ft, and maximum permanent deformation was 3.7 ft.

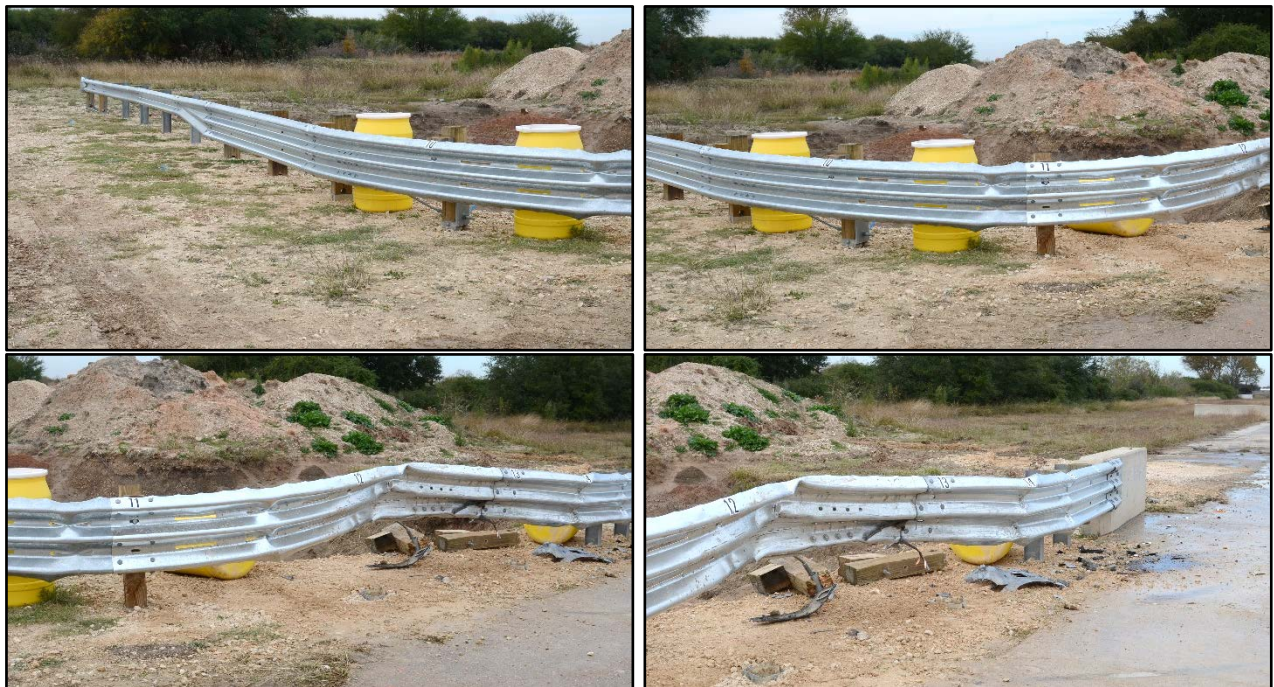
**Figure 11.4. TxDOT Low-Speed Short Radius Guardrail after Test No. 469138-3-5.**

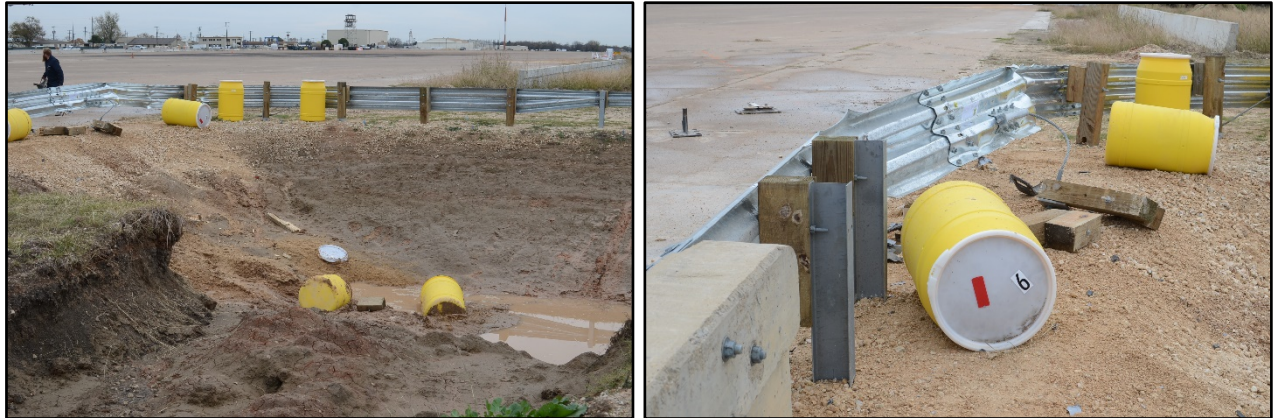
**Figure 11.5. Rear of Installation after Test No. 469138-3-5.**

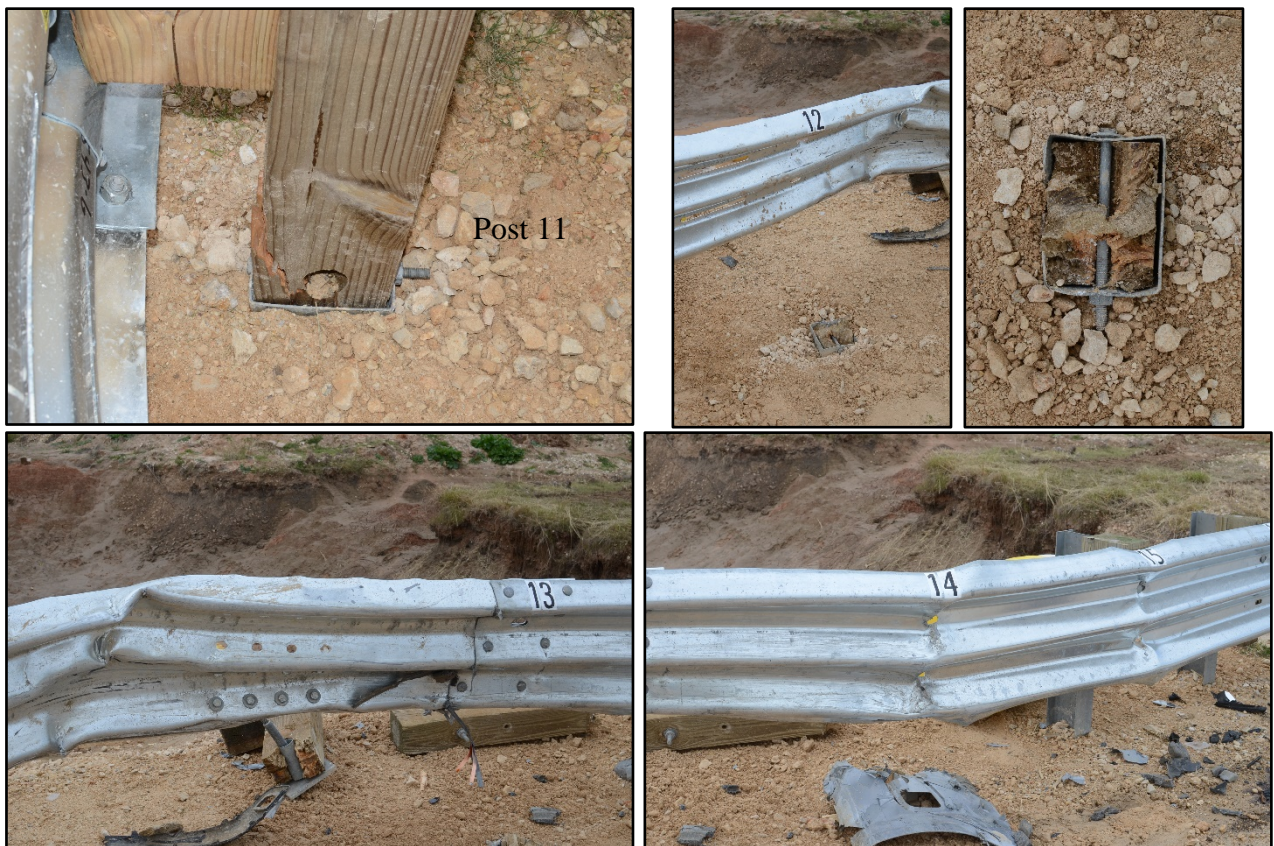
**Figure 11.6. Posts 11 through 14 after Test No. 469138-3-5.**

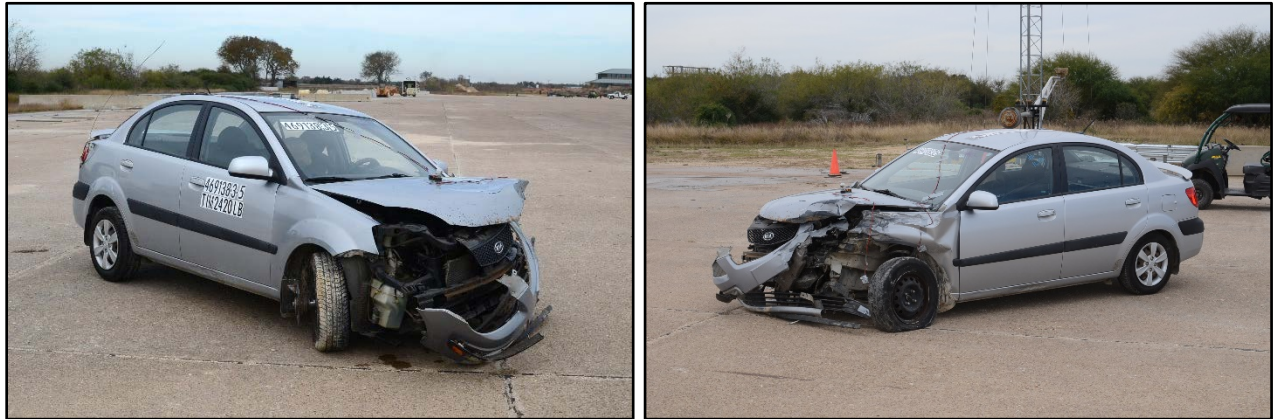
**Figure 11.7. Test Vehicle after Test No. 469138-3-5.**

Figure 11.4 shows the damage sustained by the vehicle. The front bumper, grill, radiator and support, hood, left and right front fender, left front tire and rim, and left front subframe were damaged. Maximum exterior crush to the vehicle was 26.0 inches in the front plane at the left front corner at bumper height. No occupant compartment deformation or intrusion was noted.

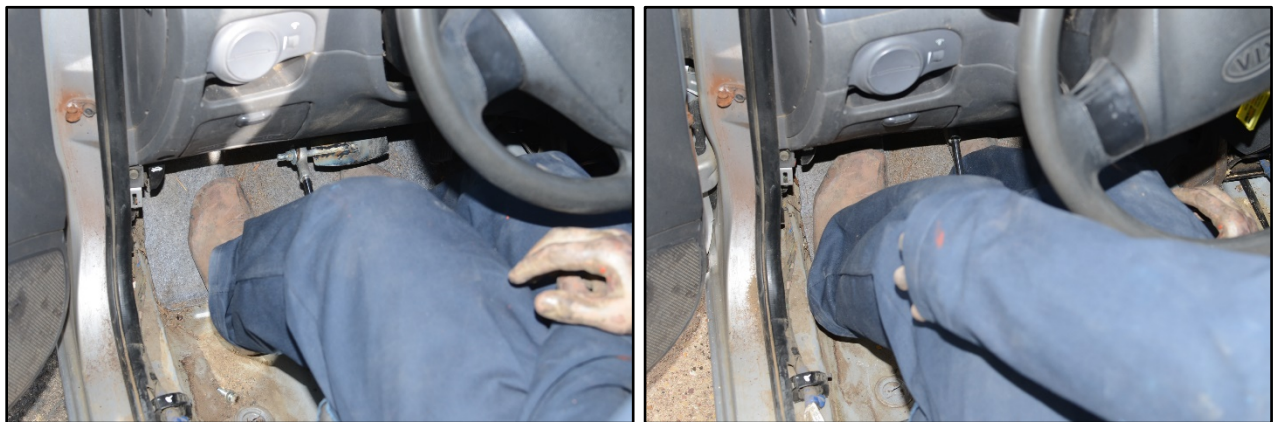
**Figure 11.8. Interior of Test Vehicle for Test No. 469138-3-5.**

Figure 11.5 shows the interior of the vehicle. Tables H.2 and H.3 in Appendix H1 provide exterior crush and occupant compartment measurements.

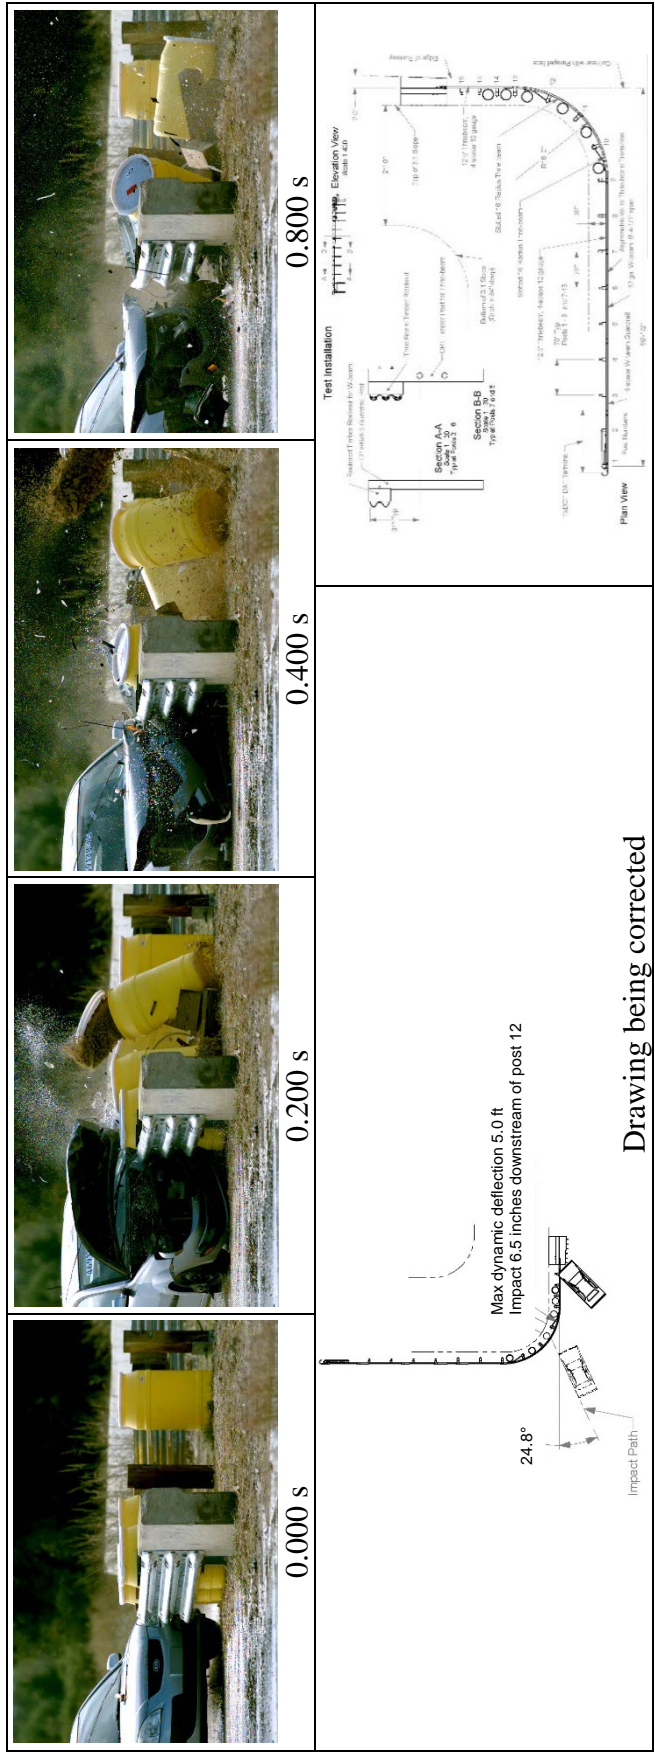
Test Agency..... Texas A&M Transportation Institute (TTI)  
 Test Standard Test No. .... Modified MASH Test 2-34  
 TTI Test No. .... 469138-3-5  
 Test Date ..... 2017-12-14

Data from the accelerometer, located at the vehicle center of gravity, were digitized for evaluation of occupant risk and are shown in Table 11.2. Figure 11.6 summarizes these data and other pertinent information from the test. Figure H.2 in Appendix H3 shows the vehicle angular displacements, and Figures H.3 through H.8 in Appendix H4 show accelerations versus time traces.

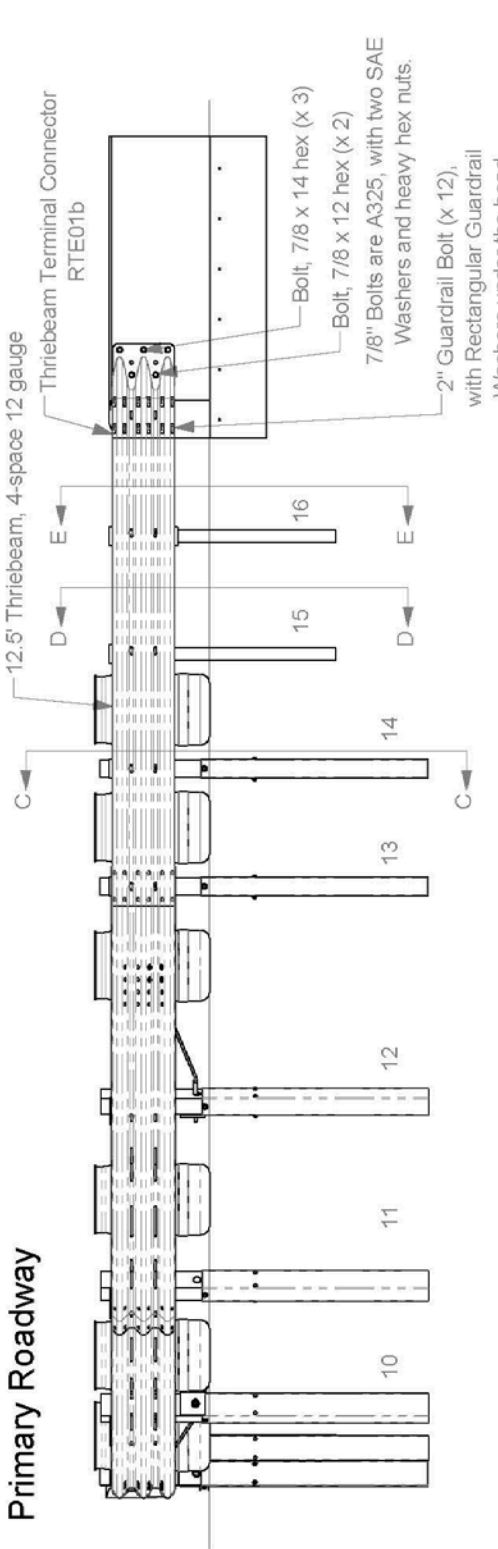
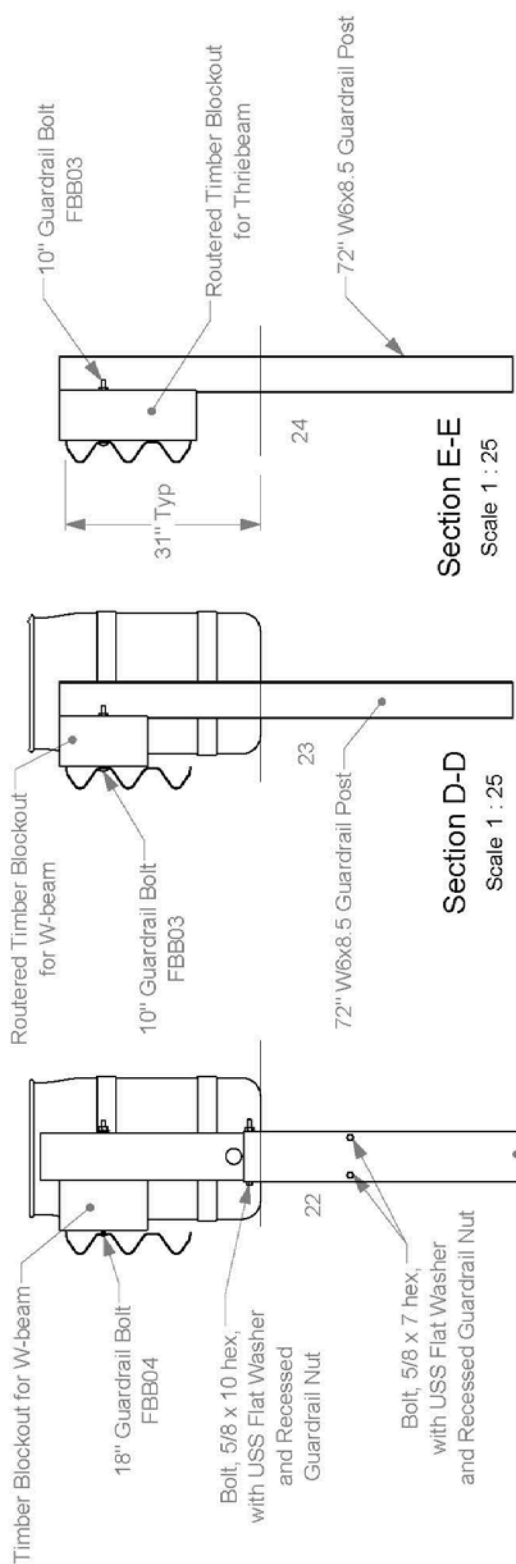
Roadside Safety and Physical Security Division - Proving Ground	
	Project 469137 1-2	16' Radius Guardrail with 3:1 Slope
Drawn By GES	Scale 1:50	Sheet 4 of 12
		2017-08-17
		Primary Roadway

**Section C-C**  
Scale 1 : 25  
All Post components  
Typical at 9 - 14

**Section D-D**  
Scale 1 : 25

**Section E-E**  
Scale 1 : 25

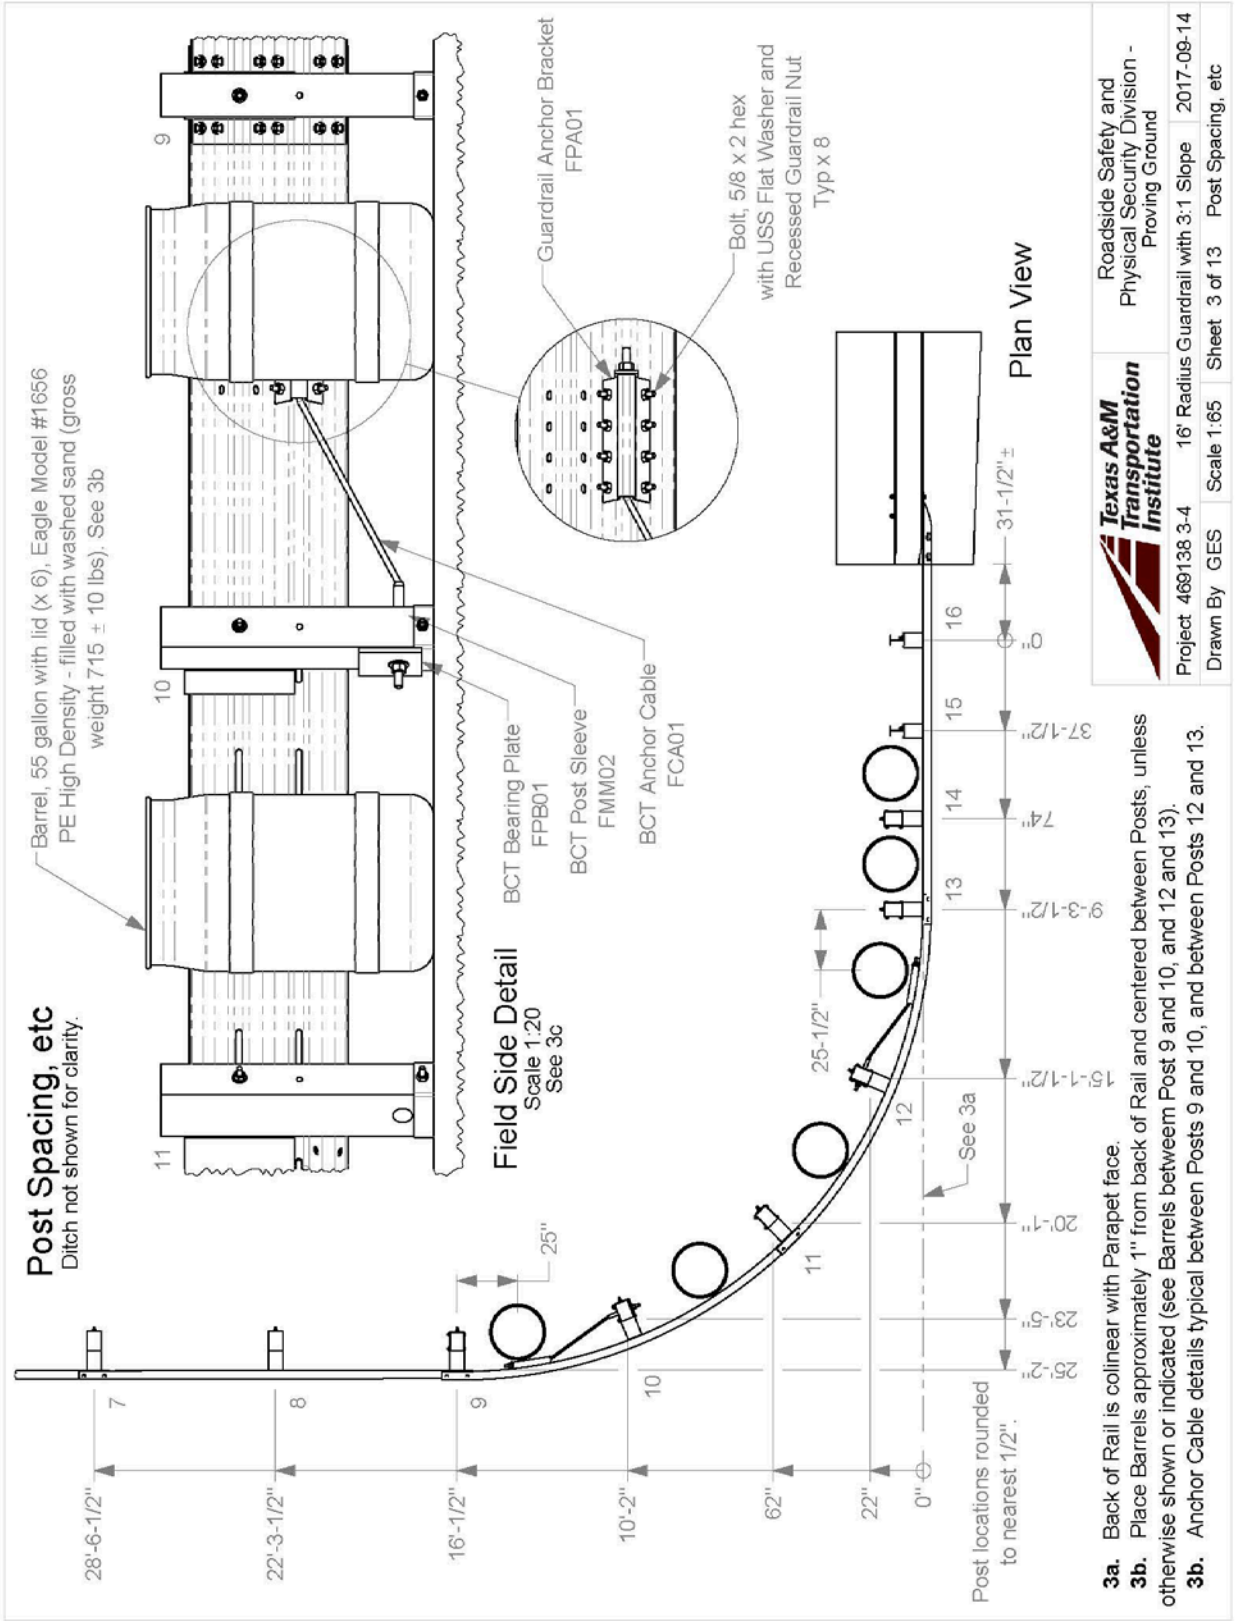
Roadside Safety and Physical Security Division - Proving Ground		
	Project 469138 3-4	16' Radius Guardrail with 3:1 Slope	2017-09-14
Drawn By GES	Scale 1:65	Sheet 3 of 13	Post Spacing, etc

- 3a.** Back of Rail is colinear with Parapet face.
- 3b.** Place Barrels approximately 1" from back of Rail and centered between Posts, unless otherwise shown or indicated (see Barrels between Post 9 and 10, and 12 and 13).
- 3b.** Anchor Cable details typical between Posts 9 and 10, and between Posts 12 and 13.

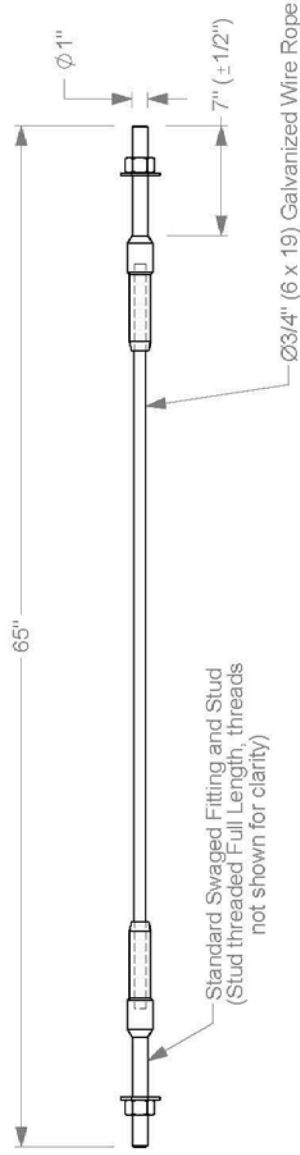
## Anchor Cable for Short Radius Rail

**13a.** The Stud shall conform to the requirements of ASTM A449 and shall be galvanized in accordance with ASTM A153. The threads shall have a Class 2A fit before galvanizing.

**13b.** The Wire Rope shall conform to the requirements of AASHTO M-30 and shall be Ø3/4", pre-formed, 6 x 19, wire strand core or independent wire rope core (IWRC), galvanized, right regular lay, manufactured of improved plow steel with a minimum breaking strength of 46,000 lbs.

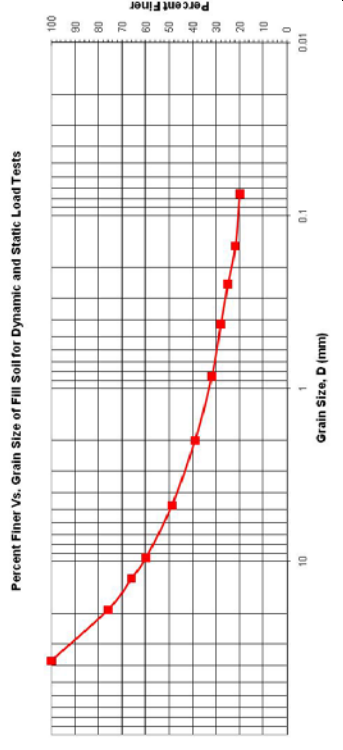
<p style="font-size: x-small;">Percent Finer Vs. Grain Size of Fill Soil for Dynamic and Static Load Tests</p>

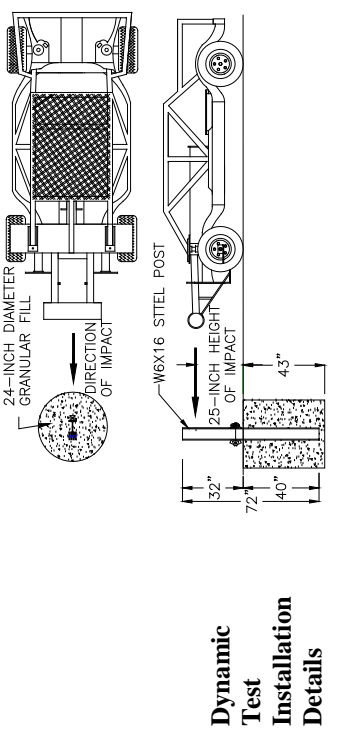
<p><b>Dynamic Test Installation Details</b></p>

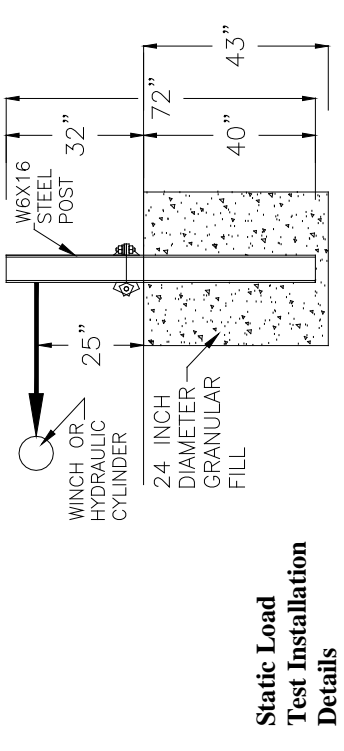
<p><b>Static Load Test Installation Details</b></p>

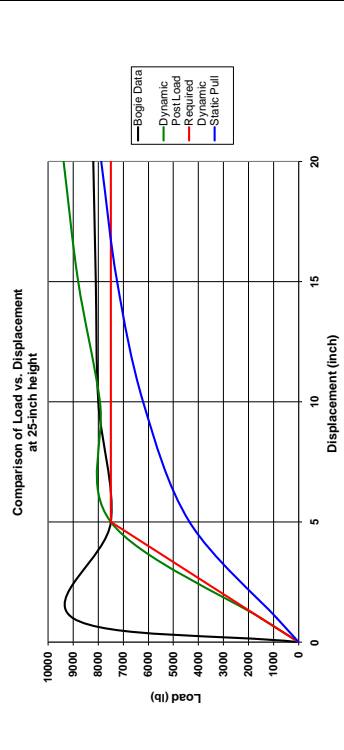
<p style="font-size: x-small;">Comparison of Load vs. Displacement at 25-inch height</p>				
<p><b>Date</b> ..... 2008-11-05</p> <p><b>Test Facility and Site Location</b> ..... TTI Proving Ground, 3100 SH 47, Bryan, TX 77807</p> <p><b>In Situ Soil Description (ASTM D2487)</b> ..... Sandy gravel with silty fines</p> <p><b>Fill Material Description (ASTM D2487) and sieve analysis</b> ..... AASHTO Grade B Soil-Aggregate (see sieve analysis above)</p> <p><b>Description of Fill Placement Procedure</b> ..... 6-inch lifts tamped with a pneumatic compactor</p> <p><b>Bogie Weight</b> ..... 5009 lb</p> <p><b>Impact Velocity</b> ..... 20.5 mph</p>

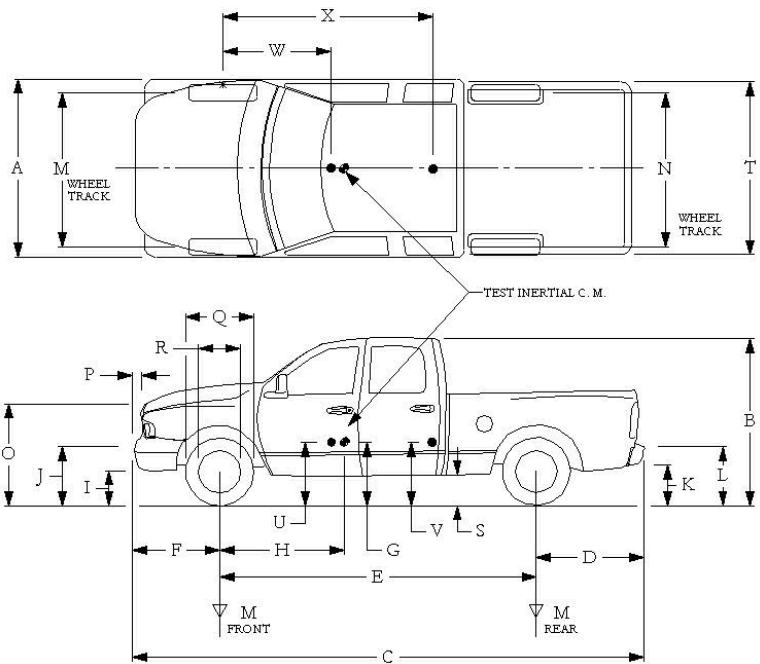
**Geometry:** inches

A	<u>78.50</u>	F	<u>40.00</u>	K	<u>20.75</u>	P	<u>3.00</u>	U	<u>27.25</u>
B	<u>75.00</u>	G	<u>28.38</u>	L	<u>29.50</u>	Q	<u>30.50</u>	V	<u>30.25</u>
C	<u>227.50</u>	H	<u>62.00</u>	M	<u>68.50</u>	R	<u>18.00</u>	W	<u>62.00</u>
D	<u>47.00</u>	I	<u>11.00</u>	N	<u>68.00</u>	S	<u>13.25</u>	X	<u>77.00</u>
E	<u>140.50</u>	J	<u>26.50</u>	O	<u>46.00</u>	T	<u>77.00</u>		
Wheel Center Height Front	<u>14.75</u>	Wheel Well Clearance (Front)	<u>6.00</u>	Wheel Well Clearance (Rear)	<u>9.25</u>	Bottom Frame Height - Front	<u>17.00</u>	Bottom Frame Height - Rear	<u>25.50</u>

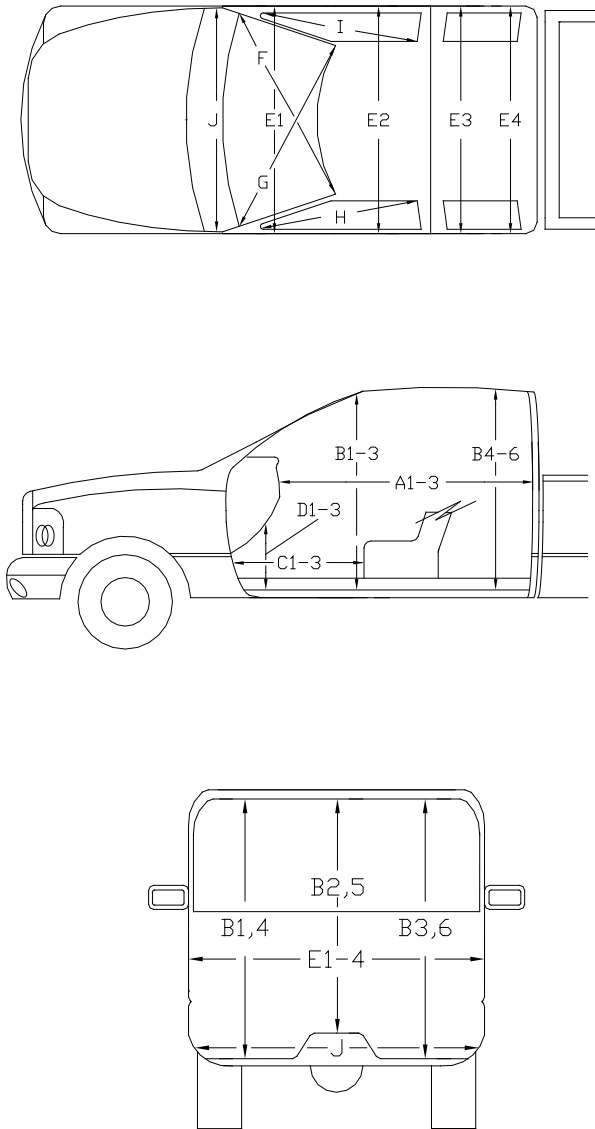
**OCCUPANT COMPARTMENT DEFORMATION MEASUREMENT**

Before	After (inches)	Differ.
A1	65.25	65.25	0
A2	63.25	63.25	0
A3	65.50	65.50	0
B1	44.50	44.50	0
B2	38.00	38.00	0
B3	44.50	44.50	0
B4	39.50	39.50	0
B5	43.00	43.00	0
B6	39.50	39.50	0
C1	26.00	26.00	0
C2	-----	-----	-
C3	26.00	26.00	0
D1	11.50	11.50	0
D2	-----	-----	-
D3	11.50	11.50	0
E1	58.75	58.75	0
E2	63.50	63.50	0
E3	63.50	63.50	0
E4	63.50	63.50	0
F	59.00	59.00	0
G	59.00	59.00	0
H	37.50	37.50	0
I	37.50	37.50	0
J*	23.25	23.25	0

\*Lateral area across the cab from driver's side kickpanel to passenger's side kickpanel.

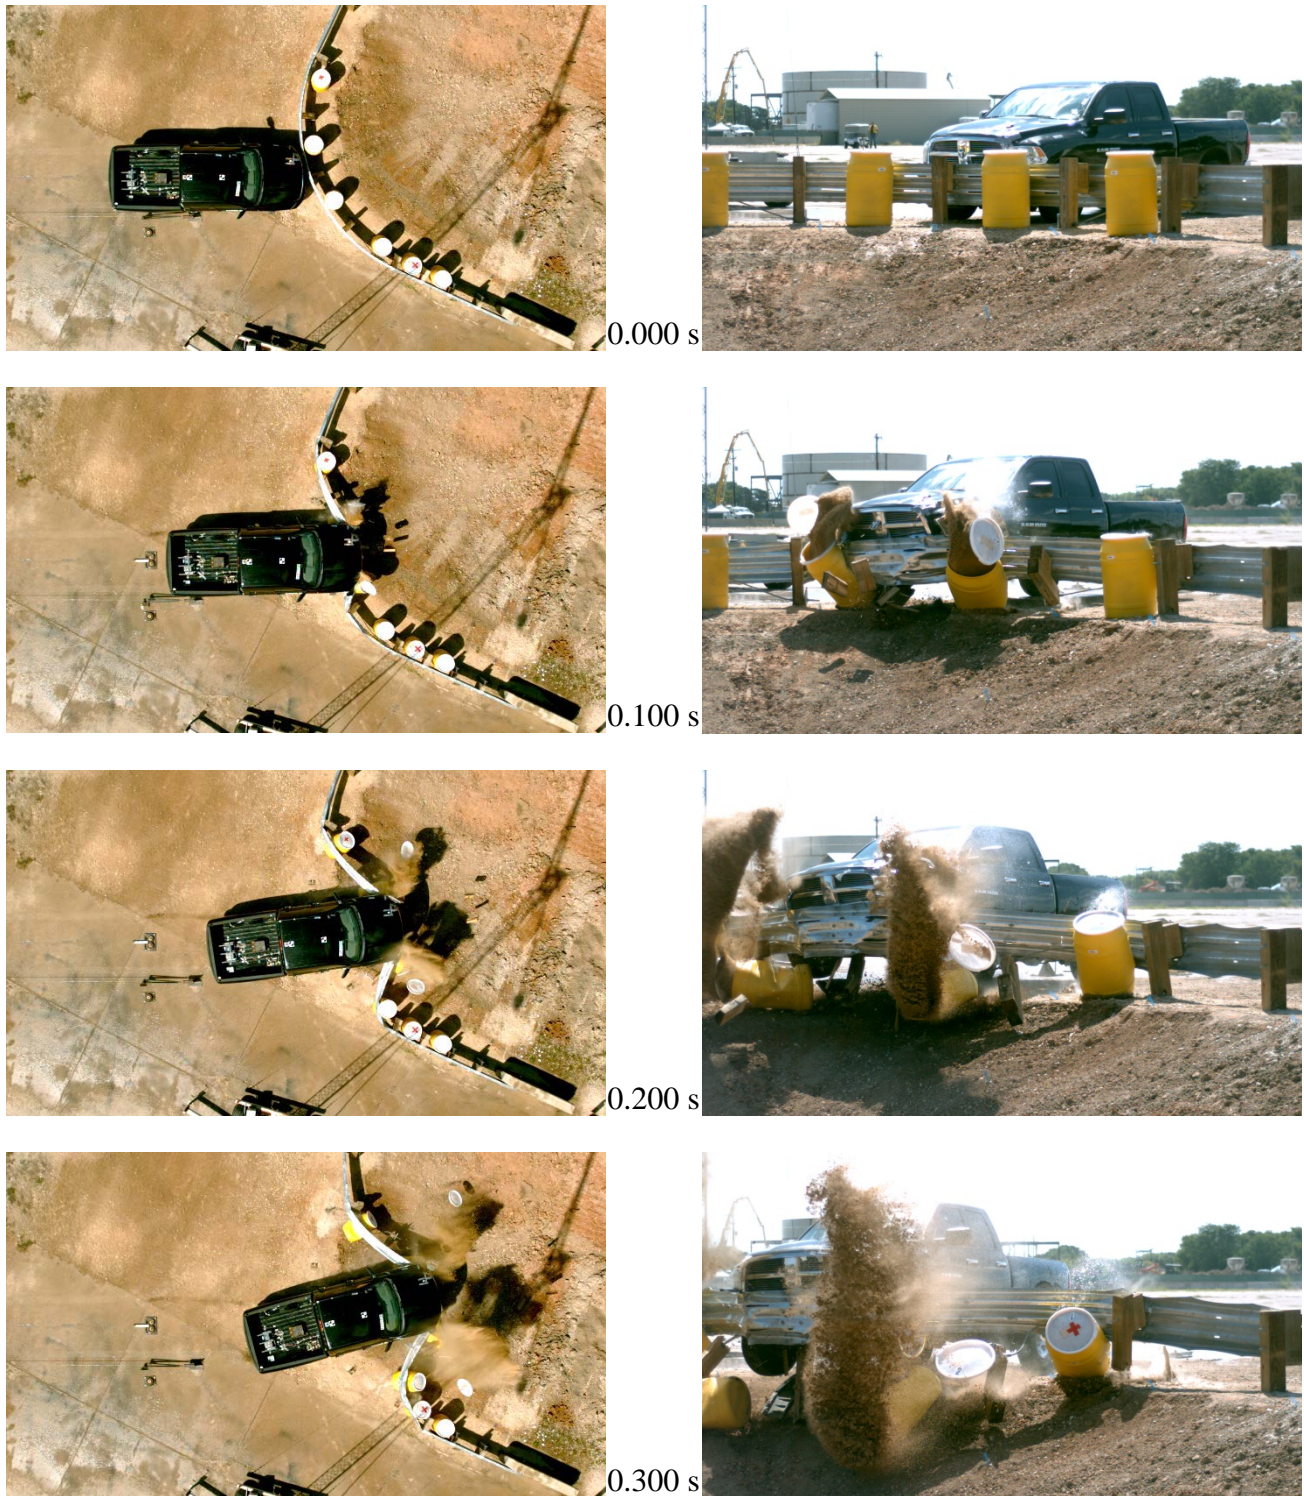
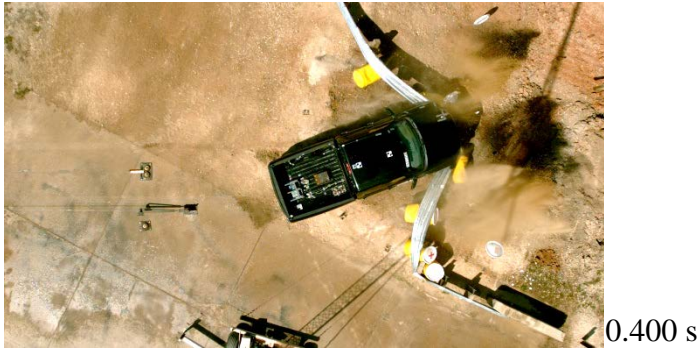
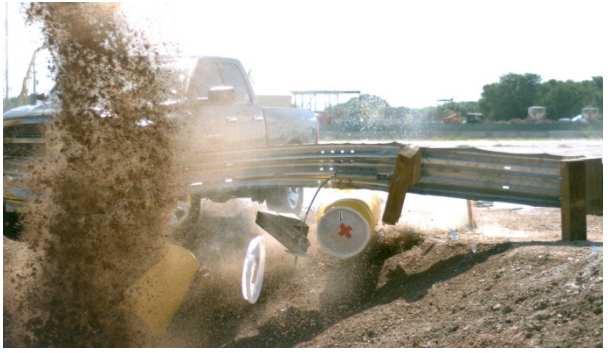
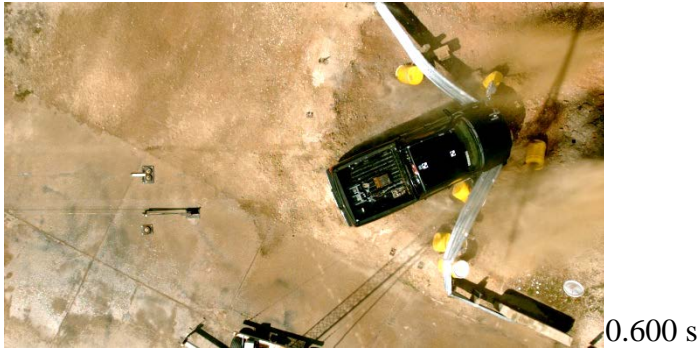
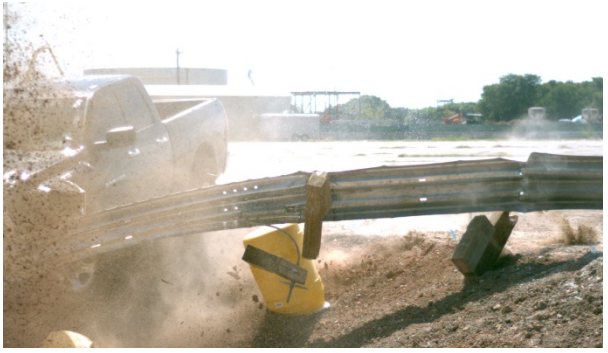
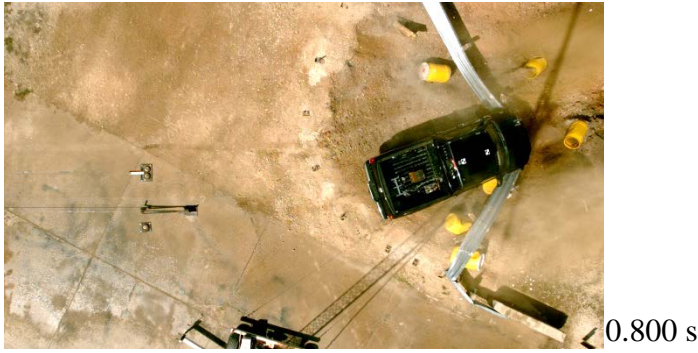
Figure D.1. Sequential Photographs for Test No. 469137-3-1 (Overhead and Rear Views).

**Figure D.1. Sequential Photographs for Test No. 469137-3-1 (Overhead and Rear Views)  
(Continued).**

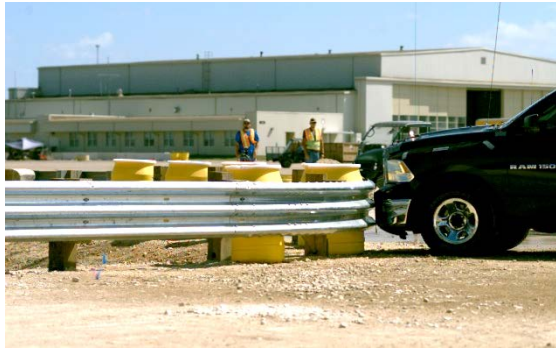
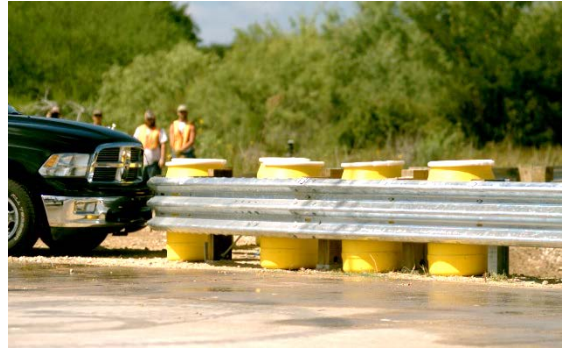
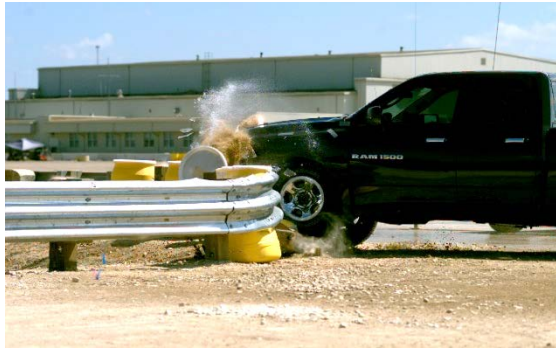
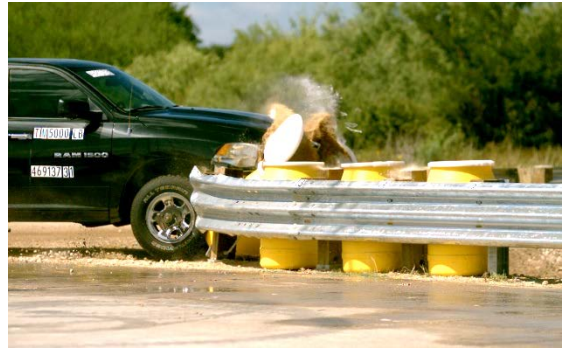
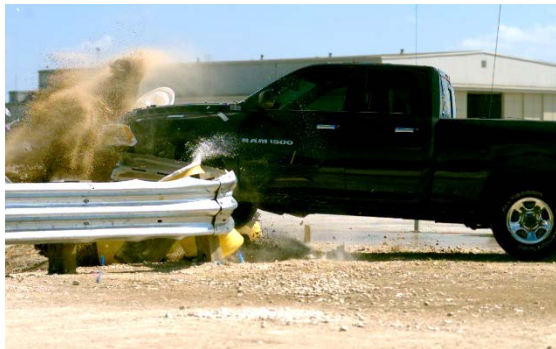
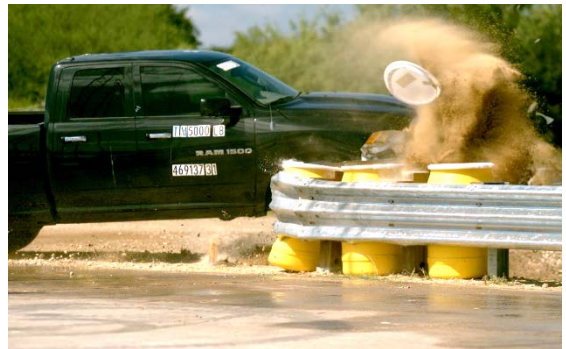
**Figure D.2. Sequential Photographs for Test No. 469137-3-1 (Perpendicular Views).**

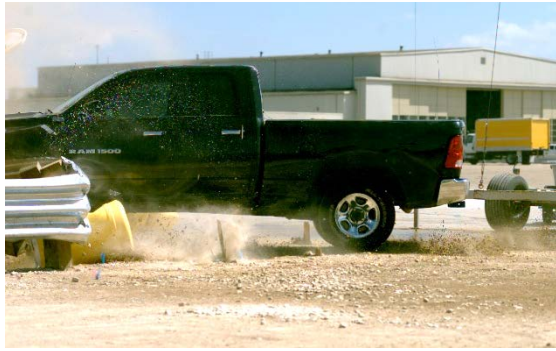
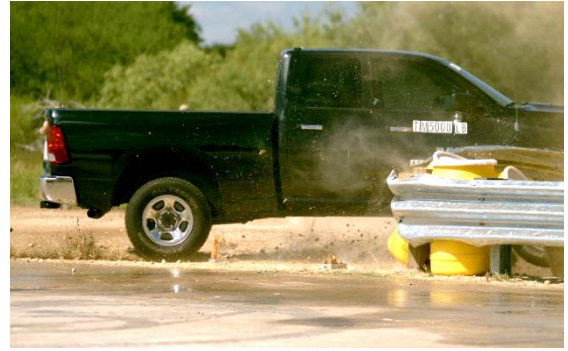
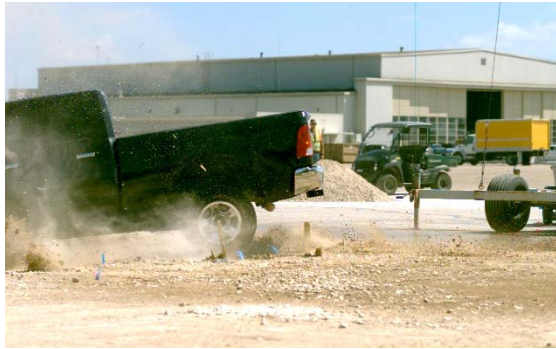
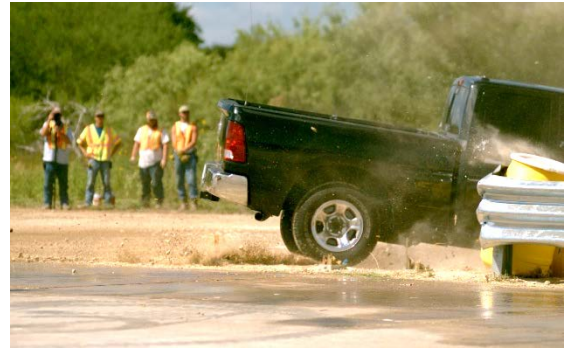
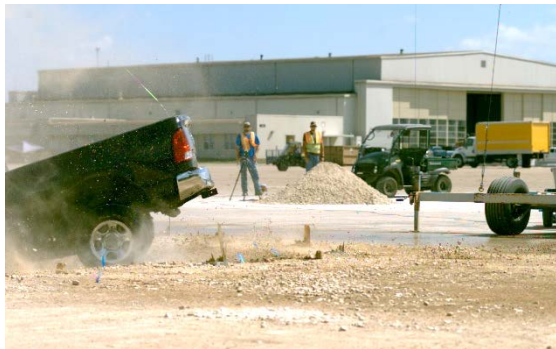
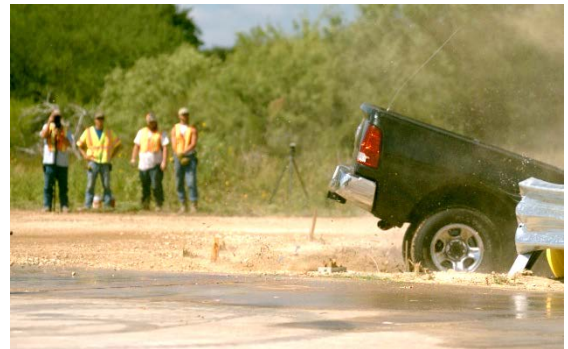
**Figure D.2. Sequential Photographs for Test No. 469137-3-1 (Perpendicular Views)  
(Continued).**

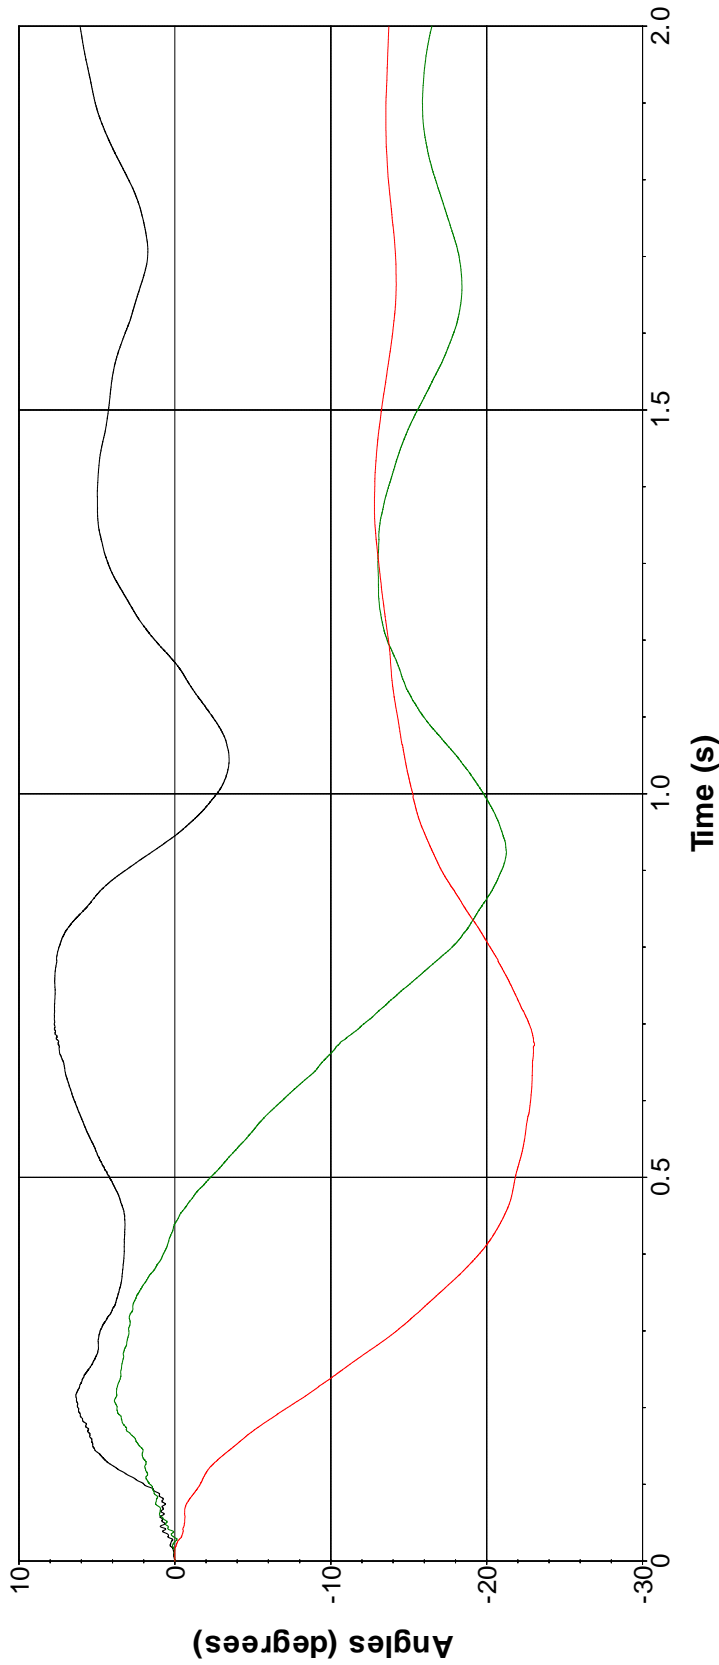
— Roll — Pitch — Yaw

Test Number: 469137-3-1  
 Test Standard Test Number: MASH Test 2-33  
 Test Article: TxDOT Low-Speed Short Radius Guardrail Treatment  
 Test Vehicle: 2011 Dodge RAM 1500 Pickup Truck  
 Inertial Mass: 5039 lb  
 Gross Mass: 5039 lb  
 Impact Speed: 44.8 mi/h  
 Impact Angle: 25.5°

**Figure D.3. Vehicle Angular Displacements for Test No. 469137-3-1.**

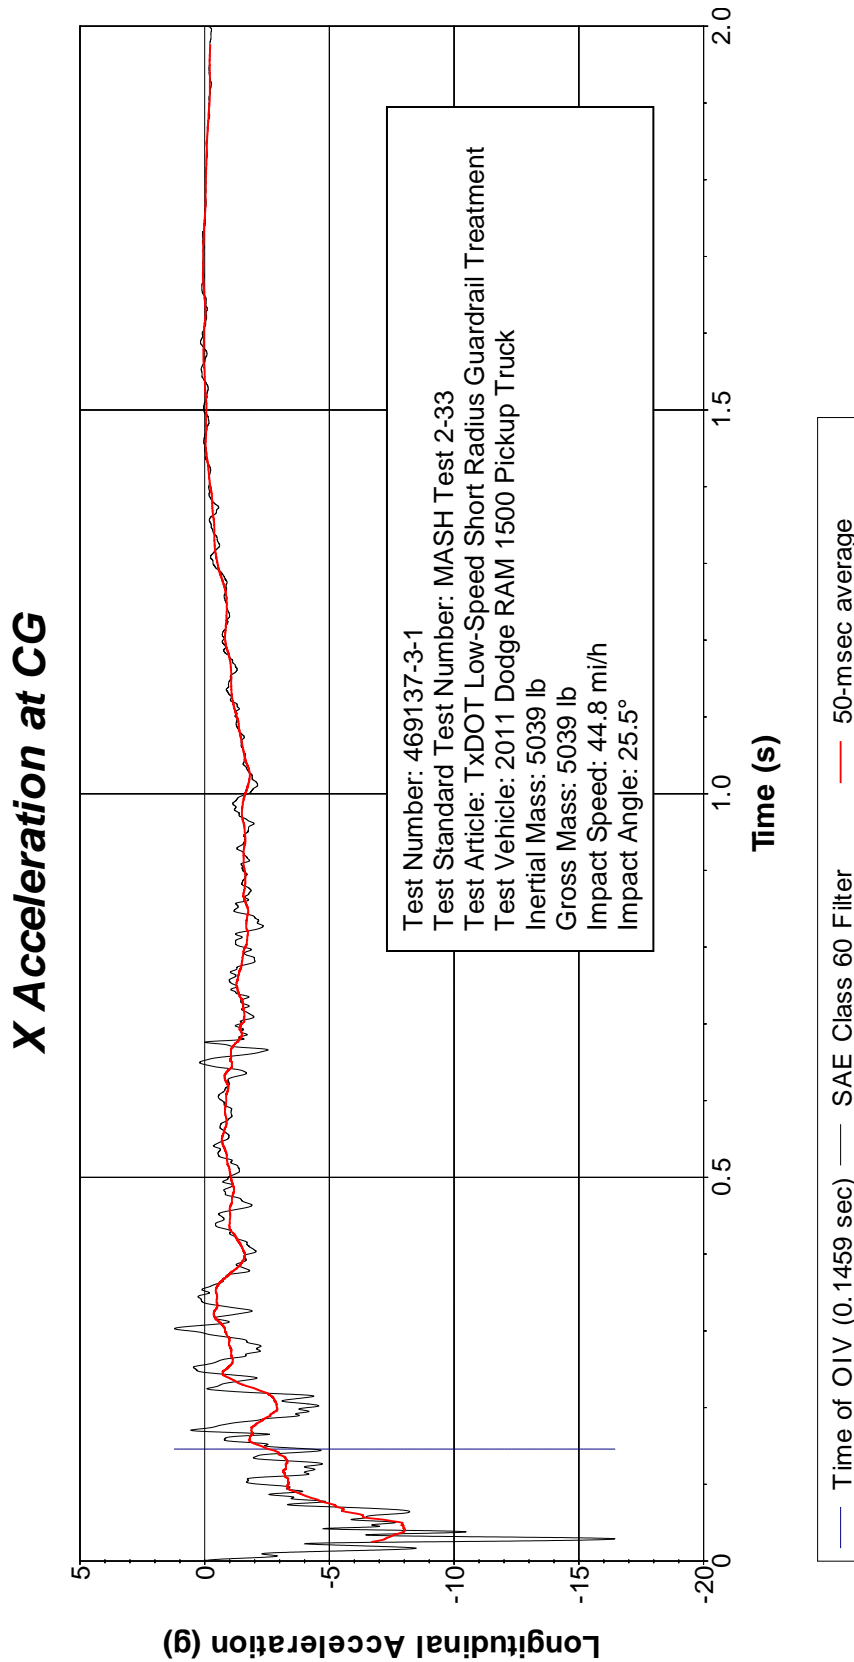
Figure D.4. Vehicle Longitudinal Accelerometer Trace for Test No. 469137-3-1 (Accelerometer Located at Center of Gravity).

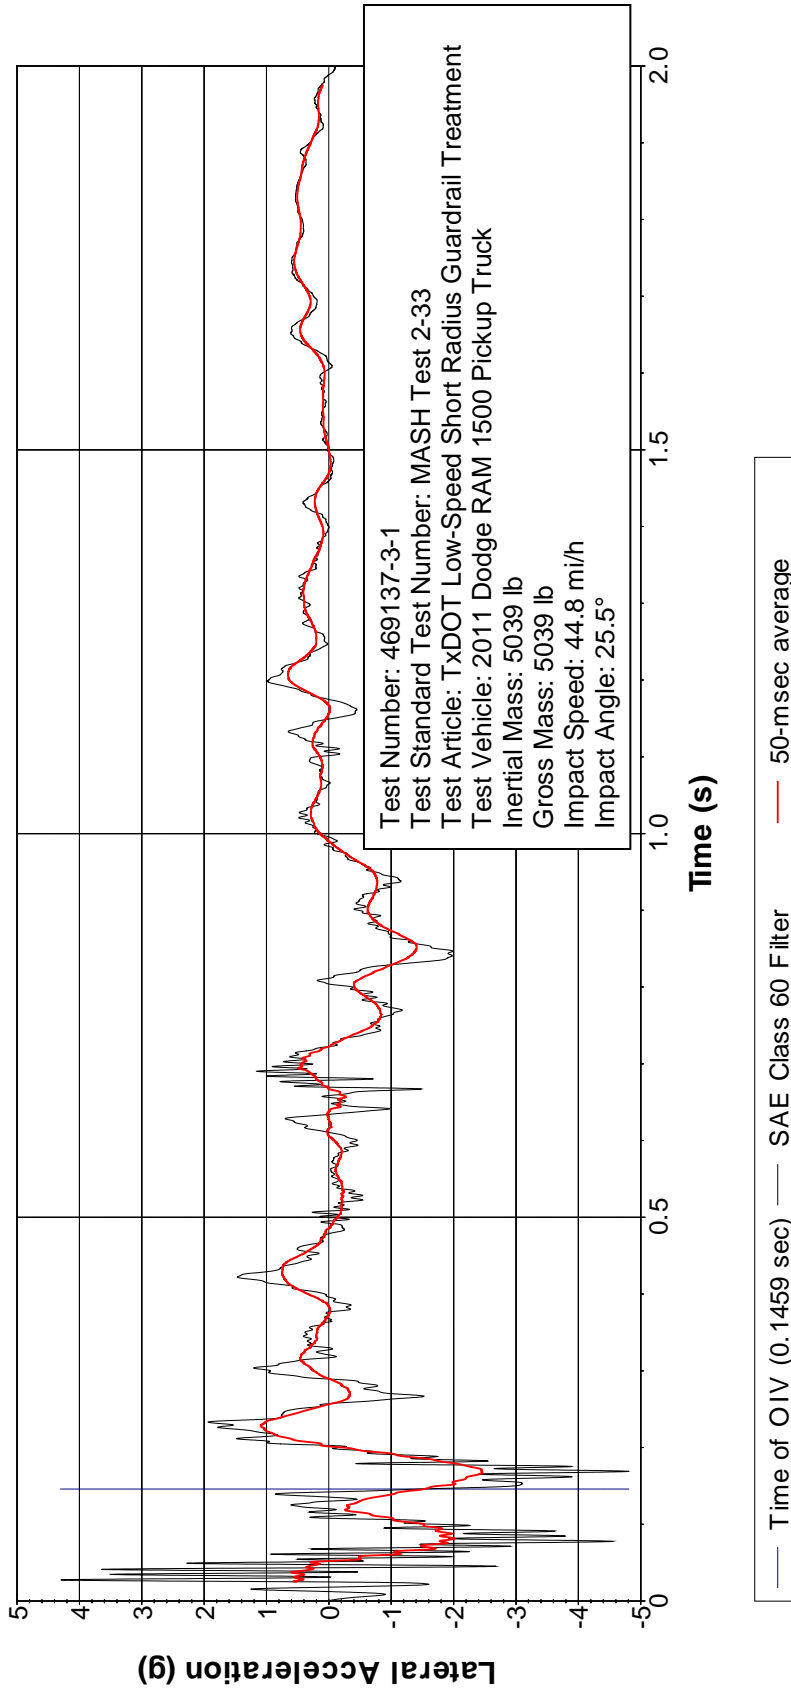
**Figure D.5. Vehicle Lateral Accelerometer Trace for Test No. 469137-3-1 (Accelerometer Located at Center of Gravity).**
