# CRASH TEST AND EVALUATION OF TL-2 SHORT RADIUS GUARDRAIL TREATMENT

**Test Report 0-6913-R1**

**TEXAS A&M TRANSPORTATION INSTITUTE  
COLLEGE STATION, TEXAS**

**TEXAS DEPARTMENT OF TRANSPORTATION**

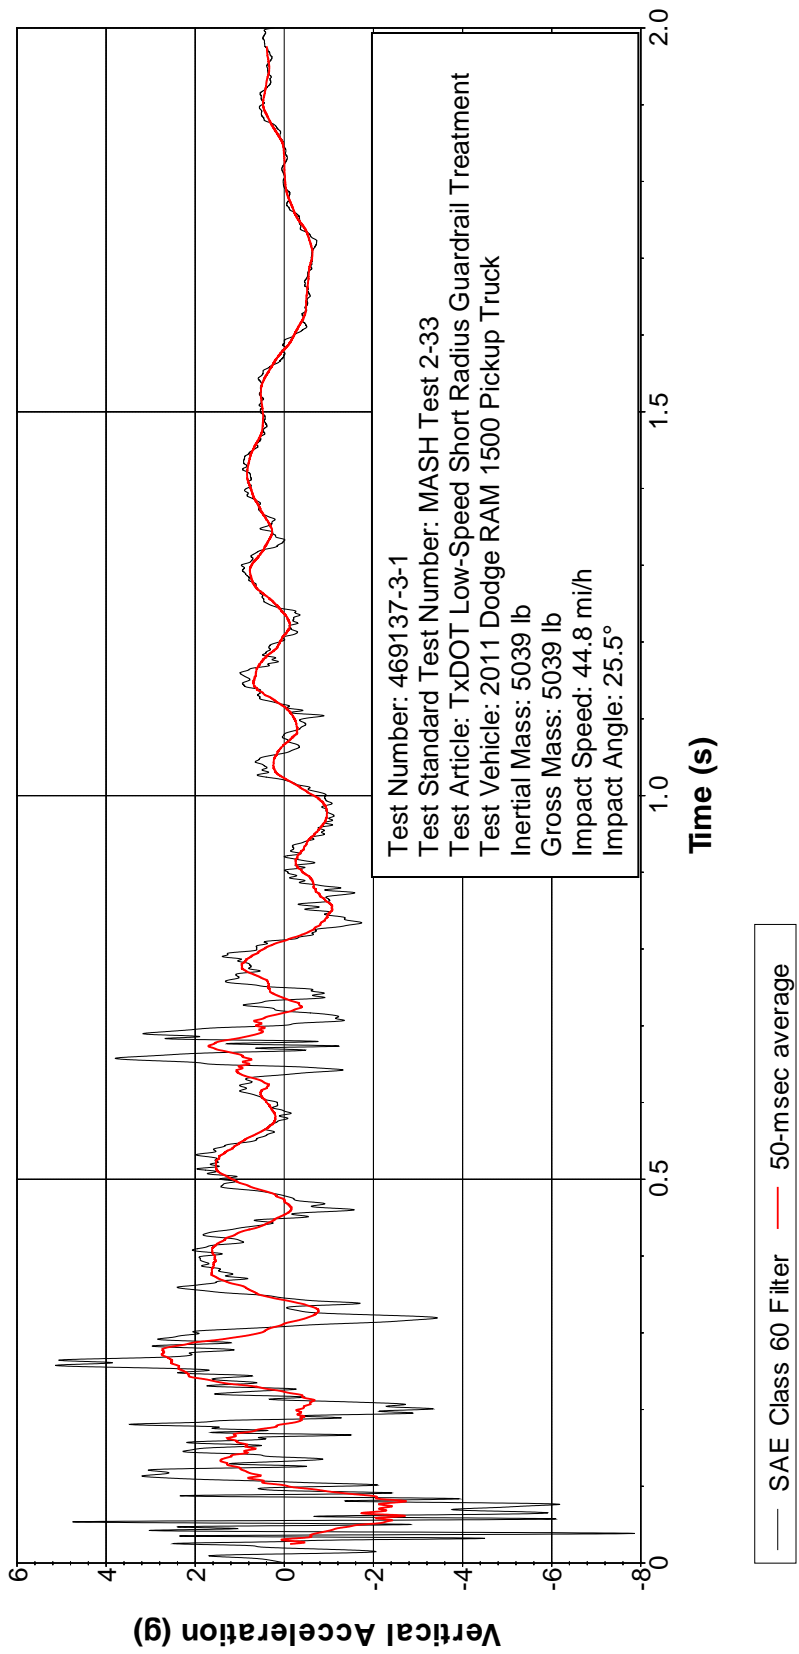
**Figure D.6. Vehicle Vertical Accelerometer Trace for Test No. 469137-3-1 (Accelerometer Located at Center of Gravity).**

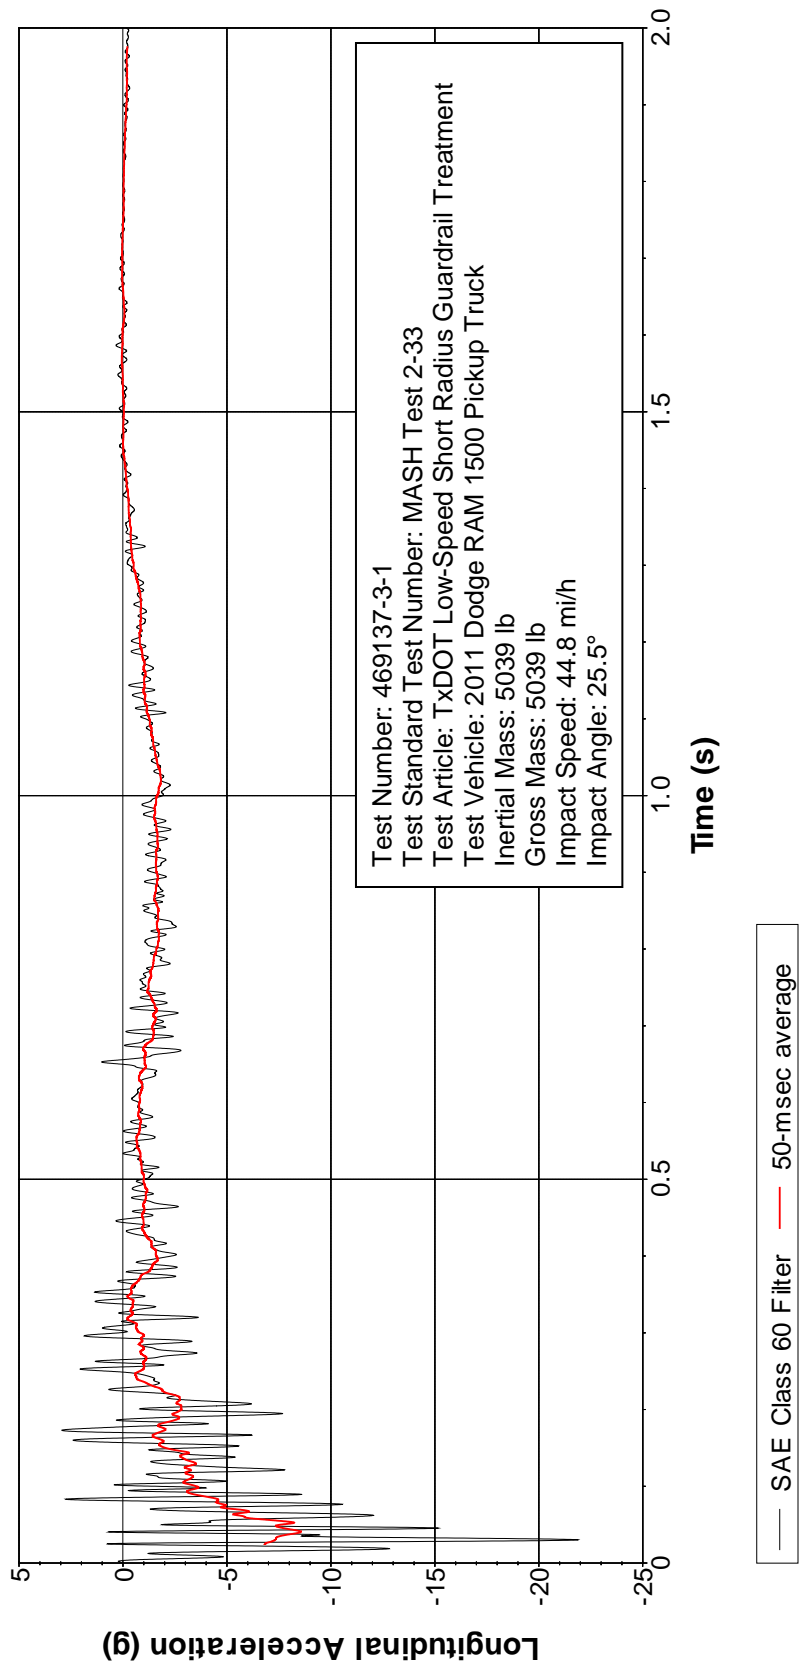
**Figure D.7. Vehicle Longitudinal Accelerometer Trace for Test No. 469137-3-1 (Accelerometer Located Rear of Center of Gravity).**

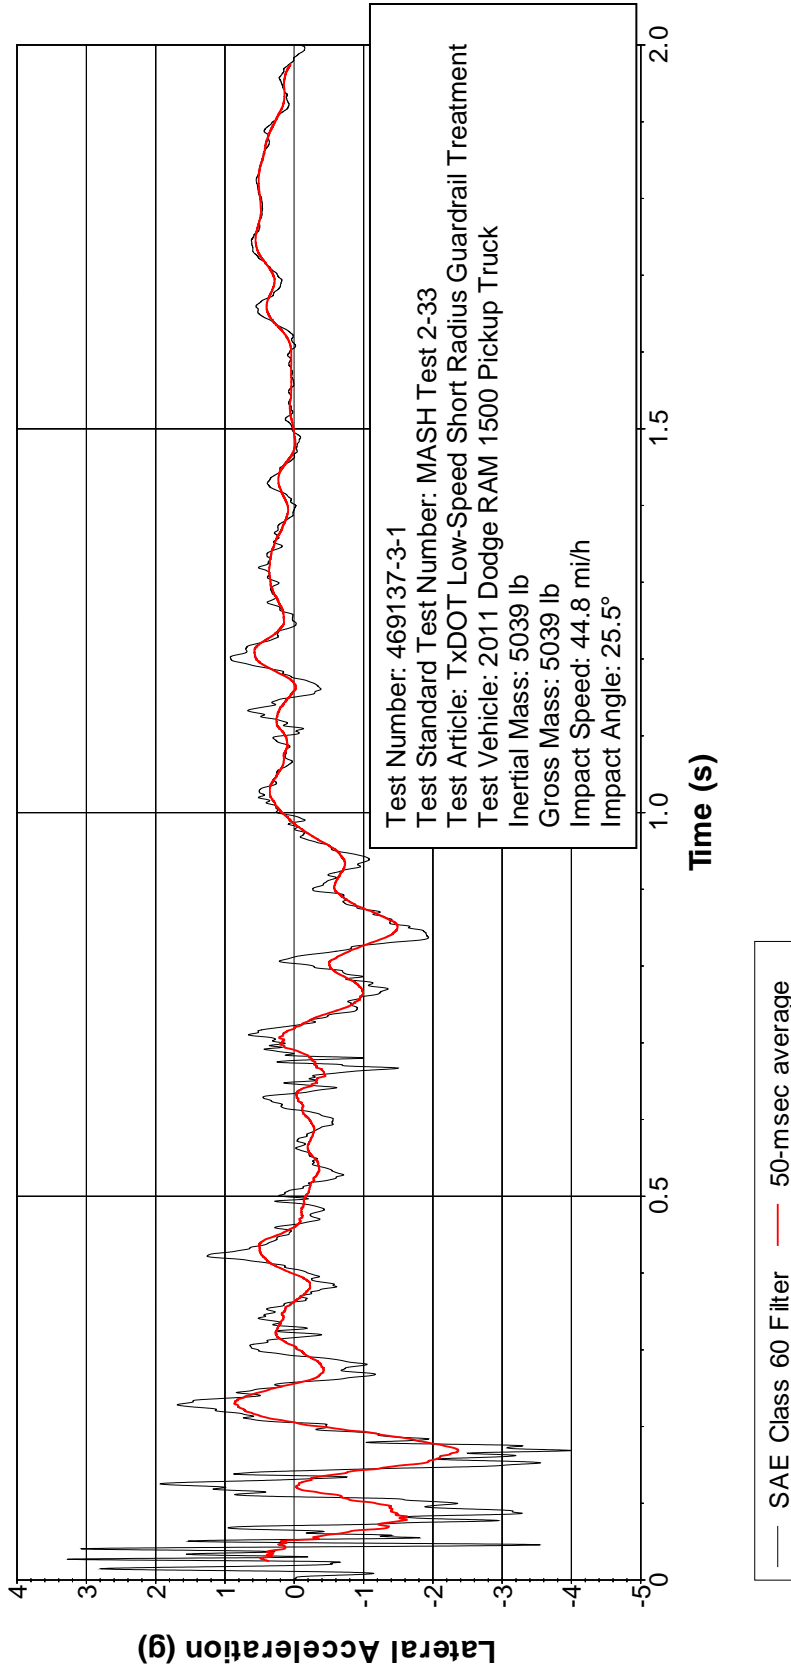
**Figure D.8. Vehicle Lateral Accelerometer Trace for Test No. 469137-3-1 (Accelerometer Located Rear of Center of Gravity).**

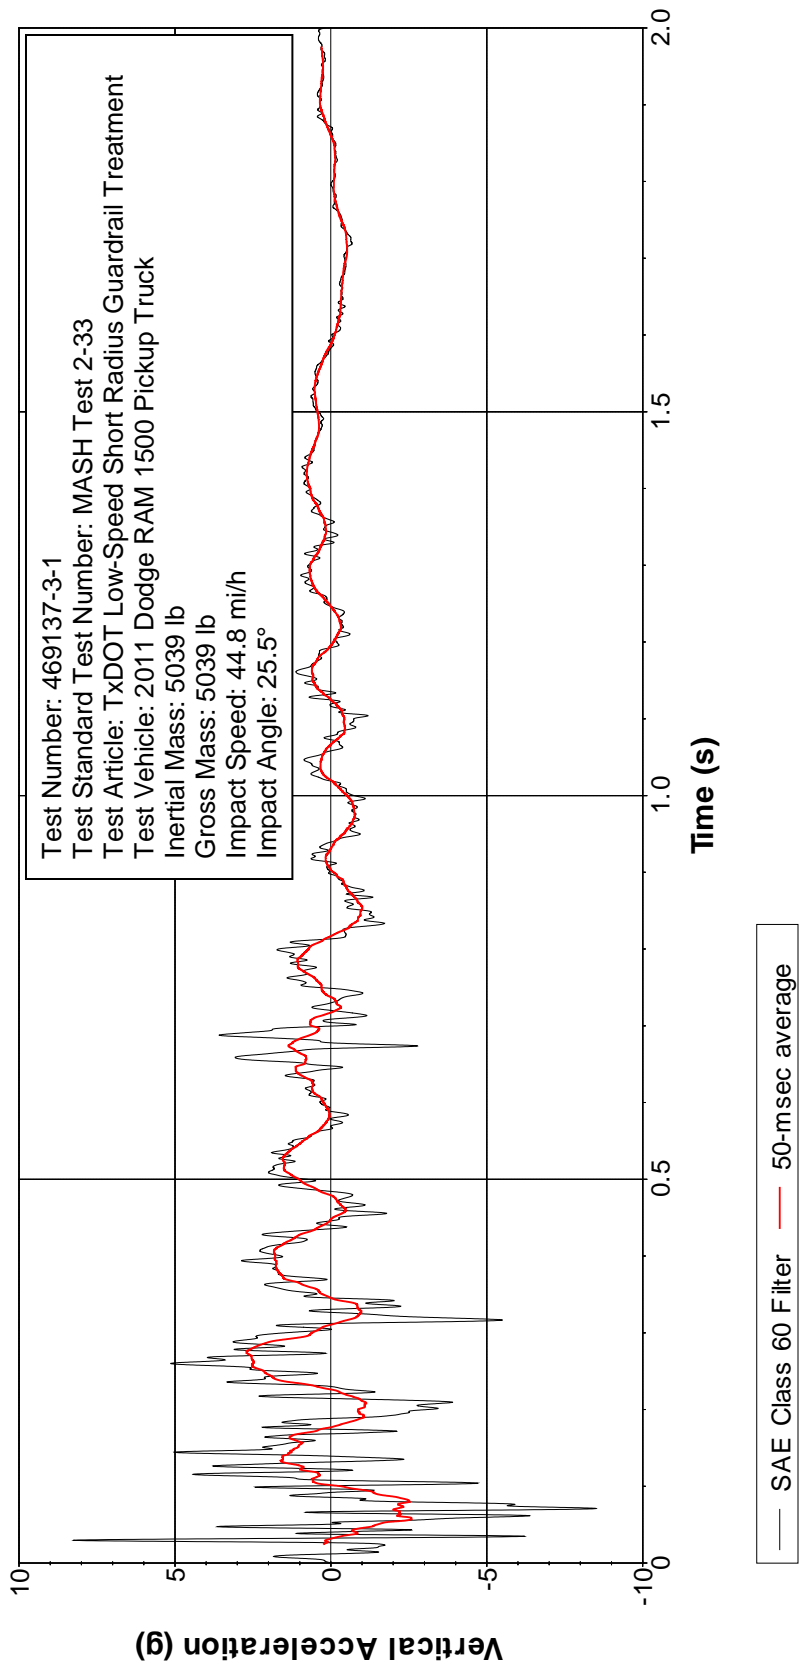
**Figure D.9. Vehicle Vertical Accelerometer Trace for Test No. 469137-3-1 (Accelerometer Located Rear of Center of Gravity).**

# Z Acceleration Rear of CG

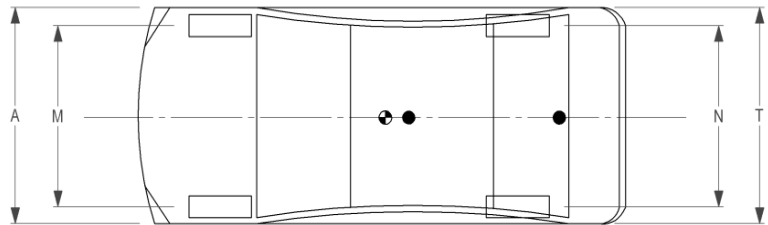
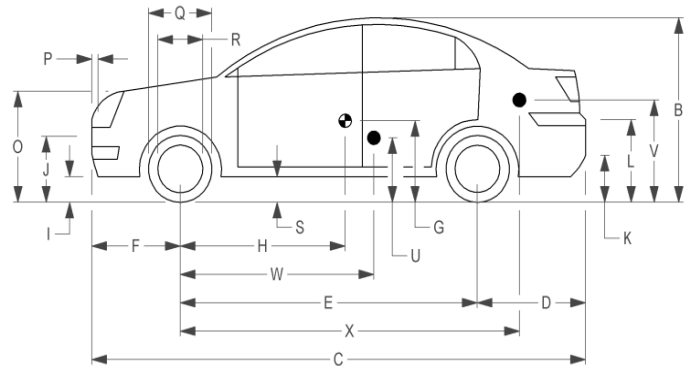
**Geometry:** inches

A	<u>66.38</u>	F	<u>33.00</u>	K	<u>10.50</u>	P	<u>4.12</u>	U	<u>15.25</u>
B	<u>58.00</u>	G	<u>-----</u>	L	<u>24.50</u>	Q	<u>22.50</u>	V	<u>20.38</u>
C	<u>165.75</u>	H	<u>35.66</u>	M	<u>57.75</u>	R	<u>15.50</u>	W	<u>35.66</u>
D	<u>34.00</u>	I	<u>7.75</u>	N	<u>57.70</u>	S	<u>9.00</u>	X	<u>107.40</u>
E	<u>98.75</u>	J	<u>21.00</u>	O	<u>28.00</u>	T	<u>66.20</u>		
	Wheel Center Ht Front	<u>11.00</u>		Wheel Center Ht Rear	<u>11.00</u>			W-H	<u>0</u>

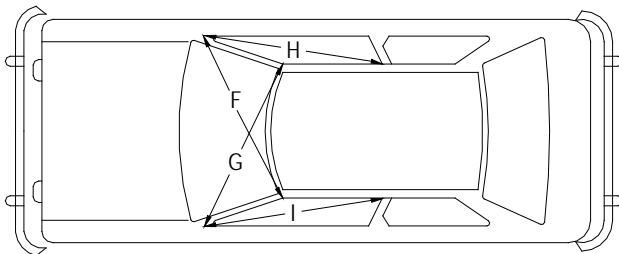
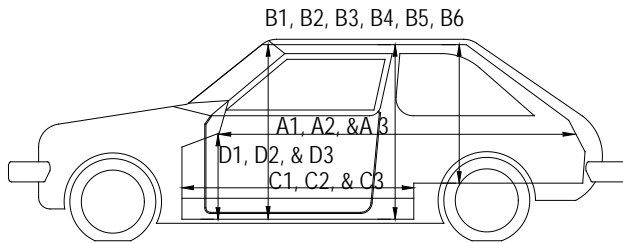
**OCCUPANT COMPARTMENT DEFORMATION MEASUREMENT**

Before	After (inches)	Differ.
A1	67.50	67.50	0
A2	67.50	67.50	0
A3	67.75	67.75	0
B1	40.50	40.50	0
B2	36.75	36.75	0
B3	40.50	40.50	0
B4	36.25	36.25	0
B5	35.75	35.75	0
B6	36.25	36.25	0
C1	26.00	26.00	0
C2	-----	-----	-
C3	26.00	26.00	0
D1	9.50	9.50	0
D2	-----	-----	-
D3	9.75	9.75	0
E1	51.50	51.50	0
E2	51.00	51.00	0
F	51.00	51.00	0
G	51.00	51.00	0
H	38.00	38.00	0
I	38.00	38.00	0
J*	51.00	51.00	0

\*Lateral area across the cab from driver's side kickpanel to passenger's side kickpanel.

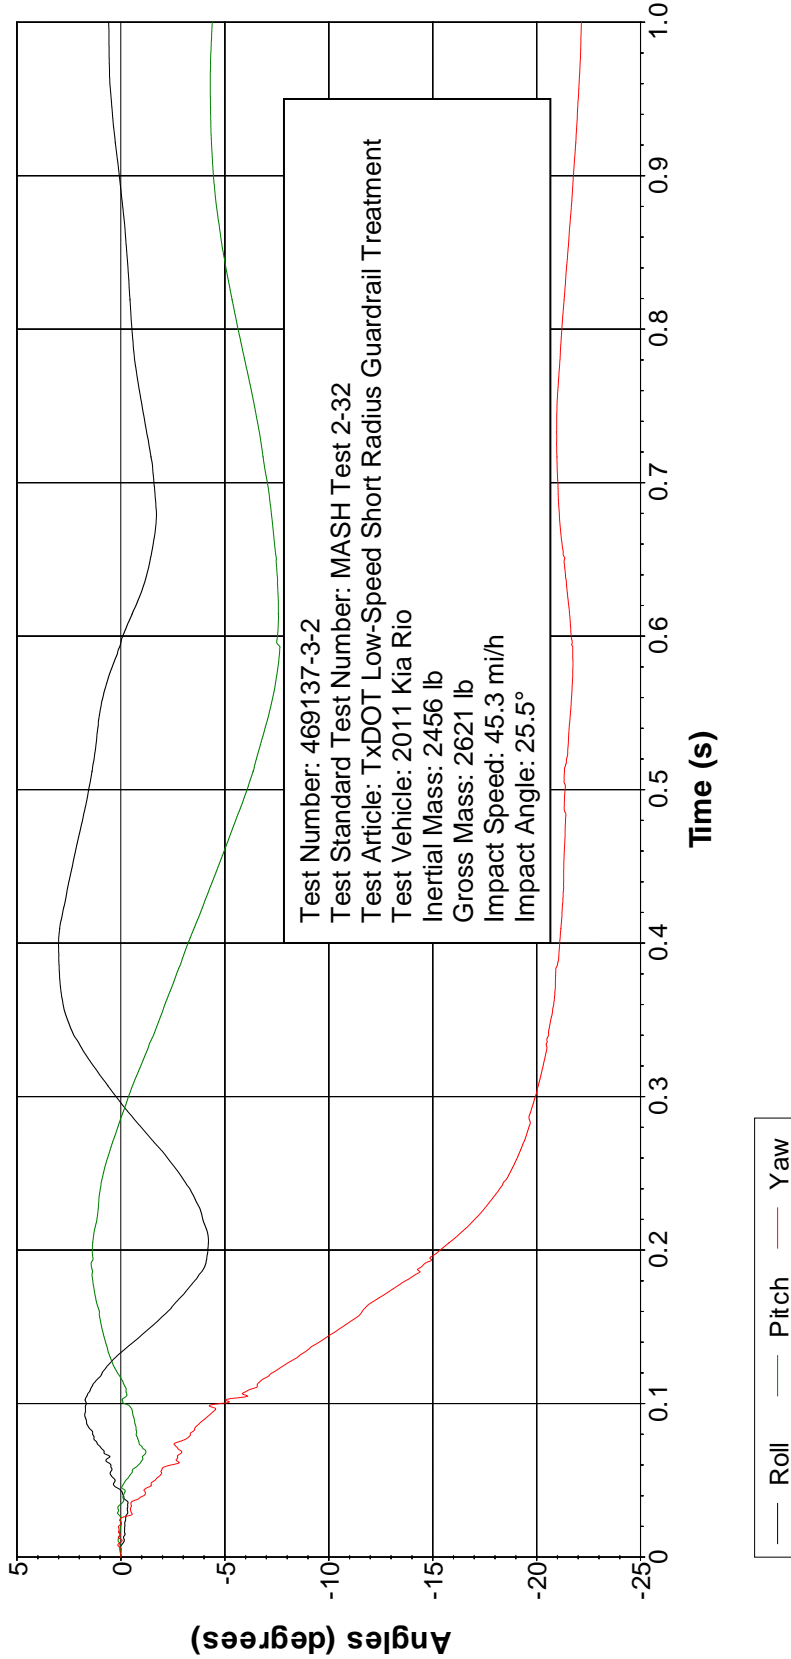
**Figure E.3. Vehicle Angular Displacements for Test No. 469137-3-2.**

**Roll, Pitch, and Yaw Angles**

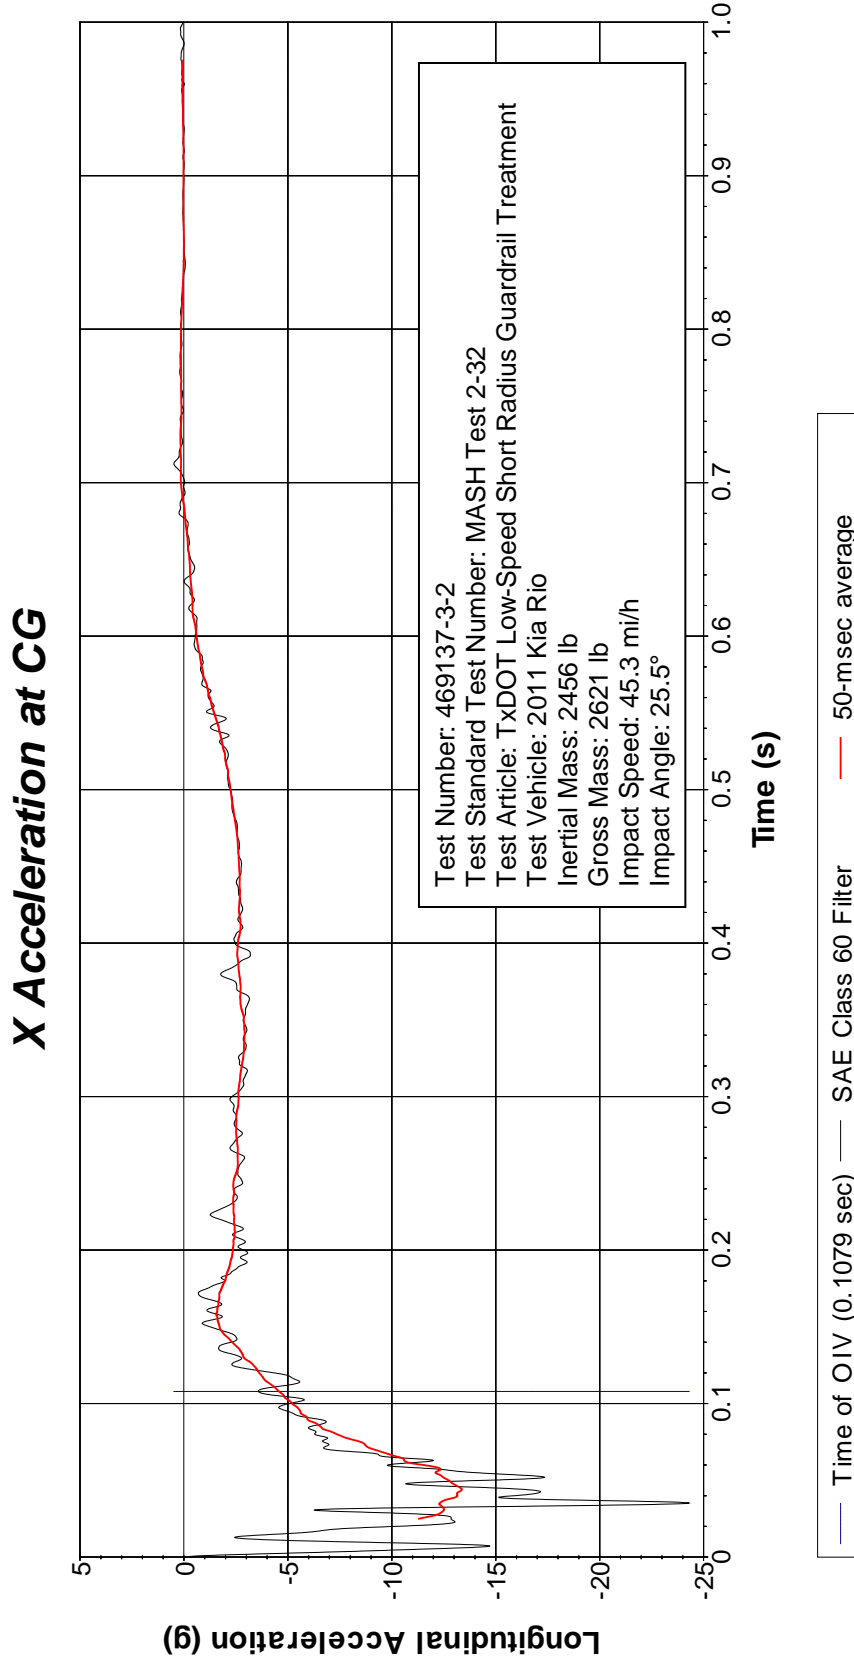
Figure E.4. Vehicle Longitudinal Accelerometer Trace for Test No. 469137-3-2 (Accelerometer Located at Center of Gravity).

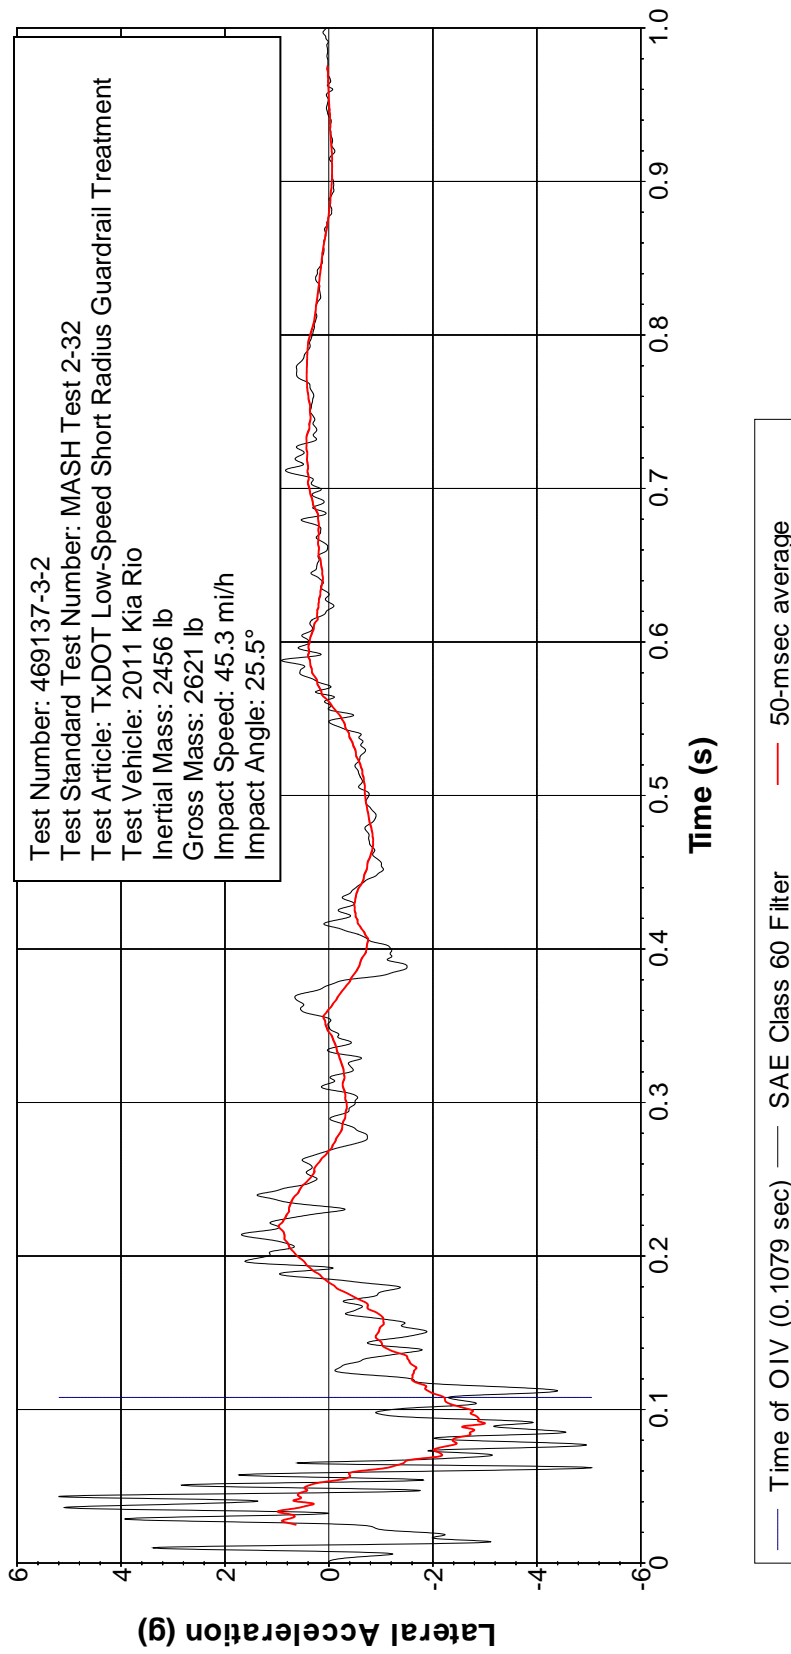
# Y Acceleration at CG

Figure E.5. Vehicle Lateral Accelerometer Trace for Test No. 469137-3-2 (Accelerometer Located at Center of Gravity).

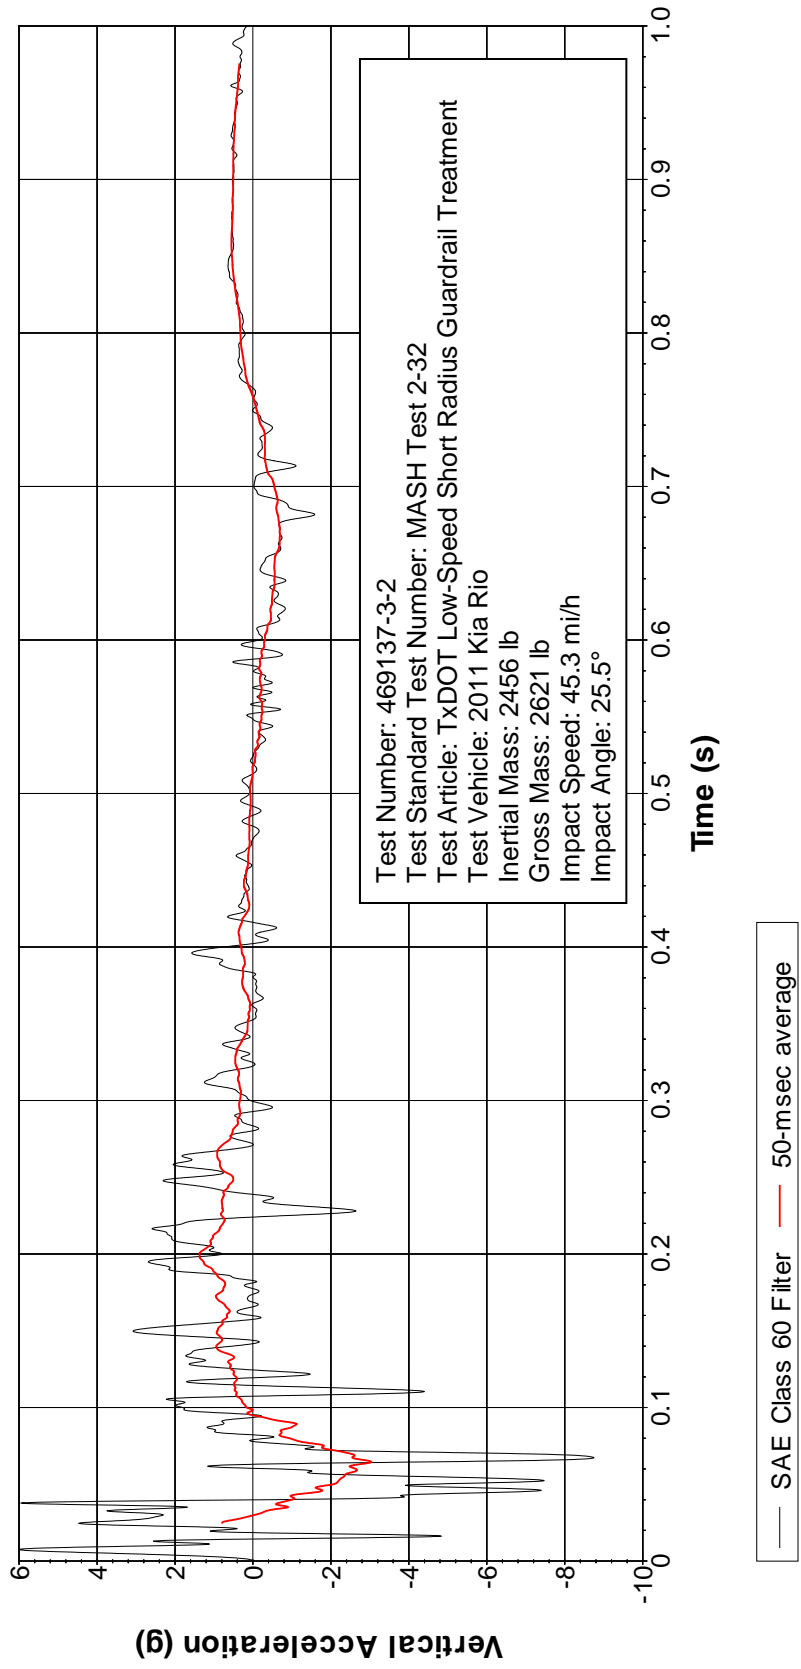
Figure E.6. Vehicle Vertical Accelerometer Trace for Test No. 469137-3-2 (Accelerometer Located at Center of Gravity).

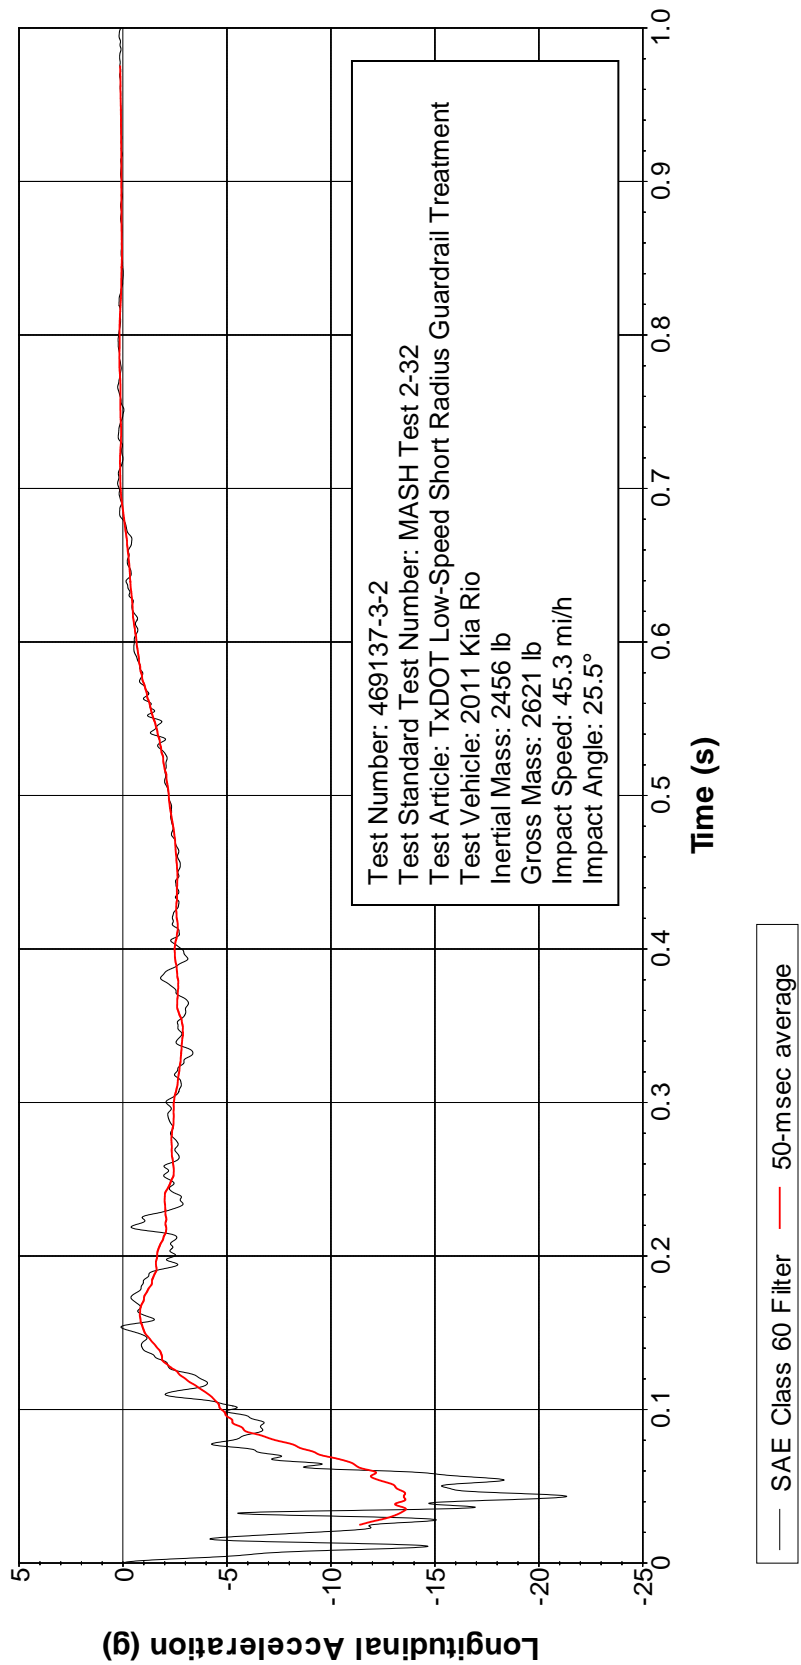
**Figure E.7. Vehicle Longitudinal Accelerometer Trace for Test No. 469137-3-2 (Accelerometer Located Rear of Center of Gravity).**

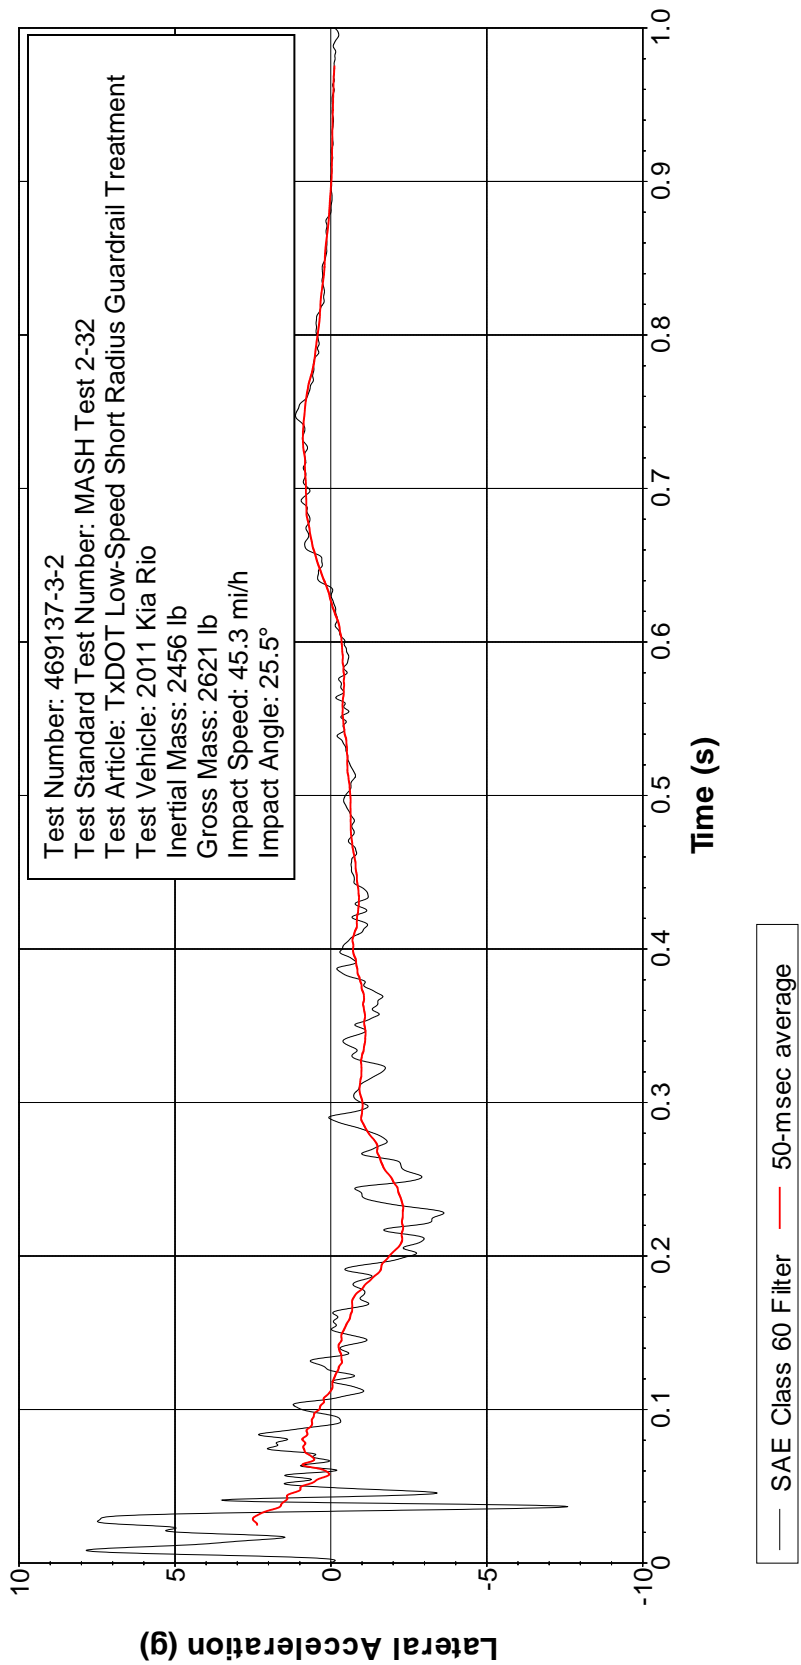
Figure E.8. Vehicle Lateral Accelerometer Trace for Test No. 469137-3-2 (Accelerometer Located Rear of Center of Gravity).

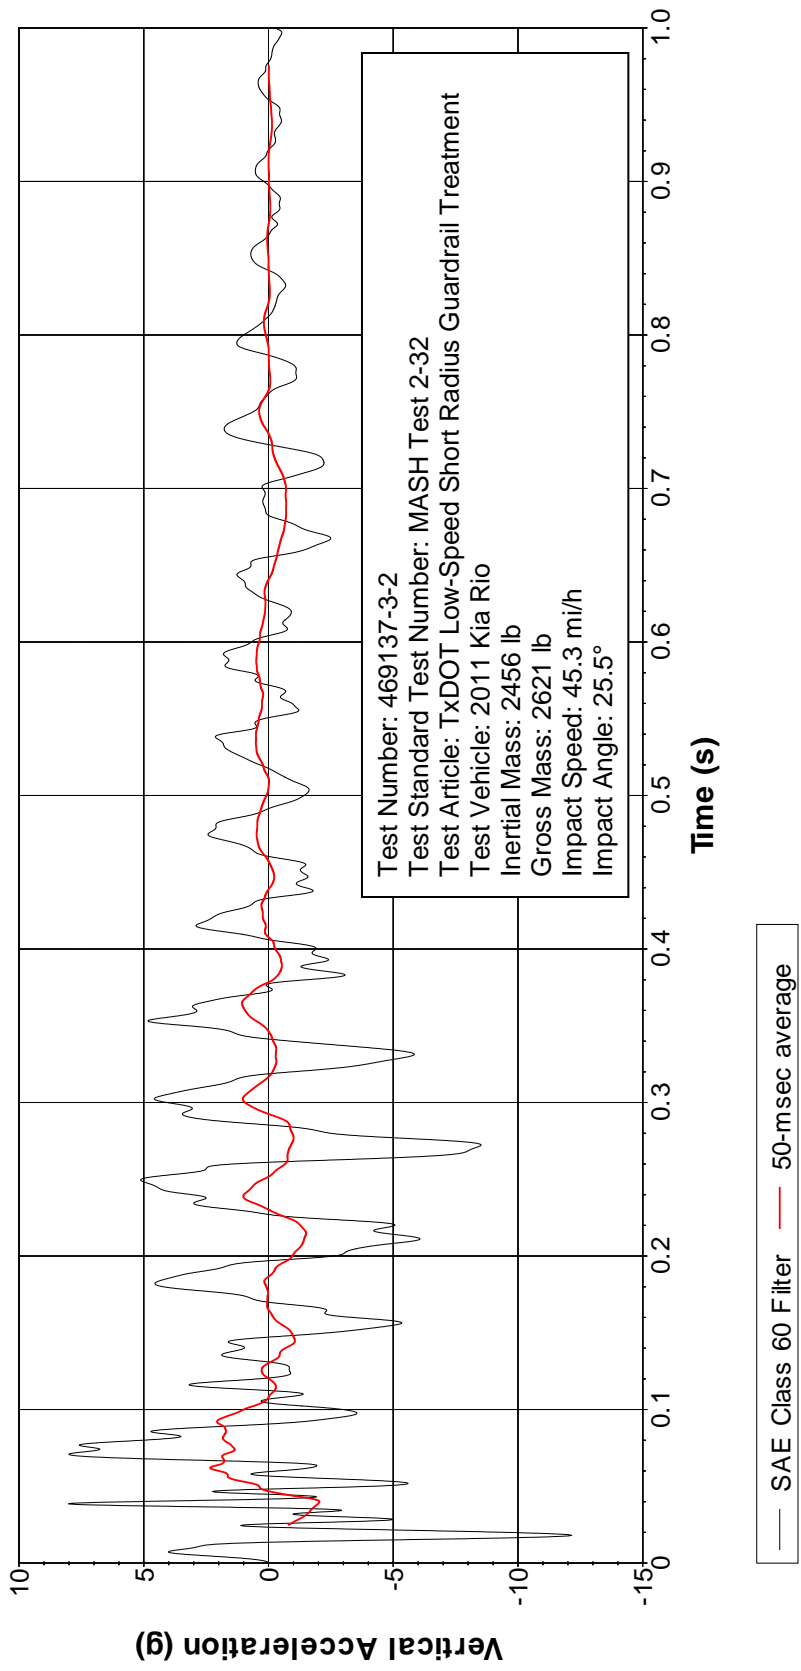
**Figure E.9. Vehicle Vertical Accelerometer Trace for Test No. 469137-3-2 (Accelerometer Located Rear of Center of Gravity).**

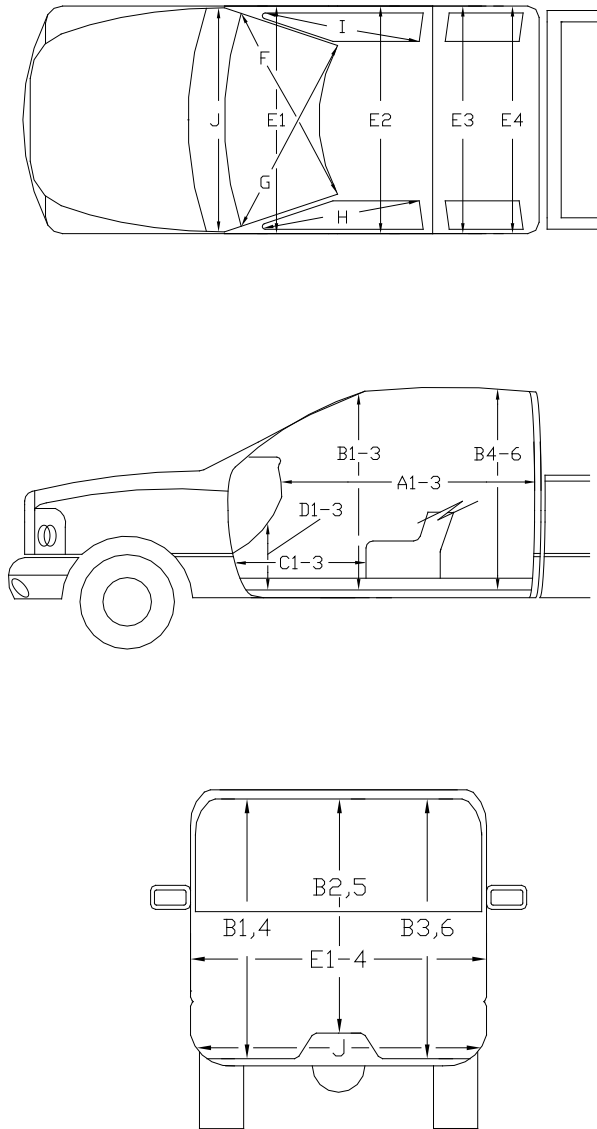
**Table F.4. Occupant Compartment Measurements of Vehicle for Test No. 469138-3-3.**

**OCCUPANT COMPARTMENT DEFORMATION MEASUREMENT**

Before	After (inches)	Differ.
A1	65.00	65.00	0
A2	63.00	63.00	0
A3	65.50	65.50	0
B1	44.50	44.50	0
B2	38.25	38.25	0
B3	44.50	44.50	0
B4	39.50	39.50	0
B5	43.00	43.00	0
B6	39.50	39.50	0
C1	27.00	27.00	0
C2	-----	-----	-
C3	27.00	27.00	0
D1	11.25	11.25	0
D2	-----	-----	-
D3	11.25	11.25	0
E1	58.75	58.75	0
E2	63.50	63.50	0
E3	63.50	63.50	0
E4	63.25	63.25	0
F	59.00	59.00	0
G	59.00	59.00	0
H	37.00	37.00	0
I	37.00	37.00	0
J*	23.00	23.00	0

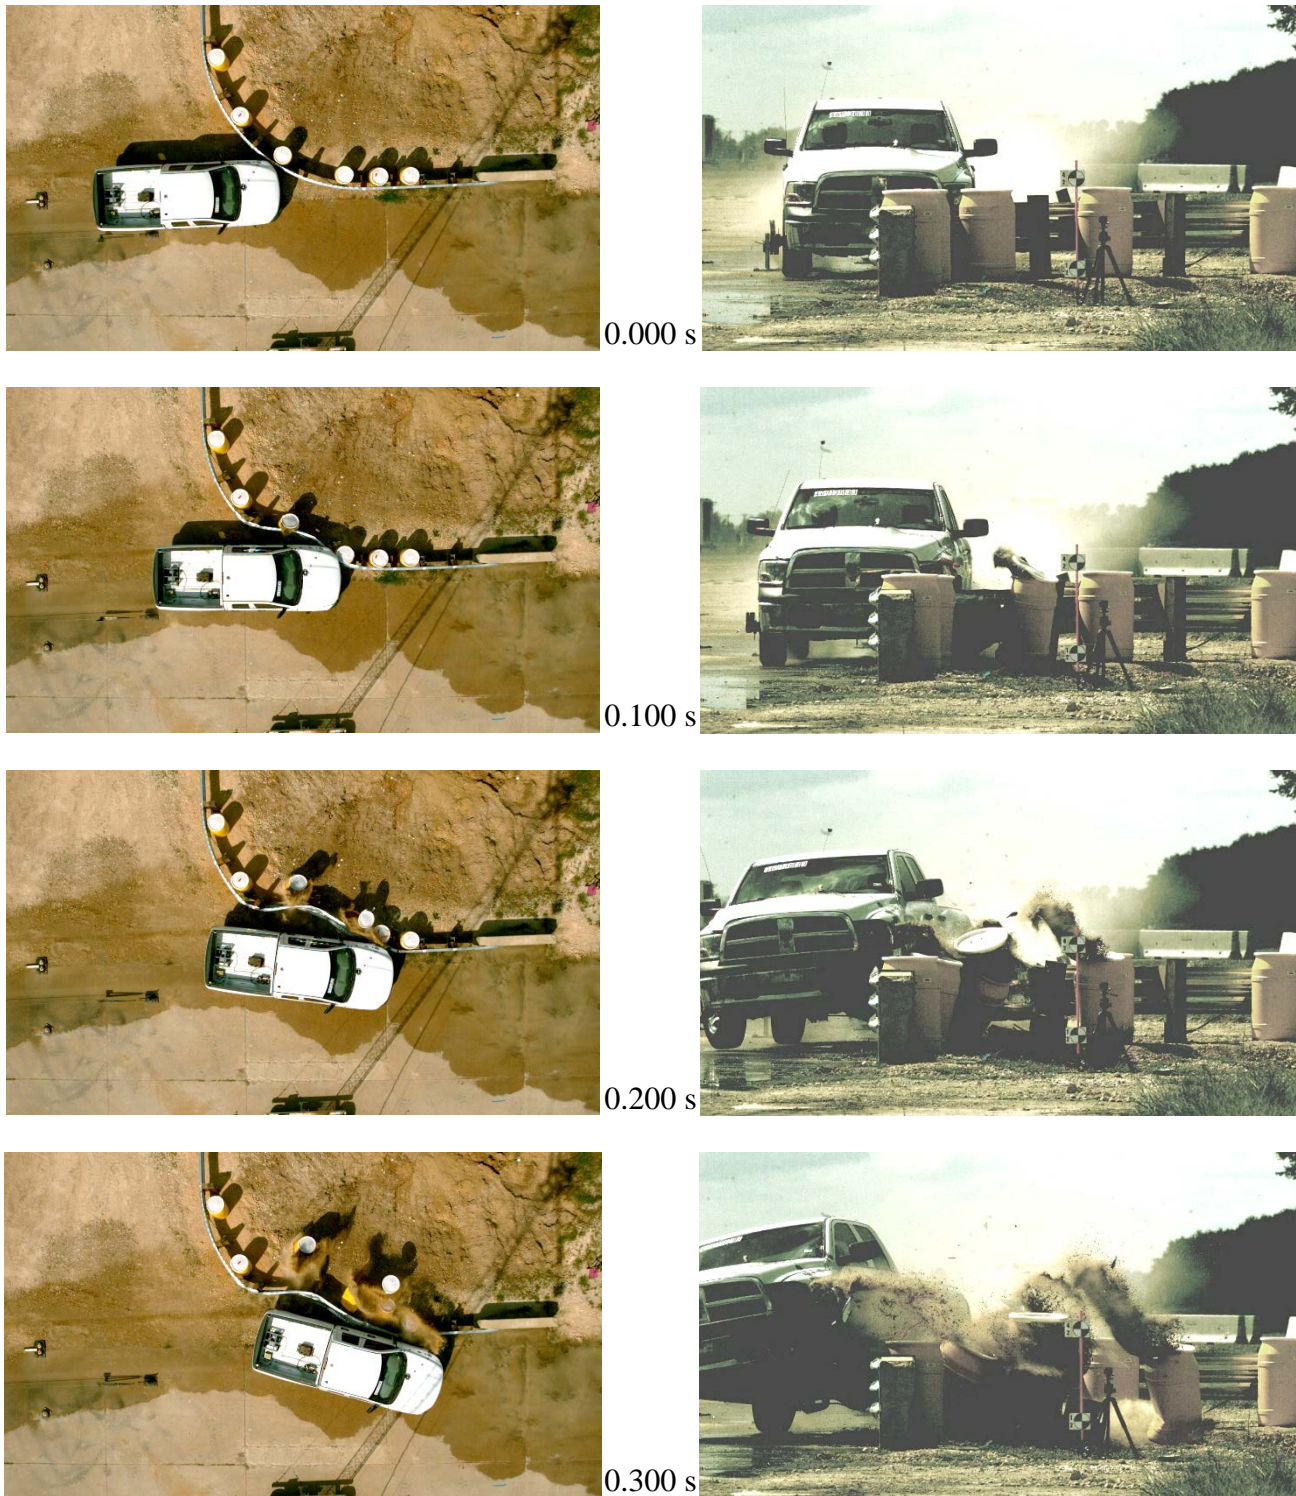
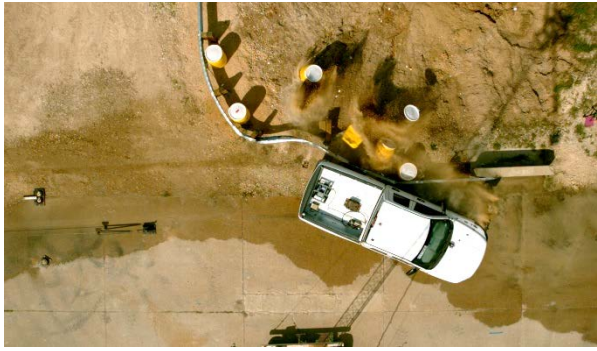
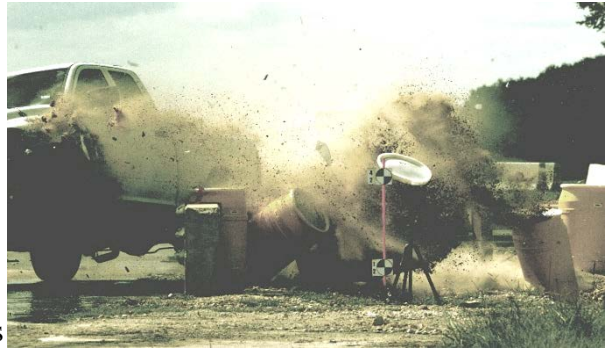
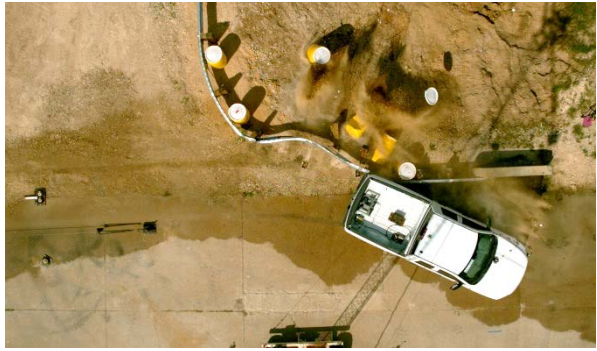
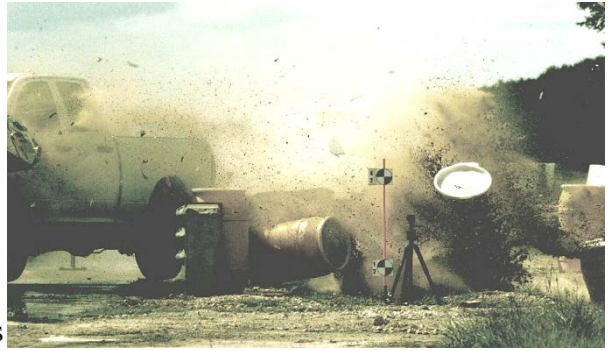
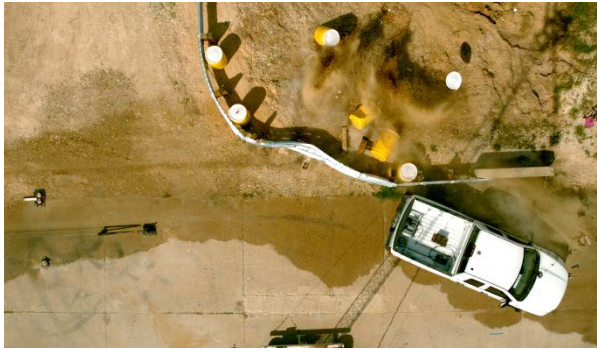
**Figure F.1. Sequential Photographs for Test No. 469138-3-3 (Overhead and Frontal Views).**

**Figure F.1. Sequential Photographs for Test No. 469138-3-3 (Overhead and Frontal Views) (Continued).**

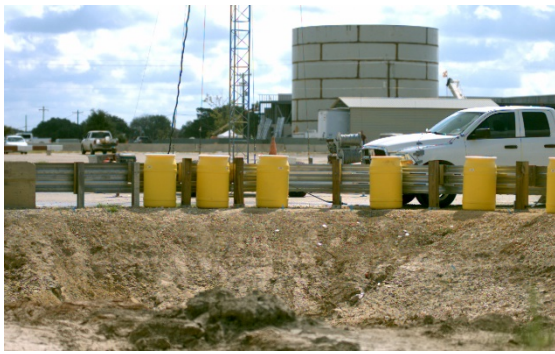
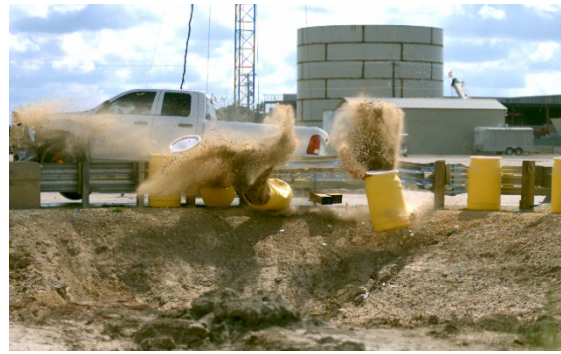
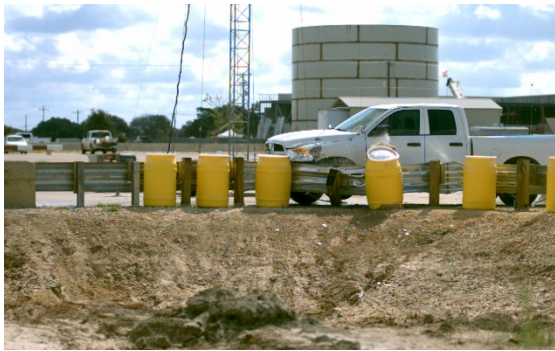
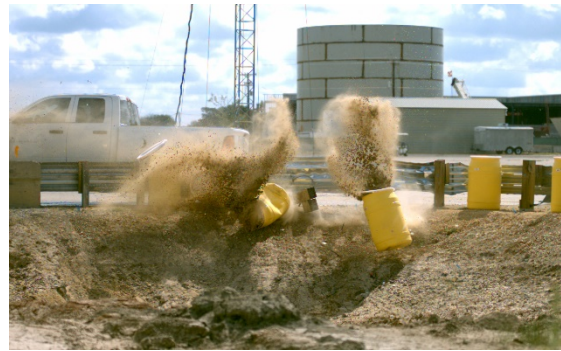
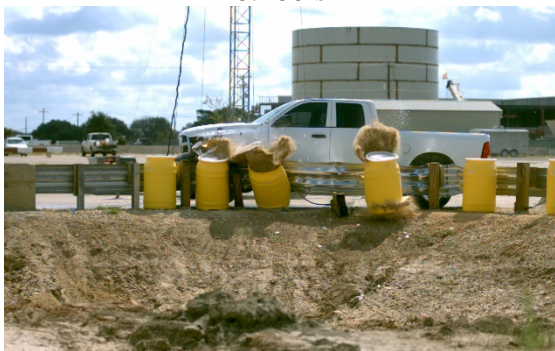
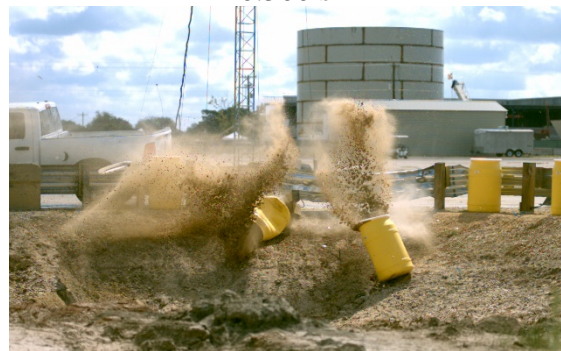
**Figure F.2. Sequential Photographs for Test No. 469138-3-3 (Perpendicular View).**

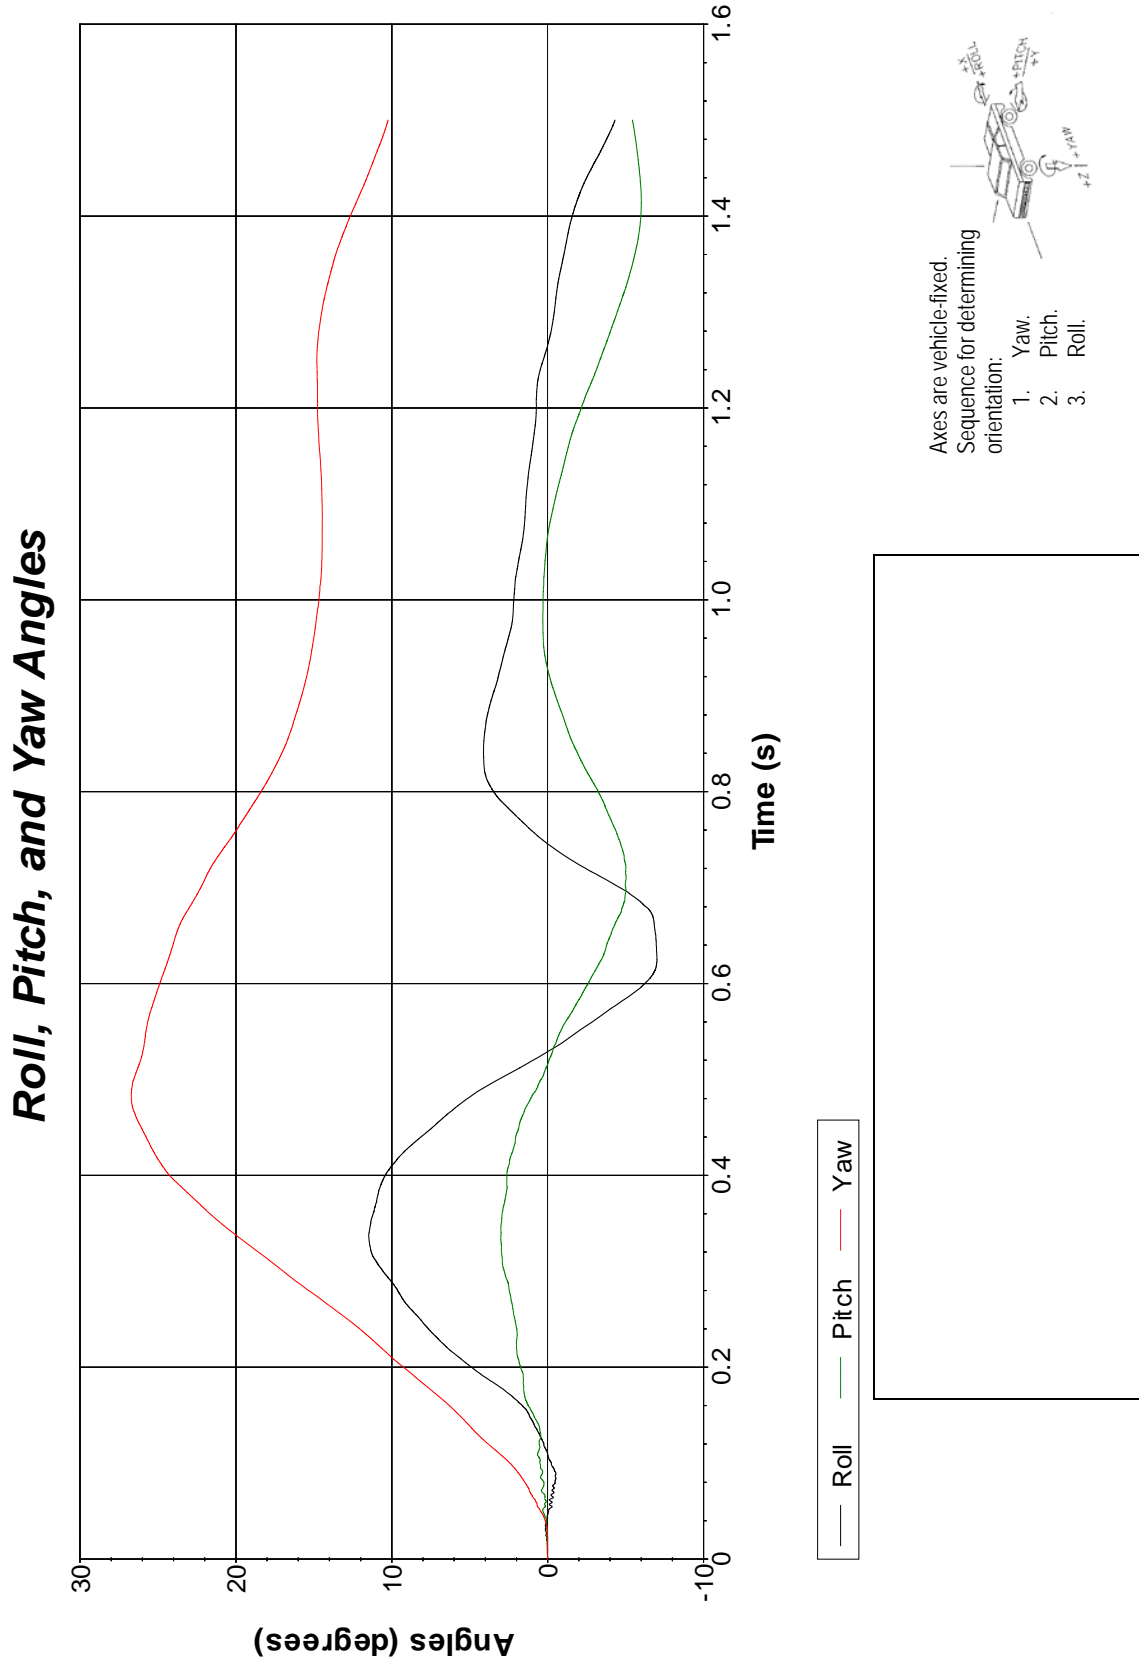
**Figure F.3. Vehicle Angular Displacements for Test No. 469138-3-3.**
