# CRASH TEST AND EVALUATION OF TL-2 SHORT RADIUS GUARDRAIL TREATMENT

**Test Report 0-6913-R1**

**TEXAS A&M TRANSPORTATION INSTITUTE  
COLLEGE STATION, TEXAS**

**TEXAS DEPARTMENT OF TRANSPORTATION**

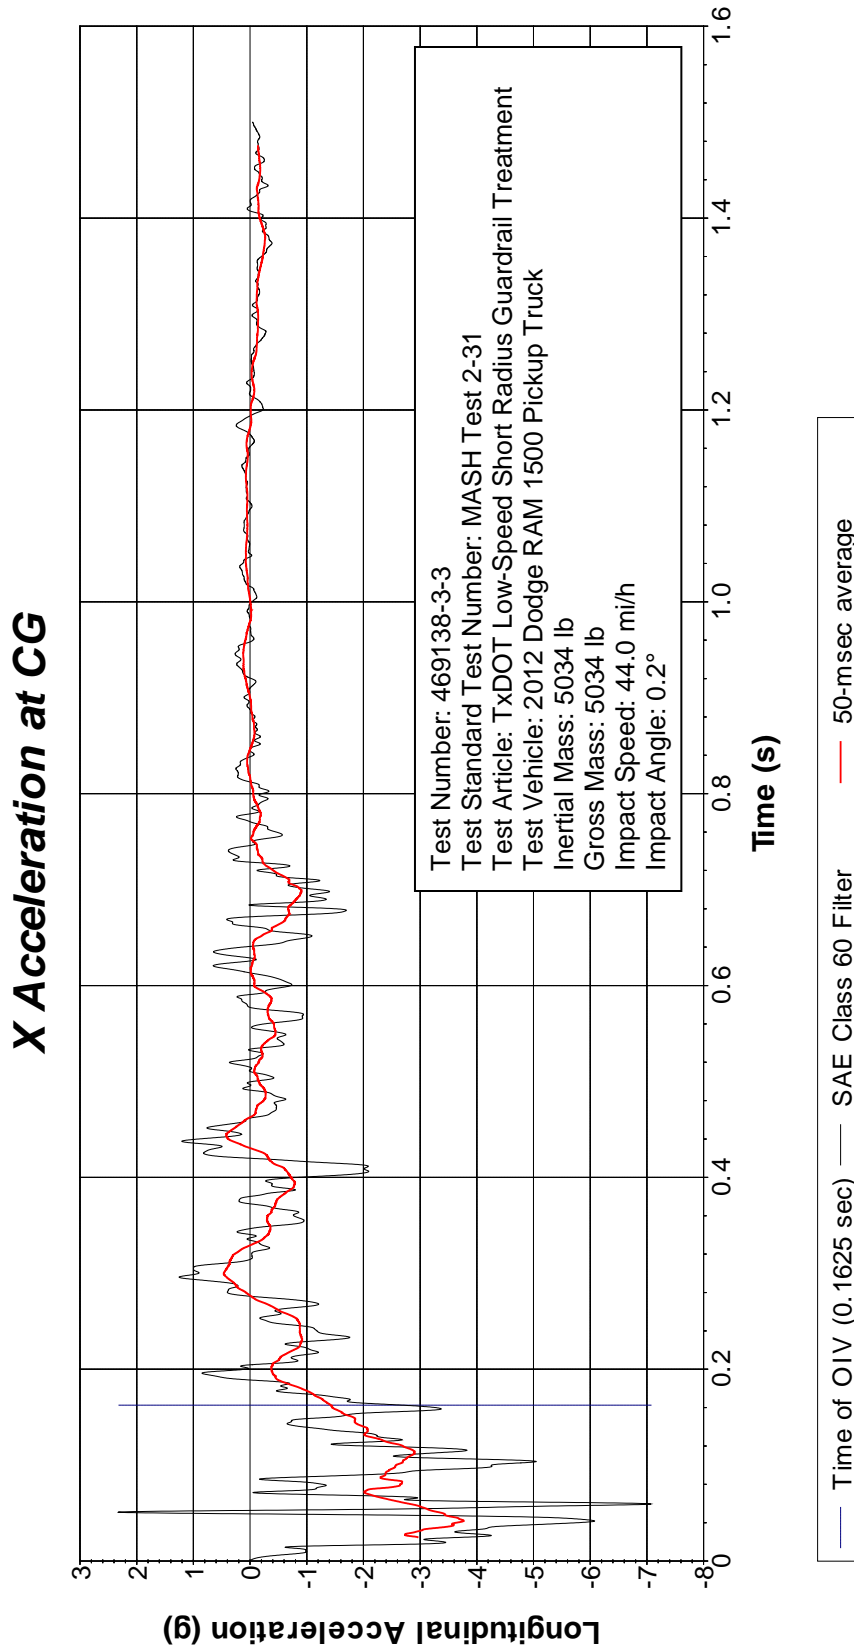
Figure F.4. Vehicle Longitudinal Accelerometer Trace for Test No. 469138-3-3 (Accelerometer Located at Center of Gravity).

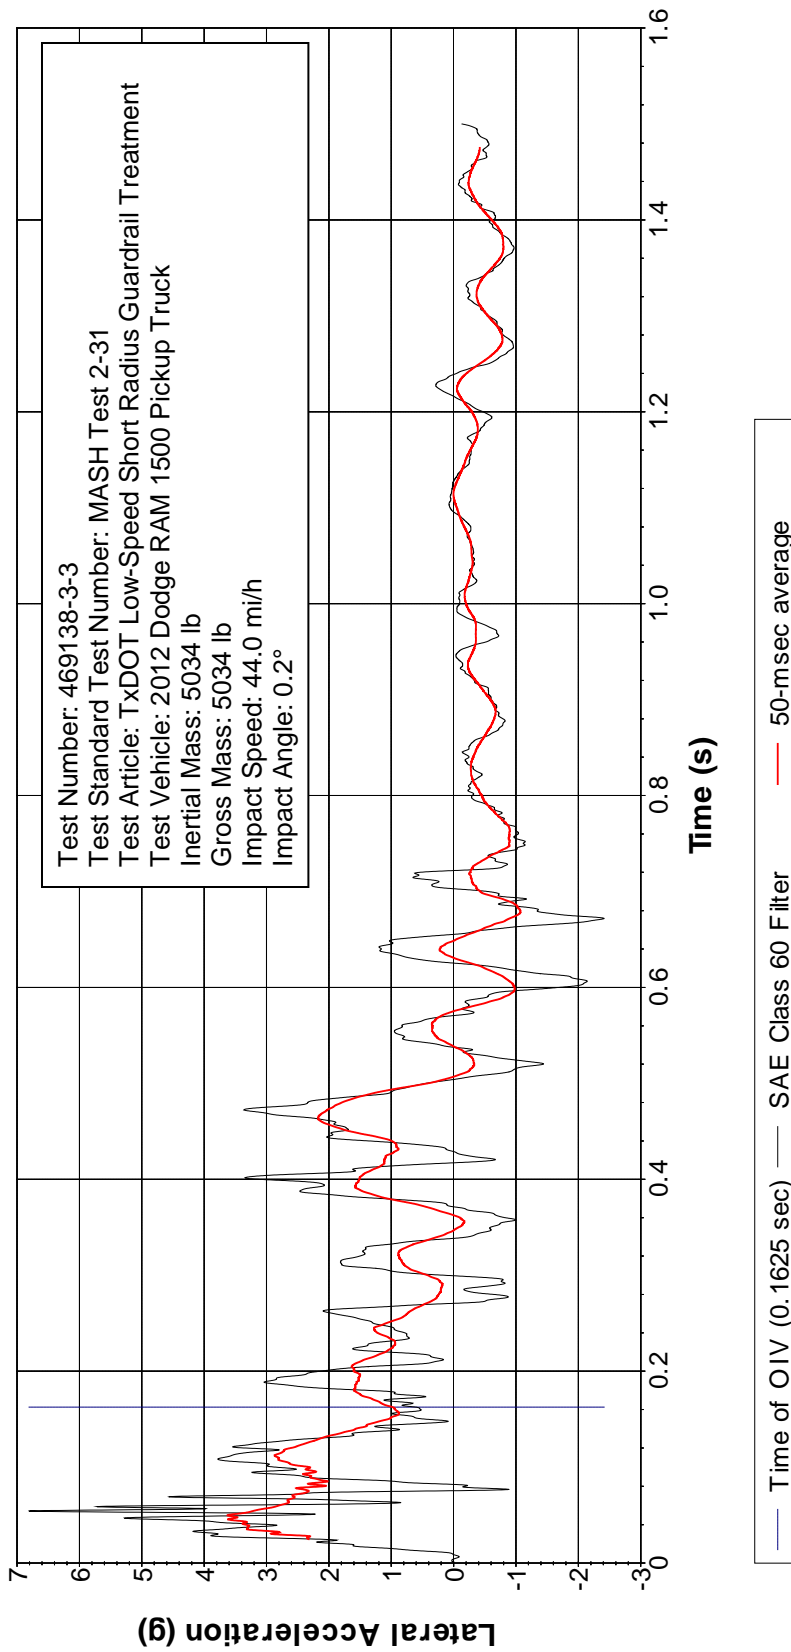
**Figure F.5. Vehicle Lateral Accelerometer Trace for Test No. 469138-3-3 (Accelerometer Located at Center of Gravity).**

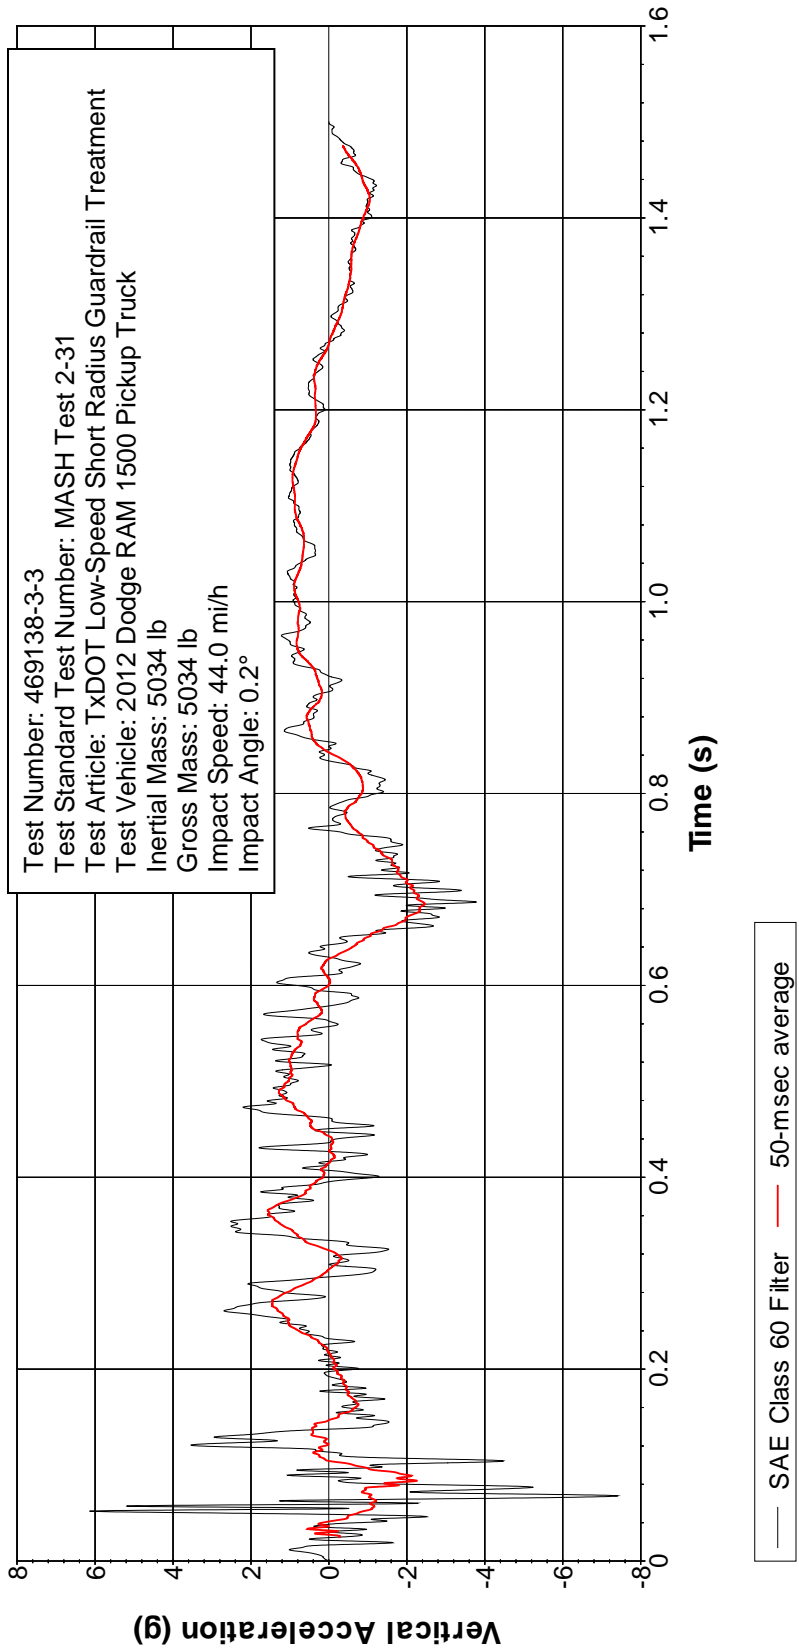
**Figure F.6. Vehicle Vertical Accelerometer Trace for Test No. 469138-3-3 (Accelerometer Located at Center of Gravity).**

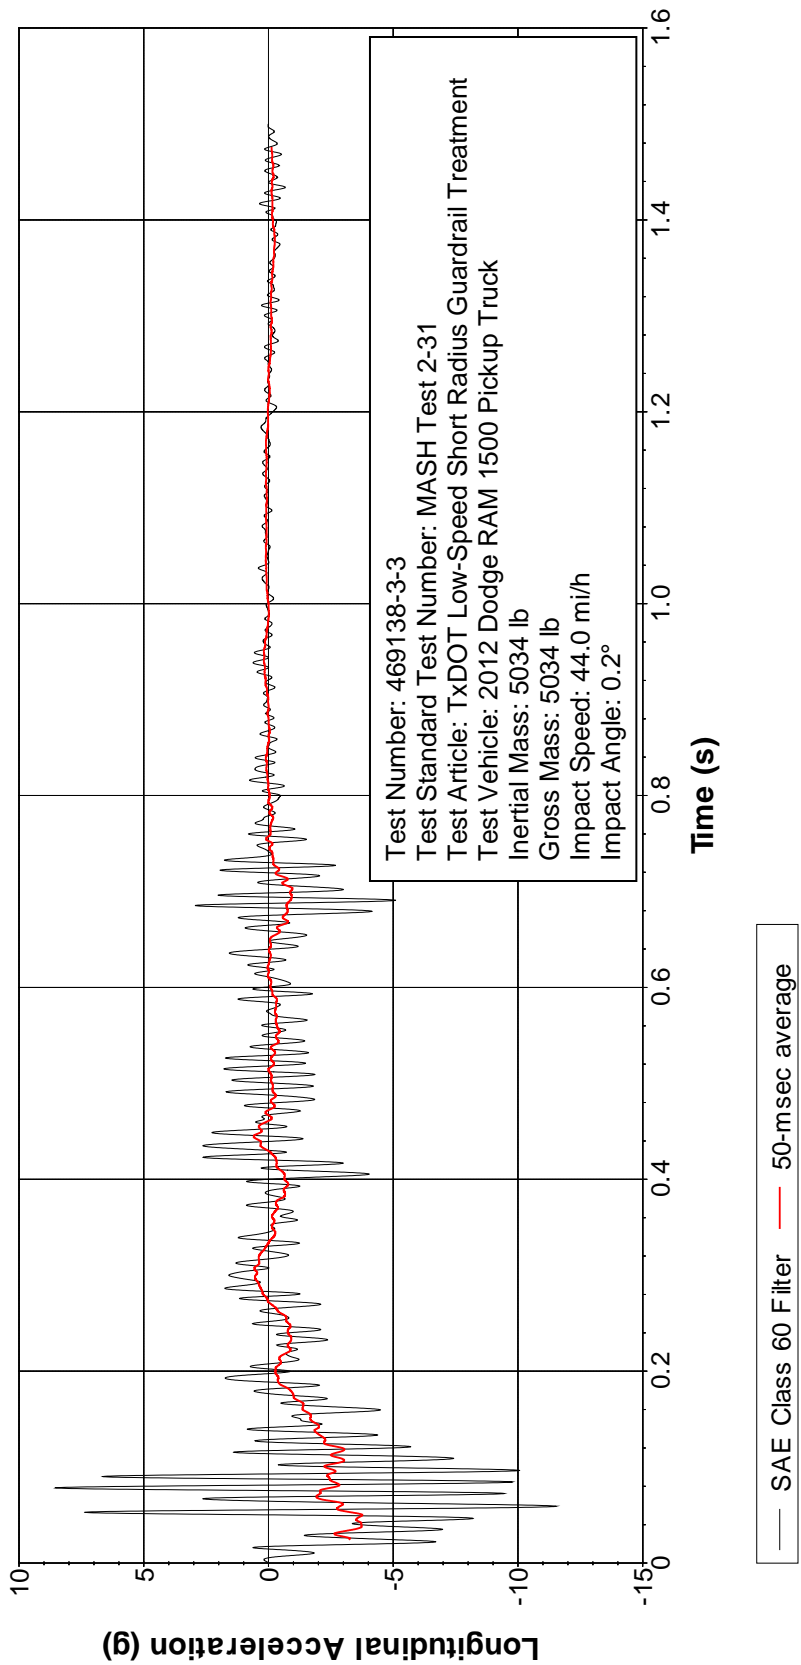
**Figure F.7. Vehicle Longitudinal Accelerometer Trace for Test No. 469138-3-3 (Accelerometer Located Rear of Center of Gravity).**

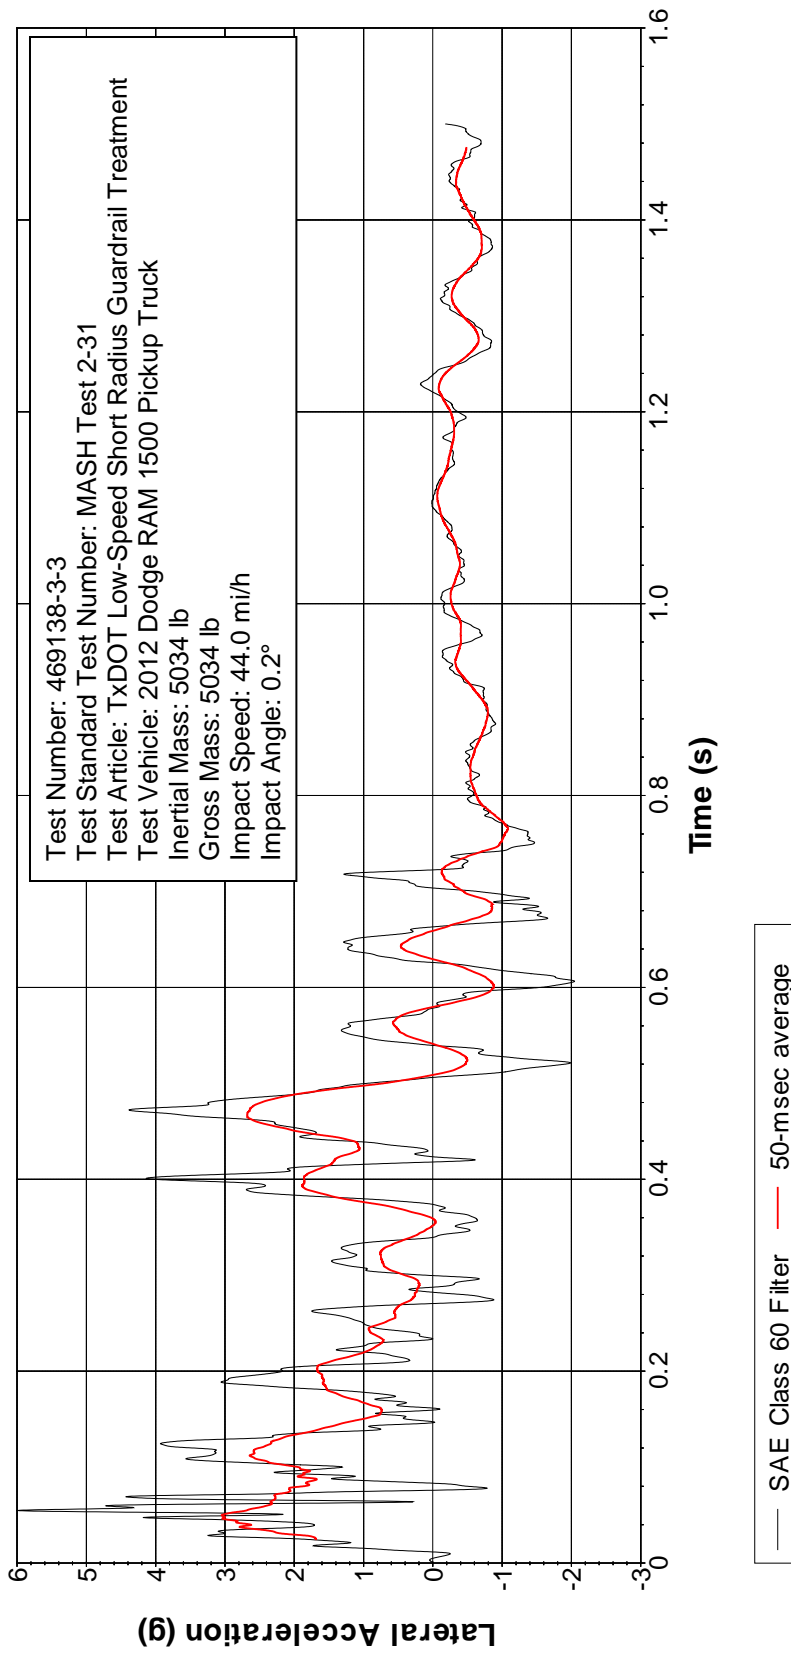
Figure F.8. Vehicle Lateral Accelerometer Trace for Test No. 469138-3-3 (Accelerometer Located Rear of Center of Gravity).

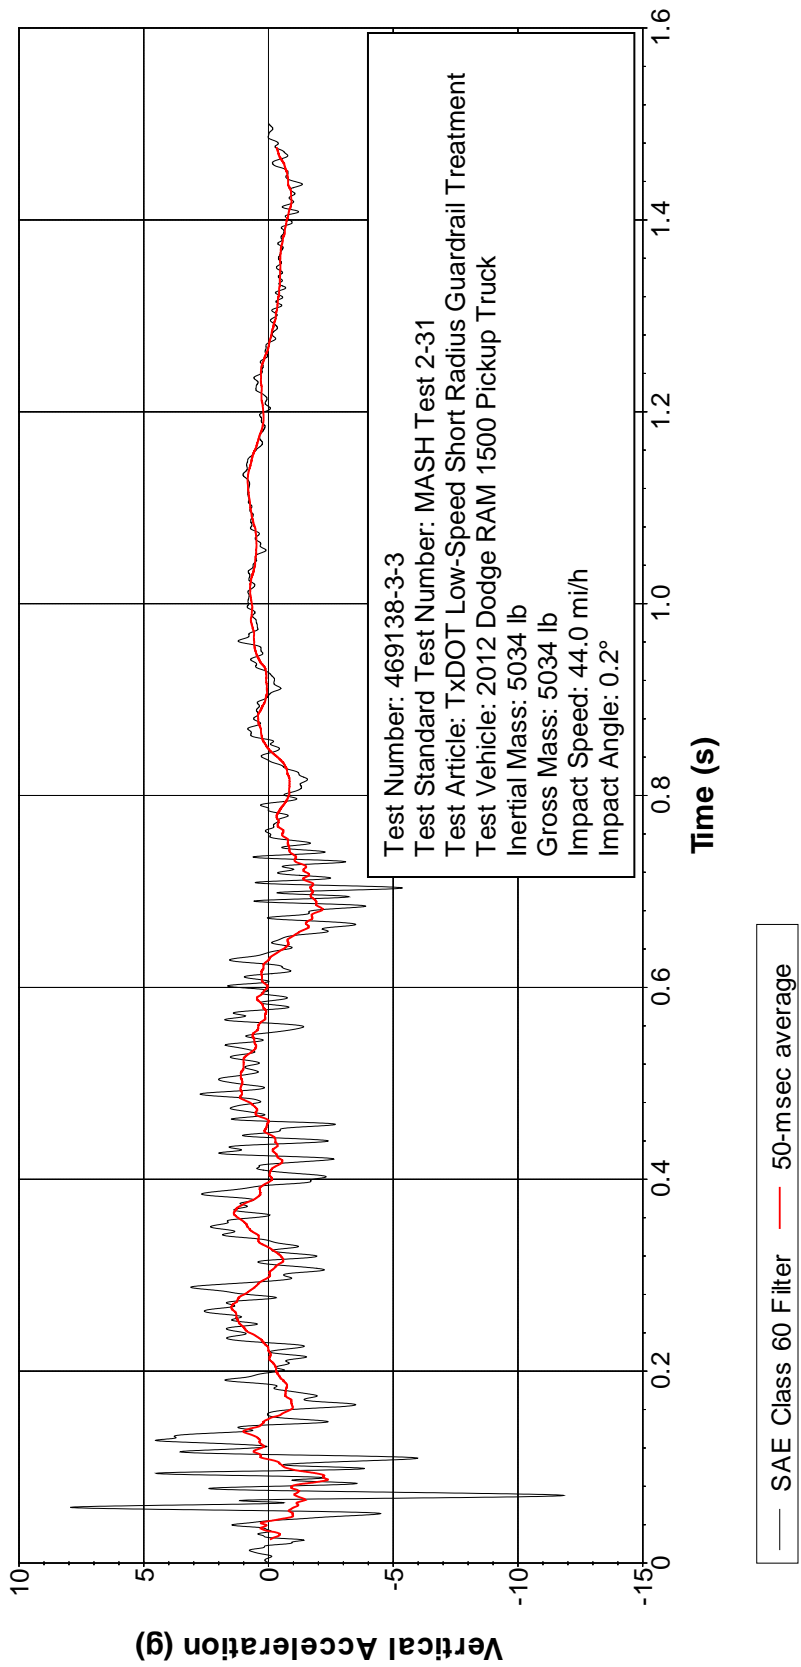
**Figure F.9. Vehicle Vertical Accelerometer Trace for Test No. 469138-3-3 (Accelerometer Located Rear of Center of Gravity).**

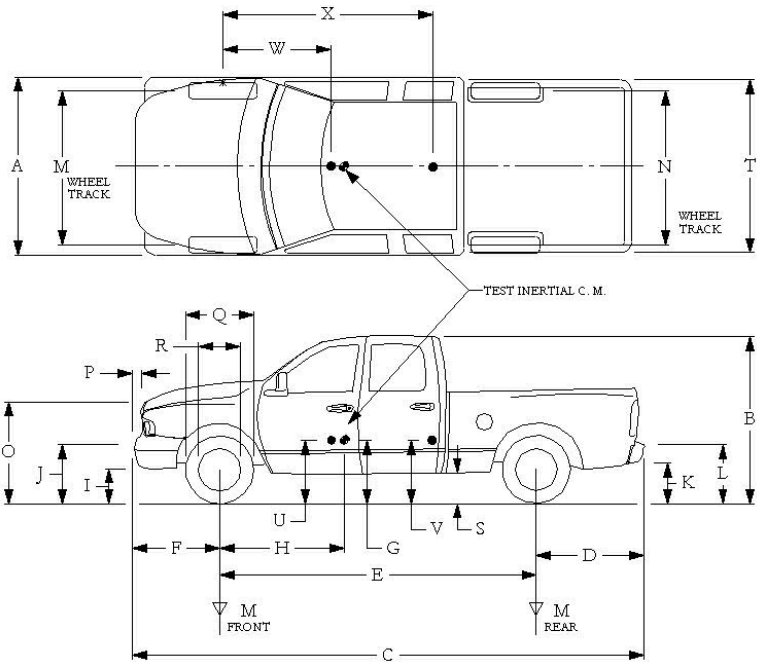
**Geometry:** inches

A	<u>78.50</u>	F	<u>40.00</u>	K	<u>18.75</u>	P	<u>3.00</u>	U	<u>27.00</u>
B	<u>75.00</u>	G	<u>28.62</u>	L	<u>28.00</u>	Q	<u>30.50</u>	V	<u>30.00</u>
C	<u>227.50</u>	H	<u>62.17</u>	M	<u>68.50</u>	R	<u>18.00</u>	W	<u>63.10</u>
D	<u>47.00</u>	I	<u>11.25</u>	N	<u>68.00</u>	S	<u>12.75</u>	X	<u>78.30</u>
E	<u>140.50</u>	J	<u>26.50</u>	O	<u>45.50</u>	T	<u>77.00</u>		
Wheel Center Height Front	<u>14.75</u>	Wheel Well Clearance (Front)	<u>6.00</u>	Bottom Frame Height - Front	<u>12.00</u>				
Wheel Center Height Rear	<u>14.75</u>	Wheel Well Clearance (Rear)	<u>9.25</u>	Bottom Frame Height - Rear	<u>25.50</u>

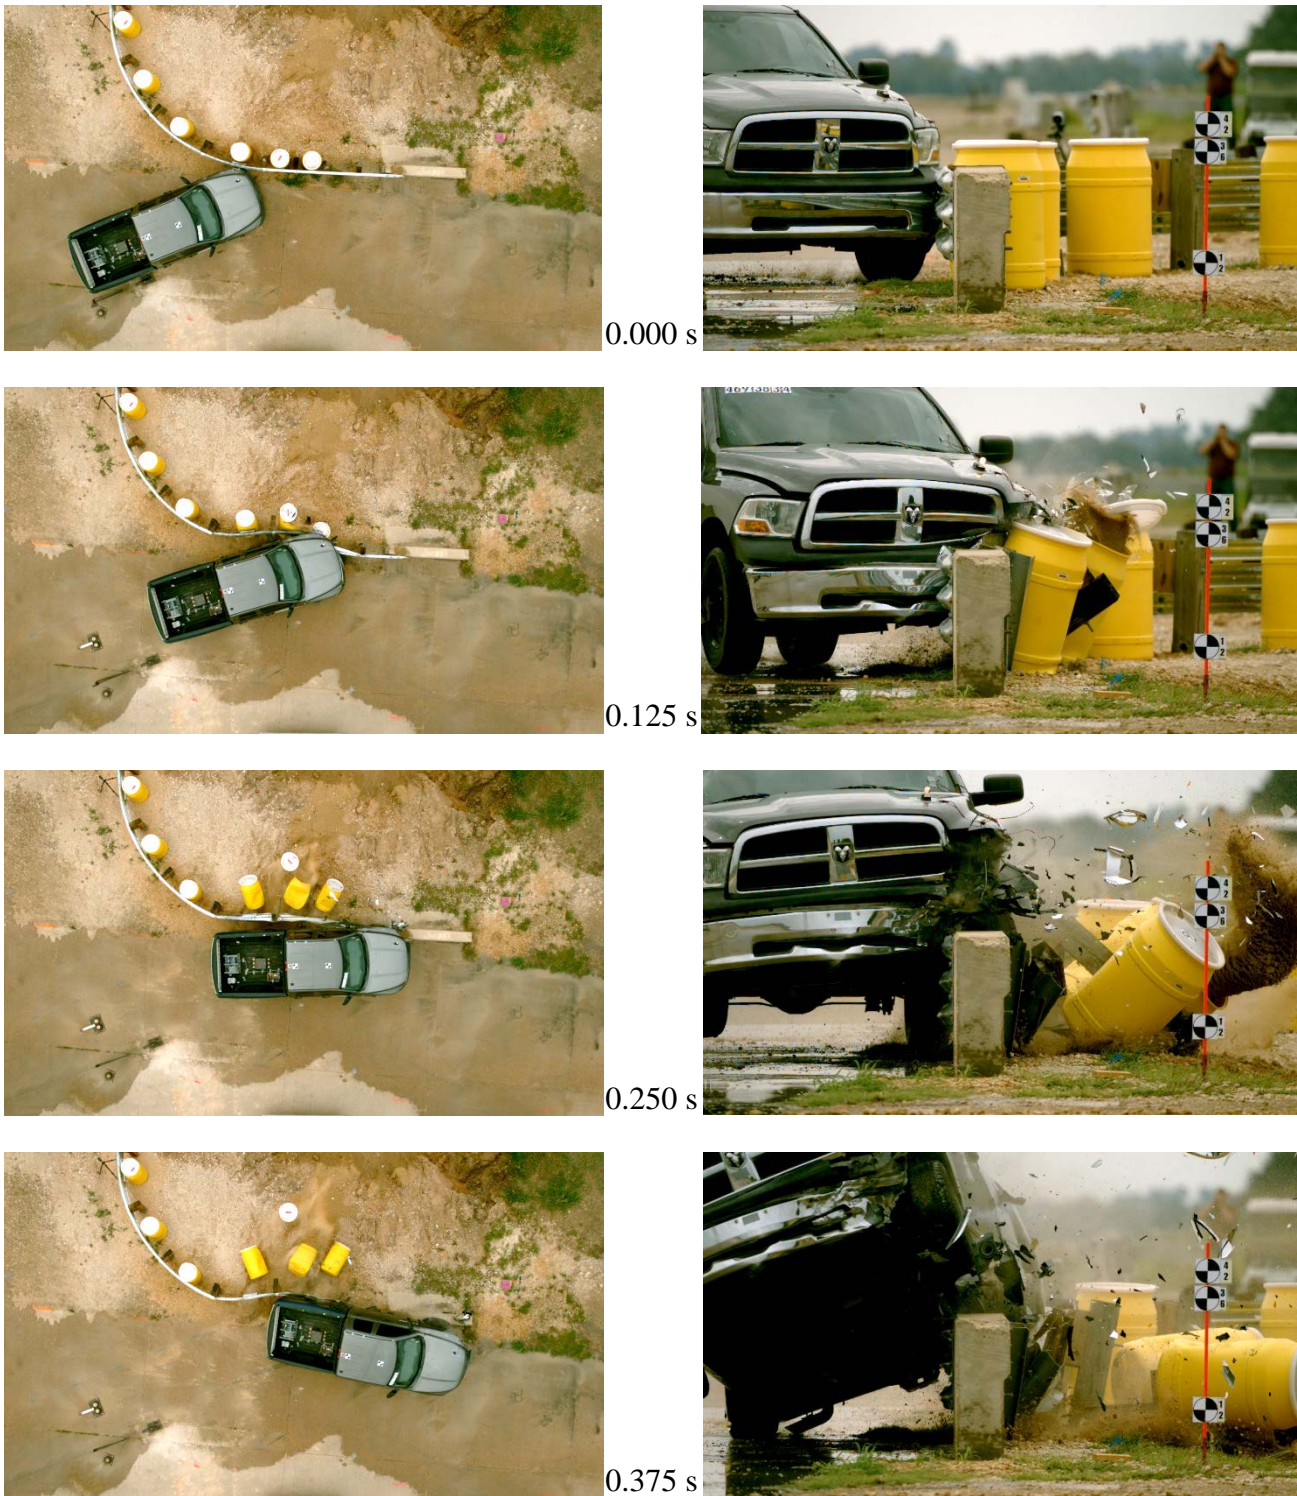
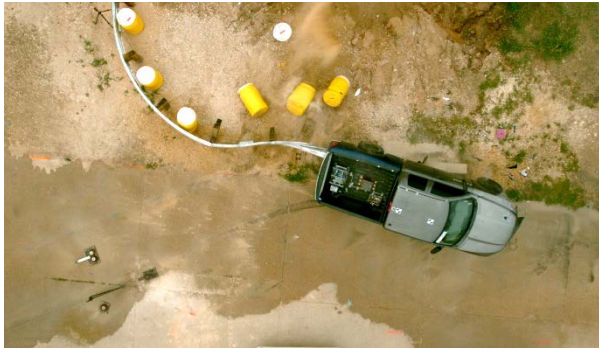
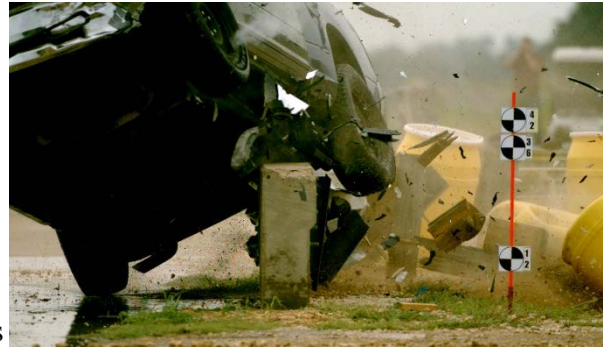
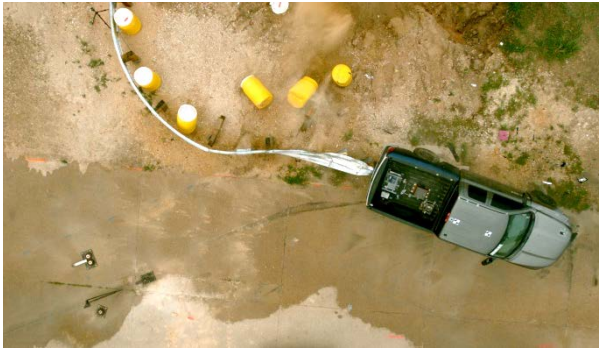
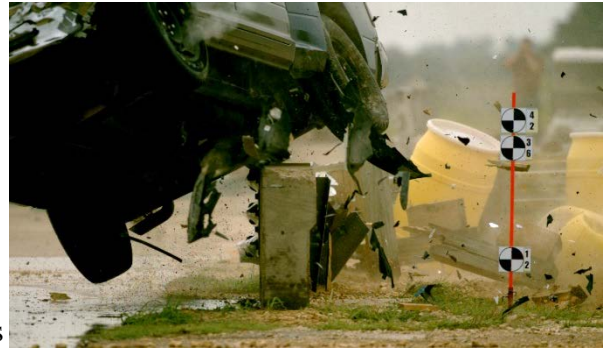
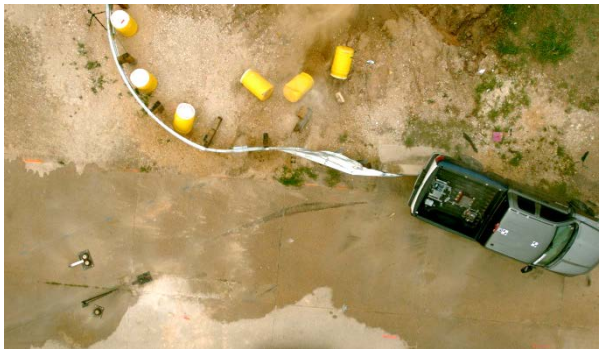
**Figure G.1. Sequential Photographs for Test No. 469138-3-4 (Overhead and Frontal Views).**

**Figure G.1. Sequential Photographs for Test No. 469138-3-4 (Overhead and Frontal Views) (Continued).**

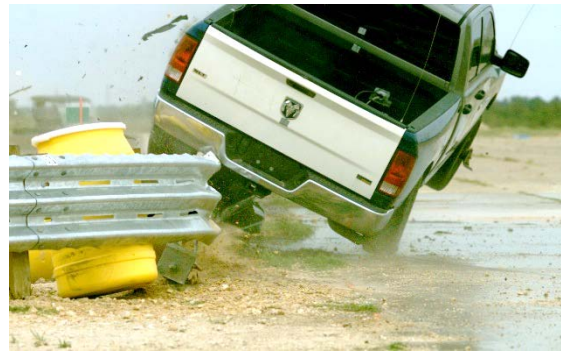
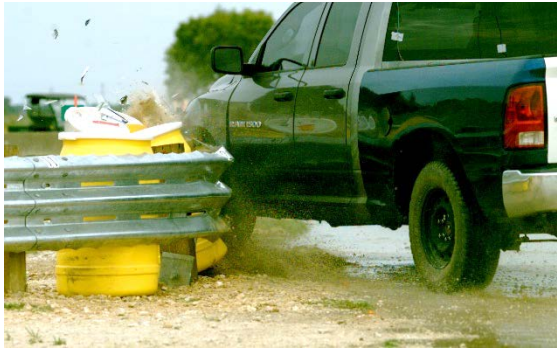
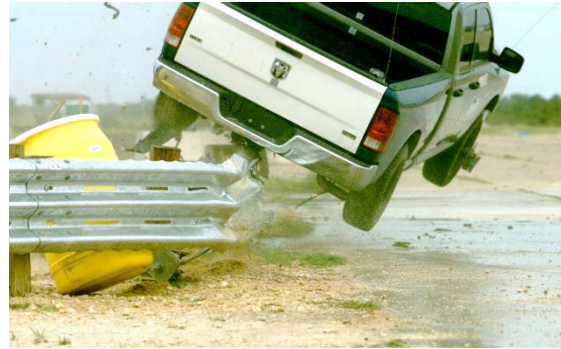
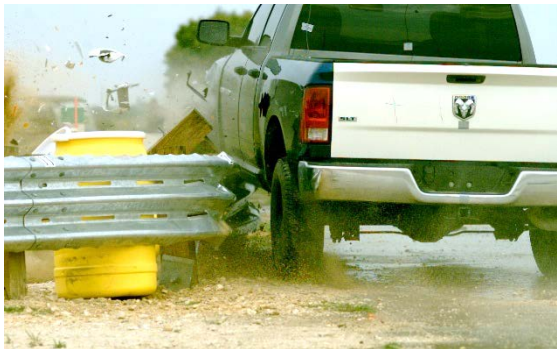
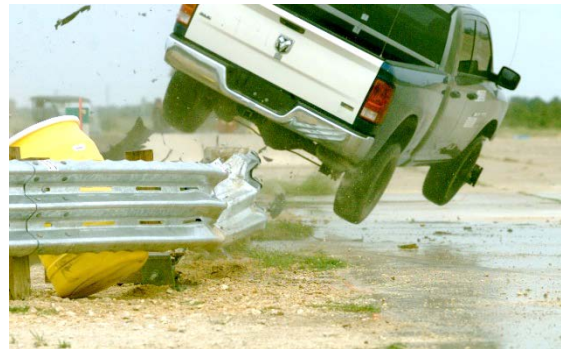
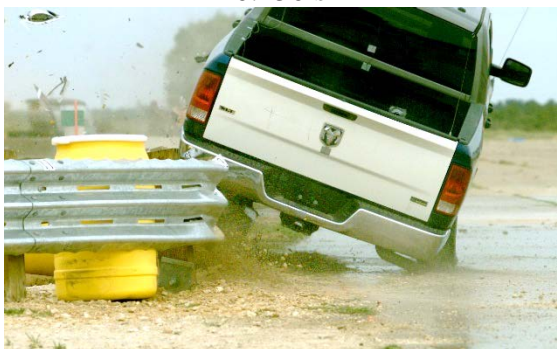
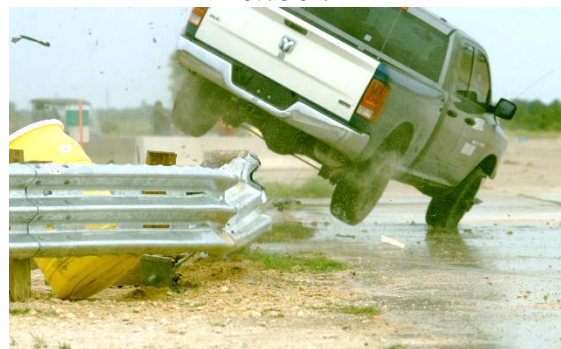
**Figure G.2. Sequential Photographs for Test No. 469138-3-4 (Rear View).**

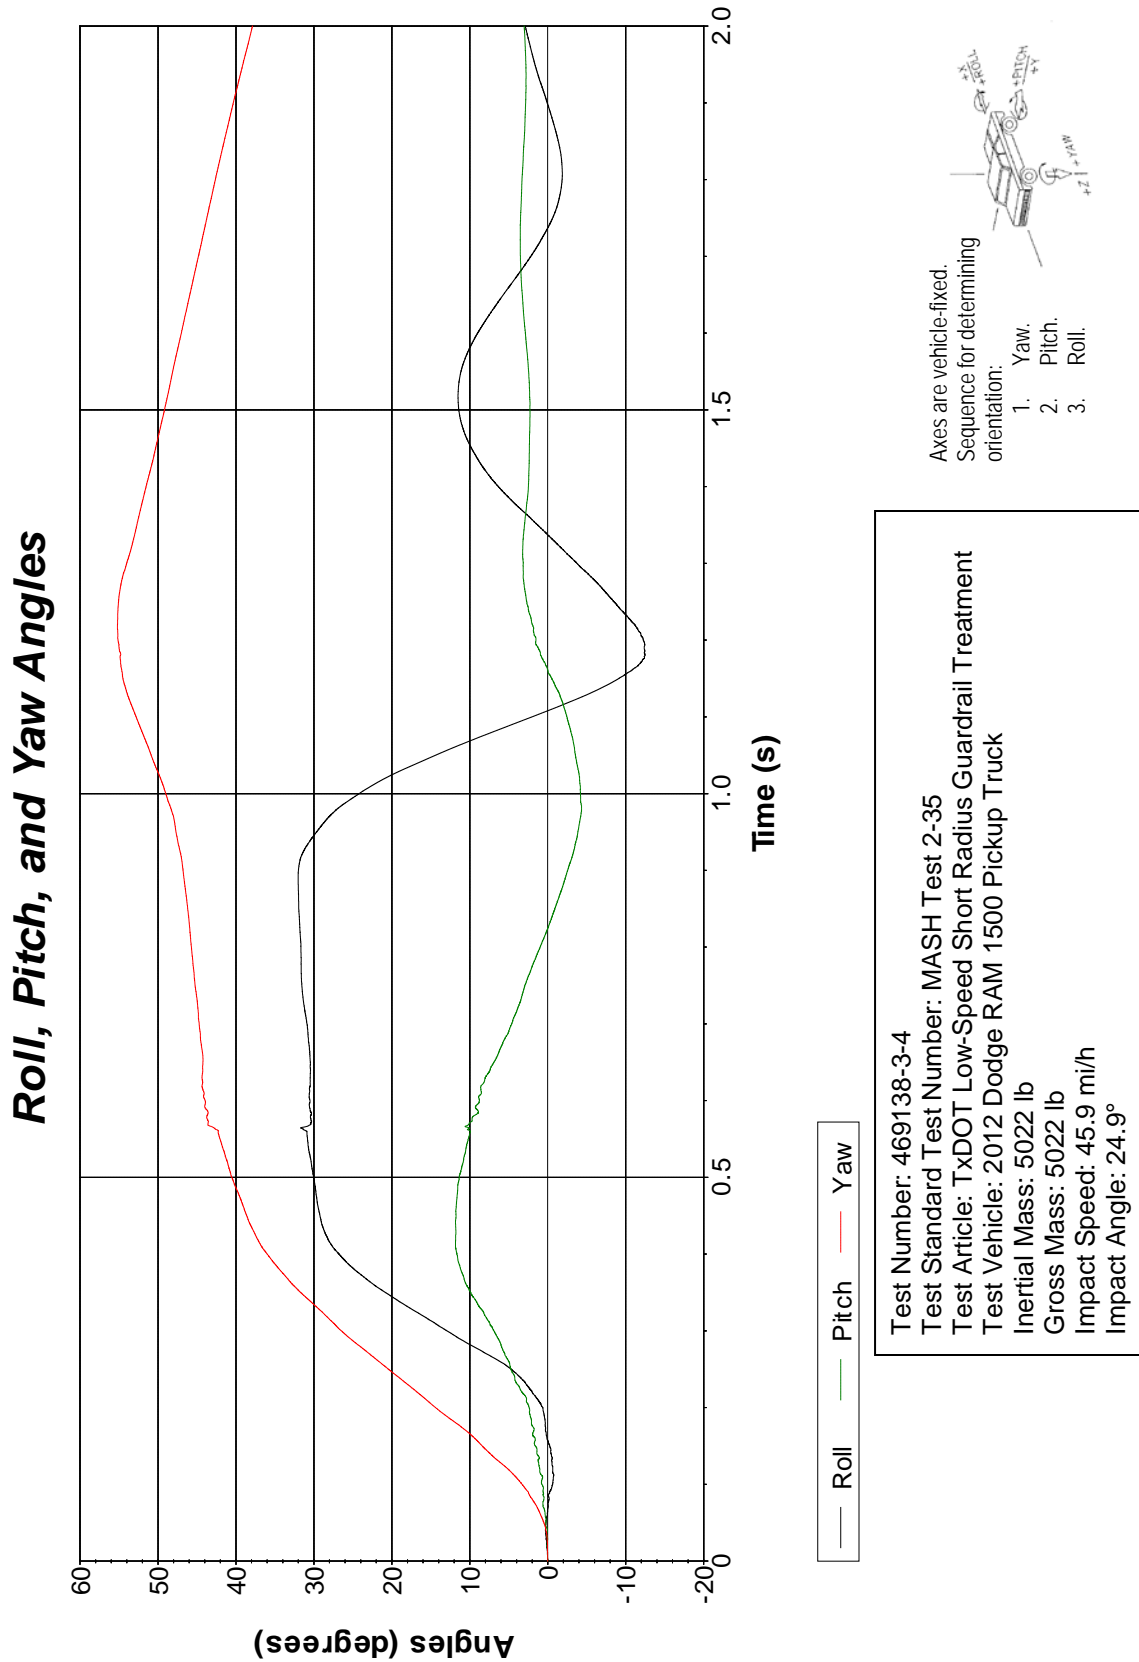
**Figure G.3. Vehicle Angular Displacements for Test No. 469138-3-4.**

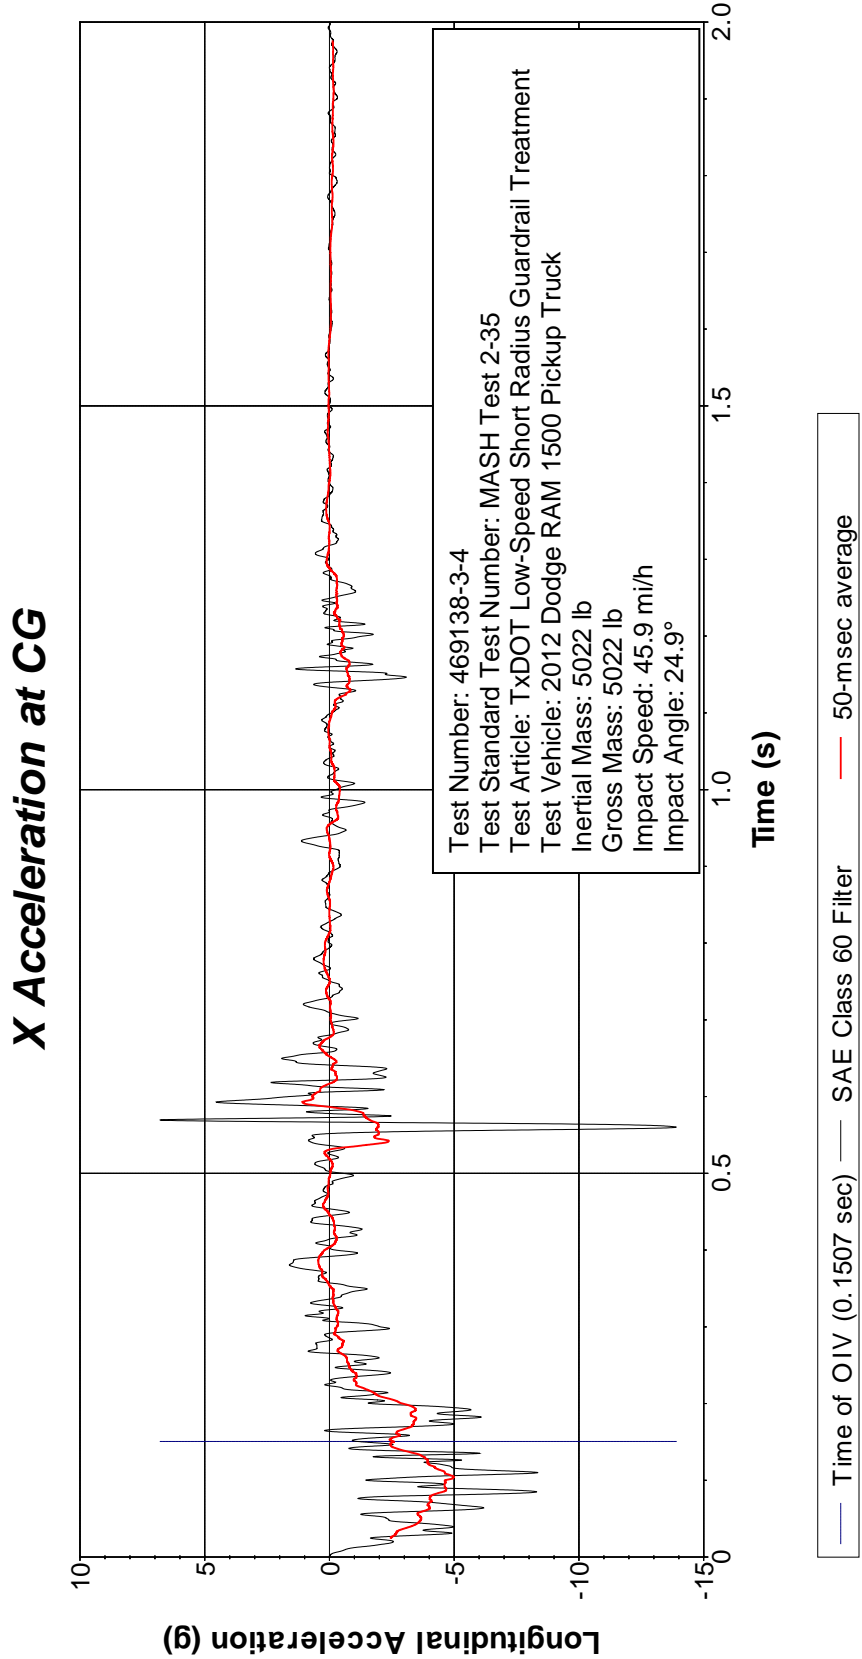
**Figure G.4. Vehicle Longitudinal Accelerometer Trace for Test No. 469138-3-4 (Accelerometer Located at Center of Gravity).**

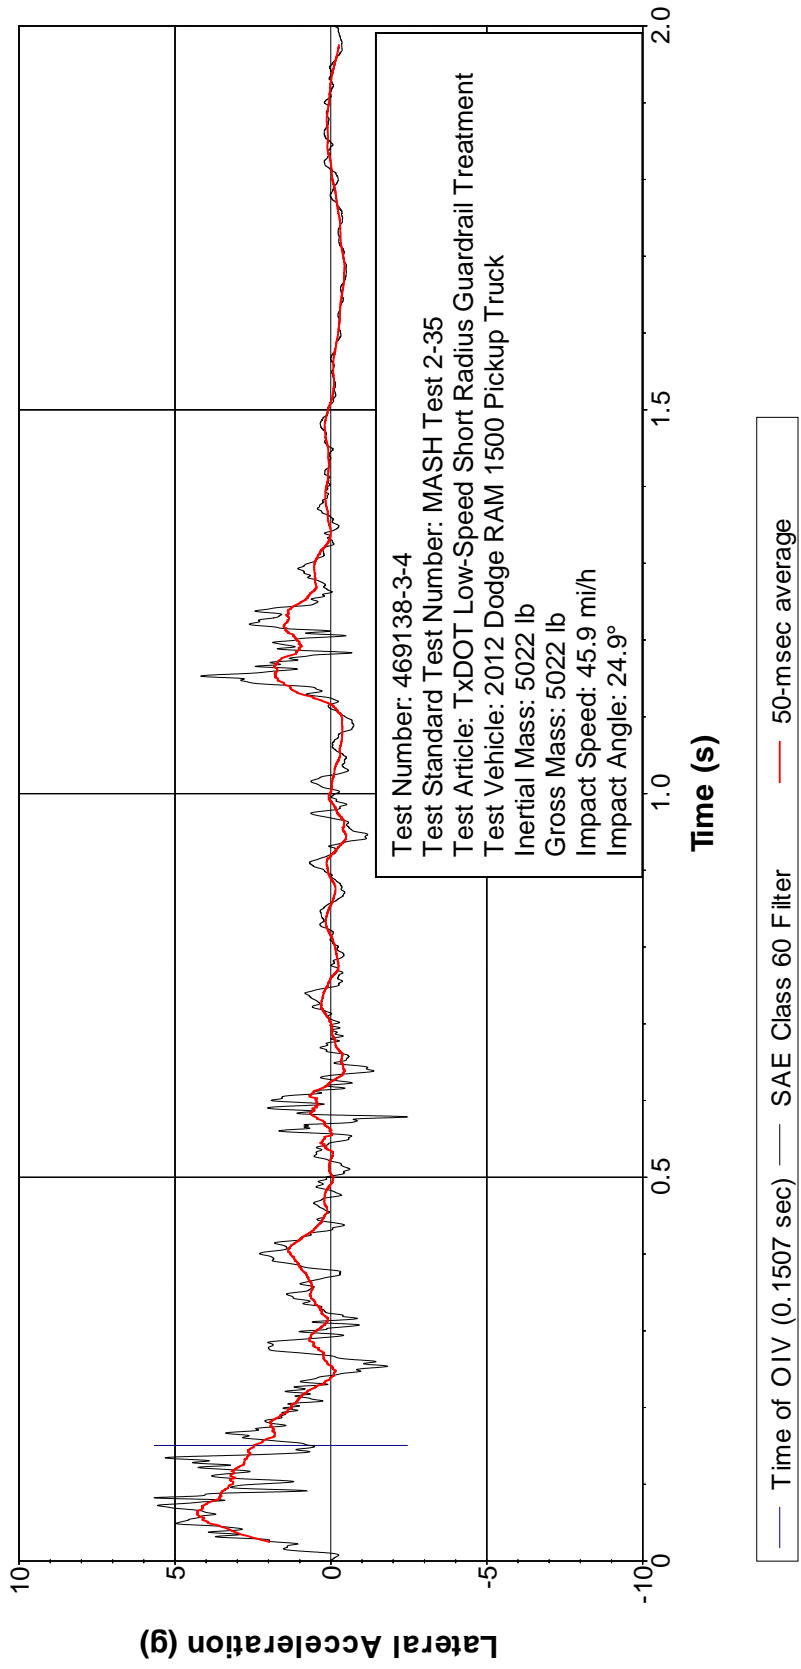
**Figure G.5. Vehicle Lateral Accelerometer Trace for Test No. 469138-3-4 (Accelerometer Located at Center of Gravity).**

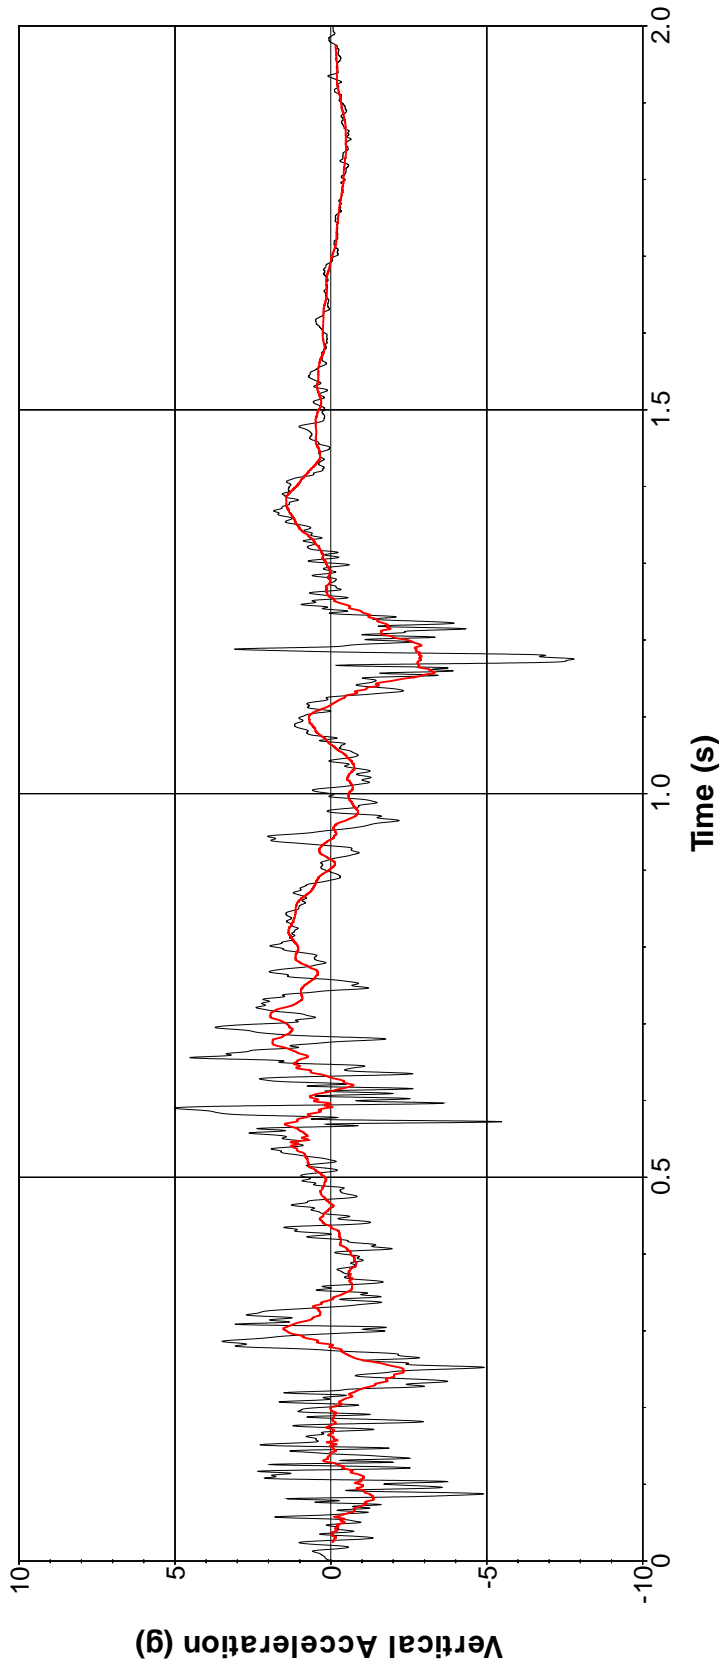
— SAE Class 60 Filter    — 50-msec average  
 Test Number: 469138-3-4  
 Test Standard Test Number: MASH Test 2-35  
 Test Article: TxDOT Low-Speed Short Radius Guardrail Treatment  
 Test Vehicle: 2012 Dodge RAM 1500 Pickup Truck  
 Inertial Mass: 5022 lb  
 Gross Mass: 5022 lb  
 Impact Speed: 45.9 mi/h  
 Impact Angle: 24.9°

**Figure G.6. Vehicle Vertical Accelerometer Trace for Test No. 469138-3-4 (Accelerometer Located at Center of Gravity).**

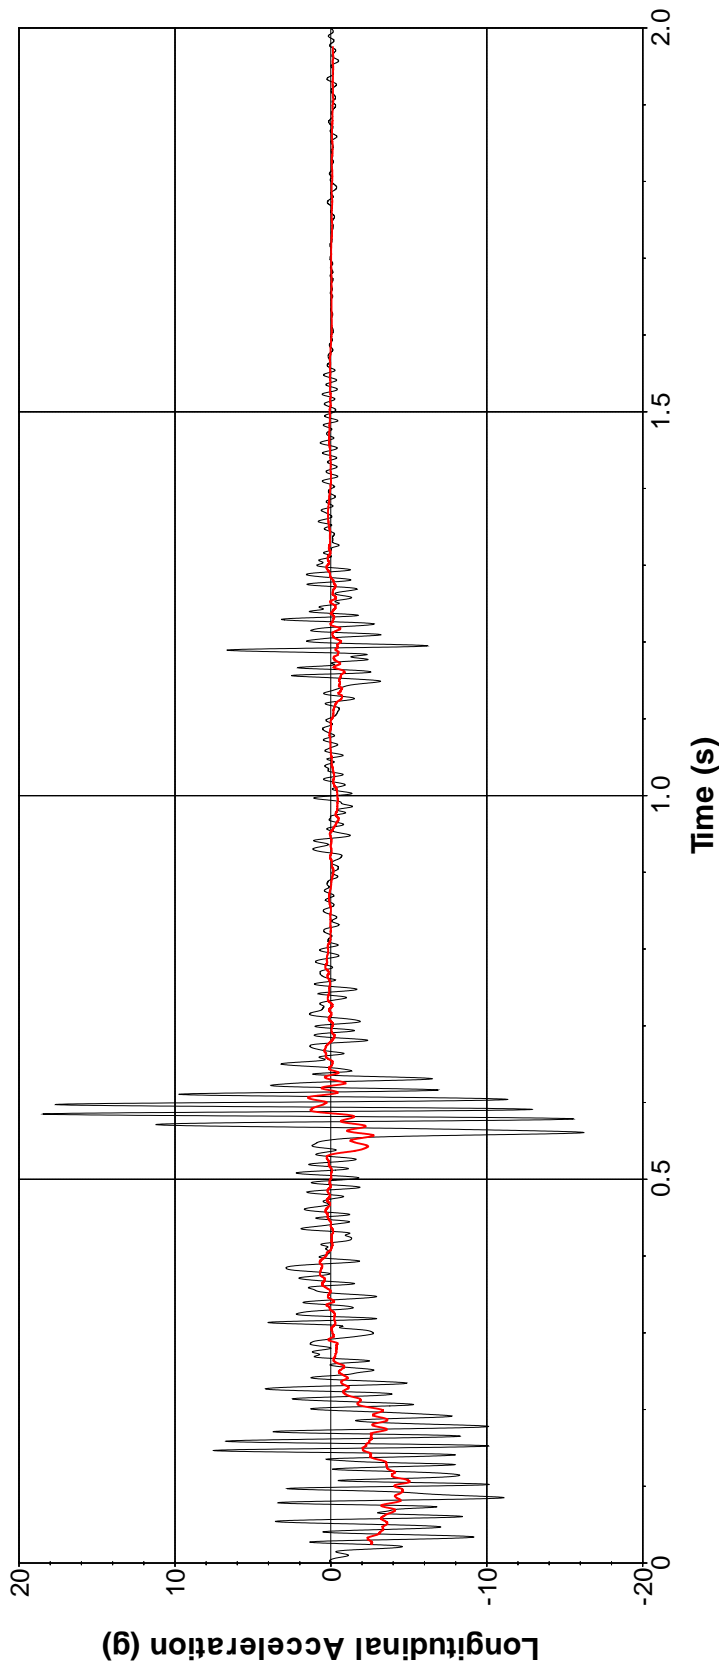
Test Number: 469138-3-4  
 Test Standard Test Number: MASH Test 2-35  
 Test Article: TxDOT Low-Speed Short Radius Guardrail Treatment  
 Test Vehicle: 2012 Dodge RAM 1500 Pickup Truck  
 Inertial Mass: 5022 lb  
 Gross Mass: 5022 lb  
 Impact Speed: 45.9 mi/h  
 Impact Angle: 24.9°

**Figure G.7. Vehicle Longitudinal Accelerometer Trace for Test No. 469138-3-4 (Accelerometer Located Rear of Center of Gravity).**

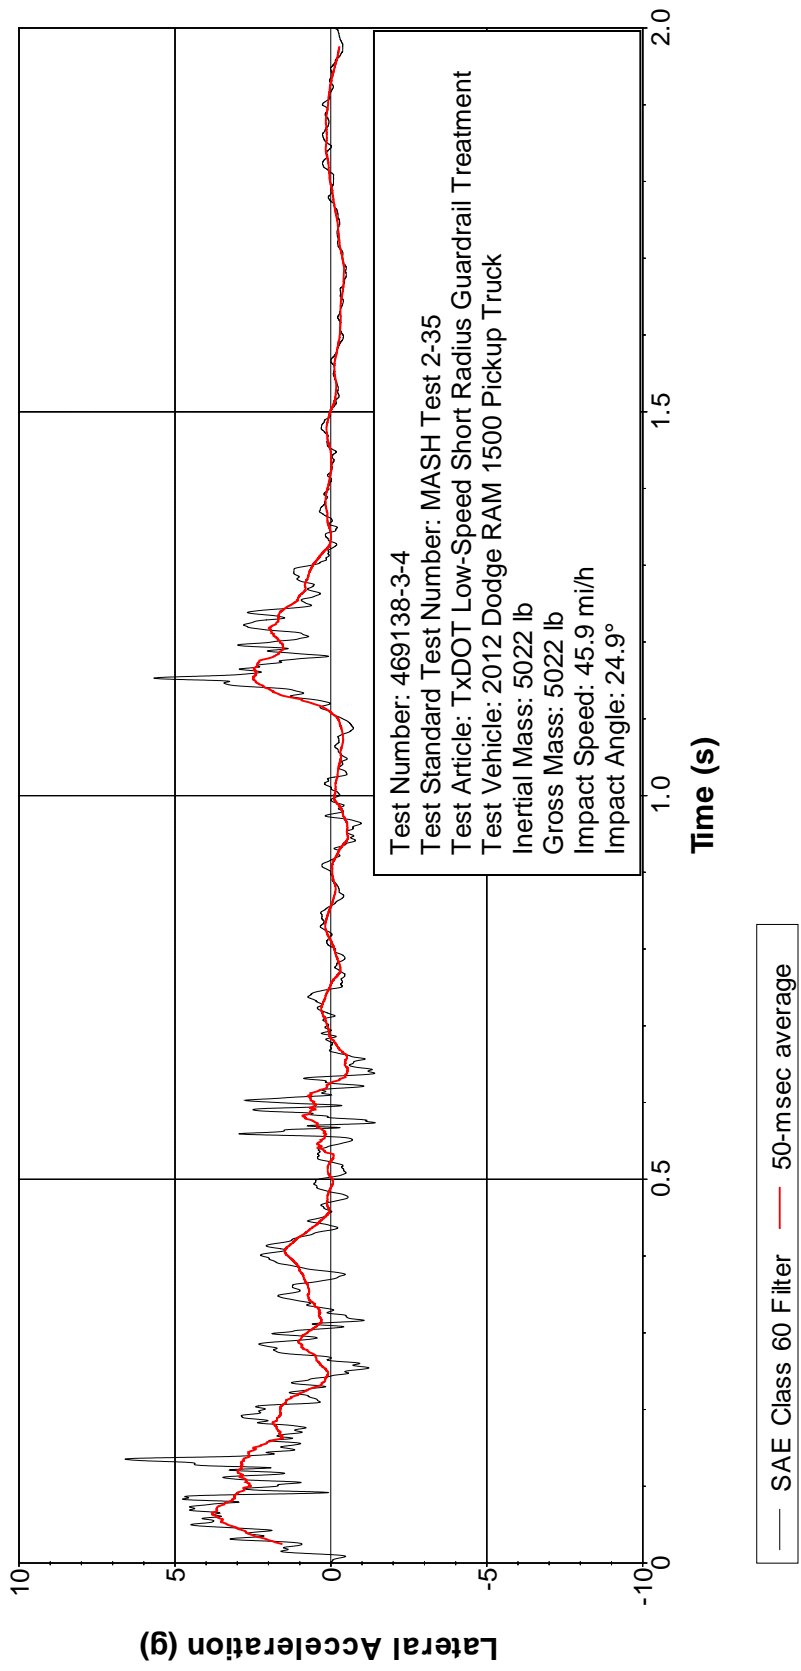
**Figure G.8. Vehicle Lateral Accelerometer Trace for Test No. 469138-3-4 (Accelerometer Located Rear of Center of Gravity).**
