# CRASH TEST AND EVALUATION OF TL-2 SHORT RADIUS GUARDRAIL TREATMENT

**Test Report 0-6913-R1**

**TEXAS A&M TRANSPORTATION INSTITUTE  
COLLEGE STATION, TEXAS**

**TEXAS DEPARTMENT OF TRANSPORTATION**

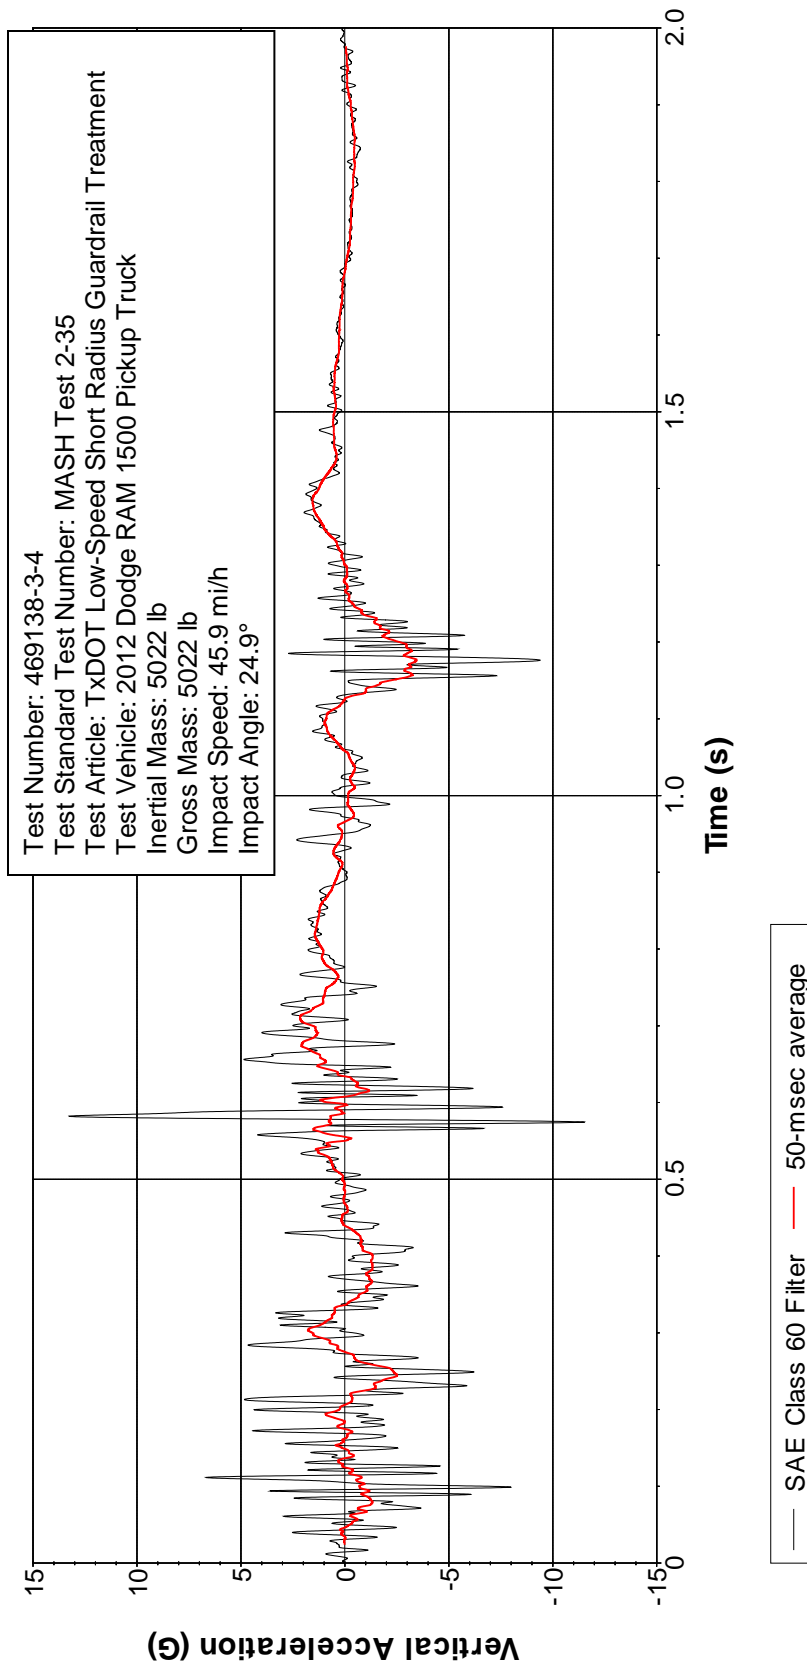
**Figure G.9. Vehicle Vertical Accelerometer Trace for Test No. 469138-3-4 (Accelerometer Located Rear of Center of Gravity).**

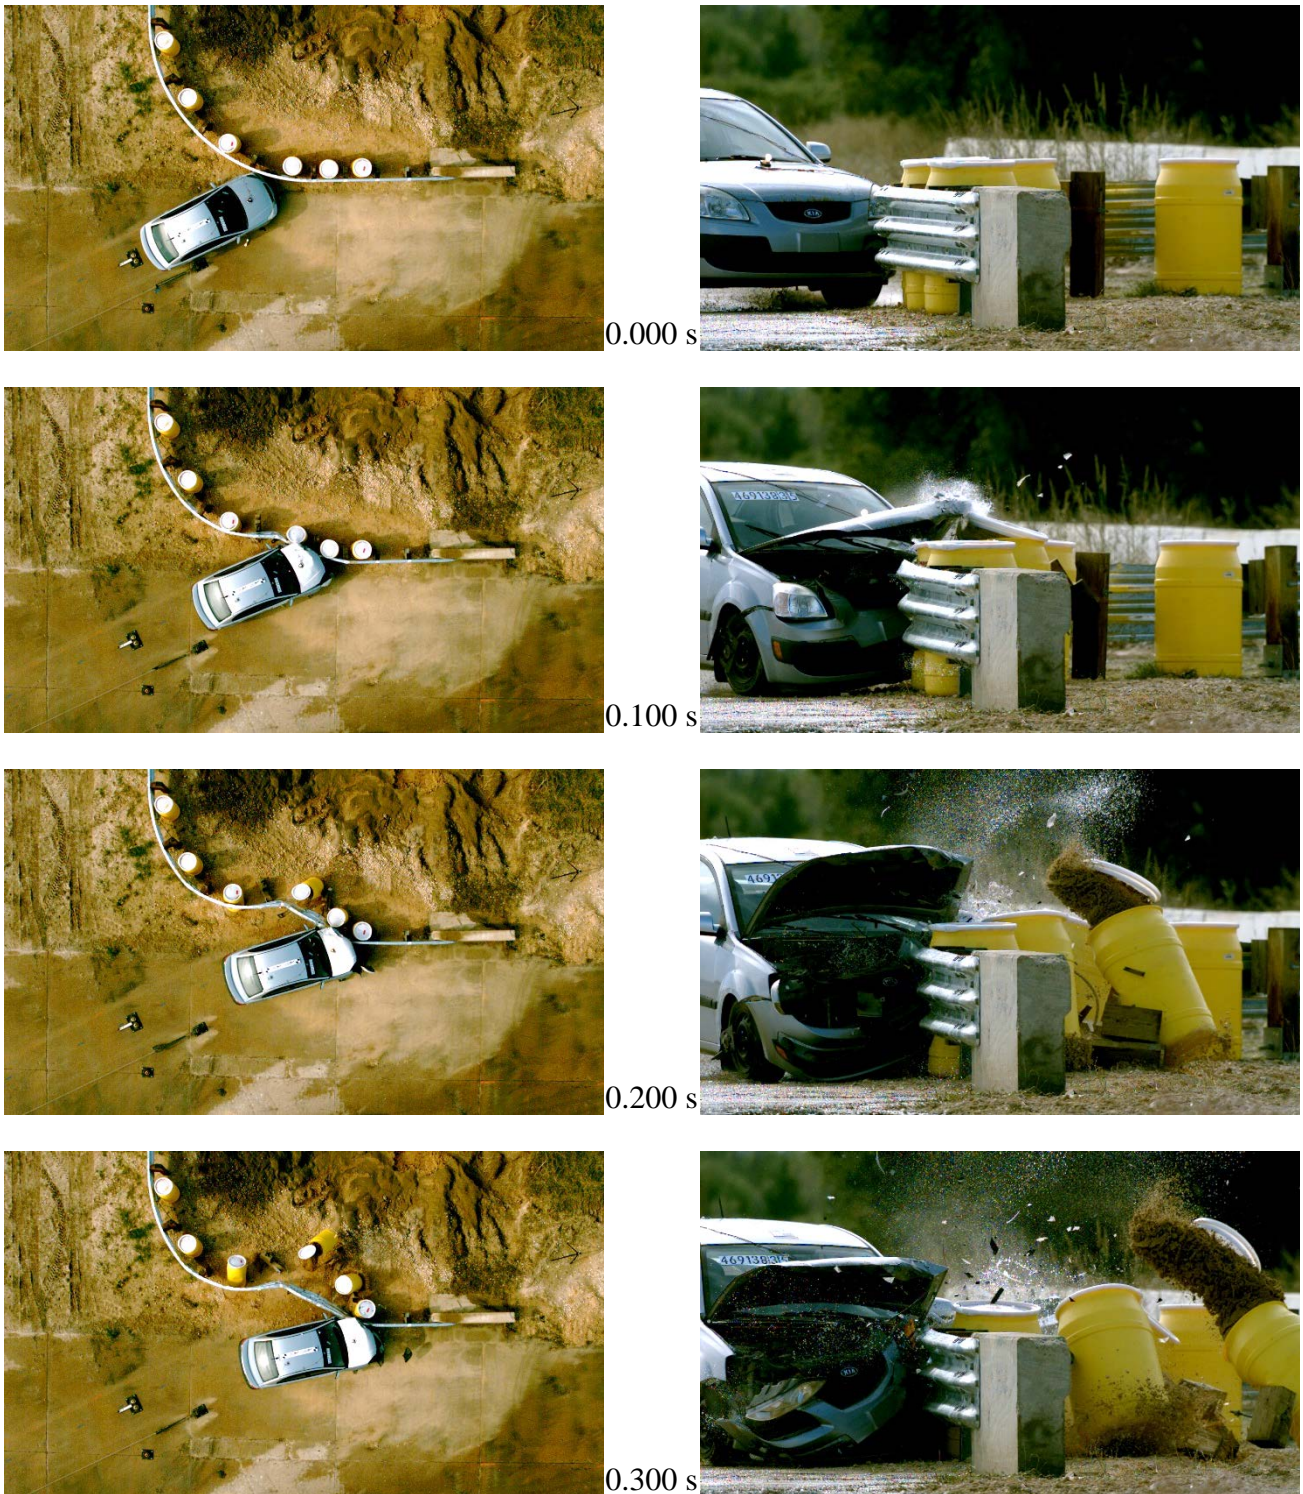
Figure H.1. Sequential Photographs for Test No. 469138-3-5 (Overhead and Frontal Views).

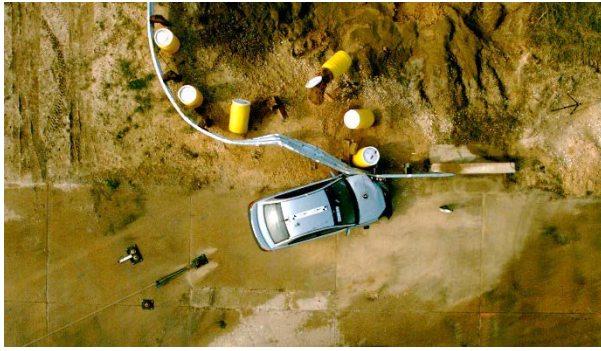
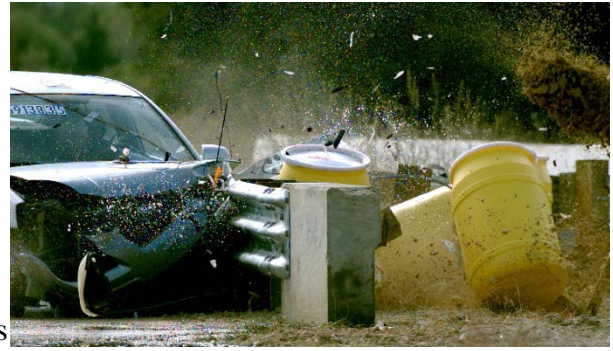
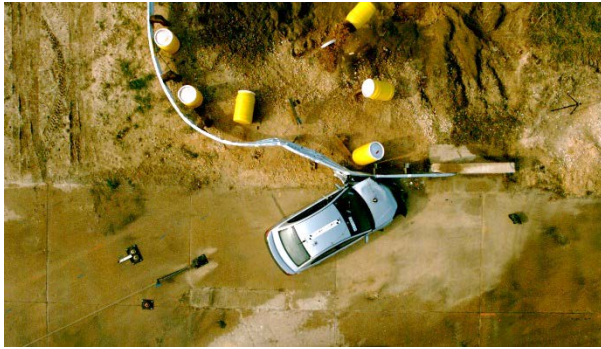
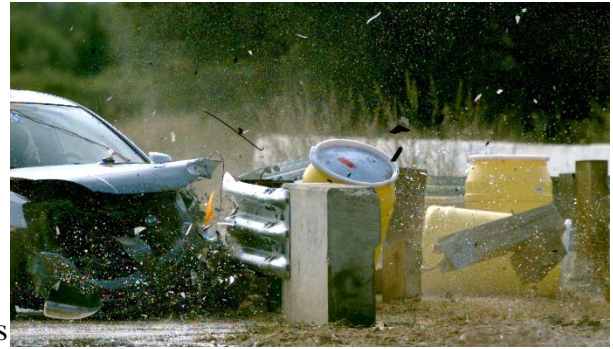
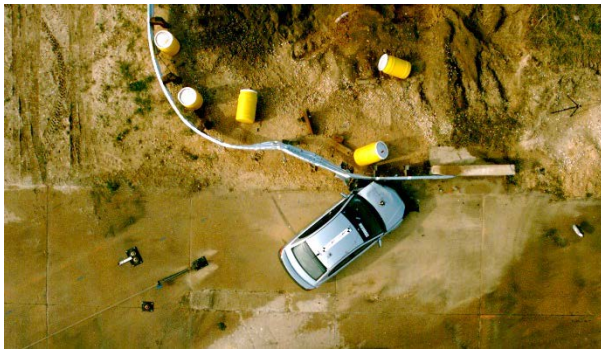
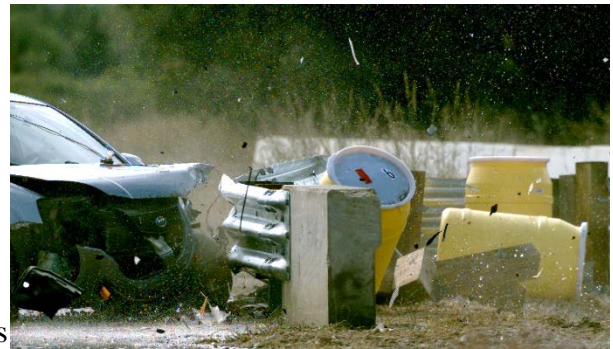
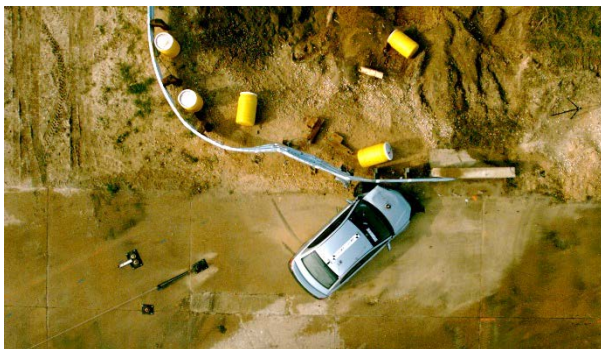
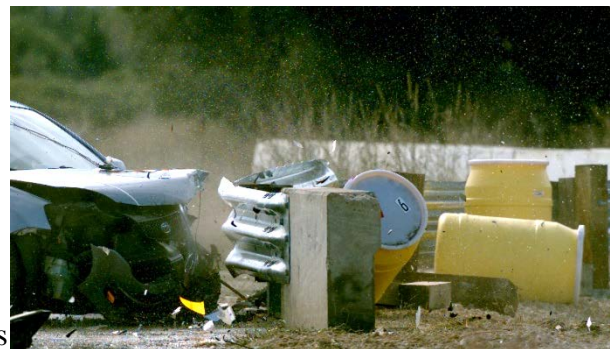
**Figure H.1D.1. Sequential Photographs for Test No. 469138-3-5 (Overhead and Frontal Views) (Continued).**

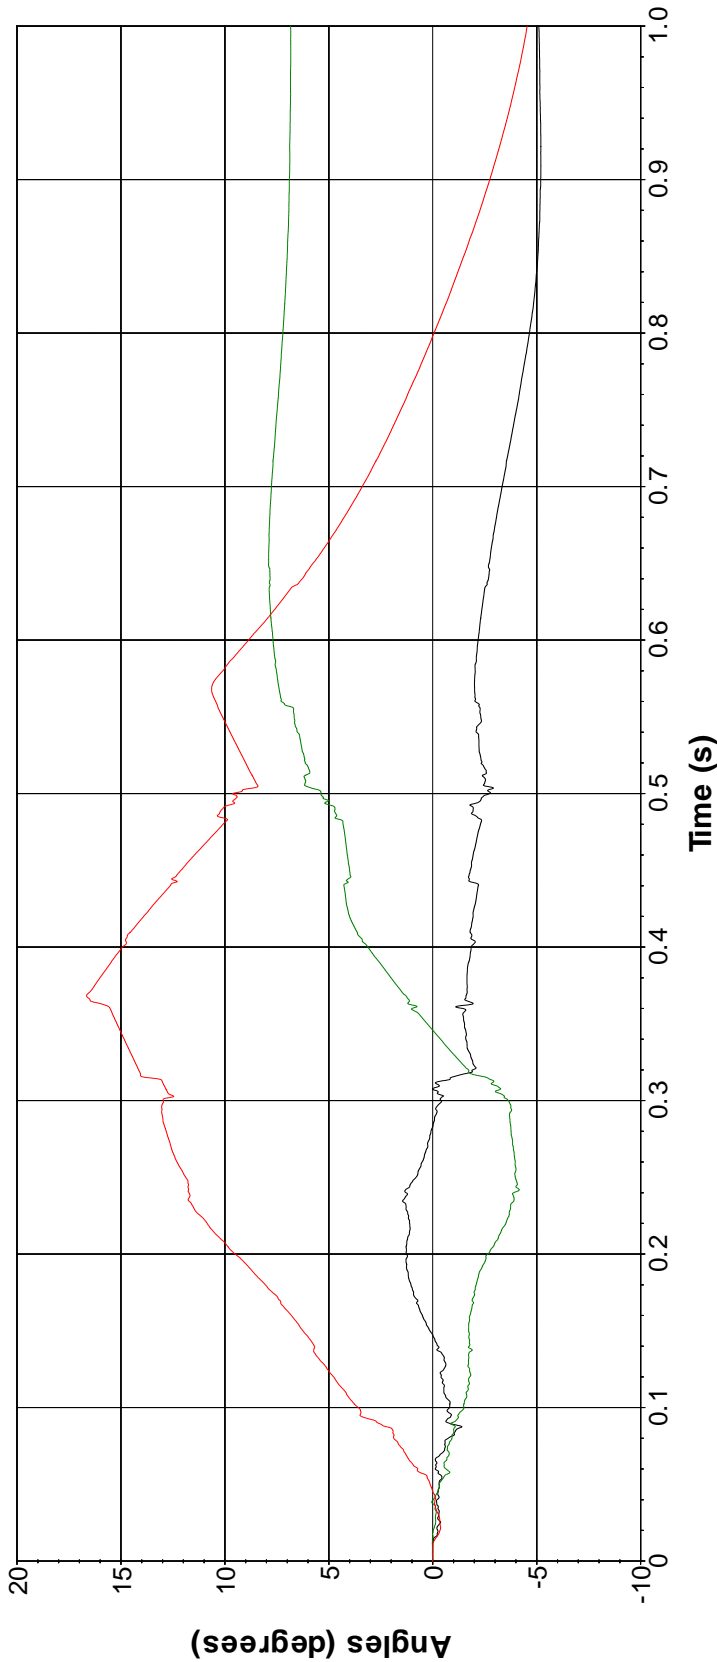
Test Number: 469138-3-5  
 Test Standard Test Number: Modified MASH Test 2-34  
 Test Article: TxDOT Low-Speed Short Radius Guardrail Treatment  
 Test Vehicle: 2009 Kia Rio  
 Inertial Mass: 2444 lb  
 Gross Mass: 2609 lb  
 Impact Speed: 44.6 mi/h  
 Impact Angle: 24.8°

**Figure H.2. Vehicle Angular Displacements for Test No. 469138-3-5.**

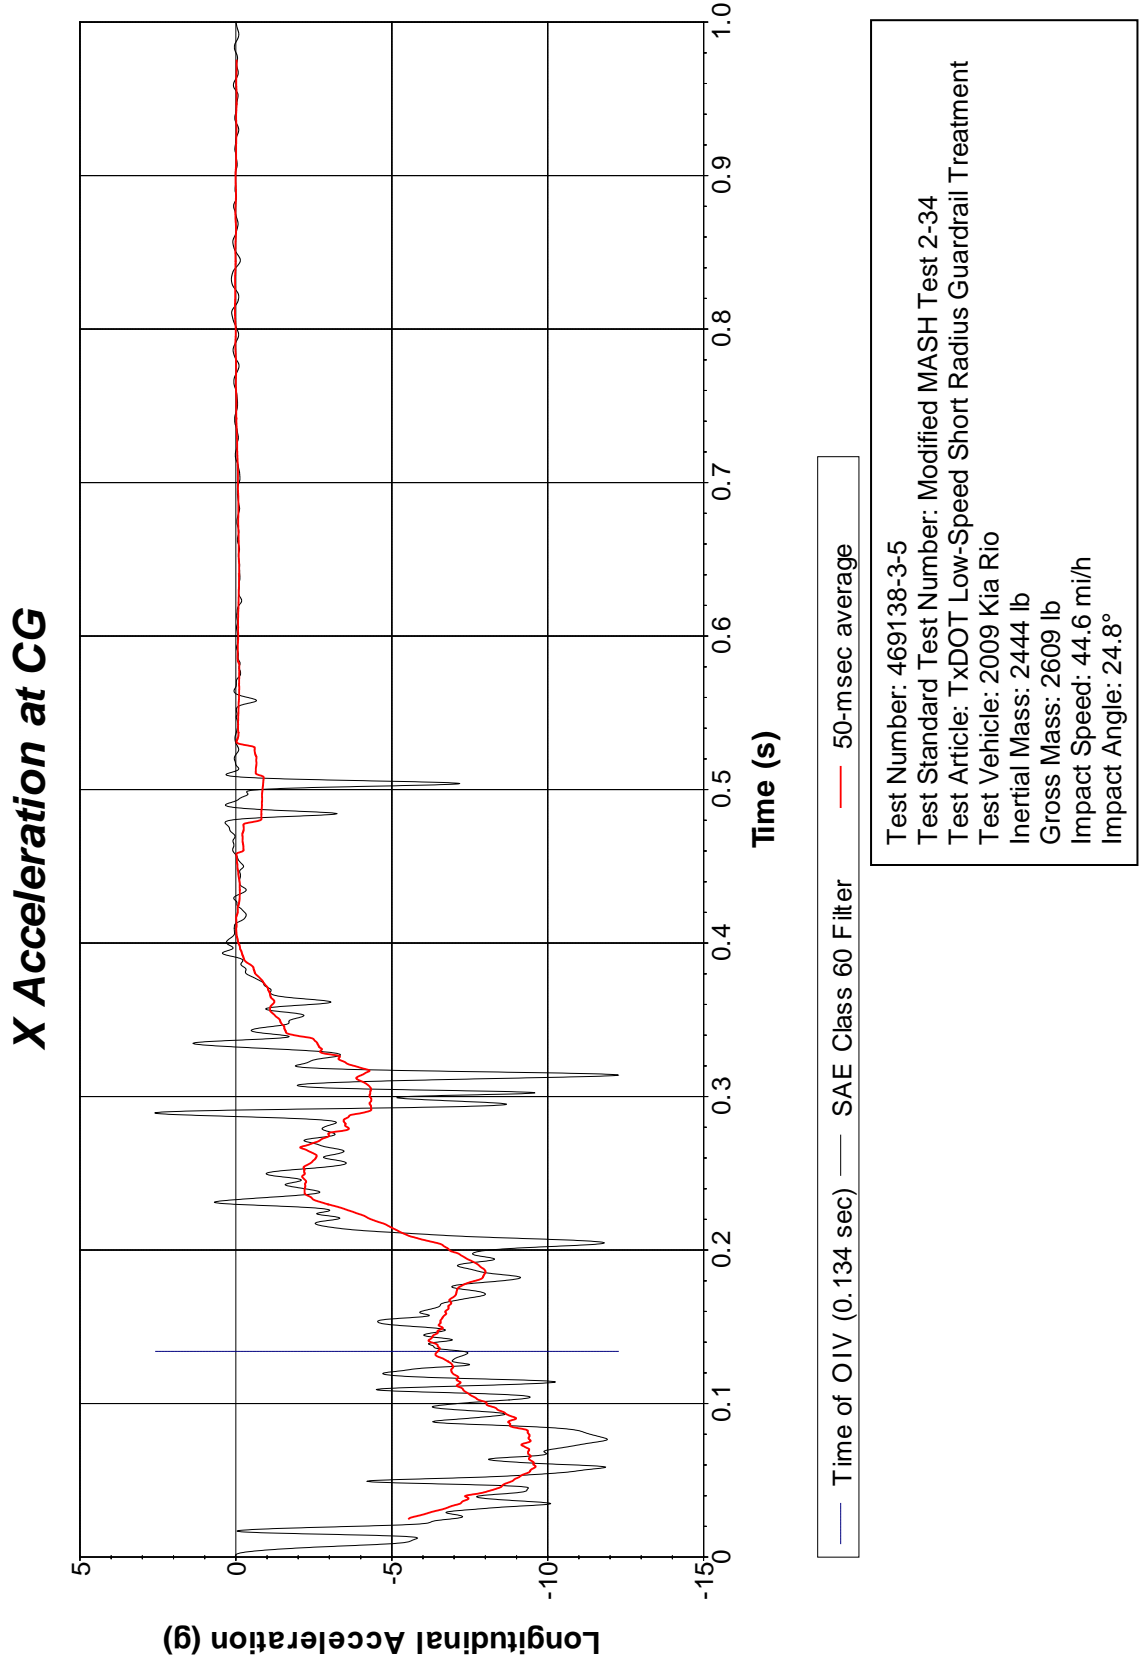
**Figure H.3. Vehicle Longitudinal Accelerometer Trace for Test No. 469138-3-5 (Accelerometer Located at Center of Gravity).**

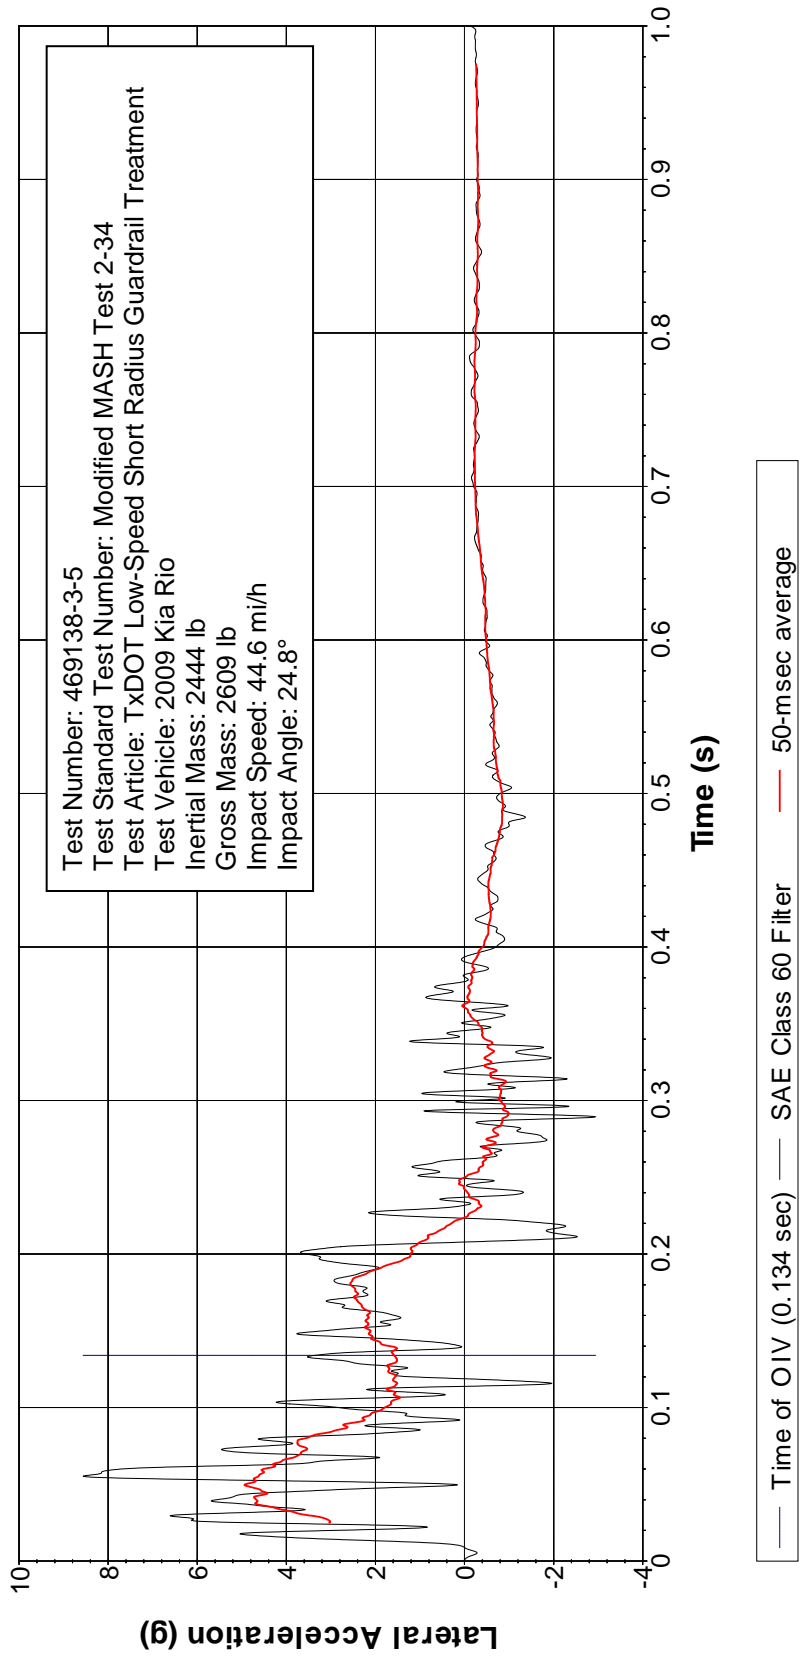
Figure H.4. Vehicle Lateral Accelerometer Trace for Test No. 469138-3-5 (Accelerometer Located at Center of Gravity).

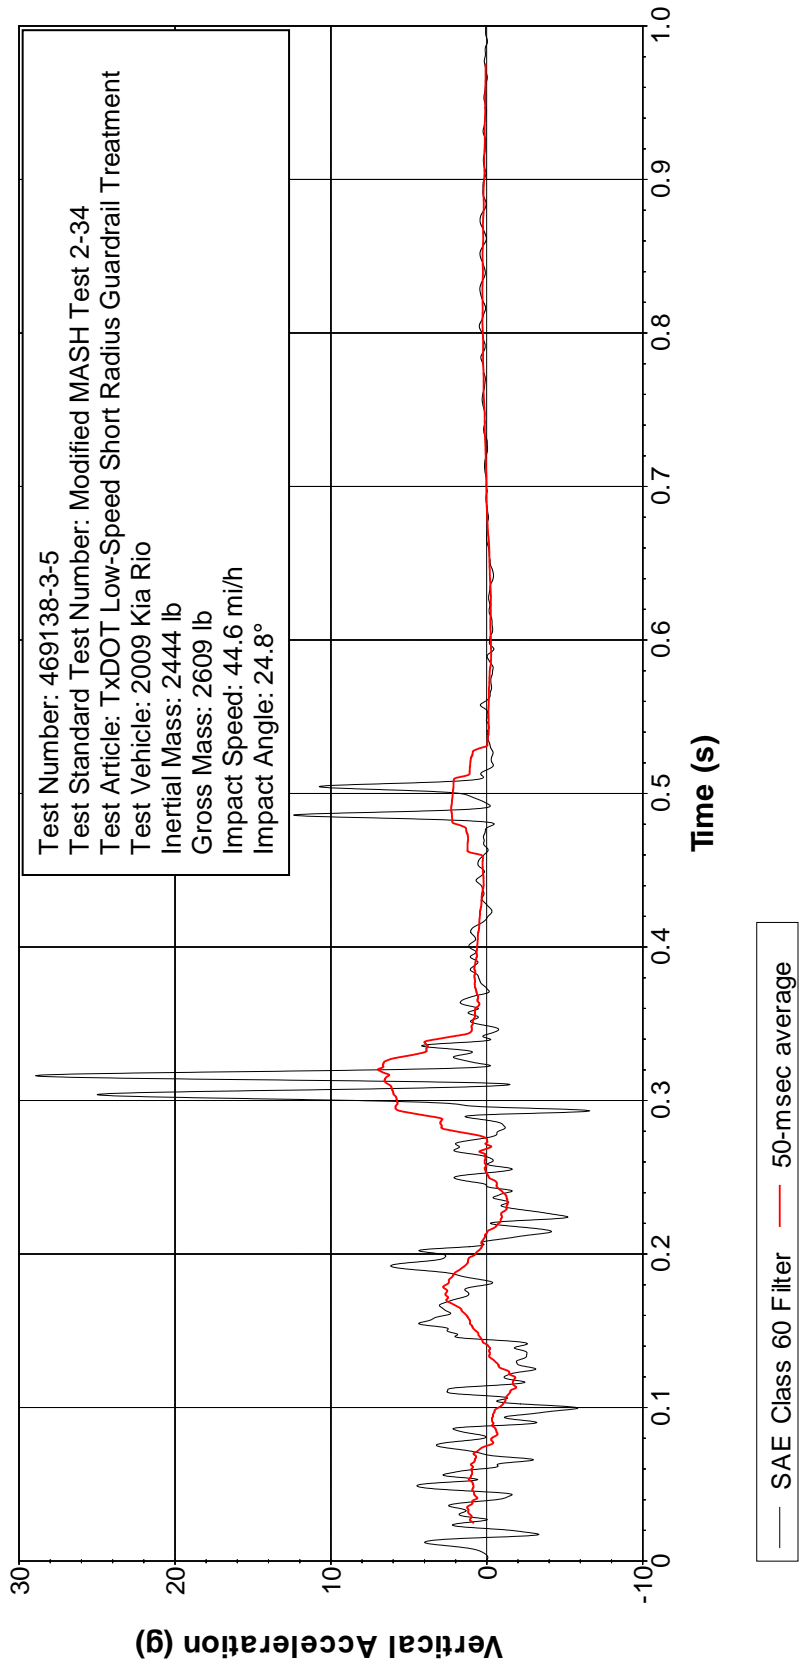
**Figure H.5. Vehicle Vertical Accelerometer Trace for Test No. 469138-3-5 (Accelerometer Located at Center of Gravity).**

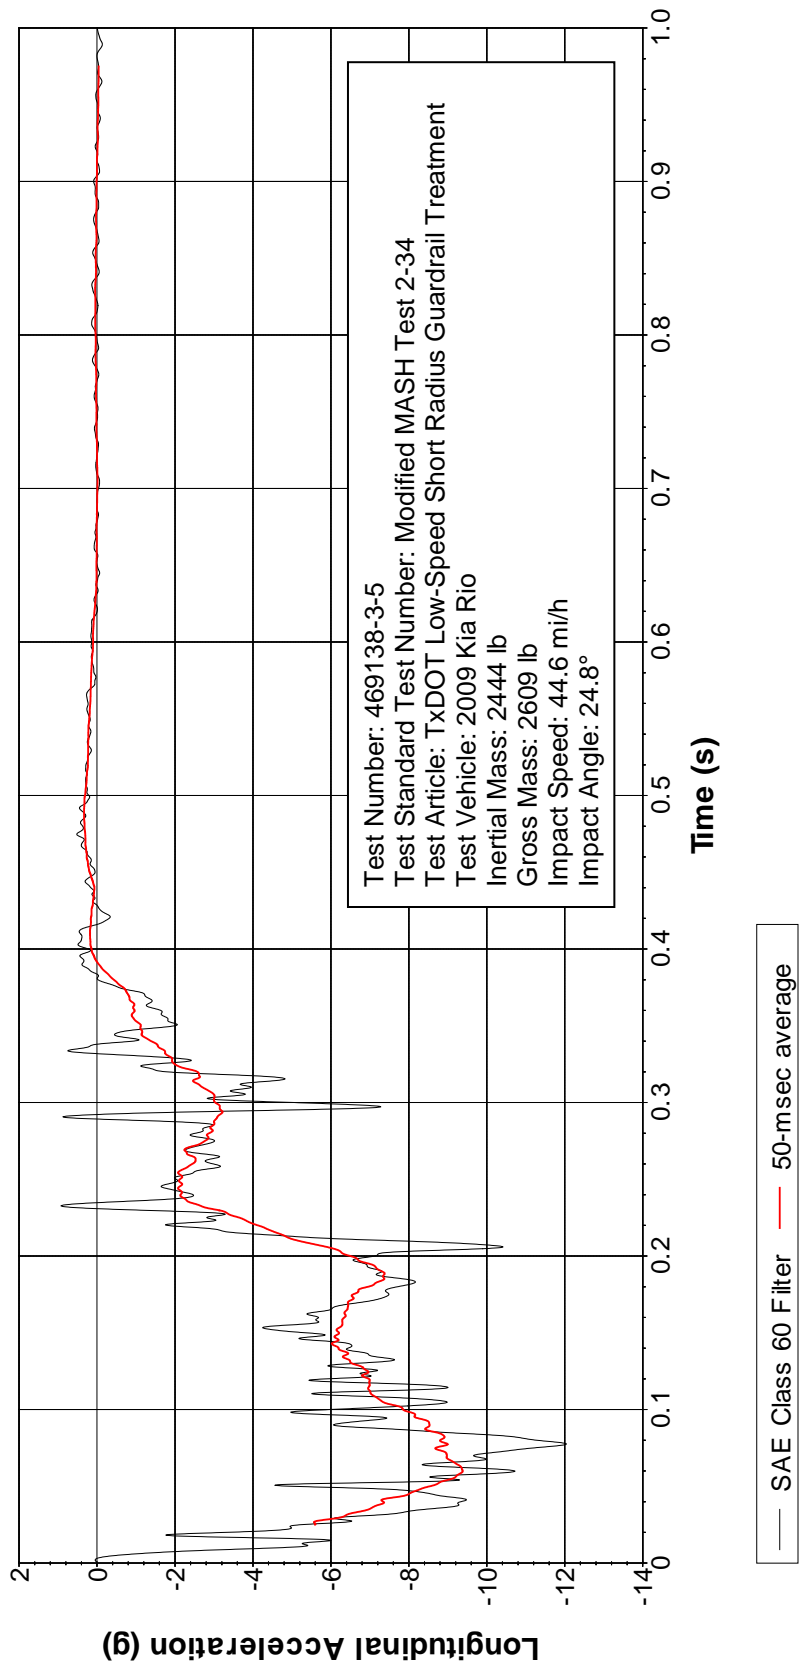
Figure H.6. Vehicle Longitudinal Accelerometer Trace for Test No. 469138-3-5 (Accelerometer Located Rear of Center of Gravity).

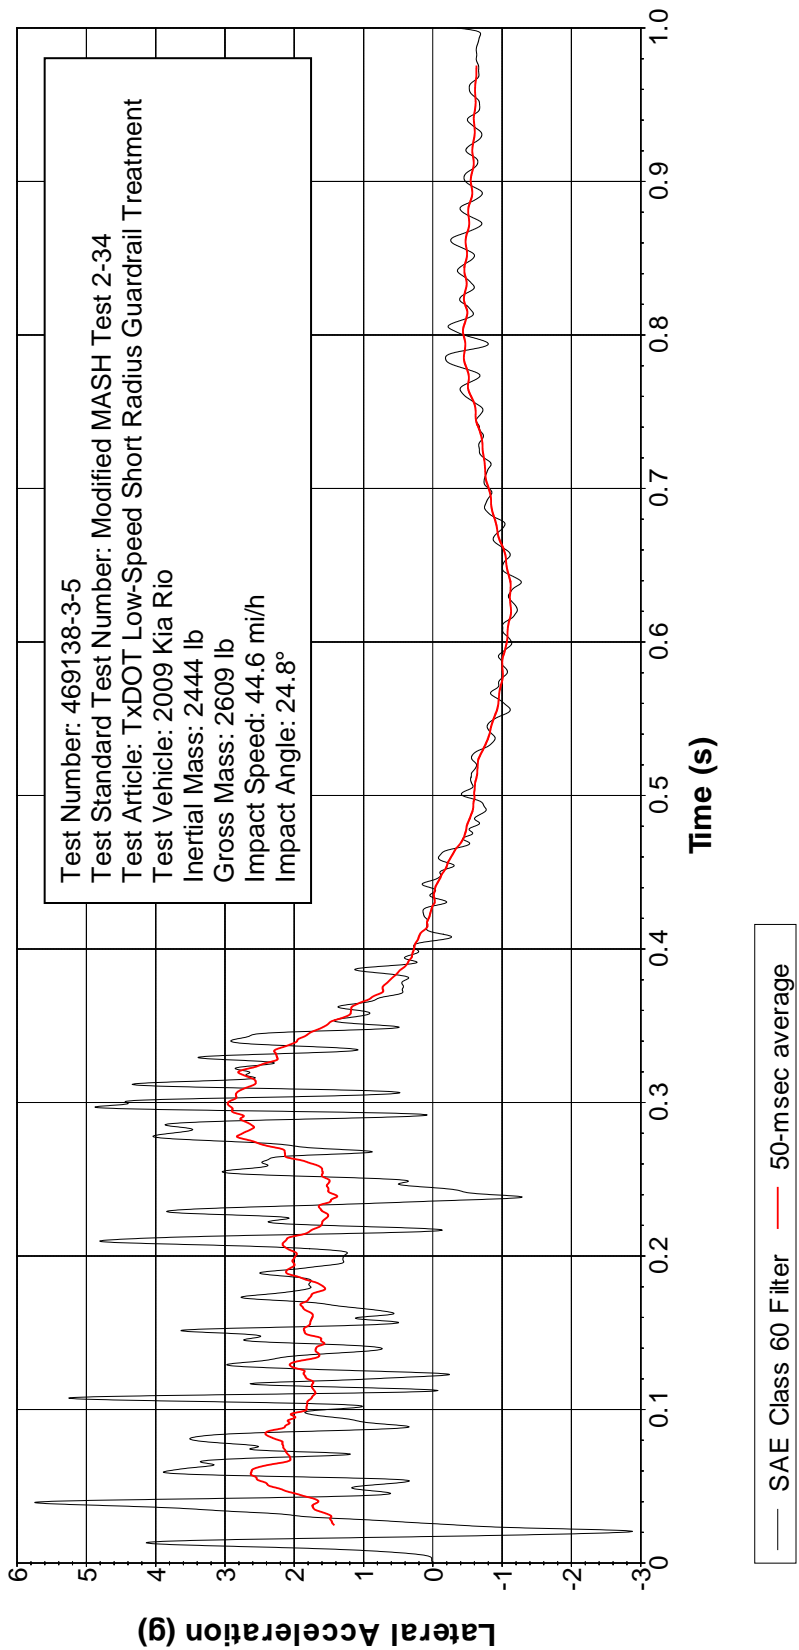
Figure H.7. Vehicle Lateral Accelerometer Trace for Test No. 469138-3-5 (Accelerometer Located Rear of Center of Gravity).

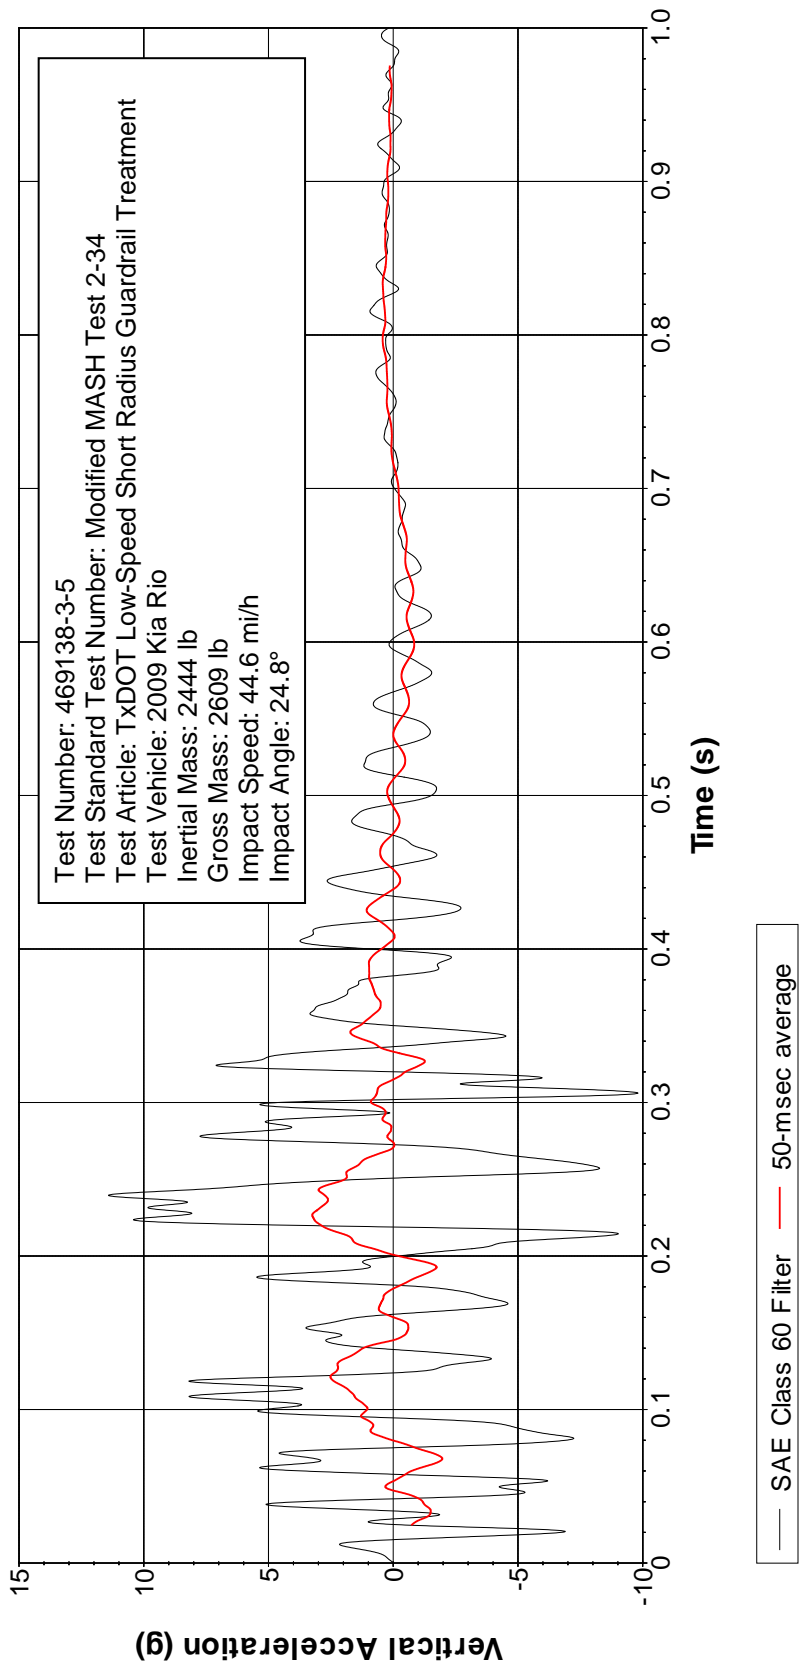
**Figure H.8. Vehicle Vertical Accelerometer Trace for Test No. 469138-3-5 (Accelerometer Located Rear of Center of Gravity).**
