U.S. Department of  
Transportation

**Federal Railroad  
Administration**

## **Effects of In-Pavement Lights on Driver Compliance with Grade Crossing Safety Equipment**

1. AGENCY USE ONLY (Leave blank)		2. REPORT DATE May 2019	3. REPORT TYPE AND DATES COVERED Technical Report September 2016 – April 2018	
4. TITLE AND SUBTITLE Effects of In-Pavement Lights on Driver Compliance with Grade Crossing Safety Equipment			5. FUNDING NUMBERS RR97A7-RJ1U5 RR97A8-RC966

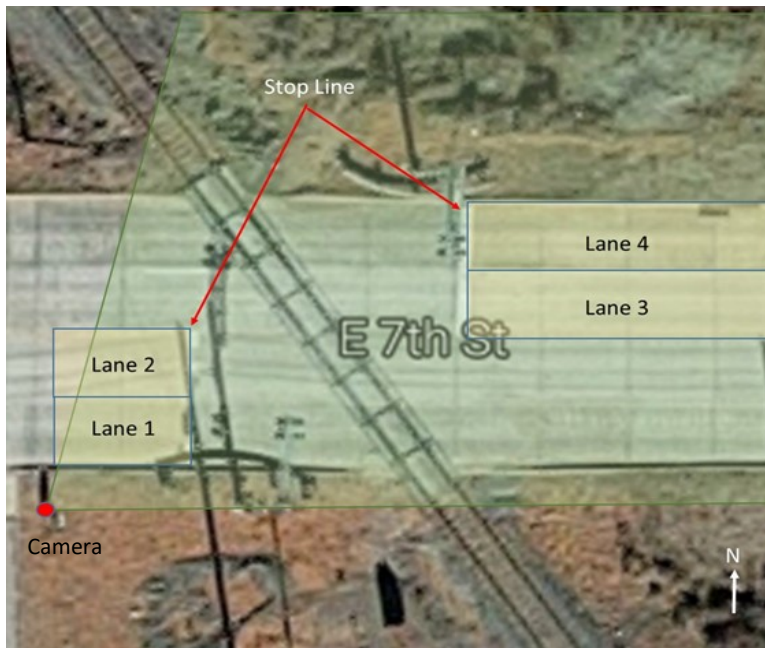
**Figure 1 – Aerial view of Elk City crossing**  
(Source: Google Maps)

The diagram above shows the location of the Volpe camera (bottom left), the approximate field of view (green shading), the identification of each travel lane, and the location of the stop lines. Seventh Street in Elk City serves as a bypass to the more congested 3<sup>rd</sup> Street, formerly U.S. Route 66. East 7<sup>th</sup> Street has its own exit off of Interstate 40. The Farmrail tracks in Elk City are a single-line Class II spur which terminates near Erick, Oklahoma, about 20 miles to the west. At one time these tracks were part of the Chicago, Rock Island & Pacific's main line, which paralleled U.S. Route 66 through Amarillo, Texas, but they no longer intersect any other rail lines to the west of Elk City. The tracks cross East 7<sup>th</sup> Street at a 52-degree angle, with a maximum timetable speed of 20 mph. While it primarily conducts freight rail operations, Farmrail owns several passenger cars which it uses for occasional charters and other events.

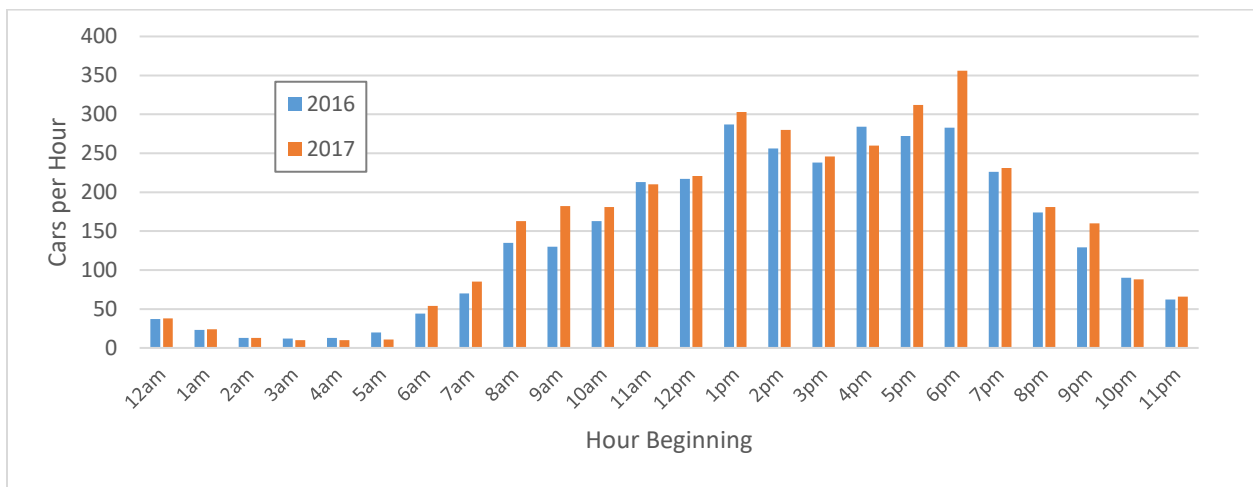
**Figure 2 – Comparison of traffic volumes on East 7th Street (first Thursday in November, 2016 and 2017)**

Researchers found it interesting that most of the increases in traffic occurred during rush hours in the morning and late afternoon. Since there was a slightly higher level of traffic in the post-deployment phase of this task, it was more likely for vehicles to have been present during crossing events. However, this should have had no significant impact on compliance rates.

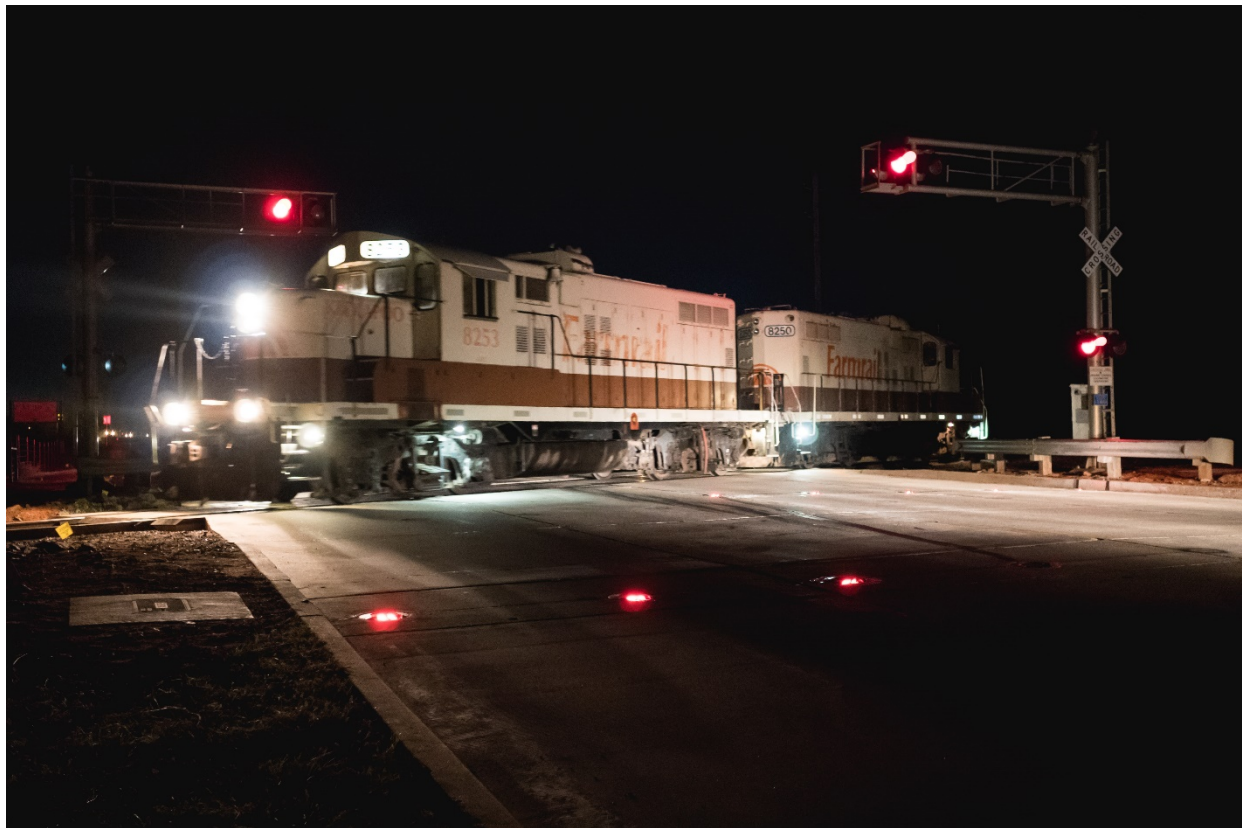
Below are two photos of the in-pavement lights in Elk City. [Figure 3](#) shows a nighttime view of the in-pavement lights, and [Figure 4](#) shows a close-up of one of the light fixtures as embedded in the pavement.

**Figure 3 – Elk City in-pavement lights, looking west**

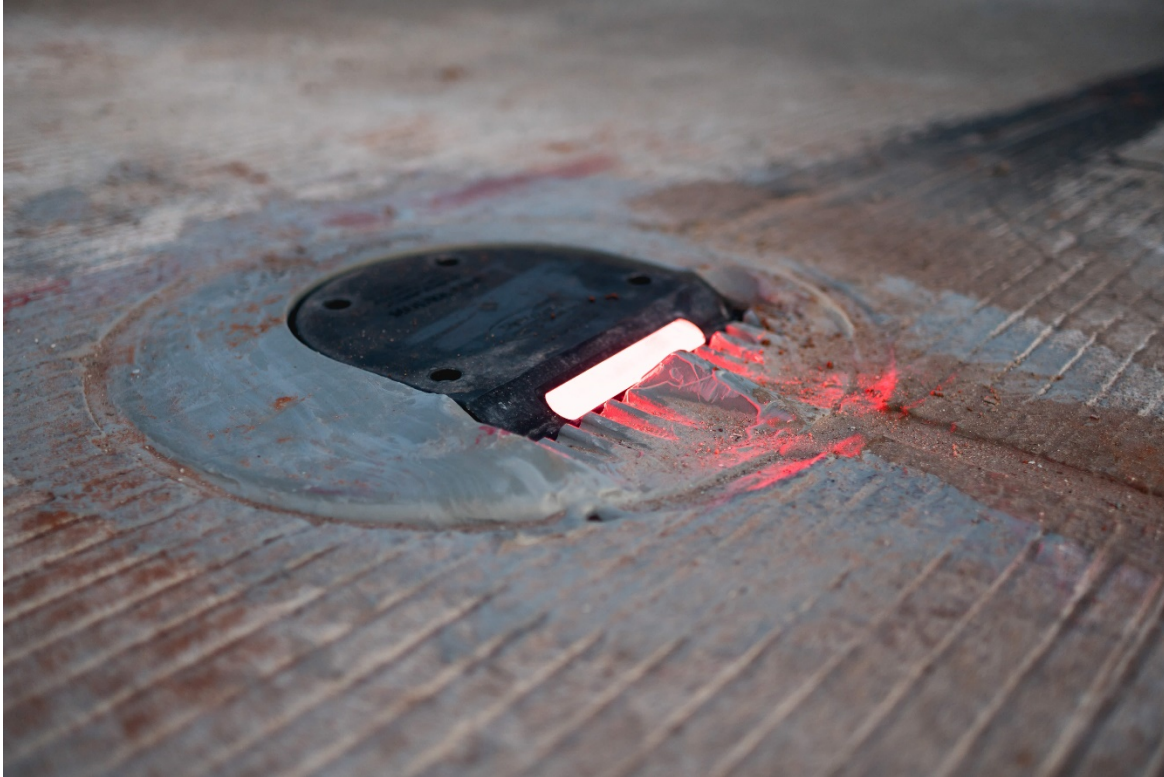
Volpe chose the Smart Crosswalk™ in-roadway warning light (IRWL) system by LightGuard Systems of Santa Cruz, California. The fixtures have snowplow-resistant steel shrouds and were controlled by a panel in a weatherproof enclosure mounted to the side of the Farmrail bungalow. The lights were triggered by the Farmrail grade crossing safety system. The in-pavement lights were programmed to flash for 5 seconds when the Farmrail system was activated, and then remain steady red until the Farmrail system deactivated.

**Figure 4 – Close-up of in-pavement light fixture in Elk City**

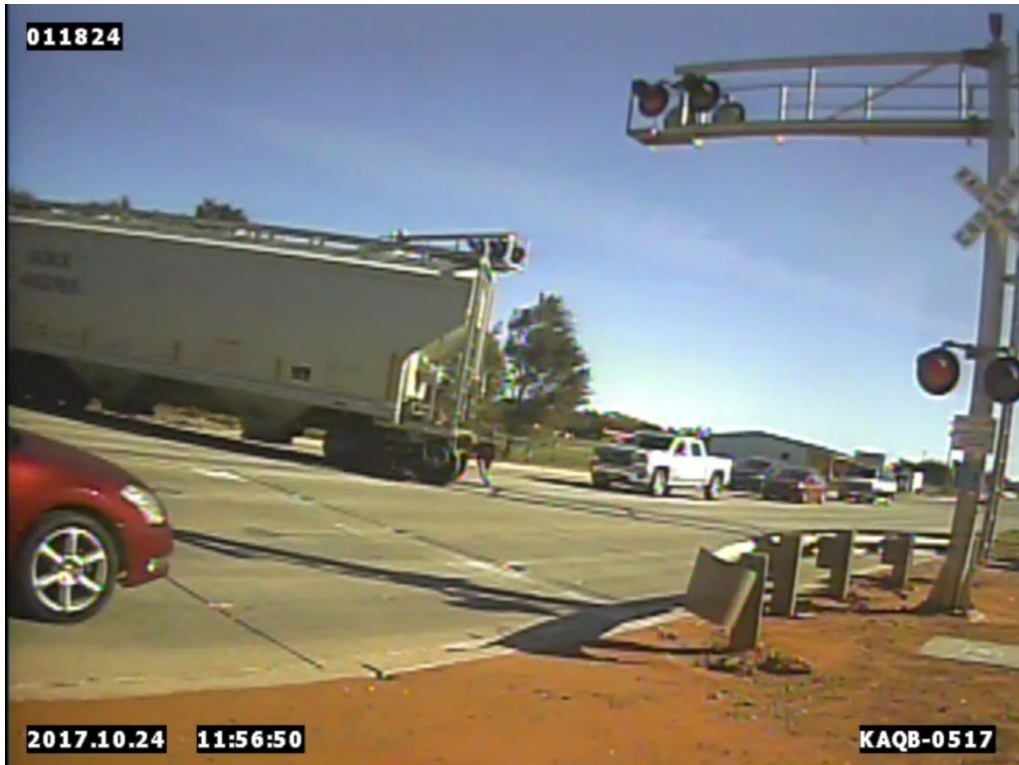
**Figure 5 – Example of the video camera’s field of view**

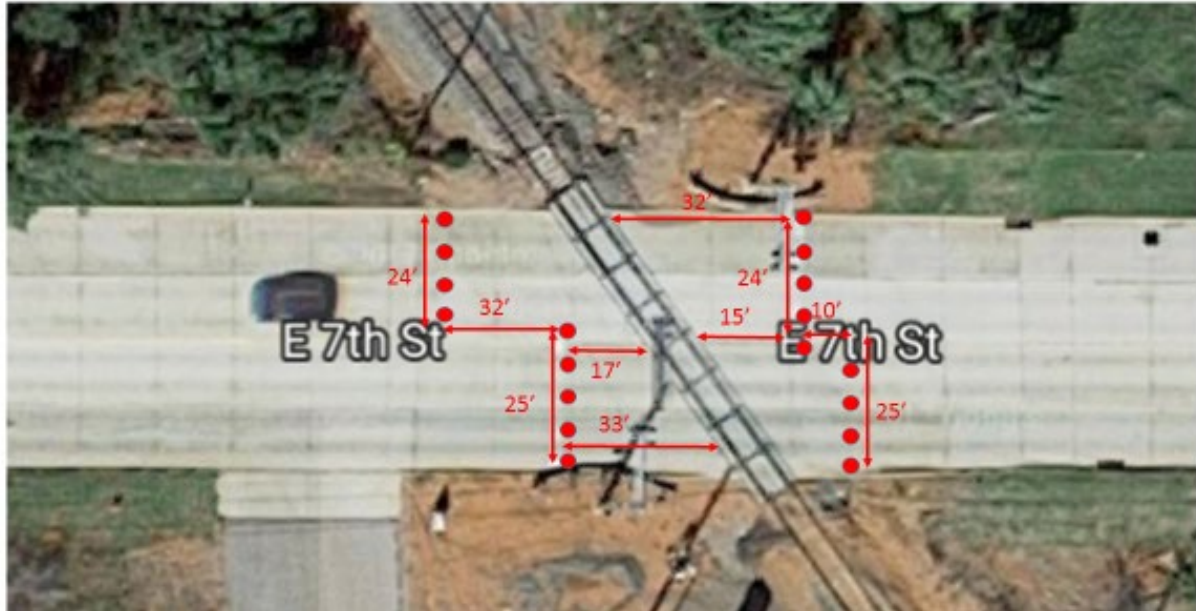
There is a large swale on the west approach to the grade crossing on East 7<sup>th</sup> Street. Because of this, the in-pavement lights cannot be seen by eastbound drivers until they get within about 100 yards of the crossing. For this reason, the lights in the opposite lane were installed 32 feet further west than those in the eastbound lane, as shown in [Figure 6](#). With this modification, the lights in the opposite lane were visible to drivers more than 200 yards from the crossing.

## In-Pavement Lights Measurements (to outside rail)

● = In-pavement Lights

**Figure 6 – Measurements of In-Pavement Light System in Elk City, Oklahoma**  
(Source: Google Maps)

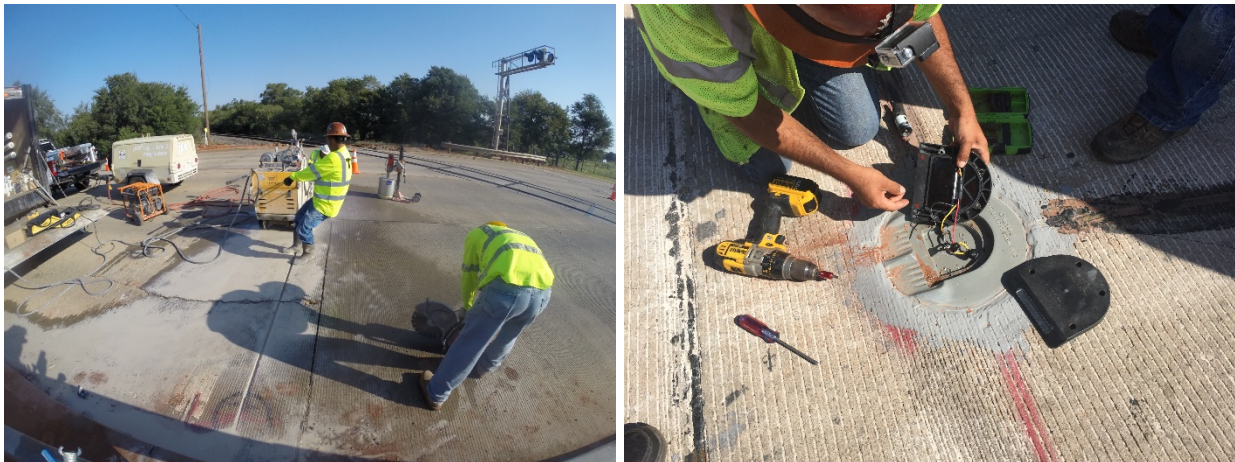
The in-pavement lighting system was installed during the second week in September, 2017. Photos of the installation are shown below in [Figure 7](#).

**Figure 7 – Installation photos**

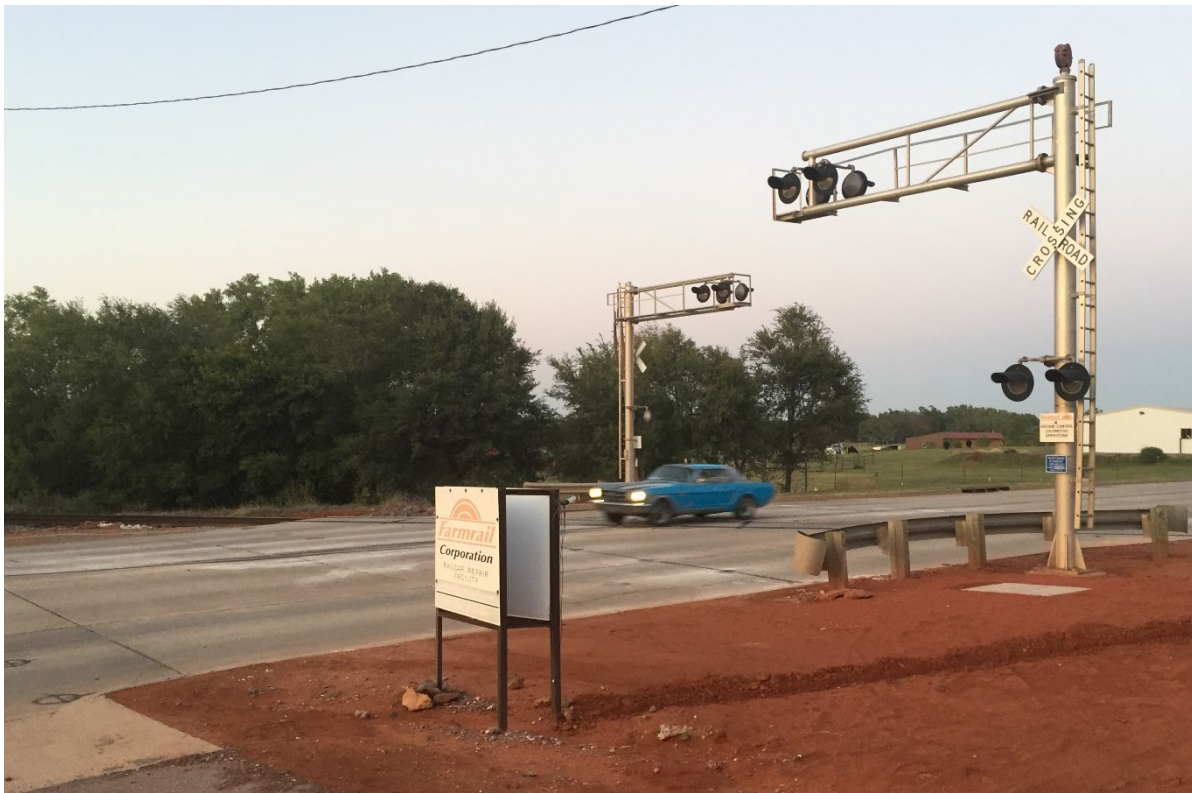
Video data was collected using an analog video camera with a wide-angle lens mounted on a Farmrail sign on the west side of the crossing, shown in [Figure 8](#). As mentioned earlier, the camera could not be mounted further west due to a paved driveway adjacent to the sign. This proved to be a limitation because researchers observed that vehicles stopping for trains sometimes stopped more than one car length from the stop line, and were not visible to the camera. This reduced the number of vehicles counted as being present during crossings and in compliance with the signals. Those that violated the signals were, of course, visible. However, this condition was the same for the pre-deployment data set as for the post-deployment data set, so the net effect on the results is believed to be negligible.

**Figure 8 – Camera Mounted on Farmrail Sign**

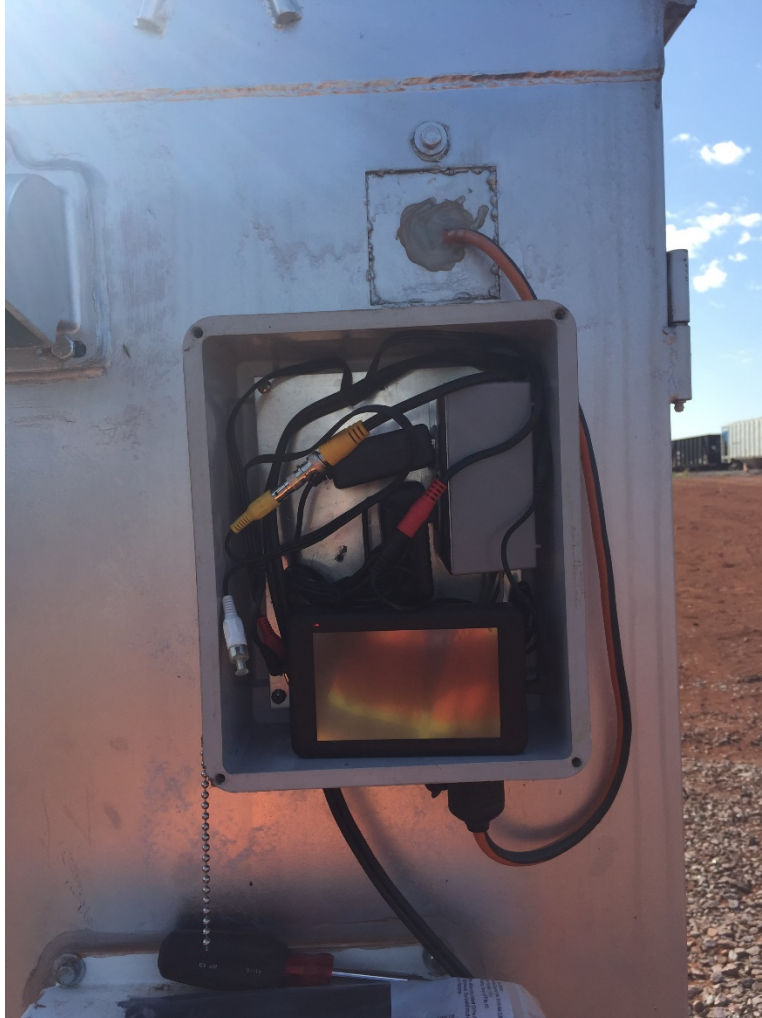
The video was recorded on a Lawmate PV-1000 DVR set to five frames per second. The recorder had a 500 GB hard drive, enabling it to record 2–3 months before needing to be replaced. The recorder was mounted inside a weatherproof fiberglass enclosure mounted to the side of the Farmrail signal bungalow. Farmrail provided AC power for the camera and DVR. The video data collection system installed at the crossing is shown in [Figure 9](#) below.

**Figure 9 – Video Data Collection System**

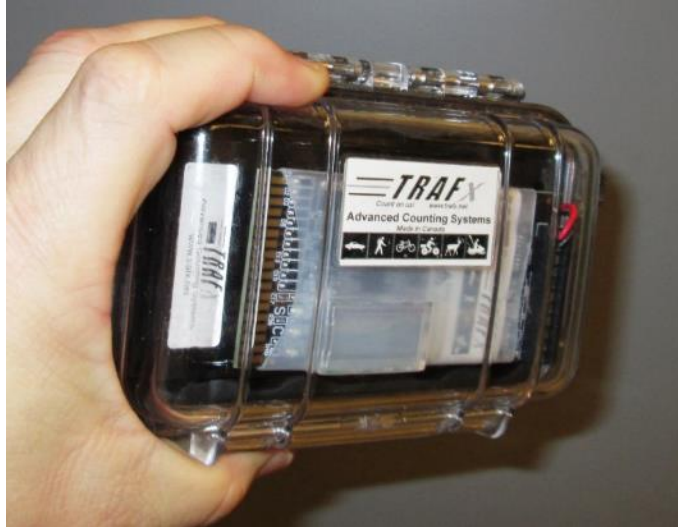
After reviewing the first few weeks of video, it became clear that it was a very inefficient process to search for train crossing events by using only the fast-forward function. In December 2016, Volpe deployed a TRAFx magnetometer near the crossing in Elk City. The magnetometer is essentially a metal detector. It was placed adjacent to the tracks inside a small fiberglass waterproof enclosure about 80 yards south of the roadway, which was far enough away from the road to not detect vehicles, but close enough to the tracks to detect trains. The enclosure was chained to a tree to prevent theft. The TRAFx magnetometer ([Figure 10](#)) was configured as follows:

- Period = 0
- Mode = VEH-4d
- Threshold = 012
- Delay = 016
- Rate = Slow

**Figure 10 – TRAFx Magnetometer**

The magnetometer proved to be very valuable in saving time while processing data. The key setting here was the period, which causes the magnetometer to collect time-stamped data for each detection. Other settings create totals per hour or day, which was not as helpful. However, there were occasional false detections (no train present), likely due to settings that were too sensitive. In April 2017, Volpe changed the settings as follows:

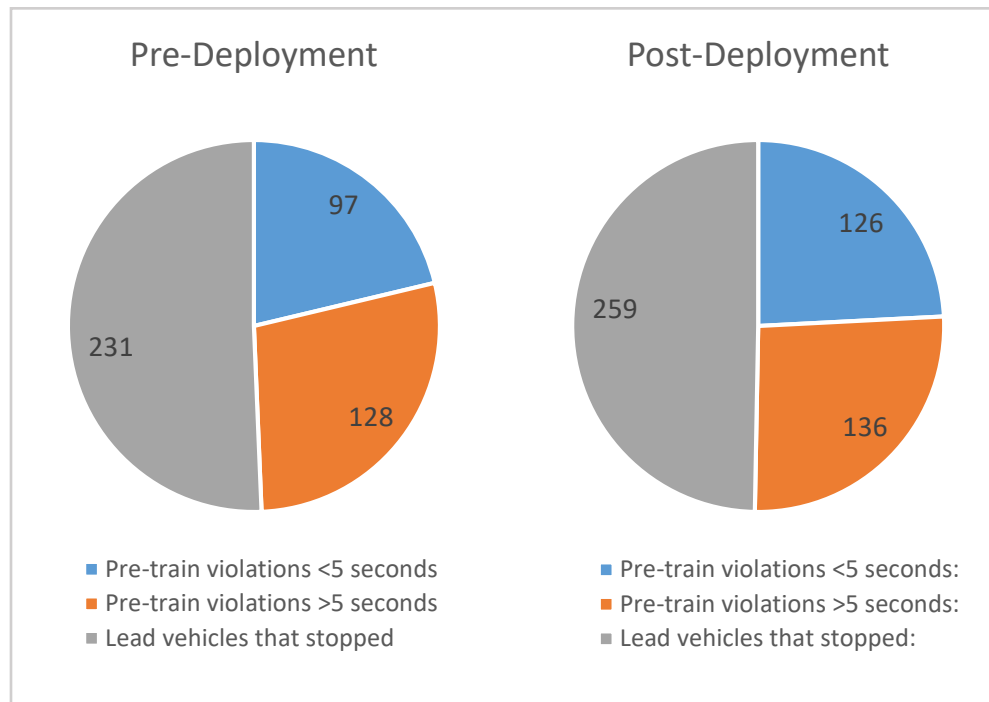
In the post-deployment phase, there was a total of 473 train events assessed. There were 262 pre-train violations, with 136 occurring 5 or more seconds after signal activation, which makes for an average violation rate of 28.75 percent. This was a decrease of 2.62 percent. These numbers are shown in [Figure 11](#).

**Figure 11 – Comparison of Pre- and Post-Deployment Vehicle Behavior**

A total of 408 train events were assessed prior to the deployment of the in-pavement lights. There was a total of 225 pre-train violations, of which 128 occurred 5 or more seconds after the signals were first activated. This yielded an average violation rate of 31.37 percent per train event. Note that some train events had more than one violation.

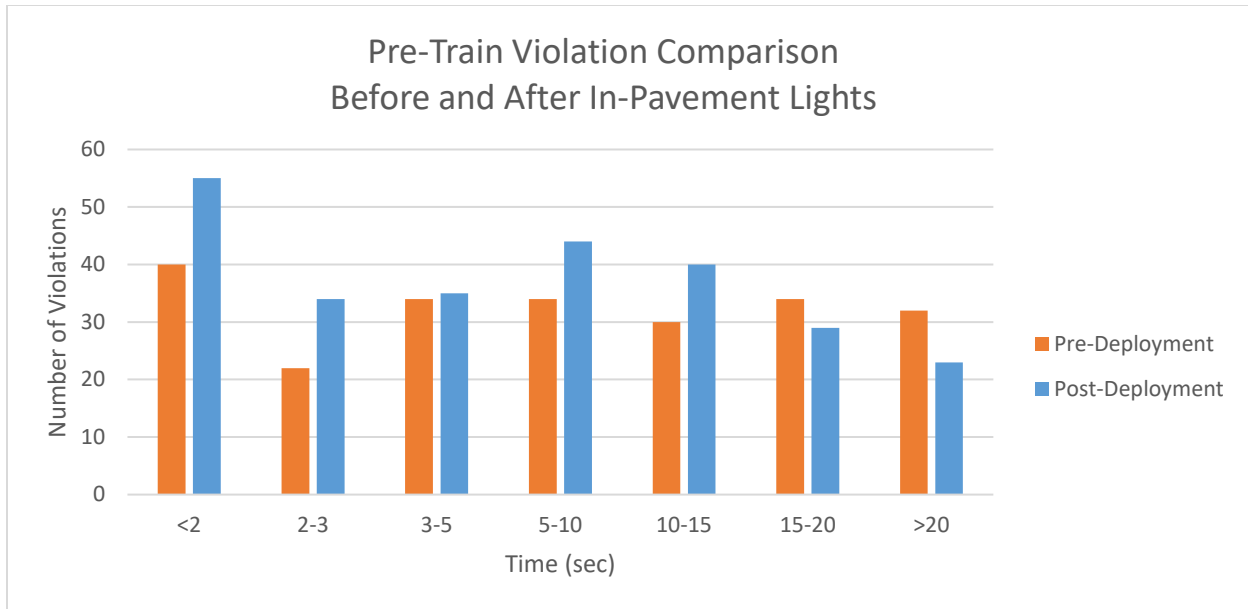
In [Figure 12](#) below, the number of vehicles crossing the tracks after selected amounts of time elapsing between signal activation and vehicles crossing the tracks is shown.

**Figure 12 – Comparison of Violation Times Before and After In-Pavement Lights**

Keeping in mind there was a 26.2 percent increase in the number of train events in the post-deployment phase, it was clear that the number of late violations (vehicles crossing more than 15 seconds after the signals were activated) decreased after the in-pavement lights were installed. This suggested the in-pavement lights were helpful in deterring the most dangerous types of grade crossing violations.

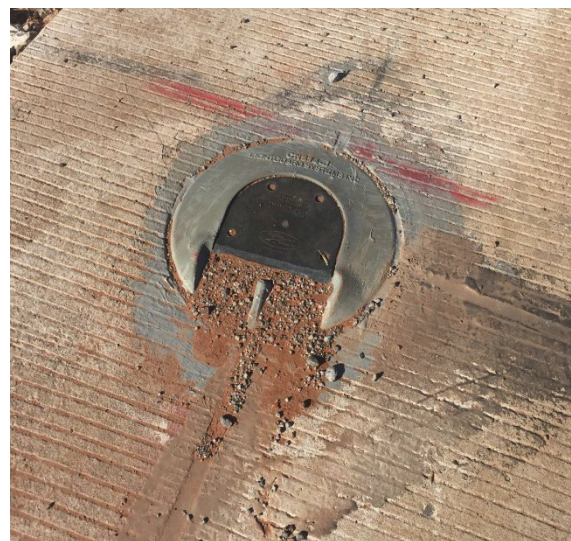
- A few weeks after installation, Elk City experienced heavy rains which caused a significant amount of soil to accumulate on the roadway. Some of this soil accumulated on the lights, obstructing them. After sweeping them off, they remained mostly clear, but over time they periodically become obstructed again. LightGuard stated that traffic passing over the lights should blow the dirt off them; however, the lights are situated mid-lane and between lanes, where tires rarely strike them. The lights closest to the shoulder and those on the east side of the crossing tended to accumulate the most dirt.

**Figure 13 – Example of dirt accumulating on in-pavement light fixture**

Although this problem was less severe in the dry season, Farmrail kept a broom on-site to keep them clean.

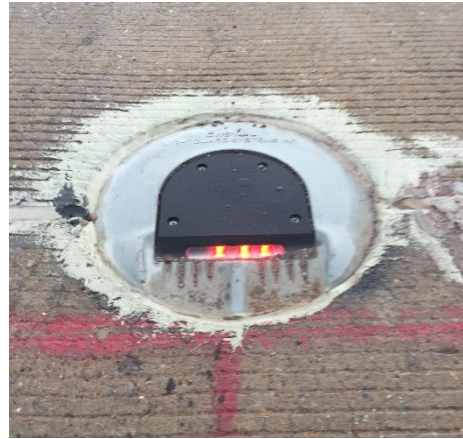
- On two occasions, one of the lights needed to be replaced. The first one occurred in November 2017 and was believed to be a faulty connection made during installation. The other was related to LEDs that burned out in one of the fixtures. Each light is comprised of about eight high intensity LEDs, and by June, 2018, one of the lights had lost five of them. Because the system was still under warranty, LightGuard arranged to replace the light free of charge. Two other fixtures had only lost one of the eight. Strangely, none of the fixtures on the west side of the crossing have lost any LEDs.

**Figure 14 – Light with Burned out LEDs**
