DOT/FAA/AM-98/19

# Analysis of Ditching and Water Survival Training Programs of Major Airframe Manufacturers and Airlines

Final Report

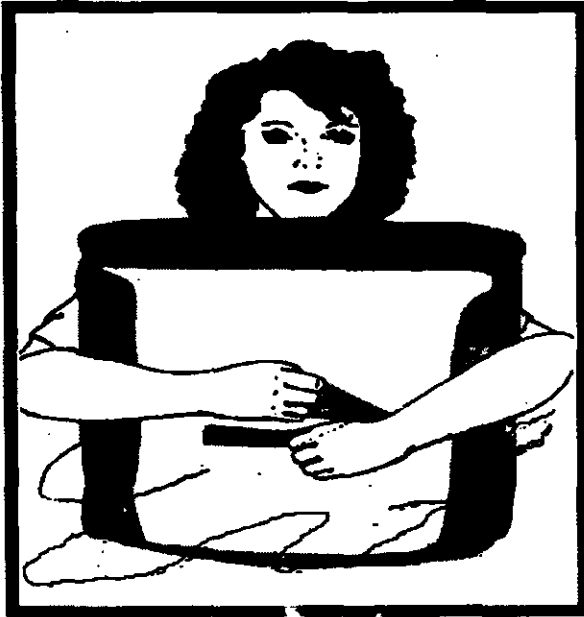
**FIGURE 1**  
**Vertical Flotation**

advise passengers to hold the cushions in front of their bodies, to rest their chins on the cushions, to wrap their arms around the cushions with their hands grasping the outside loops, and to float vertically in the water (Figure 1). Others suggest that passengers lie forward on the cushions, grasp and hold the loops beneath them, and float horizontally (Figure 2).

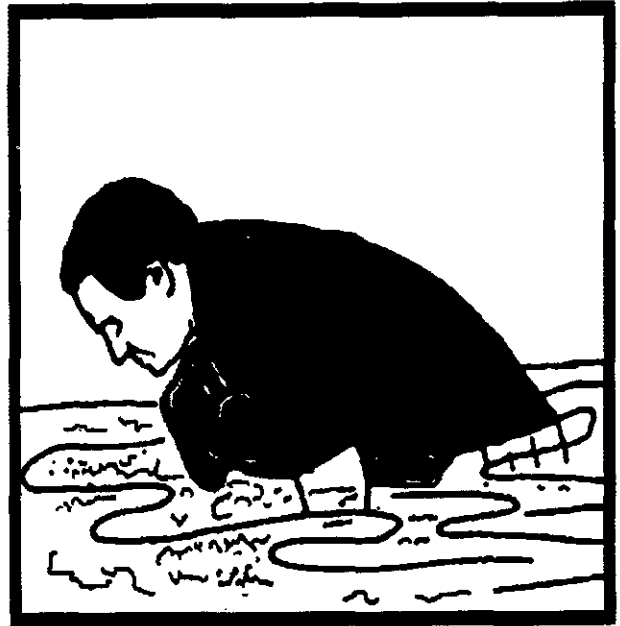
**FIGURE 2**  
**Horizontal Flotation**
