# BARRIERS IN CONSTRUCTION ZONES

## VOLUME 2

**Report No.**  
**FHWA/RD-86/093**

**VOLUME 2: Appendix A  
Full-Scale Crash Tests**

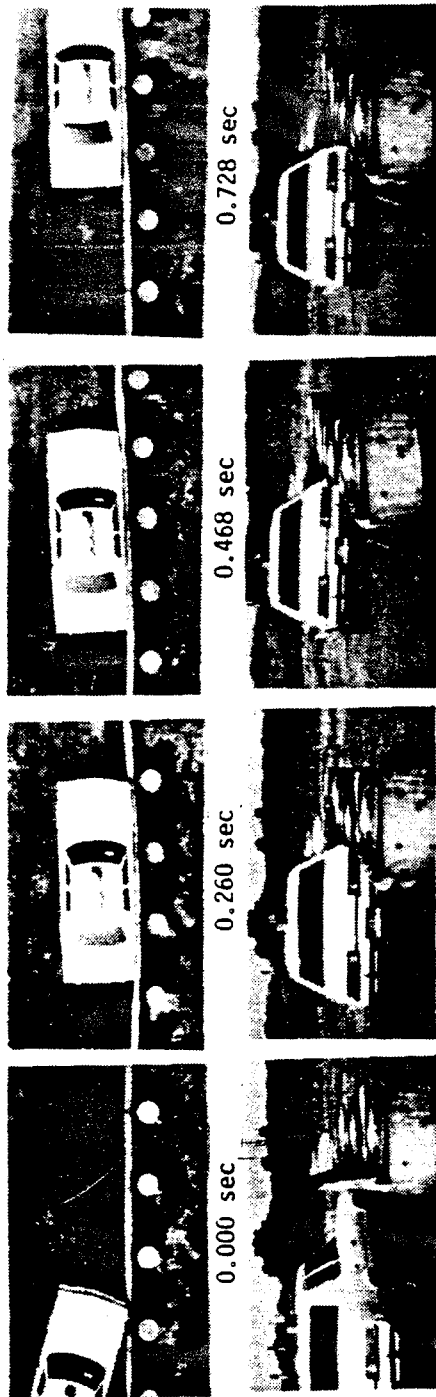
Figure 4. Summary of Results for Test 3825-1.

Stabilized Barrel  
Beam No. 3  
Construction Barrier

Test No. . . . .	3825-1	Vehicle . . . . .	1975 Grand Fury
Date . . . . .	11/08/79	Vehicle Weight . . . . .	4,500 lb (2,041 kg)
Rail . . . . .	12 gauge	Impact Speed . . . . .	44.3 mph (71.4 km/h)
Post . . . . .	Tubular W-beam	Impact Angle . . . . .	15 deg
	55 gal (208 l)	Exit Speed . . . . .	33.3 mph (53.6 km/h)
	Open Head Drum,	Exit Angle . . . . .	3.5 deg
	18 gal (68 l)	Vehicle Acceleration	
	Bottom & Body	(Max. 0.050 sec avg.)	
	w/False Bottom	Longitudinal (rt & lt avg)	-1.4 g
	& Skid Plate	Transverse . . . . .	4.0 g
Post Spacing . . . . .	6.2 ft ( 1.9 m)	Vertical . . . . .	0.8 g
Post to Anchor Spacing . . . . .	25.0 ft ( 7.6 m)	Vehicle Damage	
Beam Rail Deflection . . . . .	200.0 ft (61.0 m)	TAD . . . . .	1-RFQ-1
Max. Dynamic . . . . .	2.1 ft ( 0.6 m)	SAE . . . . .	01RFEW1
Max Permanent . . . . .	1.8 ft ( 0.5 m)

A summary of test results is presented in Figure 4. The maximum 0.050 sec average transverse acceleration was 4.0 g which is within the acceptable 5 g limit given in TRC 191 (1). The average acceleration on the vehicle, perpendicular to the barrier, from impact until the vehicle became parallel to the barrier was only 1.3 g. The longitudinal 0.050 sec average was a modest -1.4 g.

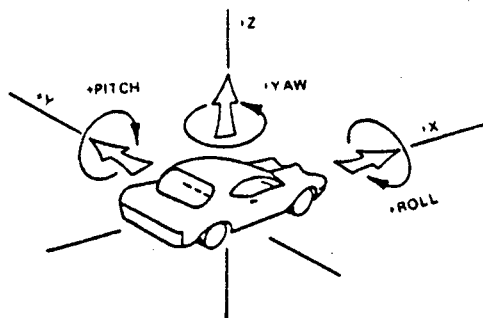
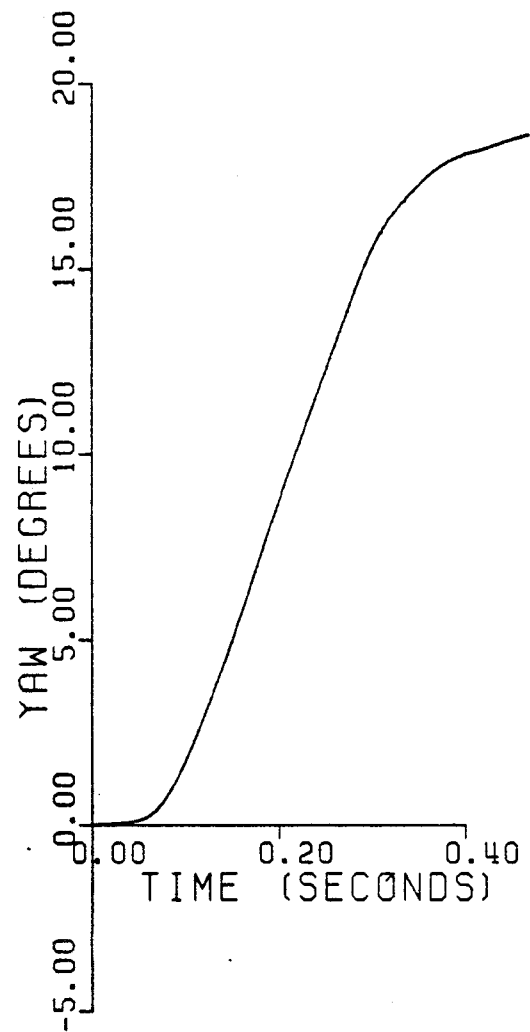
Figure 12. Vehicle Yaw Angle for Test 3825-1.

Axes are vehicle fixed.  
Sequence for determining  
orientation is:  
1. Yaw  
2. Pitch  
3. Roll

The PLOTANGL Program uses the digitized data from the yaw, pitch, and roll charts to compute angular displacement (deg) at 0.001 sec and then instructs the Versatec Plotter (Model 1200 Electrostatic Plotter) to produce three reproducible plots: yaw versus time; pitch versus time; and roll versus time. It should be noted that these angular displacements are sequence dependent with the sequence being yaw - pitch - roll for the data presented herein. These displacements are in reference to the vehicle-fixed coordinate system with the initial position and orientation of the vehicle-fixed coordinate system being that which existed at initial impact.

The linear accelerometer traces are presented in Figure 7 through 11. The angular displacements yaw, pitch and roll are presented in Figures 12, 13 and 14, respectively. The results are order related and must be evaluated in this sequence.

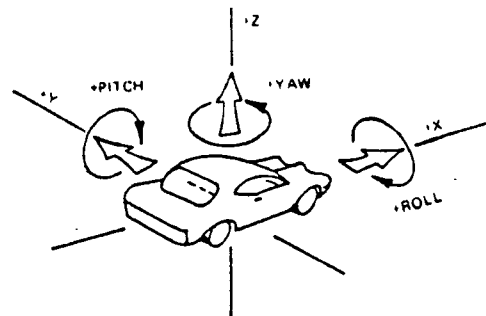
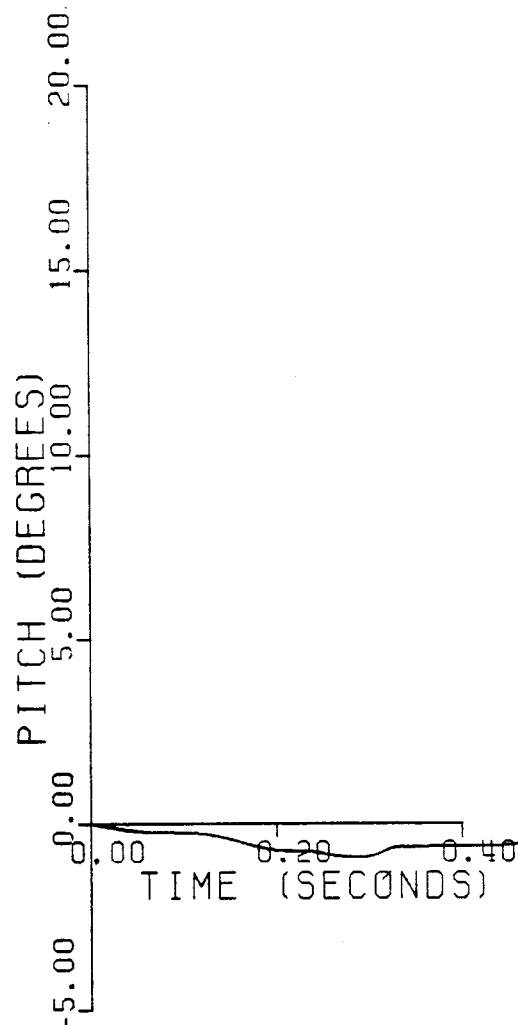
Figure 13. Vehicle Pitch Angle for Test 3825-1.

Axes are vehicle fixed.  
Sequence for determining  
orientation is:

1. Yaw
2. Pitch
3. Roll

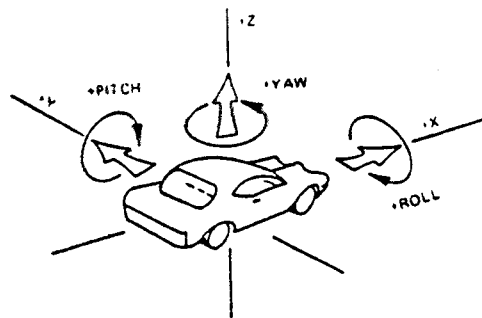
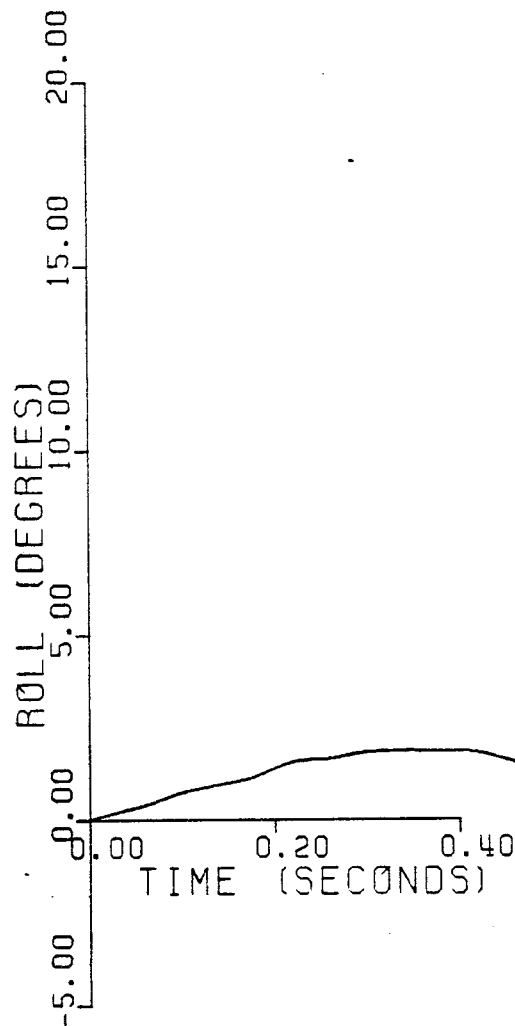
Figure 14. Vehicle Roll Angle for Test 3825-1.

Axes are vehicle fixed.  
Sequence for determining  
orientation is:

1. Yaw
2. Pitch
3. Roll

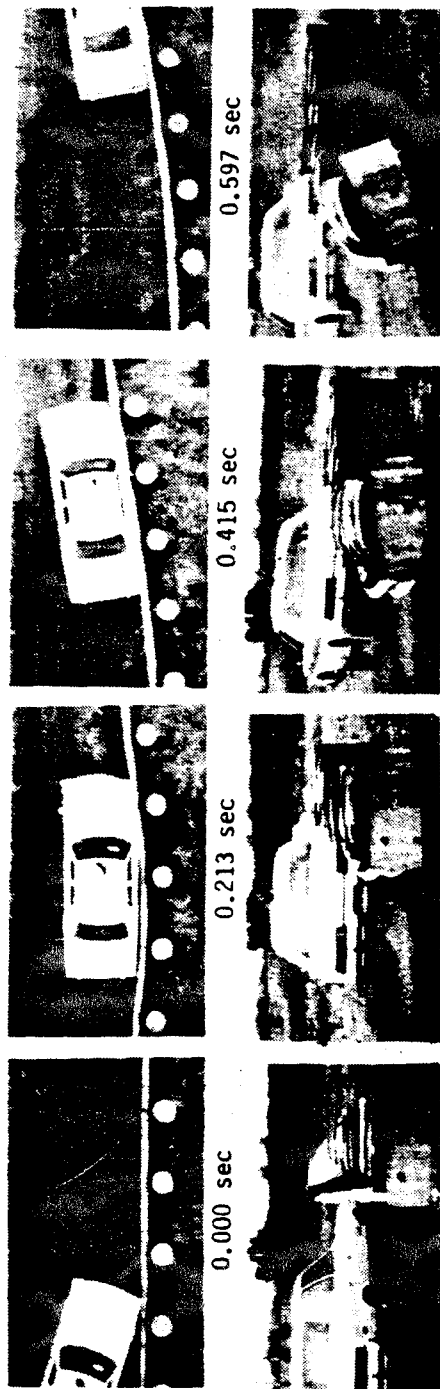
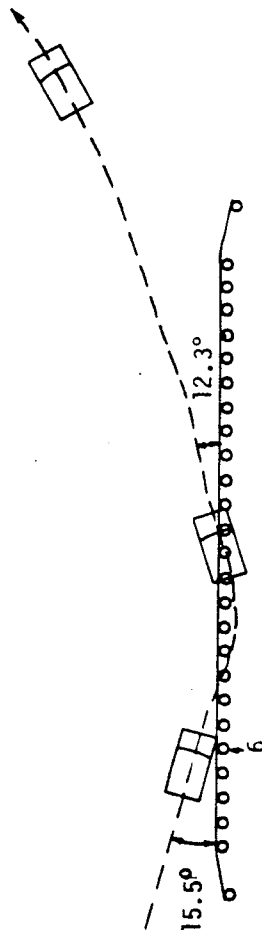
Figure 20. Summary of Results for Test 3825-2.

Test No. . . . .	3825-2	Vehicle . . . . .	1975 Grand Fury
Date . . . . .	11/08/79	Vehicle Weight. . . . .	4,500 lb (2,041 kg)
Rail . . . . .	12 gauge tubular W-beam	Impact Speed. . . . .	61.7 mph (99.4 km/h)
Post . . . . .	55 gal (208 l)	Impact Angle. . . . .	15.5 deg
	Open Head Drum,	Exit Speed. . . . .	51.9 mph (83.5 km/h)
	18 gal (68 l)	Exit Angle. . . . .	-12.3 deg
	Bottom and Body	Vehicle Acceleration	
	w/False Bottom	(Max. 0.050 sec avg)	
	& Skid Plate	Longitudinal (ft & lt avg)	-2.0 g
Post Spacing . . . . .	6.2 ft (1.9 m)	Transverse. . . . .	4.6 g
Post to Anchor Spacing	25.0 ft (7.6 m)	Vertical. . . . .	1.6 g
Length of Installation	200.0 ft (61.0 m)	Vehicle Damage	
Beam Rail Deflection		TAD . . . . .	1-RFQ-2
Max. Dynamic . . . . .	5.4 ft (1.6 m)	SAE . . . . .	OIRFEW2
Max. Permanent . . . . .	5.0 ft (1.5 m)

In Test 2, a 1975 Plymouth Grand Fury impacted the barrier at 15.5 deg and 61.7 mph (99.4 km/h). The vehicle weighed 4,500 lb (2,041 kg) including telemetry equipment. Photographs of the vehicle and barrier are shown in Figures 18 and 19. In Figure 18, the slight damage to the vehicle before Test 2 occurred in Test 1. Results of Test 2 are summarized in Figure 20.

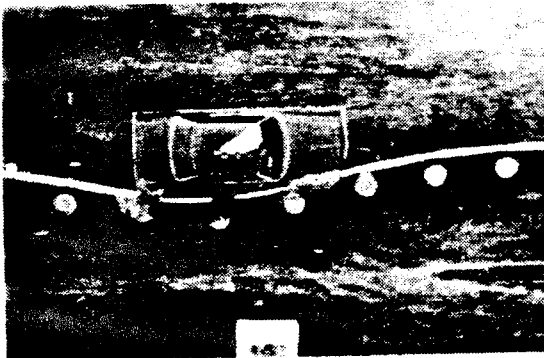
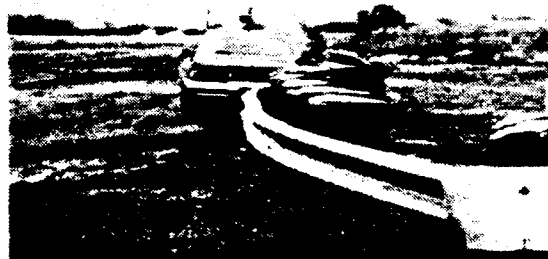
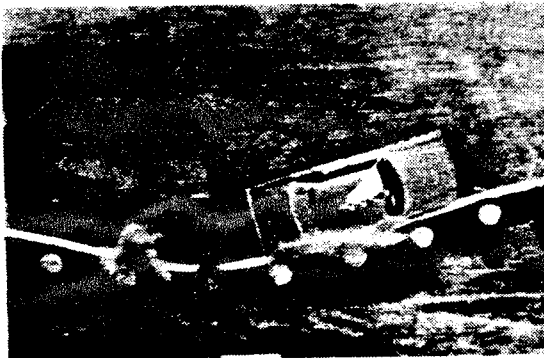
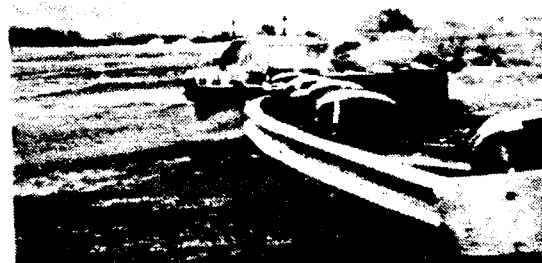
Figure 36. Sequential Photographs for Test 3825-3.

Sequential photographs of Test 3 are in Figure 36. Time, displacement, and events are summarized in Table 3. Point of impact occurred 3.0 ft (0.9 m) downstream of barrel 14. At approximately 0.210 sec the vehicle became parallel to the barrier, after which the rear of the vehicle swung into the rail 2.5 ft (0.8 m) downstream of barrel 15. By 0.236 sec the upstream barrels were beginning to rotate. By 0.641 sec, the first of the upstream barrels fell over and succeeding downstream barrels began to fall. But in the vicinity of the vehicle, the barrels remained upright and resisting throughout the test. The vehicle exited

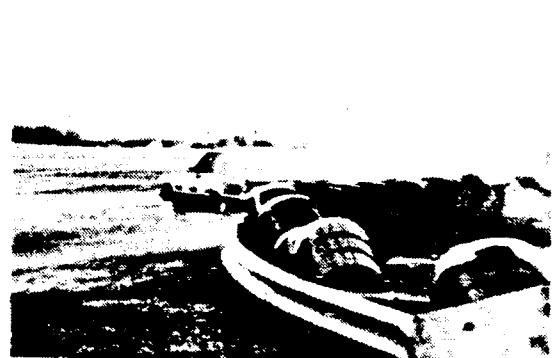
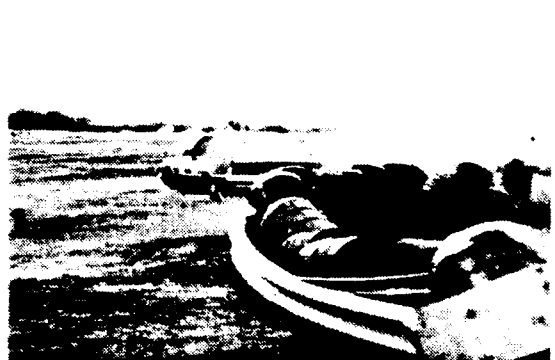
Figure 36 (Continued). Sequential Photographs for Test 3825-3.

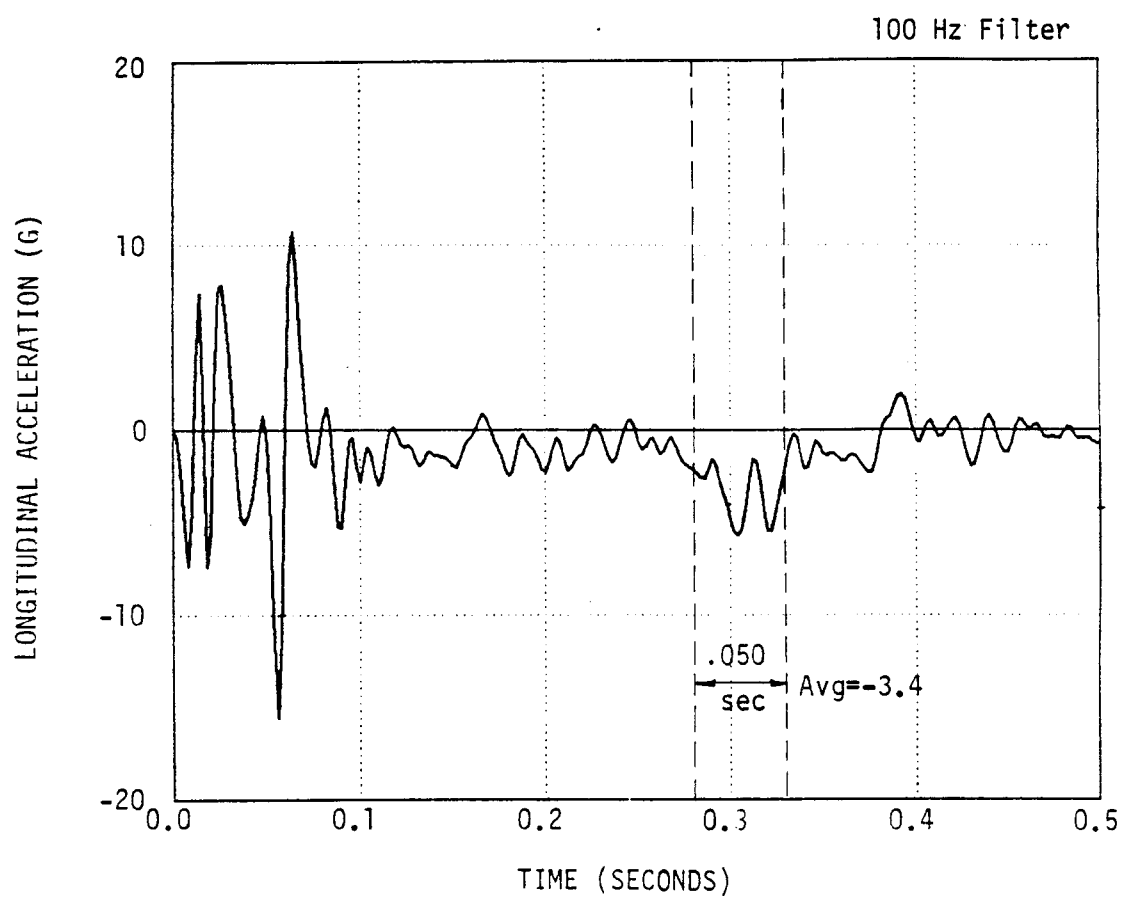
Figure 37. Vehicle Right Longitudinal Accelerometer Trace for Test 3825-3.

The linear accelerometer traces are presented in Figures 37 through 41. Yaw, pitch and roll are presented in Figures 42, 43 and 44, respectively. These results are order related and must be evaluated in this sequence. During the test the vehicle remained exceptionally level and stable as illustrated by the maximum roll and pitch of only 2.5 deg and 0.8 deg, respectively. The maximum 0.050 sec average longitudinal and transverse accelerations were -1.4 g and 5.4 g. The maximum dynamic deflection of the barrier was 11.0 ft (3.4 m); this returned to 10.7 ft (3.3 m) after the test.

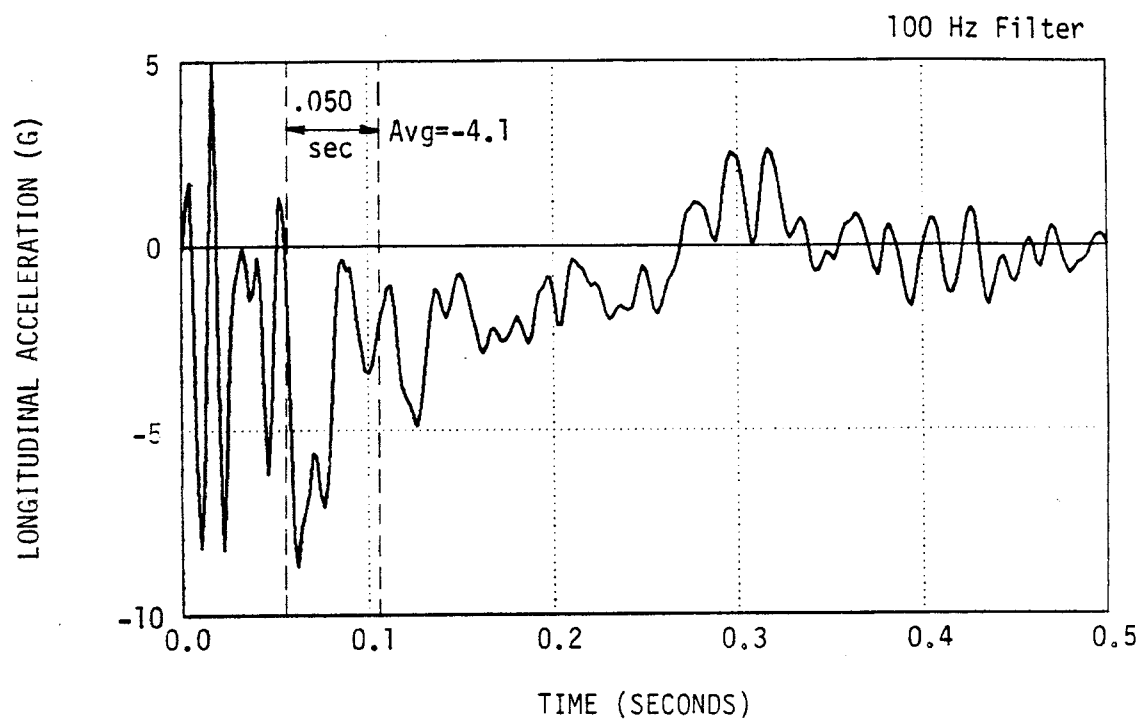
Figure 38. Vehicle Left Longitudinal Accelerometer Trace for Test 3825-3.

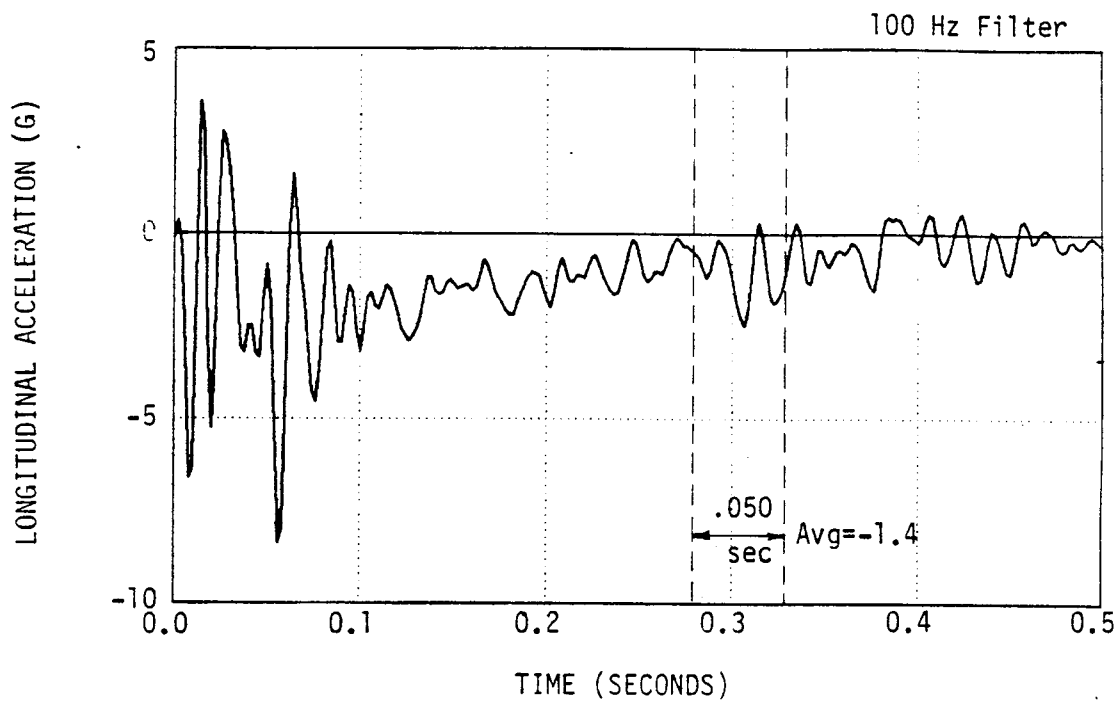
Figure 39. Vehicle Longitudinal Accelerometer Trace for Test 3825-3.  
(Averaged from Left and Right Accelerometers).

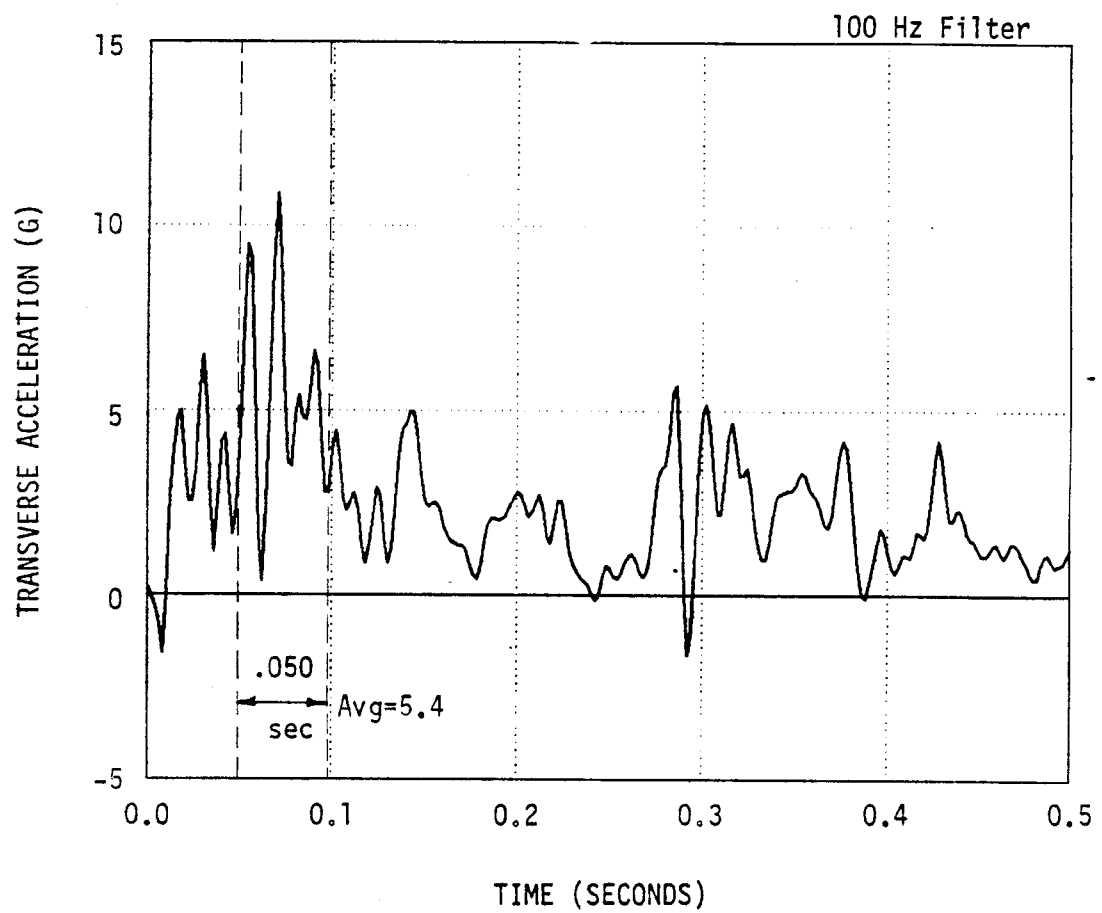
Figure 40. Vehicle Left Transverse Accelerometer Trace for Test 3825-3.

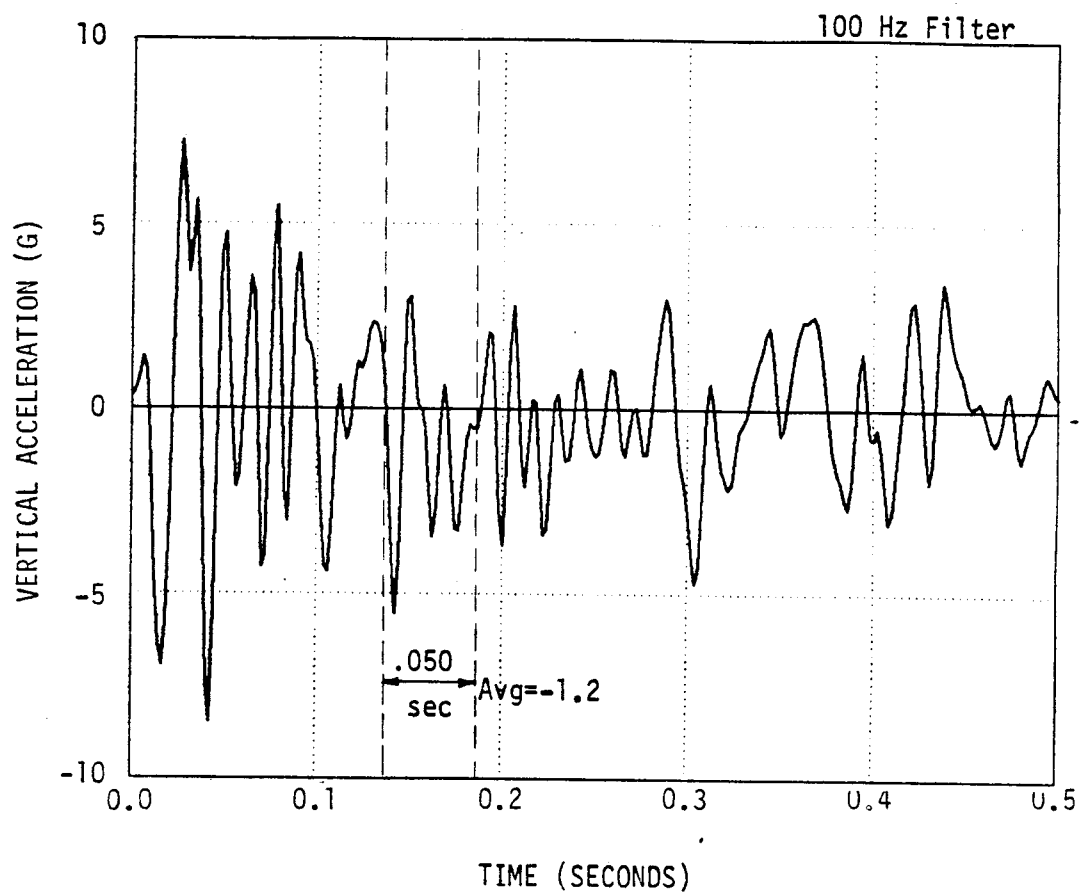
Figure 41. Vehicle Left Vertical Accelerometer Trace for Test 3825-3.

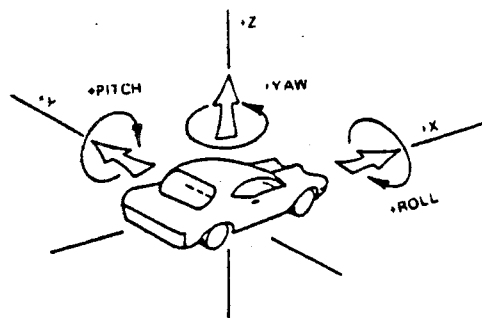
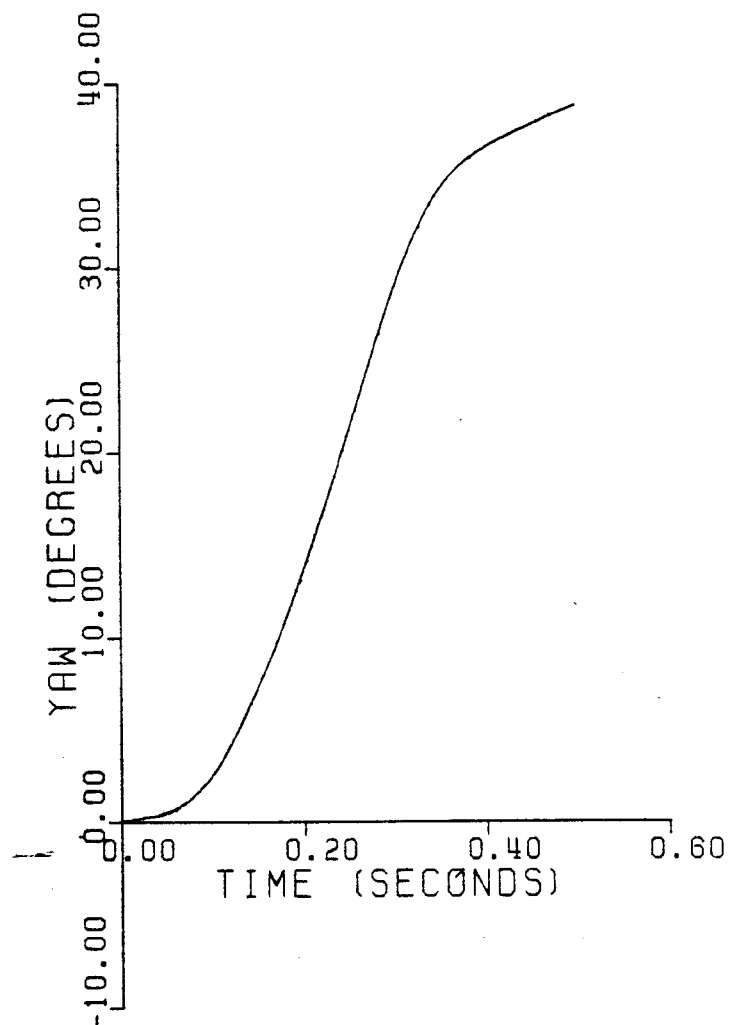
Axes are vehicle fixed.  
Sequence for determining  
orientation is:

1. Yaw
2. Pitch
3. Roll

Figure 42. Vehicle Yaw Angle for Test 3825-3.

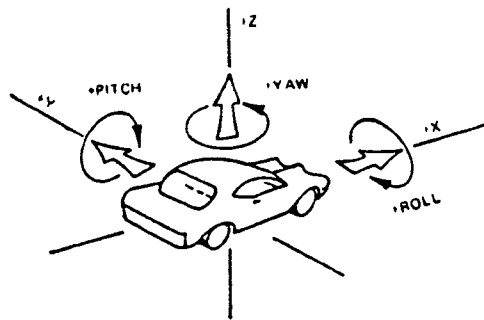
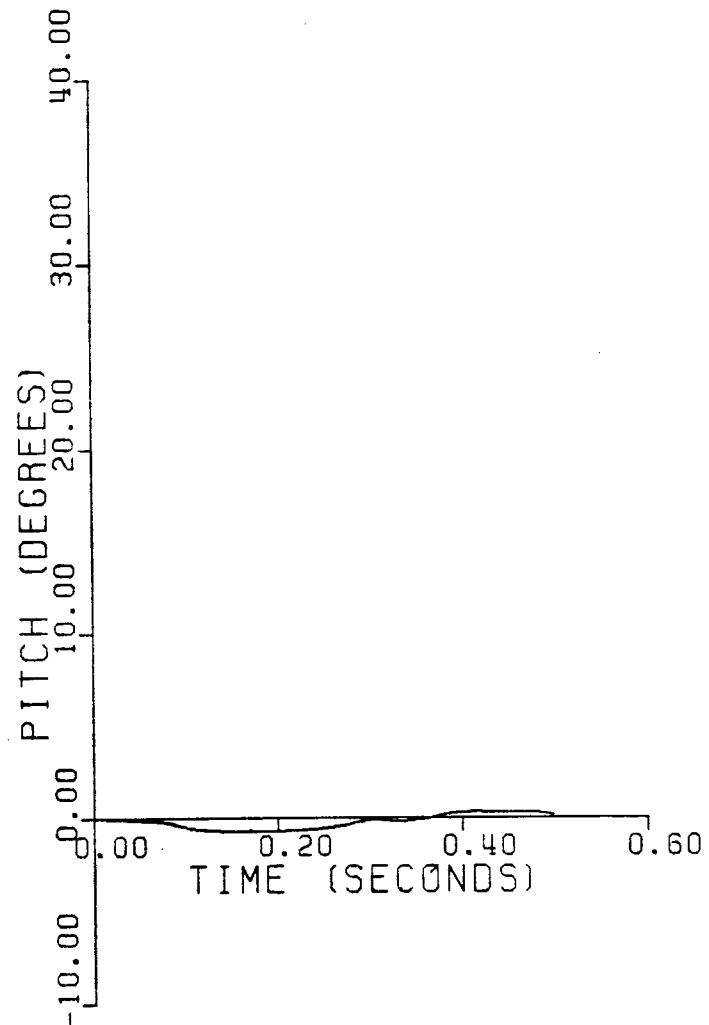
Axes are vehicle fixed.  
Sequence for determining  
orientation is:

1. Yaw
2. Pitch
3. Roll

Figure 43. Vehicle Pitch Angle for Test 3825-3.

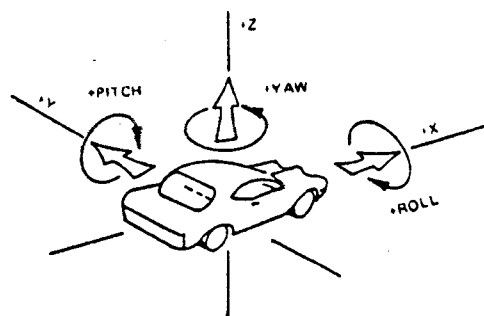
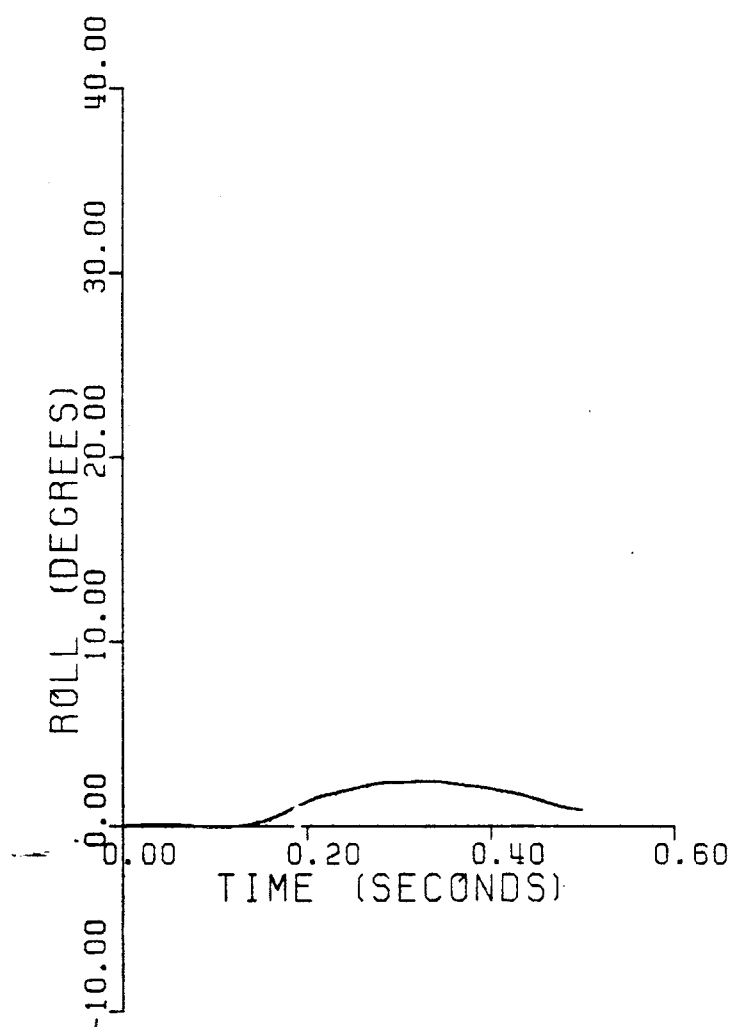
Axes are vehicle fixed.  
Sequence for determining  
orientation is:

1. Yaw
2. Pitch
3. Roll

Figure 44. Vehicle Roll Angle for Test 3825-3.

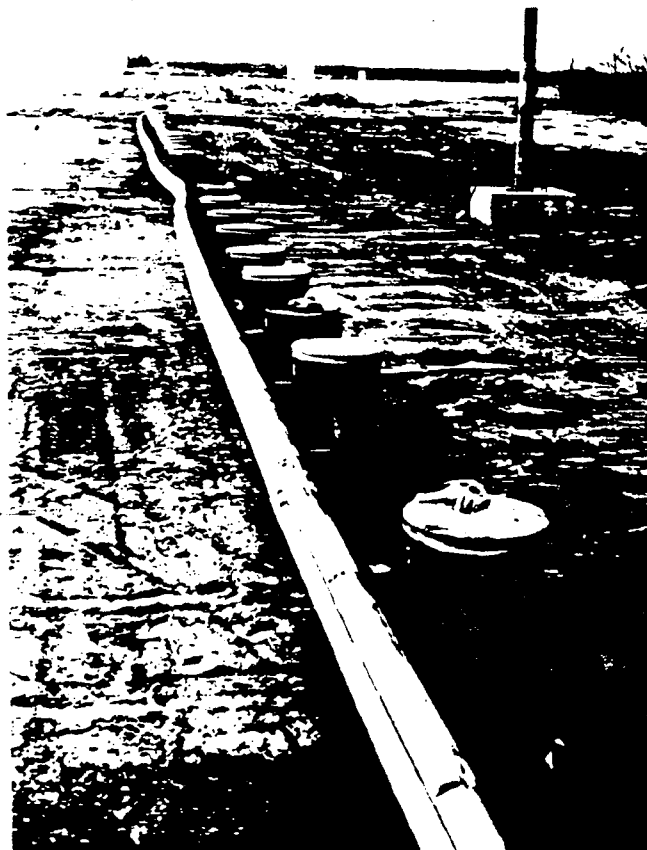
Figure 46. Barrier Repositioned After Test 3825-3.

The barrier was returned to its original position by three men with two forklifts in 90 minutes; see Figure 45. The extent of the permanent deformation after repositioning was between barrels 13 through 20. The maximum deformation occurred at barrel 16 of magnitude 5.7 in. (14.5 cm). The restored barrier is shown in Figure 46. The 25.0 ft (7.6 m) rail section between barrels 13 and 17 was replaced along with barrels 14 through 18 before testing continued.

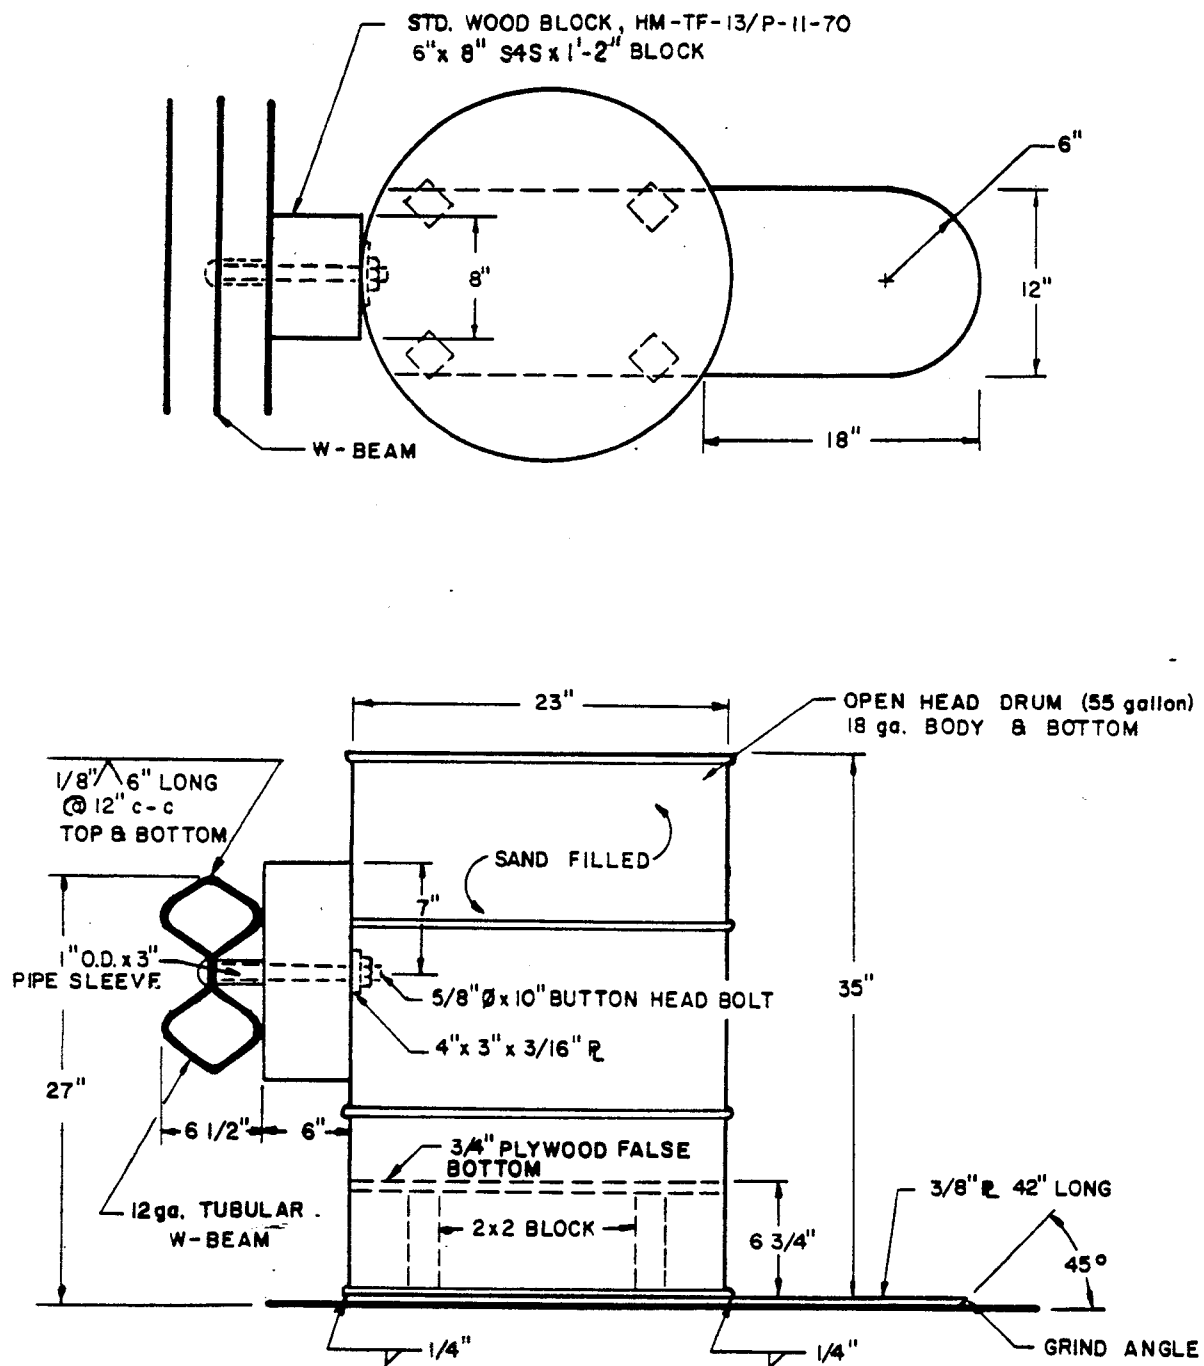
Figure 47. Stabilized Barrel System #3.

The test installation was a 12 gauge tubular W-beam mounted on 55 gal (208 l) drums (barrels) with wooden blockout and skid plate as illustrated in Figure 47. The barrels were sand filled. A false bottom in each barrel was used to raise the center of gravity of the sand to coincide with the impact force. The section of tubular W-beam was in 25.0 ft (7.6 m) lengths. The barrier was placed on unpaved level soil, similar to surfaces encountered in construction zones. The installation was 250.0 ft (76.2 m) long including a 25.0 ft (7.6 m) terminal and 25.0 ft (7.6 m) transition as shown in Figures 48 and 49. The installation was repaired by the replacement of barrels 14 through 18 as well as the rail sections between barrels 13 and 17 following Test 3825-3.

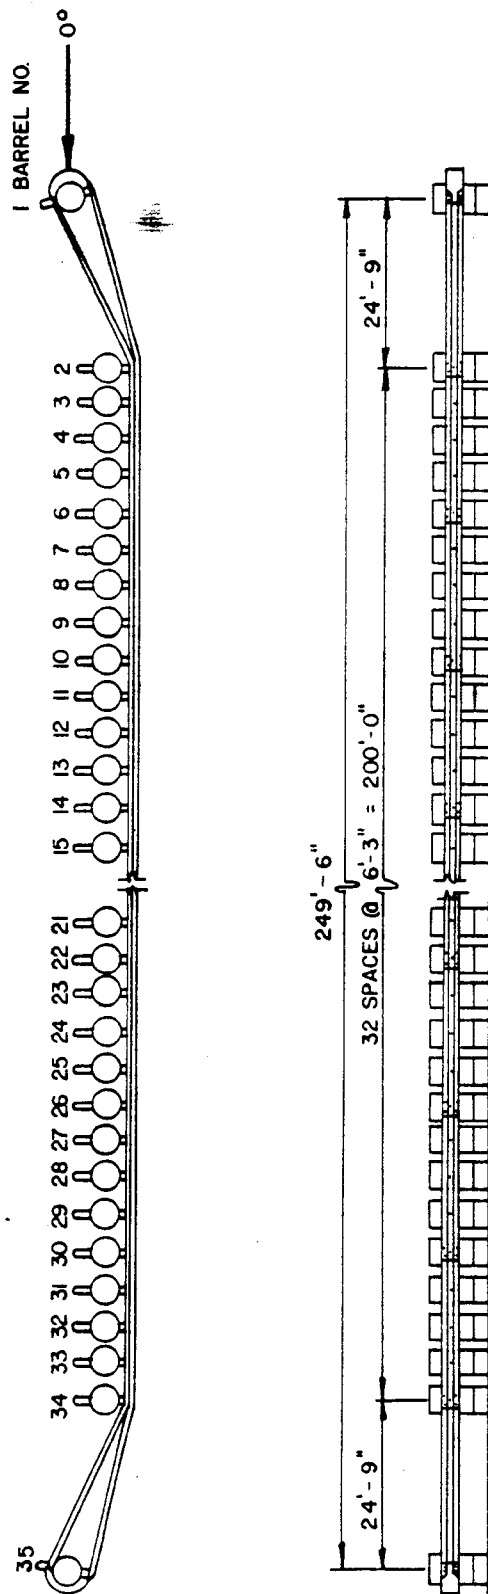
Figure 48. Test Installation 3825-4.

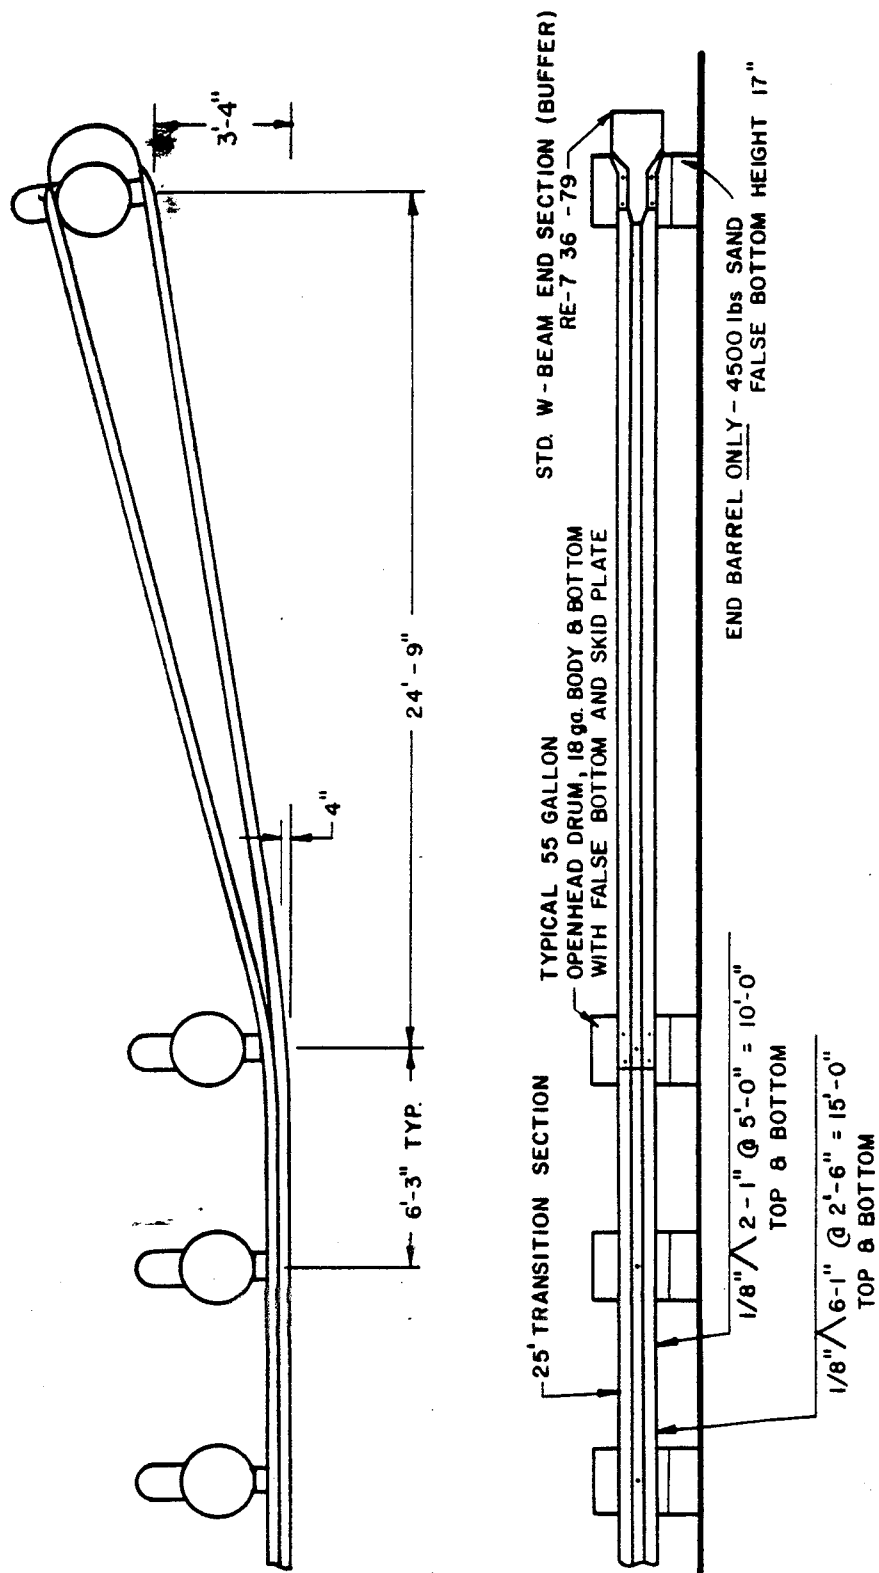
Figure 49. Terminal Detail Test 3825-4.

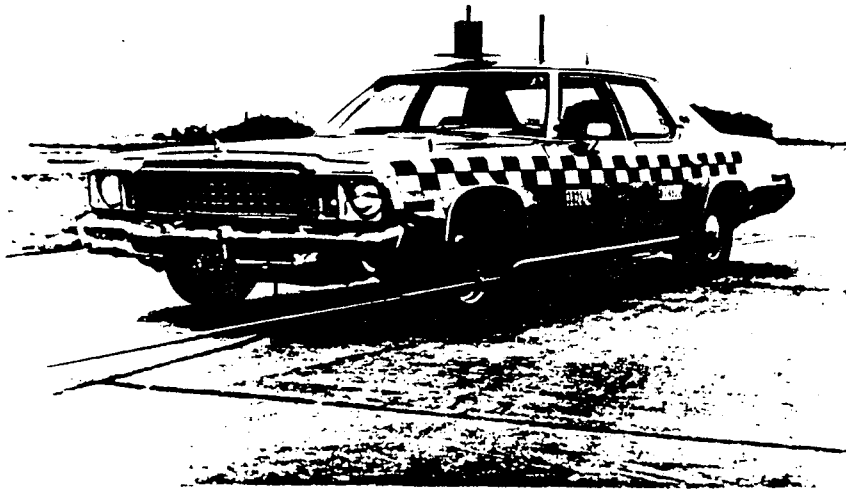
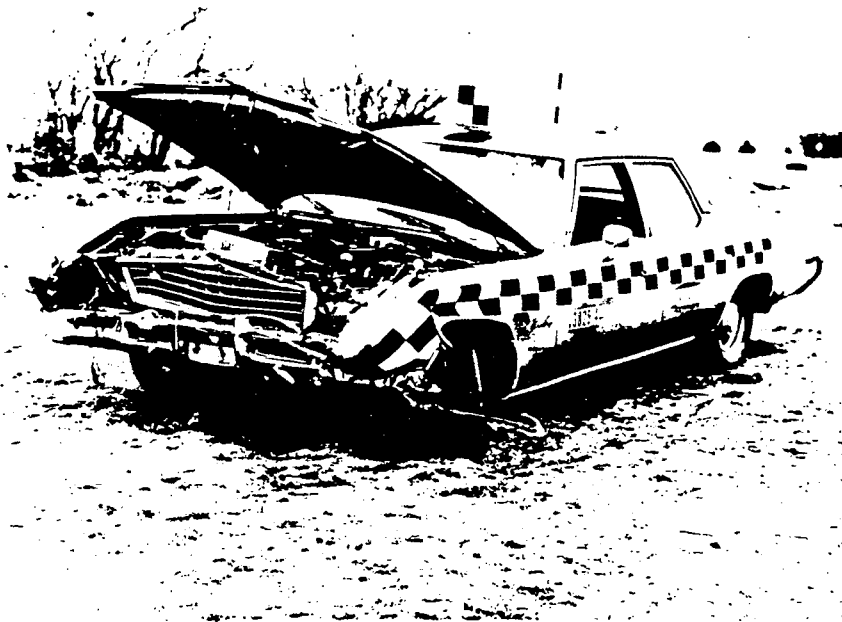
Figure 50. Vehicle Before and After Test 3825-4.

In Test 4, a 1974 Plymouth Grand Fury impacted the end of the barrier at 0 deg and 61.4 mph (98.8 km/h). The vehicle weighed 4,500 lb (2,041 kg) including telemetry equipment. Photographs of the vehicle and barrier before and after the test are shown in Figures 50 and 52. Figure 51 illustrates the impact point. Figure 53 summarizes the results of Test 4. Sequential photographs are presented in Figure 54. Table 4 is a summary of time and displacement as related to specific events.

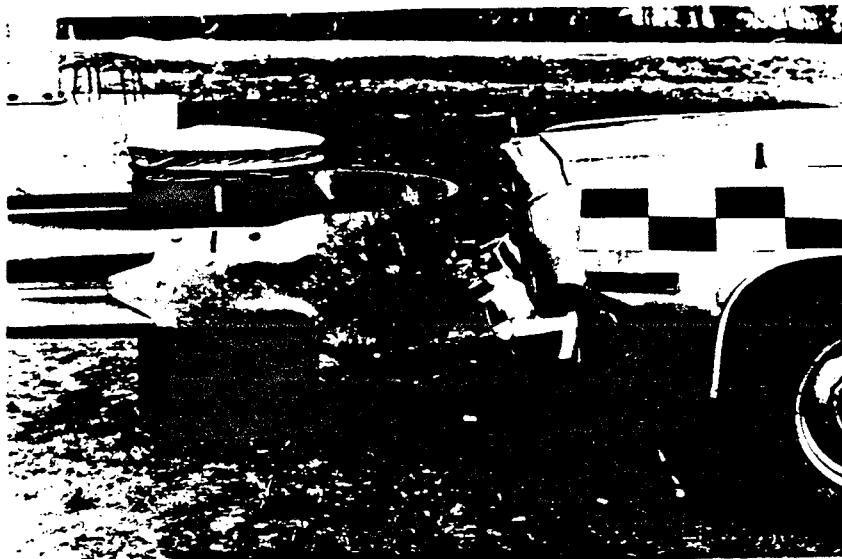
Figure 51. Impact Point for Test 3825-4.

As shown in Figure 51, impact occurred at the end of the terminal. The W-beam began to buckle upstream of barrel 2 and folded inward toward the back side of the barrier causing the vehicle to ride up and over it. Outward buckling occurred at barrels 2 and 3. The vehicle yawed to the left and came to rest behind the barrier. Damage to the front of the vehicle was extensive.

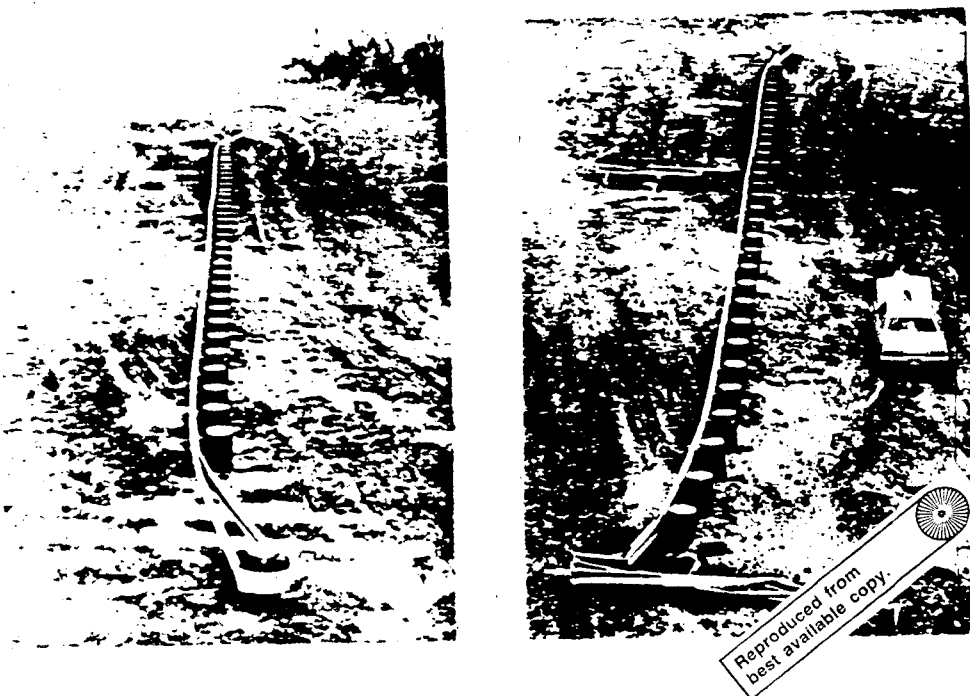
Figure 52. Rail Before and After Test 3825-4.

Although the barrier was not repaired following Test 4, the barrier was severely damaged upstream of barrel 3. Repairs that would have been required to restore the barrier included the replacement of the first two sections of W-beam and the first three barrels. Barrels 4 through 8 would also need to have been repositioned.

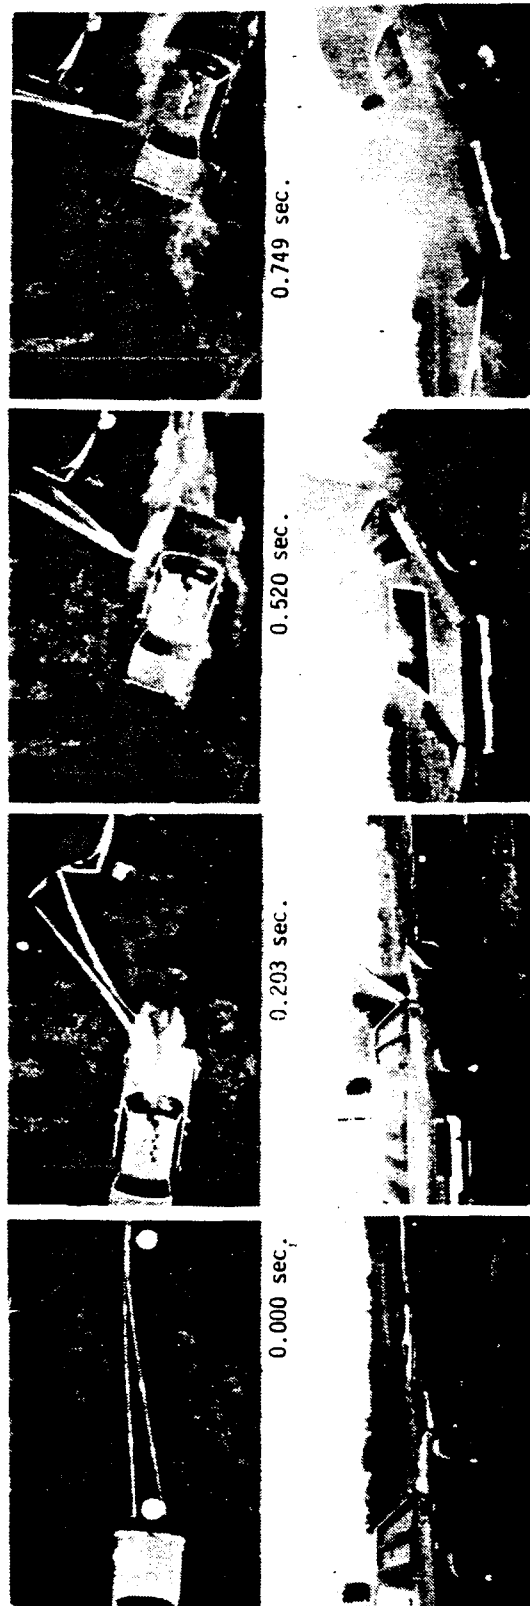
Test No. . . . .	3825-4	Vehicle . . . . .	Plymouth
Date . . . . .	3/8/80	Vehicle Weight. . . . .	4,500 lb (2,041 kg)
Rail . . . . .	12 gauge	Impact Velocity . . . . .	61.4 mph (98.8 km/h)
Post . . . . .	Tubular W-beam	Impact Angle. . . . .	0 deg
	55 gal (208 l)	Vehicle Acceleration	
	Open Head Drum,	(Max. 0.050 sec avg.)	
	18 gal (68 l)	Longitudinal. . . . .	15.8 g
	Bottom and Body	Transverse. . . . .	-3.1 g
	w/False Bottom	Vertical. . . . .	6.8 g
	& Skid Plate	Vehicle Damage	
Post Spacing . . . . .	6.3 ft (1.9 m)	TAD . . . . .	12-FD-3
Post to Anchor Spacing . . . . .	24.8 ft (7.6 m)	SAE . . . . .	12FDEW
Length of Installation . . . . .	250.0 ft (76.2 m)

Figure 53. Summary of Results for Test 3825-4.

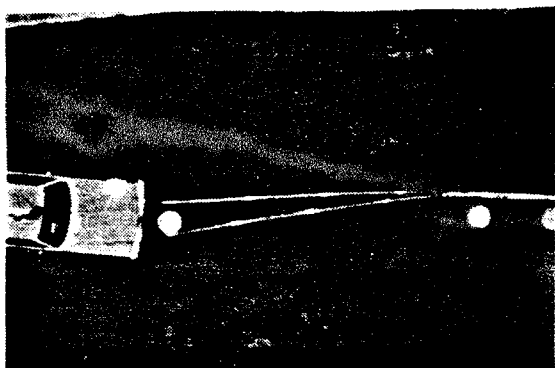
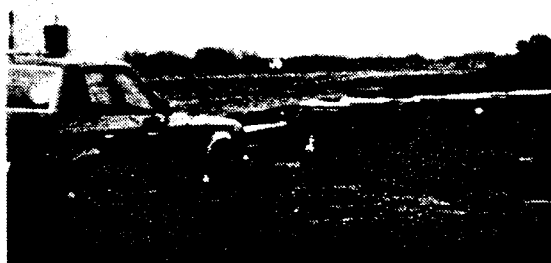
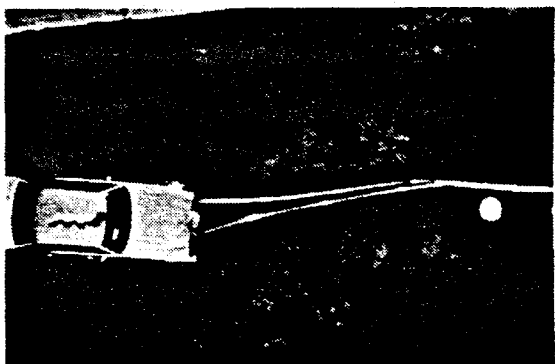
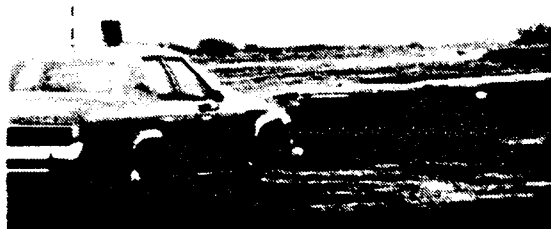
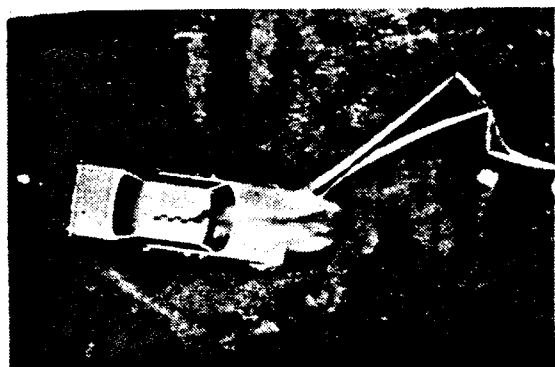
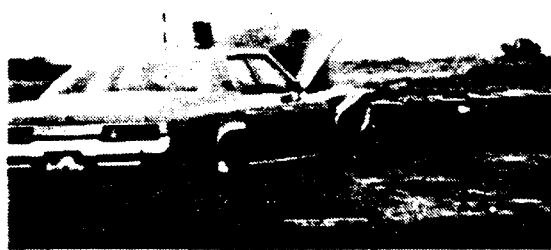
0.000 sec

0.047 sec

0.203 sec
