# BARRIERS IN CONSTRUCTION ZONES

## VOLUME 2

**Report No.**  
**FHWA/RD-86/093**

**VOLUME 2: Appendix A  
Full-Scale Crash Tests**

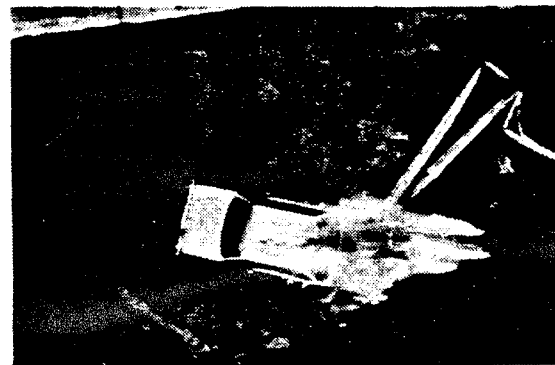
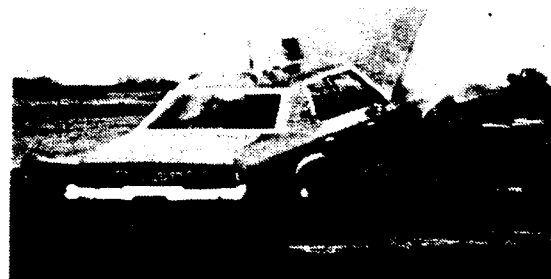
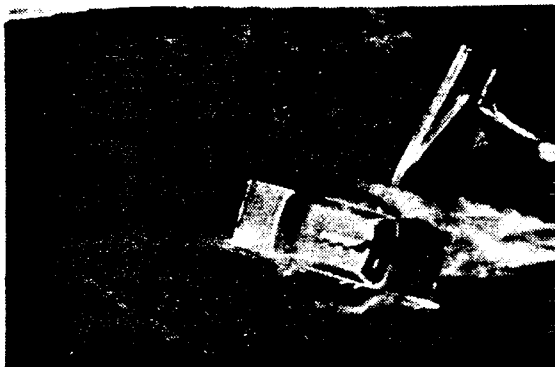
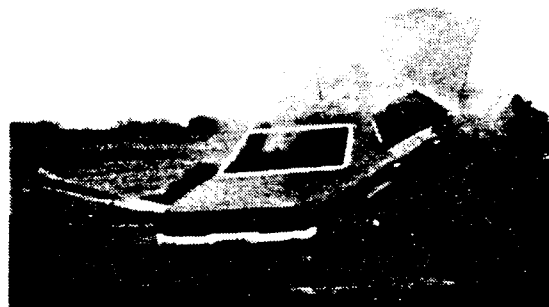
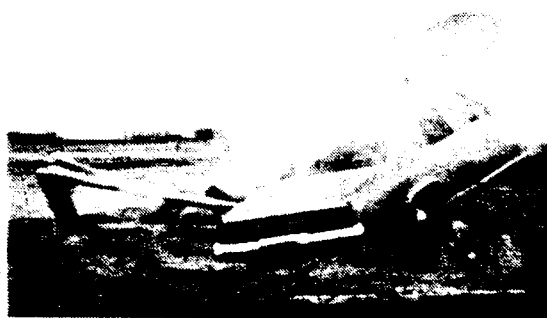
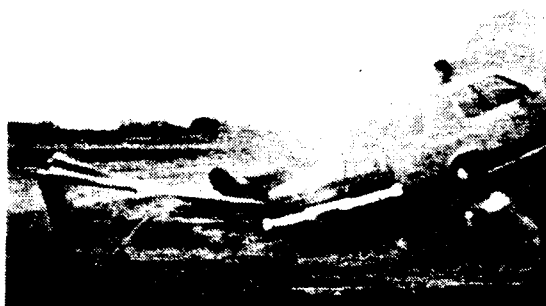
Figure 54. Sequential Photographs for Test 3825-4.

Figure 54 (Continued). Sequential Photographs for Test 3825-4.

In Test 4, a 1974 Plymouth Grand Fury impacted the end of the barrier at 0 deg and 61.4 mph (98.8 km/h). The vehicle weighed 4,500 lb (2,041 kg) including telemetry equipment. Photographs of the vehicle and barrier before and after the test are shown in Figures 50 and 52. Figure 51 illustrates the impact point. Figure 53 summarizes the results of Test 4. Sequential photographs are presented in Figure 54. Table 4 is a summary of time and displacement as related to specific events.

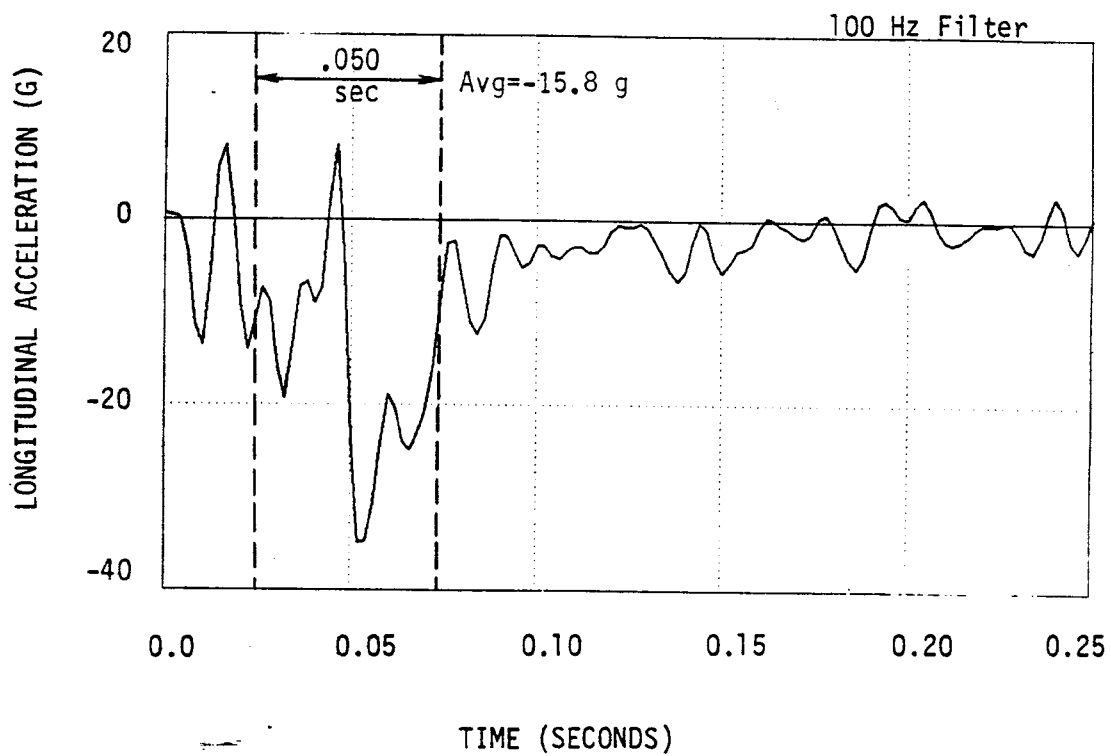
Figure 55. Vehicle Longitudinal Accelerometer Trace for Test 3825-4.

The accelerometer traces are presented in Figures 55 through 57. The maximum 0.050 sec averages were -15.8 g and 3.1 g for longitudinal and transverse acceleration, respectively. Yaw, pitch and roll are shown in Figures 58 through 60. These test results are order dependent and must be evaluated in this sequence.

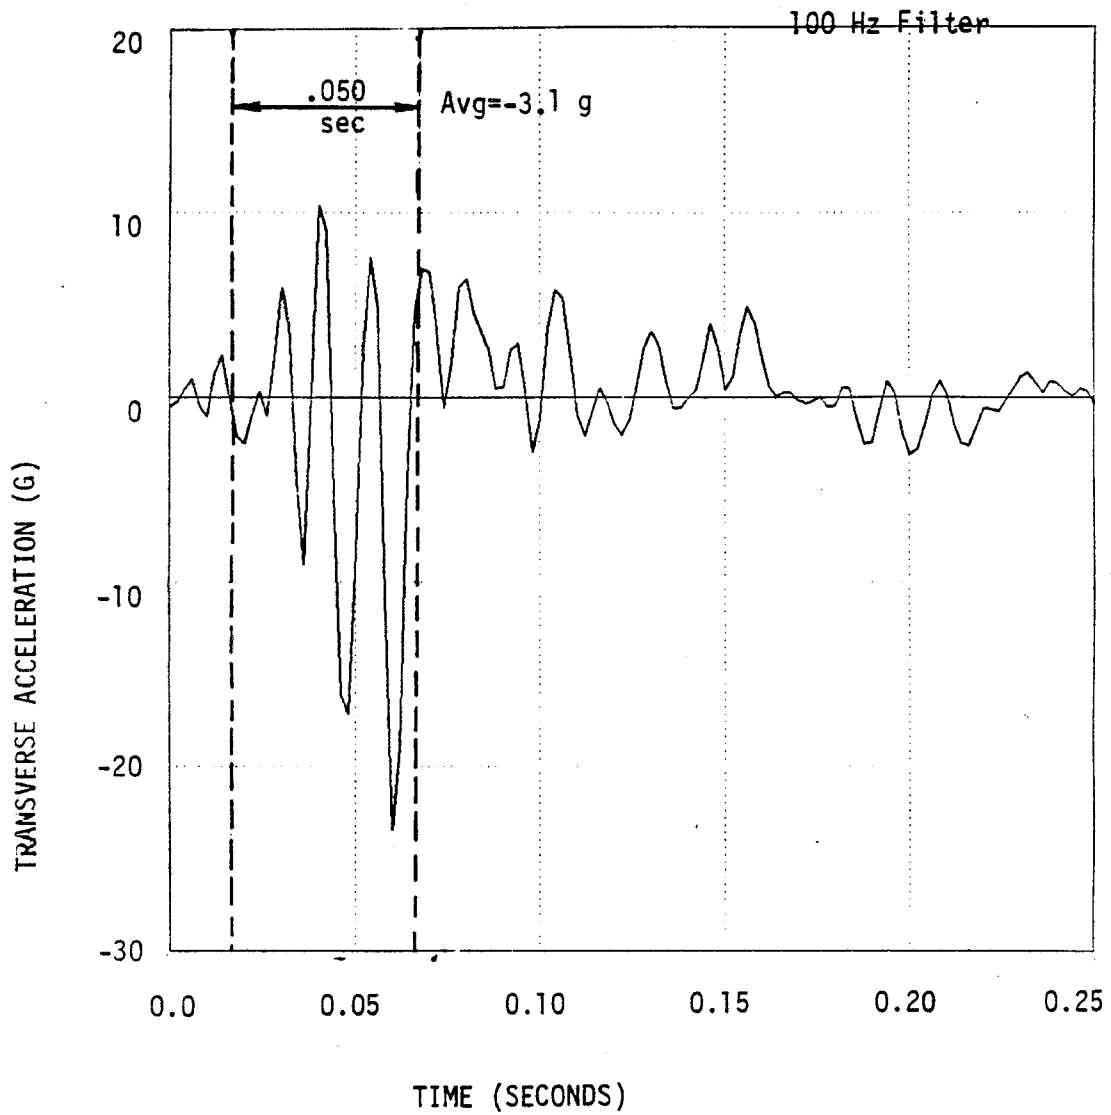
Figure 56. Vehicle Transverse Accelerometer Trace for Test 3825-4.

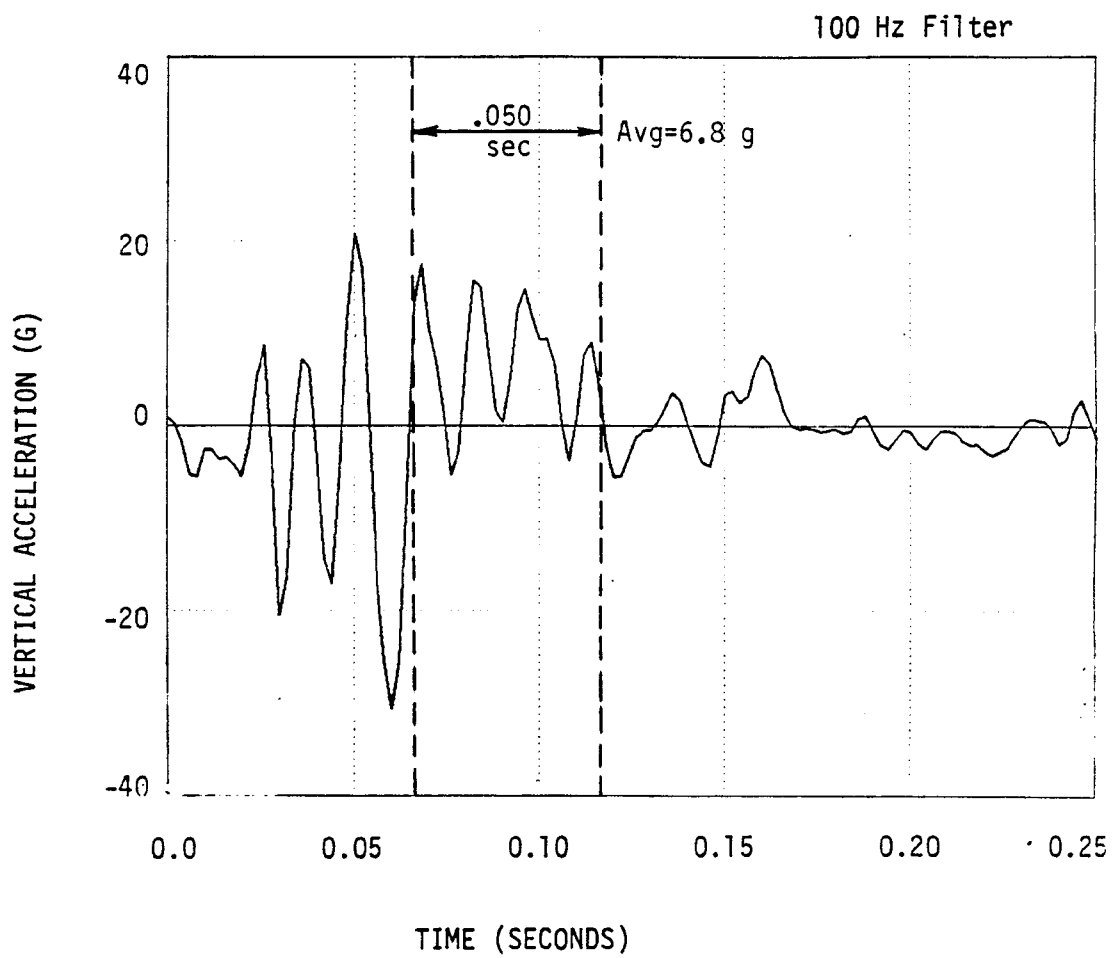
Figure 57. Vehicle Vertical Accelerometer Trace for Test 3825-4.

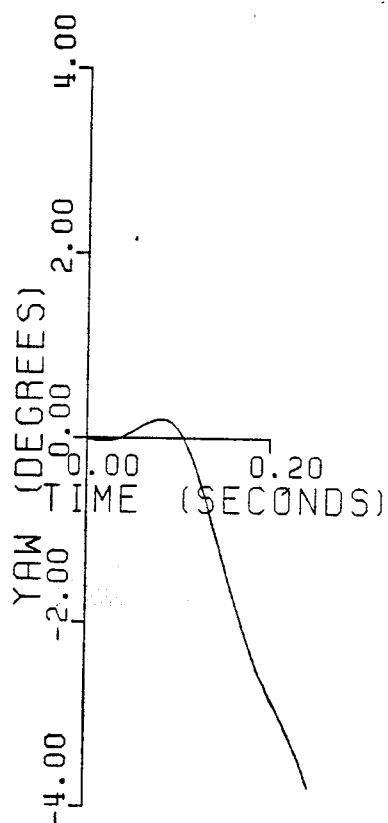
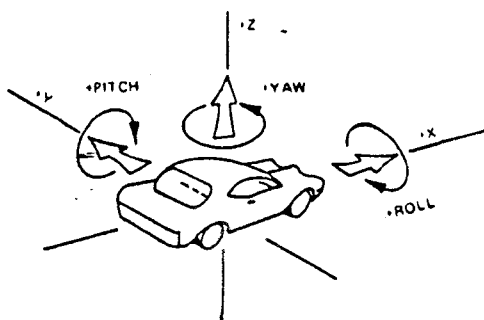
Axes are vehicle fixed.  
Sequence for determining  
orientation is:

1. Yaw
2. Pitch
3. Roll

Figure 58. Vehicle Yaw for Test 3825-4.

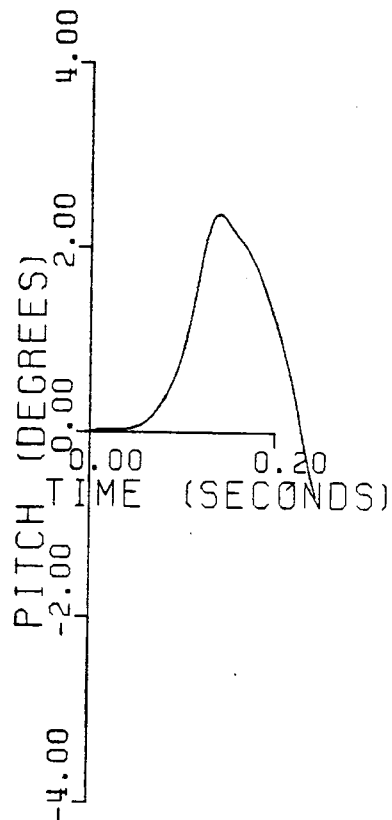
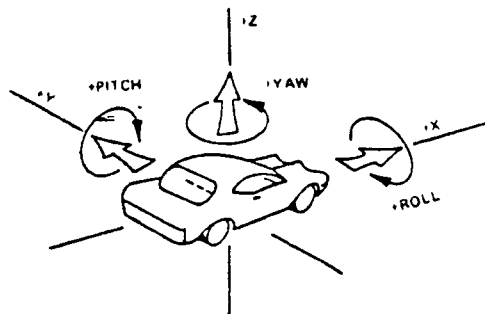
Axes are vehicle fixed.  
Sequence for determining  
orientation is:

1. Yaw
2. Pitch
3. Roll

Figure 59. Vehicle Pitch for Test 3825-4.

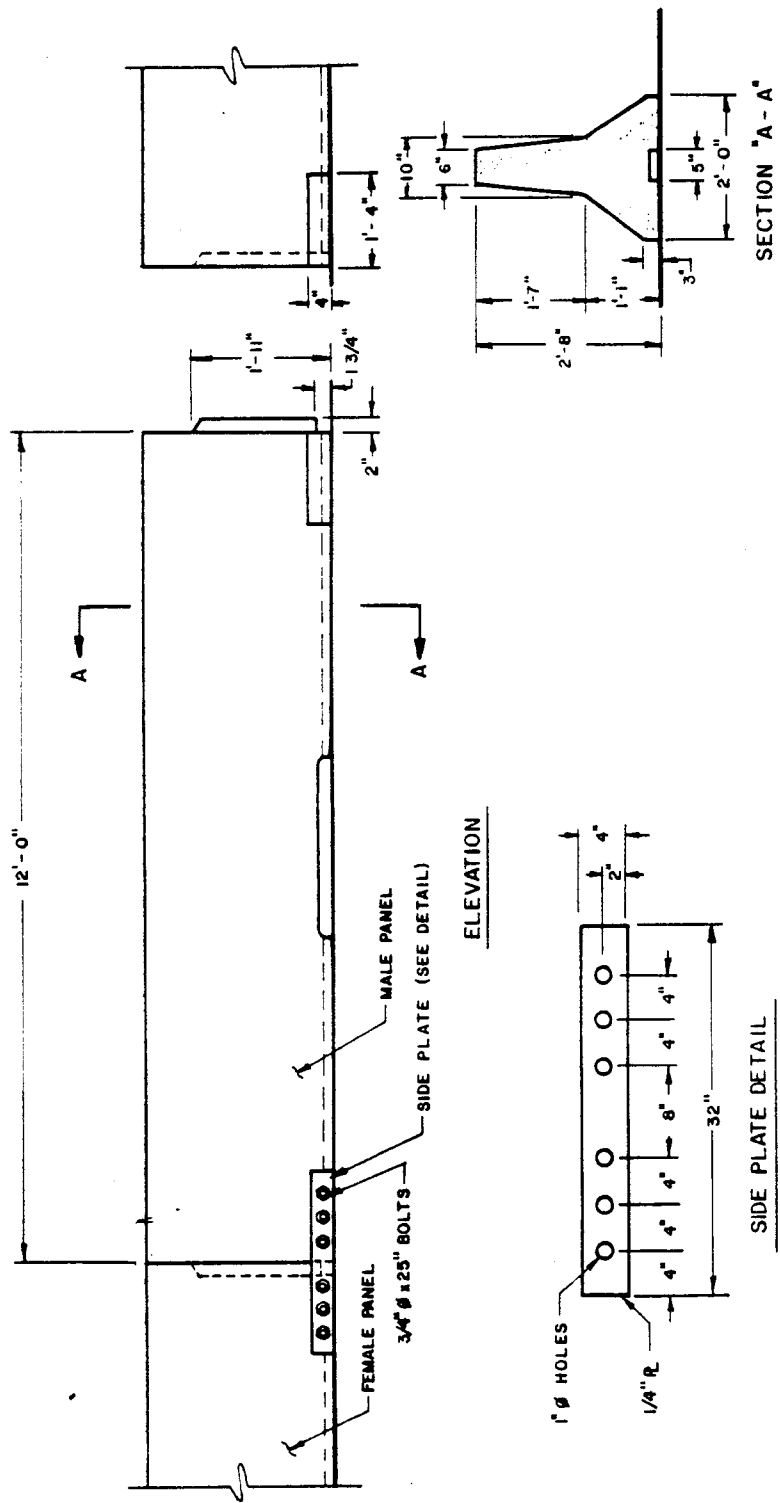
Figure 61. Portable Concrete Median Barrier Details for Test 3825-5.

The test installation was made up of 12.0 ft (3.7 m) portable concrete median barrier (CMB) sections joined by a built-in male-female vertical "tongue and groove" coupling and 0.25 in. (0.64 cm) thick side plates bolted horizontally to the base of the CMB sections at the joints as illustrated in Figure 61. The barrier system consisted of ten CMB sections combined to form an installation 120.0 ft (36.7 m) long with a projected impact point at the center of section 4 as shown in Figure 62. This installation was placed on a dry, level concrete surface similar to PCC road surfaces.

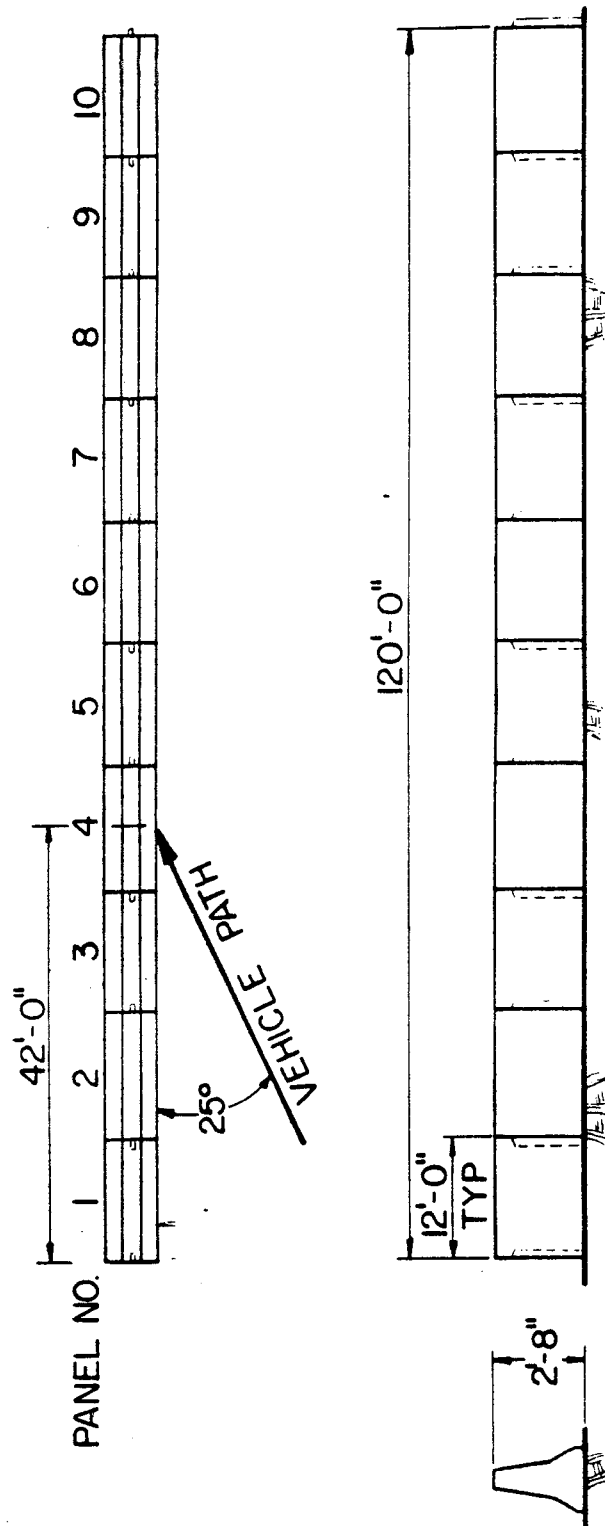
Figure 62. CMB Installation for Test 3825-5.

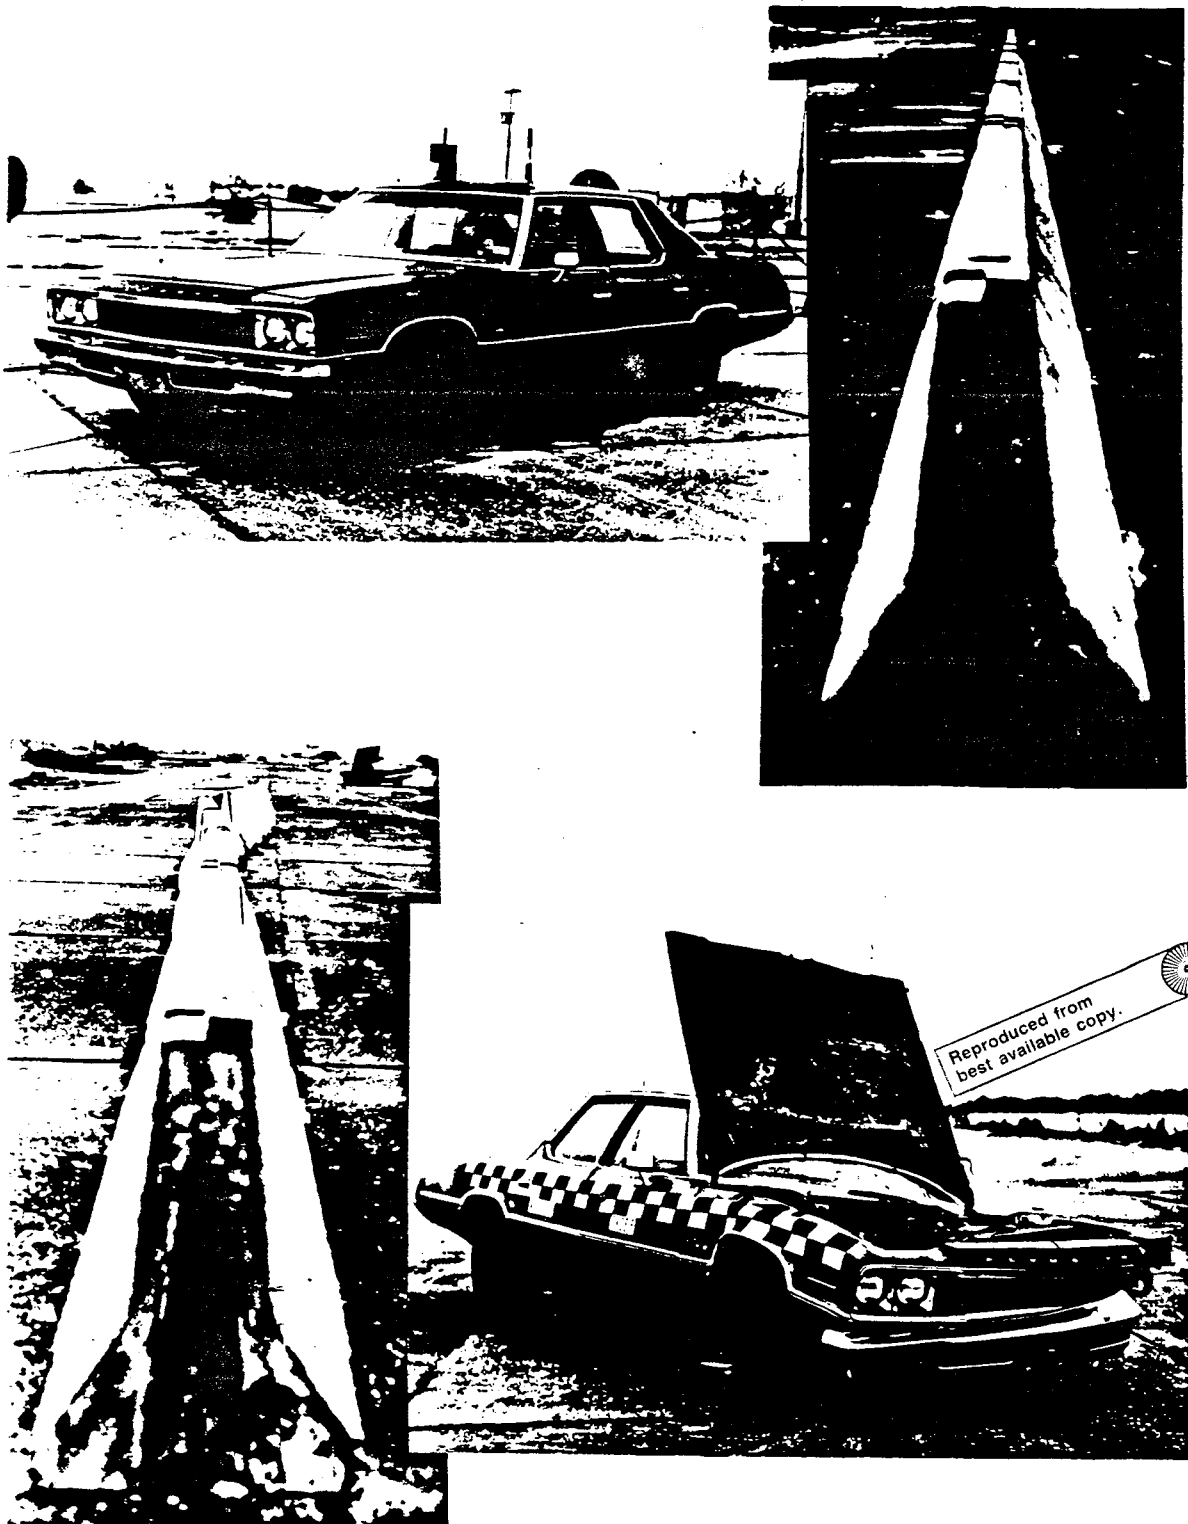
Figure 63 . Vehicle and Barrier Before and After Test 3825-5.

In Test 5, a 1974 Plymouth Fury, weighing 4,500 lb (2,041 kg) including telemetry equipment, impacted the test installation at a speed of 60.7 mph (97.7 km/h) and an angle of 25 deg. Photographs of the vehicle and barrier system before and after Test 5 are presented in Figure 63, while a summary of test results is shown in Figure 64. Sequential photographs of Test 6 are presented in Figure 65 and Table 5 lists time and displacements as related to specific events.

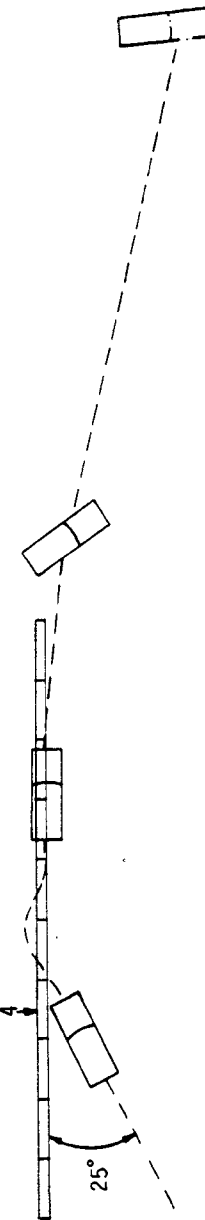
Figure 64. Summary of Results for Test 3825-5.

Test No. . . . .	3825-5	Vehicle . . . . .	1974 Plymouth Fury
Date . . . . .	1/10/80	Vehicle Weight . . . . .	4,500 lb (2,041 kg)
Barrier . . . . .	Portable Concrete	Impact Speed . . . . .	60.7 mph (97.7 km/h)
Segment . . . . .	Median Barrier	Impact Angle . . . . .	25 deg
	Vertical Tongue & Groove w/ 1/4 in. (.64 cm)	Exit Speed . . . . .	Not Applicable
	Steel Side Plates	Exit Angle . . . . .	Not Applicable
Segment Length . . . . .	12.0 ft (3.7 m)	Vehicle Acceleration (Max. 0.050 sec avg.)	
Length of Installation . . . . .	120.0 ft (36.7 m)	Longitudinal (rt & lt avg).	-6.2 g
Barrier Deflection		Transverse . . . . .	-7.5 g
Max. Dynamic . . . . .	1.6 ft (0.5 m)	Vertical . . . . .	8.2 g
Max. Permanent . . . . .	1.6 ft (0.5 m)	Vehicle Damage	
		TAD . . . . .	11FL4
		SAE . . . . .	11FLME1

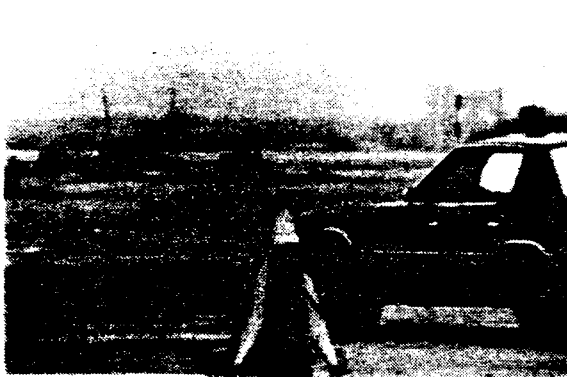
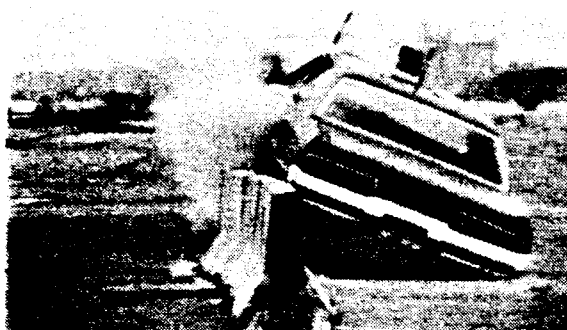
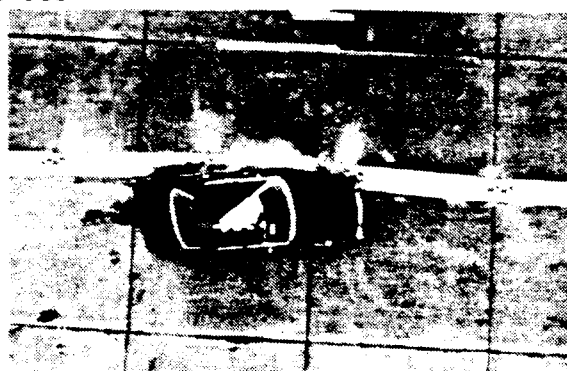
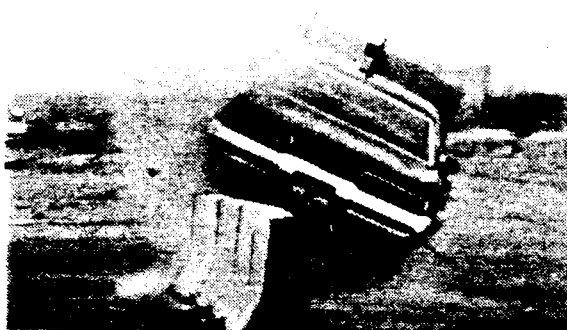
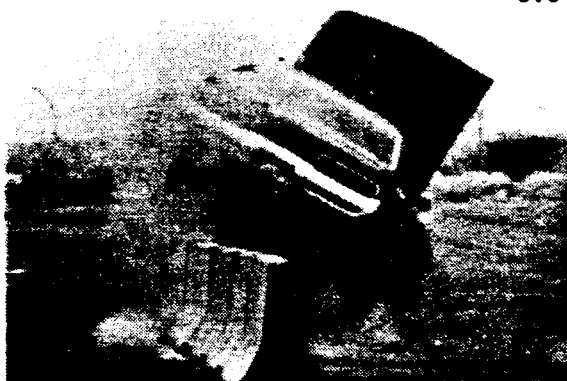
Figure 65. Sequential Photographs for Test 3825-5.

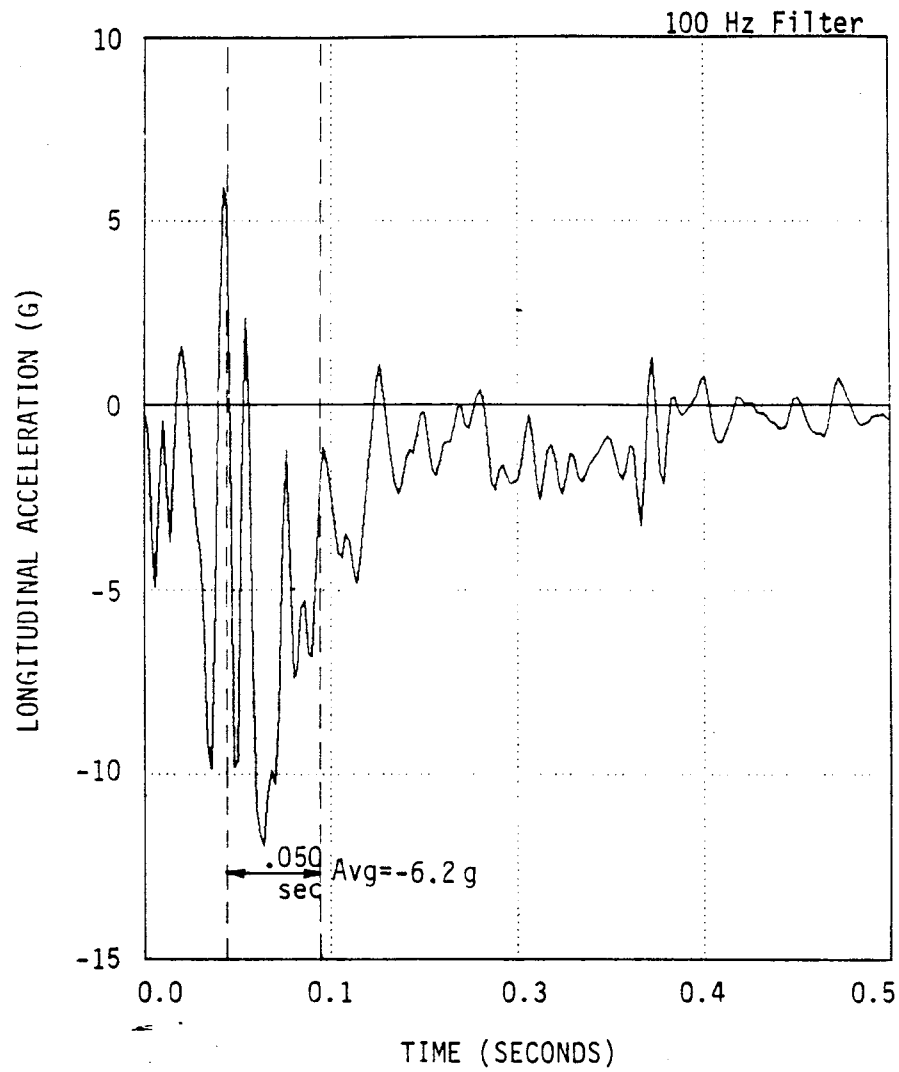
Figure 66. Vehicle Longitudinal Accelerometer Trace for Test 3825-5 (Averaged from Two Accelerometers).

the barrier. The maximum dynamic deflection of the barrier was 1.6 ft (0.5 m) and maximum permanent deflection was also 1.6 ft (0.5 m) both occurring at joint 4-5. The linear accelerometer traces for Test 5 are presented in Figures 66 through 70. The maximum 0.050 sec average longitudinal acceleration was -6.2 g while the maximum 0.050 sec average transverse and vertical accelerations were -7.5 g and 8.2 g, respectively.

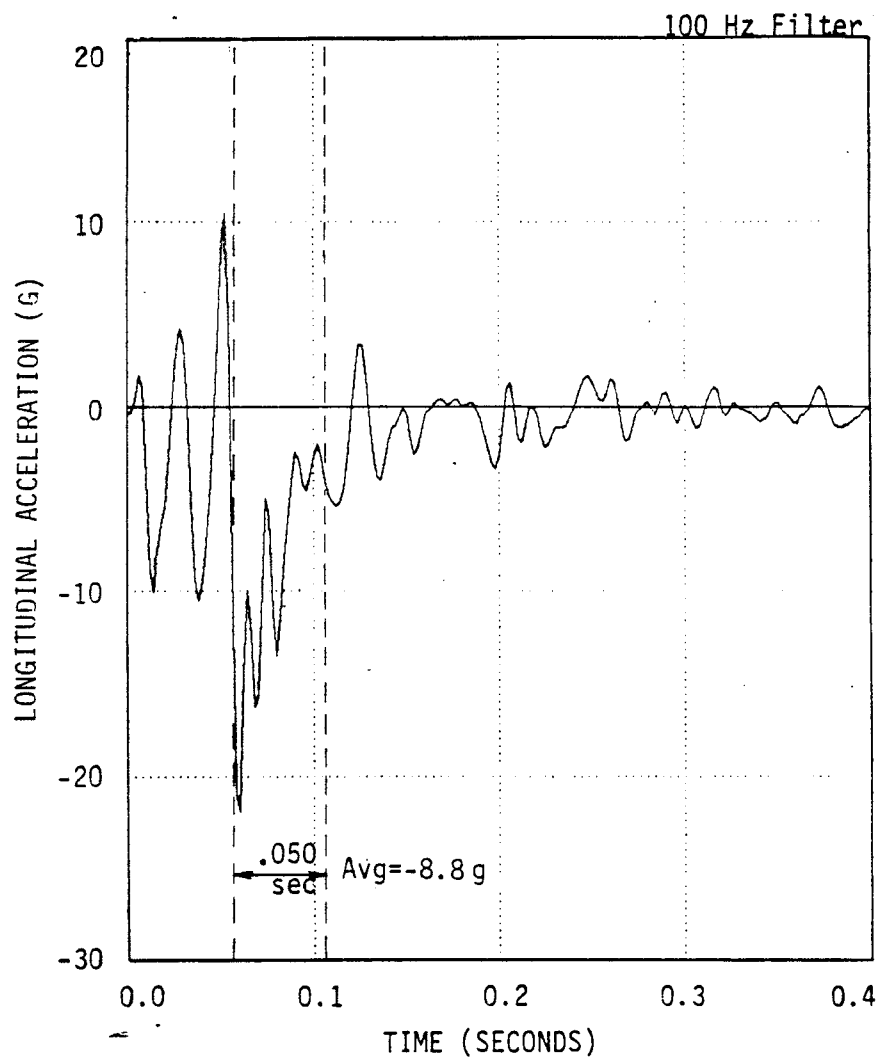
Figure 67. Vehicle Right Longitudinal Accelerometer Trace for Test 3825-5.

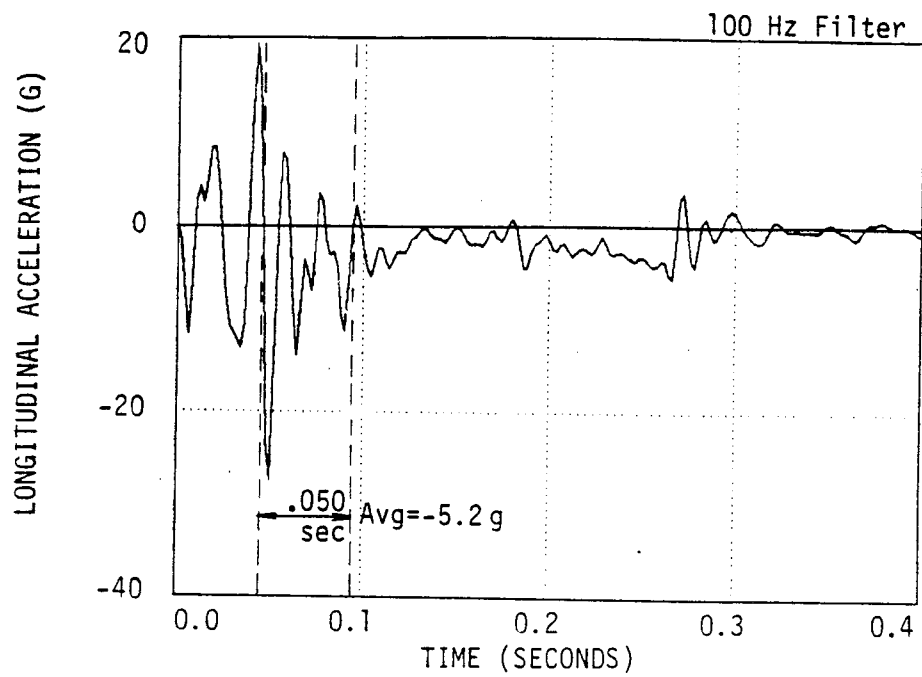
Figure 68. Vehicle Left Longitudinal Accelerometer Trace for Test 3825-5.

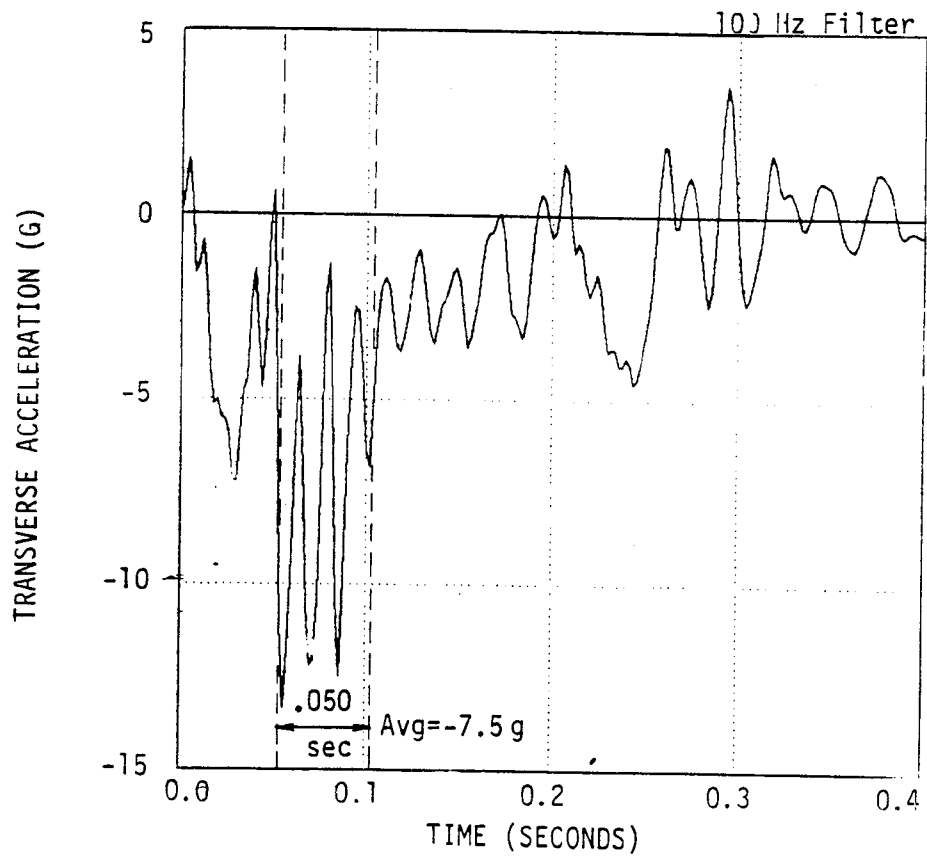
Figure 69. Vehicle Left Transverse Accelerometer Trace for Test 3825-5.

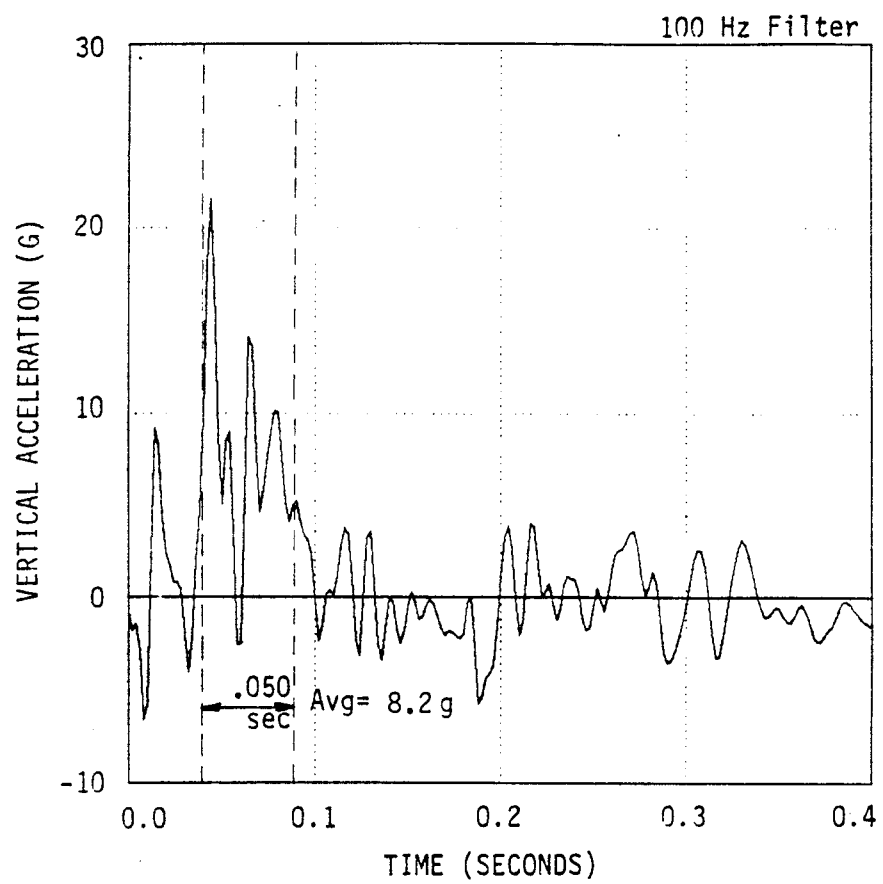
Figure 70 Vehicle Left Vertical Accelerometer Trace for Test 3825-5.

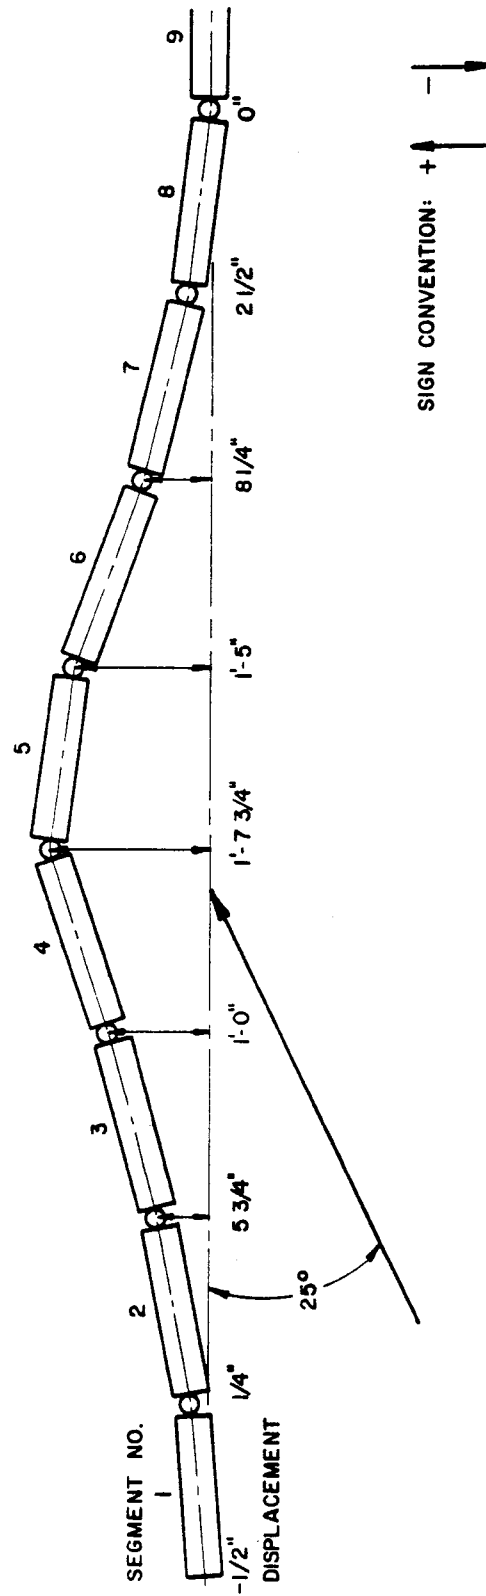
Figure 71. Permanent Barrier Deflection Test 3825-5.

The permanent barrier deflections are shown in Figure 71 while flexural cracking due to Test 5 is detailed in Figure 72. Figures 73 through 77 show specific damage to the CMB sections. Minor damage occurred due to flexural cracking and concrete spalling at the base of the joints near the impact area. Major spalling occurred at some of the joints due to interaction of the "tongue and groove" coupling when undergoing large deflections. Figure 77 specifically illustrates this type of damage.

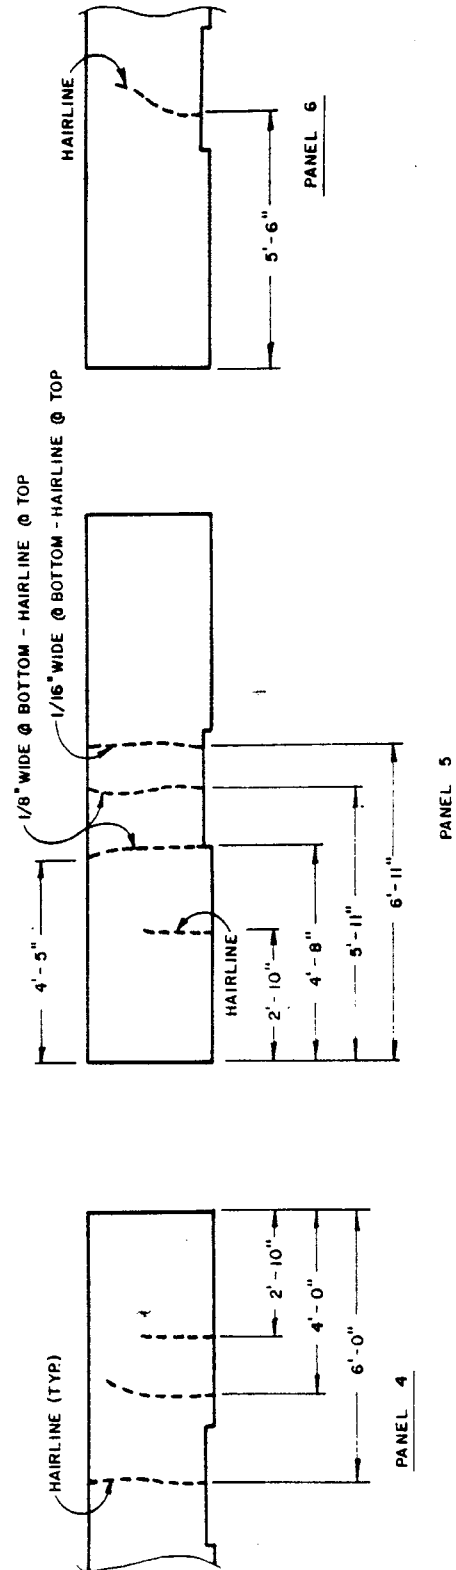
Figure 72. Flexural Cracking From Test 3825-5.

NOTE: IMPACT FACE OF PANEL IS SHOWN, CRACKS ARE ON BACK FACE.

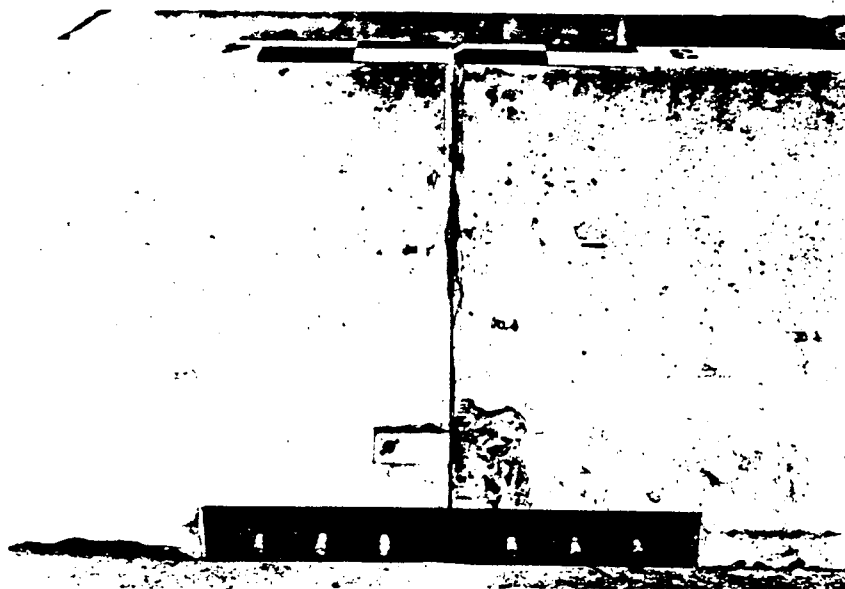
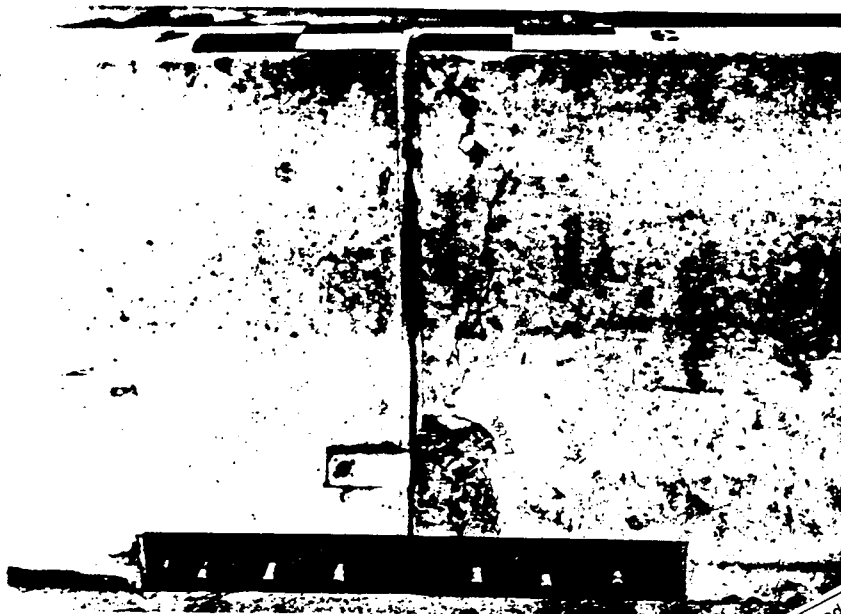
Figure 73. Joint 3-4 Back Before and After Test 3825-5.

Before

After

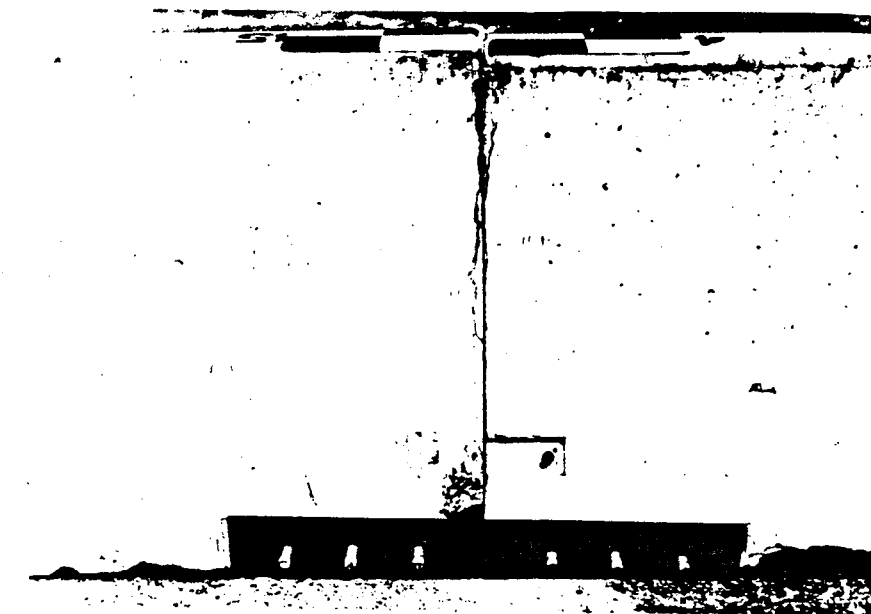
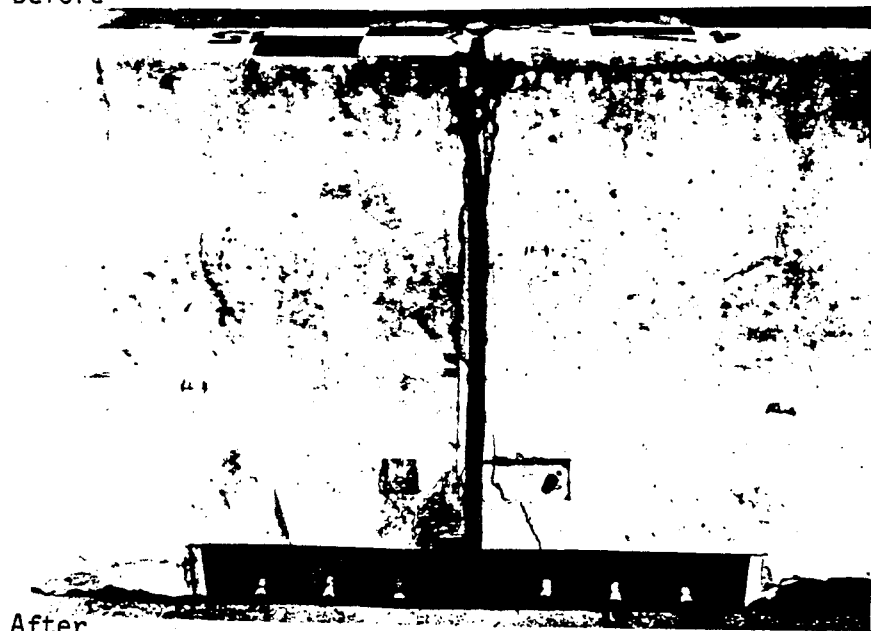
Figure 74. Joint 4-5 Back Before and After Test 3825-5.

Before

After

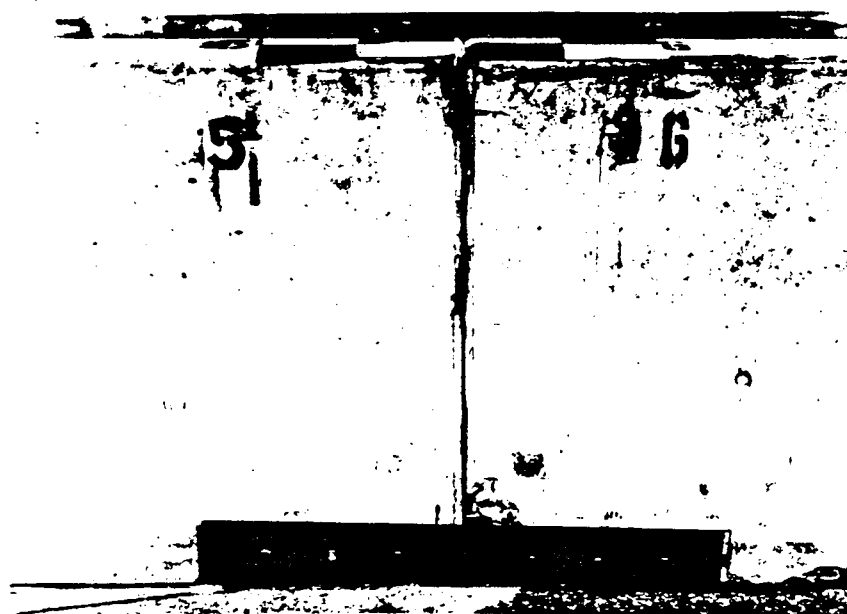
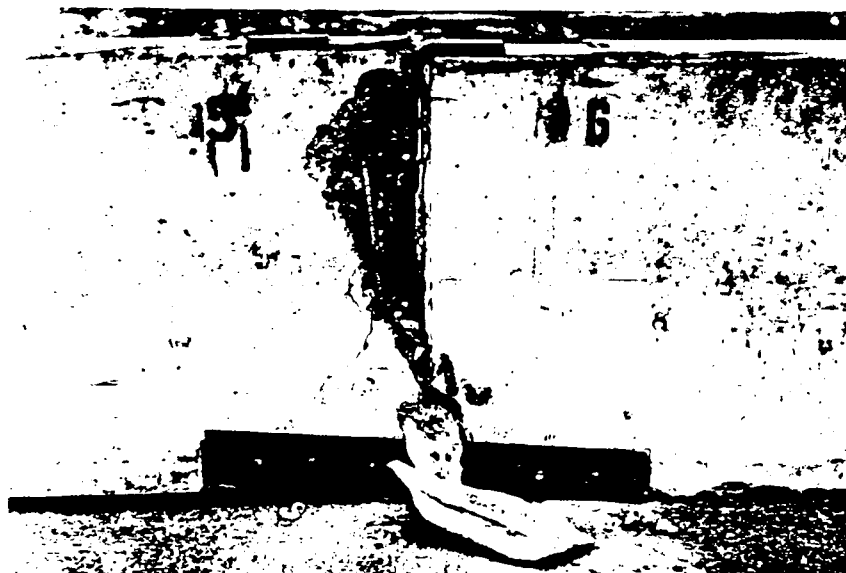
Figure 77. Joint 5-6 Front Before and After Test 3825-5.

Before

After

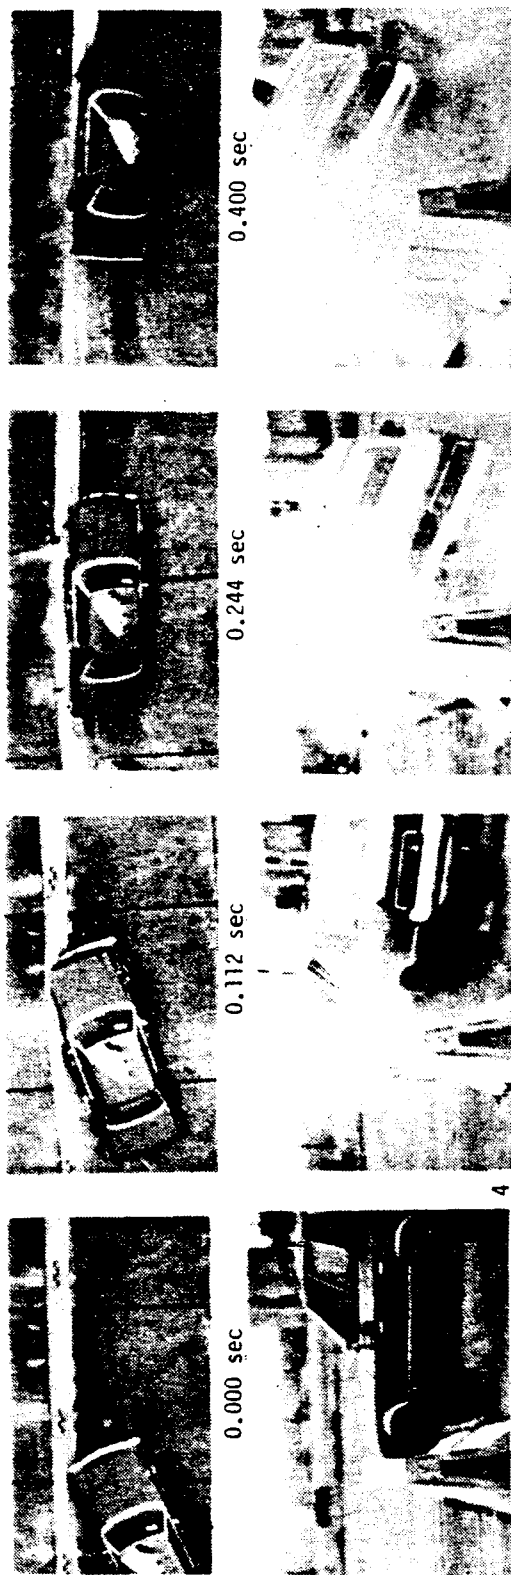
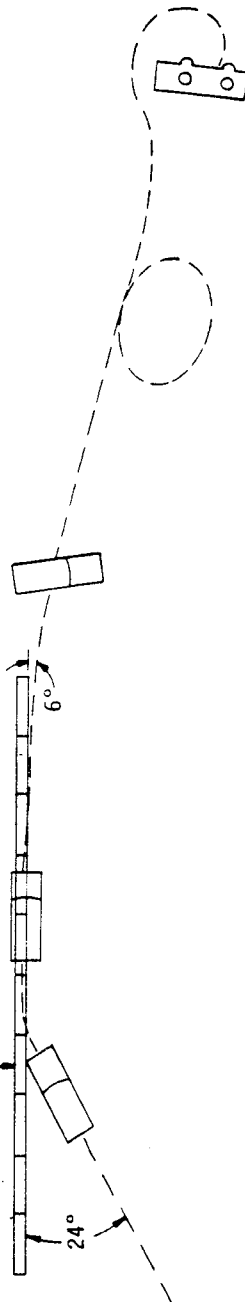
Figure 81. Summary of Results for Test 3825-6.

Test No. . . . .	3825-6	Vehicle . . . . .	1974 Plymouth Fury
Date . . . . .	1/9/80	Vehicle Weight . . . . .	4,500 lb (2,041 kg)
Barrier . . . . .	Portable Concrete	Impact Speed . . . . .	60.1 mph (96.8 km/h)
Segment . . . . .	Median Barrier	Impact Angle . . . . .	24 deg
	Vertical Tongue &	Exit Speed . . . . .	Not Applicable
	Groove w/ 3/8 in. (.95 cm)	Exit Angle . . . . .	~6 deg
Segment Length . . . . .	Steel Side Plates	Vehicle Acceleration	
Length of Installation . . . . .	12.0 ft ( 3.7 m)	(Max. 0.050 sec avg.)	
Barrier Deflection	120.0 ft (36.7 m)	Longitudinal (ft & lt avg.)	-5.6 g
Max. Dynamic . . . . .	2.0 ft ( 0.6 m)	Transverse . . . . .	-7.9 g
Max. Permanent . . . . .	1.8 ft ( 0.5 m)	Vertical . . . . .	7.8 g
		Vehicle Damage	
		TAD . . . . .	10L&T5
		SAE . . . . .	10FLEW2
			10LDES1
			00ULXW1

Portable Concrete  
Median Barrier

In Test 6, a 1974 Plymouth Fury, weighing 4,500 lb (2,041 kg) including all telemetry equipment, impacted the barrier at a speed of 60.1 mph (96.7 km/h) and an angle of 24 deg. Photographs of the vehicle and barrier system before and after Test 6 are presented in Figure 80. A summary of test results is presented in Figure 81 and sequential photographs are shown in Figure 82. Table 6 lists time and displacement as related to specific events.

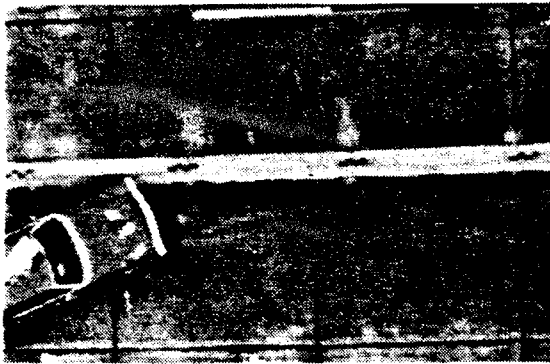
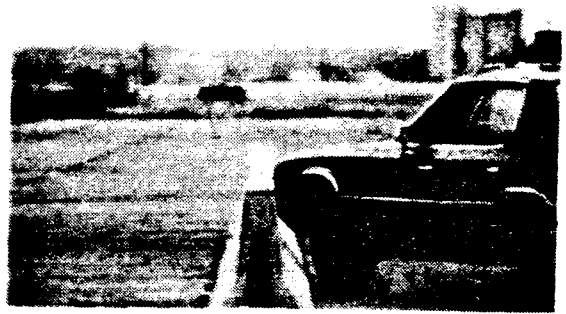
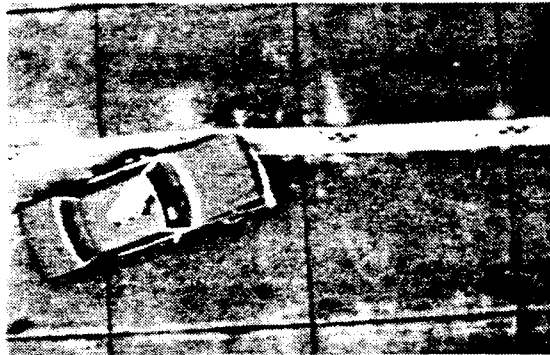
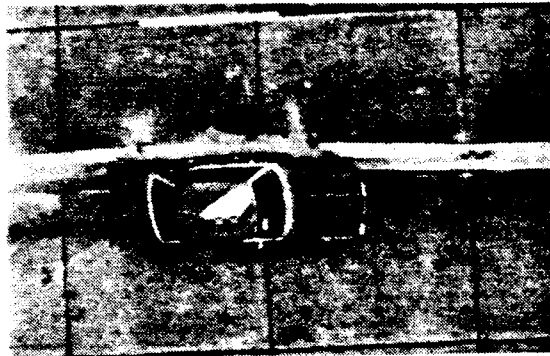
Figure 82. Sequential Photographs for Test 3825-6.

0.000 sec

0.112 sec

0.244 sec

0.400 sec
