# BARRIERS IN CONSTRUCTION ZONES

## VOLUME 2

**Report No.**  
**FHWA/RD-86/093**

**VOLUME 2: Appendix A  
Full-Scale Crash Tests**

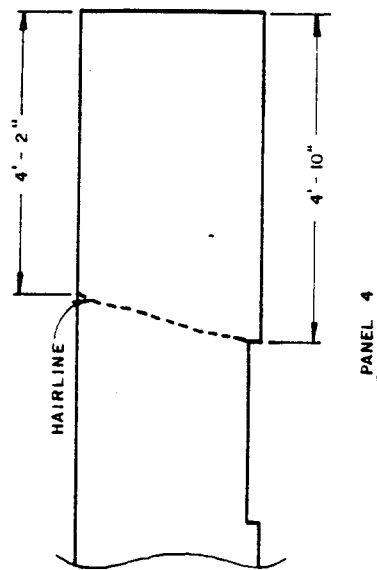
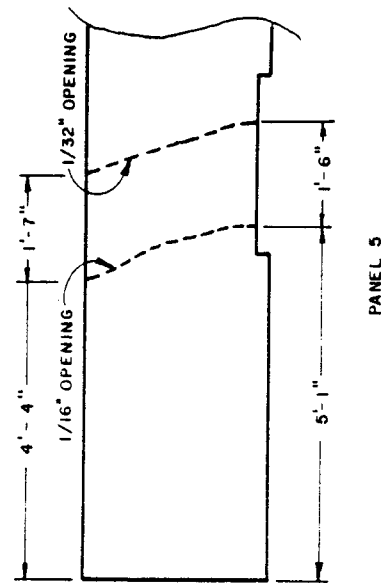
Figure 89. Flexural Cracking From Test 3825-6.

NOTE: IMPACT FACE OF PANEL IS SHOWN, CRACKS ARE ON BACK FACE.

The deflected barrier shape is shown in Figure 88 and the location of flexural cracks due to Test 6 are shown in Figure 89. Figures 90 through 94 show detailed pictures of damage to the barrier system. Minor damage to the CMB sections occurred due to flexural cracking and concrete spalling near the base of the joints in the vicinity of the impact point. Most damage occurred at the joints that underwent the largest rotations due to the "tongue and groove" coupling interaction. Damage of this type is shown specifically in Figures 90, 92 and 94.

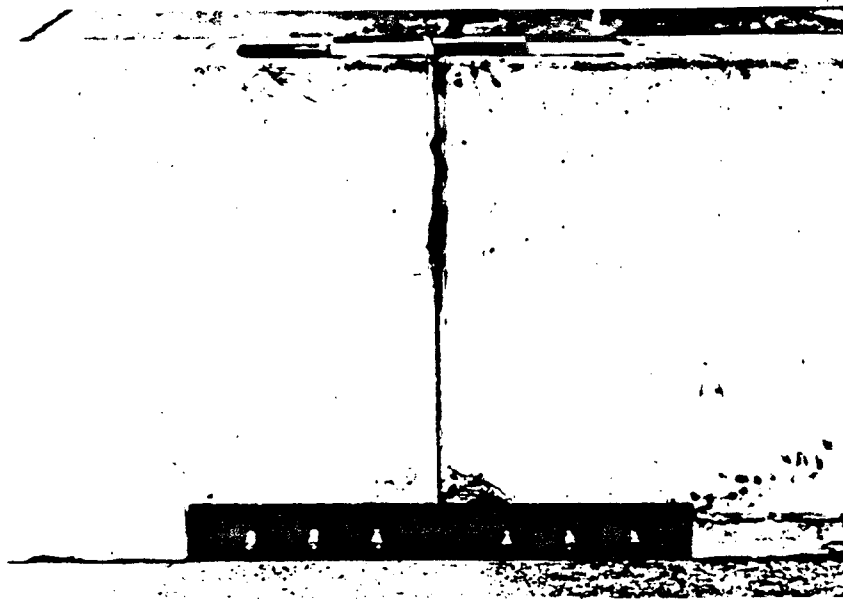
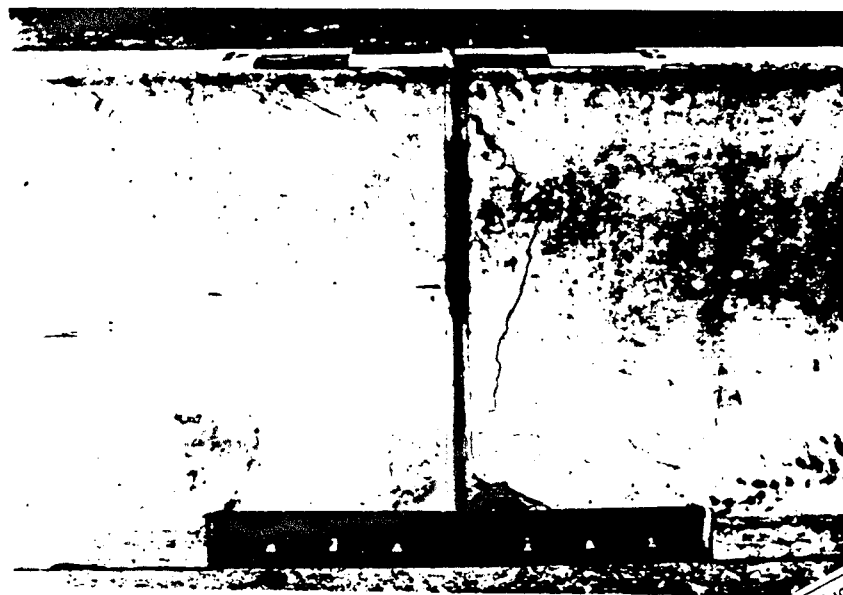
Figure 90: Joint 3-4 Back Before and After Test 3825-6.

Before

After

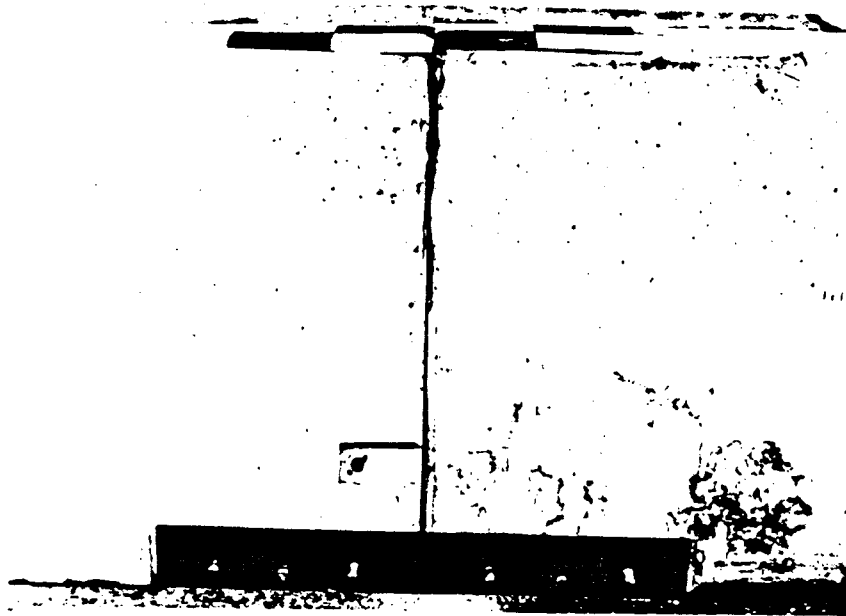
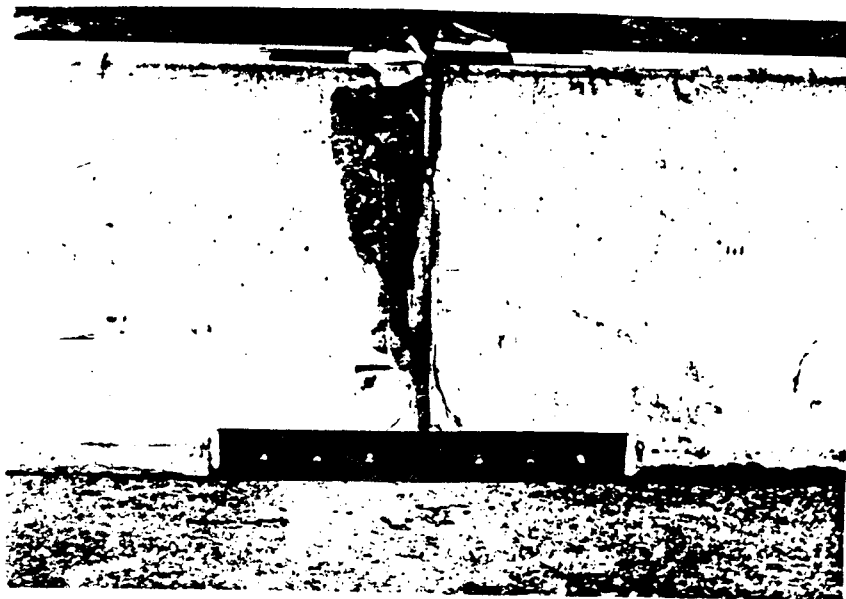
Figure 92. Joint 4-5 Back Before and After Test 3825-6.

Before

After

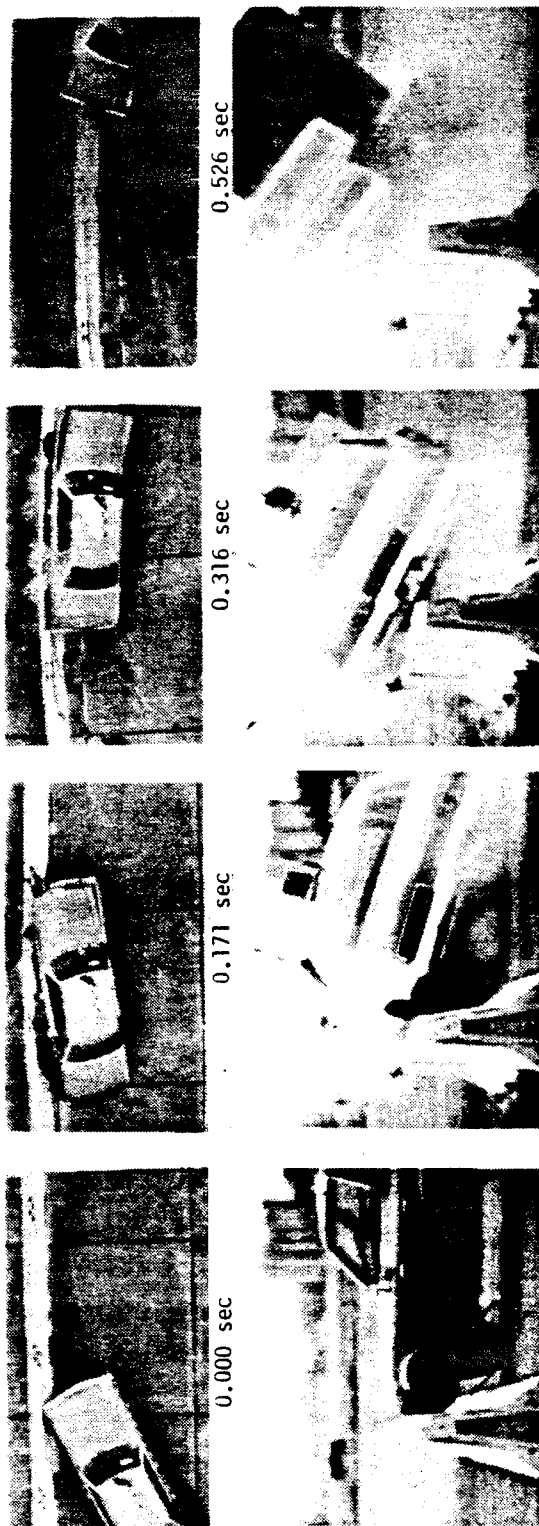
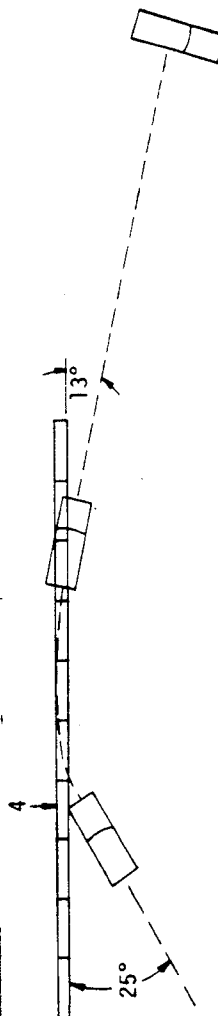
Figure 98. Summary of Results for Test 3825-7.

Test No. . . . .	3825-7	Vehicle . . . . .	1974 Plymouth Fury
Date . . . . .	1/8/80	Vehicle Weight . . . . .	4,500 lb (2,041 kg)
Barrier . . . . .	Portable Concrete	Impact Speed . . . . .	59.2 mph (95.3 km/h)
Segment . . . . .	Median Barrier	Impact Angle . . . . .	25 deg
	Vertical Tongue & Groove w/ 1/2 in. (1.3 cm)	Exit Speed . . . . .	~13°
	Steel Side Plates	Exit Angle . . . . .	~13°
Segment Length . . . . .	12.0 ft (3.7 m)	Vehicle Acceleration (Max. 0.050 sec avg.)	
Length of Installation . . . . .	120.0 ft (36.7 m)	Longitudinal (rt & lt avg.)	-5.7 g
Barrier Deflection		Transverse . . . . .	-7.1 g
Max. Dynamic . . . . .	2.3 ft (0.7 m)	Vertical . . . . .	-7.6 g
Max. Permanent . . . . .	1.8 ft (0.6 m)	Vehicle Damage	
		TAD . . . . .	10FL3
		SAE . . . . .	10FLEW2
			10LDES1

In Test 7, a 1974 Plymouth Fury, weighing 4,500 lb (2,041 kg) including all telemetry equipment impacted the barrier at a speed of 59.2 mph (95.3 km/h) and an angle of 25 deg to the barrier. Photographs of the vehicle and barrier before and after the test are shown in Figure 97. Results are summarized in Figure 98 and sequential photographs are presented in Figure 99. Table 7 lists time and displacements as related to specific events.

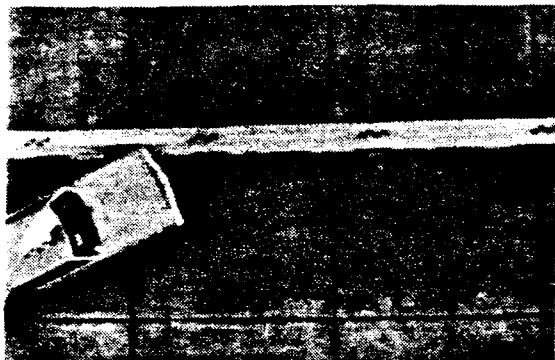
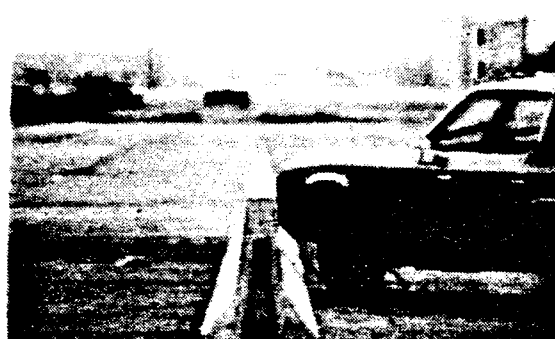
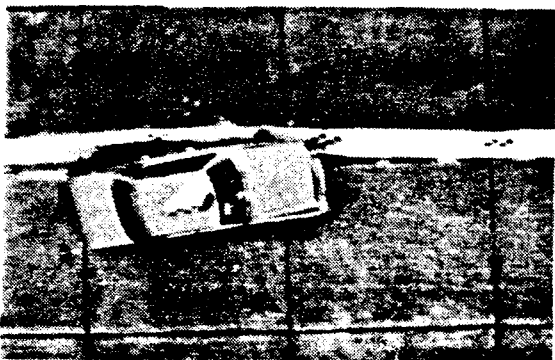
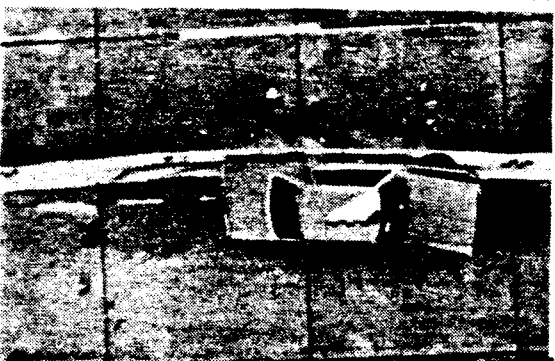
Figure 99. Sequential Photographs for Test 3825-7.

0.000 sec

0.171 sec

0.316 sec

0.526 sec

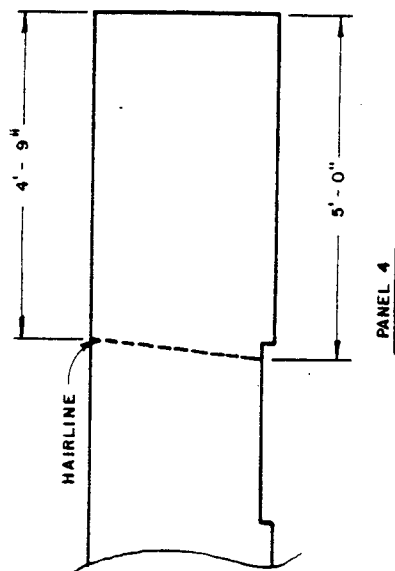
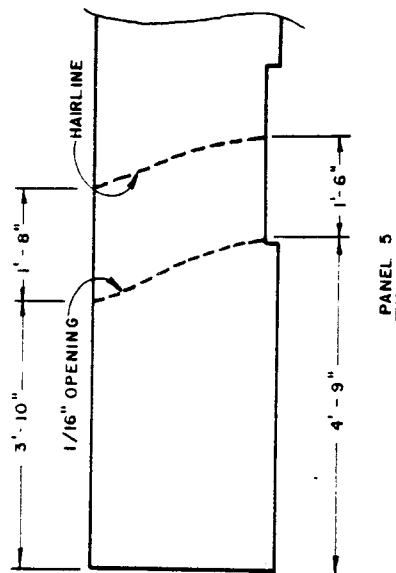
Figure 106. Flexural Cracks From Test 3825-7.

NOTE: IMPACT FACE OF PANEL IS SHOWN, CRACKS ARE ON BACK FACE.

The final permanent barrier deflected shape is shown in Figure 105 and the flexural cracks due to Test 7 in the CMB sections are shown in Figure 106. Damage to the barrier was slight due to the smooth deflection of the barrier section acting as a unit. The major portion of the damage that occurred was due to the tongue and groove interaction at the joints. Detailed pictures of the damage are shown in Figures 107 through 112. Minor cracking and spalling occurred near the initial impact point at the base of the joints where the side plates were bolted. The side plates were all intact with no tensile yielding apparent.

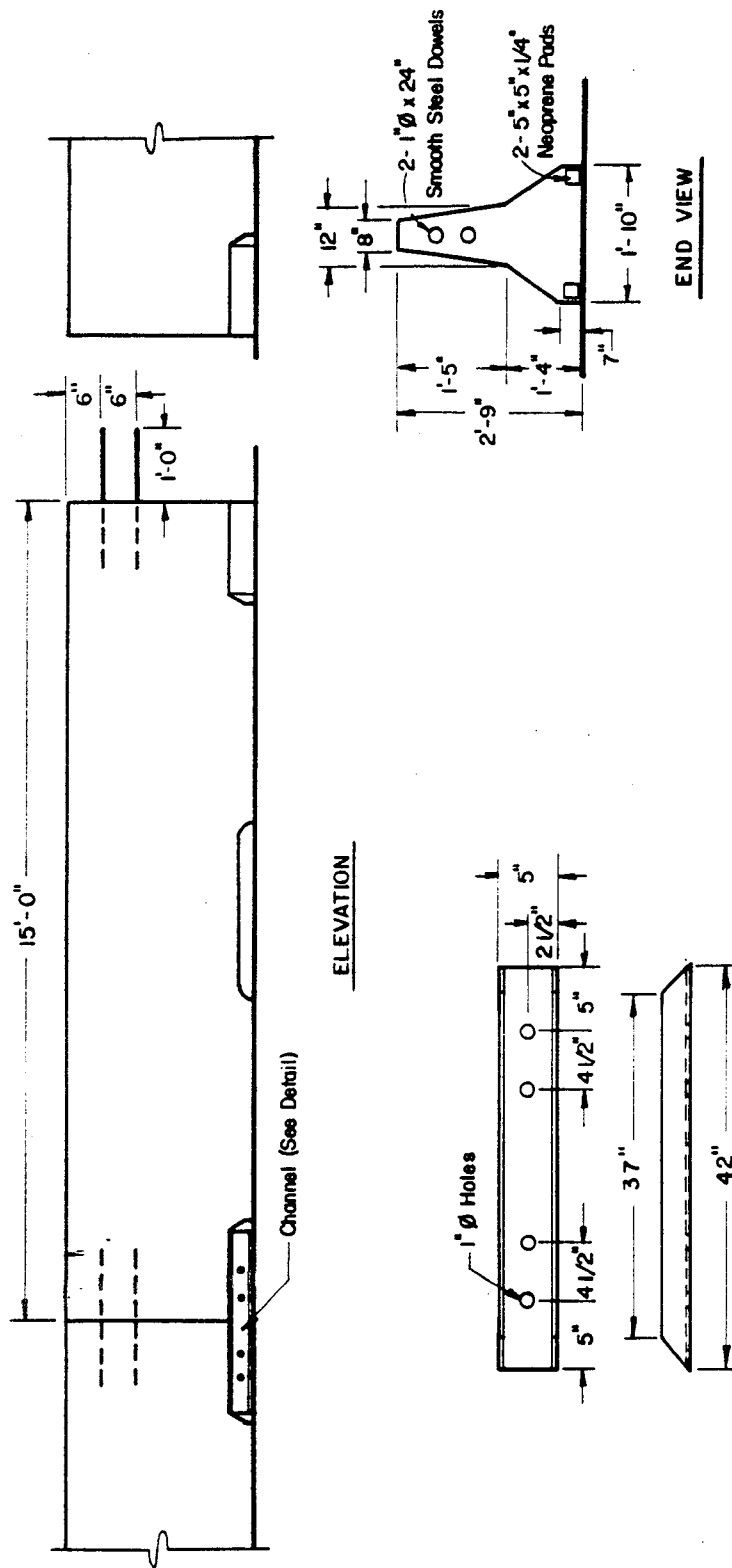
CHANNEL (C5x9.0)

Figure 113. Concrete Median Barrier Detail for Test 3825-8.

A new concrete median barrier (CMB) system was installed for Test 3825-8. Although the cross section configuration was different from the last test (narrower base with a slightly wider top), the major difference was in segment length, 15.0 ft (4.6 m), and the manner in which they were connected. Figure 113 shows the barrier details. Note that instead of the tongue and groove with flat steel splice plates employed in previous tests, the barriers are joined with smooth steel dowels and channel splice plates (Figure 114). This arrangement seemed to increase the lateral stiffness of the barrier system. Figure 115 shows the test installation, consisting of twelve CMB sections joined on a level, concrete surface similar to what would be found on a highway installation.

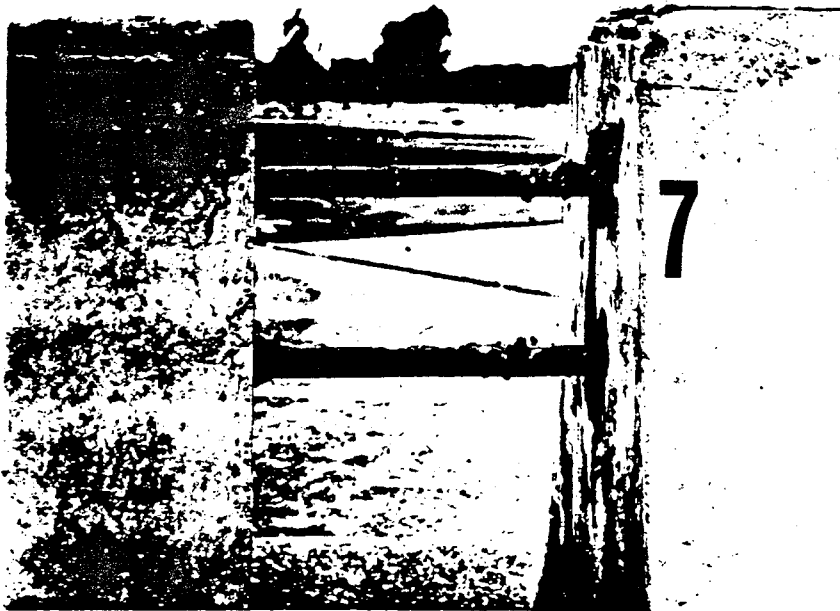
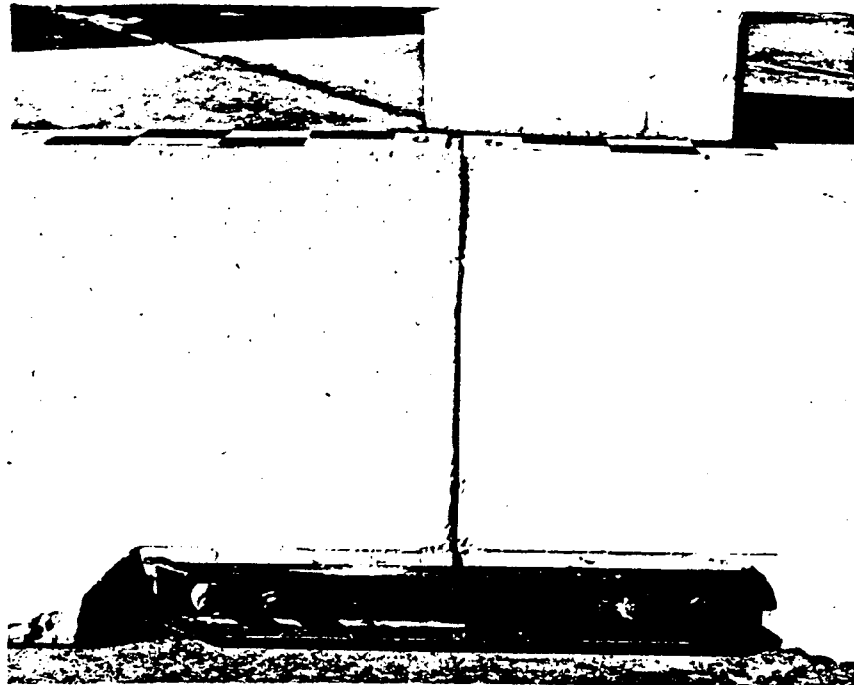
Figure 114. Fastener Details of CMB Sections for Test 3825-8.

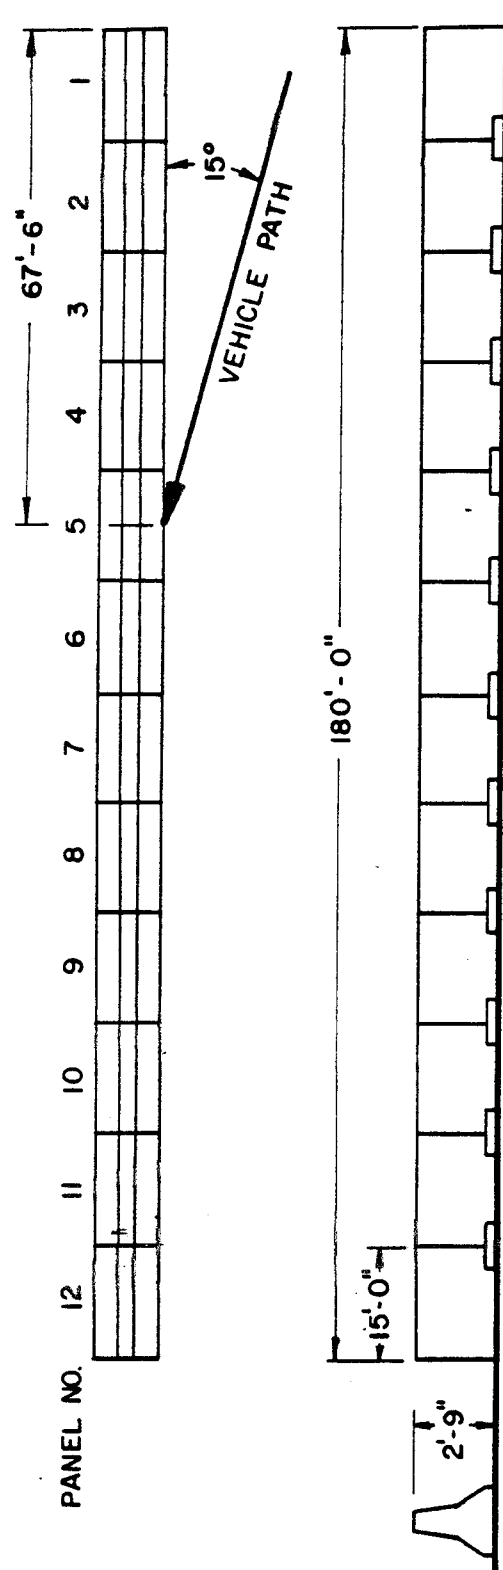
Figure 115. Barrier Installation for Test 3825-8.

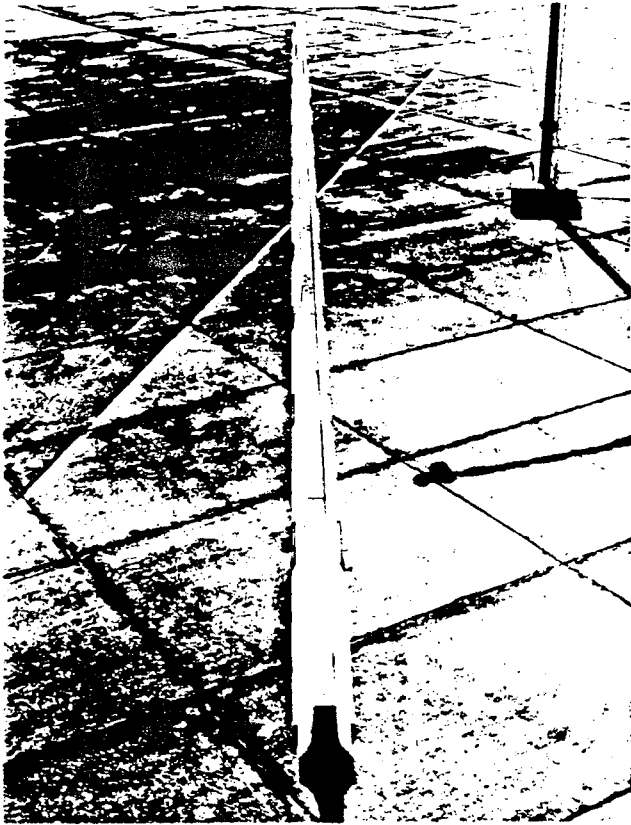
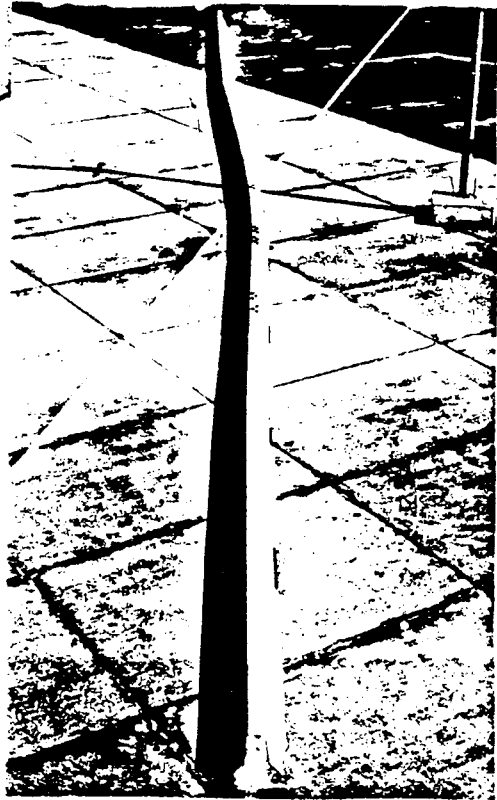
Figure 116. Barrier Before and After Test 3825-8.

In Test 8, a 1970 International Harvester school bus weighing 20,000 lb (9,072 kg) including telemetry equipment, anthropomorphic dummies, and sandbags impacted the barrier at an angle of 15 deg and a speed of 57.7 mph (92.8 km/h). Fully instrumented anthropomorphic dummies were positioned in the driver's seat (Alpha, restrained with a lap belt) and in the right front passenger seat (Beta, unrestrained). Before and after photographs of the barrier, vehicle, and dummies are shown in Figures 116 through 120. Figure 121 summarizes the test results.

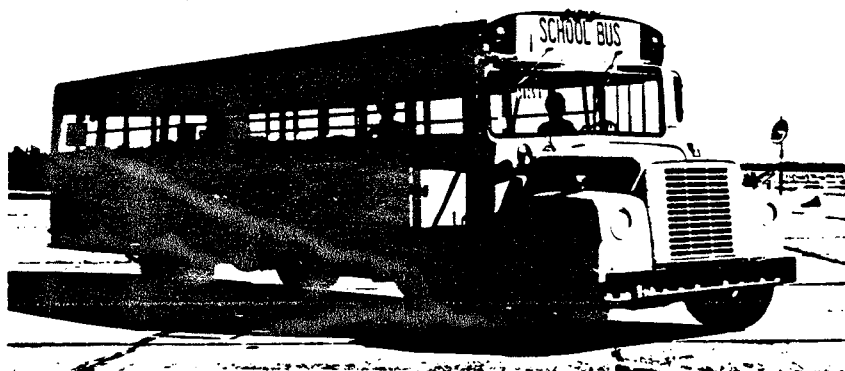
Figure 117. Vehicle Before and After Test 3825-8.

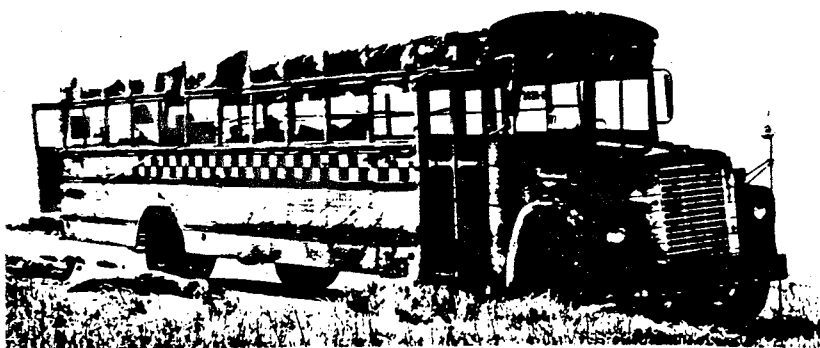
Figure 118. Vehicle After Being Righted.

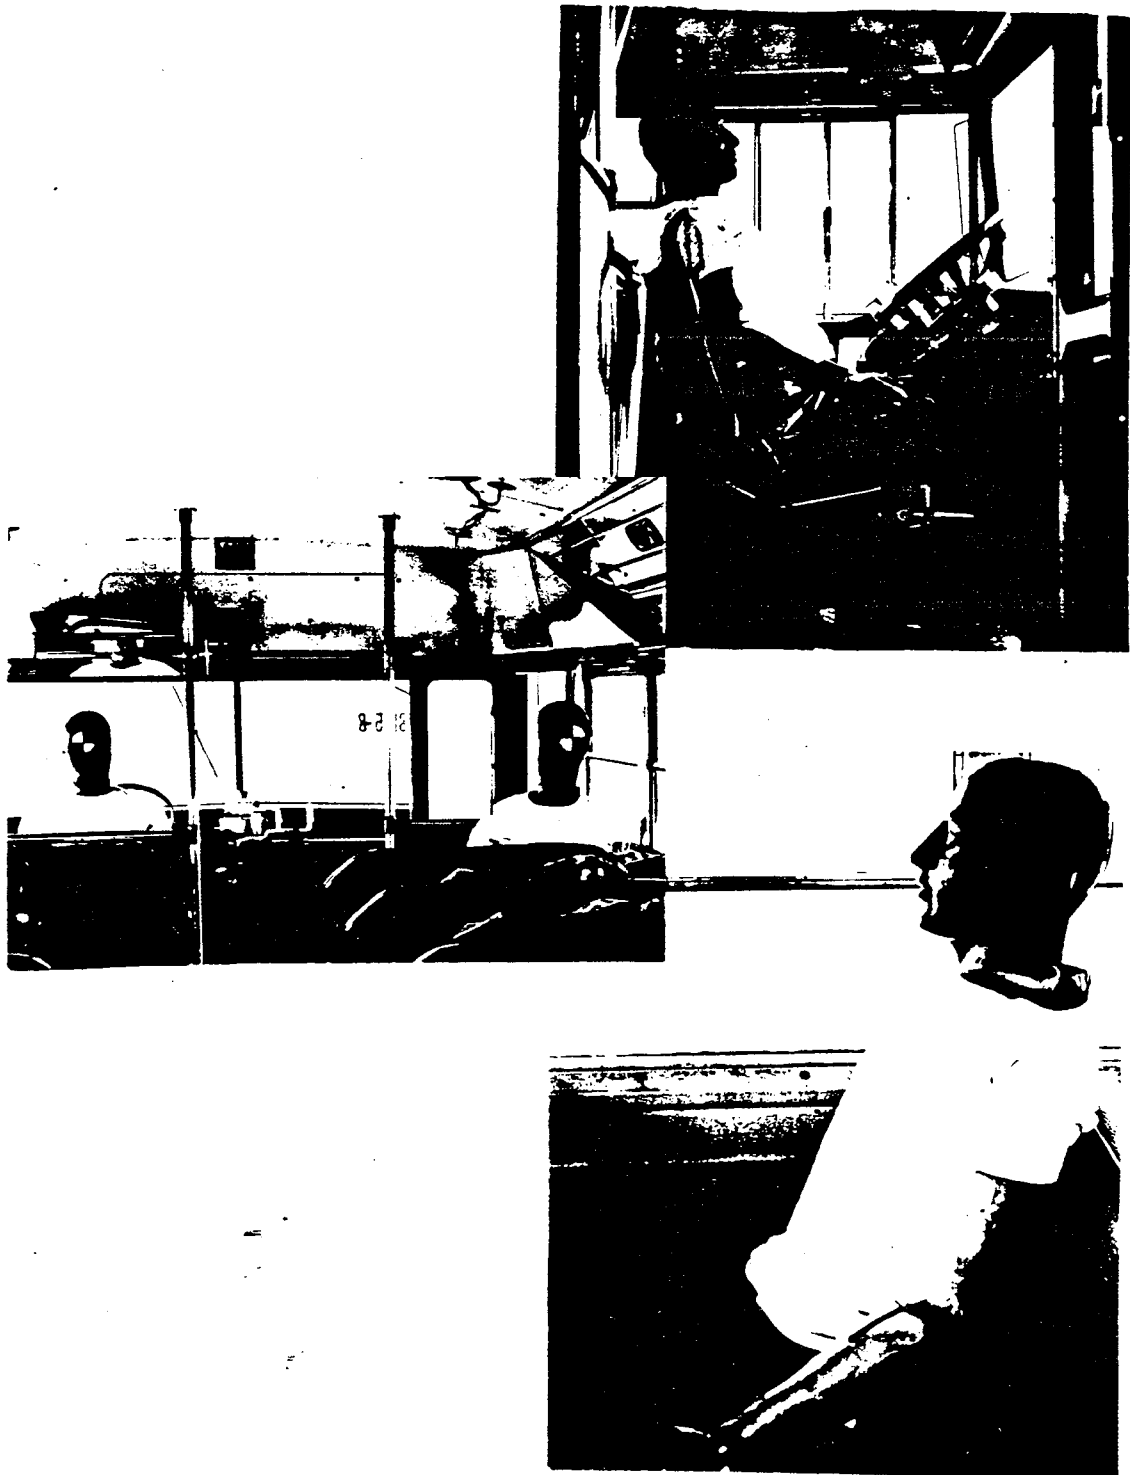
Figure 119. Vehicle Interior and Anthropomorphic Dummy Positions Before Test 3825-8.

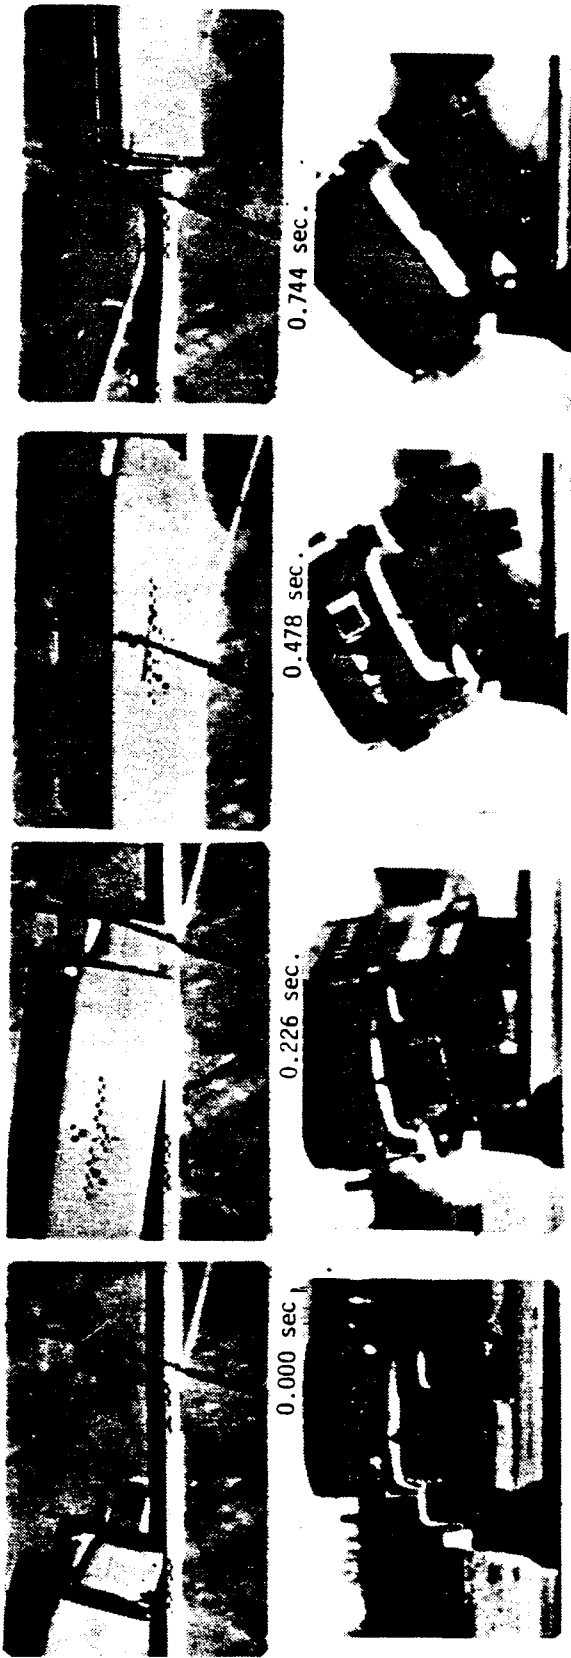
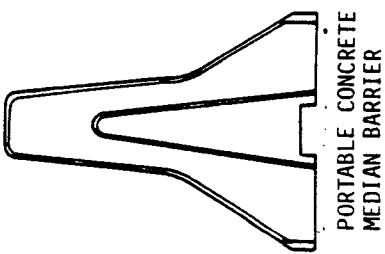
Test No. . . . .	3825-8	Vehicle . . . . .	School Bus
Date . . . . .	4/3/80	Vehicle Weight . . . . .	20,000 lb (9,072 kg)
Barrier . . . . .	Portable Concrete Median Barrier	(w/ dummies & instrumentation)	
Segment . . . . .	Vertical tongue & groove w/C5x9.0 & 1 in. dia. (2.5 cm) steel dowels	Dummy Restraints	Lap Belt
Segment Length . . . . .	15 ft (4.6 m)	Alpha (driver) . . . . .	No Restraint
Length of Installation . . . . .	180 ft (54.9 m)	Beta (passenger) . . . . .	57.7 mph (92.8 km/h)
Beam Rail Deflection		Impact Velocity . . . . .	15 deg
Max. Dynamic . . . . .	1.8 ft (0.6 m)	Exit Angle . . . . .	Bus Rolled
Max. Permanent . . . . .		Vehicle Acceleration (Max. 0.050 sec avg.)	
		Longitudinal . . . . .	-1.1 g
		Transverse . . . . .	5.3 g
		Vertical . . . . .	-1.9 g

Figure 121. Summary of Results for Test 3825-8.

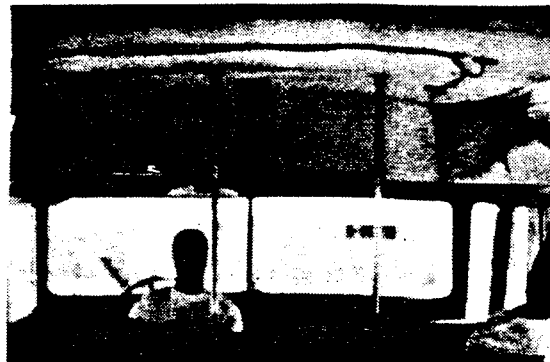
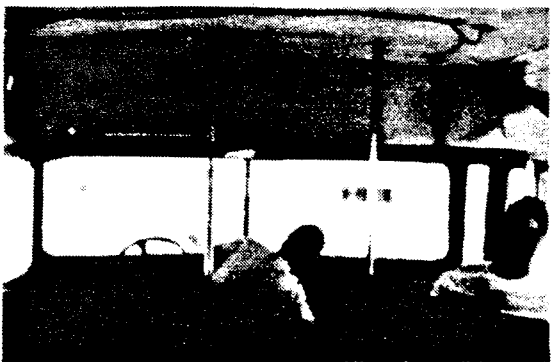
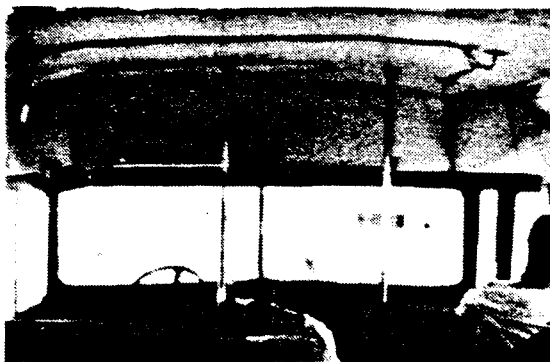
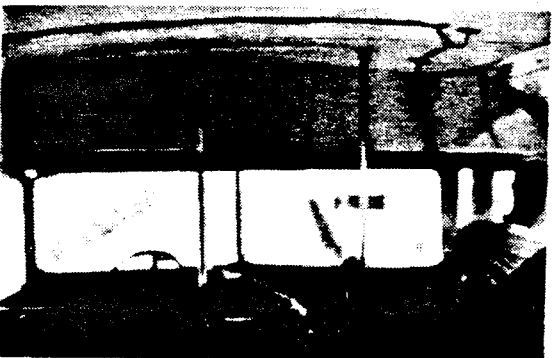
Figure 122. Interior Sequential Photographs for Test 3825-8.

The test is illustrated by interior and exterior sequential photographs in Figures 122 and 123, respectively. Impact occurred 1.2 ft (0.4 m) downstream of joint 4-5 on section 5. The right front wheel impacted initially, and the right fender rode up onto the barrier. The vehicle began to roll while the rear of the vehicle impacted the barrier. The vehicle continued to roll as it slid off of the barrier and came to rest on its side 168.0 ft (51.2 m) beyond the downstream end of the test installation. A time-displacement-event-summary for the vehicle is shown in Table 8, while Table 9 shows one for the dummies.

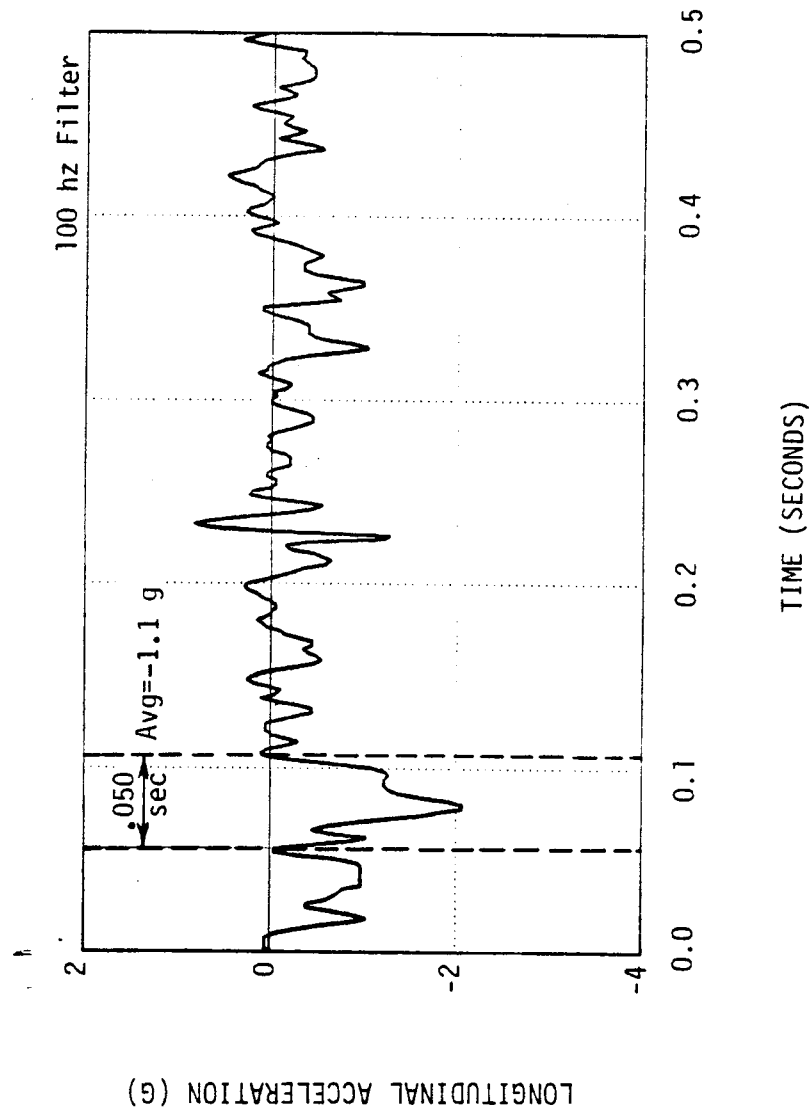
Figure 124. Vehicle Longitudinal Accelerometer Trace for Test 3825-8.

Linear accelerometer traces for the vehicle are presented in Figures 124 through 126. The maximum 0.050 sec average lateral acceleration of 5.3 g compares favorably with the 5 g acceptable limit published in TRC 191 (1). Yaw, pitch and roll are shown in Figures 127 through 129.

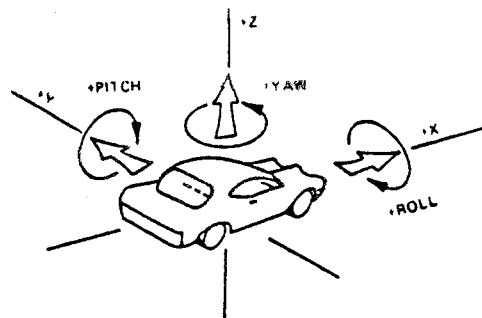
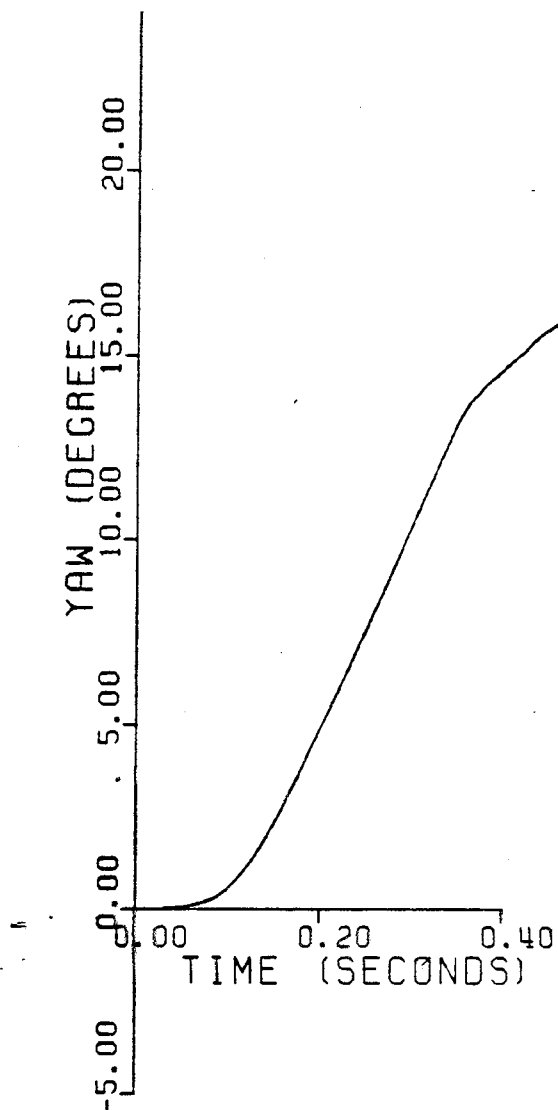
Figure 127. Yaw Verses Time for Test 3825-8.

Axes are vehicle fixed.  
Sequence for determining  
orientation is:

1. Yaw
2. Pitch
3. Roll

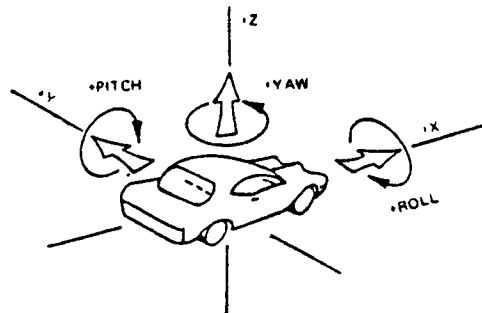
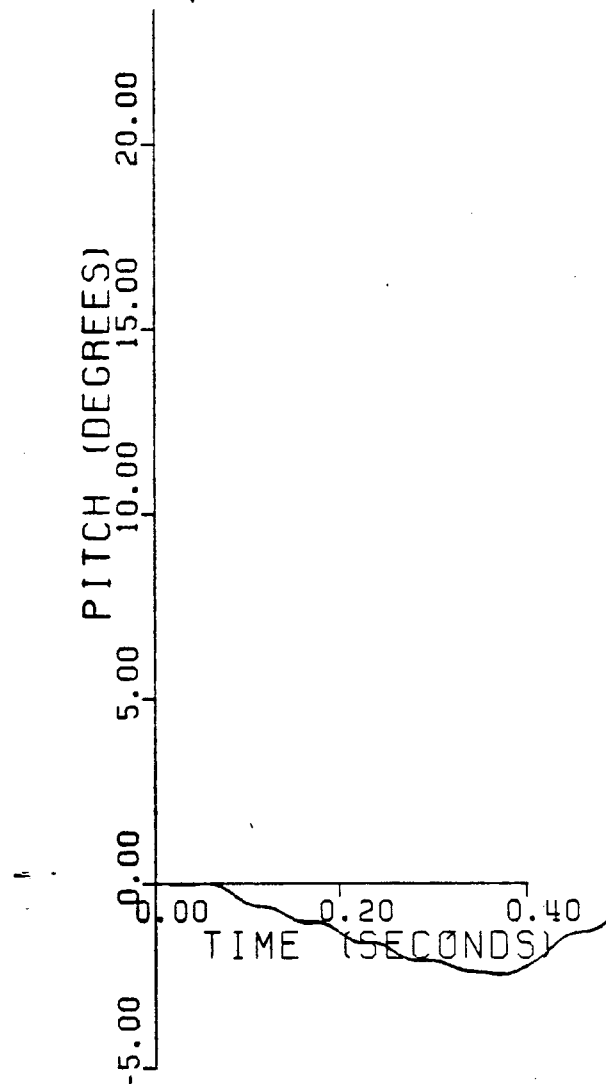
Figure 128. Pitch Verses Time for Test 3825-8.

Axes are vehicle fixed.  
Sequence for determining  
orientation is:

1. Yaw
2. Pitch
3. Roll

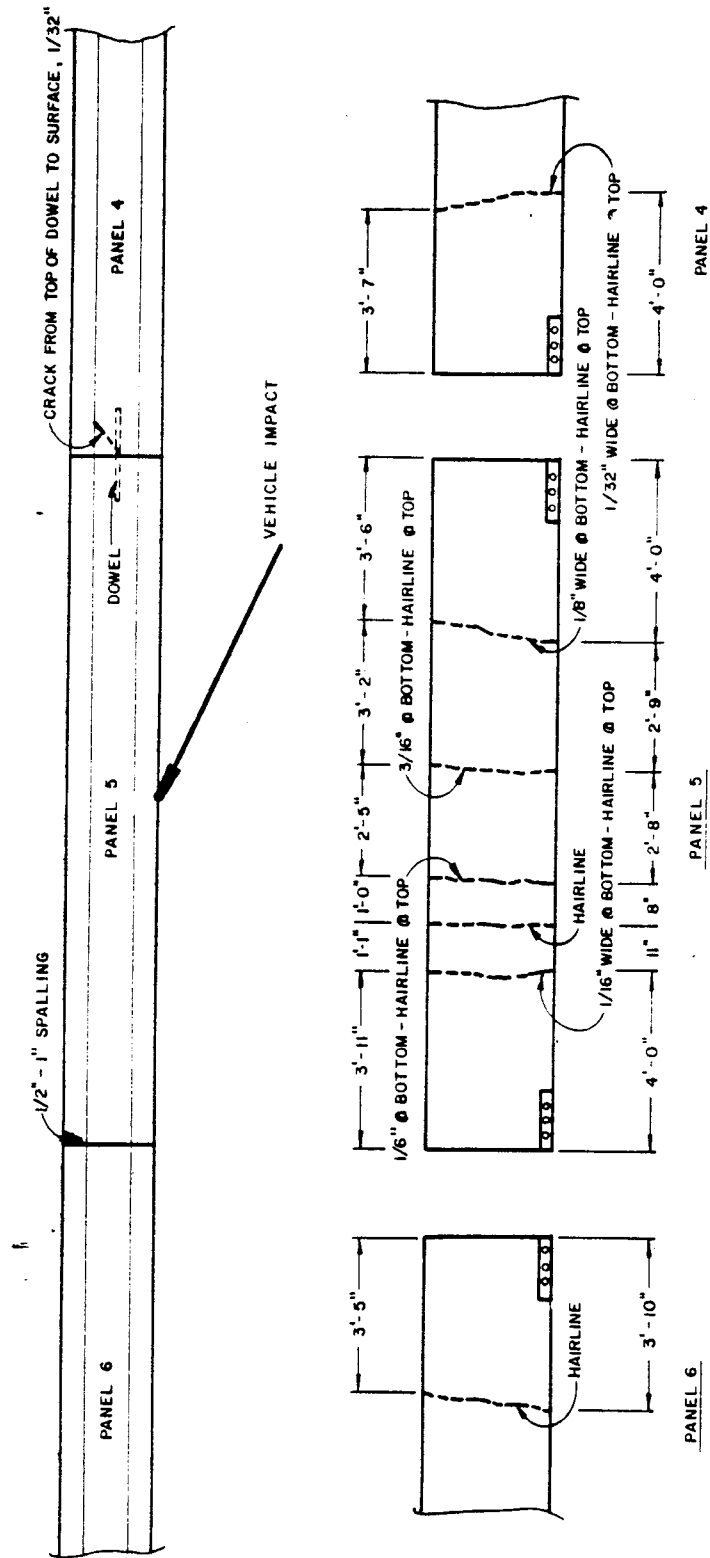
Figure 135. Flexural Cracks After Test 3825-8.

NOTE: IMPACT FACE OF PANEL IS SHOWN, CRACKS ARE ON BACK FACE

The maximum permanent deflection of the barrier was 1.8 ft (0.6 m) and occurred in section 5 adjacent to joint 5-6. Figure 134 illustrates the position of the barrier sections after the test. Damage to the CMB sections principally consisted of flexural cracking on the back faces. Some spalling occurred on the top end of panel 5 adjacent to panel 6. A crack from the top of the dowel in panel 4 (joint 4-5) also formed. Figure 135 shows the damage. Figure 136 through 138 show the joints between panels 3 and 6 before and after the test.

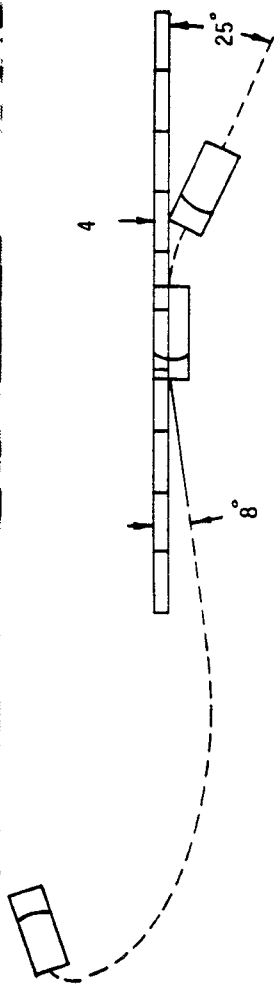
Figure 143. Summary of Results for Test 3825-9.

Portable Concrete  
Median Barrier  
w/ Guard Rail

Test No. . . . .	3825-9	Vehicle . . . . .	1976 Plymouth Fury
Date . . . . .	7/17/80	Vehicle Weight. . . . .	4,510 lb (2,046 kg)
Barrier. . . . .	Portable Concrete	Impact Speed. . . . .	63.4 mph (102.0 km/h)
Segment. . . . .	Median w/ Rail	Impact Angle. . . . .	25 deg
	Vertical Tongue &	Exit Angle. . . . .	8 deg
	Groove w/ .32 cm	Vehicle Acceleration	
	thick side plates	(Max. 0.050 sec avg.)	
Segment Length . . . . .	12 ft (3.7 m)	Longitudinal (rt & lt avg.)	-8.8 g
Length of Installation . . . . .	120 ft (36.7 m)	Transverse. . . . .	9.9 g
Barrier Deflection		Vertical. . . . .	-2.2 g
Max. Dynamic . . . . .	6.5 ft (2.0 m)	Vehicle Damage	
Max. Permanent . . . . .	6.5 ft (2.0 m)	TAD . . . . .	OIRFQ6
		SAE . . . . .	OIFREW9

In Test 9, a 1976 Plymouth Fury, weighing 4,510 lb (2,046 kg) including all telemetry equipment, impacted the barrier at a speed of 63.4 mph (102.0 km/h) and an angle of 25 deg. Photographs of the vehicle and barrier before and after Test 9 are shown in Figures 141 and 142, respectively. A summary of test results is presented in Figure 143 and sequential photographs are shown in Figure 144. Table 10 lists time and displacement as related to specific events.

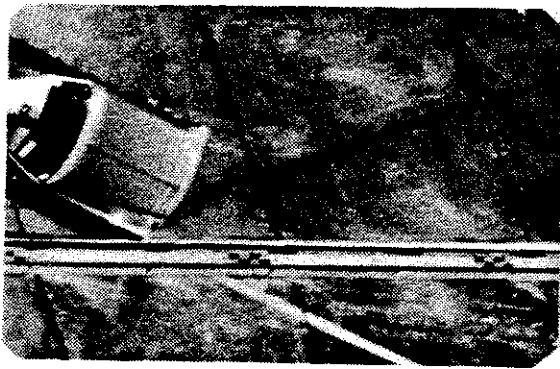
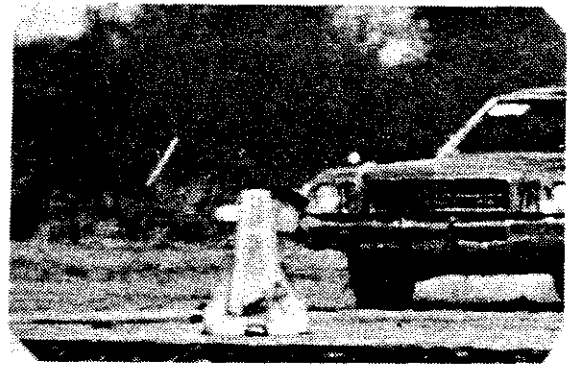
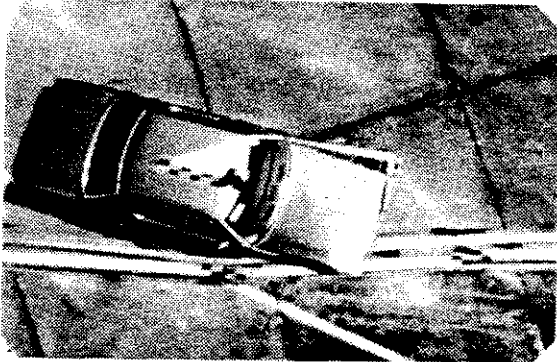
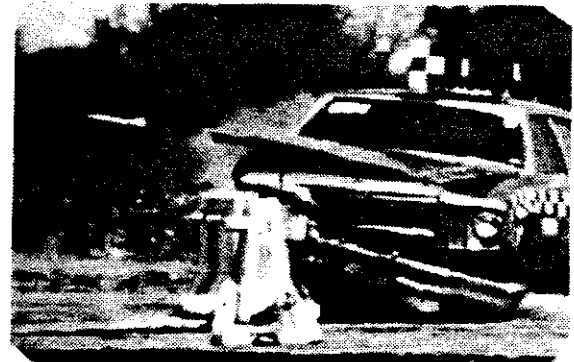
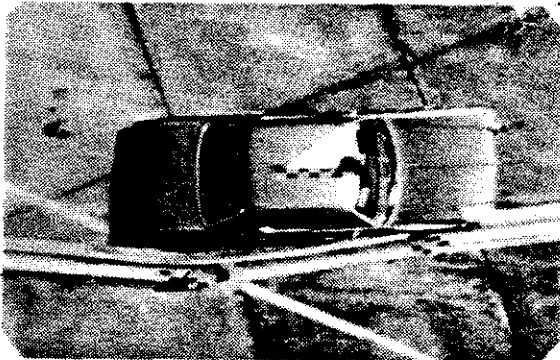
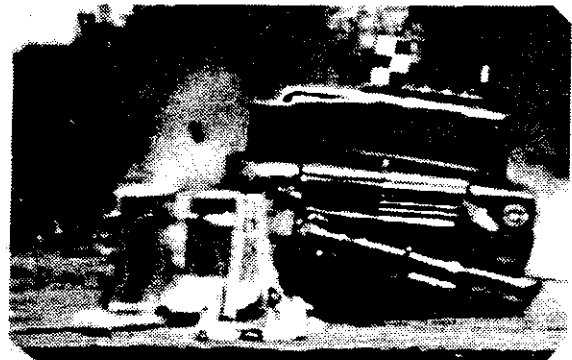
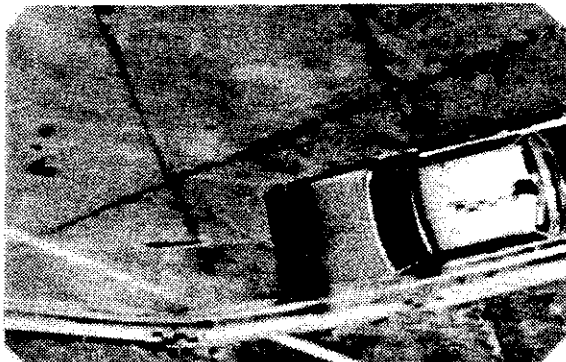
Figure 144. Sequential Photographs for Test 3825-9.

0.000 sec

0.138 sec

0.245 sec

0.377 sec

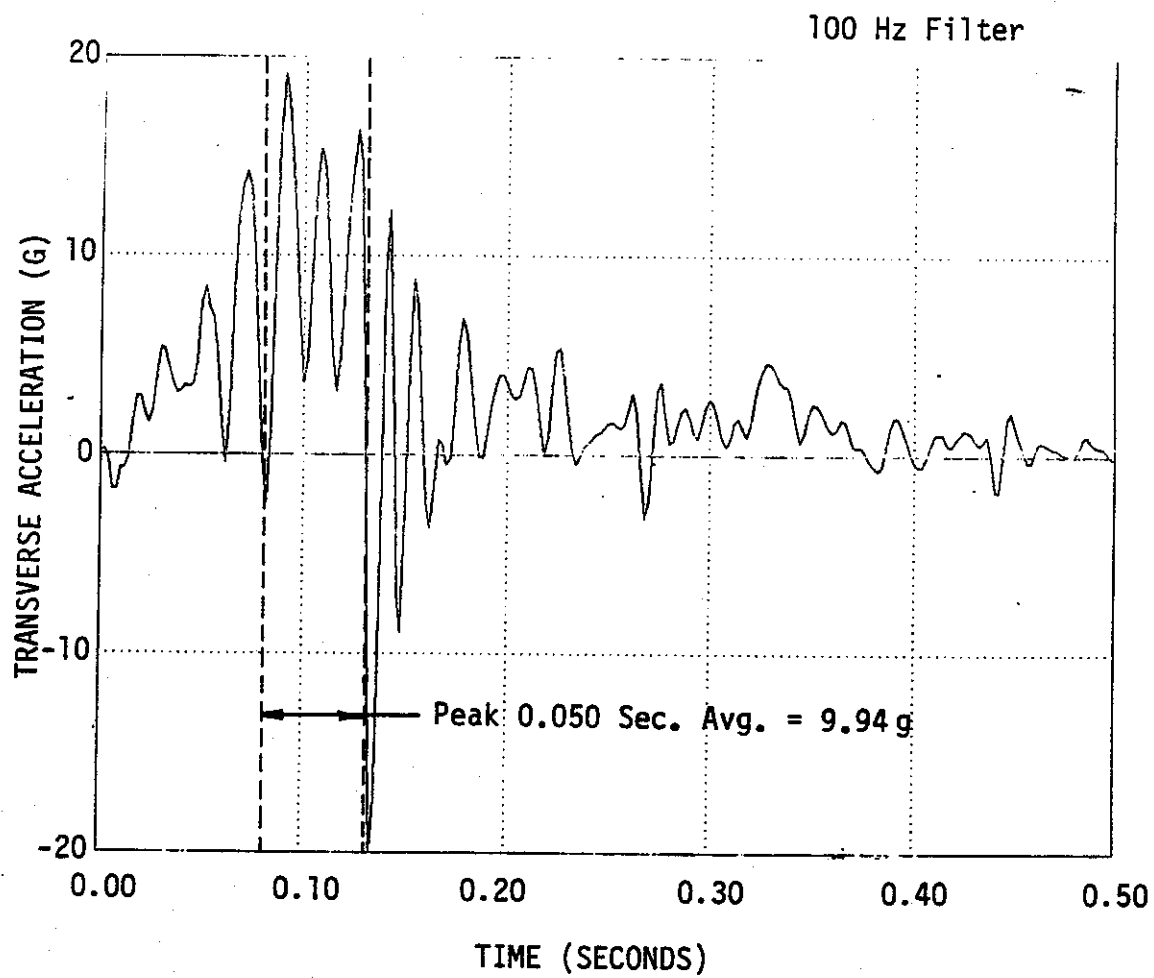
Figure 146. Vehicle Transverse Accelerometer Trace for Test 3825-9.

Linear accelerometer traces are shown in Figures 145 through 147. The maximum 0.050 sec average longitudinal and transverse accelerations were -8.8 g and 9.9 g, respectively. The permanent barrier deflection is
