# BARRIERS IN CONSTRUCTION ZONES

## VOLUME 2

**Report No.**  
**FHWA/RD-86/093**

**VOLUME 2: Appendix A  
Full-Scale Crash Tests**

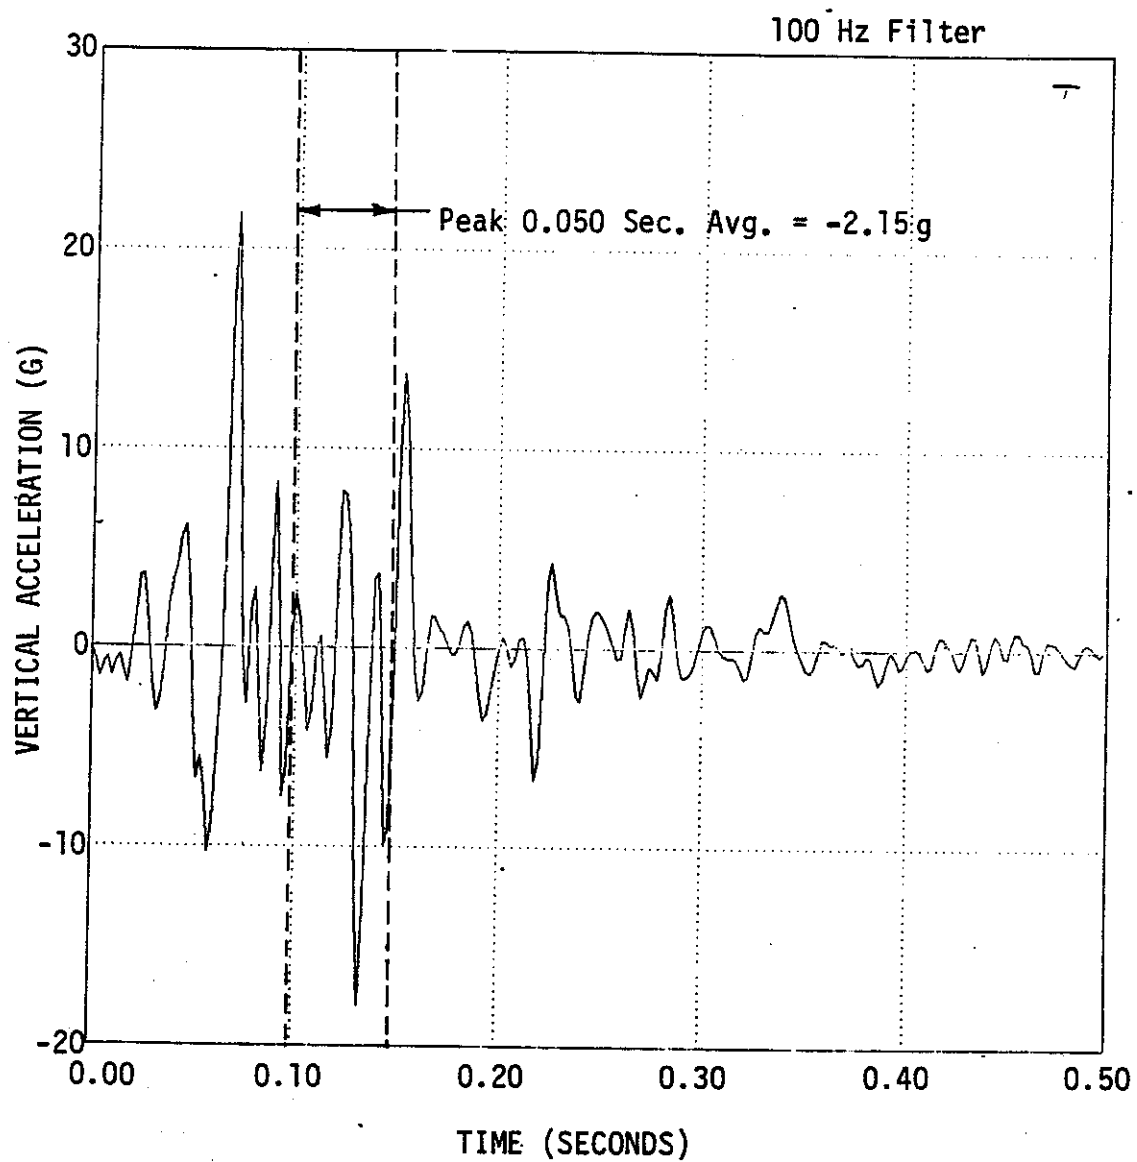
Figure 147. Vehicle Vertical Accelerometer Trace for Test 3825-9.

Linear accelerometer traces are shown in Figures 145 through 147. The maximum 0.050 sec average longitudinal and transverse accelerations were -8.8 g and 9.9 g, respectively. The permanent barrier deflection is

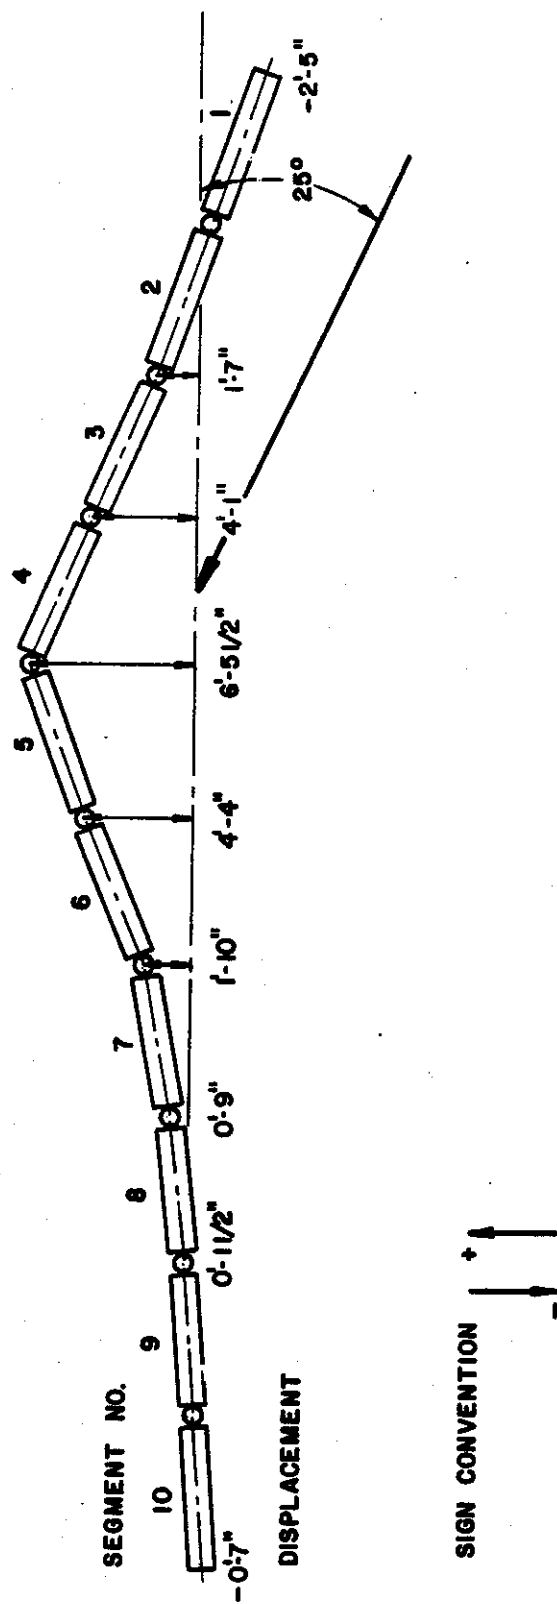
Figure 148. Permanent Barrier Deflection After Test 3825-9.

shown in Figure 148. Damage to the CMB sections was significant with the most severe damage occurring at joint 4-5 (see Figure 149). This was due to the large deflection causing large rotation of the tongue and groove joints. The 1/8 in. (0.32 cm) base plates were broken at joints 4-5, 5-6 and 6-7.

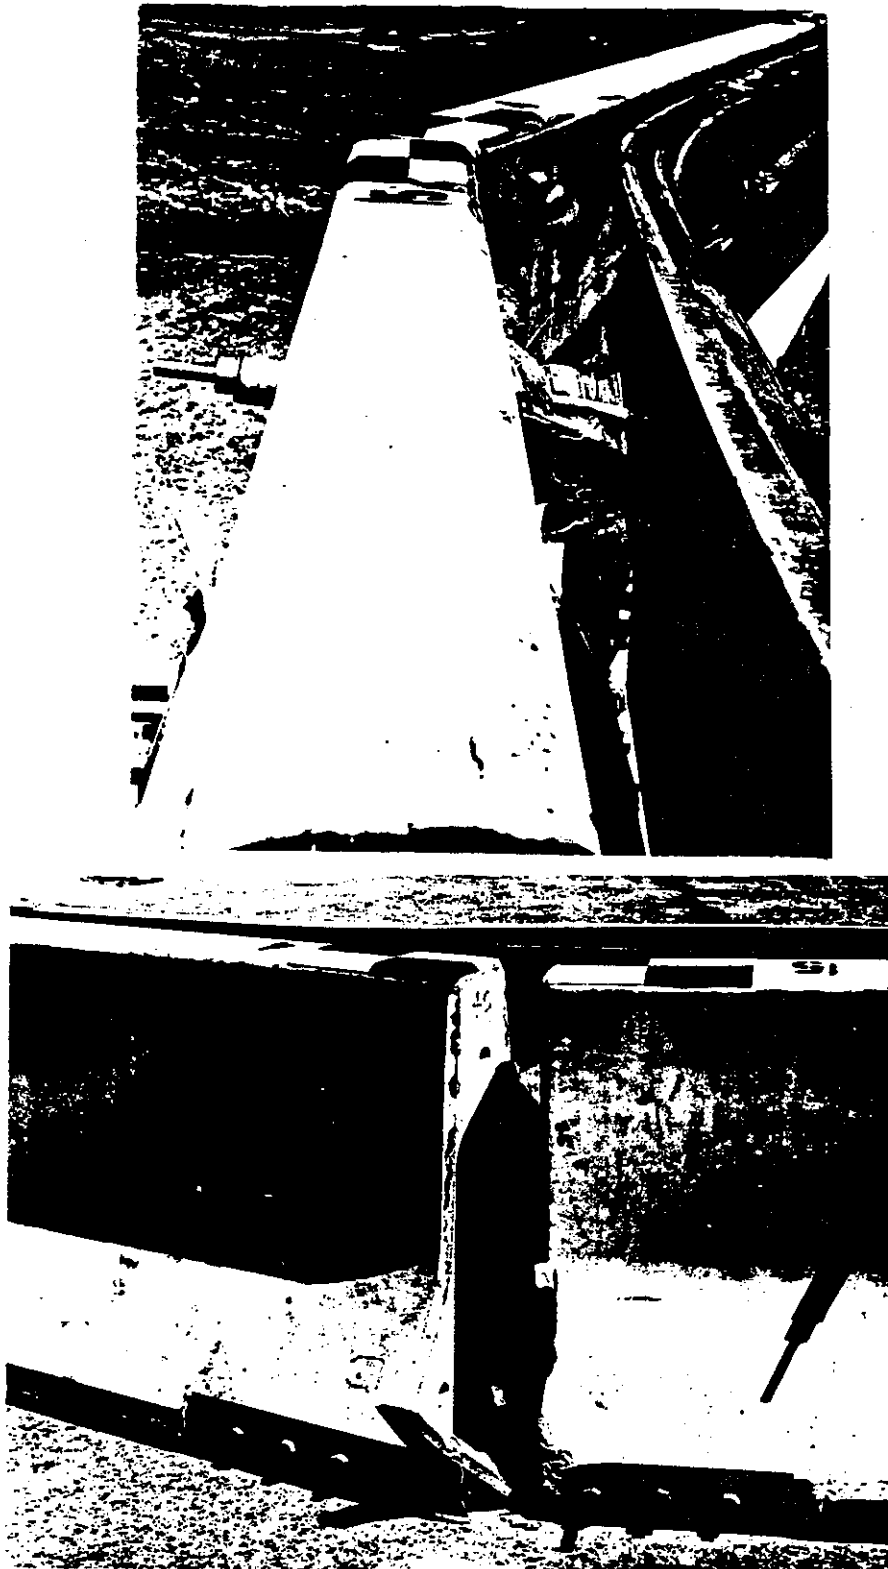
Figure 149. Damage to Joint 4-5 After Test 3825-9.
