HYA/RD-81/007

# STUDY OF PILE GROUP ACTION

Appendix E

1. Report No. FHWA/RD-81/007		2. Government Accession No. NA 22101		3. Recipient's Catalog No.	
4. Title and Subtitle FIELD STUDY OF PILE GROUP ACTION Appendix E: Evaluation of Instrumentation.		5. Report Date October 1980		6. Performing Organization Code

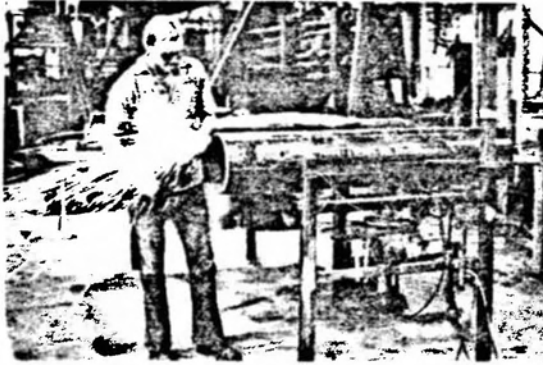
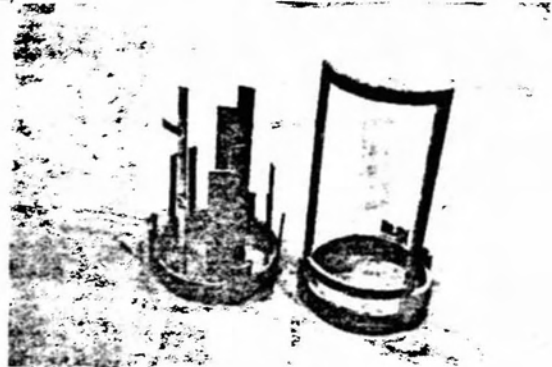
FIGURE E2. PREPARATION OF PILE SEGMENTS  
E6

a. Facing segment end

b. Marking instrument locations

c. Cleaning interior of segment

d. Instrumentation templates

- 1) The segment was placed on variable-speed driven rollers that rotated the section at approximately ten revolutions per minute. While the section was rotating, the inside was sanded with a rotary sander and the ends were beveled with a 1/8 inch (3 mm) flat area on each end. The squareness of the ends was checked, and the ends were reground if there were any high spots. The precise length of each segment was then noted so that overlength or underlength segments could be compensated for on succeeding segments on a given pile.

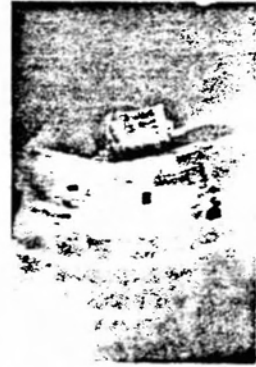
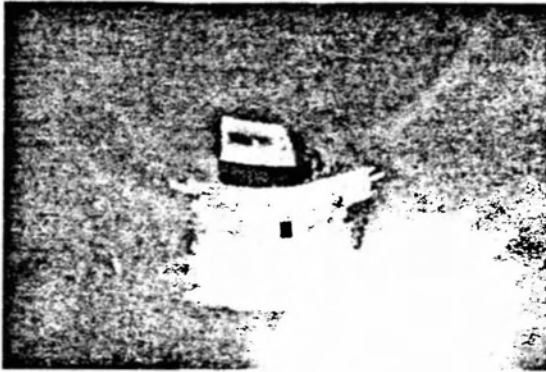
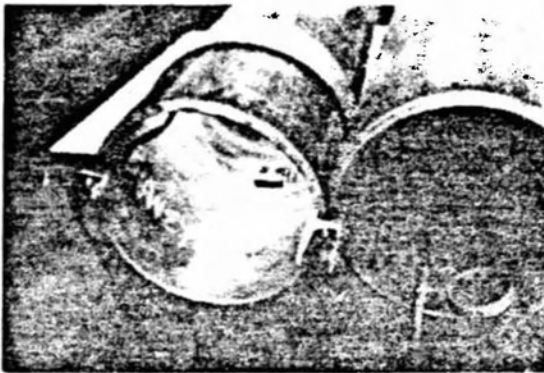
a. Dummy tab in place;  
active gage location  
marked

b. Active gage  
epoxied into  
place

c. Active and dummy gages  
wired to barrier

d. Dummy gage on tab

e. Heat curing of gages with  
band heater

FIGURE E4. VARIOUS STEPS IN PLACING STRAIN GAGES

- 1) The steel (tab or pile wall) was sanded to a smooth finish using a high-speed rotary sanding disk.
- 2) The steel was then sanded with 320 grit silicon carbide strips saturated with Bean Metal Conditioner.

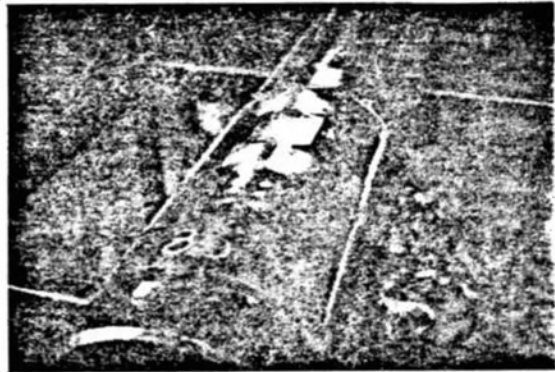
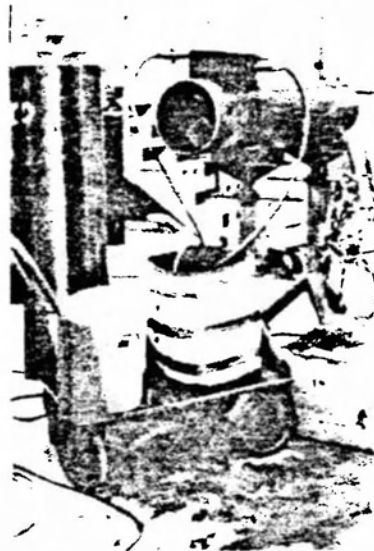
a. Pressure cell prior to attachment and tack welded into pile segment

b. Top view of cell fitted into pile segment

c. Welding of cell into segment

d. Water bath used to cool cell during welding

FIGURE E5. LATERAL PRESSURE CELL INSTALLATION  
E11

- 1) A coupon was cut out of the appropriate position (previously marked with a template) from a pile segment.
- 2) The cell was placed into the cut-out and was tack-welded in according to best fit. The supplier had welded stiffeners to strengthen the cells behind the backing plates in such a way that the plates were slightly warped in a concave fashion. To insure that the piezometer and total pressure cell faces would be flush against the soil after installation, it was decided to rotate the top edge of the plate outward about 0.2 inches (5 mm) to fit the cells so that the total pressure cell plate would be flush with, or would protrude slightly from, the general pile surface. Pressure cells 5, 14, and 20, on Piles 4 and 5, were installed in this manner, but this method proved to be unsatisfactory in general because the cell dimensions varied enough that a structurally sufficient weld could not be laid on the top edge of all the cells. It was decided, therefore, to use a standard fit for the remainder of the cells as follows: the top of the cell projected outside the pile by 1/8 inch (3 mm) and the bottom of the cell was flush with the outside of the pile.

- 3) Each cell was then welded into place all around its perimeter in two or three passes with an M.I.G. welder. (It was kept cooled by the chilled water vessel mentioned earlier.)

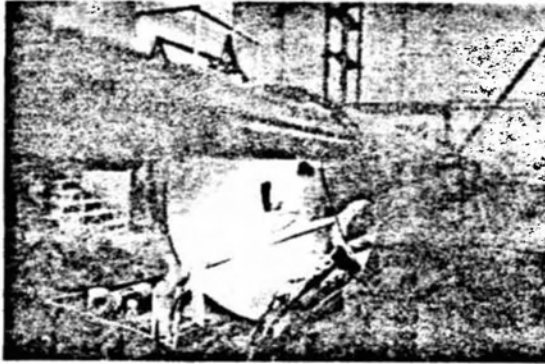
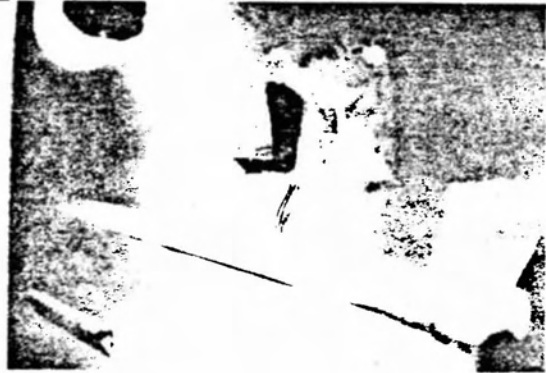
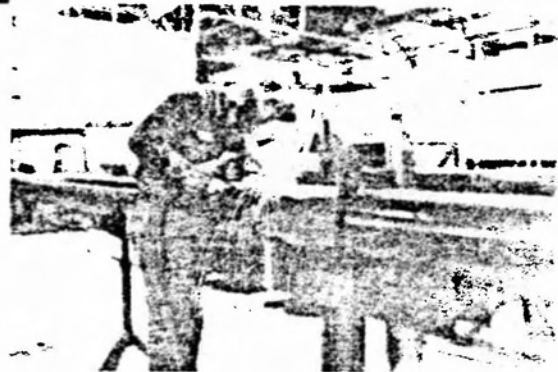
a. Ribbon cable wires ready for attachment to barrier terminal. LPC tubing and extensometer tube also visible

b. Ribbon cable wires attached to barrier terminal before final waterproofing

c. Hot-melt bonding of lead wire to pile wall and checking bridge continuity

d. Welding pile segments together

FIGURE E10. PILE ASSEMBLY

- 1) The area [a 3-inch (76 mm) wide strip] where the ribbon cable would be laid was cleaned by hand sanding and then wiped clean with acetone and tissue.
- 2) Two sections (beginning at the bottom, Segments I and J) were aligned on a heavy H-beam using the punch marks previously placed upon disassembly, and were then welded together.
- 3) The ribbon cable was pulled through toward the top of the pile, the strain gages wired, and the wiring then water-proofed with Epoxy Patch. Individual strain gages for dynamic response were then placed at appropriate levels, and their leads were brought up in a bundle with the pressure cell tubing.
- 4) Heater bands were placed on the two sections and heated to approximately 75°C to melt the hot melt compound, and the ribbon cable was then secured to the pile using a roller. (The wire was not fastened for 6 inches (150 mm) on either

- 5) Succeeding segments were aligned and welded, and gages were completed in a like manner.
- 6) The inclinometer tubing was welded into each section using a 6-inch (150 mm) weld on each side every 5 feet (1.5 m) (top end of each segment) rather than the 4-inch (10 cm) weld that failed on the short test pile.
- 7) The output of every strain gage bridge was checked with a strain indicator after each new segment was welded into place.

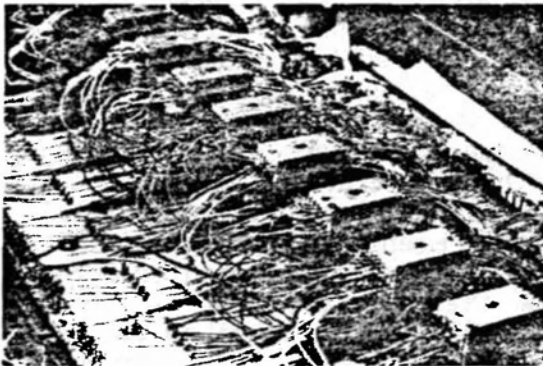
a. View of calibration device

b. Patchboard

c. Gold contact electrical switches

FIGURE E12. PHOTOGRAPHIC VIEWS OF CALIBRATION DEVICE AND PATCHBOARD

Immediately after the driving of the piles, considerable scatter occurred in the strain gage readings, making it difficult to assess exact patterns of residual stresses. It is believed that this scatter was due to the lack of opportunity to stabilize temperatures in the electrical patch board described earlier (which also contained balancing wire whose resistance was sensitive to temperature). The patchboard, through which the readout system was attached to the strain gages,
