1. Report No. FHWA/TX-01/1792-4		2. Government Accession No.		3. Recipient's Catalog No.	
4. Title and Subtitle TESTING AND EVALUATION OF THE SOLAR PANEL SIGN SUPPORT SYSTEM				5. Report Date January 2001

14. Sponsoring Agency Code	
15. Supplementary Notes Research performed in cooperation with the Texas Department of Transportation and the U.S. Department of Transportation, Federal Highway Administration. Research Project Title: Roadside Safety Hardware for Traffic Control Devices

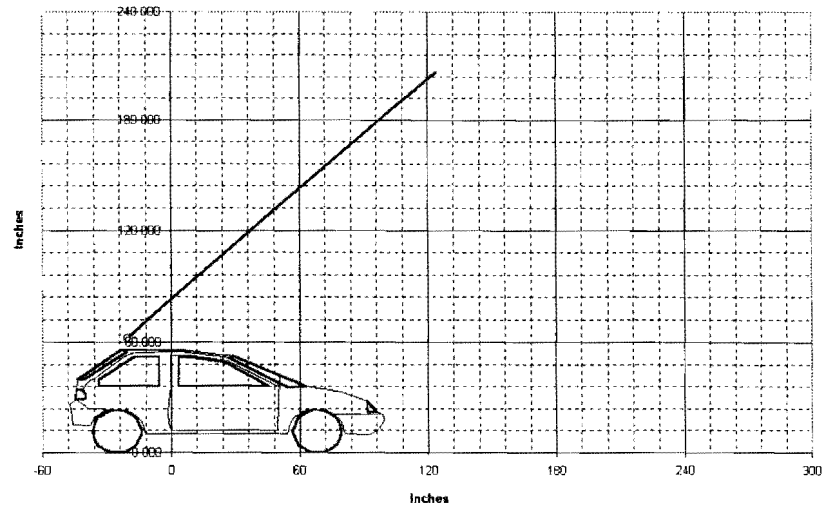
Figure 1. Simulation Results for Dual Beacon at 21.7 mi/h (35 km/h).

It was determined that the most effective method for determining the point of impact of the sign support on the vehicle was to present the results of the analysis graphically, as shown in Figures 1 through 4. Coordinates from a Geo Metro (which is currently the most common small car test vehicle) were used to create a vehicle side profile. The positions of the vehicle and support post were then tracked to the point of impact.

The analytical methodology was validated by comparing predicted outcomes from the model with results measured from previous full-scale crash tests. High-speed film from tests was used to determine various time-event data that could be compared to the model. Images were also captured from the high-speed film at the time of secondary impact with the support post to assist in the validation effort. The correlation obtained between the model and full-scale crash tests was considered satisfactory to proceed with the parametric investigation. The model predicted the installation, as proposed and shown in Figure 5, would perform satisfactorily when impacted by the 820 kg (1806 lb) passenger car at 35 km/h (21.7 mi/h) and 100 km/h (62.1 mi/h).

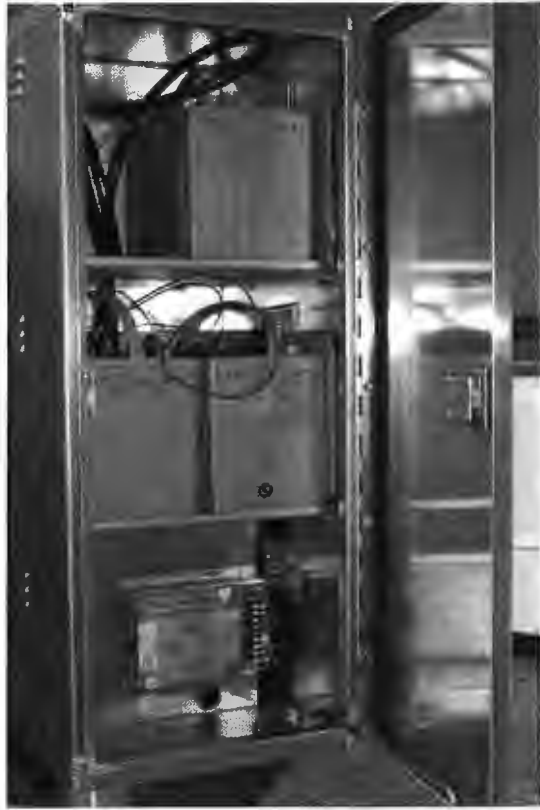
**Figure 7. Power Unit Used for Tests 417920-3 and 417920-4.**

A pedestal base sign installation equipped with photovoltaic equipment was attached to the ground with a helical type screw-in foundation anchor assembly. This installation was constructed for crash testing and evaluation. The installation was fabricated using a Pelco (model SP 1014 TX) square-cast aluminum traffic signal base with a 114 mm (4.5 in) outside diameter × 3.96 m (13 ft) long spun aluminum pole. A 16 mm × 1.2 m × 1.2 m (0.625 in × 48 in × 48 in) plywood warning sign was attached to the pole at a mounting height of 2.1 m (7.0 ft). In addition, a 305 mm (12.0 in) LED lamp, flashing yellow signal beacon was mounted directly above the sign panel. A 1429 mm × 654 mm × 89 mm (56.3 in × 25.7 in × 3.5 in) solar panel weighing 235.8 N (53 lb) was attached atop the support. The battery cabinet for the panel was mounted behind the sign panel at a height of 2.7 m and weighed 520.4 N (117 lb). The helical type screw-in foundation anchor assembly (model no. PB 5306) was placed in *NCHRP Report 350* standard soil using an auger truck. Detailed drawings of the test installation are shown in Figure 5. The system was constructed identically for each test. Photographs of the test installations are shown in Figures 6 through 8.

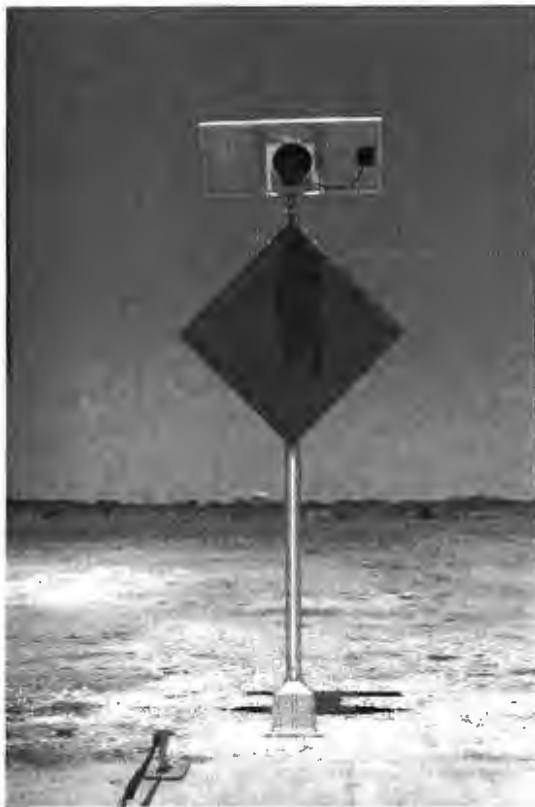
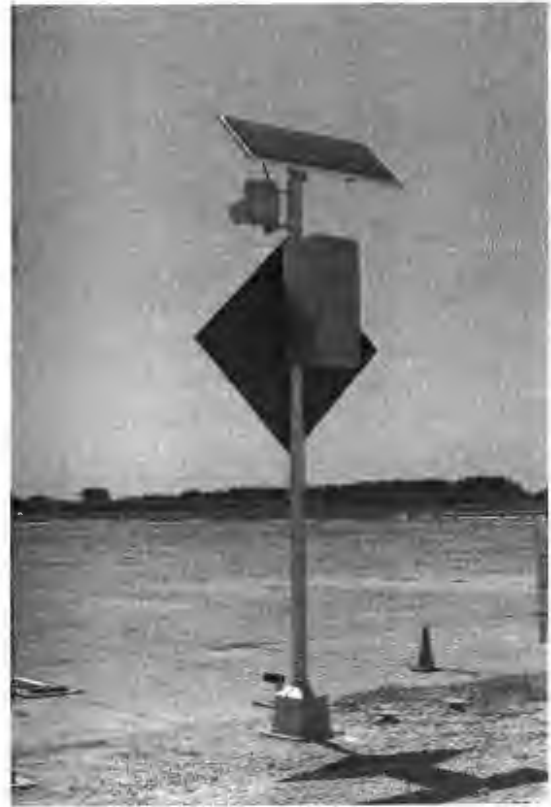
**Figure 8. Pedestal Base Sign Support before Test 417920-4.**

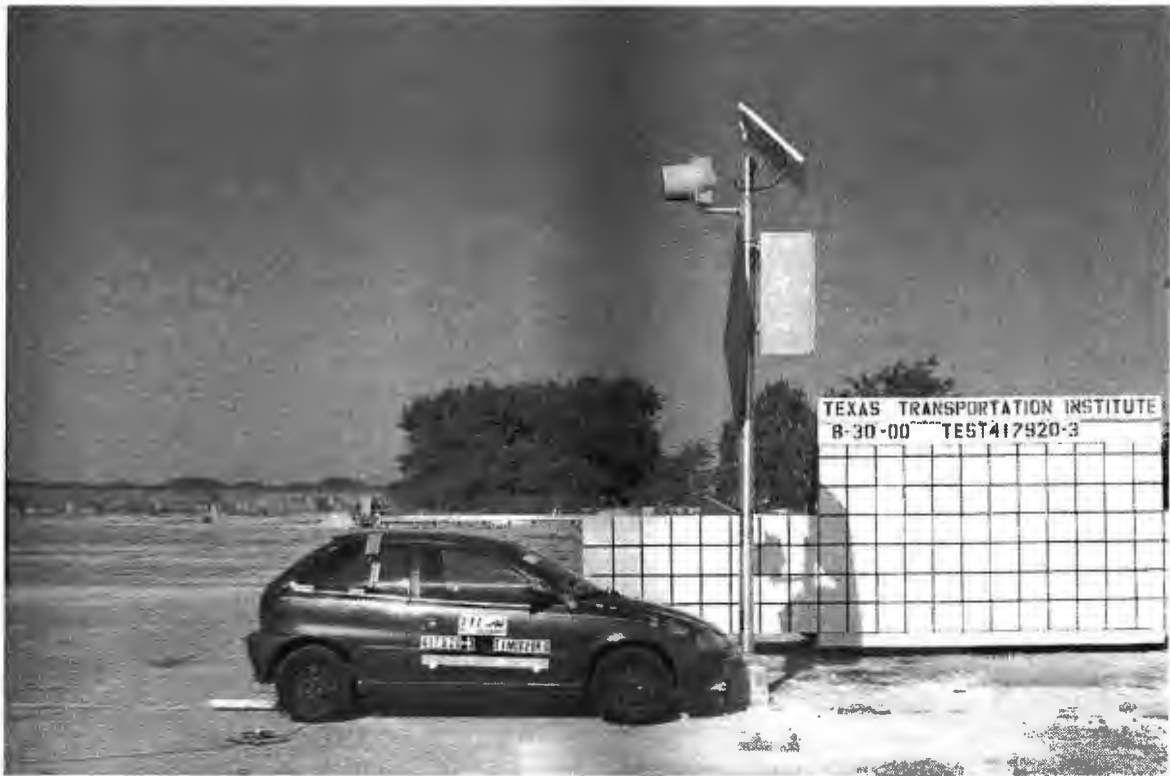
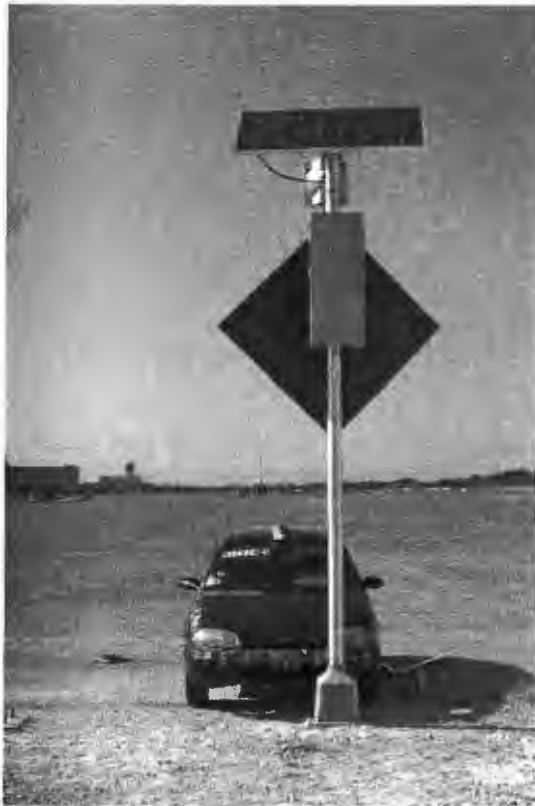
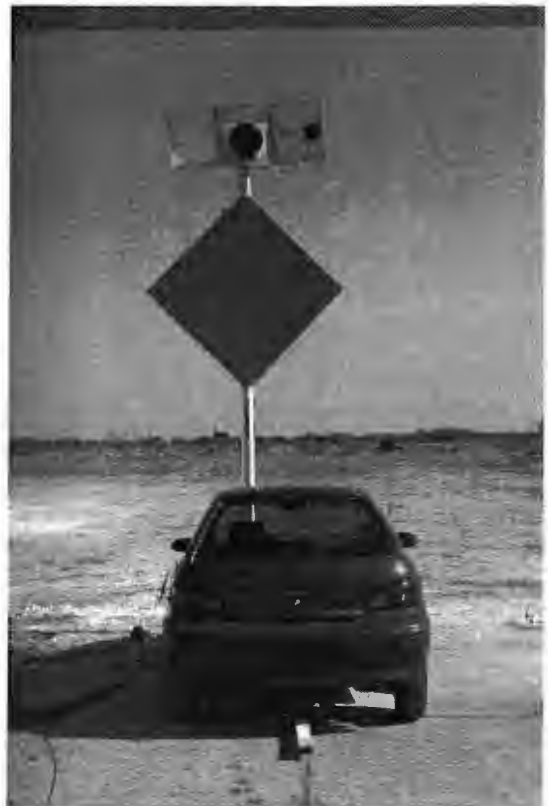
**Figure 9. Vehicle/Installation Geometrics for Test 417920-3.**

The 820 kg (1806 lb) vehicle, traveling at 35.6 km/h (22.1 mi/h), contacted the solar powered sign support system with the left quarter point of the bumper. Shortly after contact the sign support system began to move and at 0.034 s the vehicle began to rotate slightly counterclockwise. The pedestal base fractured near ground level at 0.076 s, and the vehicle continued moving forward as the sign support system rotated upward in front of the vehicle. At 0.287 s, the vehicle lost contact with the sign support system and was traveling at a speed of 20.1 km/h (12.5 mi/h). The sign support system continued upward and over the roof of the vehicle. The flashing signal beacon on the sign support system contacted the rear hatch window at 0.688 s, and the sign panel contacted the roof at 0.707 s. While still in contact with the rear hatch of the vehicle, the sign support system became parallel with the ground at 0.760 s. The vehicle lost contact with the sign support system at 2.086 s. Brakes on the vehicle were applied shortly after loss of contact, and the vehicle subsequently came to rest 19.1 m (62.7 ft) behind the point of impact. Sequential photographs of the test can be found in Appendix C, Figure 25.

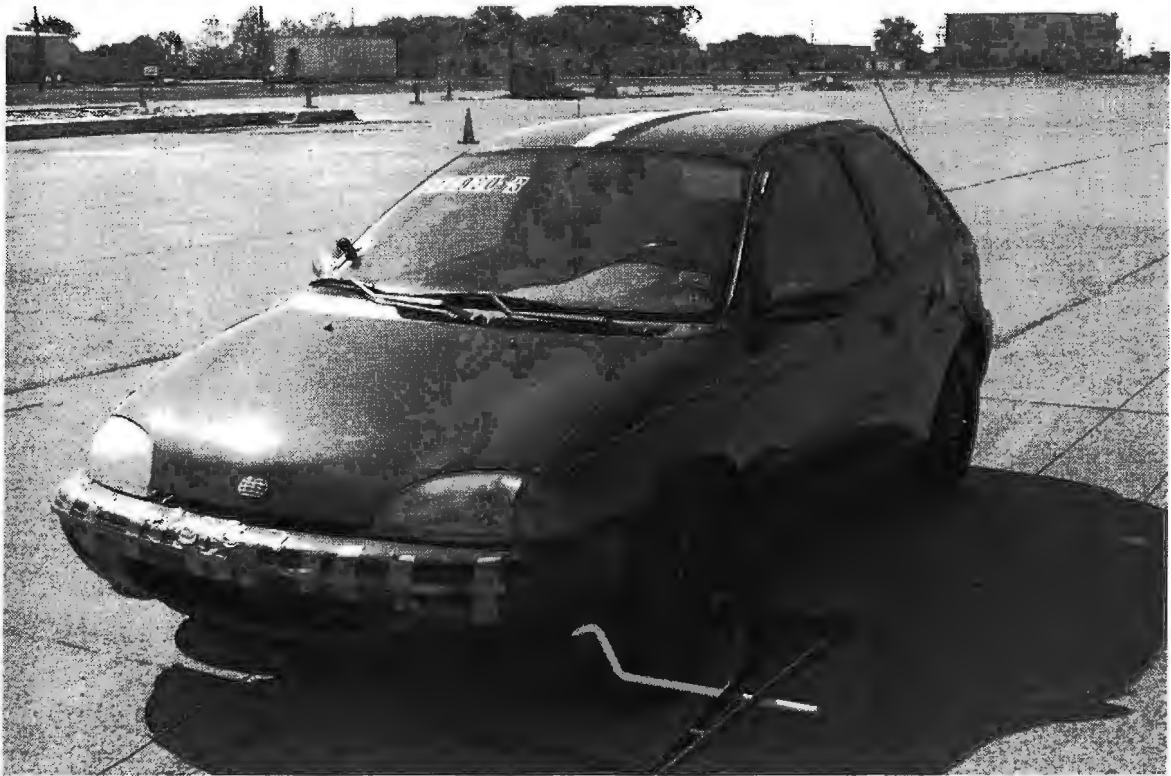
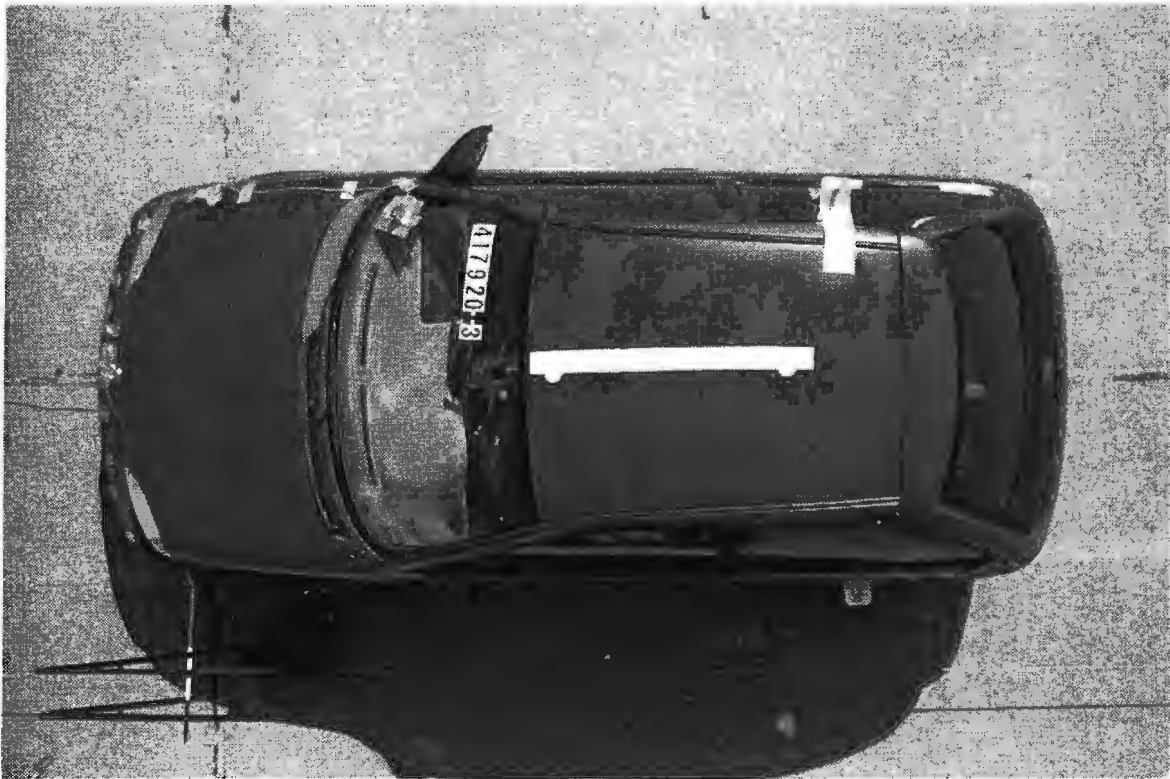
**Figure 10. Vehicle before Test 417920-3.**

The crash test used a 1995 Geo Metro, shown in Figures 9 and 10. Test inertia weight of the vehicle was 820 kg (1806 lb), and its gross static weight was 896 kg (1974 lb). The height to the lower edge of the vehicle bumper was 400 mm (15.7 in), and it was 525 mm (20.7 in) to the upper edge of the bumper. Additional dimensions and information on the vehicle are given in Appendix B, Figure 23. The vehicle was directed into the installation using the cable reverse tow and guidance system, and was released to be free-wheeling and unrestrained just prior to impact.

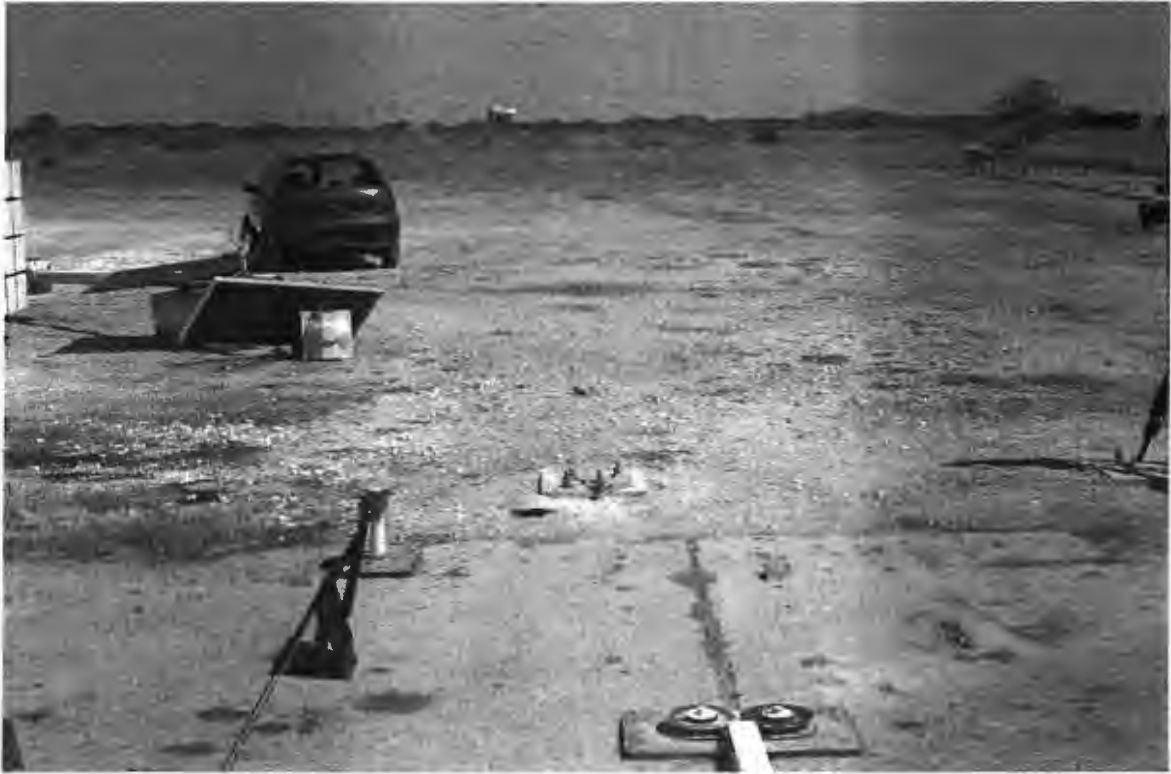
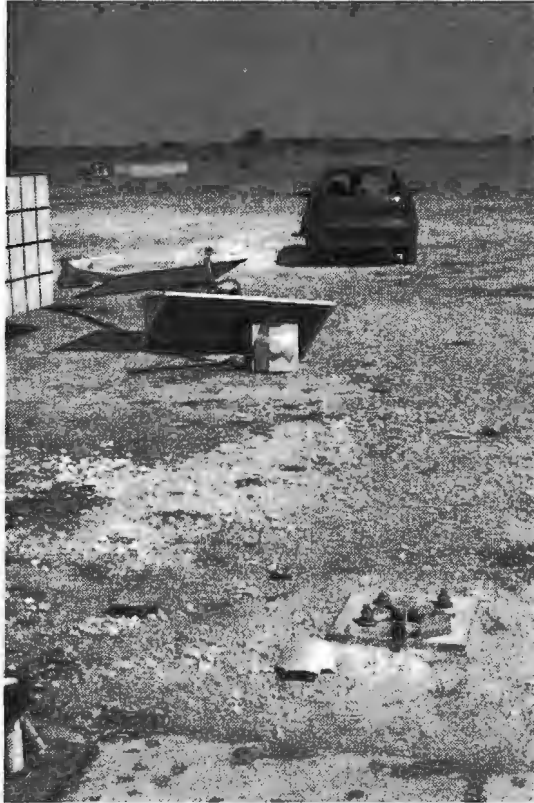
**Figure 11. After Impact Trajectory for Test 417920-3.**

Damage to the test installation is shown in Figures 11 and 12. The solar panel sign support system readily yielded to the vehicle by fracturing at the pedestal base. Test procedures fractured the base and broke the flashing signal beacon unit, but the rest of the unit remained usable. The sign system came to rest 7.0 m (23.0 ft) behind the point of contact.

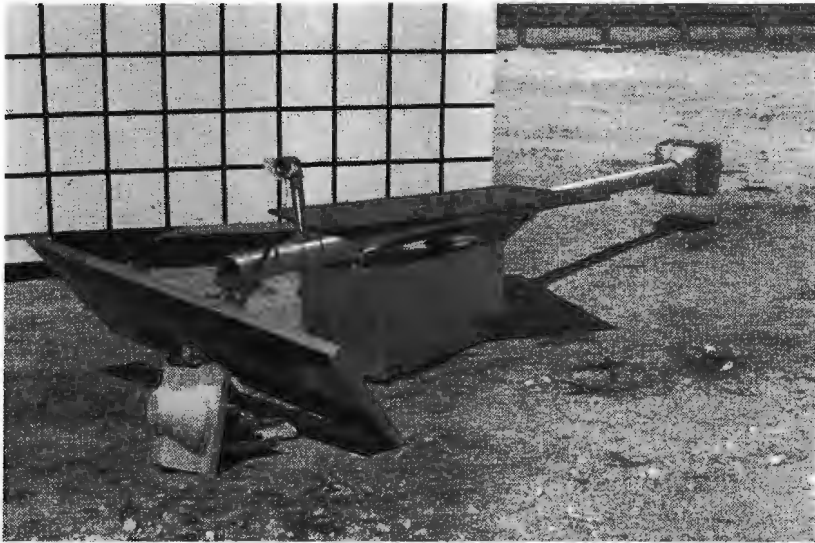
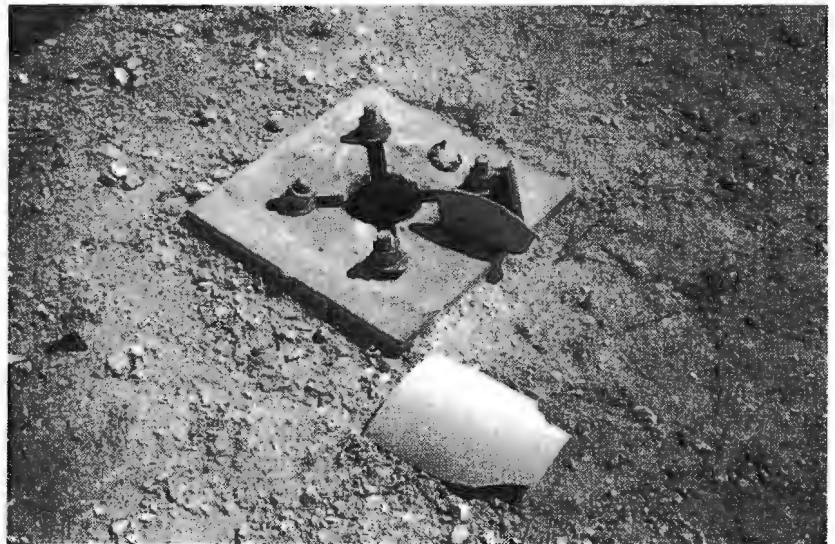
**Figure 12. Installation after Test 417920-3.**

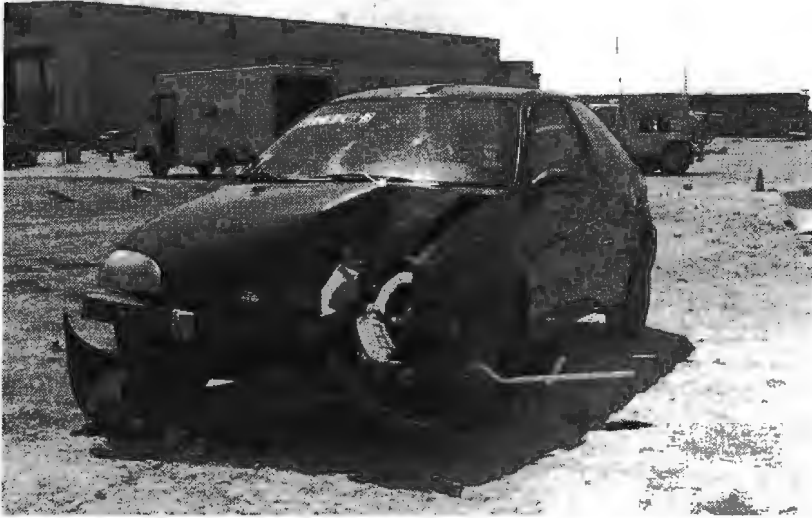
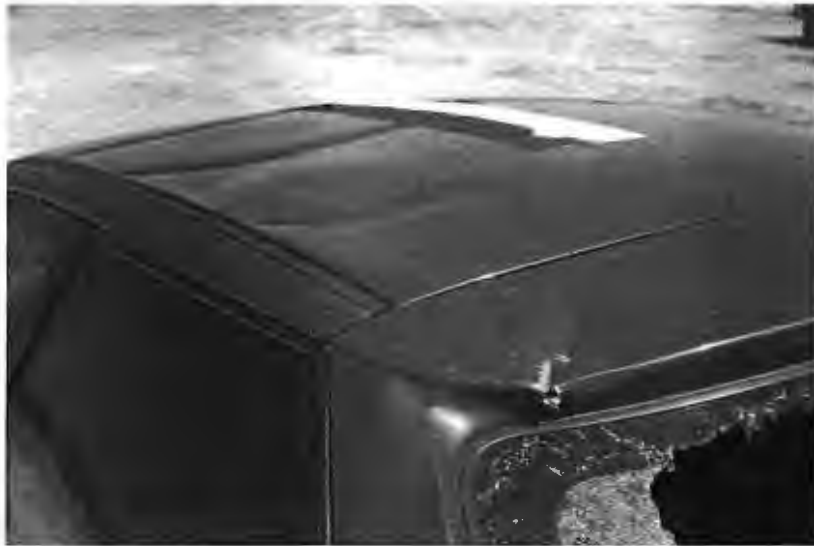
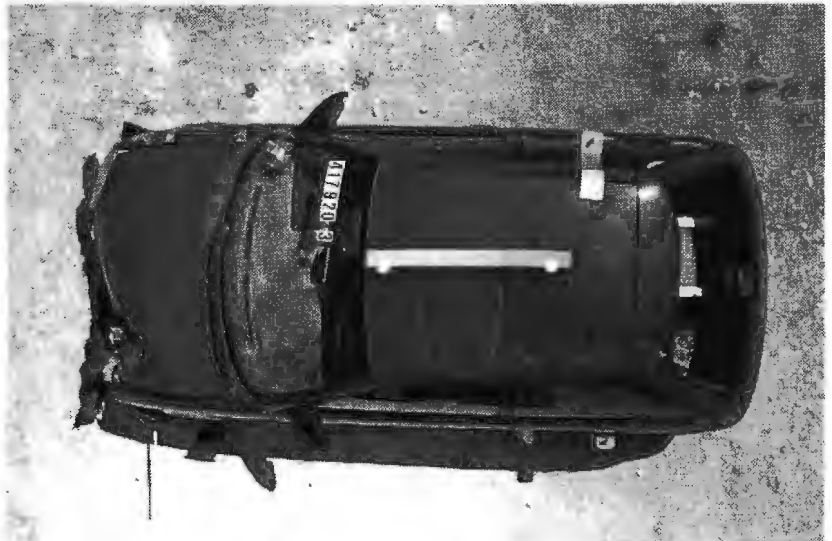
**Figure 13. Vehicle after Test 417920-3.**

The 820 kg (1806 lb) vehicle sustained damage to the left front corner, hood, roof and rear hatch as shown in Figure 13. The left side strut and CV joint were damaged, as well as the front bumper, hood, fan, radiator, radiator support, and rear window. Maximum crush to the exterior of the vehicle was 260 mm (10.2 in) at the left front quarter point. Maximum occupant compartment deformation was 25 mm (1.0 in) in the floor pan area. Photographs of the interior of the vehicle are shown in Figure 14, and exterior vehicle crush and occupant compartment measurements are shown in Appendix B, Tables 6 and 7.

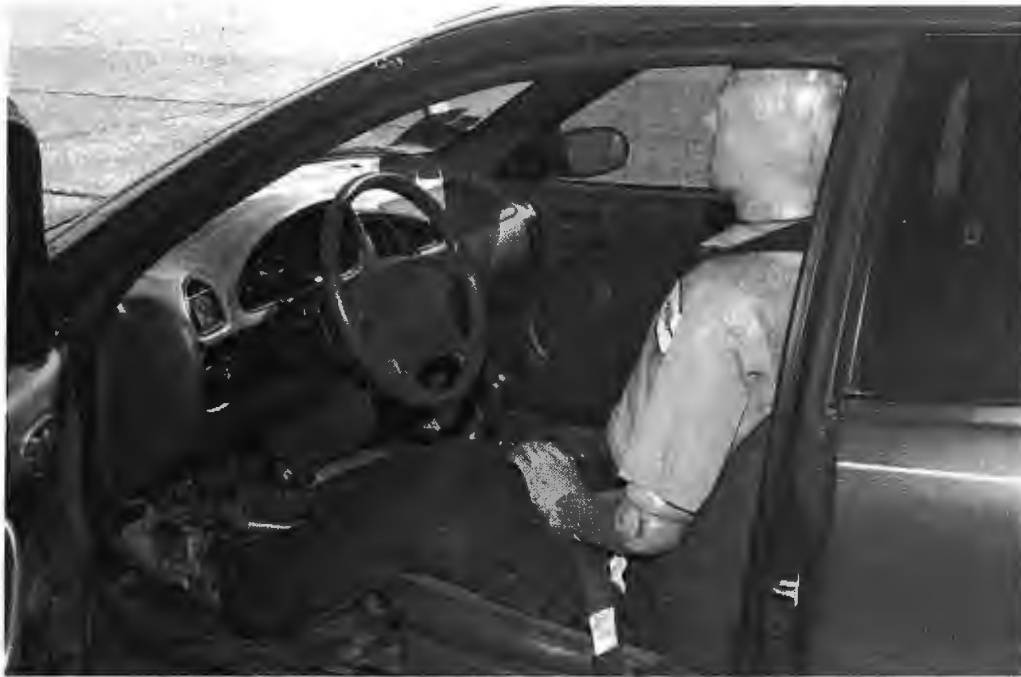
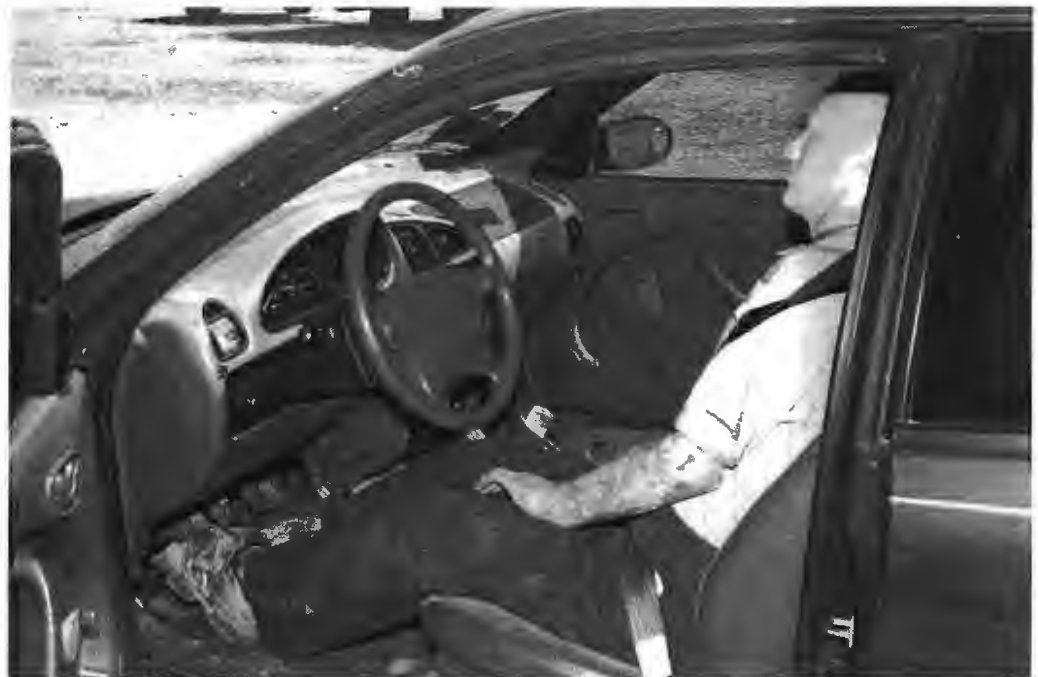
Before test

After test

**Figure 14. Interior of Vehicle for Test 417920-3.**

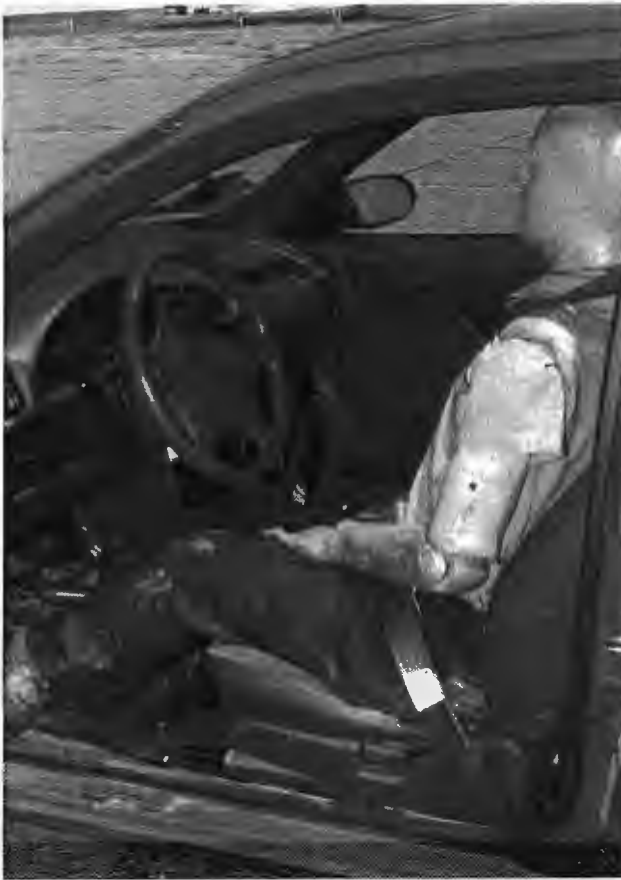
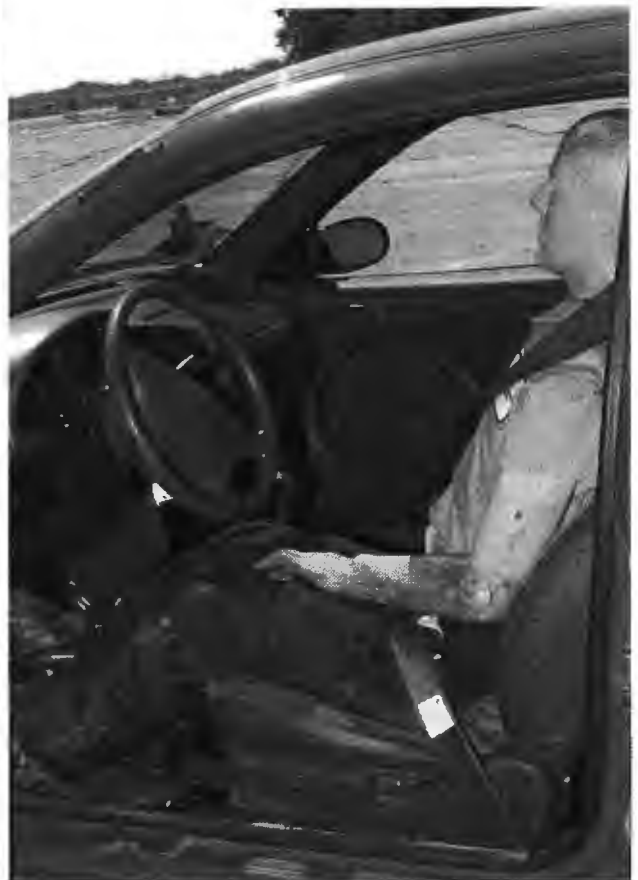
**Figure 21. Interior of Vehicle for Test 417920-4.**

Before test

After test

Result: The detached elements did not penetrate or show potential for penetrating the occupant compartment, or to present undue hazard to others in the area. Maximum deformation of the occupant compartment was 35 mm (1.38 in) in the floor pan area.

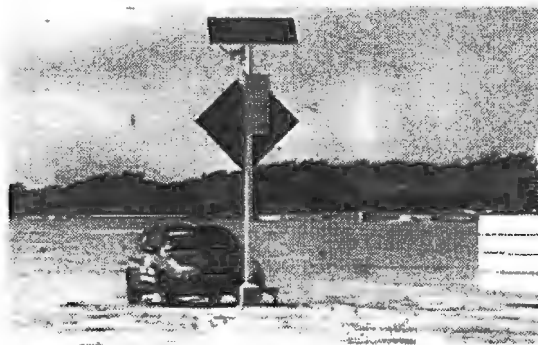
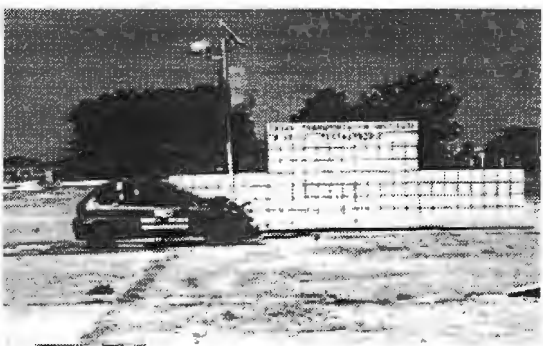
**Figure 25. Sequential Photographs for Test 417920-3  
(Perpendicular and Oblique Views).**

0.000 s

0.096 s

0.239 s

0.478 s

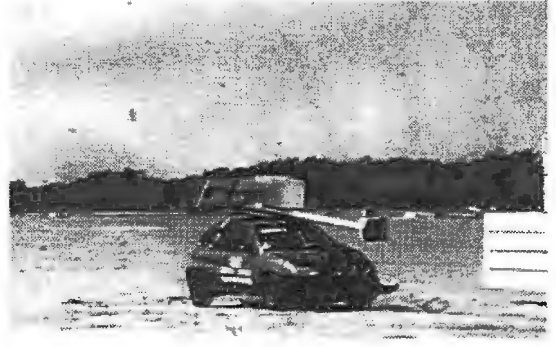
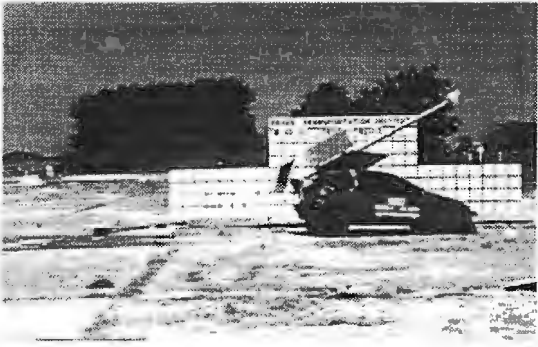
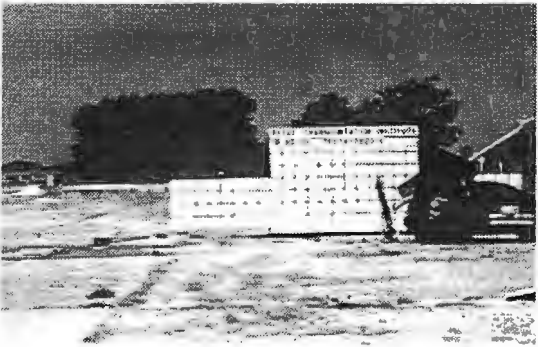
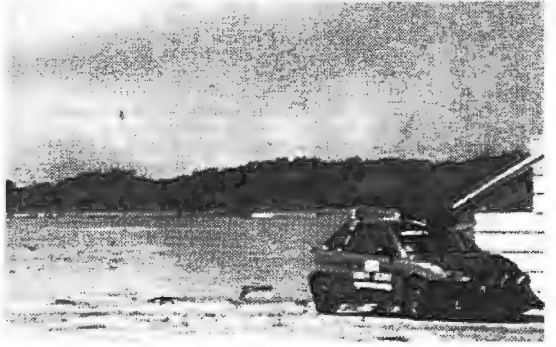
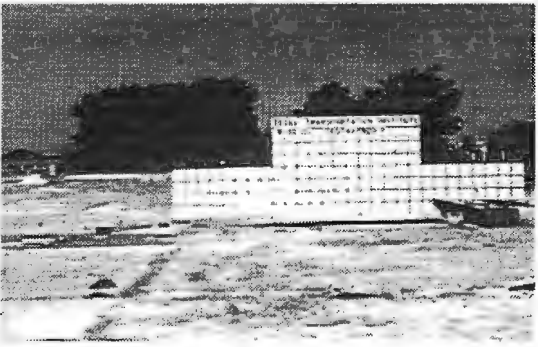
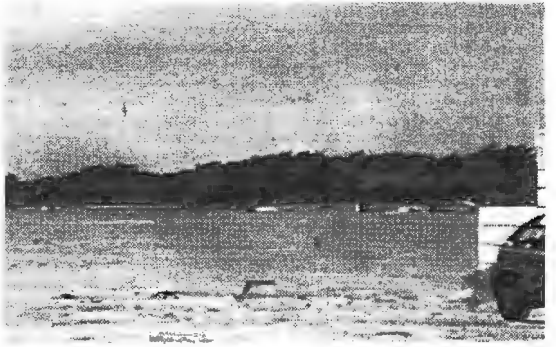
**Figure 25. Sequential Photographs for Test 417920-3  
(Perpendicular and Oblique Views) (continued).**

0.717 s

1.075 s

1.673 s

2.868 s

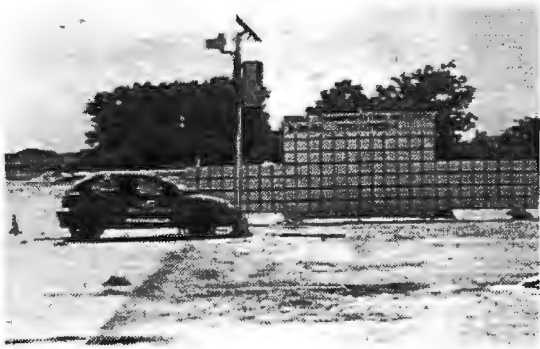
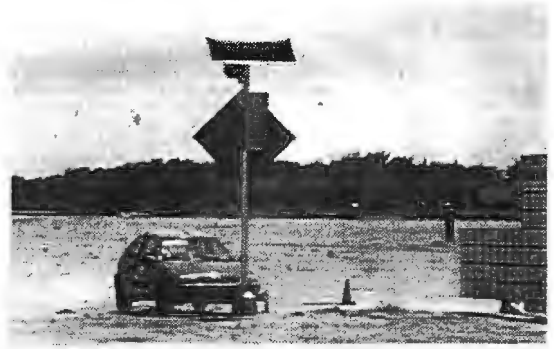
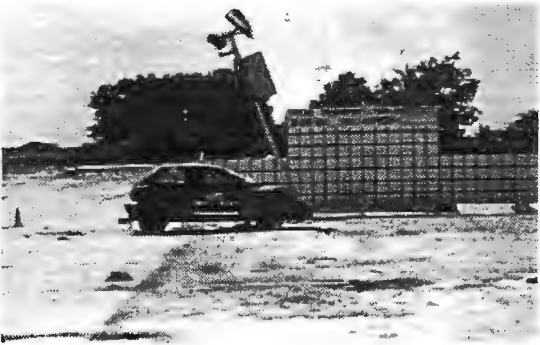
0.000 s

0.049 s

The vehicle, traveling at a speed of 99.0 km/h (61.5 mi/h), impacted the solar powered sign support system with the left front quarter point. Shortly after impact the sign support system moved, and at 0.010 s the base fractured near ground level. The sign support system began to rise in front of the vehicle at 0.024 s, and the flashing signal beacon separated from the support at 0.041 s. At 0.052 s the sign panel separated from the support, and at 0.073 s the battery cabinet opened. The solar panel separated from the support at 0.090 s. At 0.095 s, the vehicle lost contact with the sign support system and was traveling at a speed of 93.4 km/h (58.0 mi/h). As the vehicle exited the test site, the sign support continued up and over the top of the vehicle and eventually recontacted the ground at 0.373 s. Brakes on the vehicle were applied at 0.850 s after impact, and the vehicle subsequently came to rest 100.0 m (328.1 ft) behind the impact point. Sequential photographs of the test can be found in Appendix C, Figure 26.

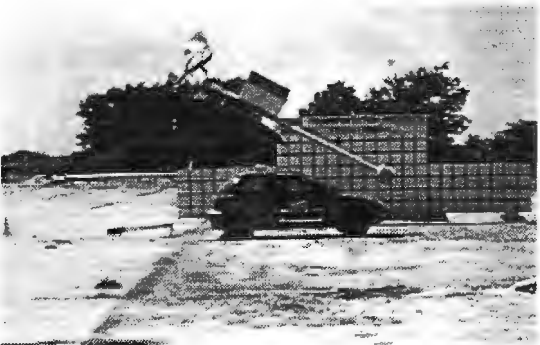
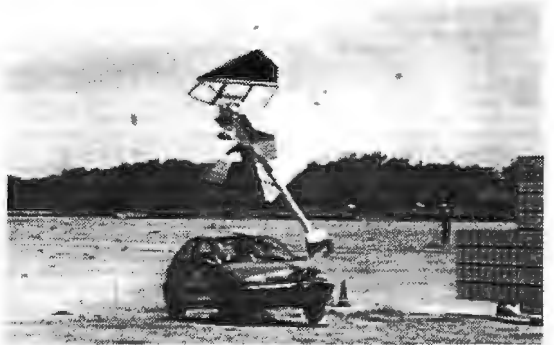
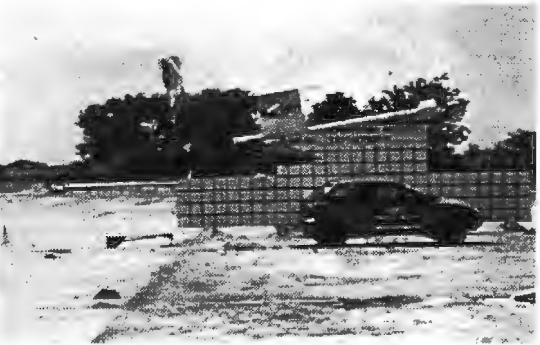
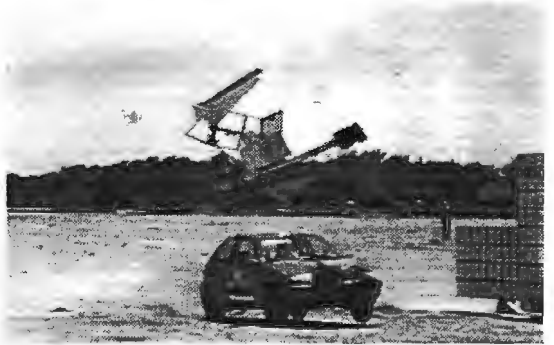
**Figure 26. Sequential Photographs for Test 417920-4 (Perpendicular and Oblique Views).**

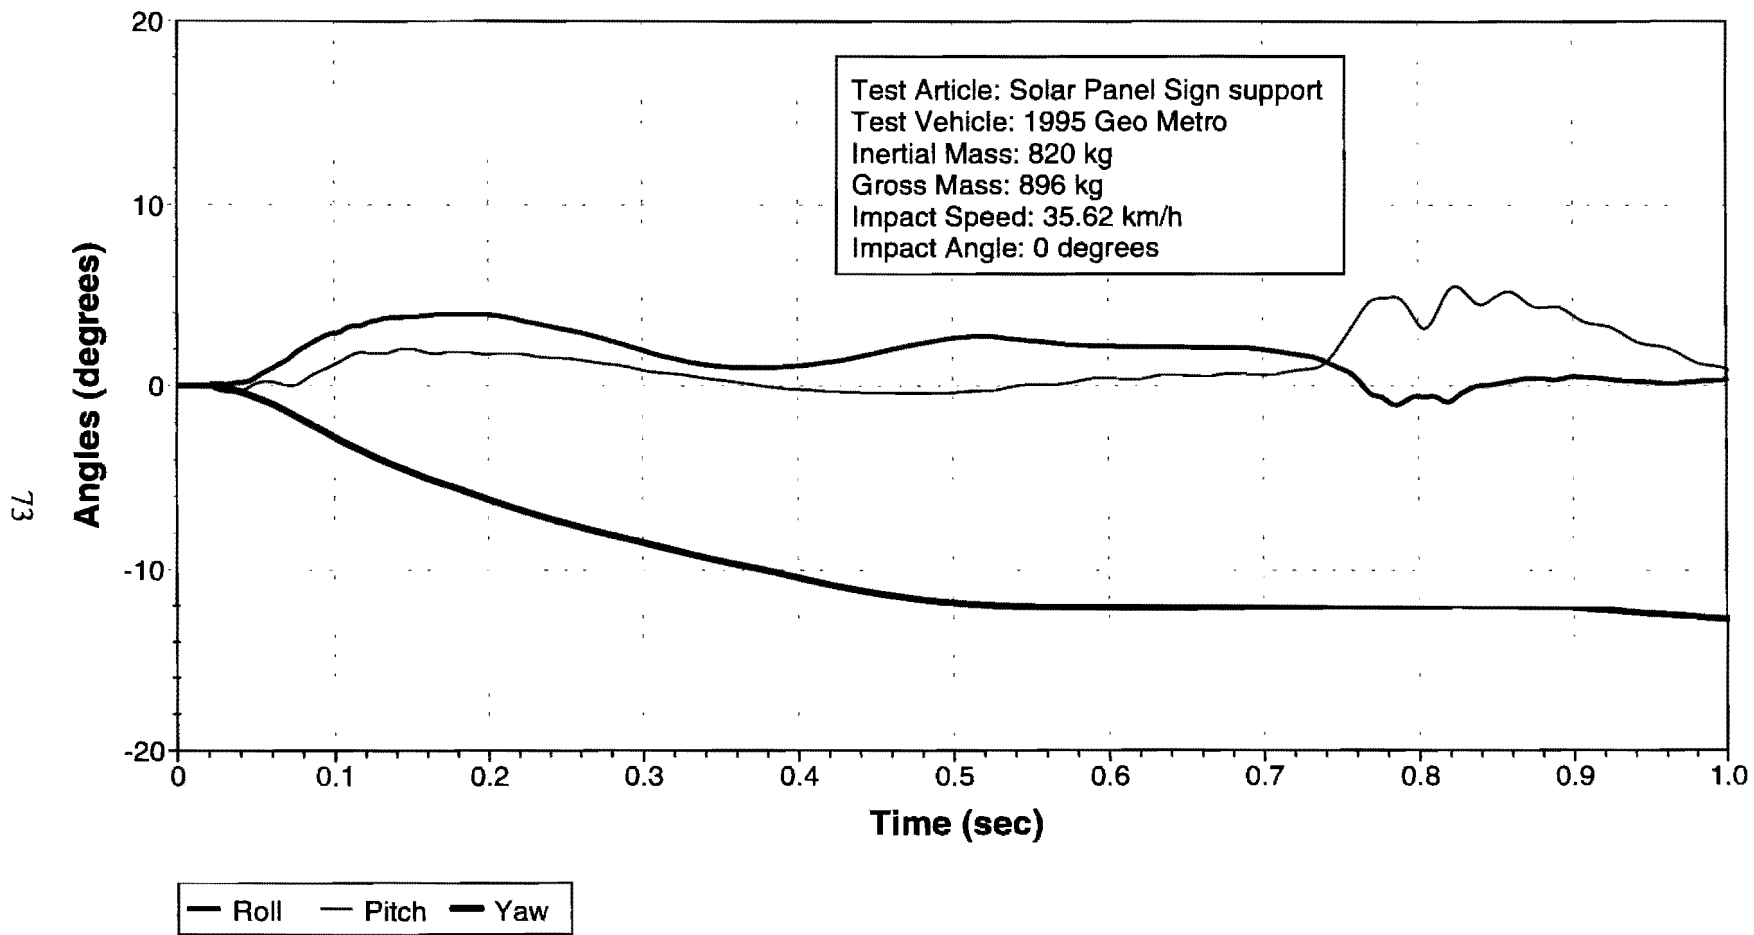
Figure 27. Vehicular Angular Displacements for Test 417920-3.

Data from the accelerometer located at the vehicle center of gravity were digitized for evaluation of occupant risk and were computed as follows. In the longitudinal direction, the occupant impact velocity was 4.3 m/s (14.1 ft/s) at 0.189 s, the highest 0.010-s occupant ridedown acceleration was -1.6 g's from 0.721 to 0.731 s, and the maximum 0.050-s average acceleration was -6.5 g's between 0.031 and 0.081 s. In the lateral direction, the occupant impact velocity was 0.3 m/s (1.0 ft/s) at 0.189 s, the highest 0.010 s occupant ridedown acceleration was -1.1 g's from 0.784 to 0.794 s, and the maximum 0.050 s average was -0.6 g's between 0.015 and 0.065 s. These data and other pertinent information from the test are summarized in Figure 15. Vehicle angular displacements are shown in Appendix D, Figure 27, and vehicle accelerations versus time traces are presented in Appendix E, Figures 29 through 31.

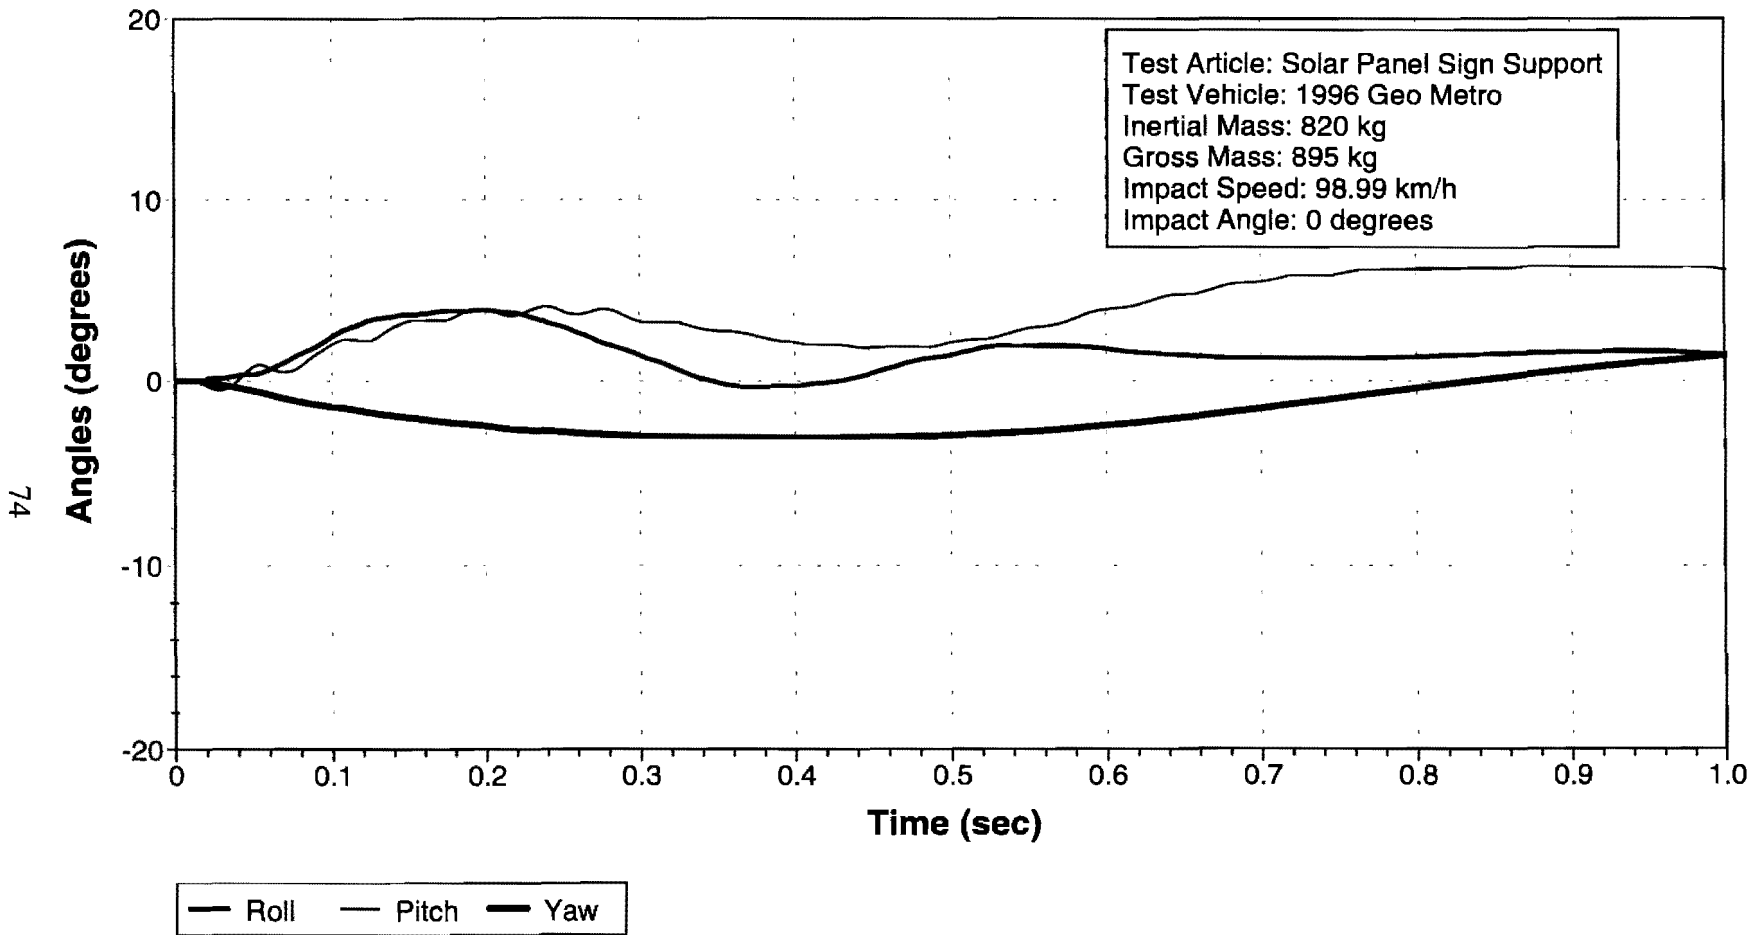
### Roll, Pitch and Yaw Angles

Data from the accelerometer located at the vehicle center of gravity were digitized for evaluation of occupant risk and were computed as follows. In the longitudinal direction, the occupant impact velocity was 1.4 m/s (4.6 ft/s) at 0.515 s, the highest 0.010 s occupant ridedown acceleration was -1.5 g's from 1.550 to 1.560 s, and the maximum 0.050 s average acceleration was -2.0 g's between 0.000 and 0.050 s. In the lateral direction, the occupant impact velocity was 0.9 m/s (3.0 ft/s) at 0.515 s, the highest 0.010 s occupant ridedown acceleration was -0.7 g's from 1.644 to 1.654 s, and the maximum 0.050 s average was -0.8 g's between 0.004 and 0.054 s. These data and other pertinent information from the test are summarized in Figure 22. Vehicle angular displacements are shown in Appendix D, Figure 28, and vehicle accelerations versus time traces are presented in Appendix E, Figures 32 through 34.

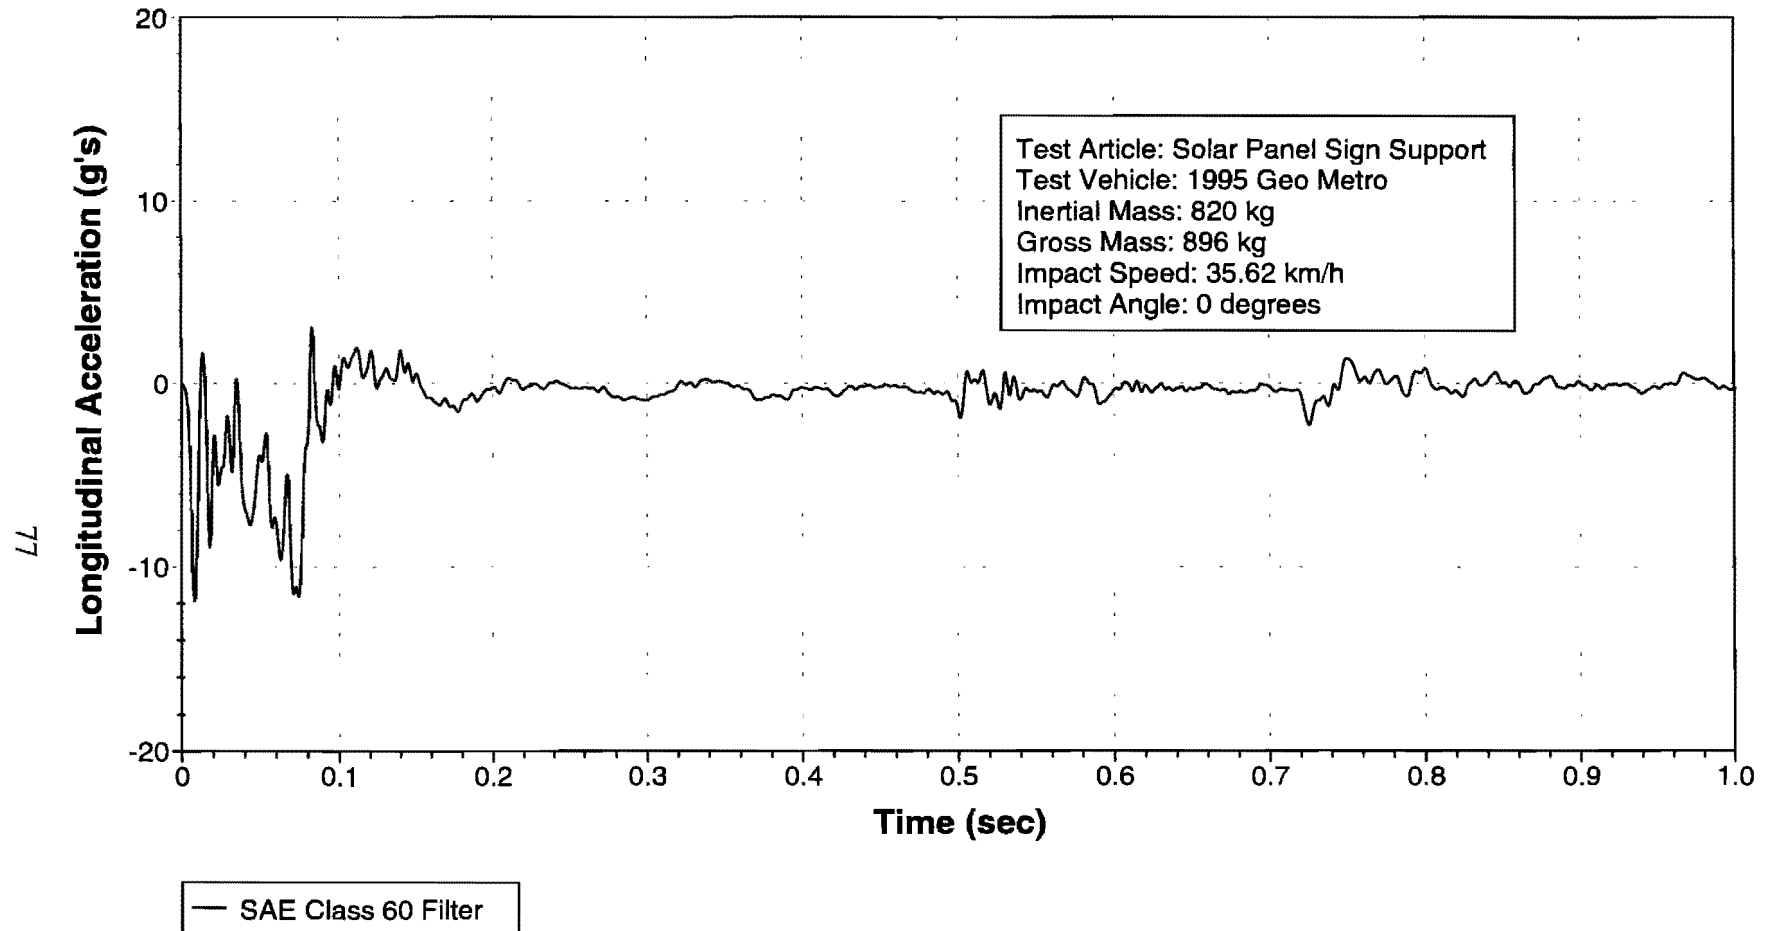
**Figure 29. Vehicle Longitudinal Accelerometer Trace for Test 417920-3.**
