1. Report No. FHWA/TX-01/1792-4		2. Government Accession No.		3. Recipient's Catalog No.	
4. Title and Subtitle TESTING AND EVALUATION OF THE SOLAR PANEL SIGN SUPPORT SYSTEM				5. Report Date January 2001

14. Sponsoring Agency Code	
15. Supplementary Notes Research performed in cooperation with the Texas Department of Transportation and the U.S. Department of Transportation, Federal Highway Administration. Research Project Title: Roadside Safety Hardware for Traffic Control Devices

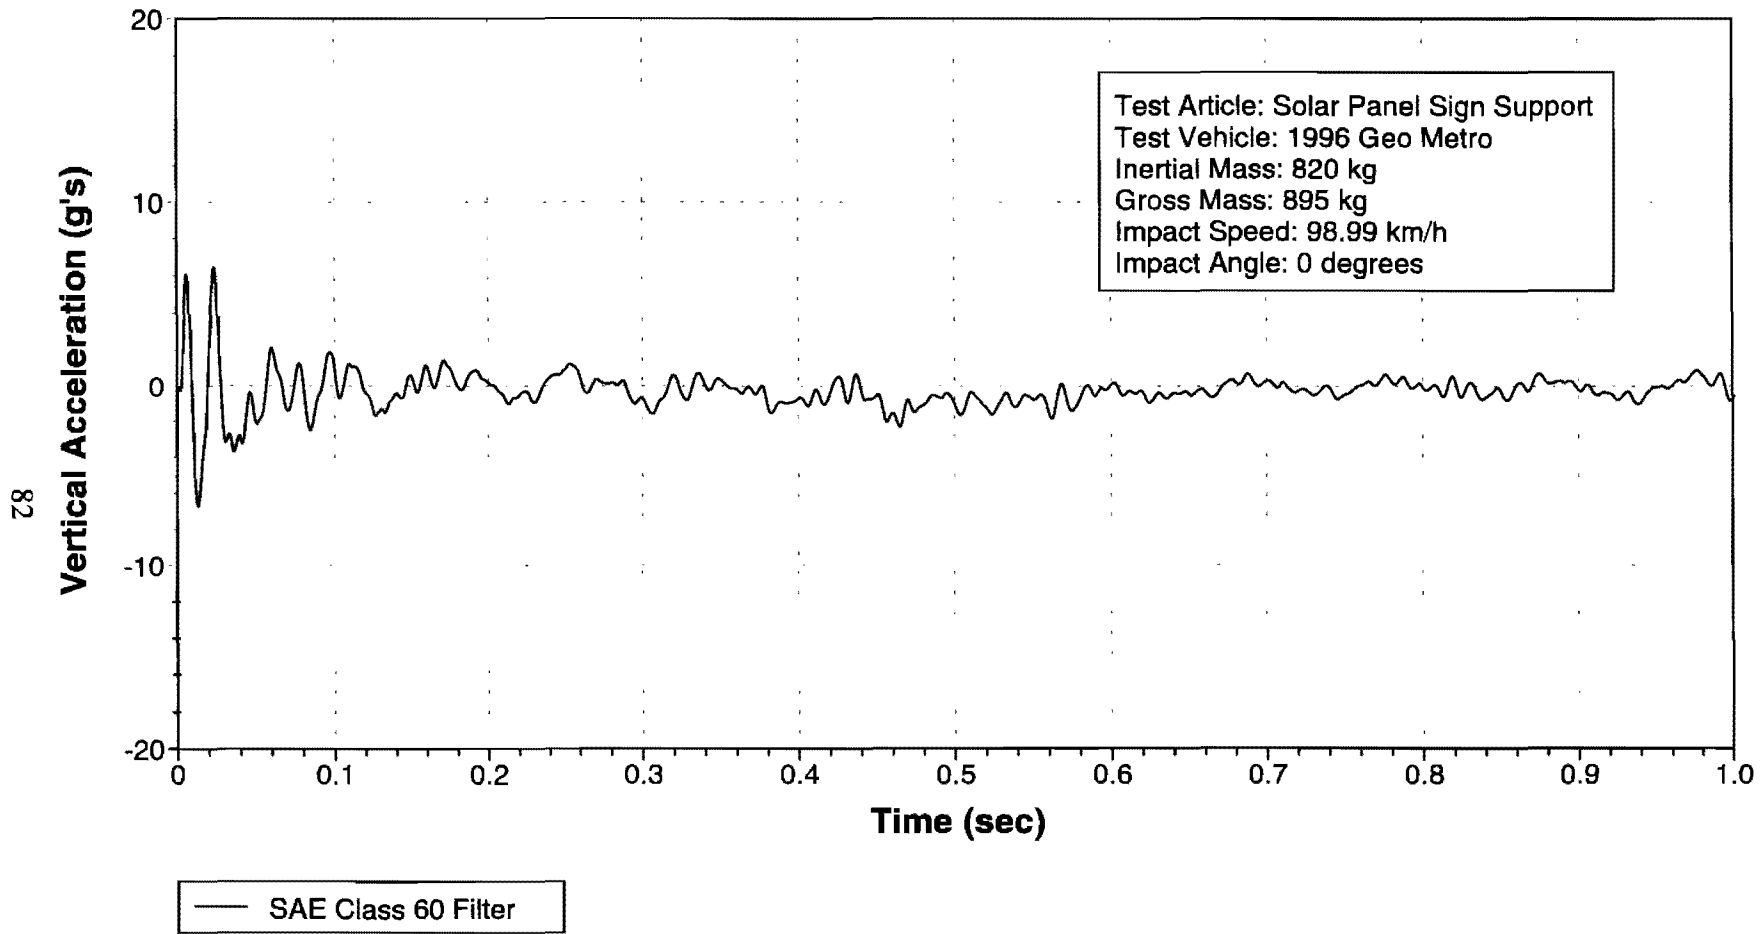
Figure 34. Vehicle Vertical Accelerometer Trace for Test 417920-4.

Data from the accelerometer located at the vehicle center of gravity were digitized for evaluation of occupant risk and were computed as follows. In the longitudinal direction, the occupant impact velocity was 1.4 m/s (4.6 ft/s) at 0.515 s, the highest 0.010 s occupant ridedown acceleration was -1.5 g's from 1.550 to 1.560 s, and the maximum 0.050 s average acceleration was -2.0 g's between 0.000 and 0.050 s. In the lateral direction, the occupant impact velocity was 0.9 m/s (3.0 ft/s) at 0.515 s, the highest 0.010 s occupant ridedown acceleration was -0.7 g's from 1.644 to 1.654 s, and the maximum 0.050 s average was -0.8 g's between 0.004 and 0.054 s. These data and other pertinent information from the test are summarized in Figure 22. Vehicle angular displacements are shown in Appendix D, Figure 28, and vehicle accelerations versus time traces are presented in Appendix E, Figures 32 through 34.
