Flight Deck Human Factors Issues in Lateral Deviations during North Atlantic (NAT) Flight Operations

Final Report – March 2020

DOT-VNTSC-FAA-20-06

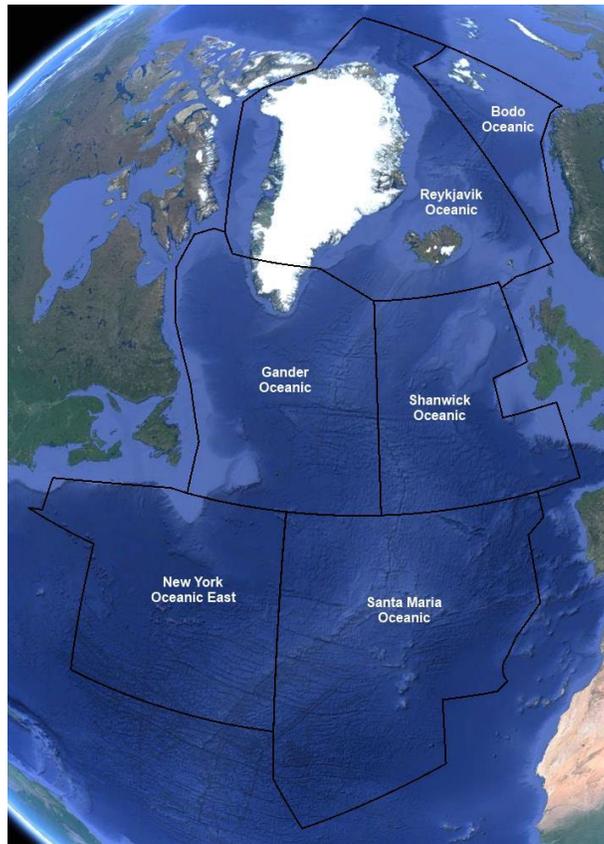
Figure 1. NAT region and geographic areas (ICAO NAT Doc 007, 2020).

Volpe Center is tasked with studying flight deck human factors issues that may be the cause of lateral deviations for flights operating in the North Atlantic (NAT) High-Level Airspace (HLA), with a focus on operations in the Organized Track System (OTS). Figure 1 illustrates the geographic areas of the NAT HLA. NAT flight operations have strict requirements for aircraft lateral and vertical navigation, as well as strict requirements for communication with the Air Navigation Services Provider (ANSP). The International Civil Aviation Organization (ICAO) oversees the management of the NAT Region, which is handled by ANSPs in Iceland (Reykjavik), Canada (Gander), Portugal (Santa Maria), United States (New York Oceanic East), Norway (Bodø), and the United Kingdom (UK, Shanwick). In altitude, the HLA includes Flight Level (FL) 285 through FL420. The OTS primarily resides in the Gander and Shanwick airspaces. The OTS contains defined routes for flights between North America and the UK/Europe at altitudes between FL350 and FL390. The OTS routes change twice daily to optimize for wind patterns.

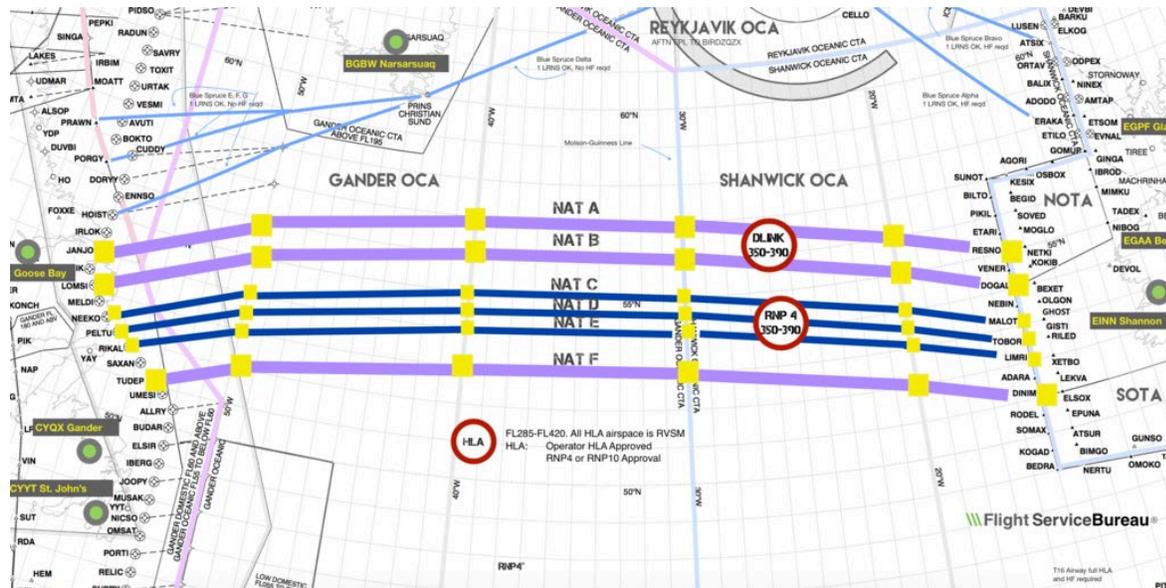
Figure 2. NAT Organized Track System (OTS) tracks for 24 February 2017, from Wikipedia ([image](#) by Coisabh, CC BY-SA 4.0)

Most waypoints in the NAT oceanic airspace are “undesigned significant points,” which are unnamed. Figure 2 shows such points along example tracks. The yellow squares along the 20 West, 30 West, 40 West, and 50 West meridian (longitude) lines are undesigned significant points. In contrast to the named oceanic entry and exit waypoints (e.g., MALOT and LIMRI off the coast of Ireland), there is no common alphanumeric name for an undesigned waypoint’s latitude and longitude coordinates in the aircraft navigation database and ANSP systems for these waypoints. While the aircraft navigation database does have an alphanumeric label that is shown on the flight deck display, the ANSP systems define such unnamed waypoints only by their latitude and longitude coordinates. Unnamed half-degree waypoints (with latitude or longitude coordinates at 30 minutes) are not often used outside of the OTS¹, but unnamed whole-degree waypoints are used throughout the NAT HLA.

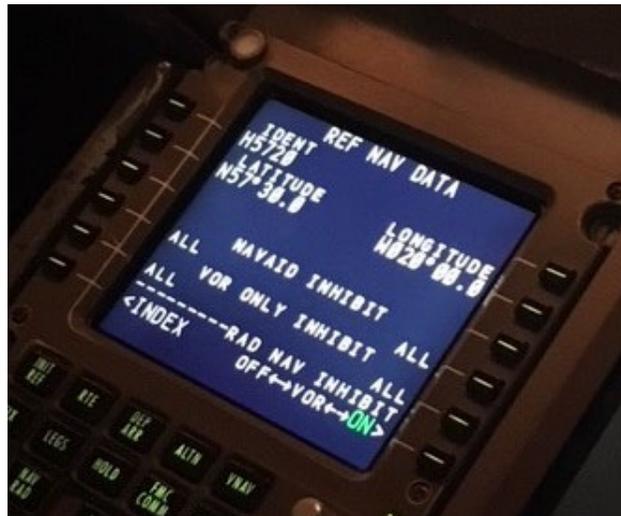
Figure 3. Waypoint data page showing the ident (H5720) and the full latitude-longitude coordinates.

We also learned about the number of steps it takes for the pilot to expand the waypoint coordinates. For example, although an FMS database may have the Hxxy label for half-degree waypoints, some operators discourage use of these names because it takes four to six key strokes to expand their waypoint coordinates on the aircraft types they fly. The pilot has to first select the waypoint, then pull it into the Control and Display Unit (CDU) scratchpad, and then pull up the reference navigation data page (see Figure 3). Instead, operators prefer pilots to use the 7-character FMS label because it only takes one key stroke to expand their waypoint coordinates. Also, within a single aircraft, pilots may see multiple naming conventions (as shown in Figure 4).

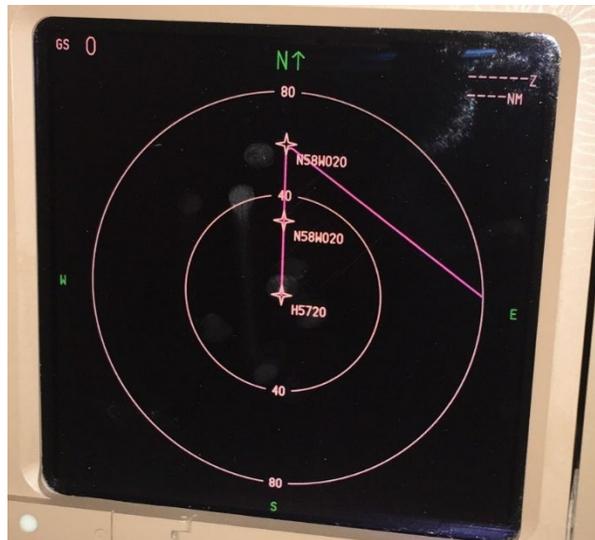
Figure 4. Navigation display on B-777 showing both the 7-character waypoint labels and the H-prefix waypoint label.
