INVESTIGATION NO. 2850
THE AKRON, CANTON & YOUNGSTOWN RAILROAD COMPANY
REPORT IN RE ACCIDENT
AT HILES, OHIO, ON
DECEMBER 13, 1944

Accident at Hiles, Ohio, on December 13, 1944, caused by
a switch being opened immediately in front of an
approaching train.

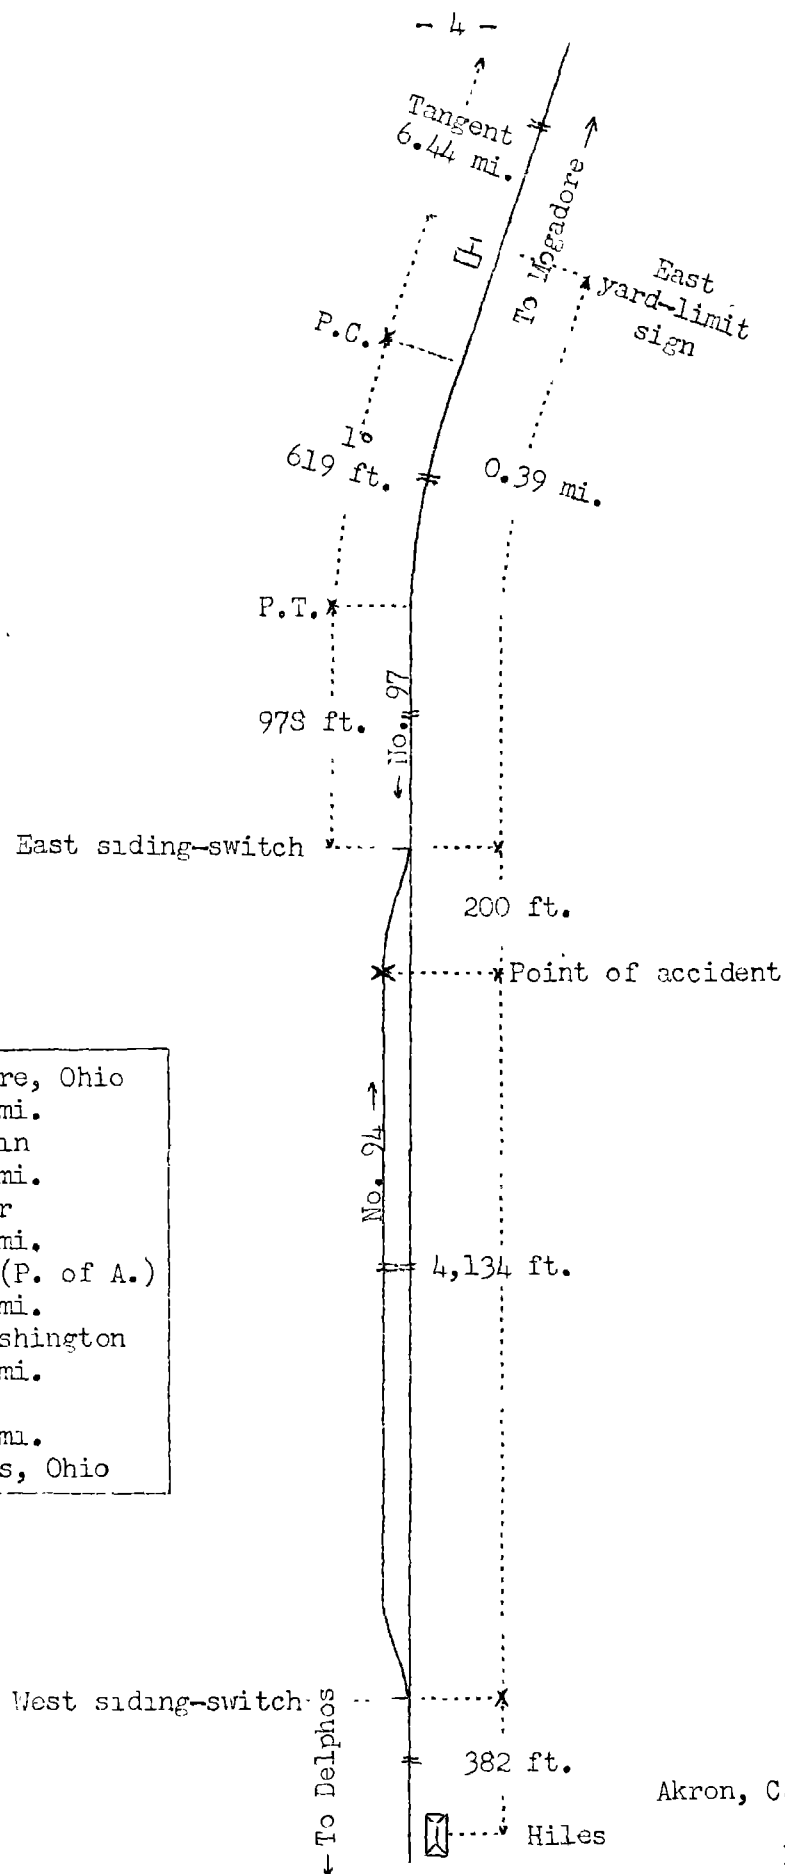
Inv-2850
Akron, Canton & Youngstown
Railroad
Hiles, Ohio
December 13, 1944

o Mogadore, Ohio	3.5 mi.
o Brittain	42.1 mi.
o Spencer	14.0 mi.
X Hiles (P. of A.)	26.6 mi.
o New Washington	28.0 mi.
o Carey	55.1 mi.
o Delphos, Ohio
