INTERSTATE COMMERCE COMMISSION

REPORT OF THE DIRECTOR

ACCIDENT ON THE

ALTON RAILROAD

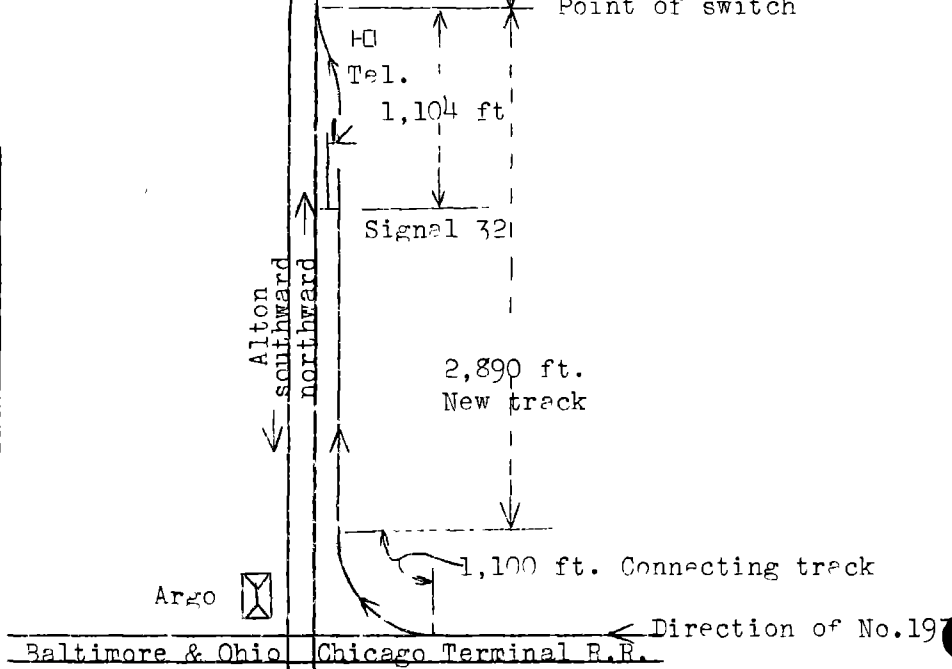
Inv. No. 2342
 Alton R. R.
 Summit, Ill.
 April 1, 1939

○	Chicago, Ill.	
		10.3 mi.
○	Glenn	
		1.6 mi.
○	Summit	
		0.78 mi.
X	Point of accident	
		0.82 mi.
○	Argo, Ill.

Baltimore and Ohio freight trains use the Alton Railroad yard at Glenn and the Alton tracks between Glenn and Argo. Summit is an intermediate station located 1.2 miles north of Argo. The accident occurred on the northward main track at a point 1,965 feet south of the depot at Summit. Approaching this point from the north, there is a tangent 7,735 feet in length, followed by a $0^{\circ}45'$ curve to the left 4,369 feet in length; the accident occurred on this curve at a point 3,696 feet from its northern end. The grade is practically level at the point of accident.
