INTERSTATE COMMERCE COMMISSION

REPORT NO. 3720

THE ATCHISON, TOPEKA AND SANTA FE
RAILWAY COMPANY

CHICAGO, ROCK ISLAND AND PACIFIC
RAILROAD COMPANY

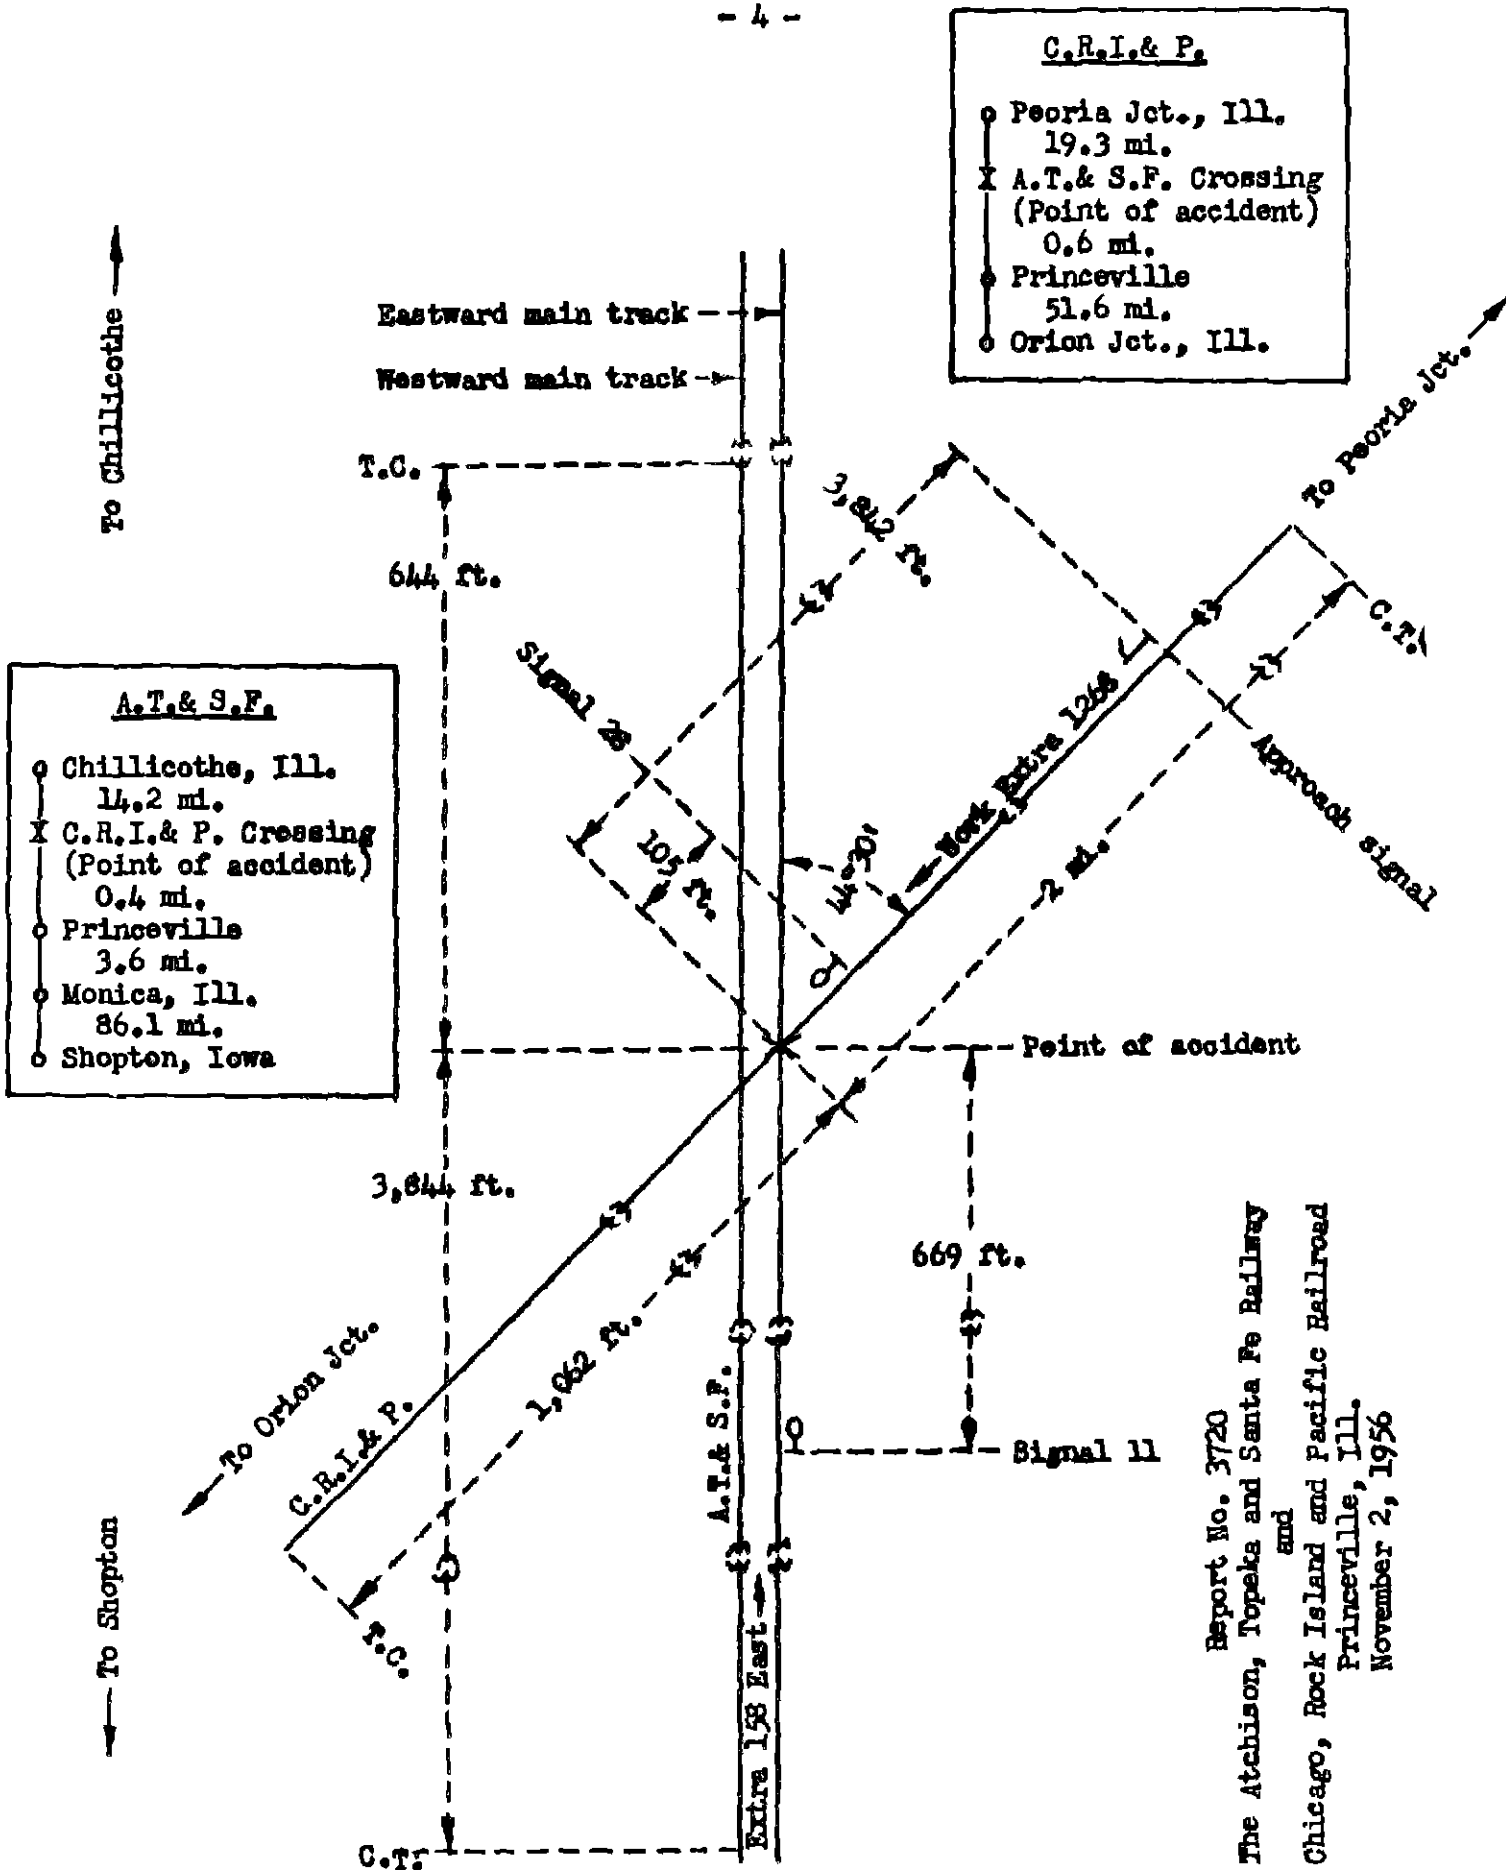
Report No. 3720
 The Atchison, Topeka and Santa Fe Railway
 and
 Chicago, Rock Island and Pacific Railroad
 Princeville, Ill.
 November 2, 1956
