INVESTIGATION NO. 3175
THE ATCHISON, TOPEKA AND SANTA FE
RAILWAY COMPANY
REPORT IN RE ACCIDENT
AT AKRON, KANS., ON
MARCH 28, 1948

Inv. No. 3175
 Atchison, Topeka and Santa Fe Railway
 Akron, Kans.
 March 28, 1948

Location of Accident and Method of Operation

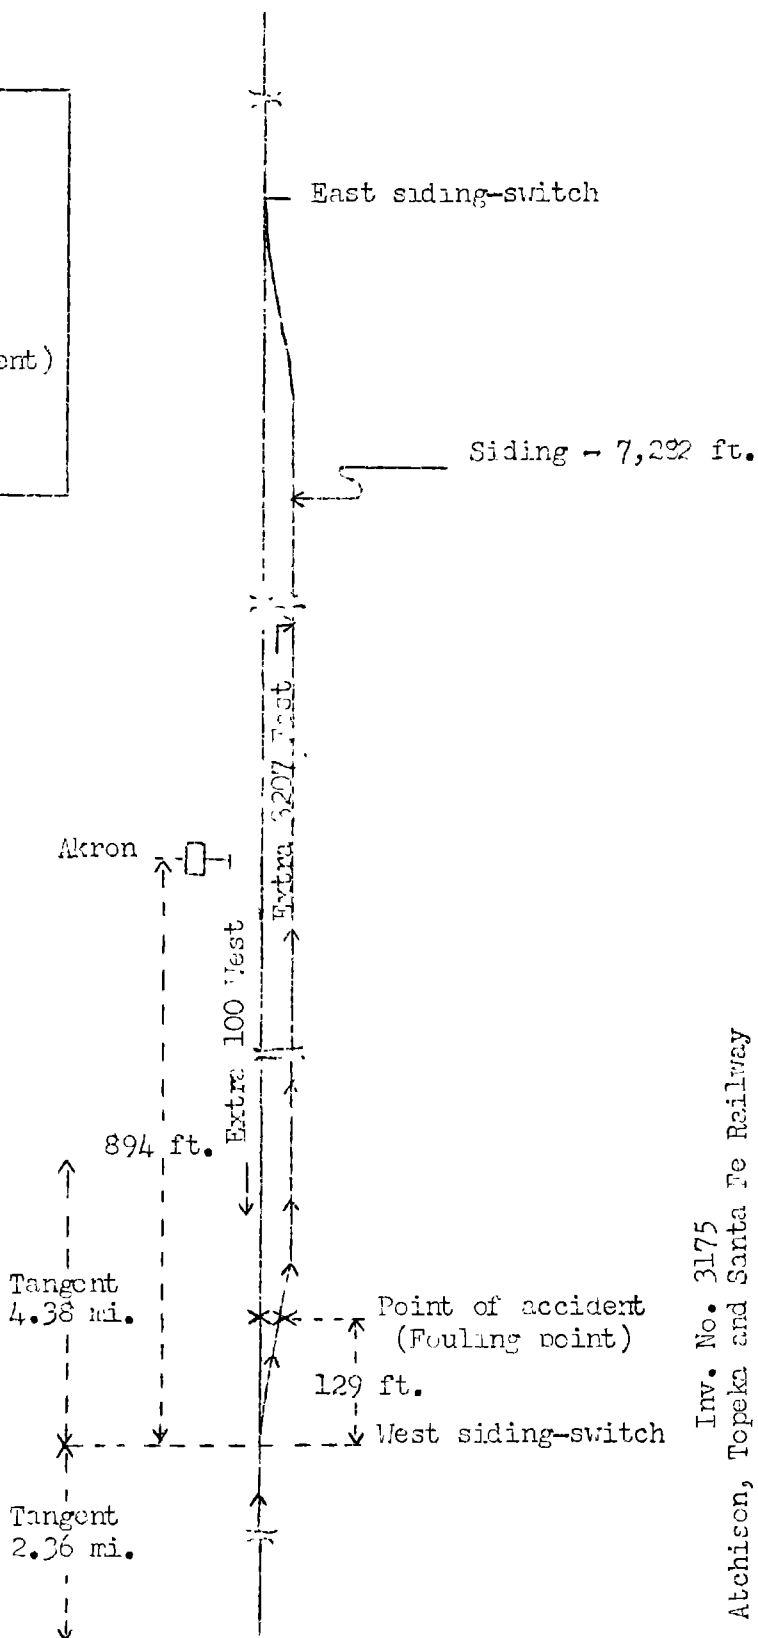
○	AG Tower	0.3 mi.
○	Augusta, Kans.	16.9 mi.
○	Rock	6.2 mi.
X	Akron	(Point of accident)
		7.3 mi.
○	W. N. Jct., Winfield, Kans.

This accident occurred on that part of the Middle Division extending between AG Tower, Augusta, and W.N. Jct., near Winfield, Kans., 30.7 miles, a single-track line, over which trains are operated by timetable and train orders. There is no block system in use. At Akron, 7.3 miles east of W.N. Jct., a siding 7,282 feet in length parallels the main track on the south. The west switch of this siding is 894 feet west of the station sign. The accident occurred at the fouling point of the main track and the turnout of the west siding-switch, at a point 120 feet east of the switch. The main track is tangent throughout a distance of 4.38 miles immediately east of the west siding-switch and 2.56 miles westward. The grade is 0.50 percent descending westward.

The capacity of the siding at Akron is 153 cars. The switchstand at the west siding-switch is located on the south side of the main track. It is provided with a red circular target 18 inches in diameter and an oil burning switch lamp. The center of the target is 5 feet 11-1/4 inches above the tops of the ties, and the center of the switch lamp is 7 feet 7-3/4 inches above the tops of the ties. When the switch is lined for entry to the siding, the switch target is at right angles to the track and the switch lamp displays a red aspect in the direction of an approaching train.
