-----  
ACCIDENT ON THE  
ATCHISON, TOPEKA AND SANTA FE RAILWAY

-----  
BARNES, OKLA.

-----  
JUNE 24, 1940

-----  
INVESTIGATION NO. 2433

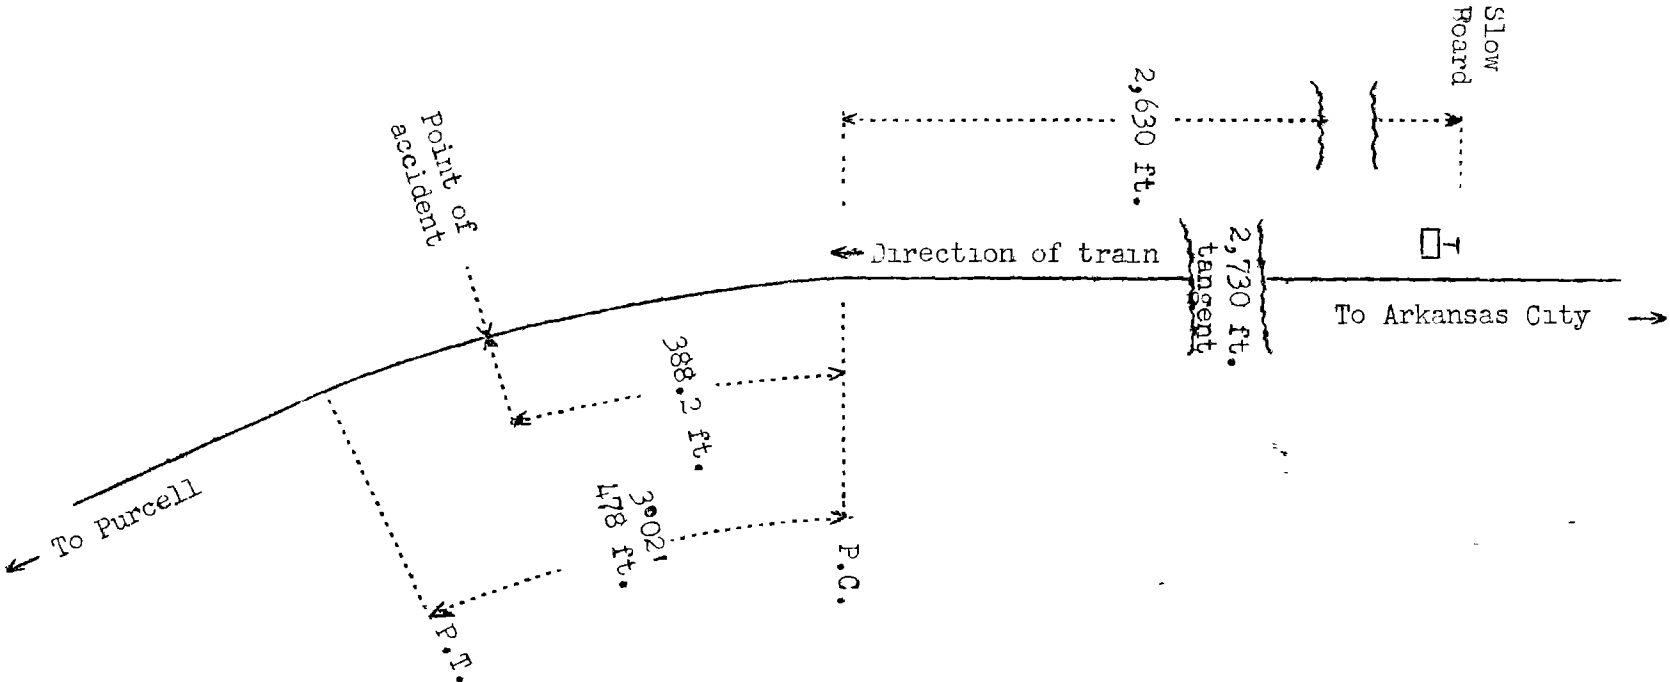
Inv. No. 2433  
 Atchison, Topcka and Santa Fe Ry.  
 Barnes, Okla.  
 June 24, 1940

○	Arkansas City, Kans.
○	25.5 mi.
○	Ponce City, Okla.
○	17.9 mi.
○	Red Rock
○	14.8 mi.
○	Perry
○	17.2 mi.
○	Mulhall
○	3.7 mi.
○	Barnes
○	2.0 mi.
X	Point of accident
○	2.7 mi.
○	Lawrie
○	3.2 mi.
○	E. O. Jct.
○	2.2 mi.
○	Guthrie
○	31.4 mi.
○	Oklahoma City
○	33.3 mi.
○	Purcell, Okla.
