INVESTIGATION NO. 2475
THE ATCHISON, TOPEKA & SANTA FE RAILWAY COMPANY
REPORT IN RE ACCIDENT
AT DEL MAR, CALIF., ON
DECEMBER 31, 1940

Railroad: Atchison, Topeka & Santa Fe
Date: December 31, 1940
Location: Del Mar, Calif.
Kind of accident: Derailment
Train involved: Freight
Train number: Extra 1676
Engine number: 1676
Consist: 39 cars, caboose
Speed: 50 m. p. h.
Operation: Timetable, train orders and
automatic block-signal system
Track: Single; tangent; level
Weather: Cloudy
Time: 8:45 p. m.
Casualties: 3 killed
Cause: Accident caused by landslide

Accident at Del Mar, Calif., on December 31, 1940, caused
by landslide.

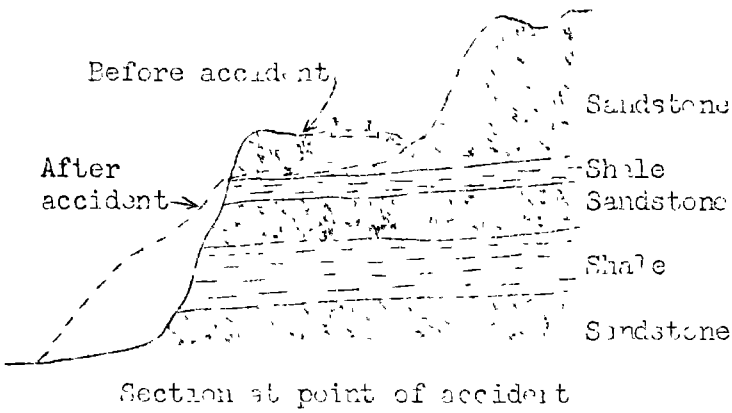
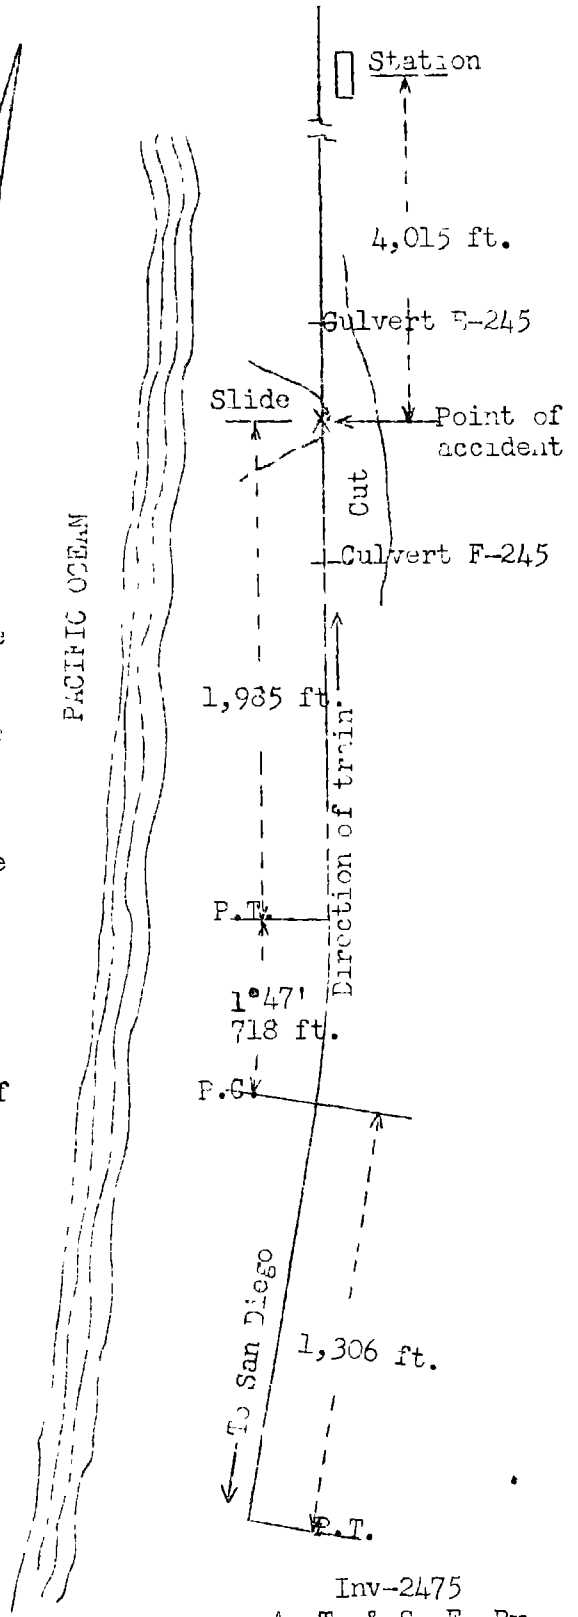
° Fullerton, Calif. 79 mi.
 ° Del Mar 23.5 mi.
 X point of accident 5.6 mi.
 ° San Diego
 ° National City, Calif.

PACIFIC OCEAN
