INVESTIGATION NO. 2925

THE ATCHISON, TOPEKA AND SANTA FE
RAILWAY COMPANY

REPORT IN RE ACCIDENT

AT FRANCONIA, ARIZ., ON

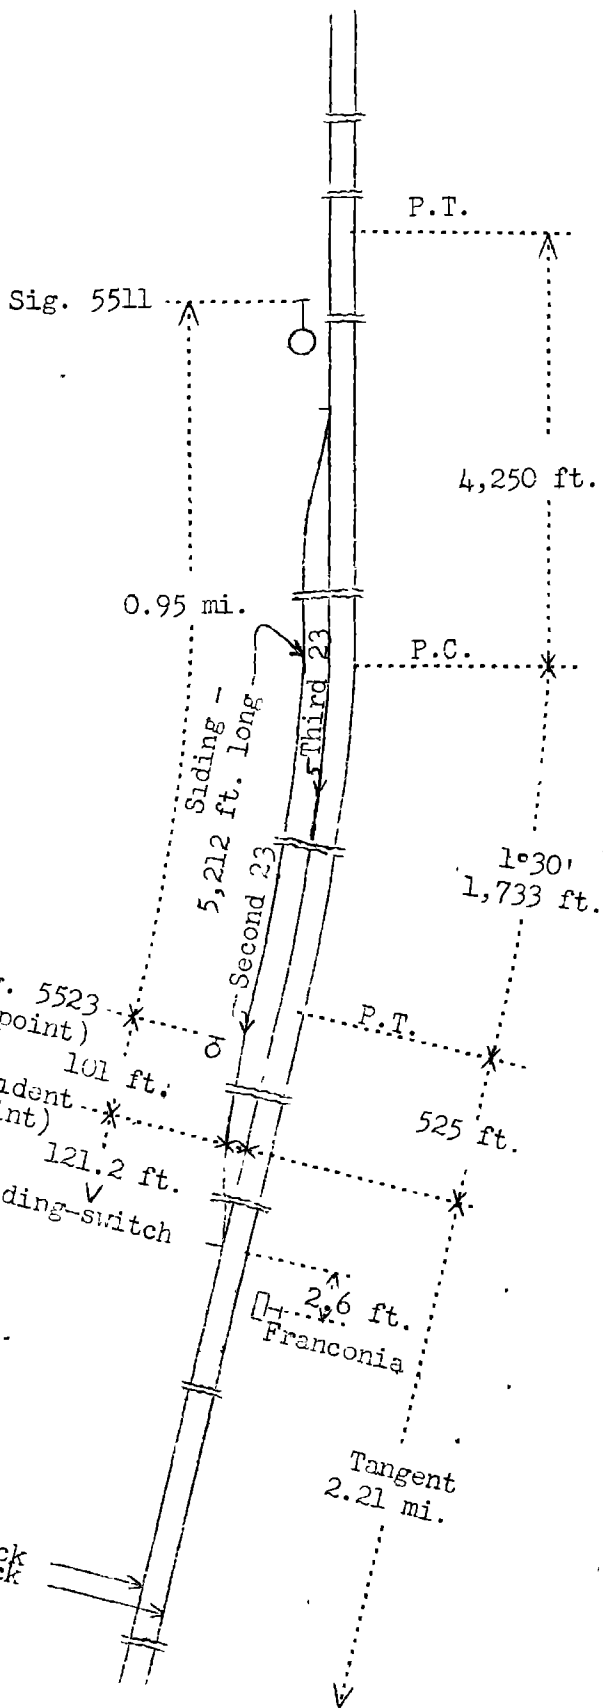
Inv. No. 2925
 Atchison, Topcka and Santa Fe Railway
 Franconia, Ariz.
 August 21, 1945

← To Needles

Westward main track
 Eastward main track

The third car of Second 23 was derailed to the north and stopped on its right side at the west siding-switch. The fourth car was derailed and stopped at the rear of the third car and leaned to the north at an angle of about 45 degrees. The front truck of the fifth car was derailed. The engine of Third 23 was derailed to the right, stopped about 120 feet west of the point of collision, and leaned to the north at an angle of about 45 degrees. The third and fourth cars of Second 23 and the engine of Third 23 were badly damaged.
