INVESTIGATION NO. 2753
THE ATCHISON, TOPEKA & SANTA FE RAILWAY COMPANY
REPORT IN RE ACCIDENT
AT GALLUP, N. MEX., ON
DECEMBER 18, 1943

Accident at Gallup, N. Mex., on December 18, 1943, caused by failure to provide an adequate block-signal system between signals 1561 and 1581, and by an engine fouling a main track without proper protection immediately in front of an approaching train.

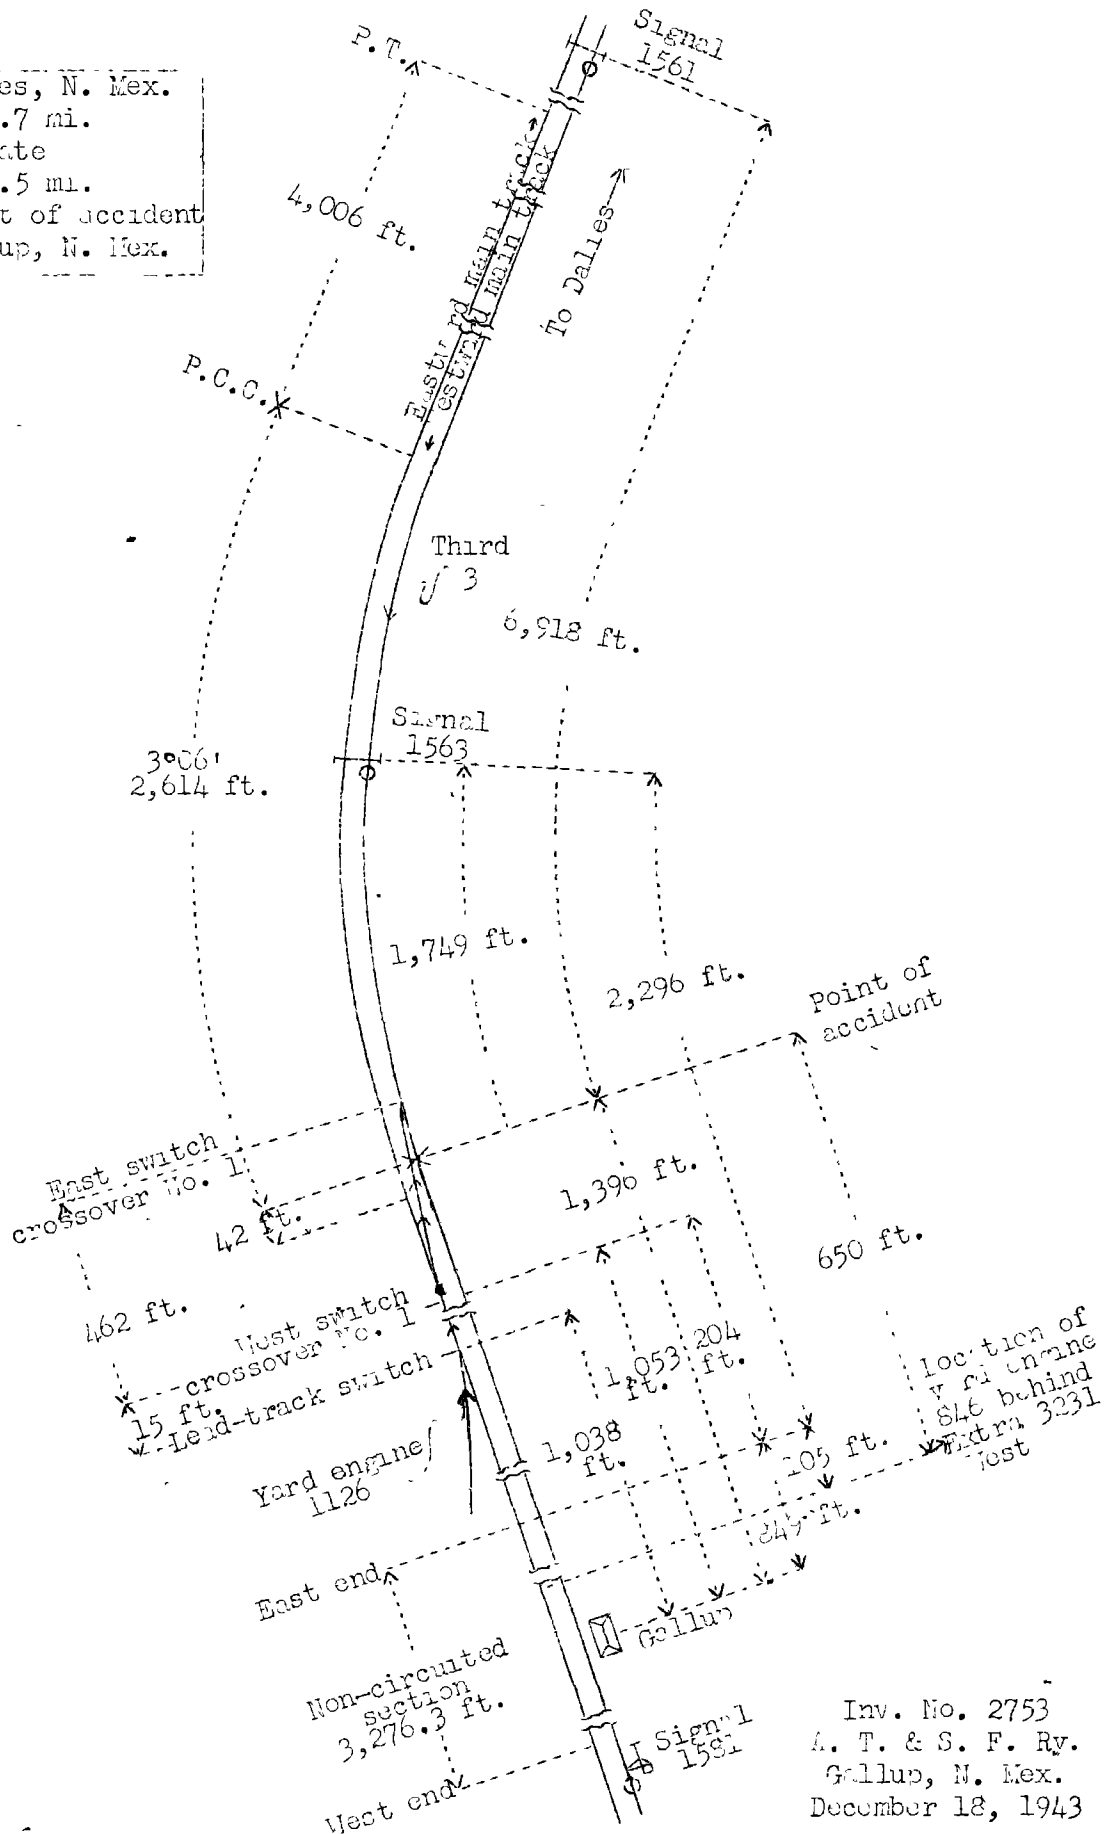
Inv. No. 2753
A. T. & S. F. Ry.
Gallup, N. Mex.
December 18, 1943

- o Dalles, N. Mex. 118.7 mi.
- o Wingate 11.5 mi.
- X Point of accident Gallup, N. Mex.

Location of Accident and Method of Operation

As Third 3 was approaching Gallup, the speed was about 60 miles per hour. A road foreman of engines, who was on the left side of the engine, and the enginemen were maintaining a lookout ahead. Because of dense fog, visibility was restricted to a distance of about 300 feet. Signal 1561 displayed proceed. The first the employees on the engine knew of any abnormal condition ahead was when their engine reached a point about 900 feet east of signal 1563, where two torpedoes were exploded. The engineer made a service brake-pipe reduction and, when the engine was about 300 feet east of signal 1563, the speed was reduced to about 55 miles per hour, then the fireman observed simultaneously the signal displaying red and lighted fuses in the vicinity of the signal. He immediately called a warning to the engineer, who moved the brake valve to emergency position. The speed of Third 3 was reduced to about 30 miles per hour at the time of the collision, which occurred at a point 1,749 feet beyond signal 1563.
