INVESTIGATION NO. 2587

THE ATCHISON, TOPEKA & SANTA FE RAILWAY COMPANY

REPORT IN RE ACCIDENT

NEAR HOBART, CALIF., ON

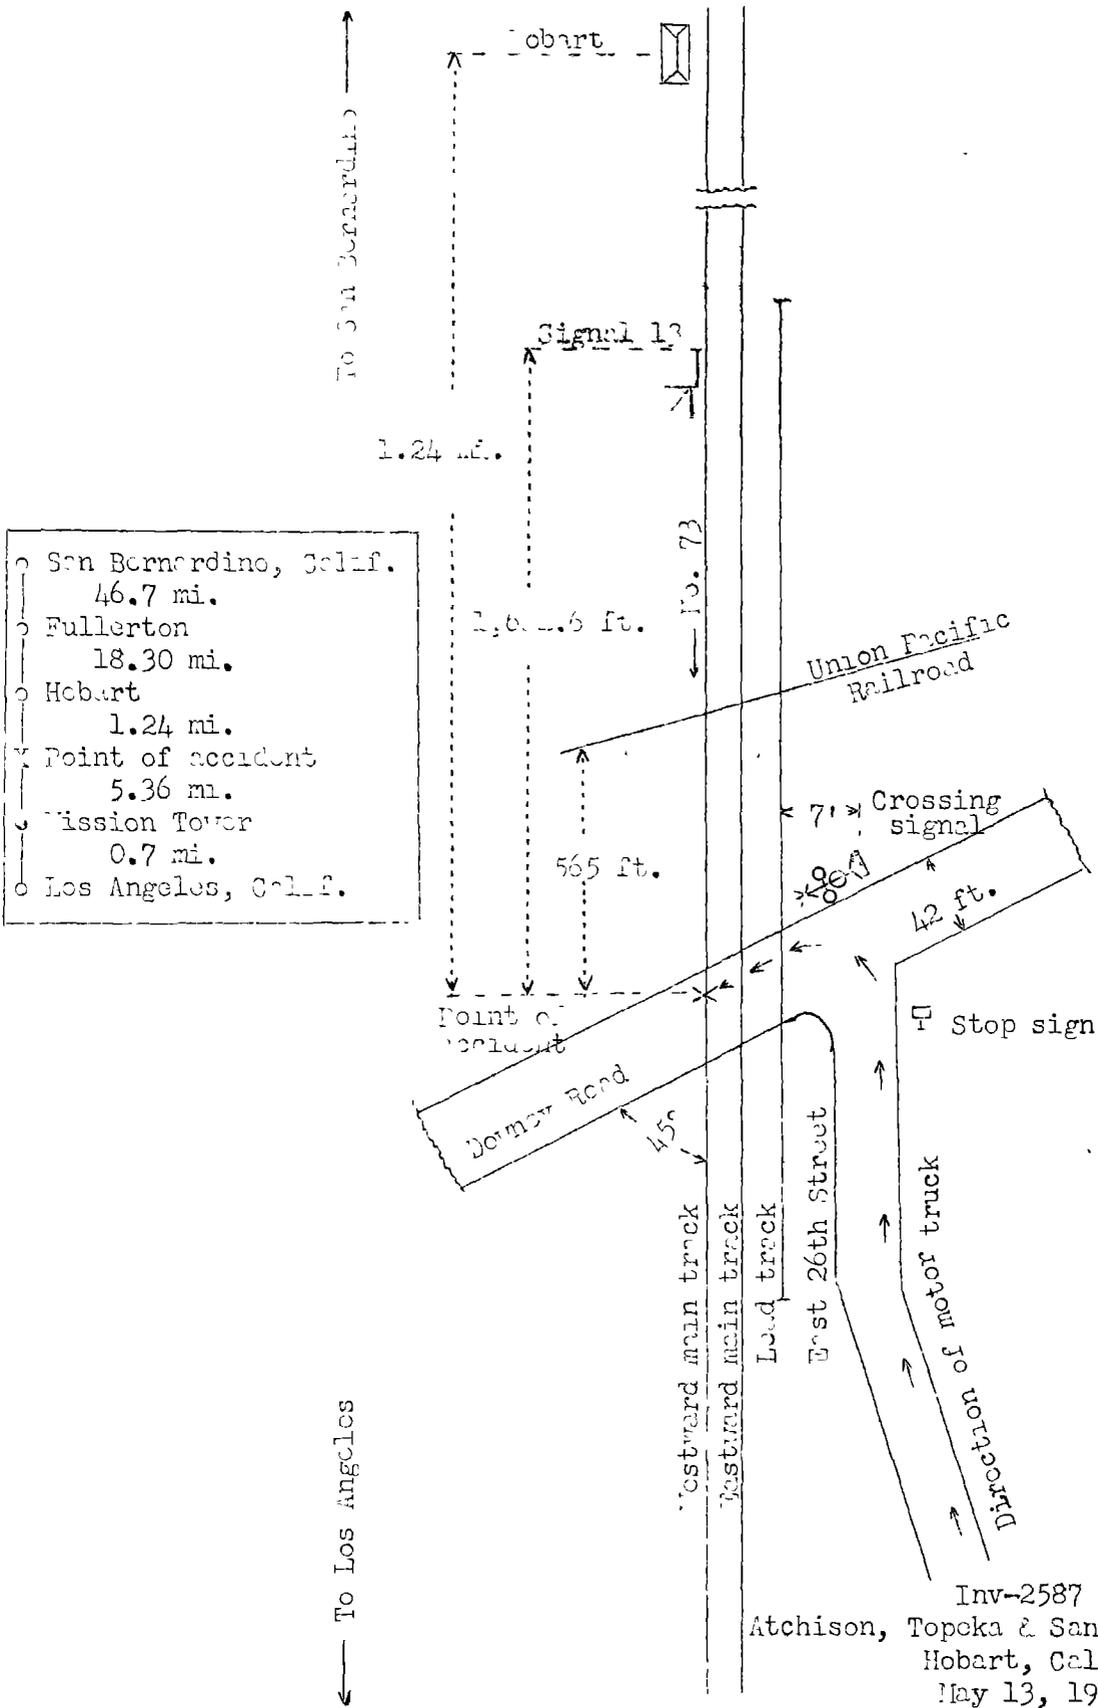
Location of Accident and Method of Operation

This accident occurred on that part of the Los Angeles Division designated as the Third District, which extends between San Bernardino and Los Angeles, Calif., a distance of 72.3 miles. In the immediate vicinity of the point of accident this is a double-track line over which trains are operated by timetable, train orders and an automatic block-signal system. The accident occurred on the westward main track at a point 1.24 miles west of the station at Hobart where the railroad is crossed at grade by Downey Road. At the point of accident a lead track parallels the two main tracks on the south. As the point of accident is approached from the east on the railroad the track is tangent approximately 1 mile to the point of accident and a considerable distance beyond. At the point of accident the grade for west-bound trains is 0.518 percent ascending.
