REPORT NO. 3546
THE ATCHISON, TOPEKA AND SANTA FE
RAILWAY COMPANY
IN RE ACCIDENT
AT MOORE, OKLA., ON
NOVEMBER 13, 1953

Accident at Moore, Okla., on November 13, 1953, caused by
a motor-truck occupying a rail-highway grade crossing
immediately in front of an approaching train.

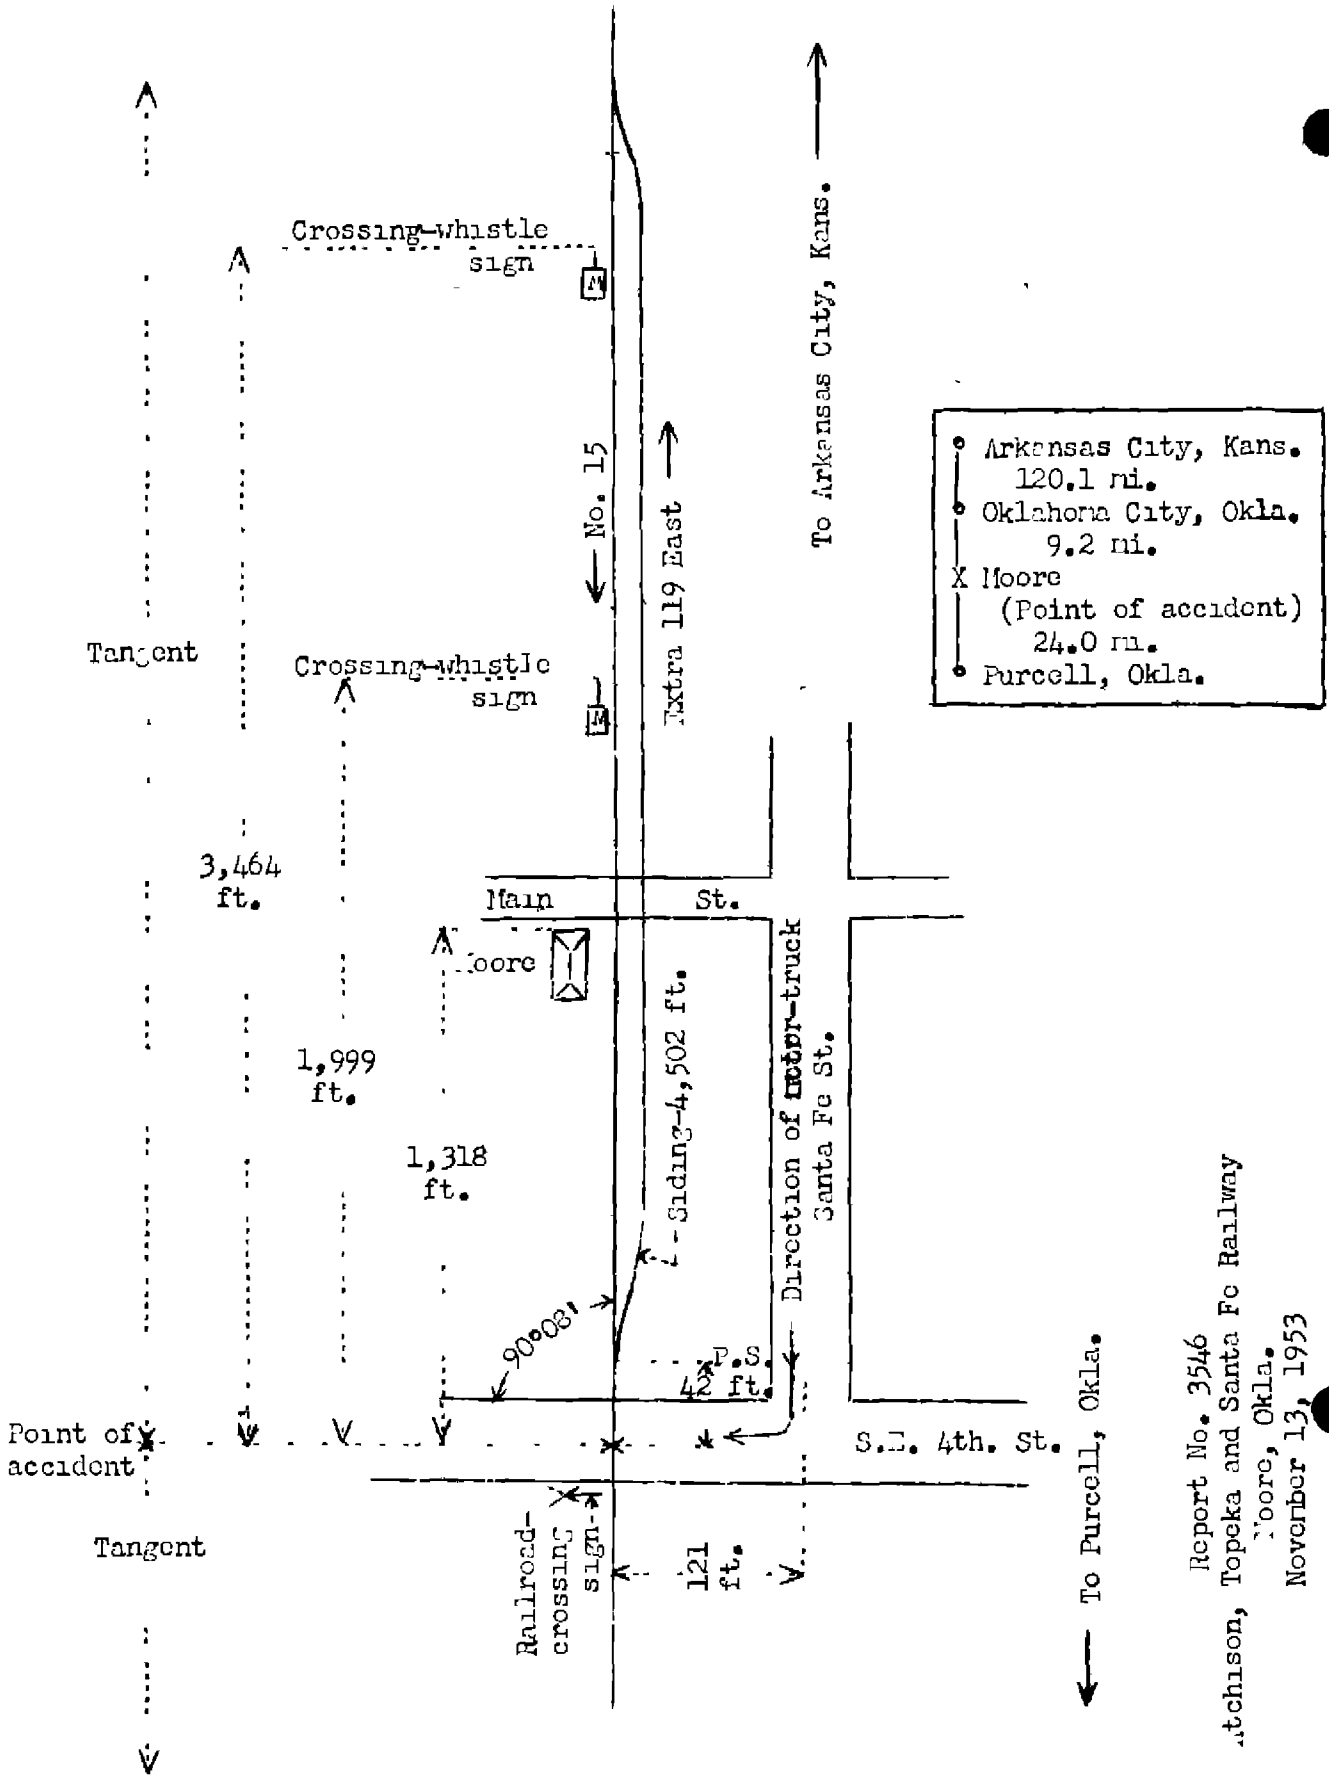
Report No. 3546
 Atchison, Topeka and Santa Fe Railway
 Moore, Okla.
 November 13, 1953

• Arkansas City, Kans.
 120.1 mi.
 • Oklahoma City, Okla.
 9.2 mi.
 X Moore
 (Point of accident)
 24.0 mi.
 • Purcell, Okla.
