INVESTIGATION NO. 2768
THE ATCHISON, TOPEKA & SANTA FE RAILWAY COMPANY
REPORT IN RE ACCIDENT
NEAR PEREA, N. MEX., ON
JANUARY 24, 1944

Accident near Perea, N. Mex., on January 24, 1944, caused
by failure properly to control the speed of the
following train in accordance with signal indications.

Inv. No. 2768
A. T. & S. F. Ry.
Perea, N. Mex.
January 24, 1944

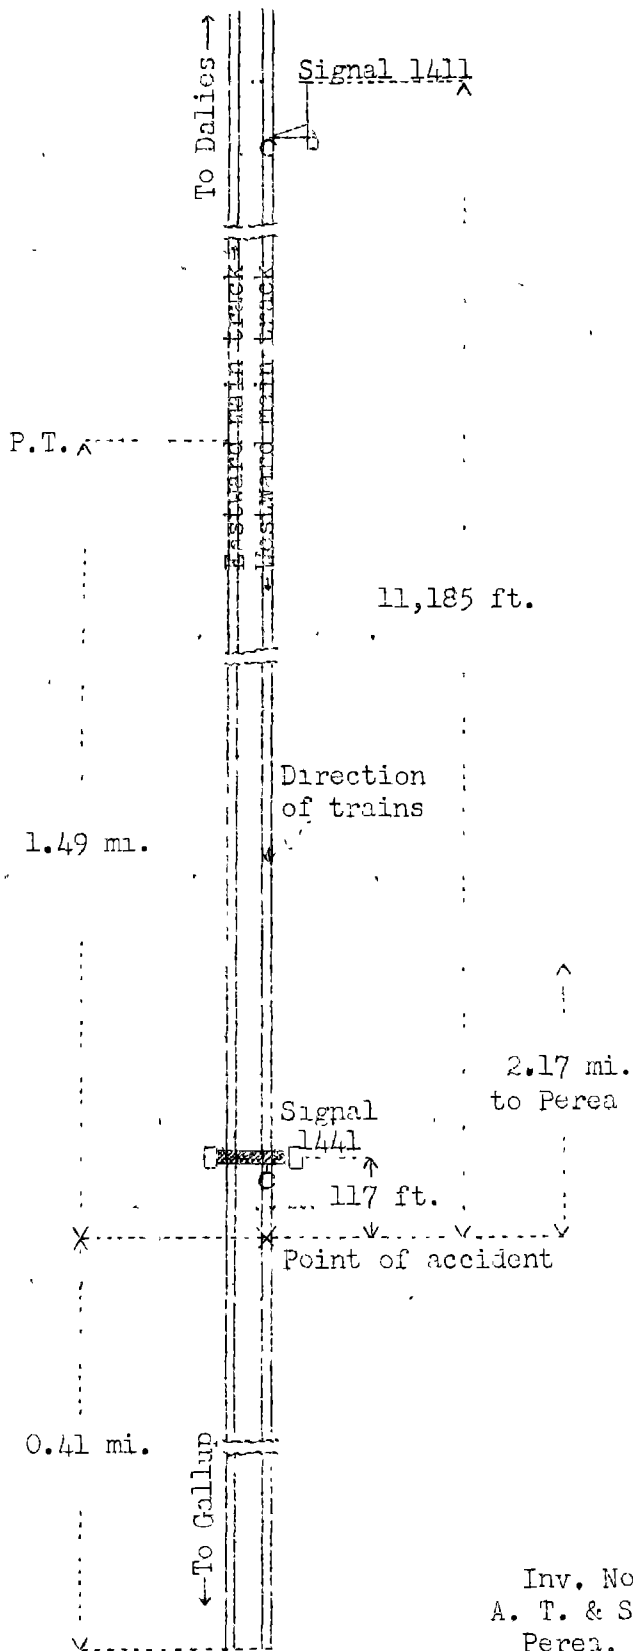
o	Dalies, N. Mex.	98.20 mi.
o	Thoreau	16.30 mi.
o	Perea	2.17 mi.
X	Point of accident	13.53 mi.
o	Gallup, N. Mex.

Location of Accident and Method of Operation
