REPORT OF THE DIRECTOR  
BUREAU OF SAFETY

ACCIDENT ON THE  
ATCHISON, TOPEKA & SANTA FE RAILWAY

PLAINES, ILLINOIS

INVESTIGATION NO. 2385

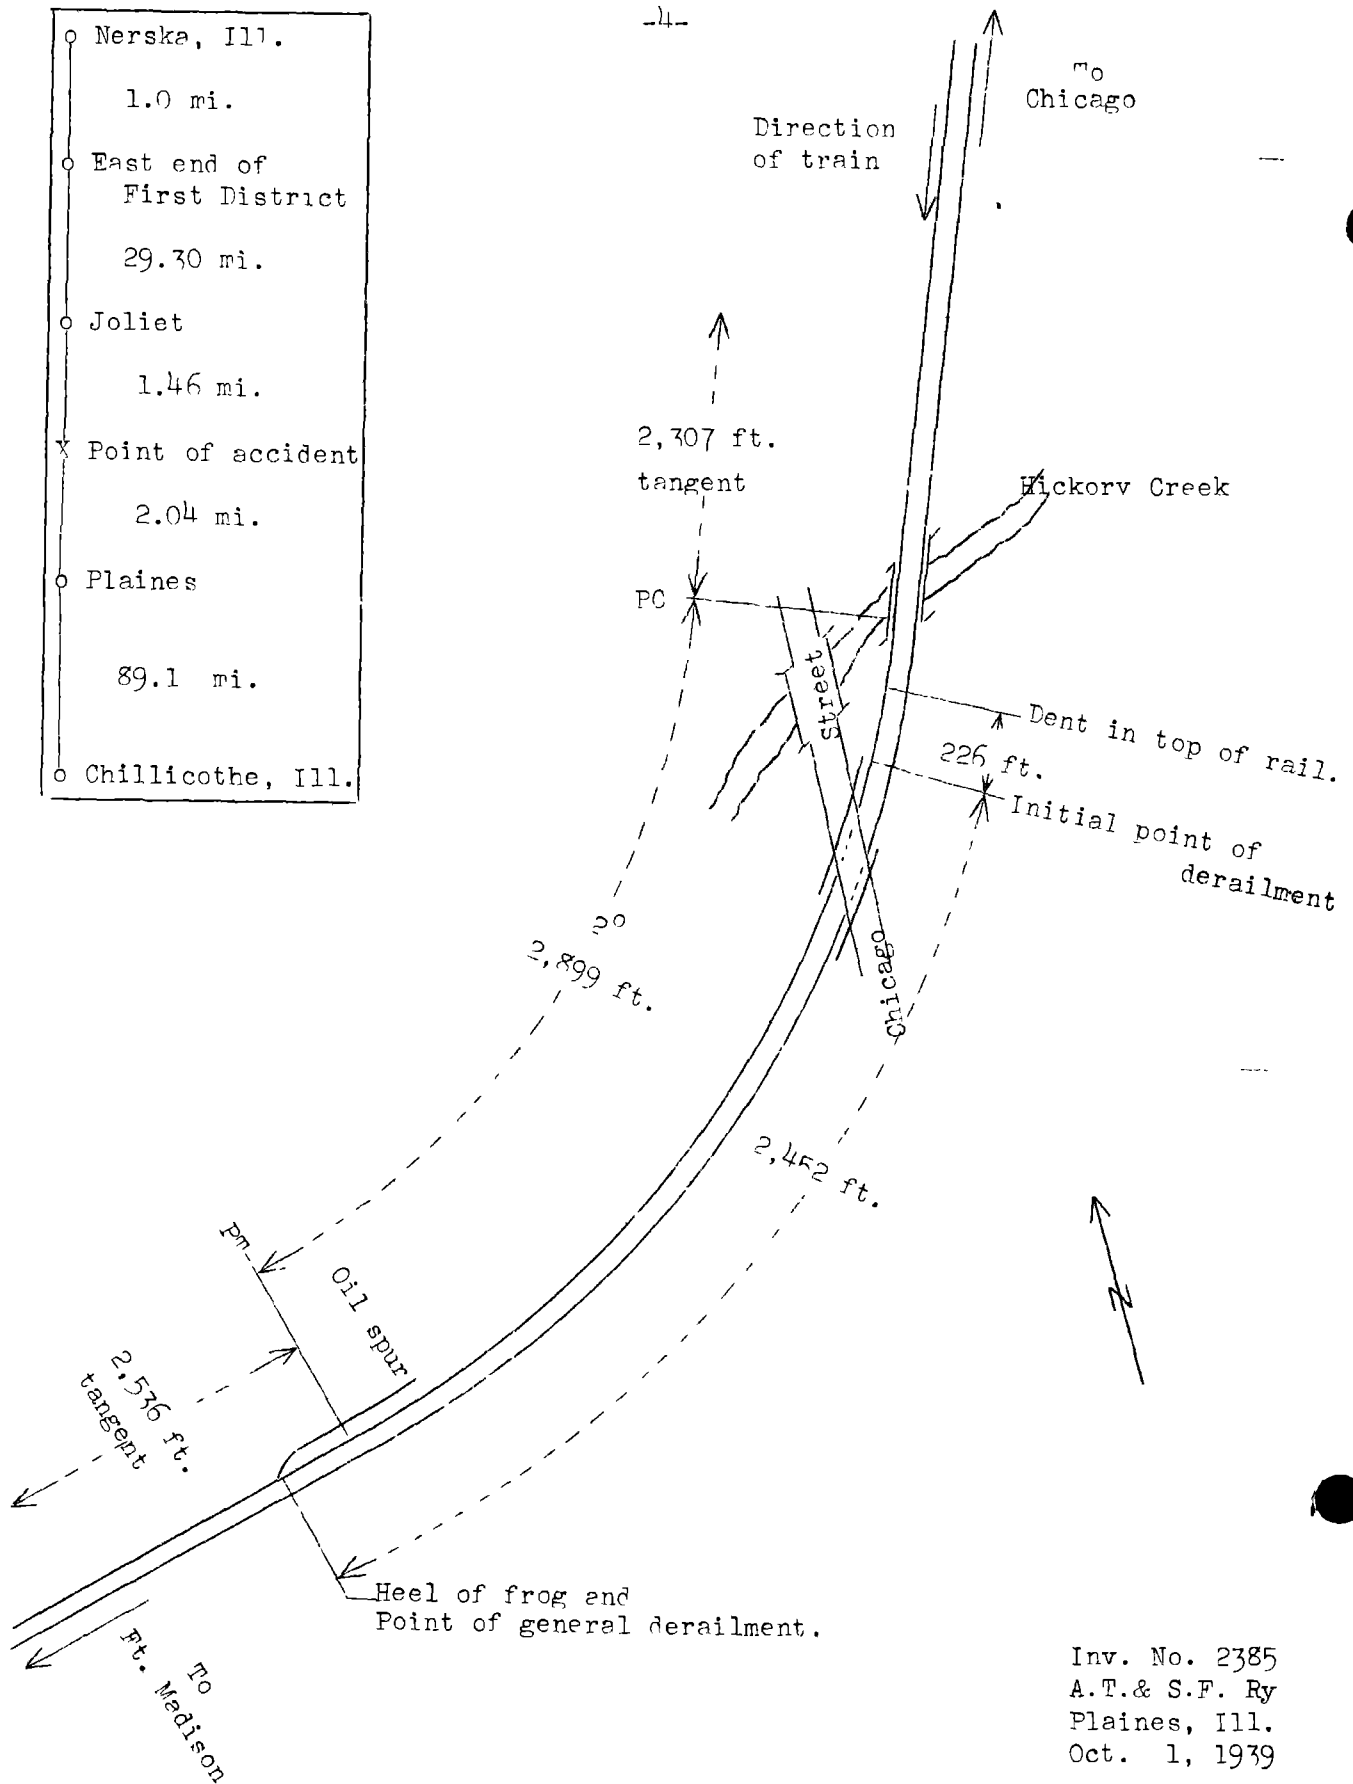
Inv. No. 2385  
 A.T. & S.F. Ry  
 Plaines, Ill.  
 Oct. 1, 1939

o Nerska, Ill.	
	1.0 mi.
o East end of First District	
	29.30 mi.
o Joliet	
	1.46 mi.
x Point of accident	
	2.04 mi.
o Plaines	
	89.1 mi.
o Chillicothe, Ill.

This accident occurred on that part of the Illinois Division designated as the First District which extends between Chillicothe and a point 1 mile west of Nerska, Ill., a distance of 121.9 miles. In the vicinity of the point of accident this is a double-track line over which trains are operated by timetable, train orders, and an automatic block system. The derailment occurred on the westward main track at a point 2.04 miles east of Plainos, and 1.46 miles west of Joliet. Approaching from the east there is a tangent 2,307 feet in length, which is followed by a 2° curve to the right 2,899 feet in length, including spirals; the initial derailment occurred 413 feet from the east end of this curve, at which point the superelevation is 4 inches. Beginning at the west end of the curve involved there is a tangent 2,535 feet in length, on which the general derailment occurred at the heel of a switch frog located 192 feet west of the east end of the tangent. The grade for west-bound trains is slightly descending, being 0.40 percent at the point of general derailment.
