## INTERSTATE COMMERCE COMMISSION

REPORT OF THE DIRECTOR OF THE BUREAU OF SAFETY CONCERNING AN  
ACCIDENT ON THE ATCHISON, TOPEKA & SANTA FE RAILWAY  
AT SAN BERNARDINO, CALIF., ON DECEMBER 29, 1933.

April 5, 1934.

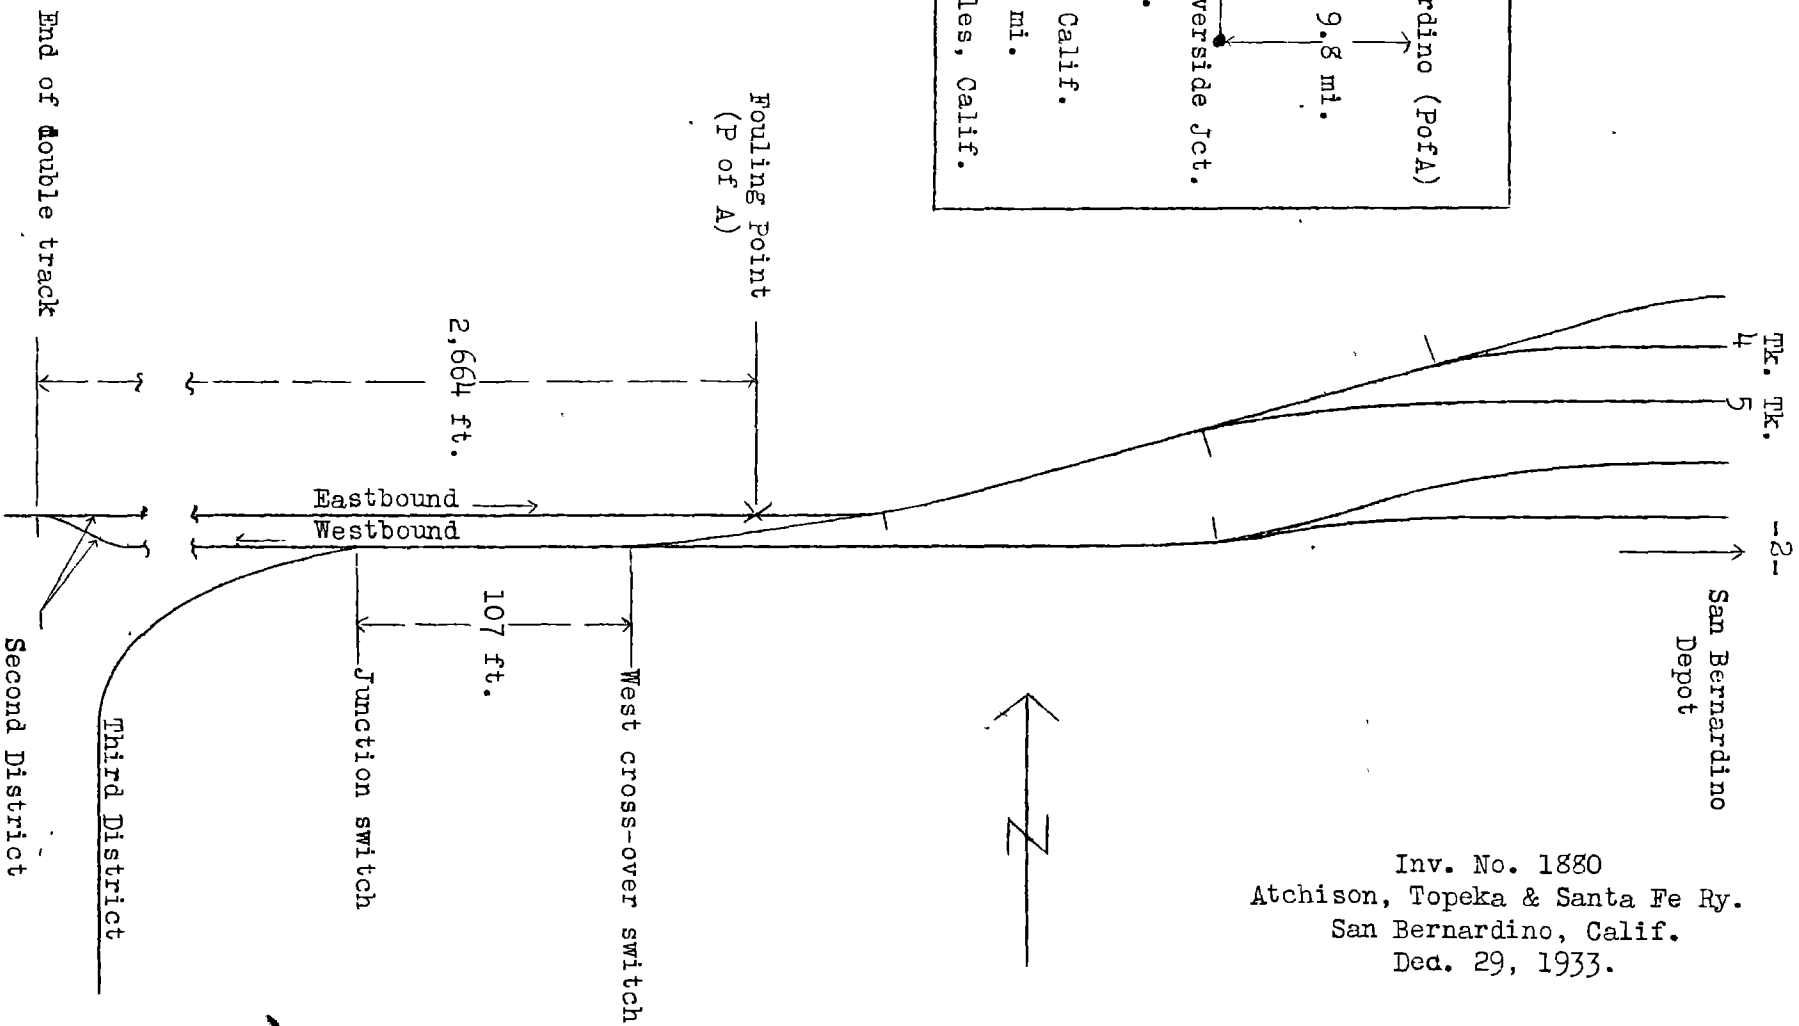
Inv. No. 1880  
 Atchison, Topeka & Santa Fe Ry.  
 San Bernardino, Calif.  
 Dec. 29, 1933.

This accident occurred within yard limits, just east of the junction point of the Second and Third Districts of the Los Angeles Division, at the western end of the station. All east-bound trains are required by special rule in the time table to stop at the junction of the Second and Third Districts, which also is the end of automatic block-signal territory, unless a proceed signal is received from the switch tender, this signal being given with a green flag or light to trains approaching on the Second District and with a yellow flag or light to trains approaching on the Third District; the various switches in the immediate vicinity are hand operated and not connected with the block signal system west of the station. There is no superiority of trains between the junction and a point near Fifth Street tower, 3,203 feet farther east, all trains and engines being required to move at restricted speed within these limits. There are two main tracks extending a short distance west from the station, trains running with the current of traffic keeping to the left, and the point of accident was at the fouling point of a cross-over between these tracks, the west switch of the cross-over being located 107.3 feet east of the junction switch. Approaching this point from the west on the Second District, the track is tangent for a distance of 5,500 feet, while the grade for 1,400 feet west of the point of accident is 1.22 percent descending for east-bound trains.
