INVESTIGATION NO. 2927

THE ATCHISON, TOPEKA AND SANTA FE
RAILWAY COMPANY

REPORT IN RE ACCIDENT

AT SANTA ANITA, CALIF., ON

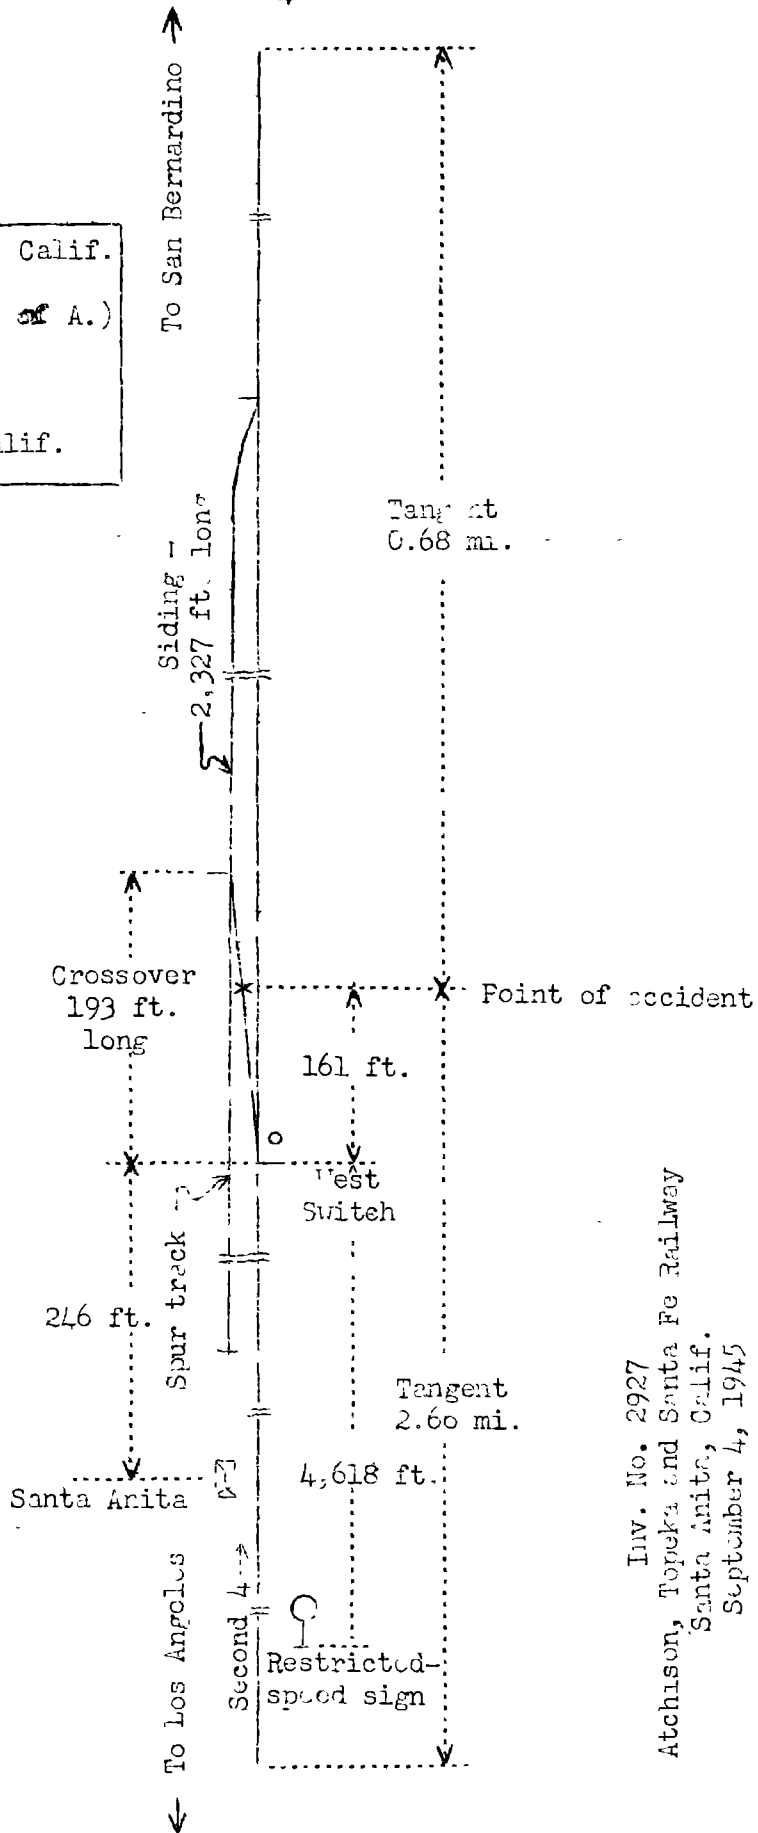
Inv. No. 2927
 Atchison, Topeka and Santa Fe Railway
 Santa Anita, Calif.
 September 4, 1945

- o San Bernardino, Calif.
44.5 mi.
- X Santa Anita (P. of A.)
2.2 mi.
- o Lamanda Park
13.1 mi.
- o Los Angeles, Calif.

Location of Accident and Method of Operation
