INTERSTATE COMMERCE COMMISSION

REPORT NO. 3703

THE ATCHISON, TOPEKA AND SANTA FE
RAILWAY COMPANY

IN RE ACCIDENT

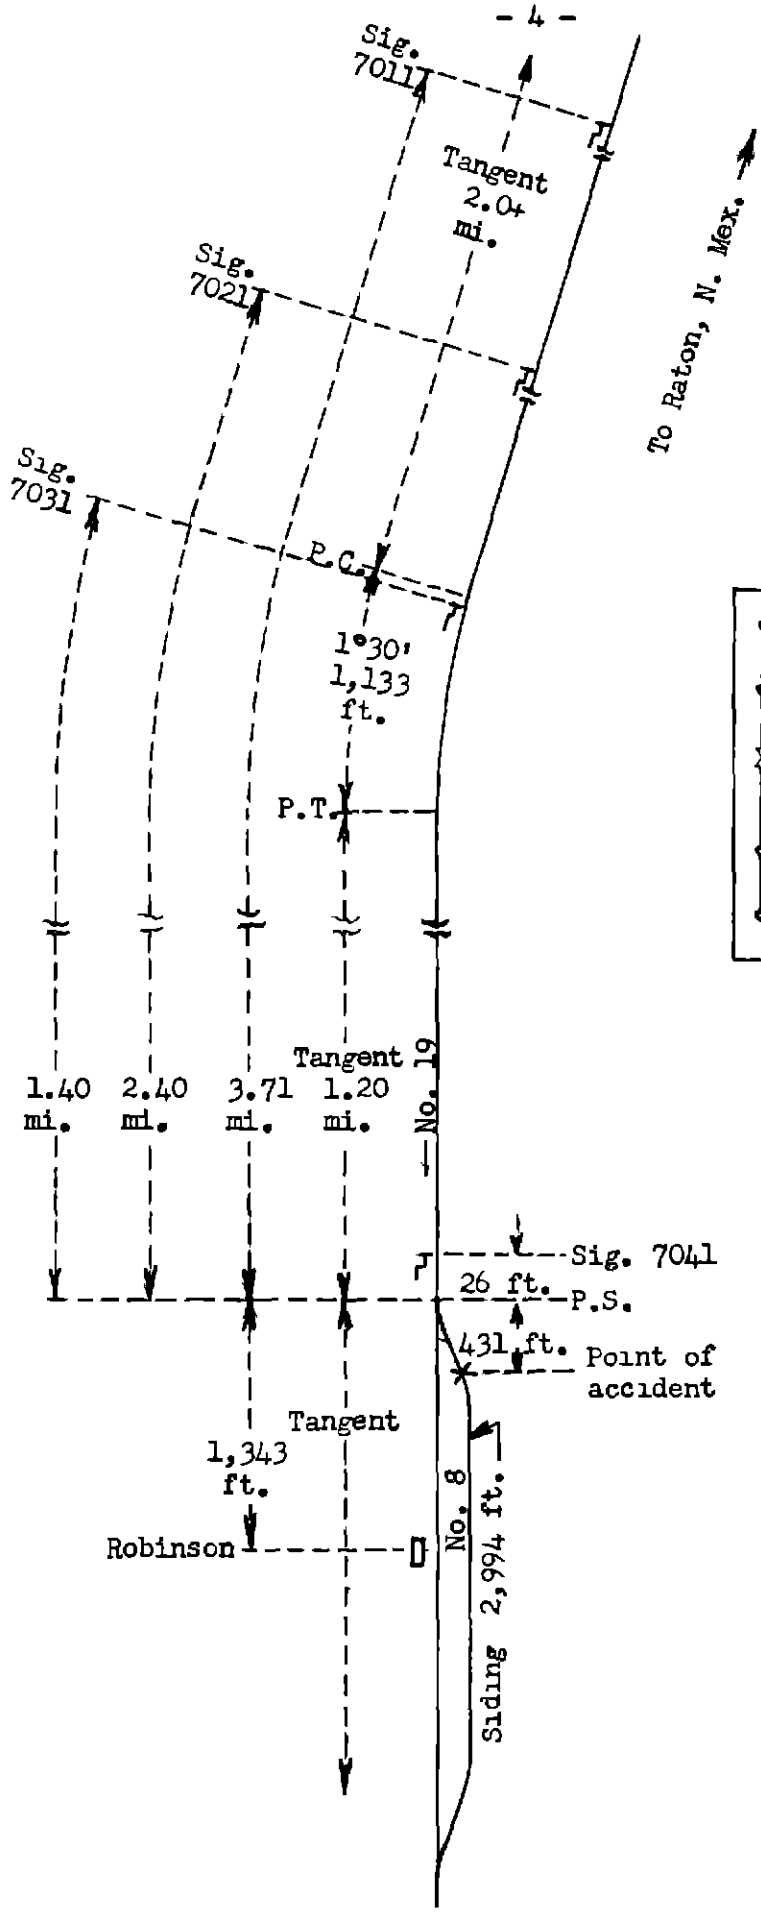
Report No. 3703
 Atchison, Topeka and Santa Fe Railway
 Robinson, N. Mex.
 Sept. 5, 1956

○	Raton, N. Mex.	39.6 mi.
○	Springer	6.1 mi.
X	Robinson	(Point of accident)
		20.0 mi.
○	Wagon Mound	44.1 mi.
○	Las Vegas, N. Mex.
