INVESTIGATION NO. 2733
THE ATLANTIC COAST LINE RAILROAD COMPANY
REPORT IN RE ACCIDENT
AT BELLEBLUFF, VA., ON
OCTOBER 17, 1943

Accident at Bellbluff, Va., on October 17, 1943, caused
by a broken rail.

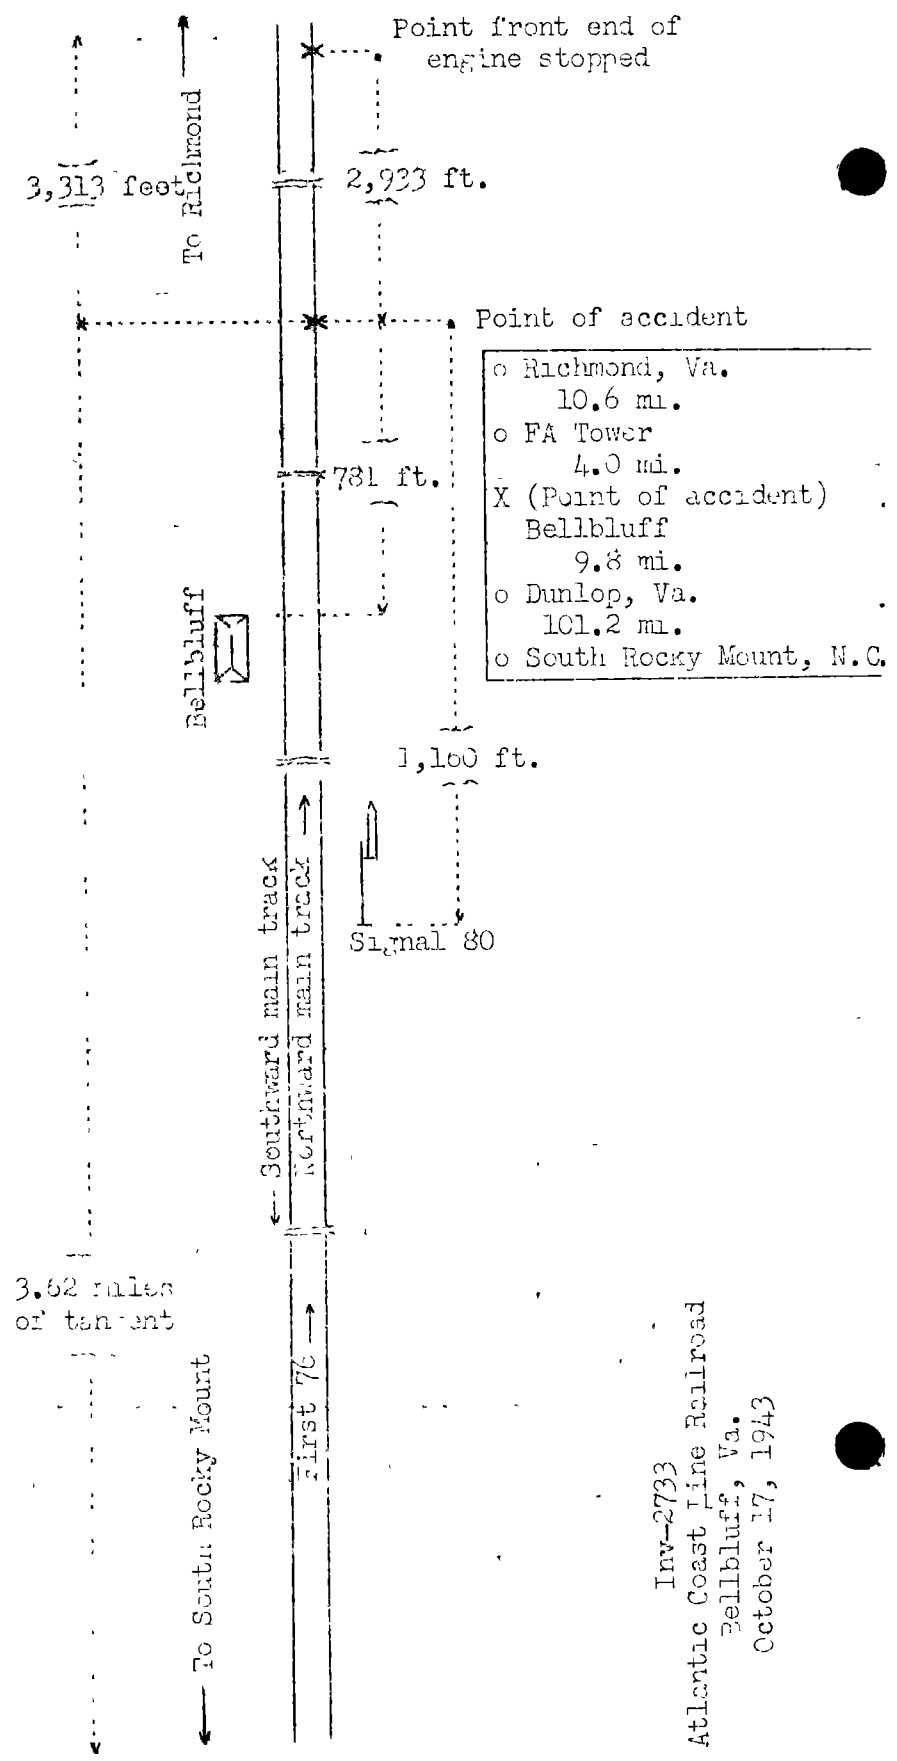
Inv-2733
 Atlantic Coast Line Railroad
 Bellbluff, Va.
 October 17, 1943

After the accident a broken rail was found on the west side of the track. The rail was broken into many pieces, 13 of which were recovered. These pieces were scattered throughout a distance of 540 feet north of the point of accident. The first break occurred midway between two ties at a point 14 feet 8 inches north of the receiving end of the rail. The ends of the pieces at this break were battered downward at an angle of about thirty degrees. The adjacent ends of the pieces at the third break, 5 feet 11 inches northward, were battered considerably.

A flange mark appeared on the receiving end of the rail at this break. Breaks Nos. 2, 4, 5, 6 and 7 apparently were the result of the derailment. At the first break there was a progressive detail fracture covering about 12 percent of the cross-sectional area of the head and extending to the outside edge of the head about 1/2 inch below the top of the rail. In this portion of the fracture the metal was darkened by oxidation, which condition indicated that the rail had been defective for some time prior to the accident. The ends of the pieces at this break had been polished by friction; therefore, the exact extent of the fracture could not be determined, but most of the head of the rail, the web, and the base indicated new break. This fracture occurred beneath a rail burn caused by the slipping of driving wheels, and it extended inward from the outside edge 1-5/8 inches and was approximately 1/8 inch deep. Breaks Nos. 1, 2, 3, 5 and 6 occurred at points where rail burns existed. There were also two other rail burns on the piece which was 14 feet 8 inches long. Using a standard rail-bending device, tests were conducted to determine the strength of this piece of rail at the two rail burns. The first test was made at a point 5 feet 2 inches north of the receiving end, and the rail broke easily. A fracture existed at this point but it did not extend to the outer surface. The second test was made 12 feet 3-1/2 inches north of the receiving end, and the rail cracked under a deflection of 1/2 inch, and broke under a deflection of 5/8 inch. At this burn a crack 1-1/2 inches long started at a point 1/4 inch below the top of the rail, extended diagonally downward at an angle of 15 degrees, and stopped 1/4 inch south of the point of fracture. At the point of fracture there was a burn extending inward from the outside edge 1-1/4 inches and downward to a depth of 3/8 inch. Below this burn a horizontal crack started at the outside surface of the head and extended inward 1-1/2 inches. Immediately below the horizontal crack there was a progressive fracture, half-moon in shape, 3/4 inch wide and 3/8 inch deep. The outer edge of this fracture was about 1/4 inch inward from the outside edge of the head.
