REPORT NO. 3511
ATLANTIC COAST LINE RAILROAD COMPANY
IN RE ACCIDENT
AT FLEMING, GA., ON
JANUARY 17, 1953

Accident at Fleming, Ga., on January 17, 1953, caused by
failure to operate train No. 8 in accordance with
signal indications.

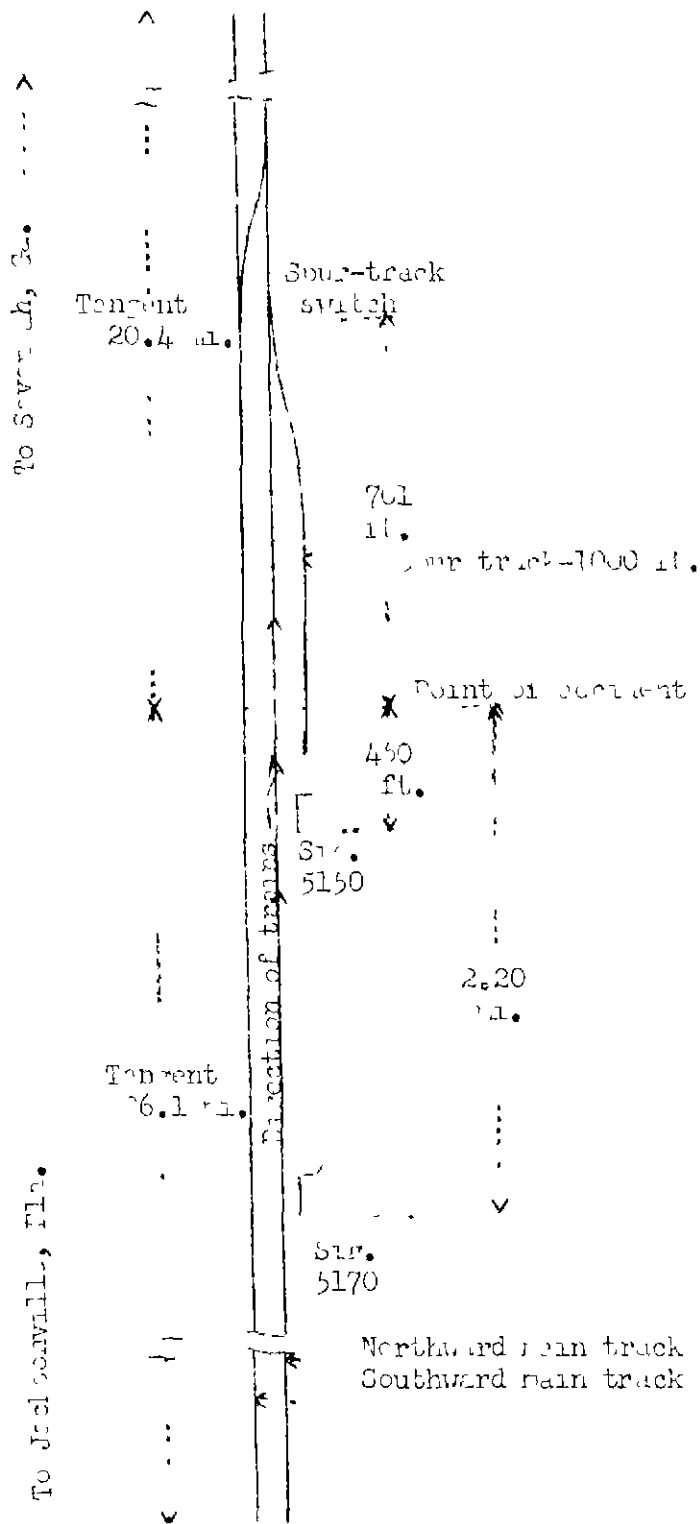
Report No. 2511
 Atlantic Coast Line Railroad
 Fleming, Ga.
 January 17, 1933

- Savannah, Ga.
- 11.2 mi.
- Burroughs
- 8.3 mi.
- Daniel
- 4.6 mi.
- Fleming
- (Point of accident)
- 14.0 mi.
- Waltherville
- 7.7 mi.
- Ludwick
- 6.4 mi.
- Docturborn
- .5 mi.
- Jasper, Ga.
- 25.2 mi.
- Jacksonville, Fla.
